Report on the investigation of  
the starboard boiler explosion resulting in  
one fatal and one serious injury on board the  
Liquid Natural Gas tanker

***Hilli***

10 October 2003

**Report No 4/2007**  
**March 2007**

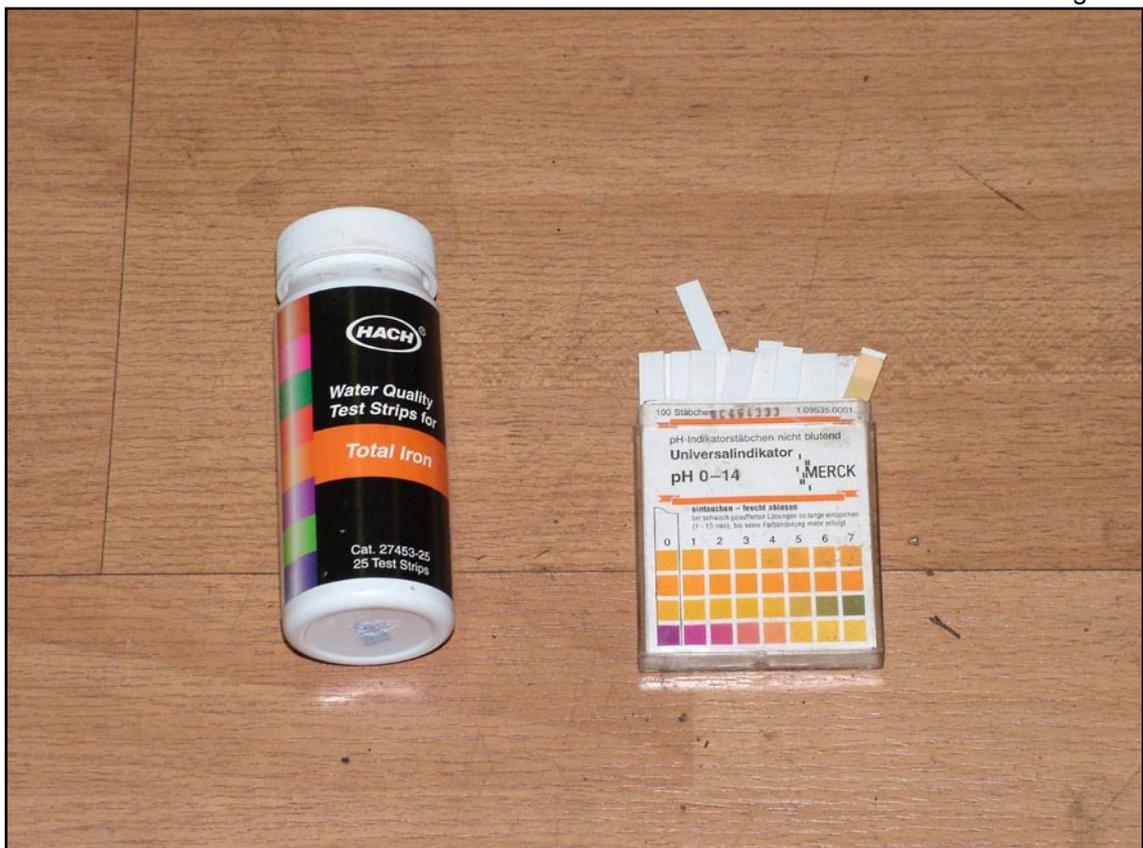
Figure 5

Fe and pH test equipment

The overseer used dissolved iron comparator strips (**Figure 5**) to give a check on the progress of the chemical clean. A constant level, rather than an increase, of dissolved iron in the cleaning fluid provided an indication that no more corrosion products were being removed from the boiler. However, this interpretation relied on the cleaning fluid being of sufficient acidity and the inhibitor being fully effective throughout the cleaning process.

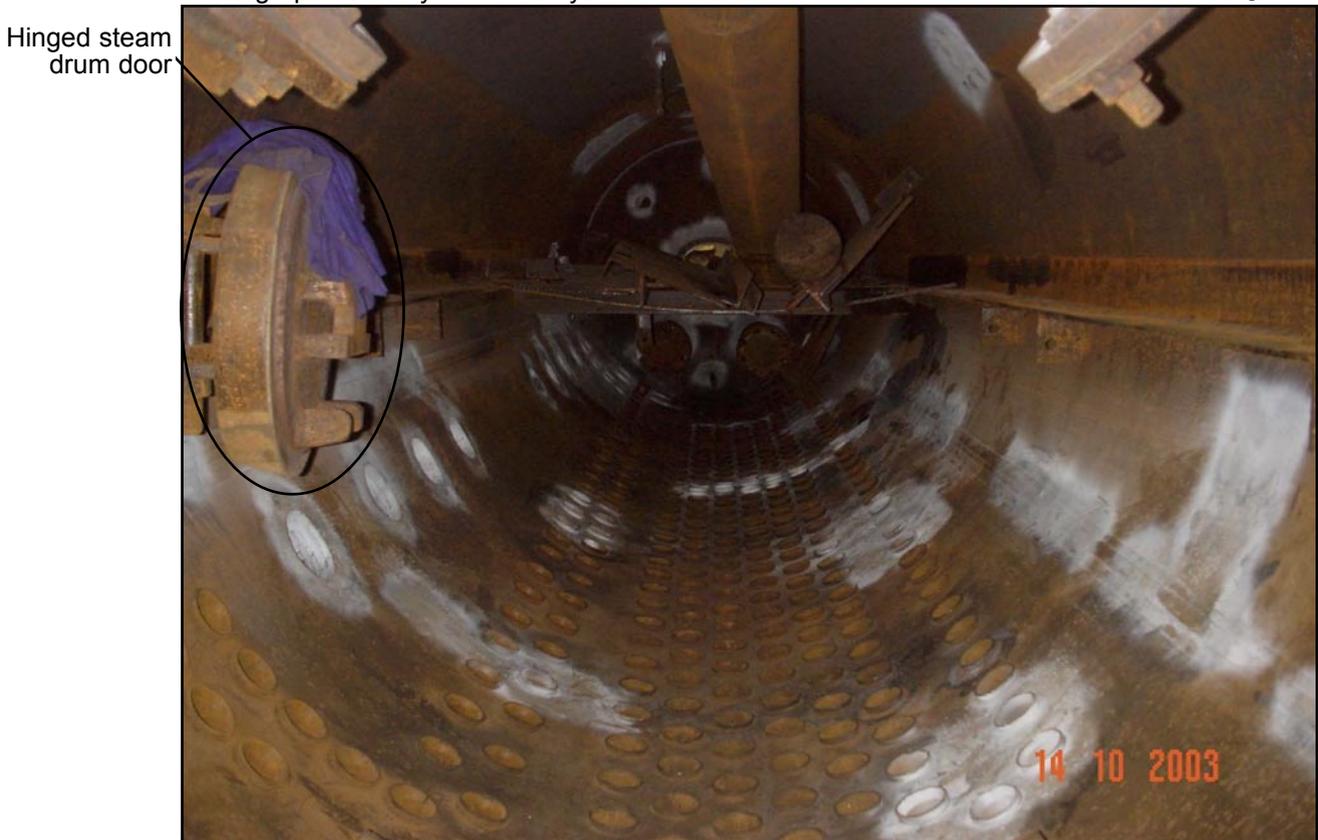
Figure 8

Starboard boiler – open steam drum

At 2200 Mr Walton and the overseer approached the opened steam drum. The overseer was surprised that the boiler room ventilation fans were not running and there appeared to be no method of forced ventilation to purge the steam drum of gases. However, he did not say anything to Mr Walton about his concerns. Both men looked into the steam drum and noticed that the internal surface was clear of scale and corrosion products. Neither Mr Walton nor the overseer had any equipment with them to test for the presence of toxic or flammable gases in the steam drum.

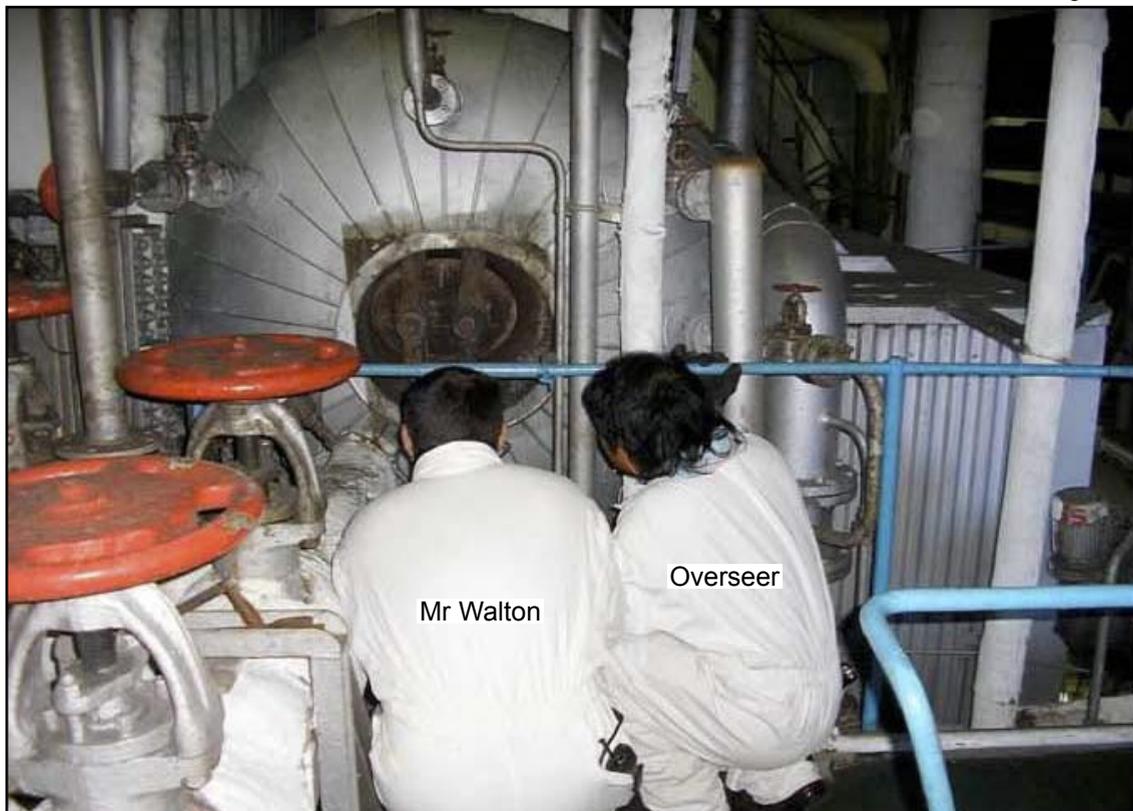
Figure 9

Re-enactment of Mr Walton's and the overseer's positions in front of the starboard boiler steam drum immediately prior to the explosion

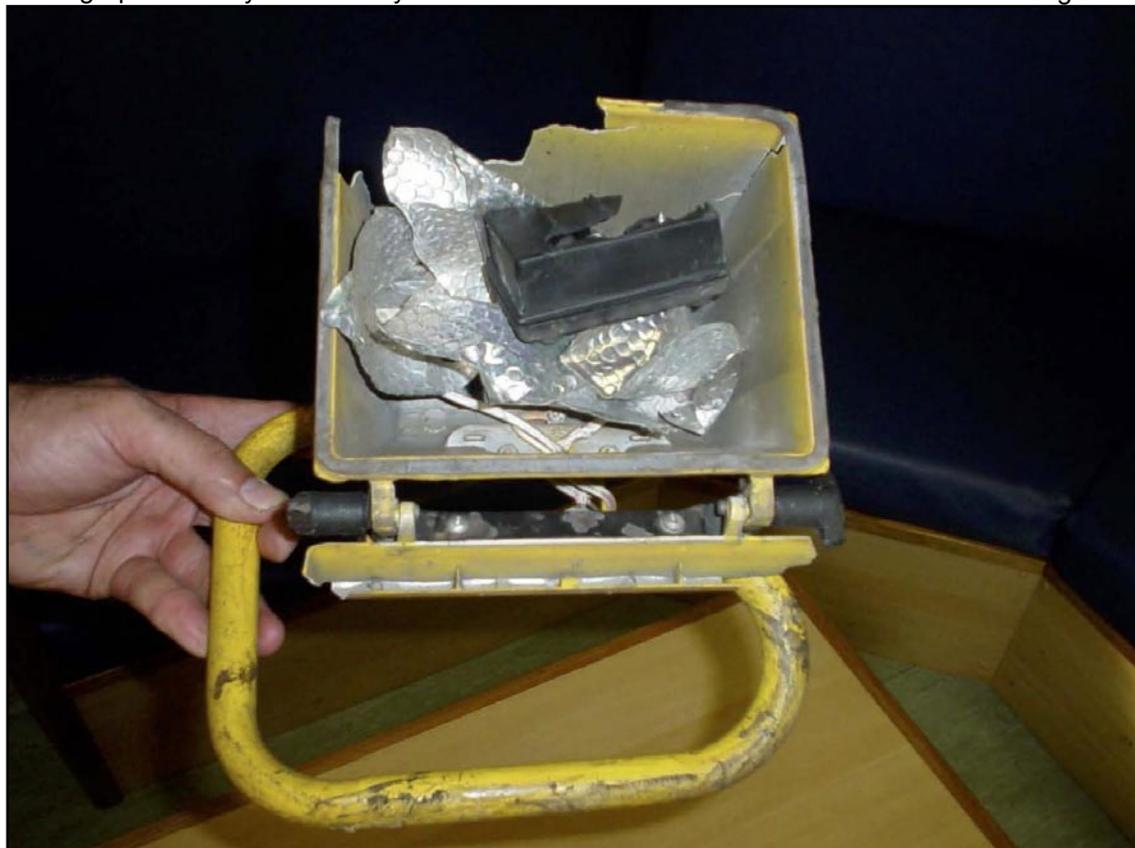
Figure 10

The Technical Superintendent noticed the now badly damaged halogen lamp and saw that its lens was missing (**Figure 10**). He also observed that the area was hot, and there was a slight haze, but there were no obvious, unusual smells. With the exception of a very small paper fire, and barely noticeable scorching of a small area of paintwork, there was no other evidence of explosion or fire.

Damaged halogen lamp

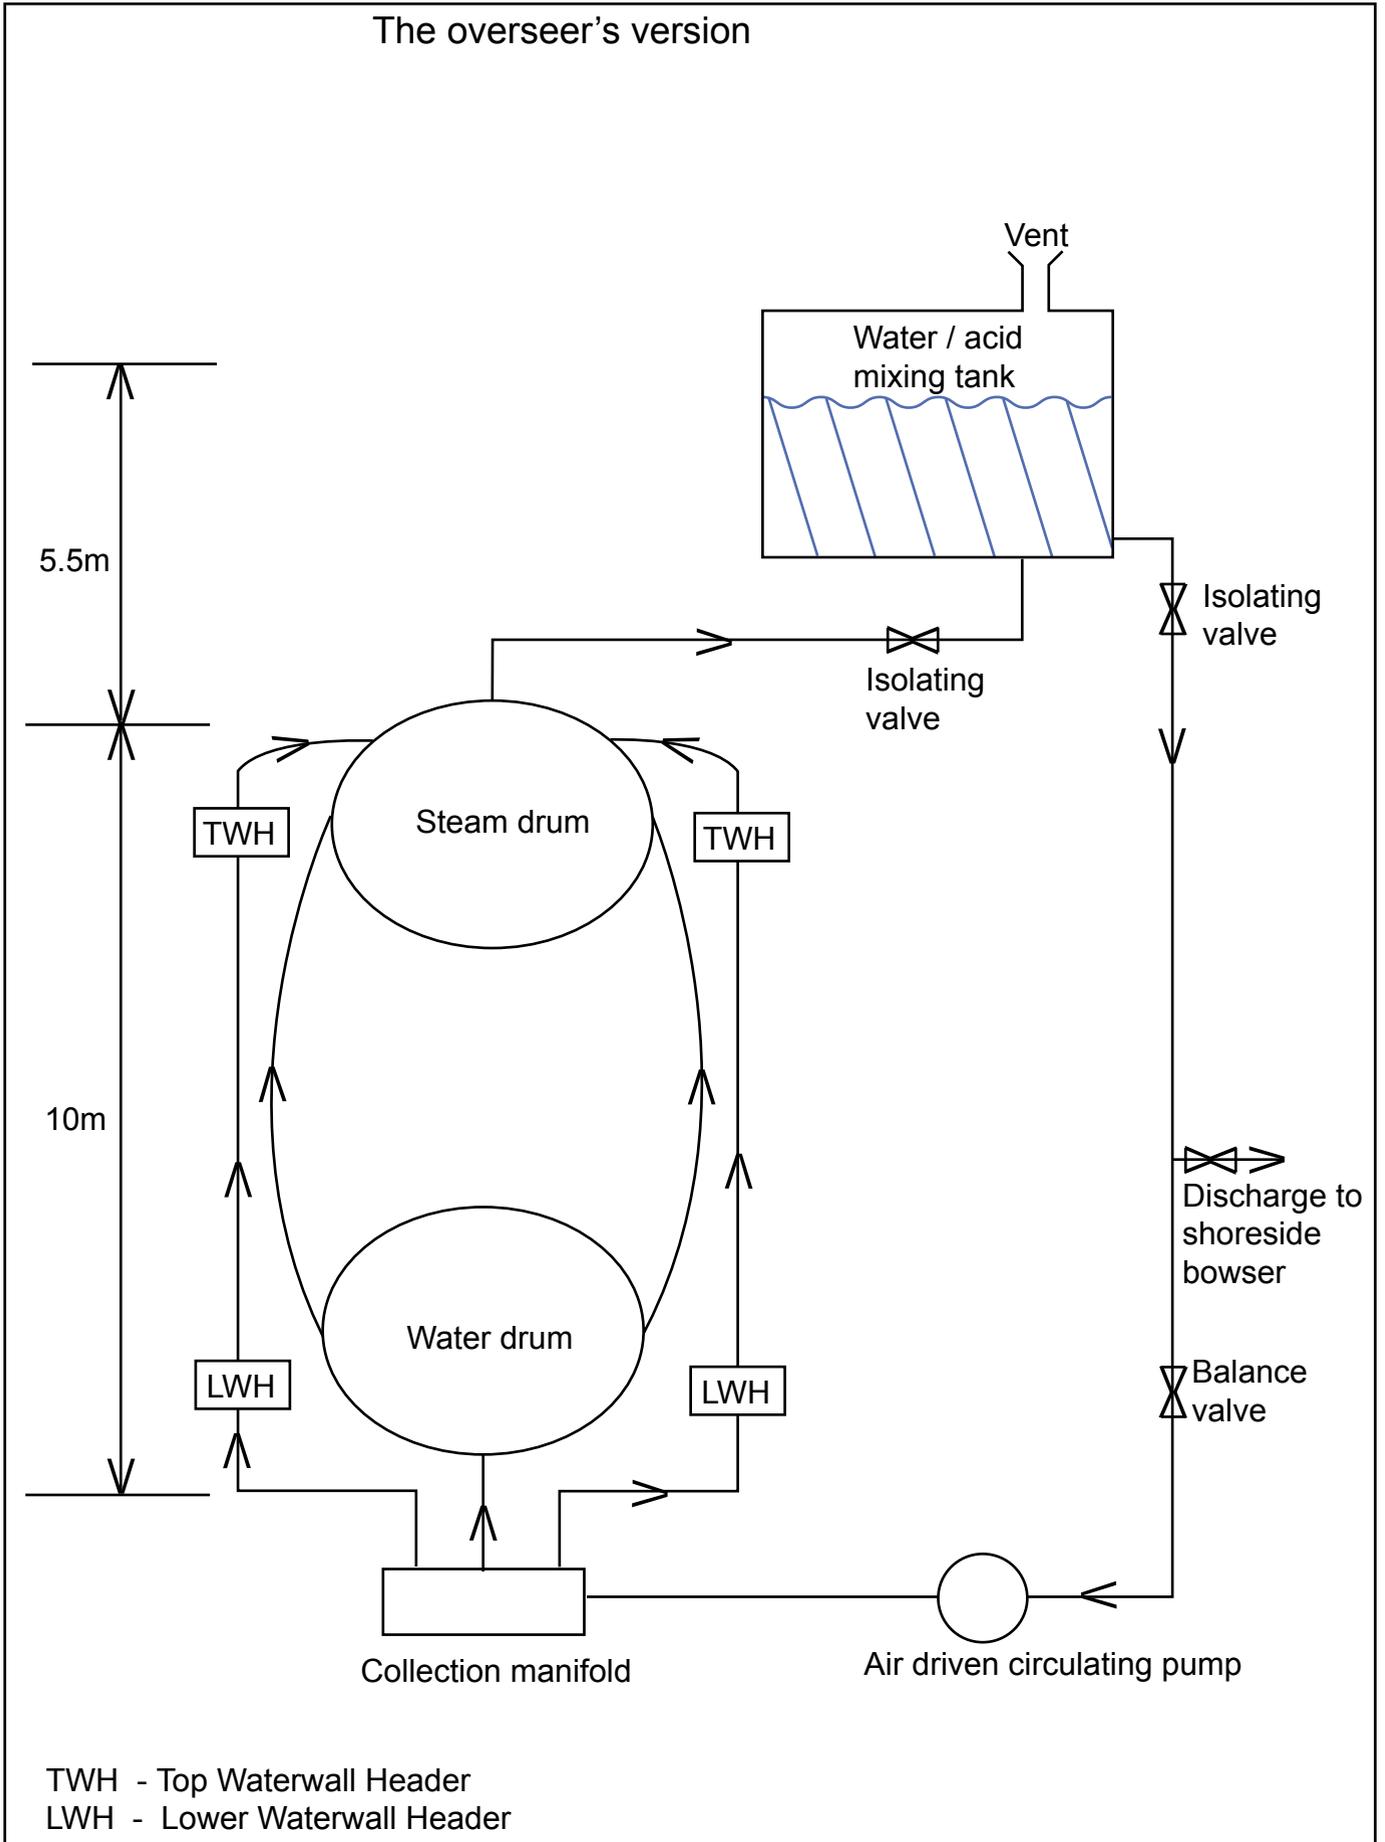
There are only two probable connections that would have been made to ventilate the boiler. The first would have entailed connecting a flexible hose to the second safety valve's 100mm bore flange (**Figure 12**) on the steam drum, and leading it to a position on the upper deck. This is considered unlikely. Most of those interviewed could remember only one hose fitted to the safety valves, and this would have been the gravity feed hose from the water/acid mixing tank.

Schematic of the overseer's interpretation of the boiler cleaning water/acid circulation

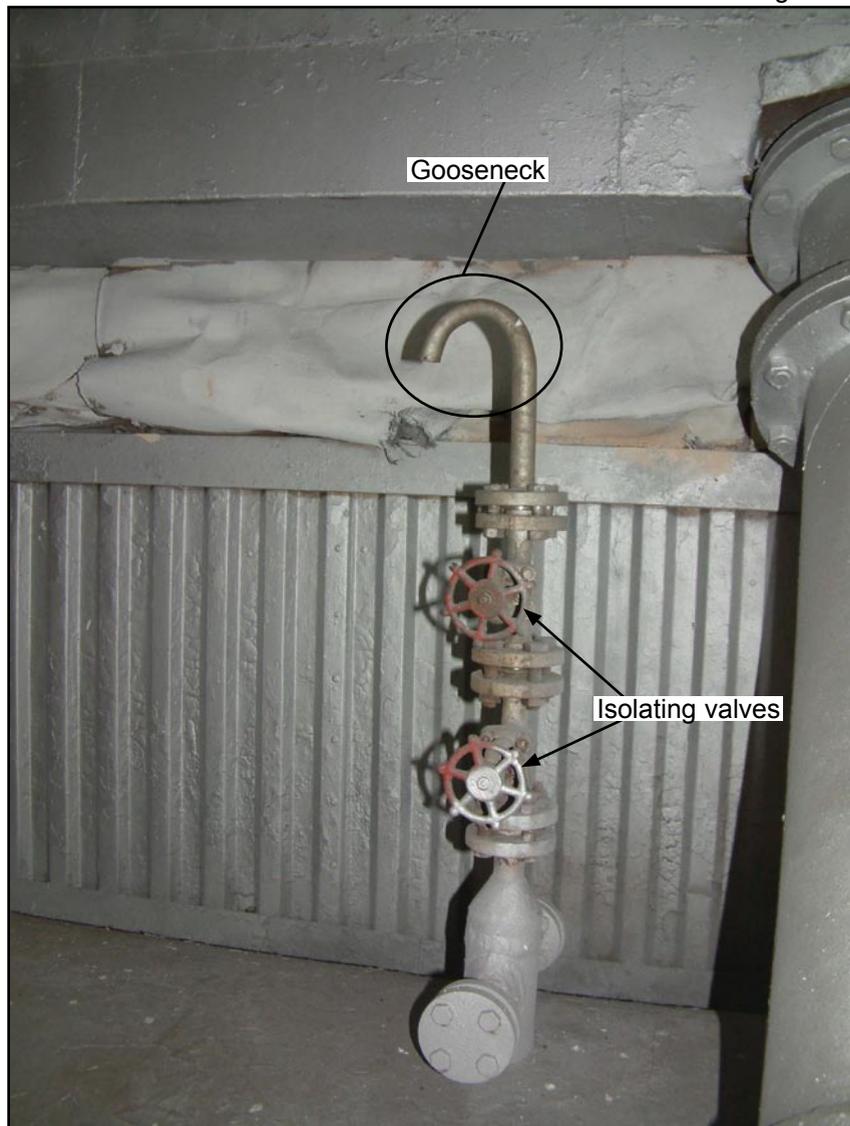
The only other likely option would have been to connect a small bore hose to the steam drum air release cock arrangement (**Figure 16**). This could have been fitted either to the goose neck, or directly to one of the flanges if the goose neck had been removed. In each case, the hose would have been led vertically, and secured, to allow the gases to escape to atmosphere.

Starboard boiler – steam drum air cock arrangement

Had a hose been connected, there are a number of reasons why this might have been ineffective: the internal bore of the air release pipework was small, at 20mm; it was possible that it was of insufficient bore, even if unobstructed, to carry away the volume of gases being generated; it might have been that Mr Walton simply overlooked opening one or both of the valves; it was possible that the hose collapsed because of poor securing arrangements, causing the hose to “crimp” and create a blockage that prevented ventilation; and finally, a door might have been closed on the hose, or another object inadvertently placed on it, causing a restriction.
