Report on the investigation of
the grounding of the
inter-island passenger vessel

Trident VI

in Percée Passage, off Herm Island
near Guernsey in the Channel Islands

**Report No 01/2004
January 2004**

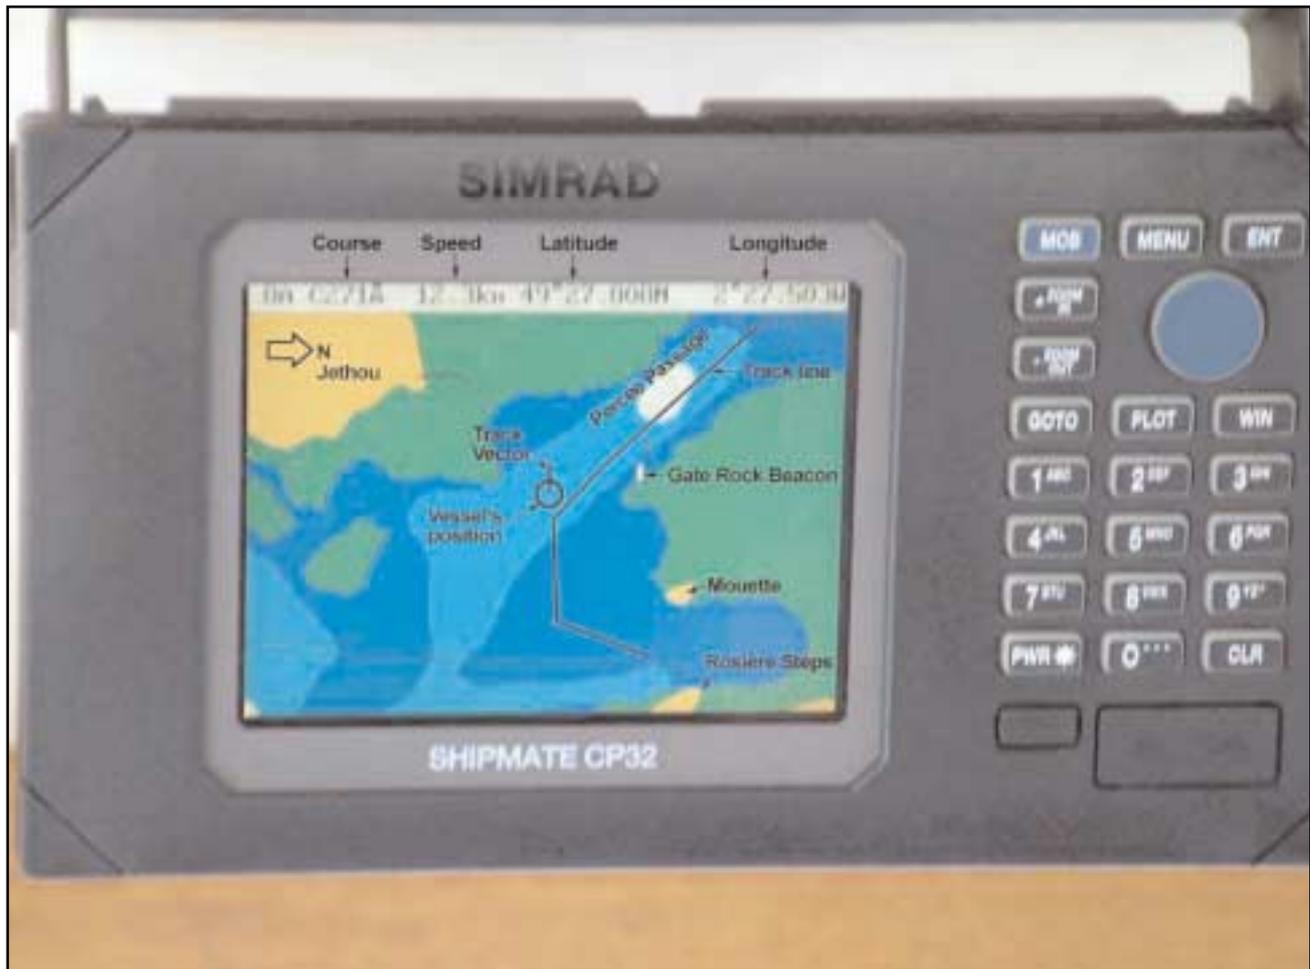
Once on course, the skipper found that the vessel was to port of the track shown on the GPS/electronic chart plotter, and too close to the rocks on that side (**see photograph 2**). The lights on the compass and the rudder indicators were not illuminated. The vessel was on full speed, to gain maximum steerage response.

Trident V's chart plotter and her position in relation to the track line, which was similar to that of *Trident VI's* after leaving Rosière Steps for St Peter Port

Having made the turn, he found that, from observations of the radar and the plotter, the vessel was to the port of the centre track-line on the electronic chart of the narrow channel (**see photograph 2**). It is not unusual for any vessel making such a large alteration as 130° into a narrow channel, to steady initially to one side or another of the centre line.

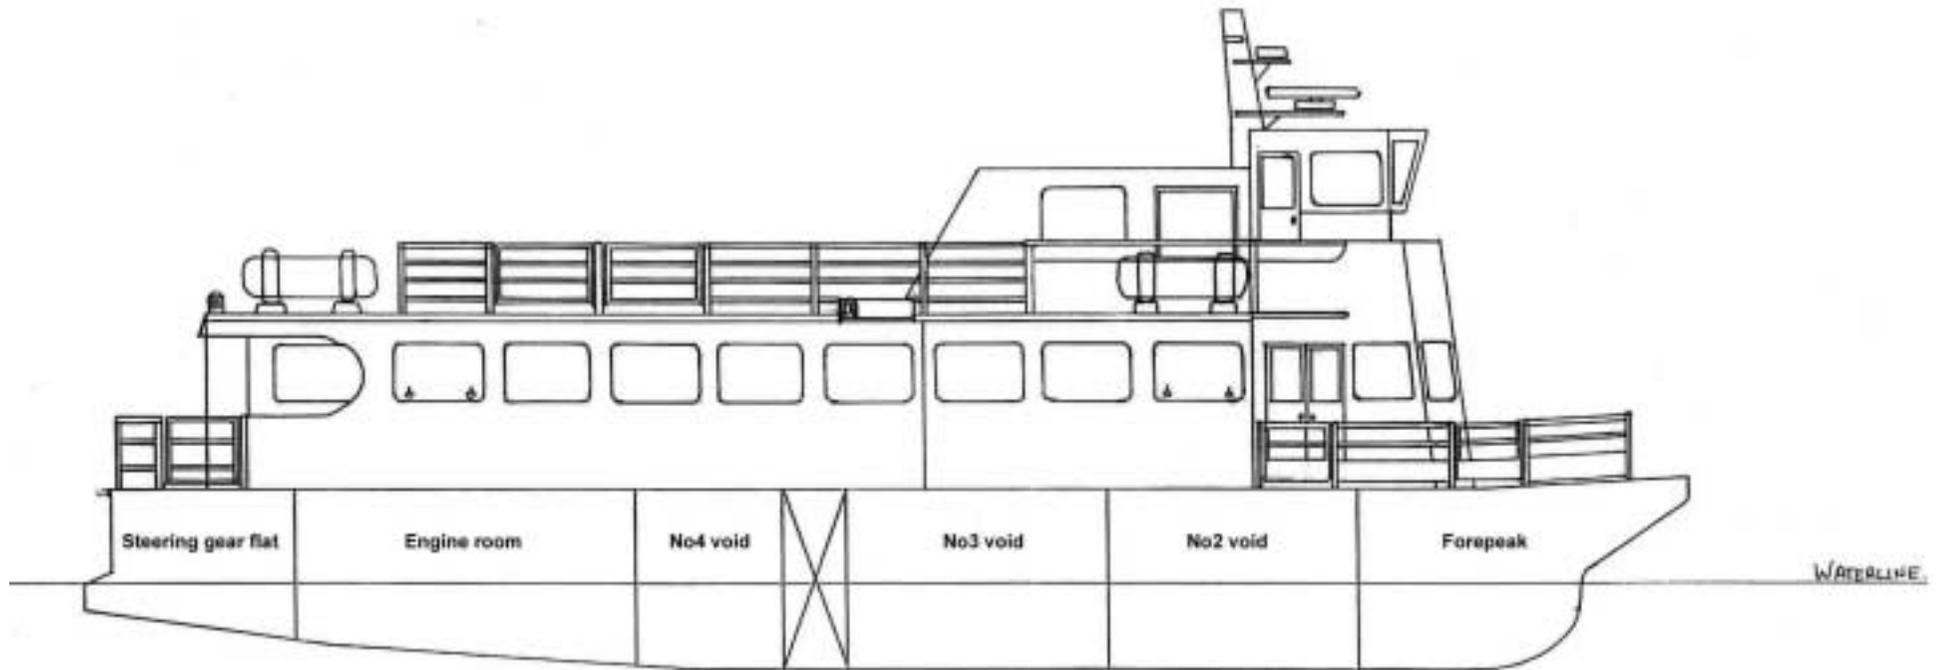
Once the passengers had been evacuated from *Trident VI*, the crew checked the void spaces and found the forward three compartments in the port hull were open to the sea (**see Figure 2**).

A profile of *Trident VI* showing the subdivision of the hulls

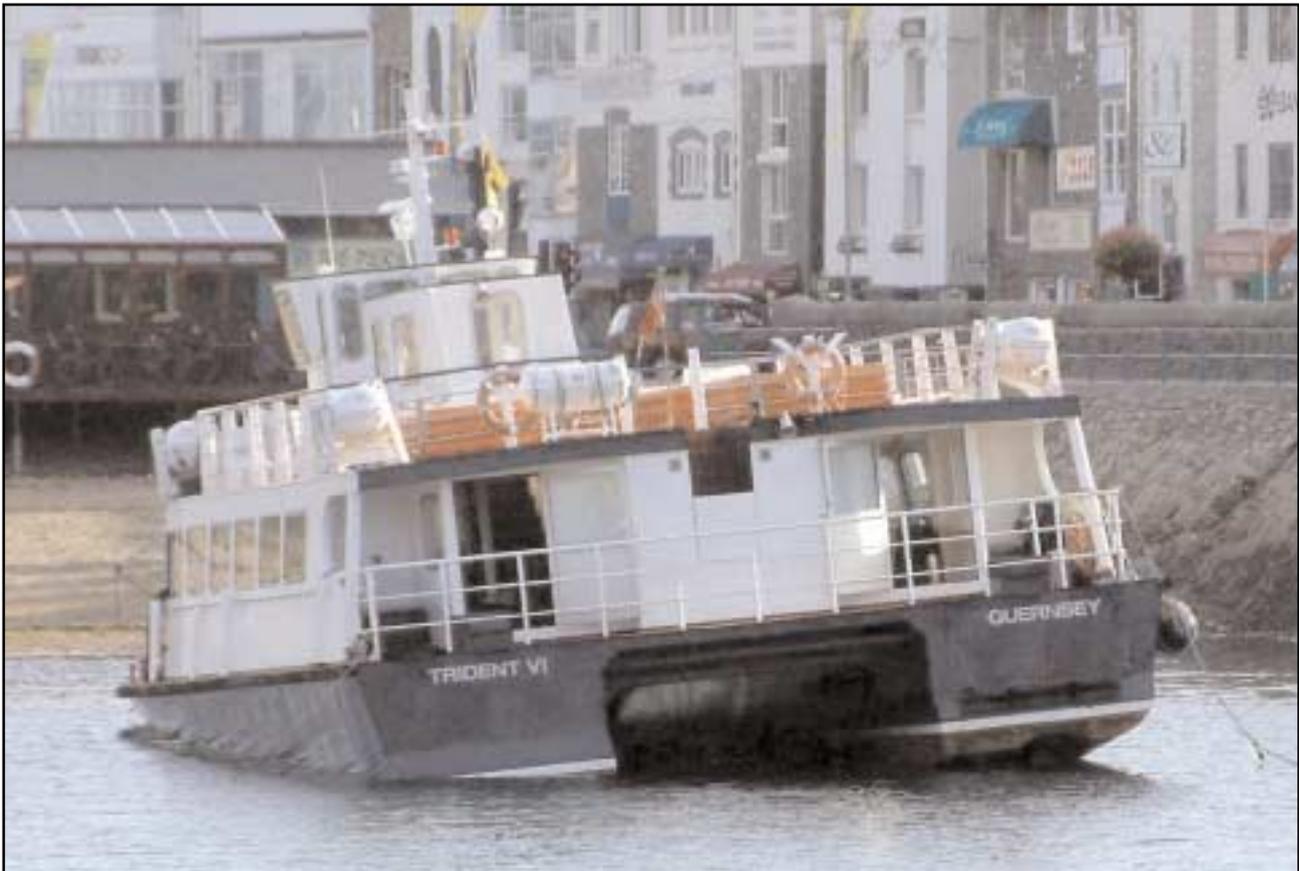
One of the RNLI crewmen on board *Trident VI* steered her back to St Peter Port, following the RNLI lifeboat. He commented on how difficult it was to steer. She was placed on the Careening Hard in St Peter Port at about 0200 (**see photograph 3**).

Trident VI afloat at the Careening Hard, St Peter Port harbour, on the day after the accident

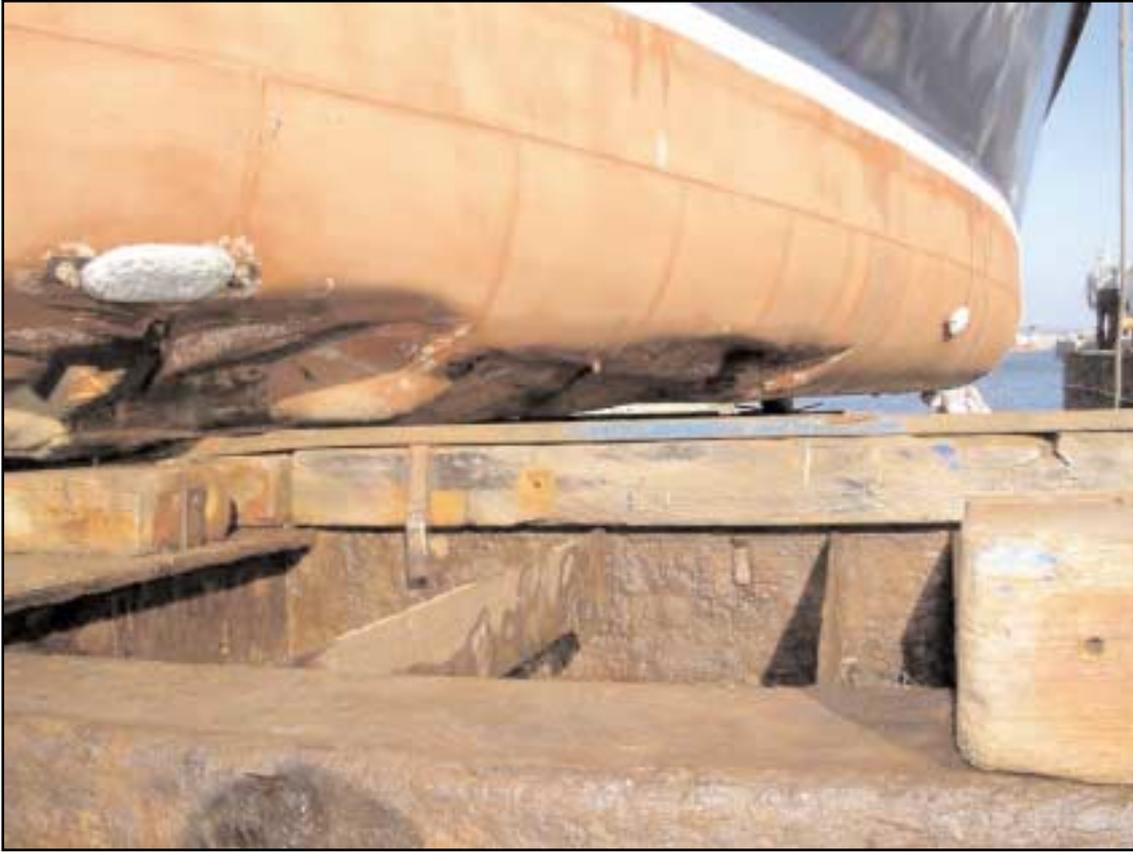
Photograph 6

The bottom plates of the forward three compartments, about 10m in length, of the port hull, suffered many indentations, splits and breaches, which caused flooding (**see photographs 6 and 7**).

View looking aft showing the side damage to the forward part of the port hull

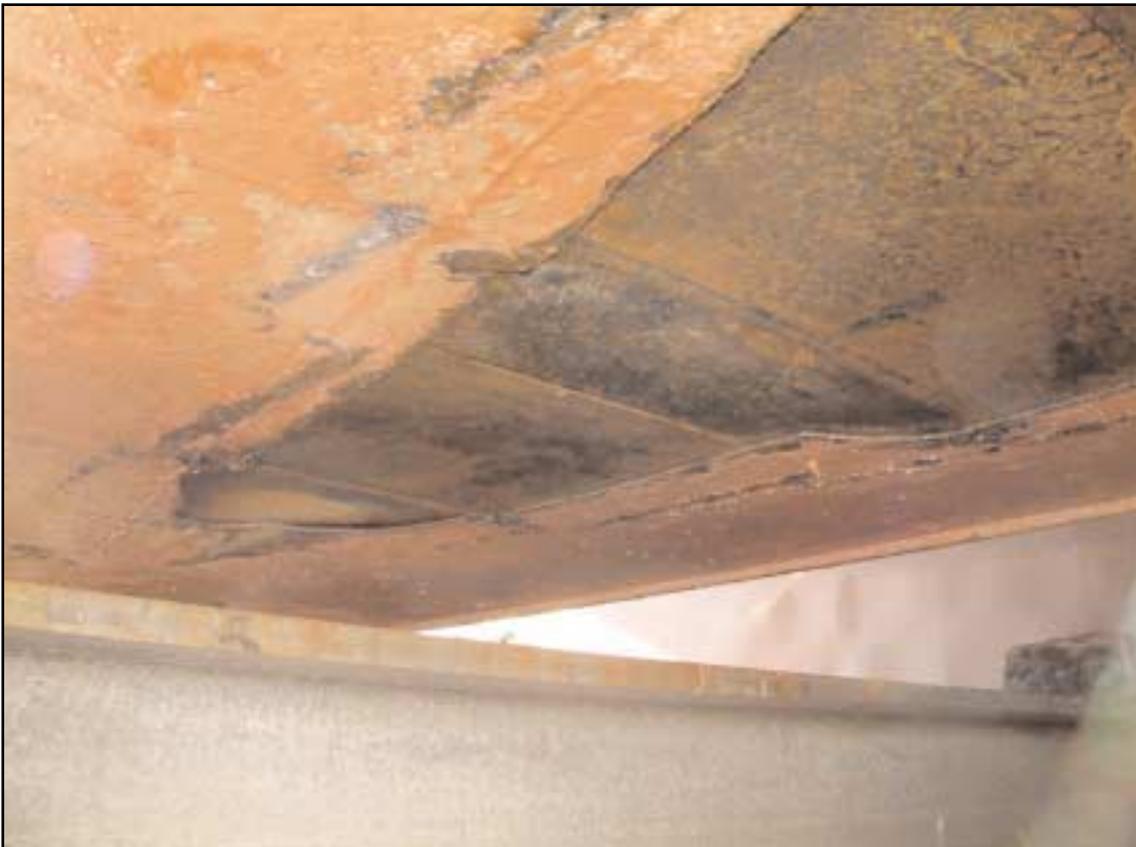
Photograph 7

View looking up at the bottom of the port hull showing temporary repair plates

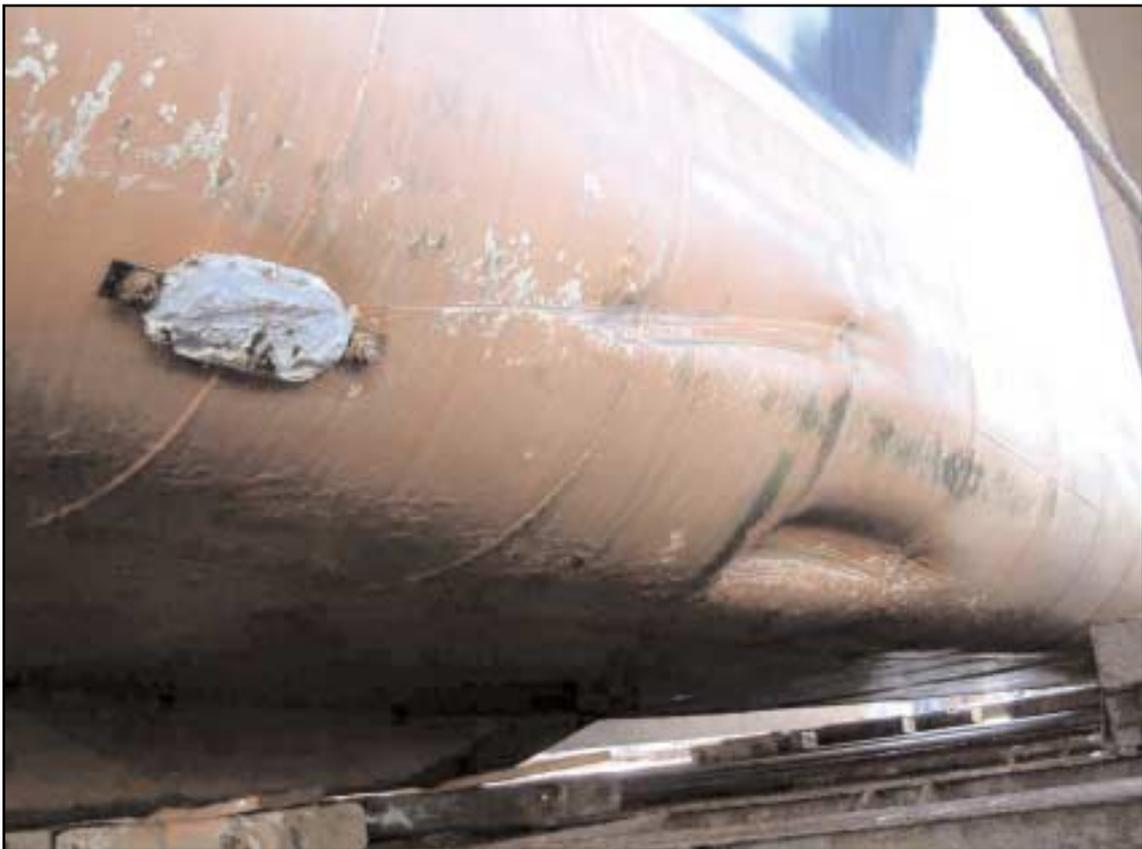
The starboard hull was dented, but not breached, on the outer side, about 8m from aft. There were some fresh longitudinal scrape marks to the hull and the propeller shaft leading from the dent towards aft (**see photograph 8**).

View looking forward showing the damage to the after part of the starboard hull

The likely scenario to cause the type of damage *Trident VI* sustained when she grounded was that, initially, the starboard quarter made contact with the rocks. This caused the vessel to then rotate quickly to starboard, which resulted in the forward part of the port hull grounding.

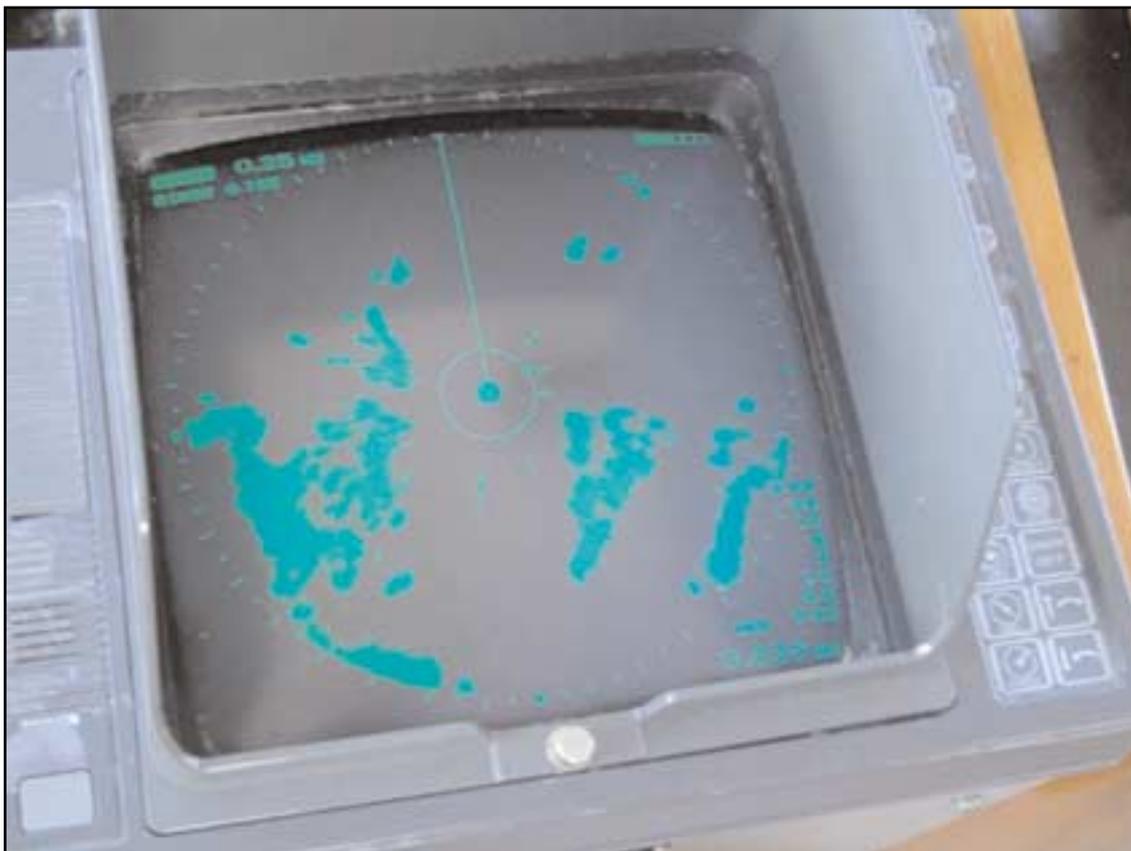
One of the two radar screens in use on *Trident V*
(similar to the units fitted on *Trident VI*)

heading, which increased the more rapidly the vessel turned. The situation on *Trident VI* was further complicated by the fact that the picture re-orientated itself sporadically, thereby losing the picture for short periods of time.

With an unstabilised radar, the vessel's heading marker on the screen remains stationary and, when altering course, other targets on the screen rotate. This causes the targets to 'blur' or merge with each other. On the other hand, with a stabilised radar, the heading marker moves when the vessel alters course; and the targets do not blur or merge. Had *Trident VI's* radar been stabilised, the skipper would have seen that the rate of change of heading was too great, and that the vessel was crossing the channel too quickly towards the opposite side.

The MAIB recommends that the States of Guernsey Board of Administration encourage operators of this type of passenger vessel to install fluxgate compasses to generate stabilisation to their radars and chart plotters.
