Report on the investigation of  
the loss of  
***Kirsteen Anne***  
Firth of Lorn  
31 December 2002  
with the loss of her two crew

Marine Accident Investigation Branch  
First Floor  
Carlton House  
Carlton Place  
Southampton  
United Kingdom  
SO15 2DZ

**Report No 19/2003  
July 2003**

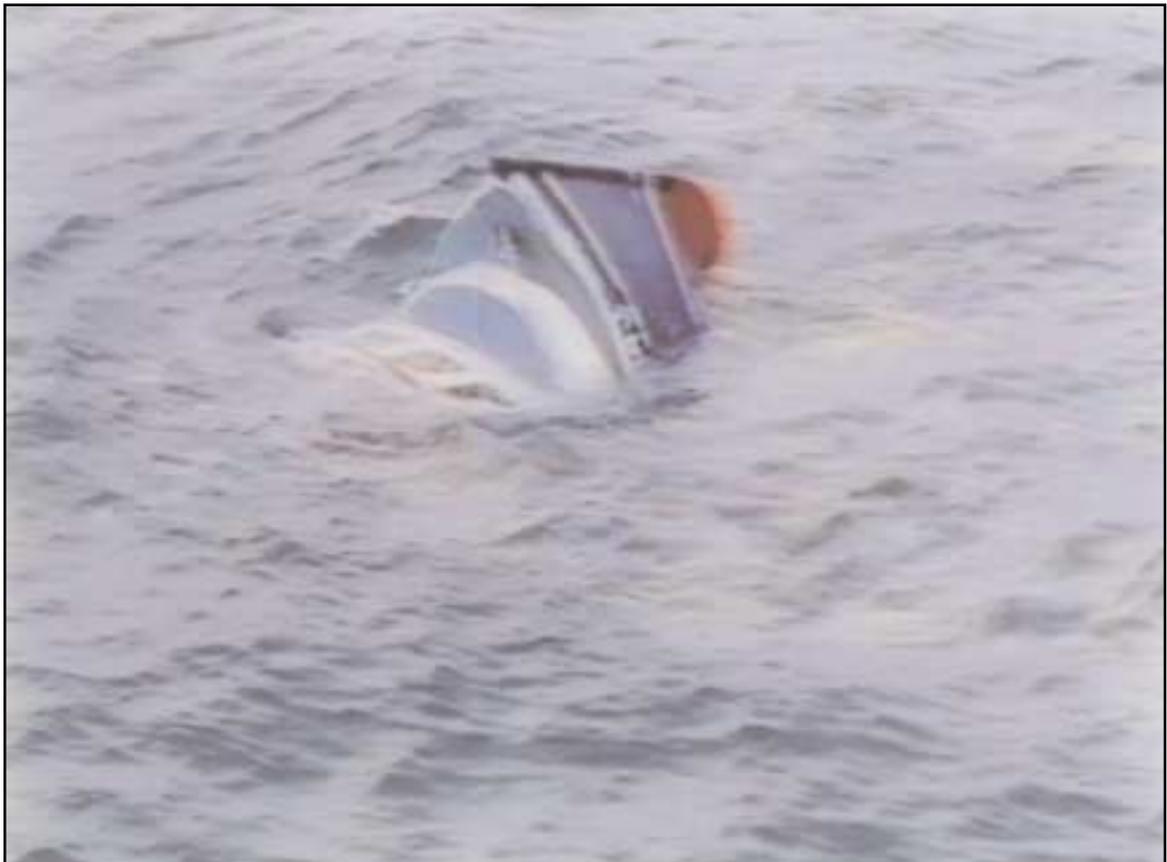
Figure 2

Photograph of *Kirsteen Anne* when found

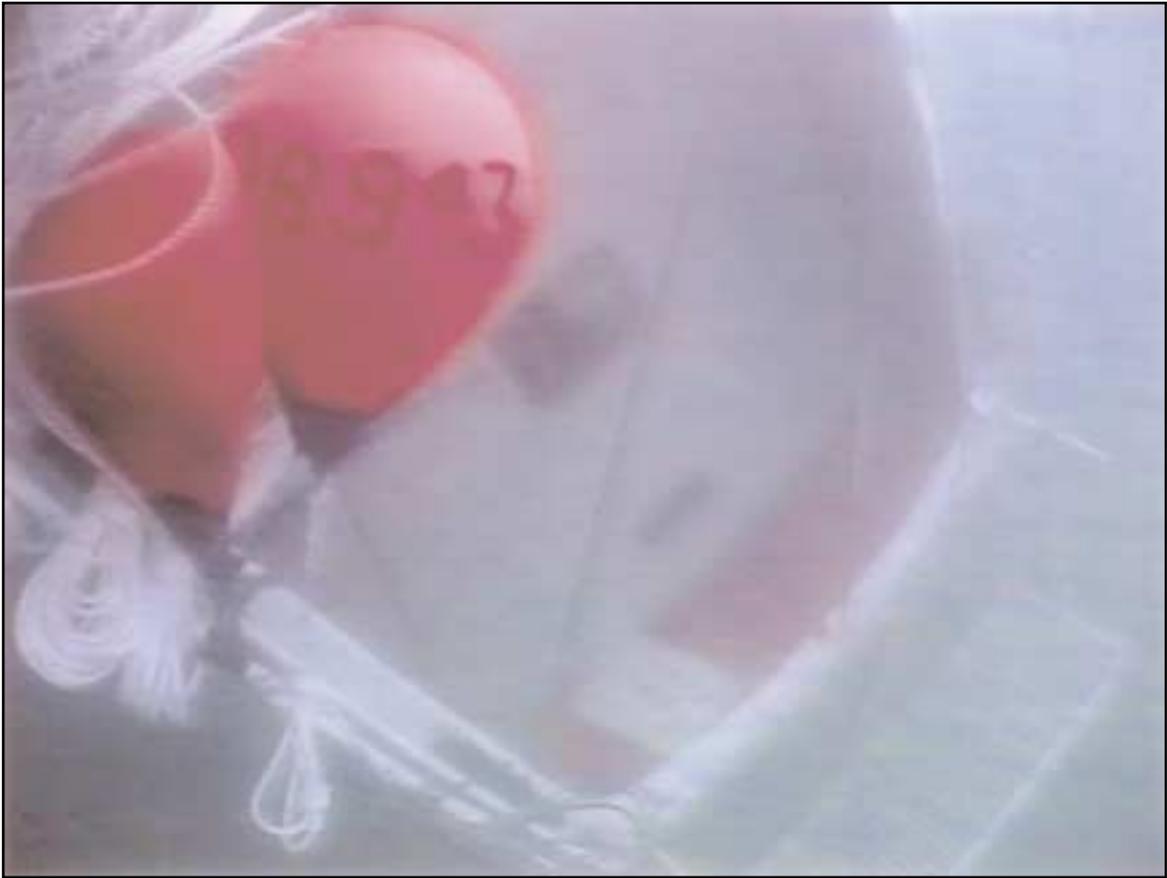
Figure 4

The Strathclyde police diving unit conducted an underwater search of *Kirsteen Anne* and her fishing gear during 1 and 2 January, and a search of the seabed on 3 January. The vessel remained partly submerged and was tethered to the seabed by the fleets of creels she had been carrying. A diagram showing the disposition of the creels in relation to the vessel and the seabed is shown at **(Figure 3)**. During the search of the vessel, the deck covers to the rudder space and bilge were found on deck on the port side of the stern transom **(Figure 4)**, and the GRP engine cover was missing.

Photograph showing deck cover on stern transom

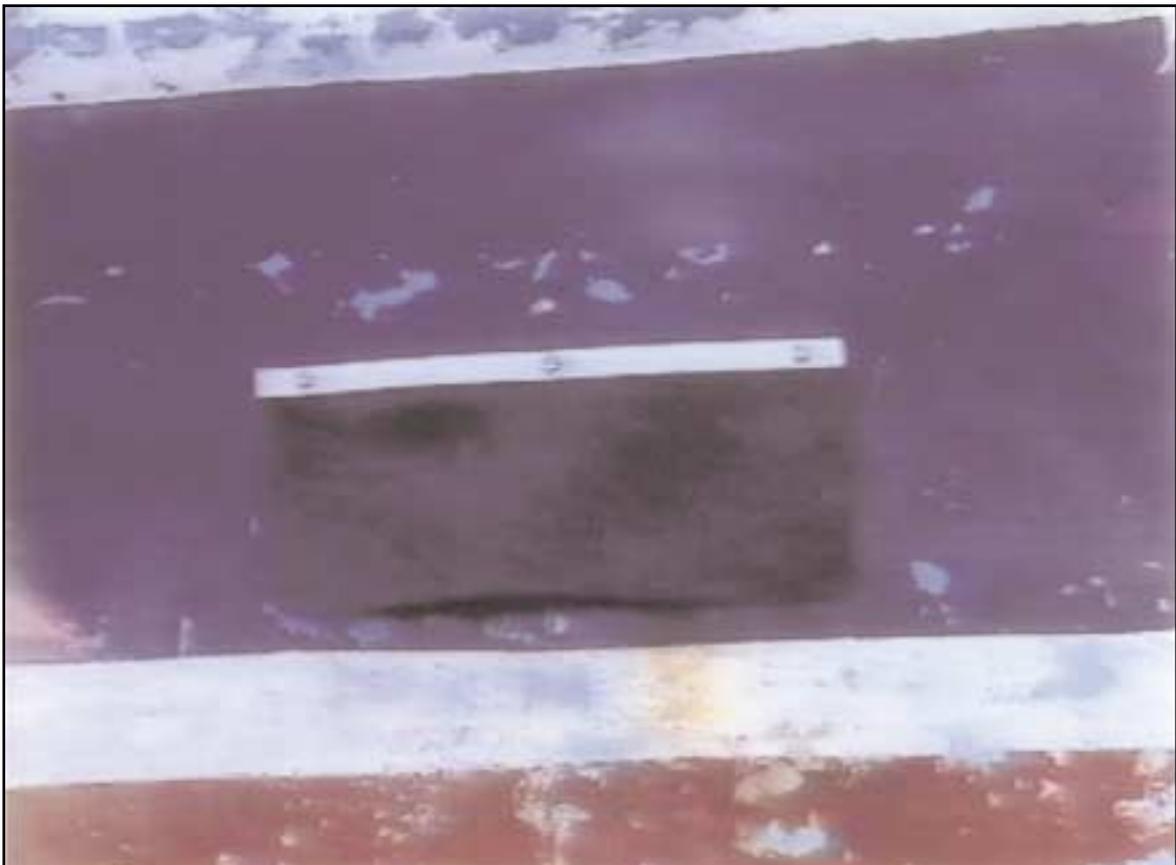
Figure 5

Photograph of freeing port with rubber flap

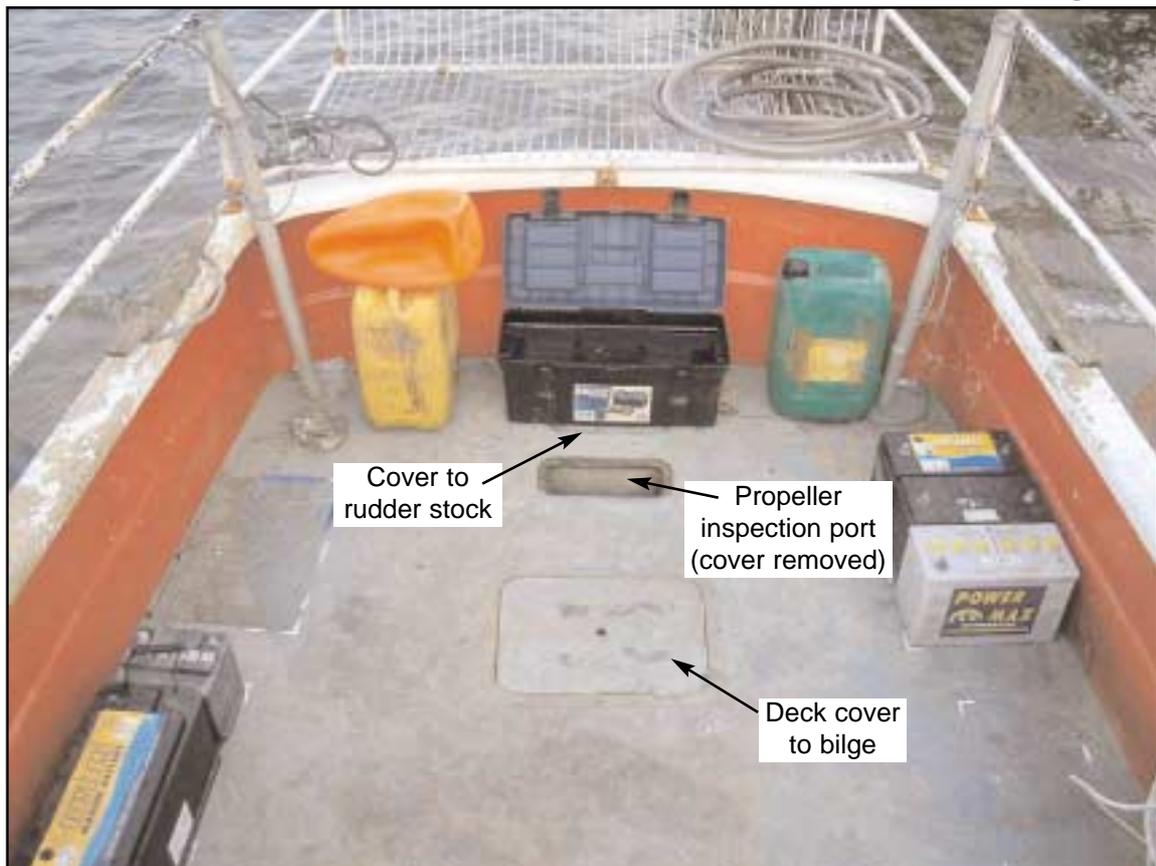
Figure 6

Although the deck was GRP and sealed around its edges, access covers to the rudder stock and bilge area on the aft deck (**Figure 6**) were not watertight. The middle of the three covers shown could be removed to allow inspection of the propeller.

Photograph showing location of deck openings

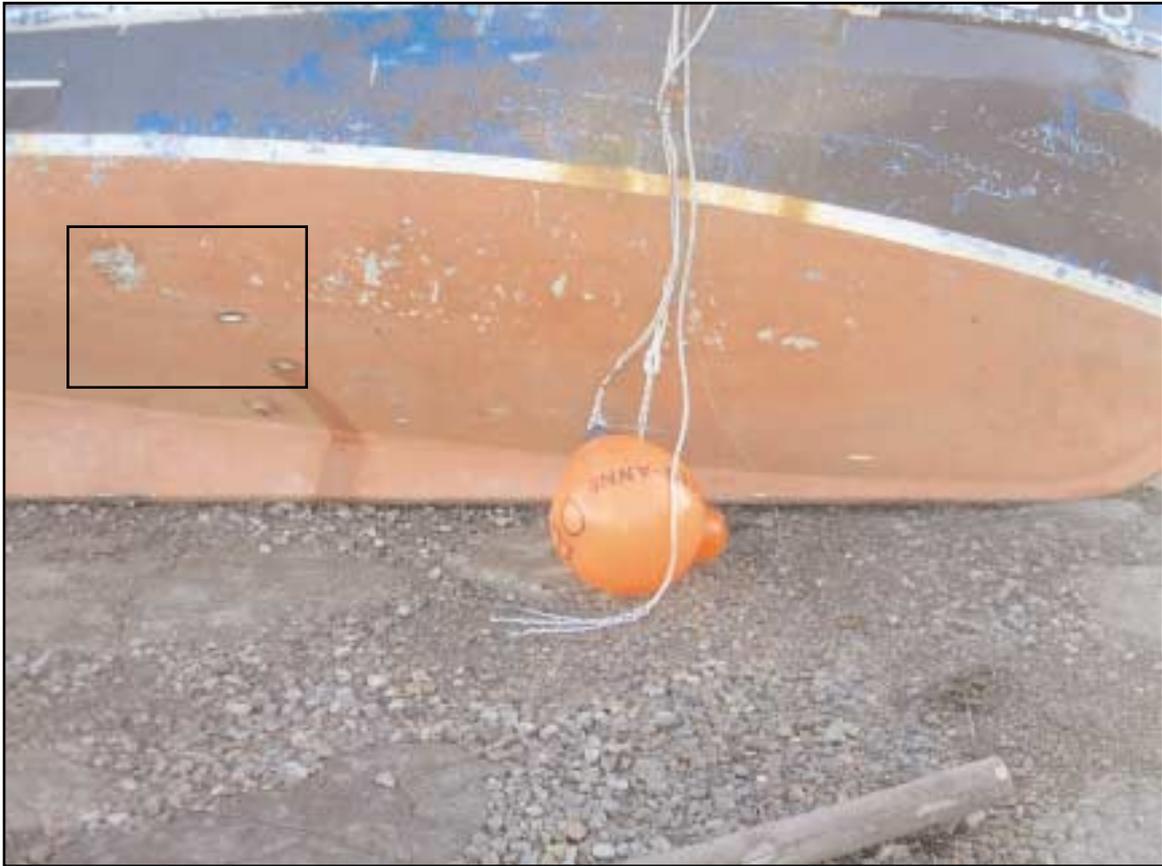
Figure 9

- Three distinct indentations were noted amidships, below the waterline on the starboard side, the lowest of which had punctured the hull (**Figure 9**).

Photograph showing the marks and puncture on the starboard side

The marks and hull puncture found on *Kirsteen Anne*'s starboard side must have been caused by contact with another object. This damage might have occurred during the vessel's recovery when it is reported there was contact between the cutter *Searcher* and *Kirsteen Anne*. There is also a possibility, however, that the puncture was caused during the recovery of the fleets south of Kerrera. The hulls of many creel boats are strengthened in the vicinity of the pot-hauler to prevent such occurrences. If the puncture to the hull was caused before capsizing, this would have increased the water ingress to the bilge.

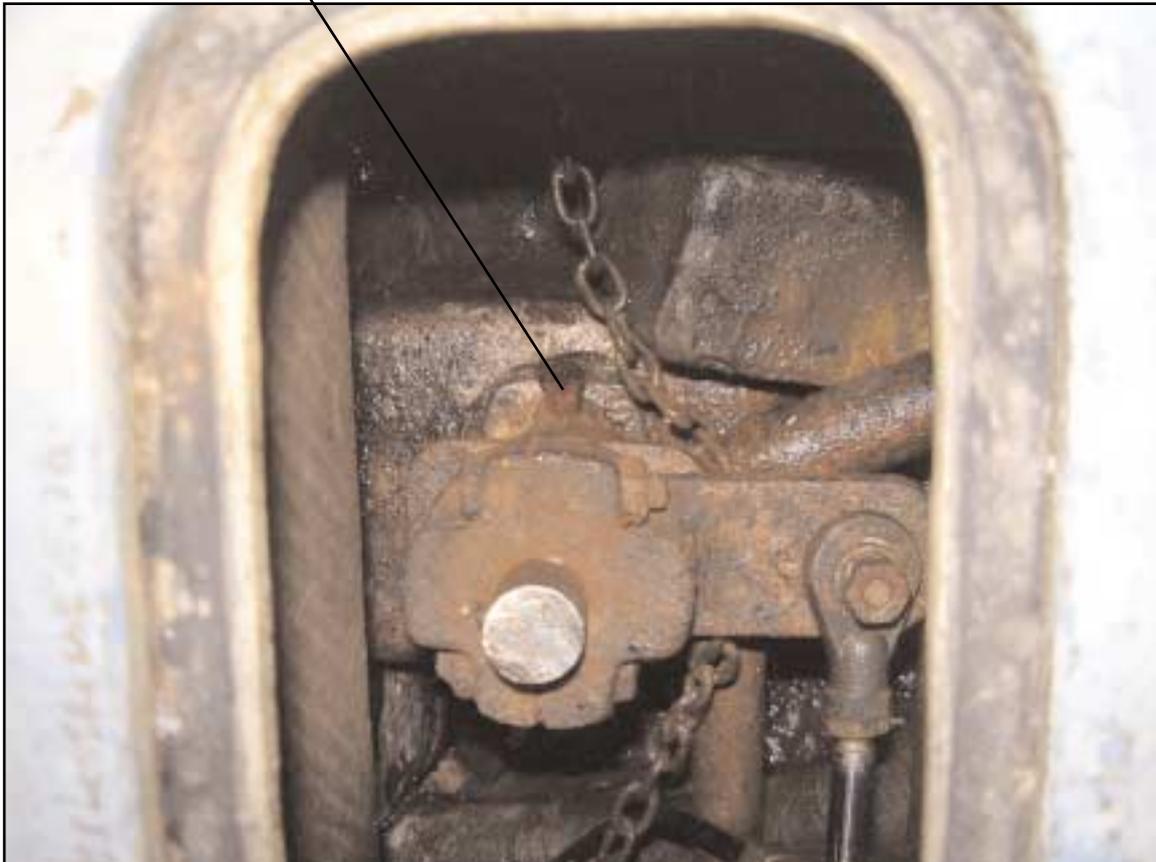
Figure 10

- On 24 December, the crew were seen pumping water via a hand-operated bilge pump at least every hour, and it is believed they fitted a wooden wedge in a hole in the rudder stock caused by a missing grease nipple to stop seawater from coming in. Crew B had also spoken to friends about the possibility of water also coming through the stern gland, but it is reported he had checked and confirmed that this was not the case.

- Eighty creels (52 D shaped, and 28 rectangular), and approximately 1200m of back lines were recovered.
- A wooden bung used in lieu of a missing grease nipple was in place on the starboard side of the rudder stock (**Figure 10**).

Photograph showing a wooden bung in the rudder stock

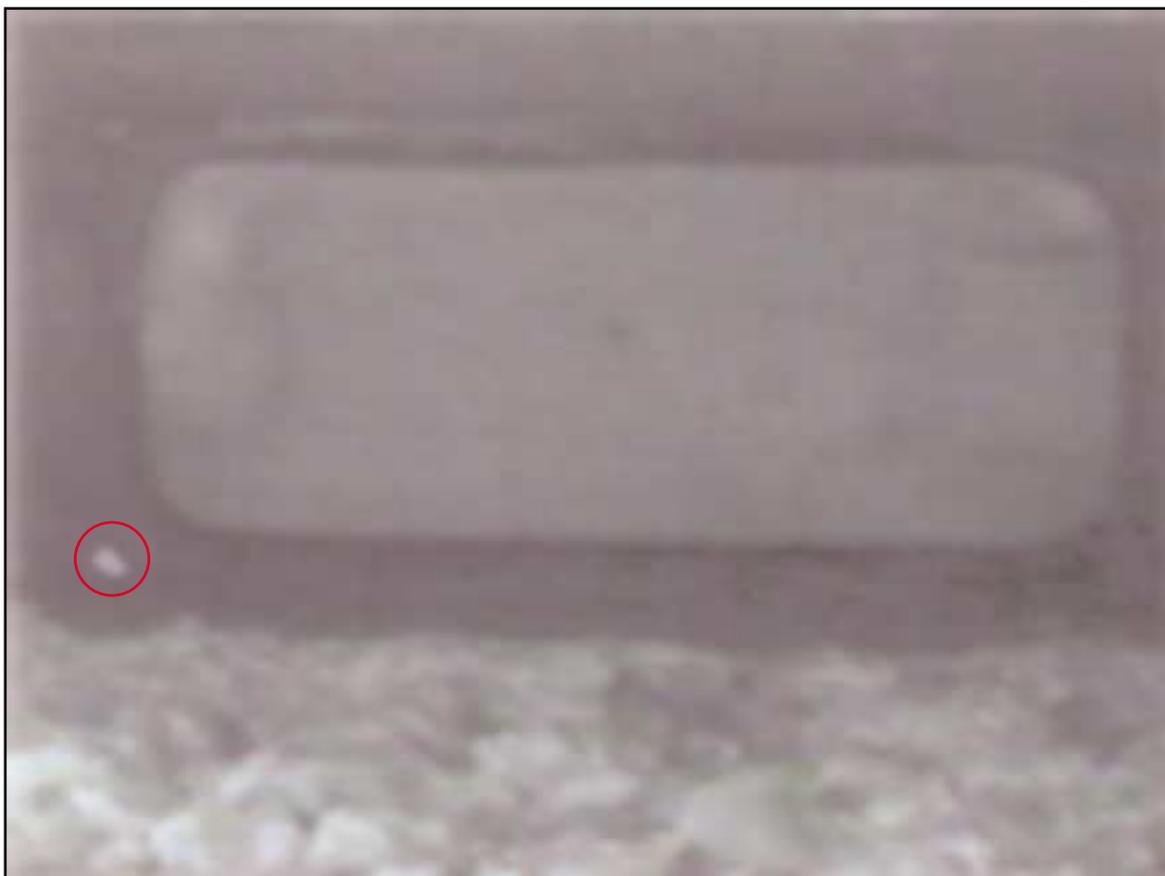
- A 75mm hole was found in the GRP between the top corner of the propeller inspection port and bilge (**Figure 11**).
- With the boat towed through the water at very slow speed in an unloaded condition, water was observed to ingress from the rim of the propeller inspection port cover. No water ingress from the rudder stock or propeller stern gland was evident.

Photograph showing hole at the top of the propeller inspection port

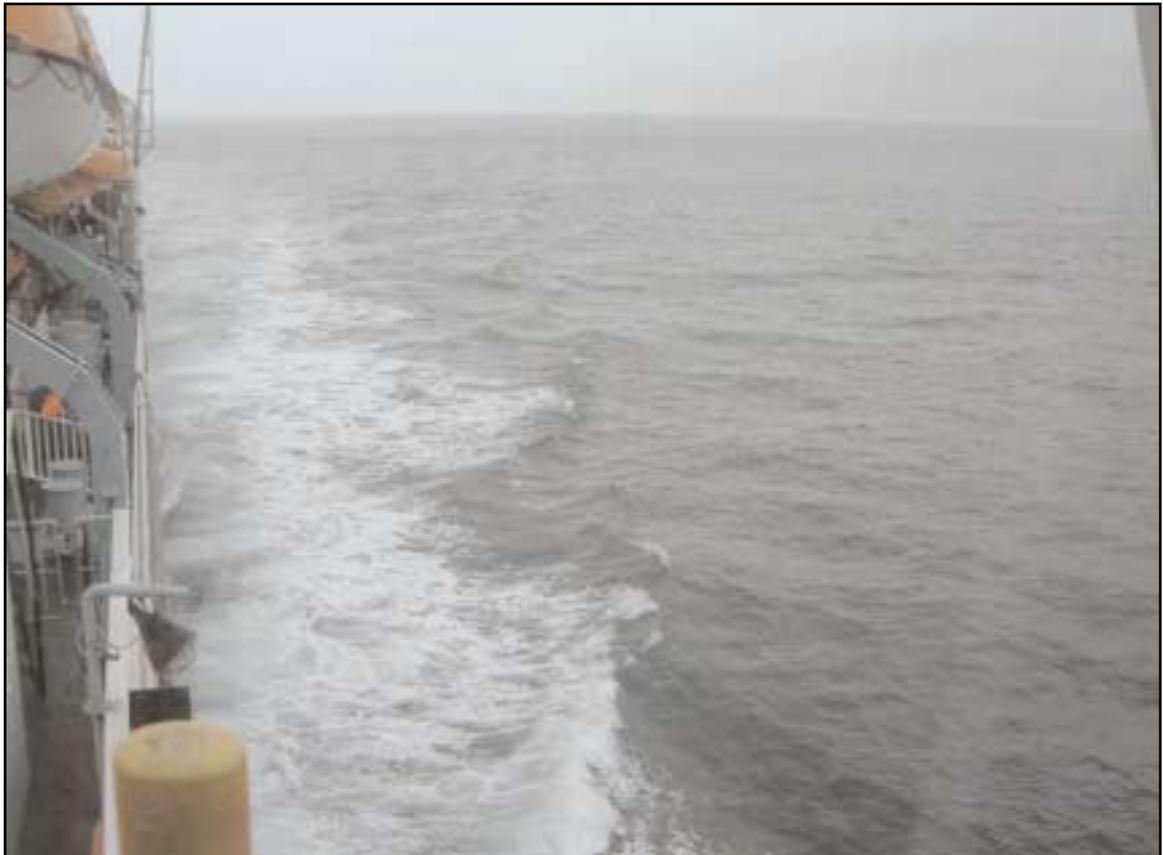
Figure 12

The vessel overtaken at a close distance by *Isle of Mull* might have been *Kirsteen Anne*, and in such situations the wake of a larger vessel can destabilise smaller ones. In this case, however, examination of the wake produced by *Isle of Mull* at 14.5 knots (**Figure 12**) shows the wake to be relatively small. It is considered such wake would have dissipated very quickly in the reported sea conditions, and therefore had only a negligible effect on vessels in close proximity.

Photograph showing the wake of mv *Isle of Mull* at 14.5 knots

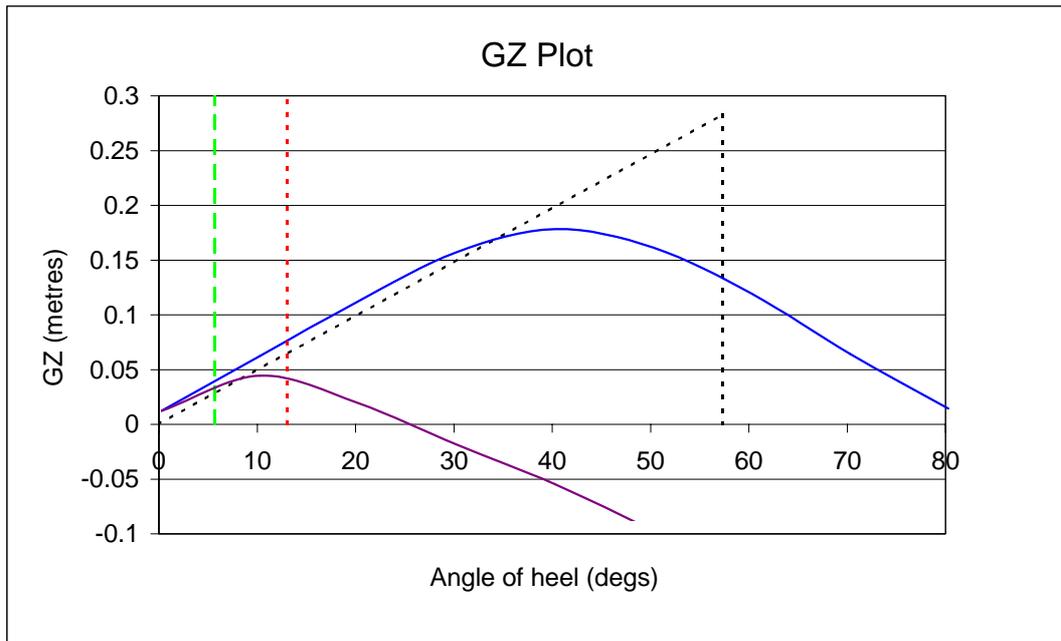
Examination of the data, and resulting analysis from the inclining experiment (**Annexes A and B**), shows the predicted stability performance of *Kirsteen Anne*, in the estimated loaded condition when lost, was very poor in comparison to the stability criteria required by larger fishing vessels. Although the vessel possessed some righting moment, it was not enough to ensure an adequate margin of safety during fishing operations.

Criteria*	Case 1	Case 2
Angle of immersion of (degs) (Case 1- port freeing port, Case 2- deck hatch)		5.620	12.984
Area under GZ curve between 0 & 30 degrees (metre.radians)	0.055	0.039	0.008
Area under GZ curve between 0 & 40 degrees (metre.radians)	0.09	0.067	0.008
Area under GZ curve between 30 & 40 degrees (metre.radians)	0.03	0.028	0.000
Maximum GZ (metres)	0.2	0.160	0.032
Angle of heel at which maximum GZ occurs (degrees)	30	40.430	9.636
Positive GZ heel range (degrees)		80.300	21.730
GMF (metres) (upright)	0.35	0.283	0.335

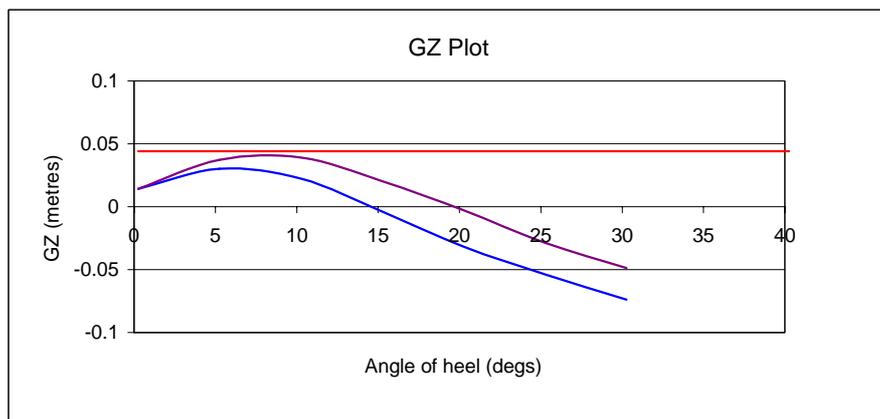
The flooding scenario demonstrates that only 0.26 tonnes of water is needed to cause marginal stability. Bearing in mind the very poor watertight integrity of the deck, coupled with the low freeboard, it is highly likely that sea water entered the hull on the day of the accident. Approximately, 0.26 tonnes equates to a 5-6 cm depth of water in the bilge.

STABILITY SUMMARY	Criteria*	Case 1	Case 2
Area under GZ curve between 0 & 30 degrees (metre.radians)	0.055	0.002	0.005
Area under GZ curve between 0 & 40 degrees (metre.radians)	0.09	0.002	0.005
Area under GZ curve between 30 & 40 degrees (metre.radians)	0.03	0	0
Maximum GZ (metres)	0.2	0.016	0.027
Angle of heel at which maximum GZ occurs (degrees)	30	5.806	7.788
Positive GZ heel range (degrees)		11.722	16.442
GMF (metres) (upright)	0.35	0.225	0.316
