Report on the investigation of

a lifeboat accident on

mv *Galateia*

Report No 25/2002
July 2002

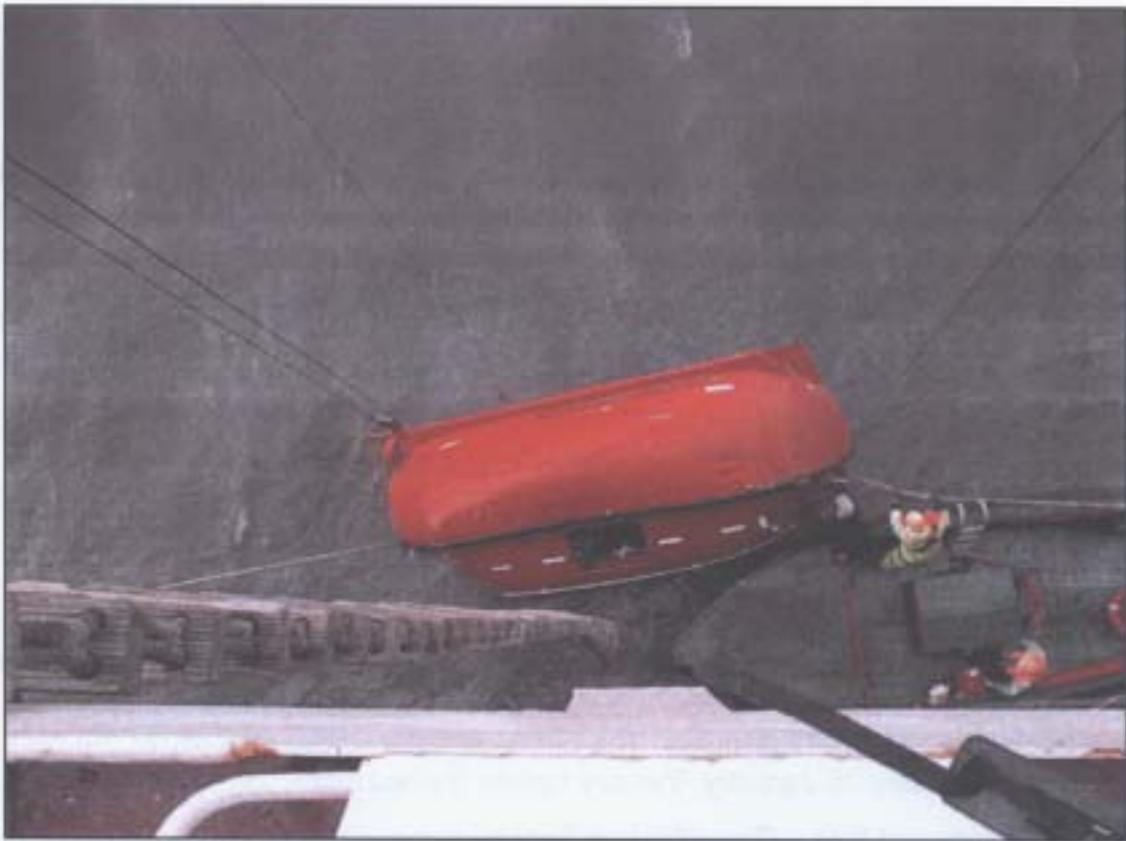
Port Authority launch alongside assisting in righting the lifeboat

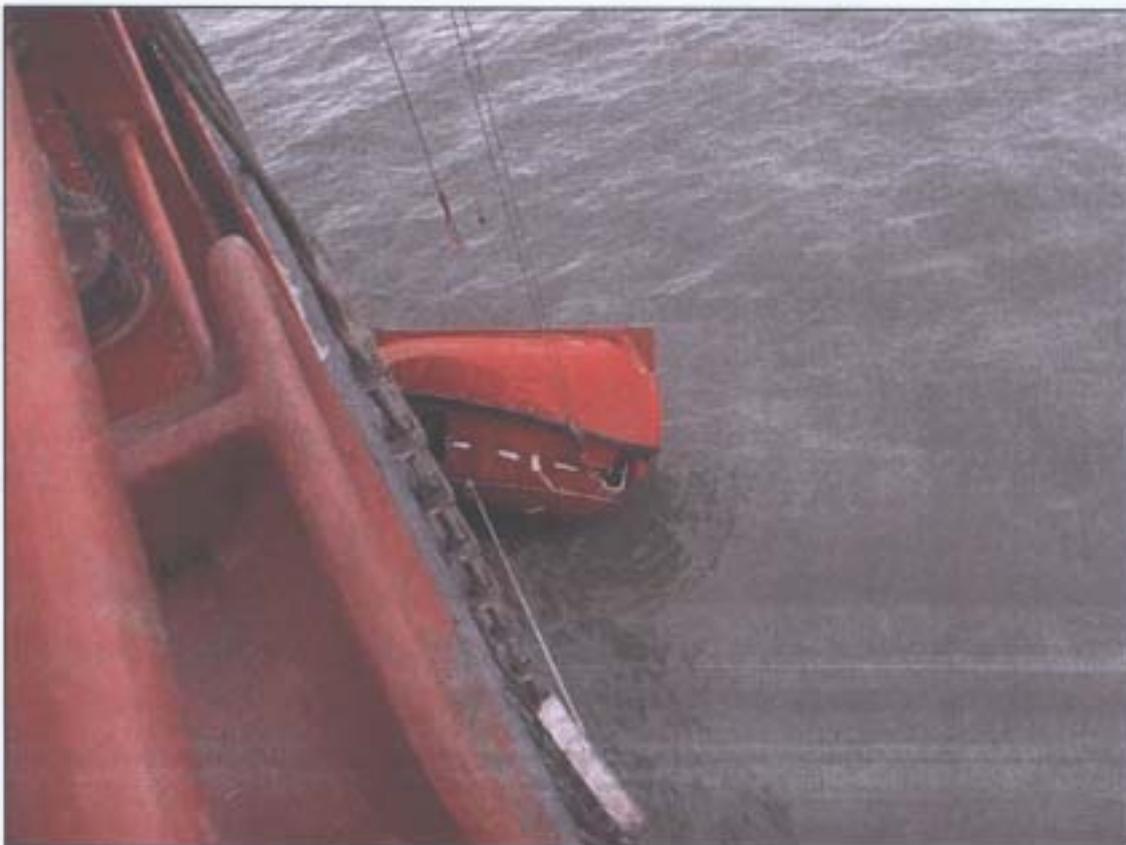
The partially capsized lifeboat - the falls had been lowered in preparation for righting the lifeboat

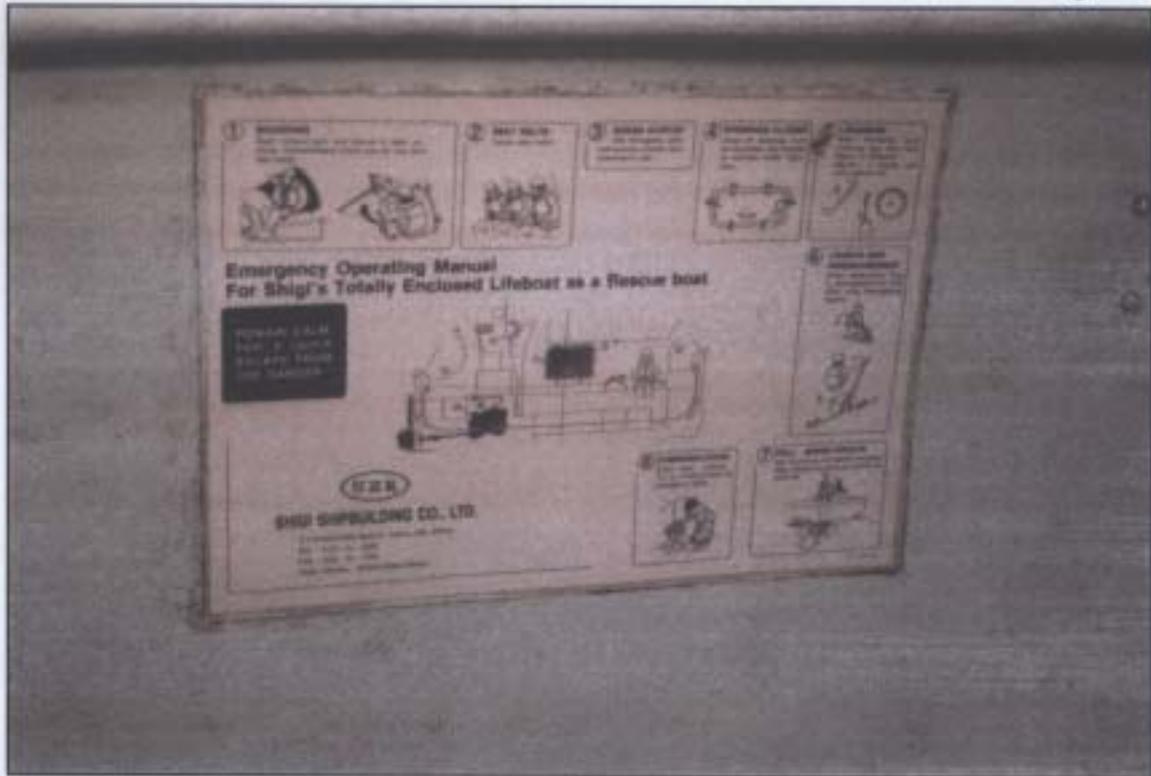
Figure 1

Operating instructions pasted on inside of lifeboat canopy

2.3.1 The lifeboat release instructions pasted on the inside of the lifeboat canopy were not very clear, nor were the item numbers clearly legible. In fact, some of the item numbers had completely worn off. As these are critical in identifying the order in which the procedure is to be followed, their loss greatly increased the chances of a mistake being made. The warning notice, which was part of the instructions supplied by the manufacturing company to the MAIB, was not included in the procedural notices pasted on the internal lifeboat canopy. That notice included a pictorial illustration of the correct cam plate position, as well as the correct position of the locking pin before lifting. The lifeboat manufacturers subsequently confirmed that this "Warning" notice was sent out in August 1997 to all users who could be identified. *Galateia's* owners could not be found at that time and, therefore, no notice reached them, hence the omission. That omission has since been rectified and "Warning" notices have been sent to the vessel for inclusion in the safety manual and to be pasted on the inside of the lifeboat canopies.

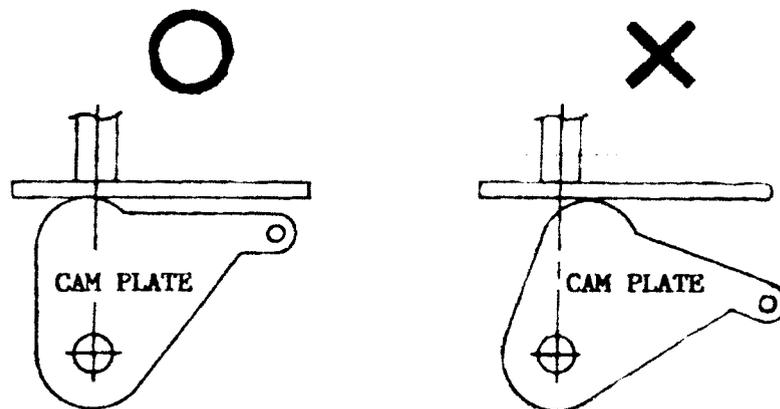
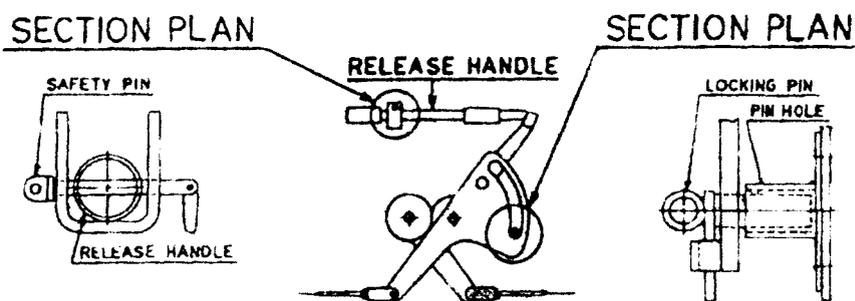
These latest guidance notes did not form part of the instructions pasted on the inside of the lifeboat canopies, nor were they seen in the safety manual.

Warning notice **not** issued to vessel until after accident

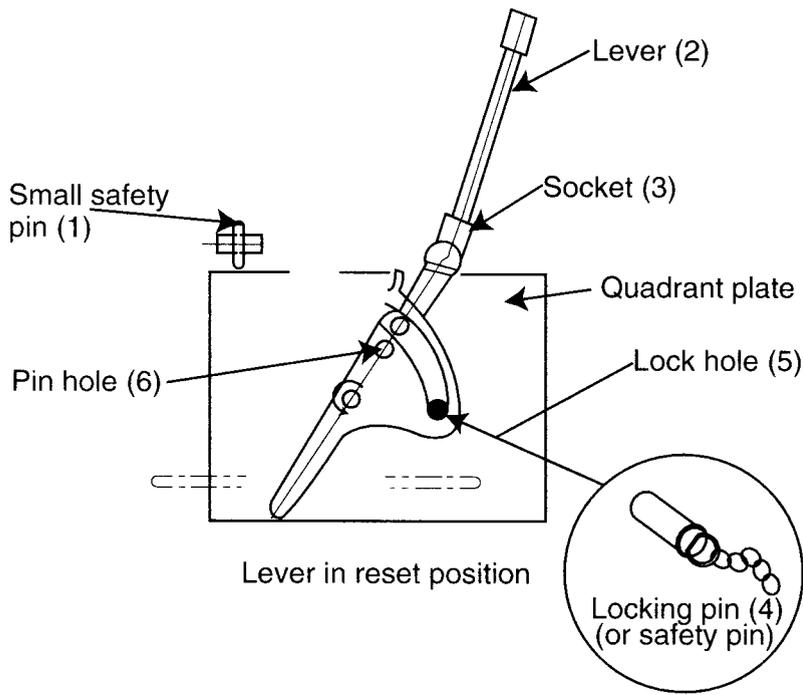
- 2.2.1 The primary cause of the simultaneous release of the hooks when at the davit head was the absence of the locking pin in the quadrant (**see Figure 4**) [lock hole (5)].

The central operating lever is placed adjacent to the coxswain's position, often in such a fashion that the gearing, quadrant and very important safety pin cannot be viewed easily. Indeed it is often impossible for the user to obtain the same view of the mechanism as it is shown on the instruction panel, he can see it only from above, making the important components difficult to identify. This problem is aggravated by these parts being below the bottom boards of the boat in an area of darkness.

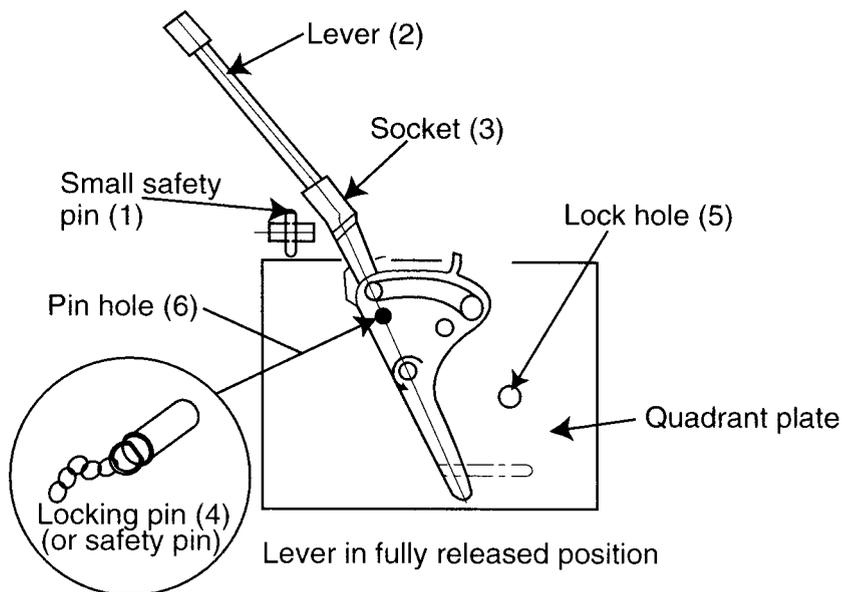
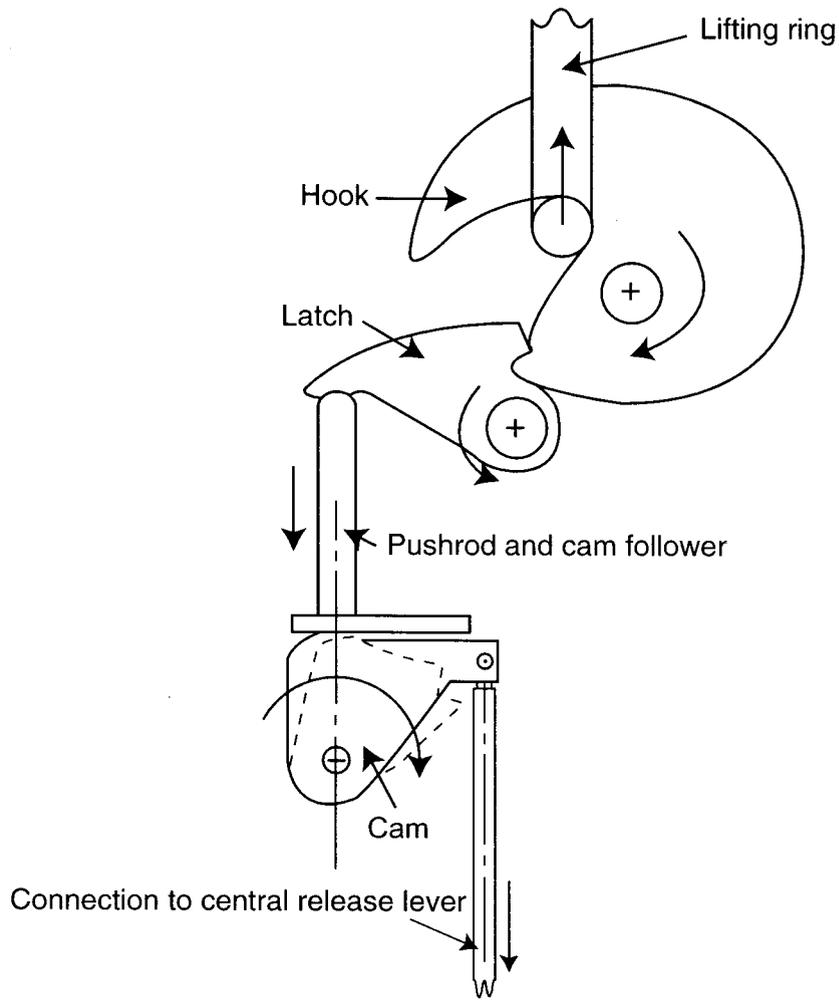
As both hooks released simultaneously, it suggests that the reset mechanism had not been pulled right back, thus leaving both cam plates slightly off the horizontal. Nothing would happen while the chief officer was holding the handle, but once he released it, lifeboat/crew movements could cause total release. If only one cam was slightly off the horizontal it is unlikely that both hooks would have released (**see Figures 5, 6 and 7**).

Diagrammatic arrangement of hook release mechanism and the direction of movement of its components during release. Improper resetting of the cam, as shown dotted, can induce an opening moment leading to inadvertent release.

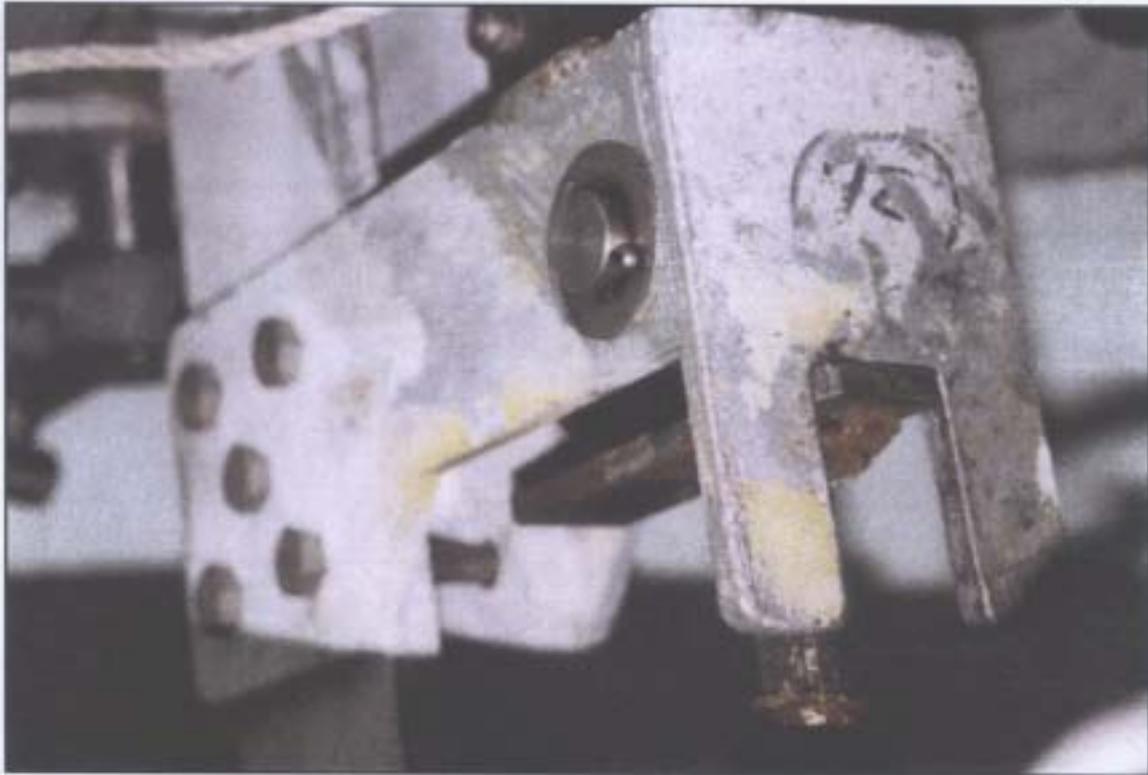
Figure 6

View of hook release gear in locked position

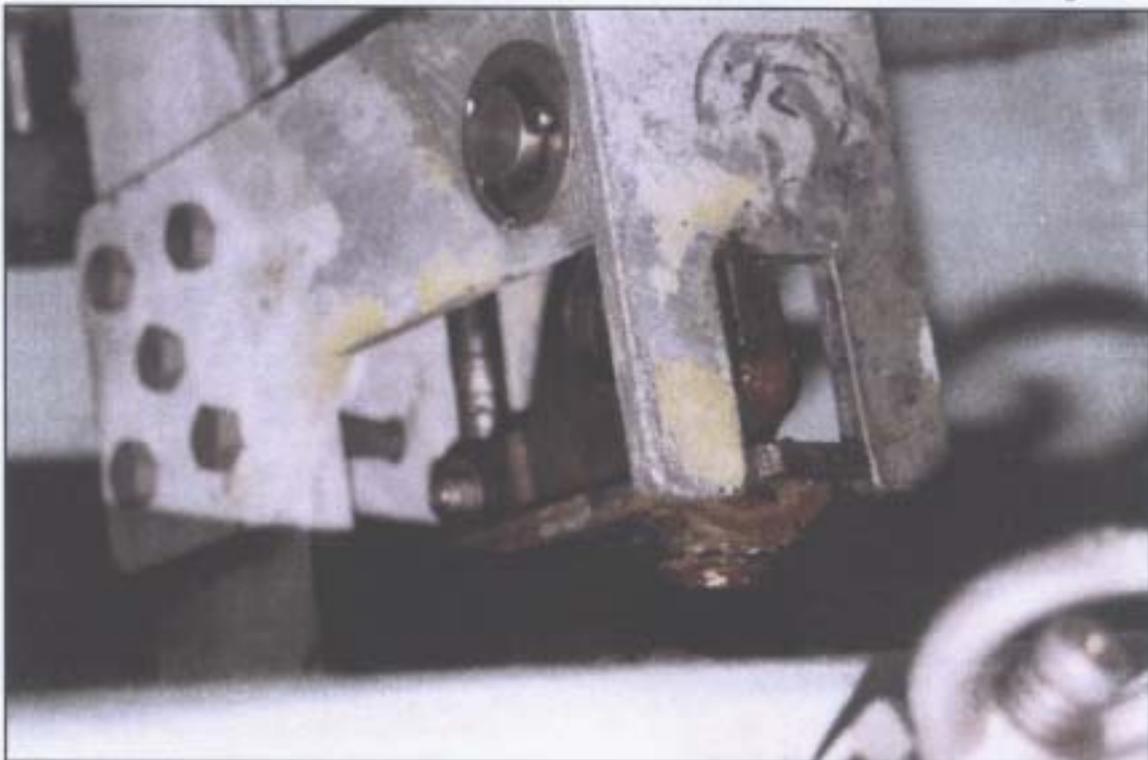
Figure 7

View of hook release gear in open position

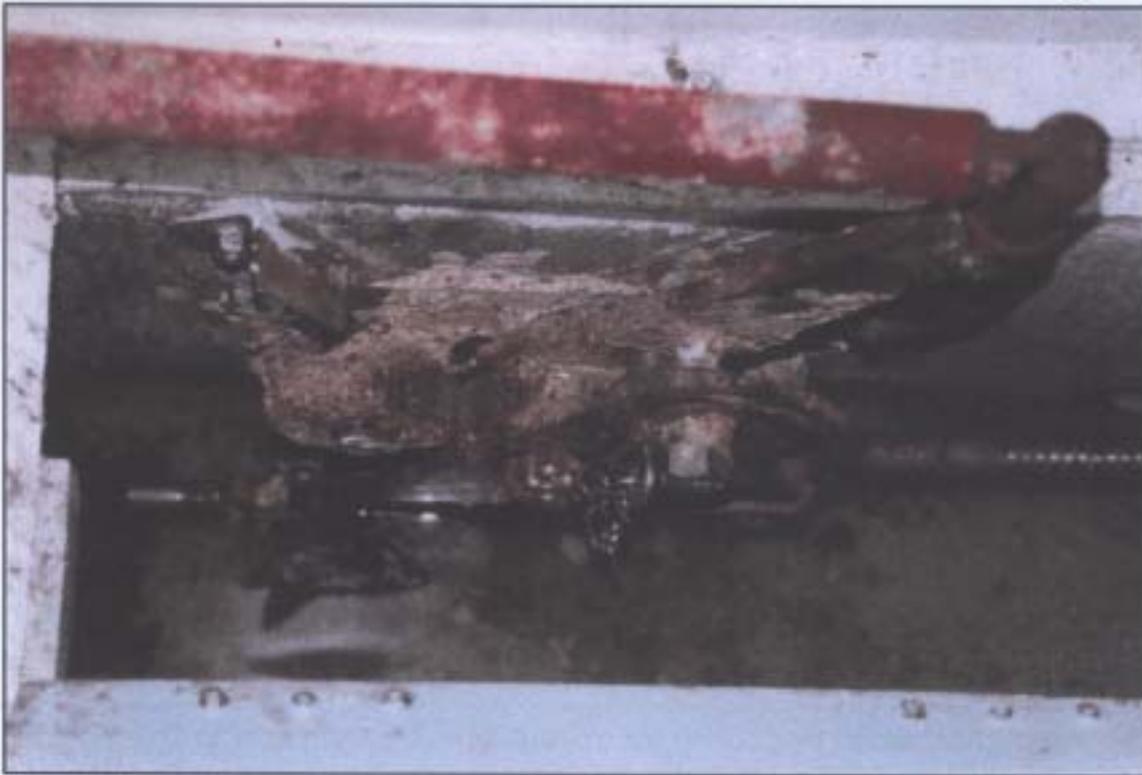
Figure 8

View of release gear with operating handle in stowed position
Note: Locking pin still in operating position

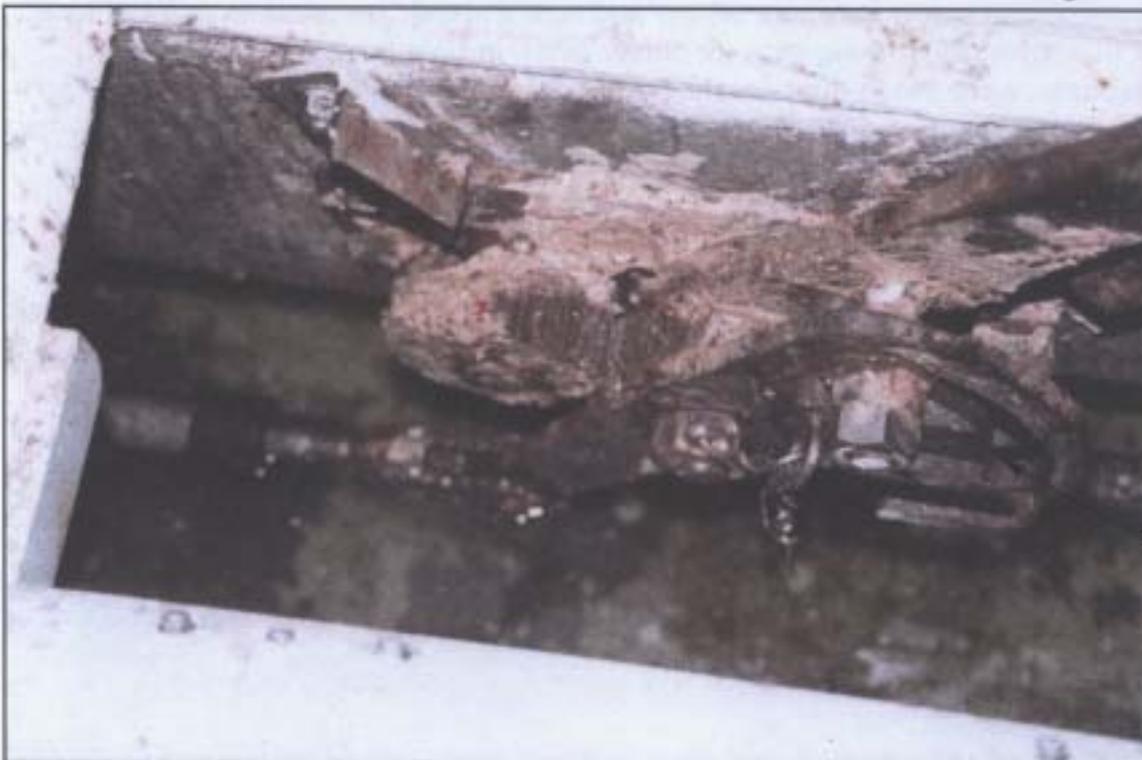
Figure 9

Close-up view of release gear showing quadrant in reset position **but** locking pin in released position

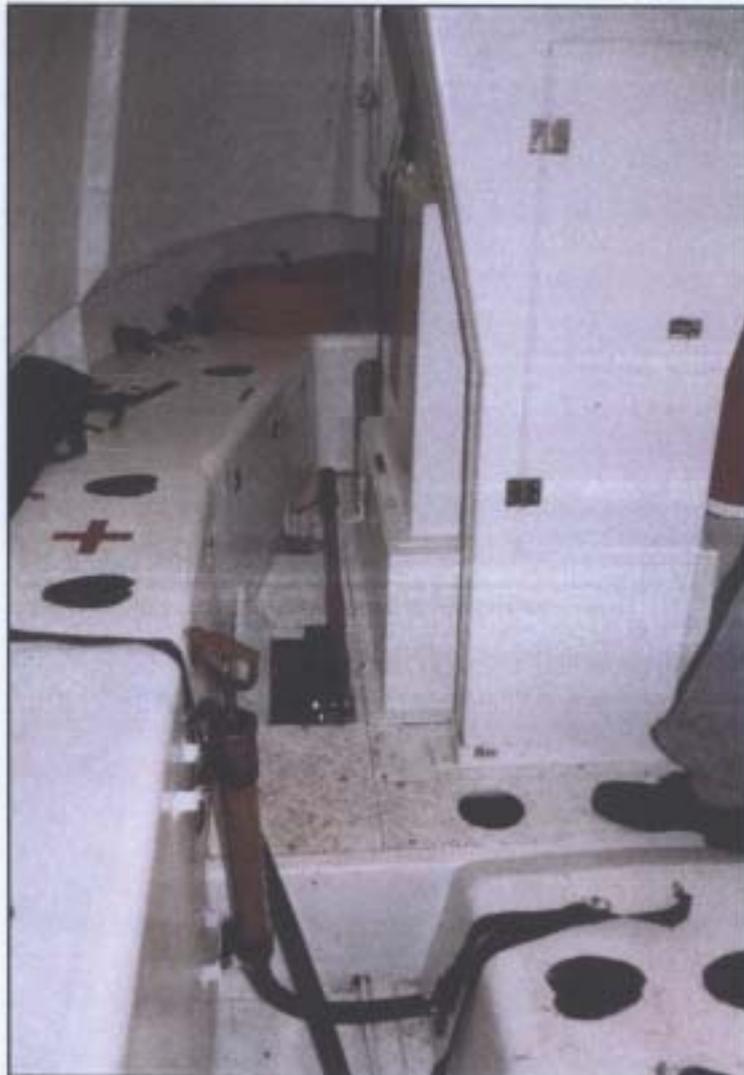
Figure 10

Furthermore, the release gear is positioned low down in the boat on the starboard side next to the control station and below the bottom boards. In this position, the operator is unable to get a clear view of the mechanism, or see the position of the locking pin. At night, without a torch, it would be impossible - it would have to be done by touch. Under emergency conditions this is not acceptable. With the operating mechanism in this position, access is difficult not only for visibility but also for maintenance. It is possible, however, for the crew to sight the operation of the hook mechanism at each end of the boat, and to check that the cam plate is in the correct horizontal position before hoisting.

General view of inside starboard lifeboat showing difficult access to operating gear

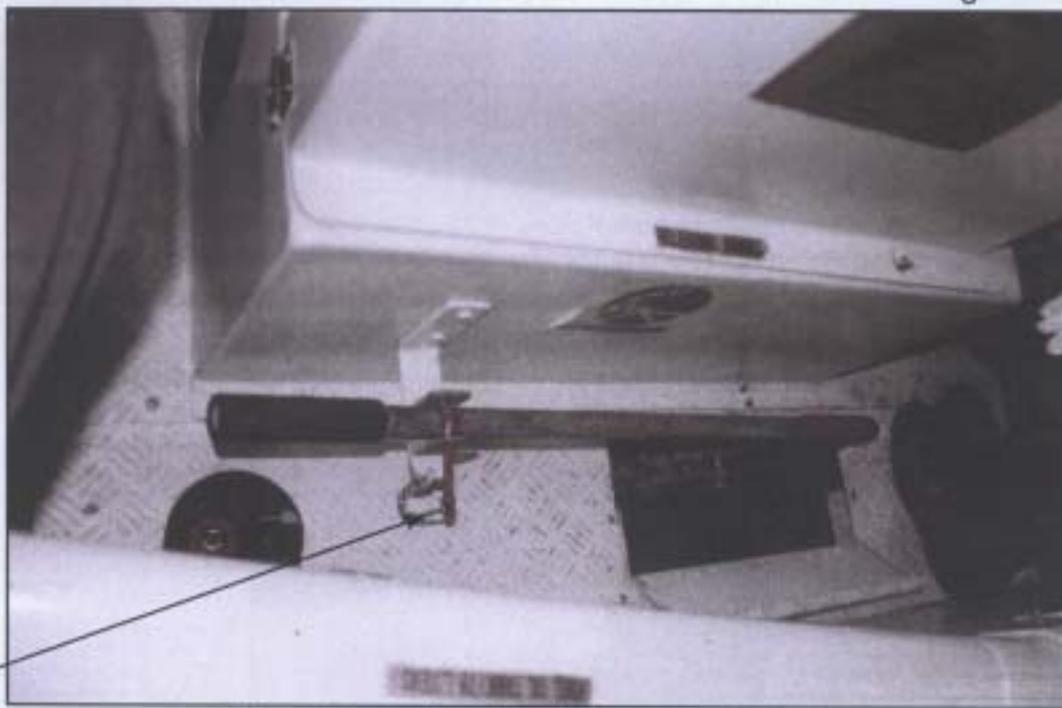
Figure 11

View of operating handle in stowed position

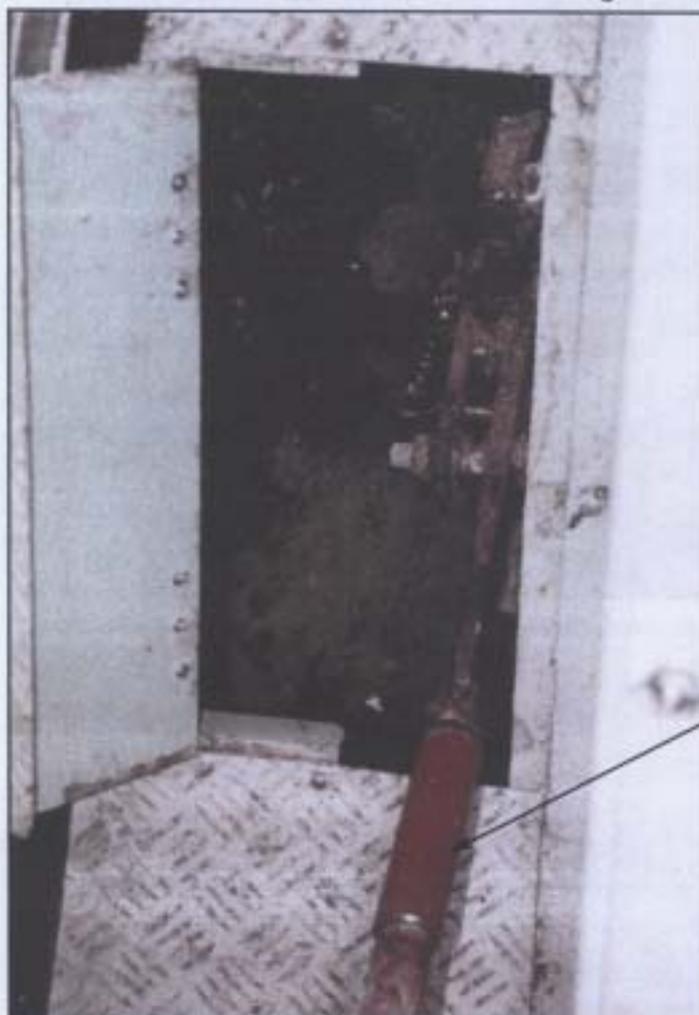
Figure 12

General view of access to release gear

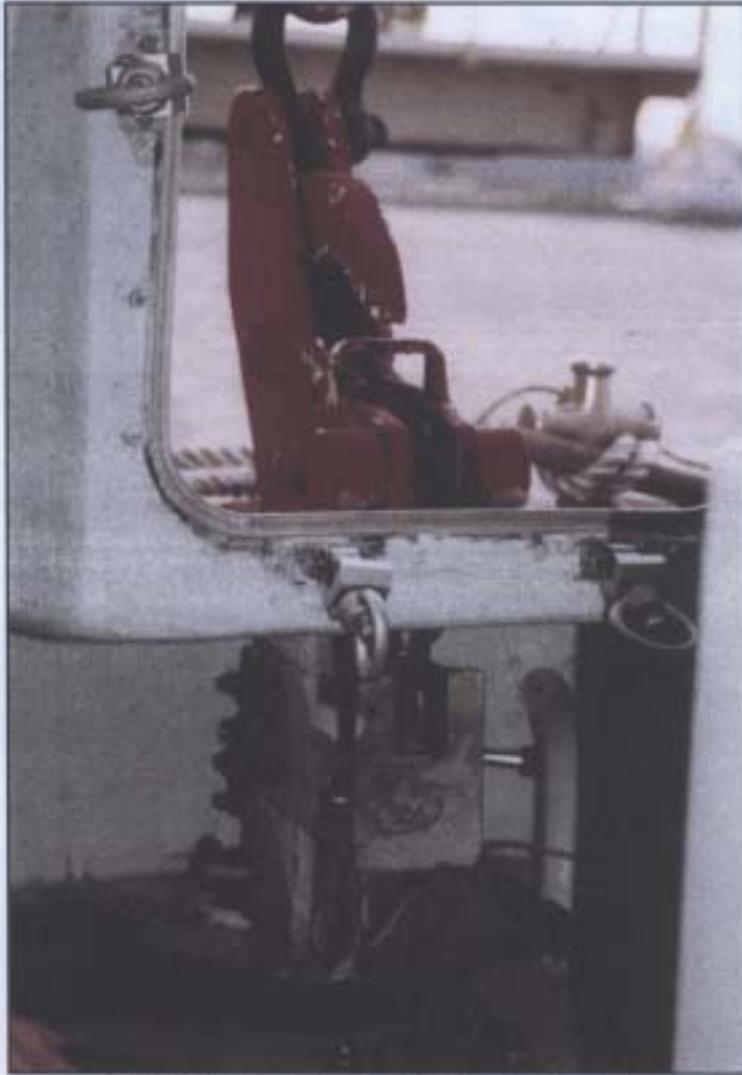
Figure 13

General view of stern hook mechanism

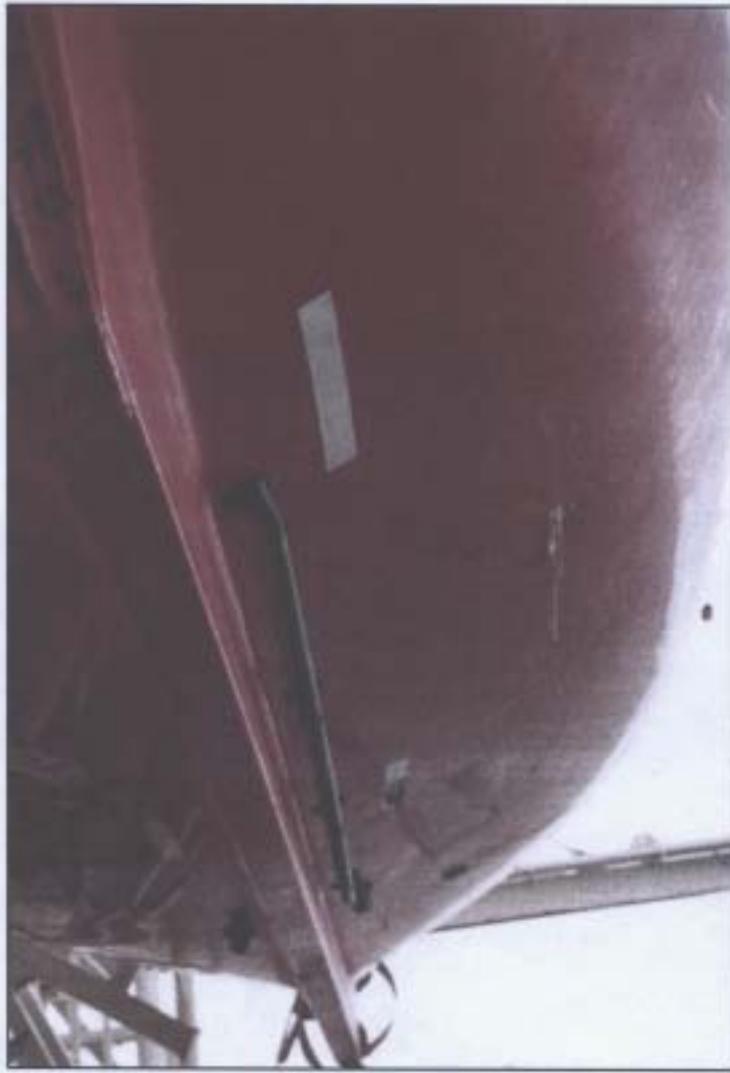
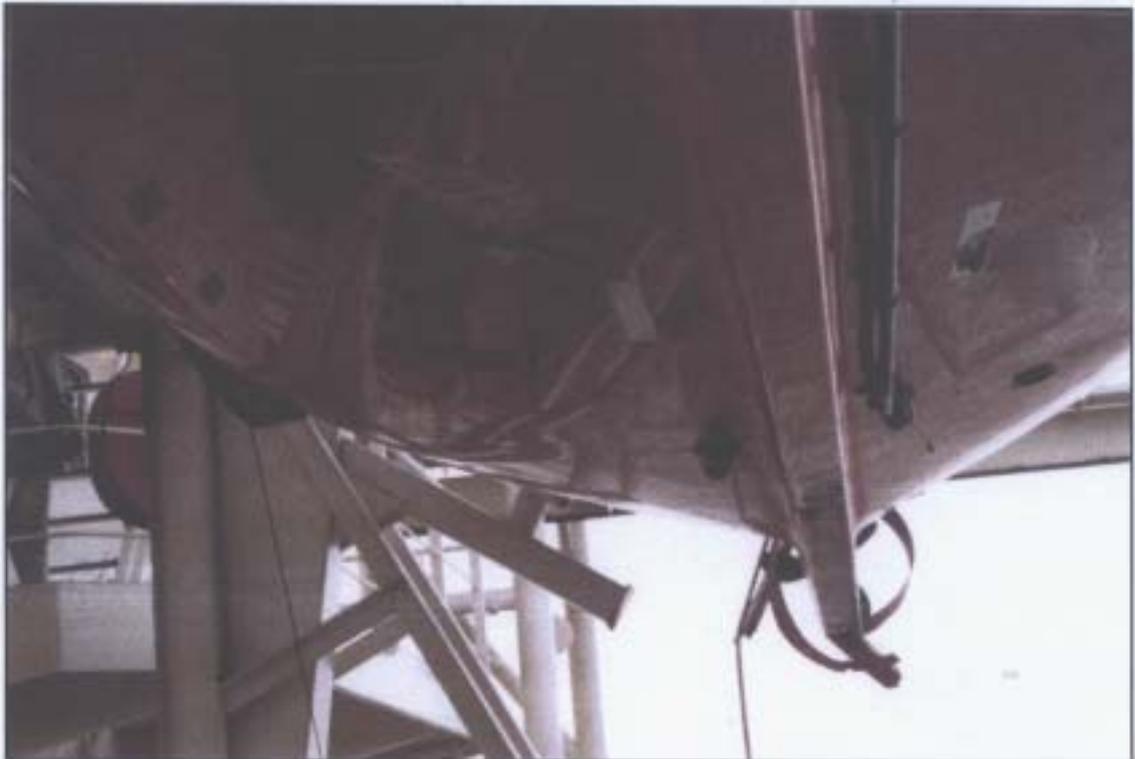
An examination of the lifeboat showed that the rudder, propeller guard ring and skeg were damaged, with scrape marks and two hull penetrations; one on the port side and one on the starboard side. Additional hull damage may become evident during detailed examination at the repair yard. Some damage was also present on the aft end of the canopy together with apparently minor damage to internal fittings.

Figure 14 - Damage to hull due to striking deck equipment during fall

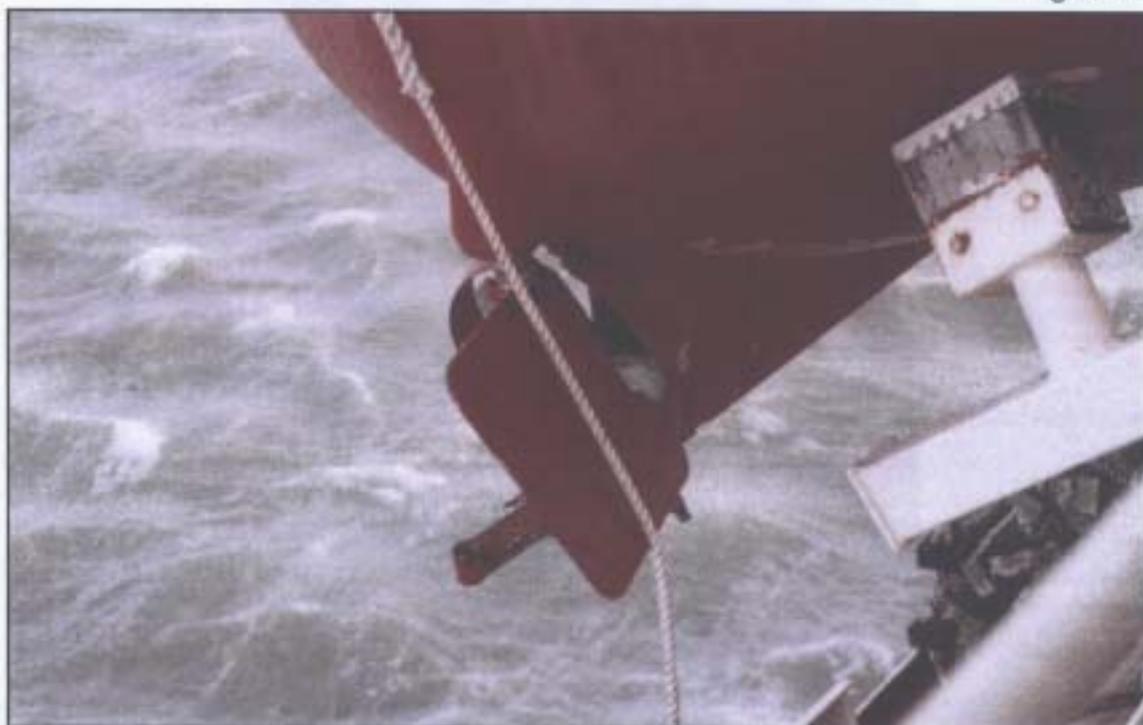
Figure 15

Damage to rudder assembly
