Report on the investigation of
the grounding of
Lagik
at Port Sutton Bridge on
13 December 2000

Marine Accident Investigation Branch
First Floor
Carlton House
Carlton Place
Southampton
United Kingdom
SO15 2DZ

**Report No 42/2001
December 2001**

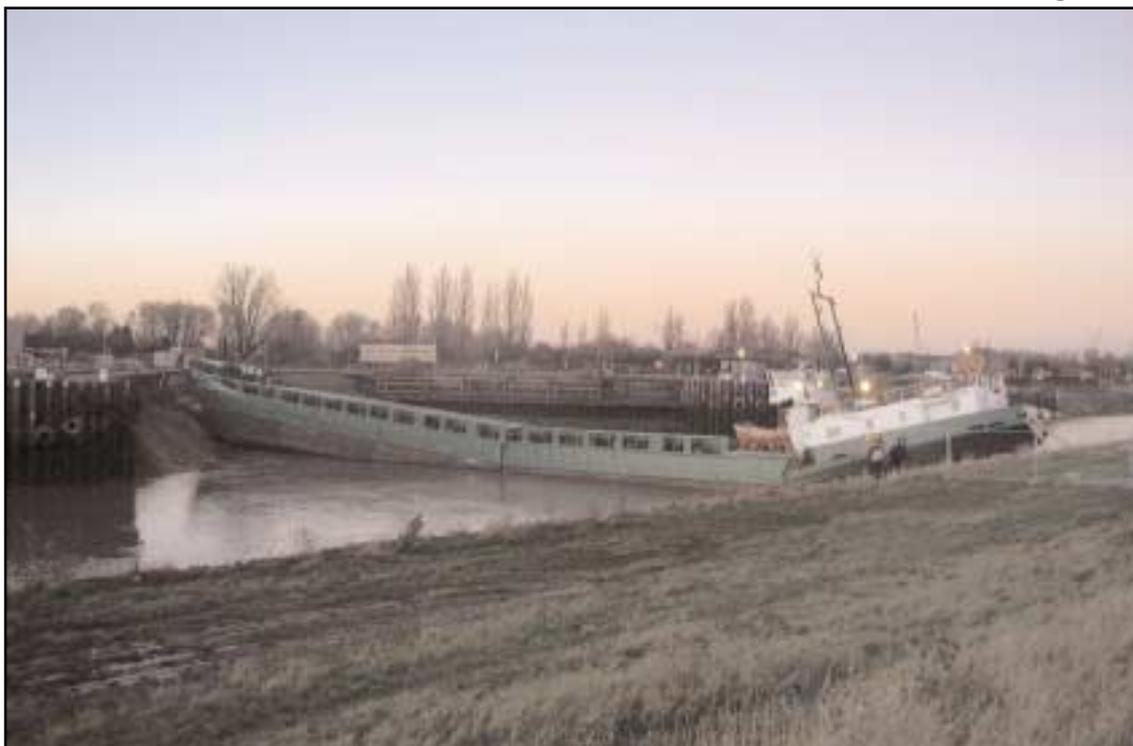
Figure 4

The tide was ebbing and the water level falling. The combination of the cargo weight and the falling tide became too much for the vessel's hull. At around 2315 cracking noises were heard coming from the cofferdam under the accommodation. The master went on to the main deck and could see fracturing occurring in the deck plating and side shell, and it became apparent that the vessel had broken her back. The pilot then informed the emergency services, and the fire brigade arrived within a few minutes. All eight persons on board left the vessel by a ladder from the stern on to the east riverbank. No injuries were sustained in the accident. At around 0200 the pilot informed Yarmouth Coastguard by VHF from his office. The Maritime and Coastguard Agency's (MCA) oil pollution response team was also informed.

The vessel settled further into the silt on the riverbed with each succeeding tide, and subsequently broke further to become effectively bent into three separate sections. It was clear that the vessel was a constructive total loss. Some minor pollution occurred. The counter-pollution team from the MCA was mobilised on 14 December **(see Figures 4-9 for views of *Lagik* aground)**.

Lagik's aground at low water

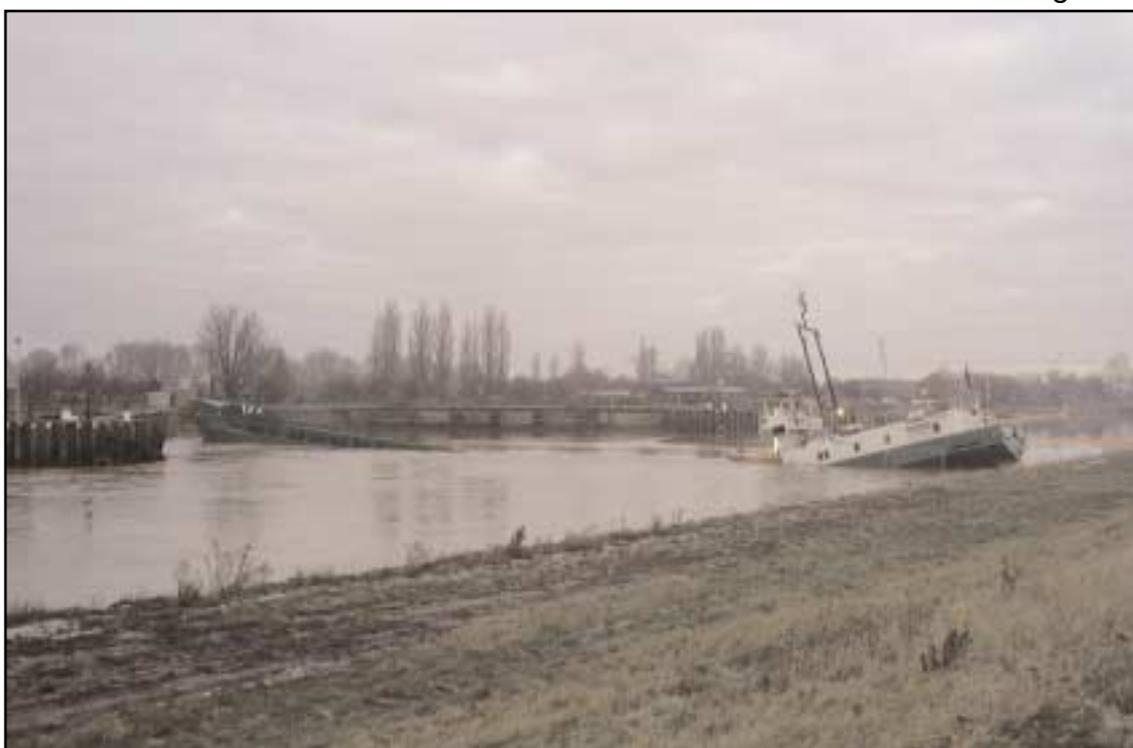
Figure 5

Lagik's aground at high water

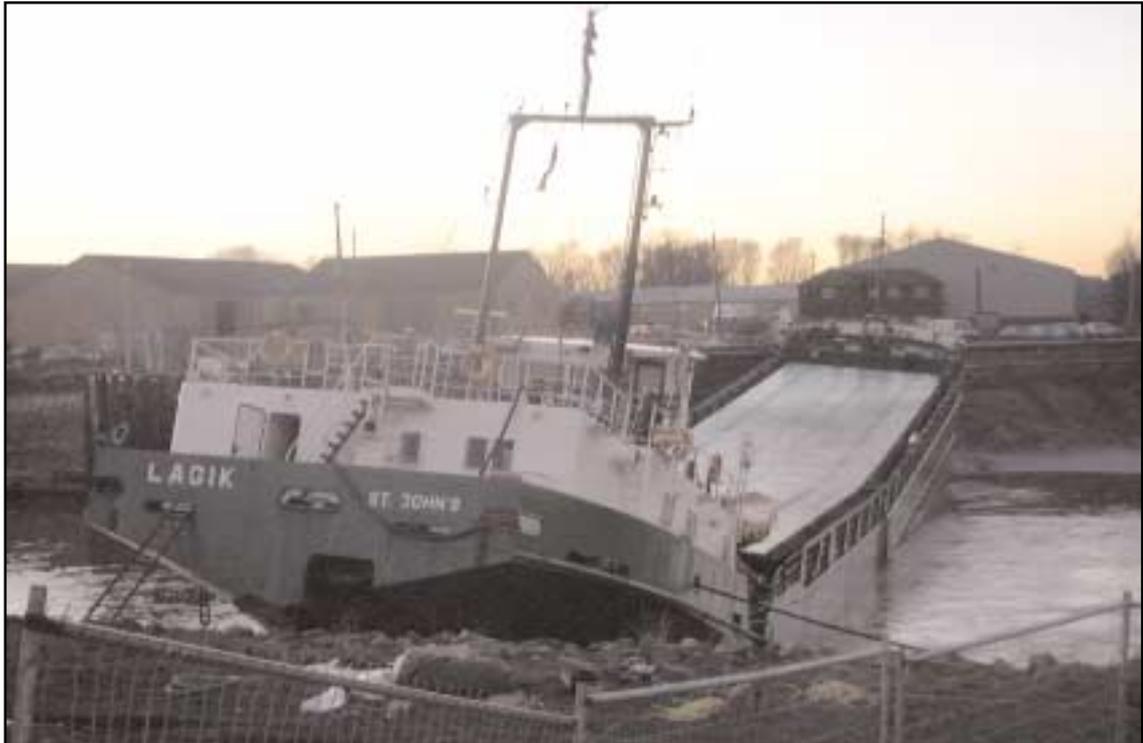
Figure 6

View from the east bank

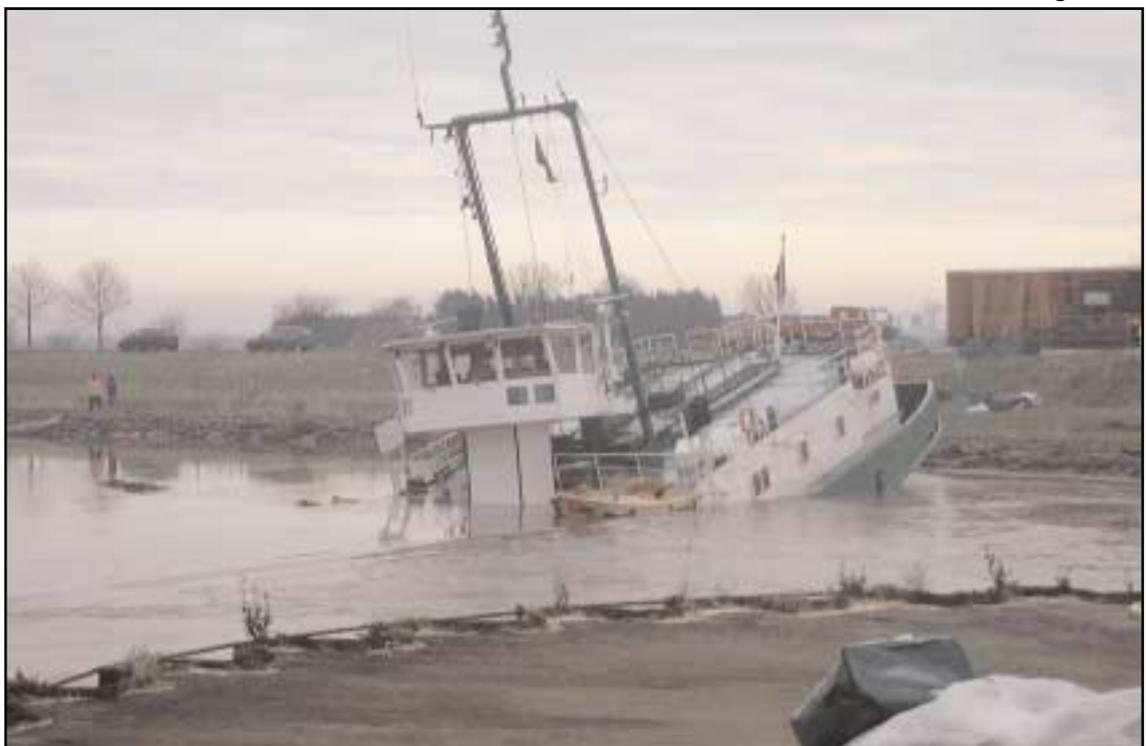
Figure 7

View from the west bank

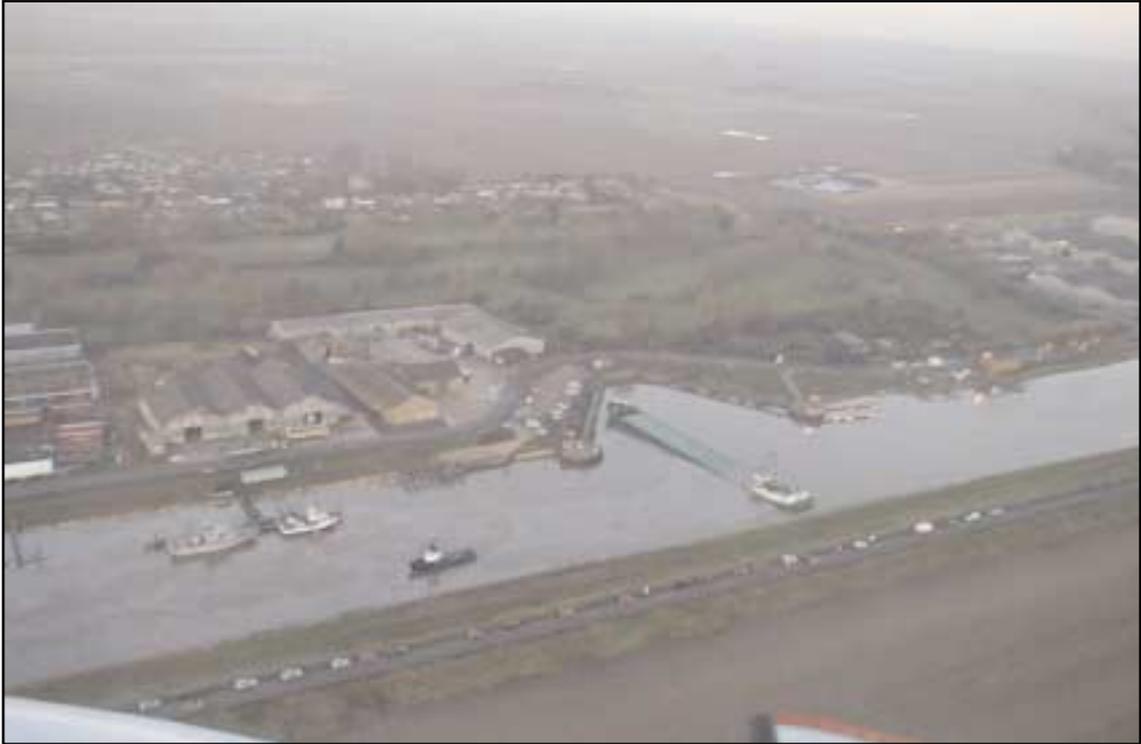
Figure 8

Aerial view from the east (note some pollution)

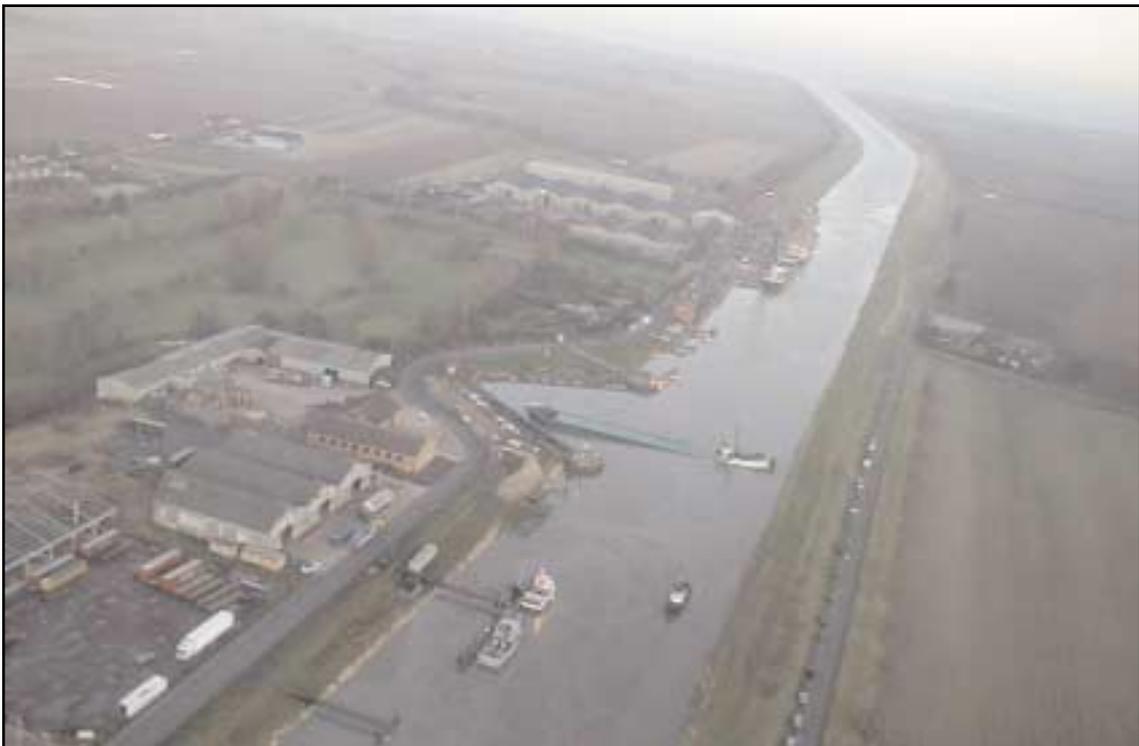
Figure 9

Aerial view from the south

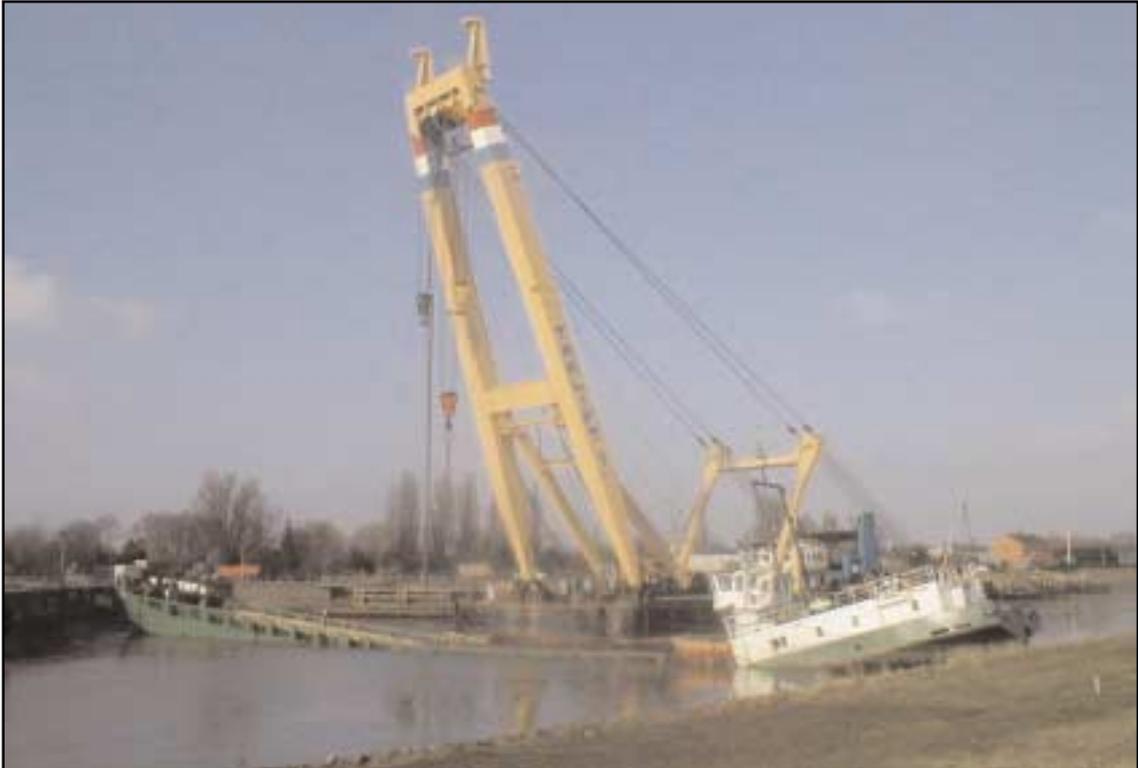
Figure 10

Floating crane moving into position

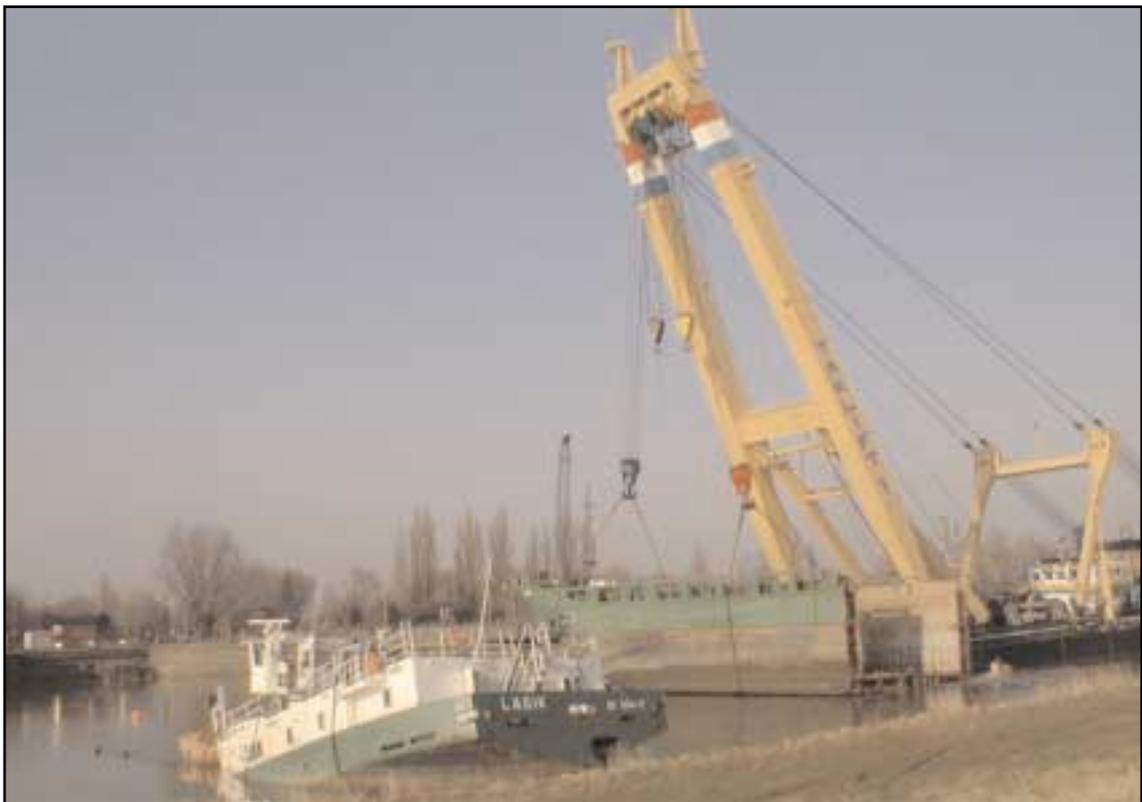
Figure 11

Floating section of *Lagik* is removed

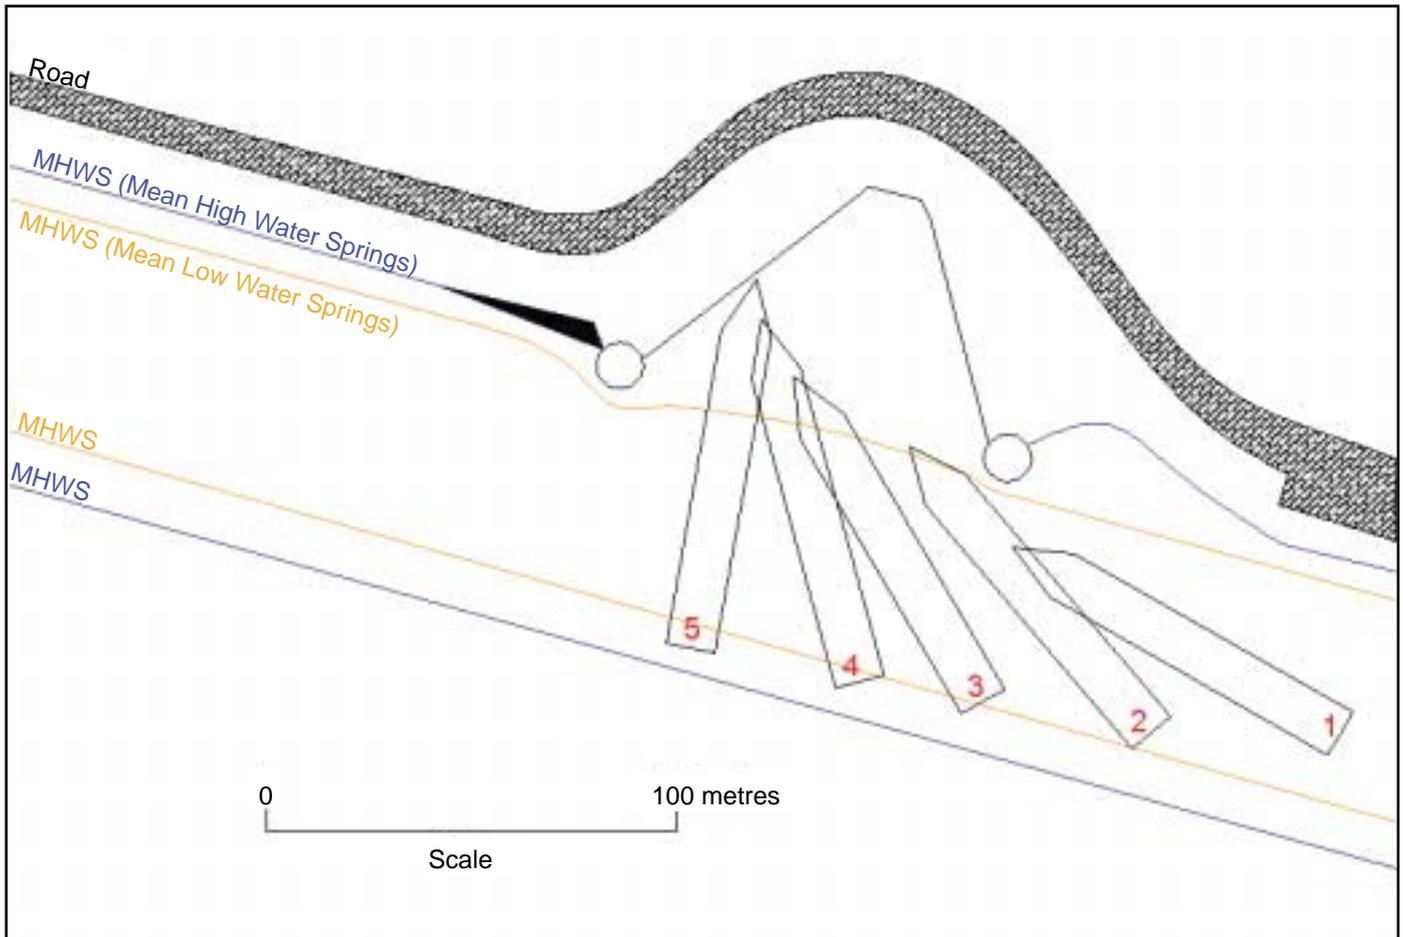
The turn and momentum were lost, and the vessel was out of control. It was unfortunate that the point at which the bow struck the swinging basin and the point on the east riverbank where the stern grounded, equalled a distance of almost exactly the vessel's length. This ensured that as soon as the stern went aground, which was within seconds of the bow's impact, the vessel became wedged in position **(see Figure 12 for an interpretation of the vessel's actual movements)**.

Interpretation of the vessel's actual movements during the incident
(5 represents the grounding position)
