Report on the investigation
of an accident on
the general cargo vessel

Baltiyskiy-107

resulting in the death of a seaman
on the 10 September 2000
while on passage from
Riga, Latvia, to Poole, UK

Report No 20/2001

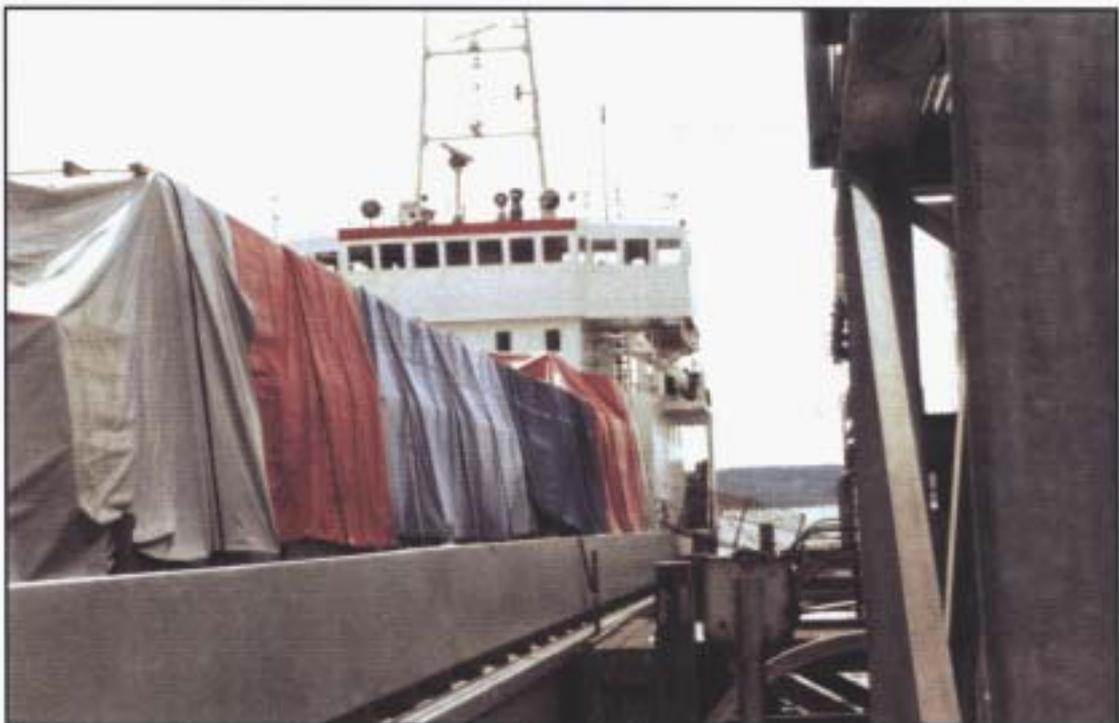
Figure 2

General view of port side showing deck cargo covered in tarpaulins

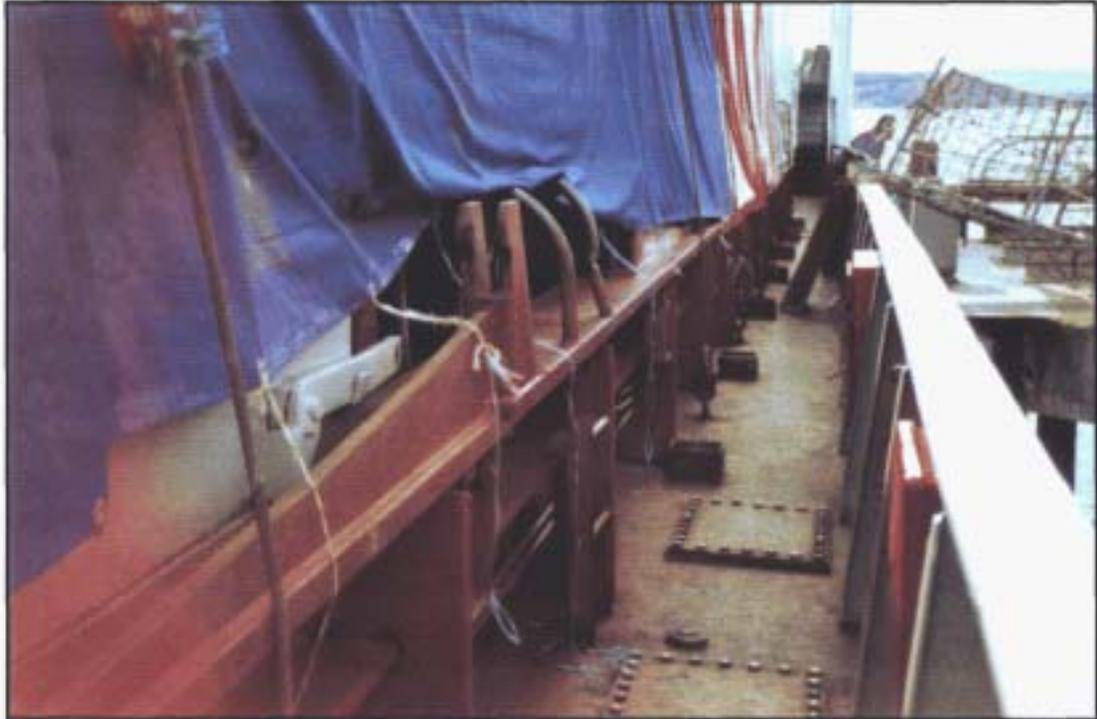
Figure 3

Port side between hatches 2 & 3 showing loose tarpaulin

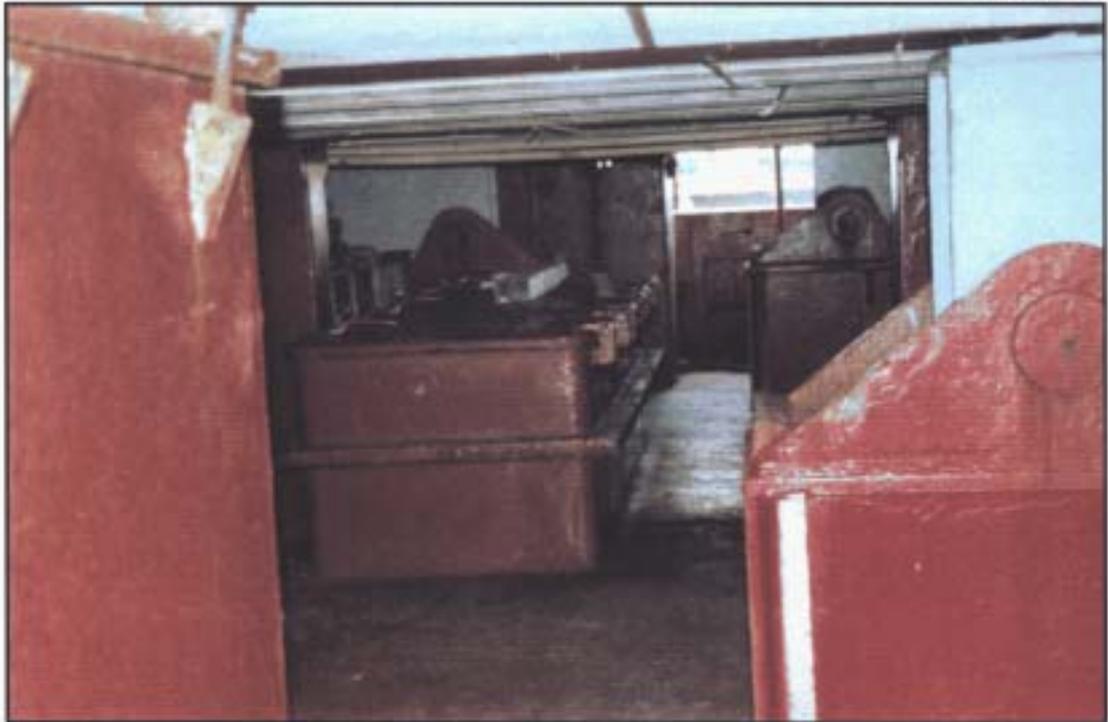
Figure 4

View of deck space between hatches 2 & 3 with deck cargo in place
- note limited headroom

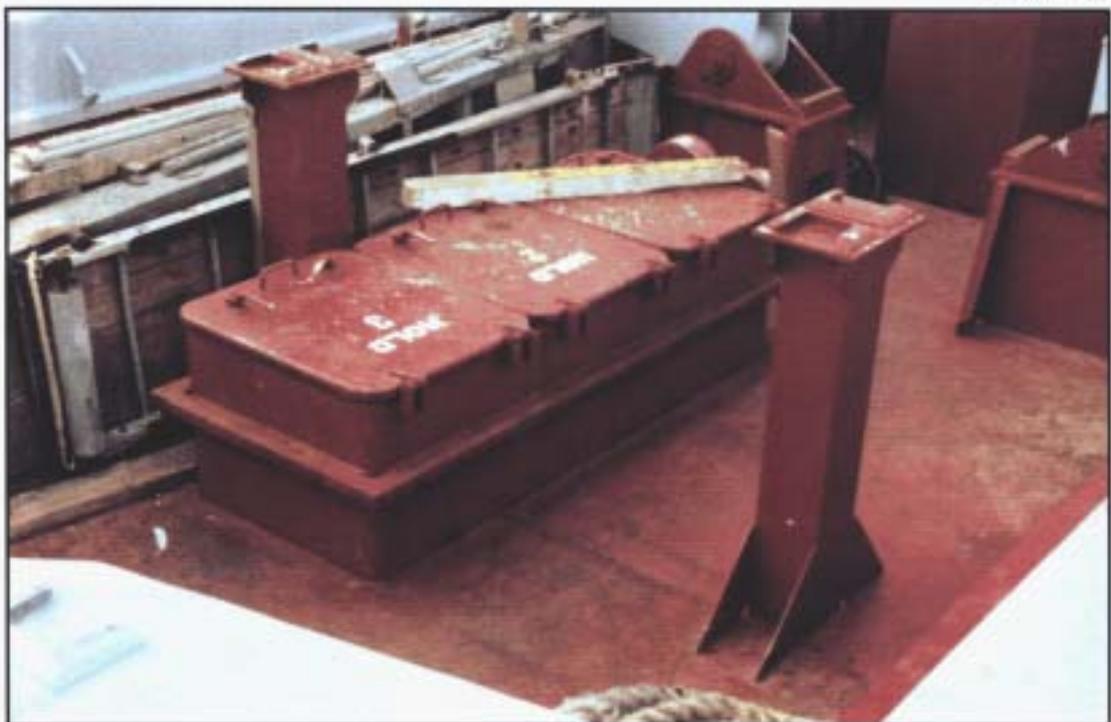
Figure 5

View of hold access hatches between holds 2 & 3 with deck cargo removed.
Entry to No 2 hold is the middle hatch

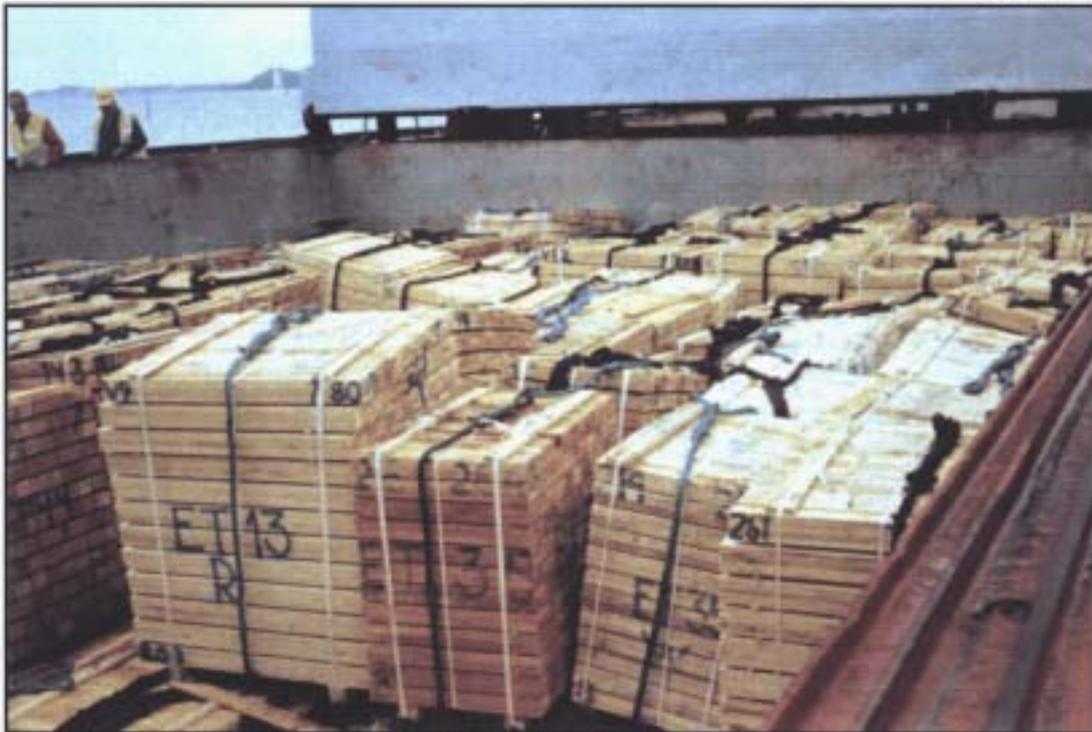
- 2.3.1 With all the packaged timber carried in the holds being described on the phytosanitary certificates as being free of any disinfestation or disinfection treatment, the atmosphere in the holds should not have presented any problem other than the natural smell of sawn timber. In Nos 1 and 3 holds, this was the situation when they were opened in Poole. In No 2 hold, however, there was a distinctive sharp smell noticed by both the Poole stevedores on first opening, and in Goole when the hold was re-opened after the voyage from Poole (**Figures 6 and 7**).

As No 2 hold had been open in Poole for some hours while the death was being investigated, and some timber packages were removed temporarily, the return of the sharp smell suggested that the cause was either in the timber itself, or in the ship's bilges. The latter was discounted on completion of discharge; leaving the timber as the prime suspect.

General view of No 2 hold with deck cargo removed

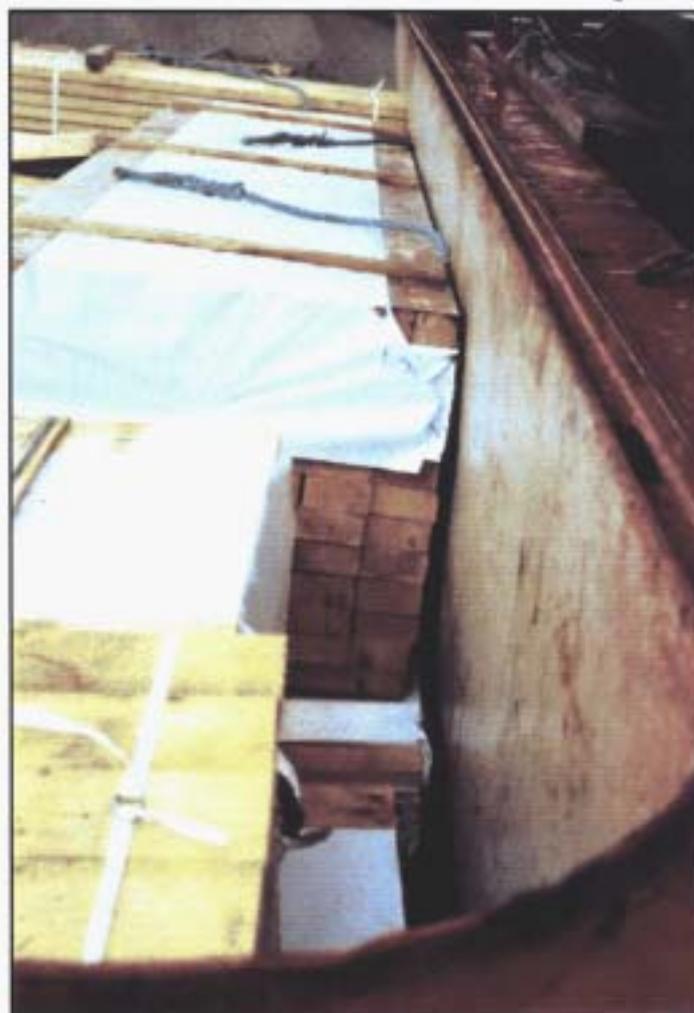
Figure 7

Looking from port to starboard at aft end of No 2 hold

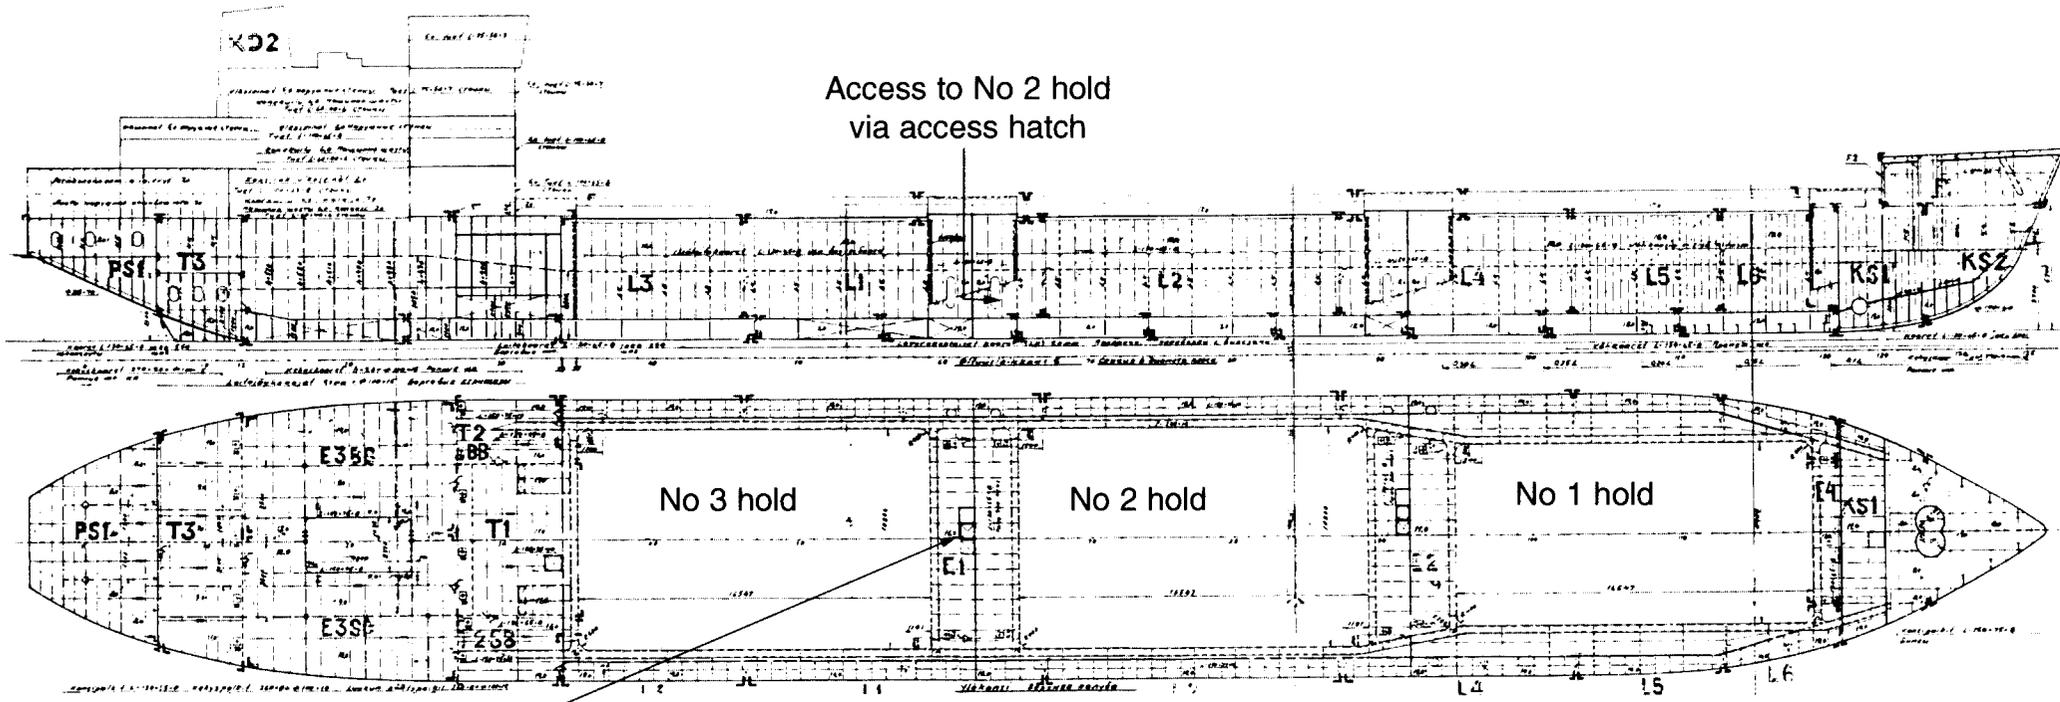
1. Outline deck arrangement of *Baltiyskiy-107*

Access to No 2 hold
via access hatch

Access hatch to No 2 hold
