Report on the investigation of

a fatal accident on board

mfv Dunan Star (CY 26)

Report No 38/2000

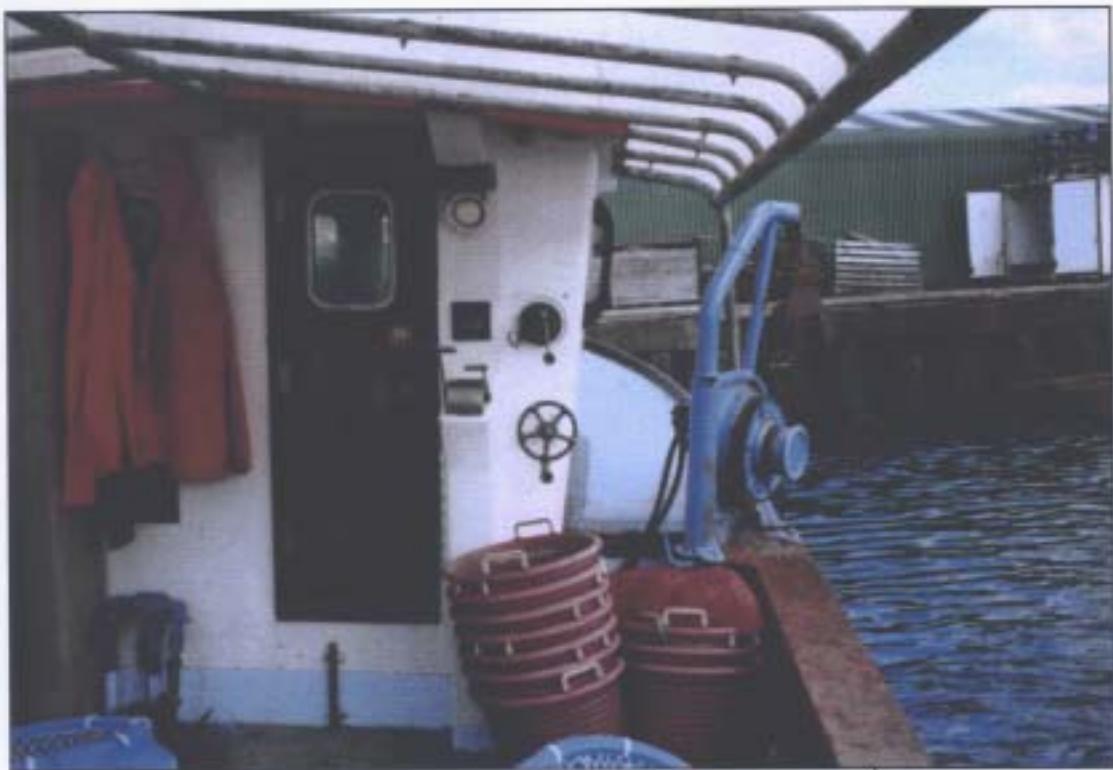
Figure 2 - Pot hauler and control position

An additional helm position was situated on deck on the starboard side of the wheelhouse, close to the hydraulic pot hauler and its controls.

After hauling, re-baiting and stacking the third fleet of pots, preparations were made for shooting. The skipper, who remained on deck, set *Dunan Star* on a course for shooting using the additional controls on the starboard side of the deck forward.

The skipper immediately rushed forward to the dual controls on the starboard side and put the engines full astern in an effort to release the weight on the back rope. He also grabbed a knife, which was to hand. However, by this time the deckhand had been pulled over the side and was nowhere to be seen.

The skipper then grabbed the next pot in rotation, jammed it under the gunwale and cut the pot from the back rope, creating more slack. This enabled him to get the back rope into the hauler and to start heaving.

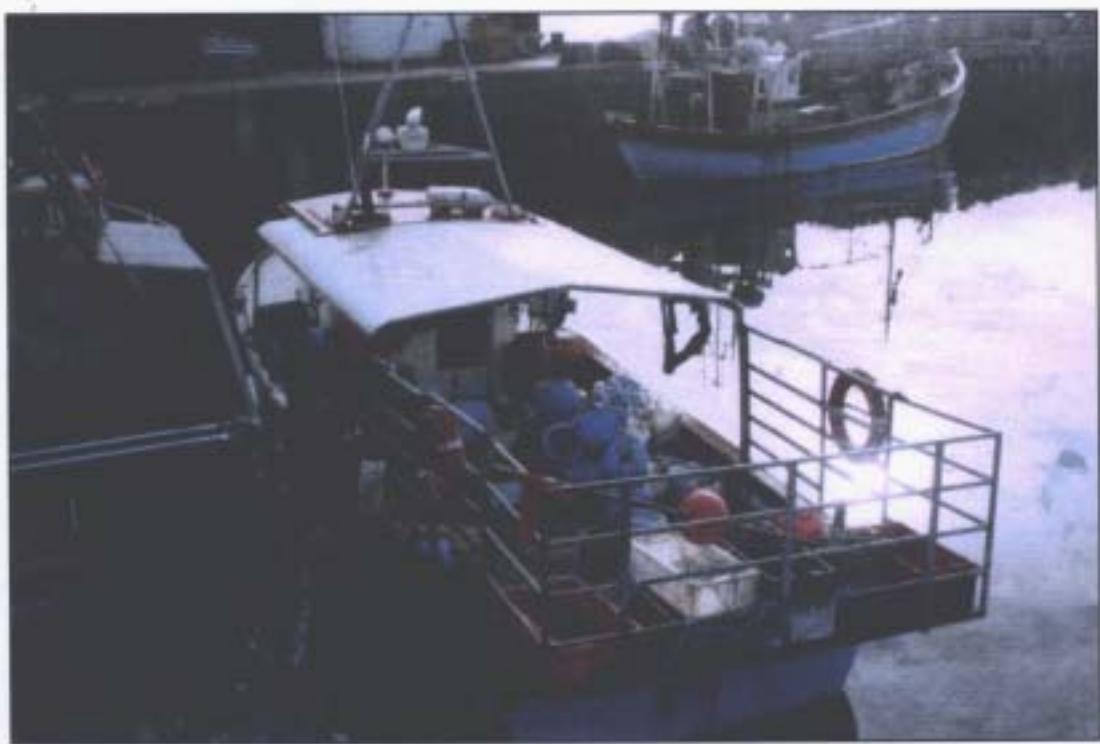
Figure 3 - Working deck

A shooting bar (a vertical steel pole set into the gunwale or similar arrangement) guides the back rope over the vessel's bulwark as the rope is pulled from the pile across the deck by the forward motion of the vessel.

The pots are taken from the stack in reverse order. A crewman lifts the pot from the stack and passes it over to another crewman positioned at the shooting bar. The pot is then lifted on to the gunwale and held until it is pulled overboard. One man has to complete both tasks if the crew is reduced to two men, and the skipper is in the wheelhouse during the shooting operation. It then requires the crewman on deck to move about, increasing the risk of being snagged in the back rope.

The crewman holds the pot on the gunwale, and the back rope crosses the deck near his feet. As each pot goes overboard, the next pot in sequence is placed on the gunwale ready for shooting. Meanwhile the back rope is still being pulled overboard, and often whips across the deck in bights. The crewman must take particular care at the shooting position to ensure that he is not caught by one of these bights.

After approximately 53 pots had been shot, leaving 6 or 7 on deck, the skipper went to pick up the next pot in rotation, when he heard the deckhand scream. He turned round and saw a bight of back rope around the deckhand's leg. He was hanging on to the starboard rail in an attempt to prevent himself being dragged over the side by the way on the vessel, and the weight of the pots that had already been shot.

The cause of the accident was the casualty becoming entangled in a bight of back rope and being dragged over the side.

- To adopt an alternative deck system, such as a detachable pot/toggle system, which would prevent the crew coming into contact with the back rope during shooting operations.
- To provide the crew with working type lifejackets when working on deck on board their vessels.

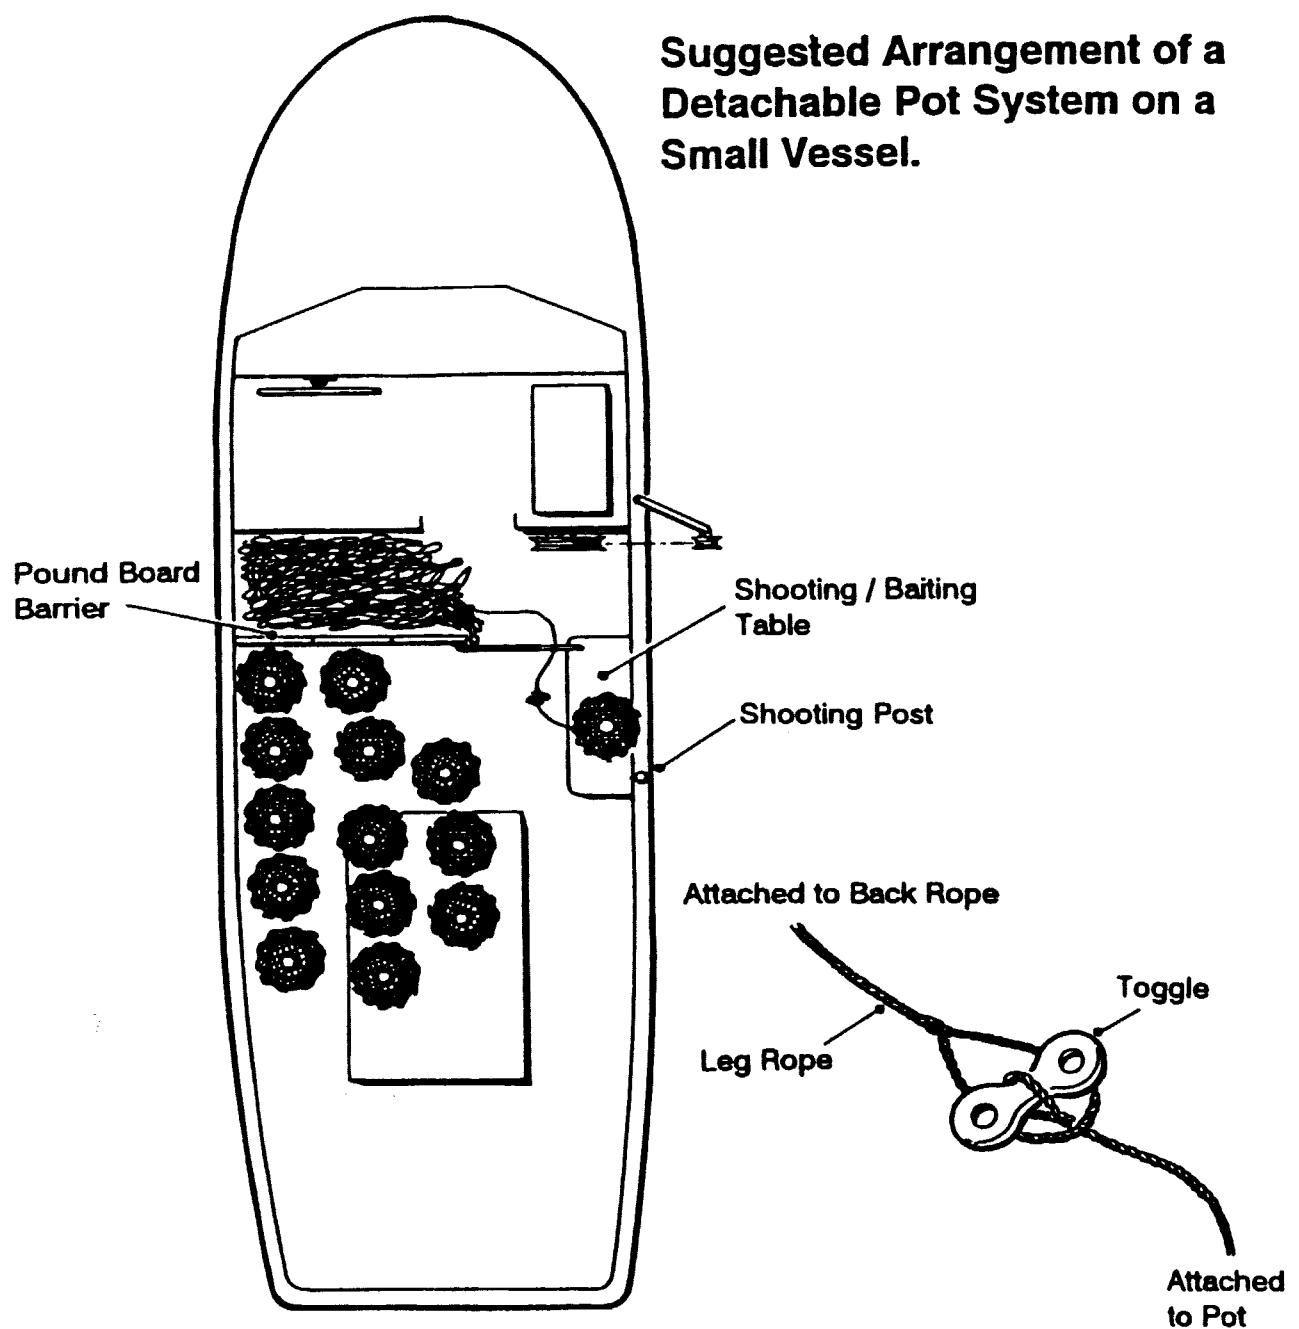
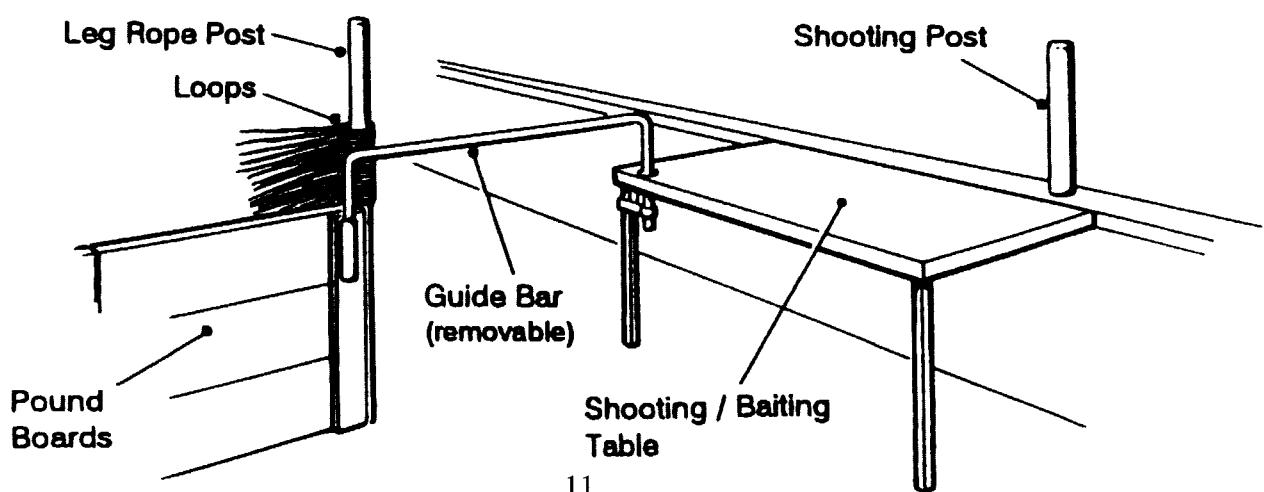
Figure 4

The key to this system is a toggle clip which connects into a loop to join together the two-piece leg rope at a point quite close to the pot. During hauling, each pot is detached from the back rope, allowing the pot to be stored independently of the rope.

The loops on the leg rope are placed, in order, over a vertical pole. When the pots are shot, the toggle is connected back to the loop, and the pot is allowed to go over the side of the vessel.

Apart from the ability to stack the pots out of sequence, the system gives more compact storage of the back rope, allowing a division to be constructed, separating the rope from the deck area where the crew handle the pots (**Figure 4**).

Suggested Arrangement of a Detachable Pot System on a Small Vessel.

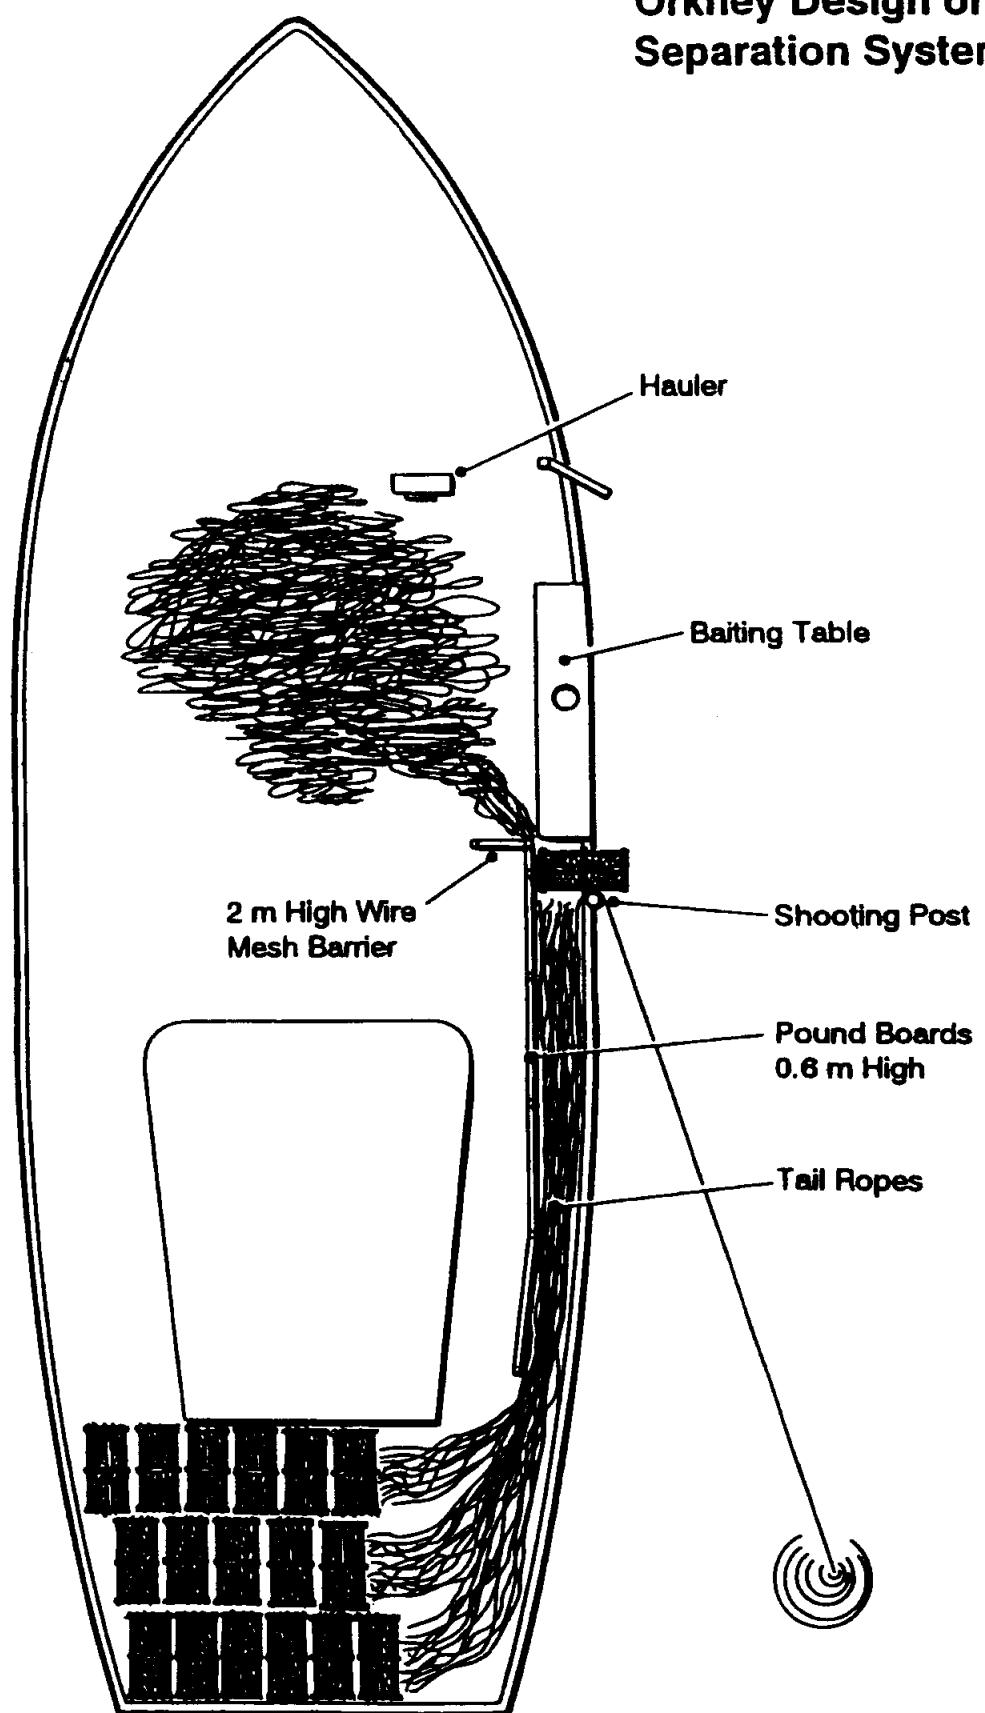
A method of separating the back rope and leg ropes from the crew is by using pound boards or divisions. The design of the barrier will depend on the layout of the vessel, and the stacking of the pots.

Figure 5 shows a separation system devised by an Orkney skipper who introduced it after one of his crewmen was killed when he became snagged in the back rope while shooting.

Orkney Design of a Separation System
