**Report on the investigation of
an accident to the
skipper of the fishing vessel
Wakil II (BW 147)
3.5 miles south-west of St Bees Head
on 10 April 2000**

Marine Accident Investigation Branch
First Floor, Carlton House
Carlton Place
Southampton
United Kingdom
SO15 2DZ

Report No 40/2000

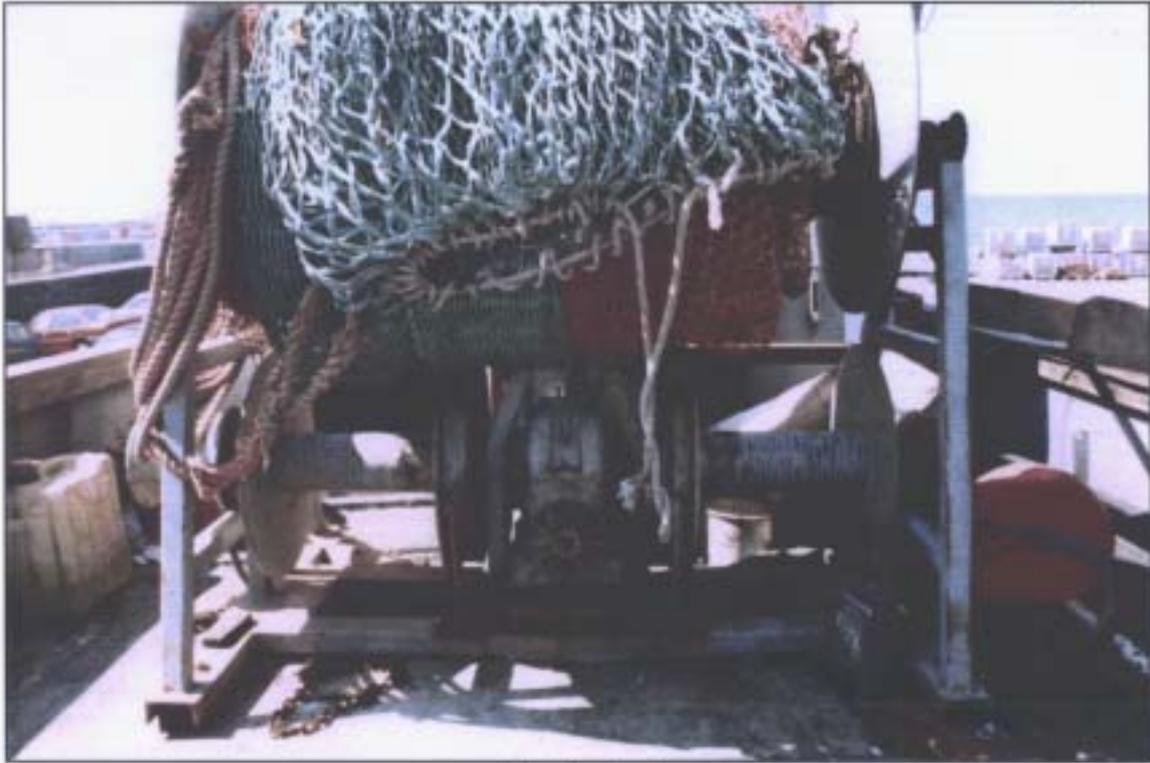
Figure 3

The hydraulic trawl winch was powered independently from the main engine by a 9kW, twin cylinder Petter diesel. The operating control lever for the winch was situated on the forward side. The winch was not fitted with a dead man's handle.

Trawl winch

Back on deck, while the gear was being heaved up, the skipper continued grading prawns from the previous haul into the boxes. While in a position near to the port winch barrel, he lost his footing and fell on to the port trawl warp as it was being heaved on to the winch.

He fell awkwardly, and the sleeve of his oilskin jacket caught on a shackle connecting the heavy warp to the light warp. He was dragged on to the port barrel of the winch. The sleeve of his jacket became trapped in the winch from the cuff to the neck, pinning him to the deck underneath the winch barrel.

The winch was not fitted with a dead man's handle, a device requiring the operator to apply pressure to the control lever during operation. Because of this, it was possible for the skipper to leave the winch while it was heaving.

Had a device, such as a dead man's handle, been fitted to the winch control, the skipper would not have been where he was, with the winch running, when the accident occurred.

2. Consider carrying out a risk assessment.
3. Consider fitting a dead man's handle to the winch control on board his vessel.

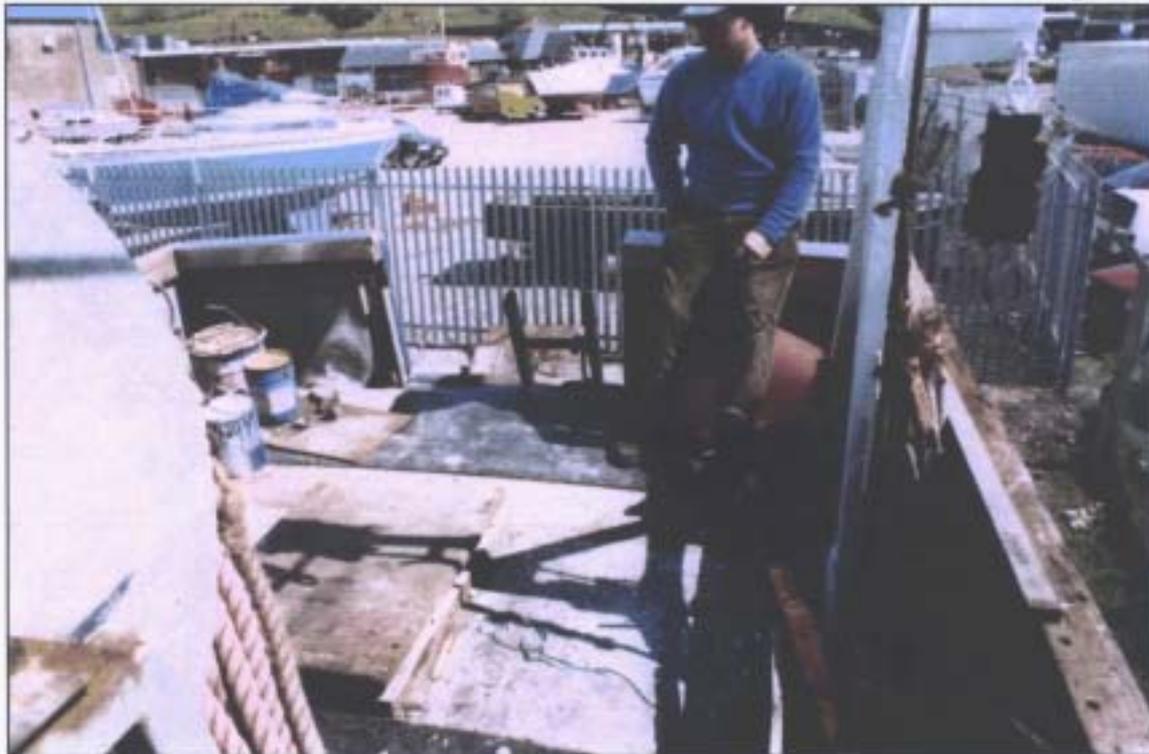
Figure 4

Working deck

With the deck so cluttered, the skipper had to step on the fish boxes when moving around.

It was normal practice for the skipper to clear the working deck of any obstructions before hauling. However, on this occasion, because not all the catch had been graded from the previous haul, an unnecessary hazard was created by the six fish boxes on the small working deck aft.

Had the working deck been cleared before commencing the hauling operation, in accordance with the skipper's normal practice and the advice given in *Fishermen and Safety*, the hazard would not have existed, and the accident might have been avoided.
