Report of the investigation
of the loss of two crewmen from
fv Astra II
while berthed at Carbost pier,
Loch Harport, Isle of Skye
on 2 April 2000

Report No 31/2000

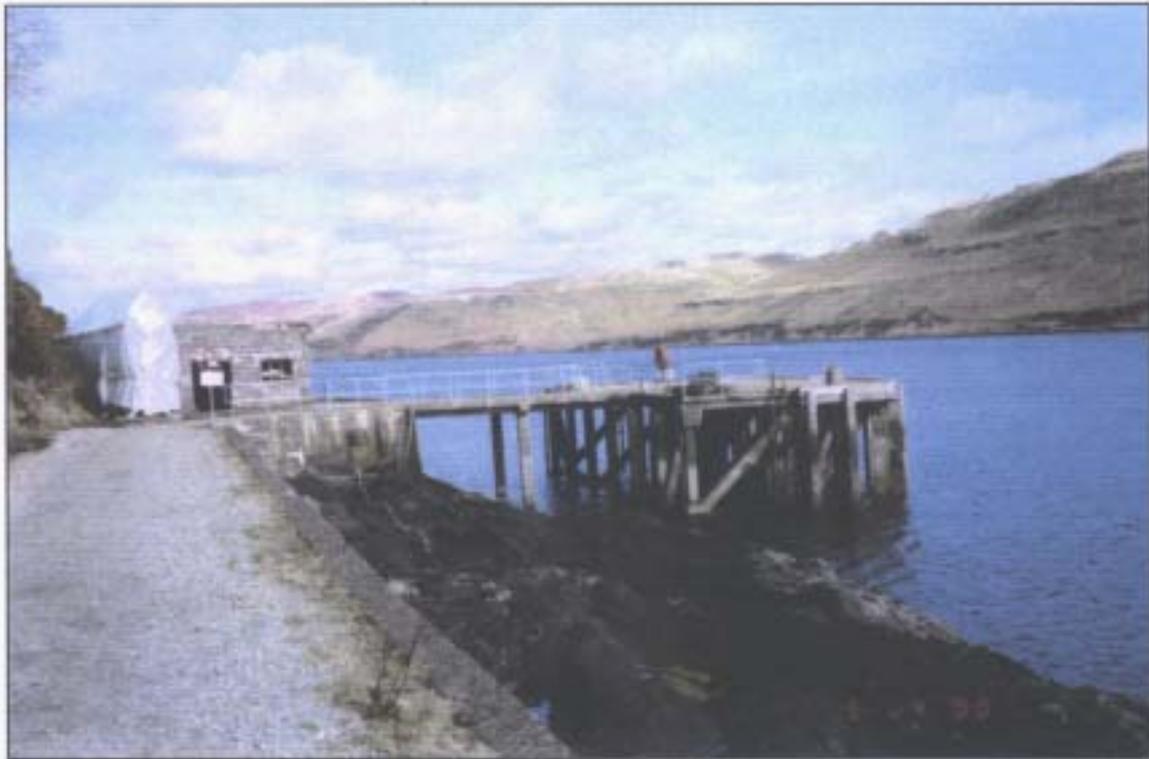
Carbost pier and approach path

The absence of artificial lighting would make this pier and its approach path particularly hazardous to anybody using it at night. This is the main difference between this pier and quays normally found in commercial harbour areas.

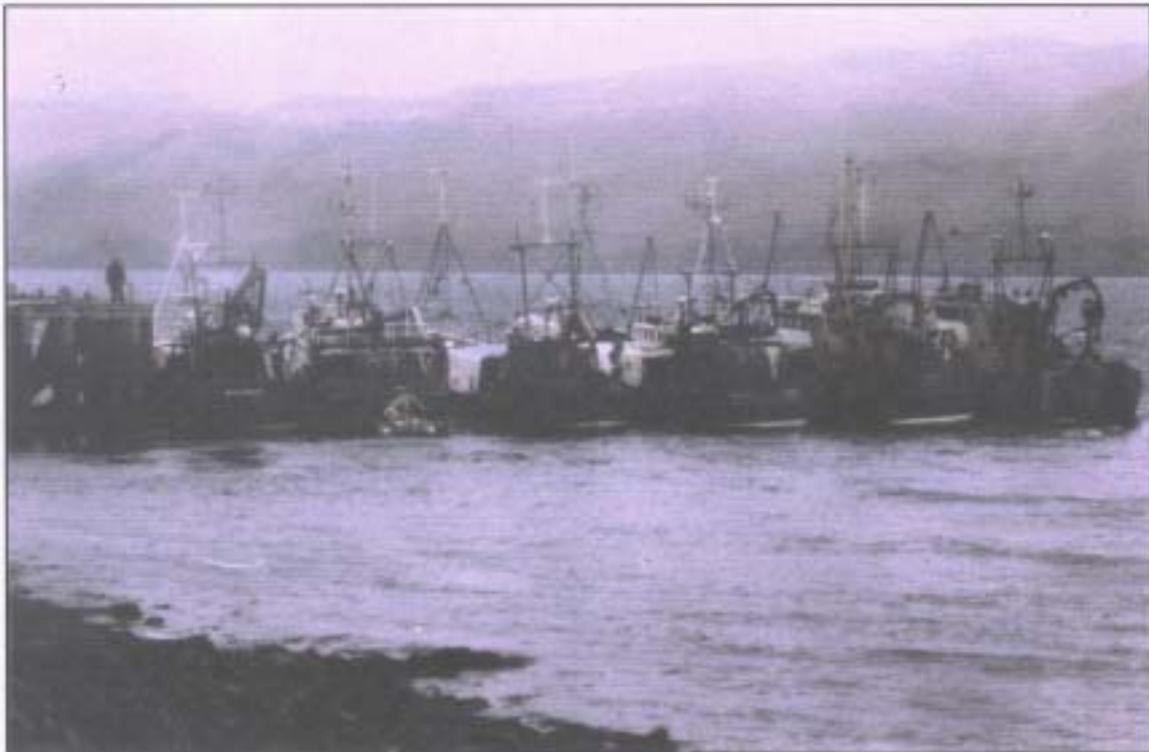
Fishing vessels at Carbost pier on 2 April. *Astra II* is at the extreme right. The vessel that had been third from the pier at the time of the accident sailed before this photograph was taken.
