**Report on the investigation of
the flooding and foundering of
*fv Annandale (BF 89)***

**16 miles NNE of the Shetland Islands
on 23 March 2000**

Report No 5/2001

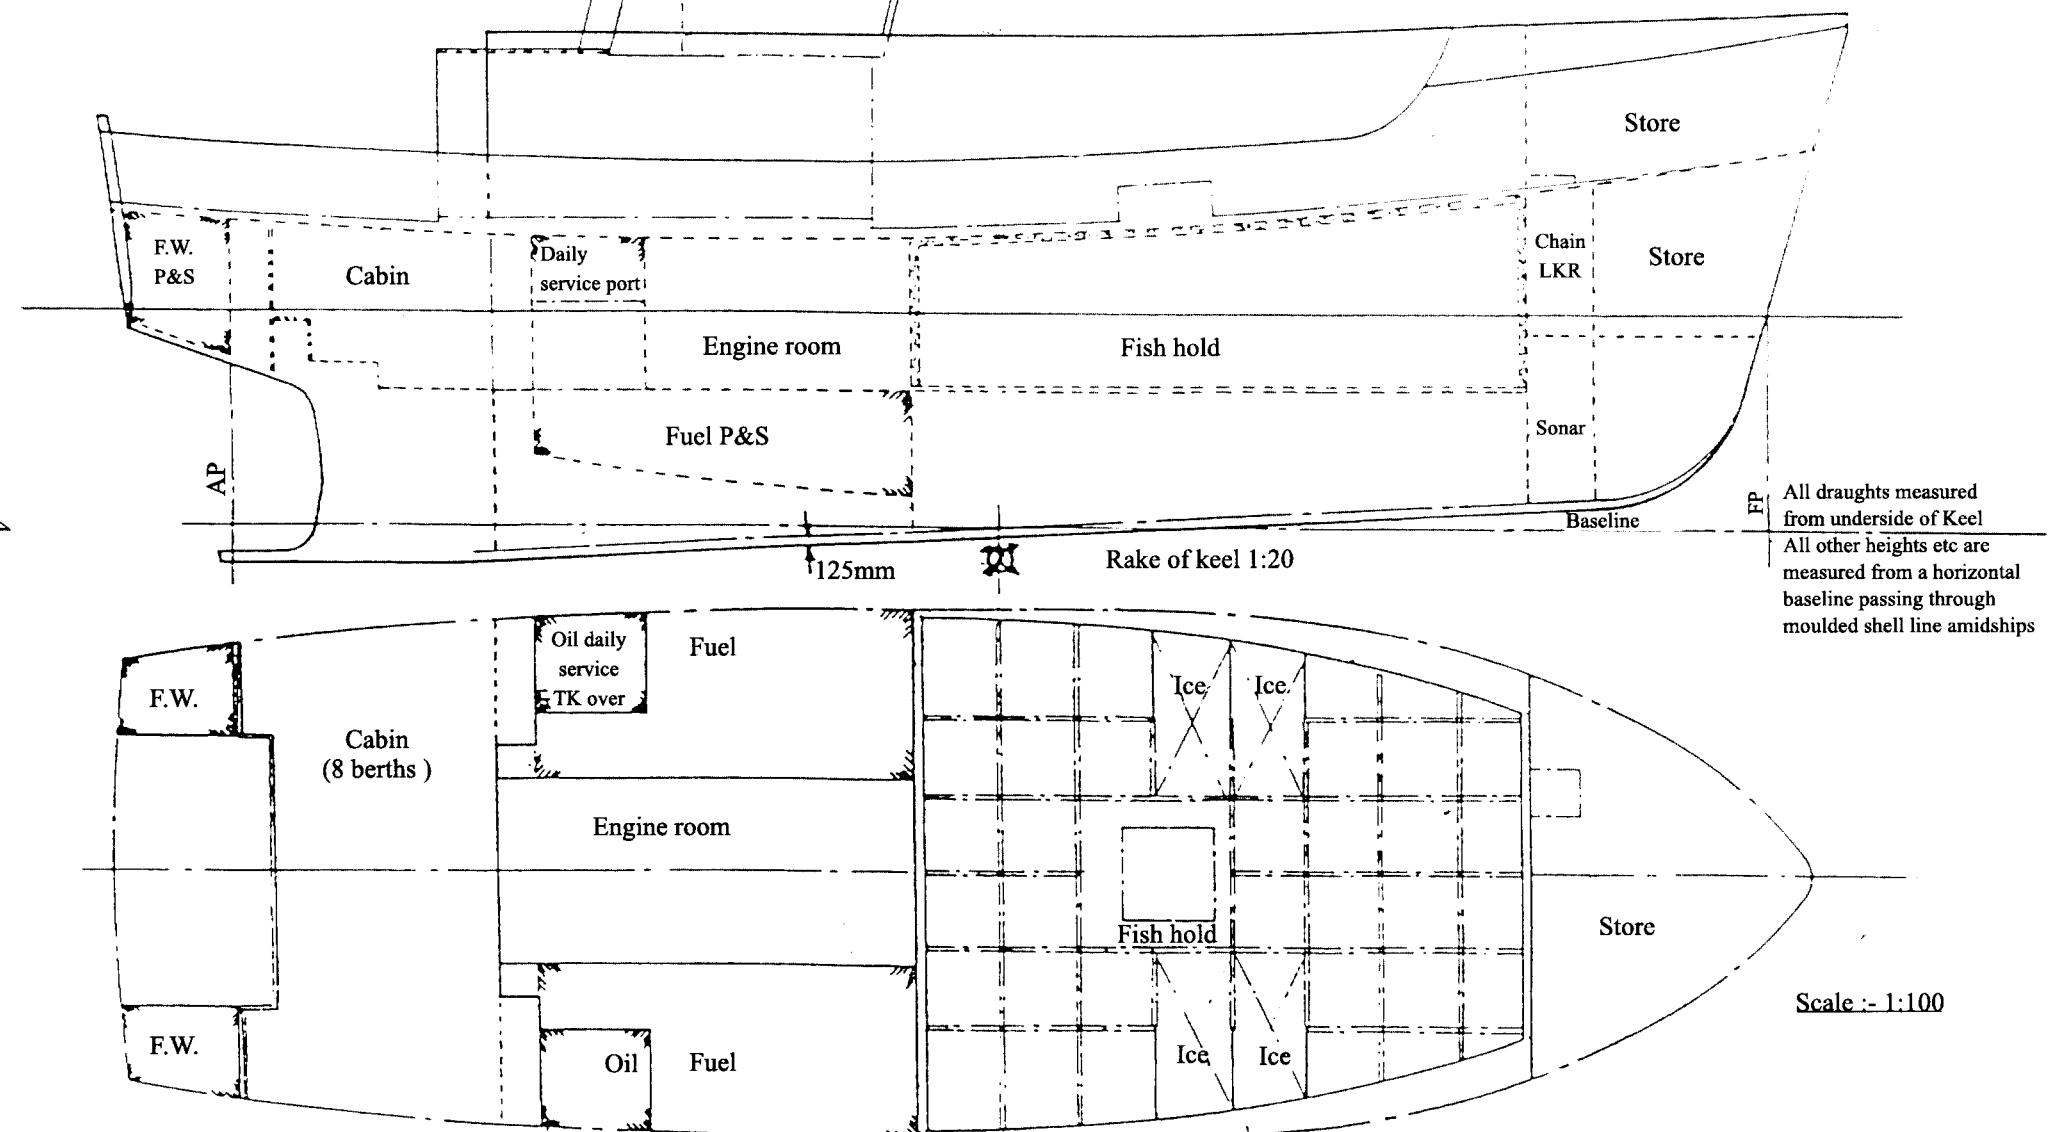
Annandale BF89 - General Arrangement

Under deck, the accommodation was situated aft. Forward of this were the engine room, fishroom, chain locker and forepeak.

Bulkheads separated the engine from the cabin and fishroom. The bulkhead between the cabin and engine room was non-watertight. The bulkhead between the engine room and the fishroom was watertight.

Annandale was required under *The Fishing Vessel (Safety Provision) Rules 1975*, to have a watertight machinery compartment. She did not meet this requirement as the flooding, observed by the skipper, spread aft into the cabin space, which meant the aft bulkhead in the engine room was not watertight.
