**Report of the Investigation
of heavy weather damage
to Hovercraft GH-2007**

The Princess Anne

**while crossing from Calais to Dover
on 29 February 2000**

Report No 26/2000

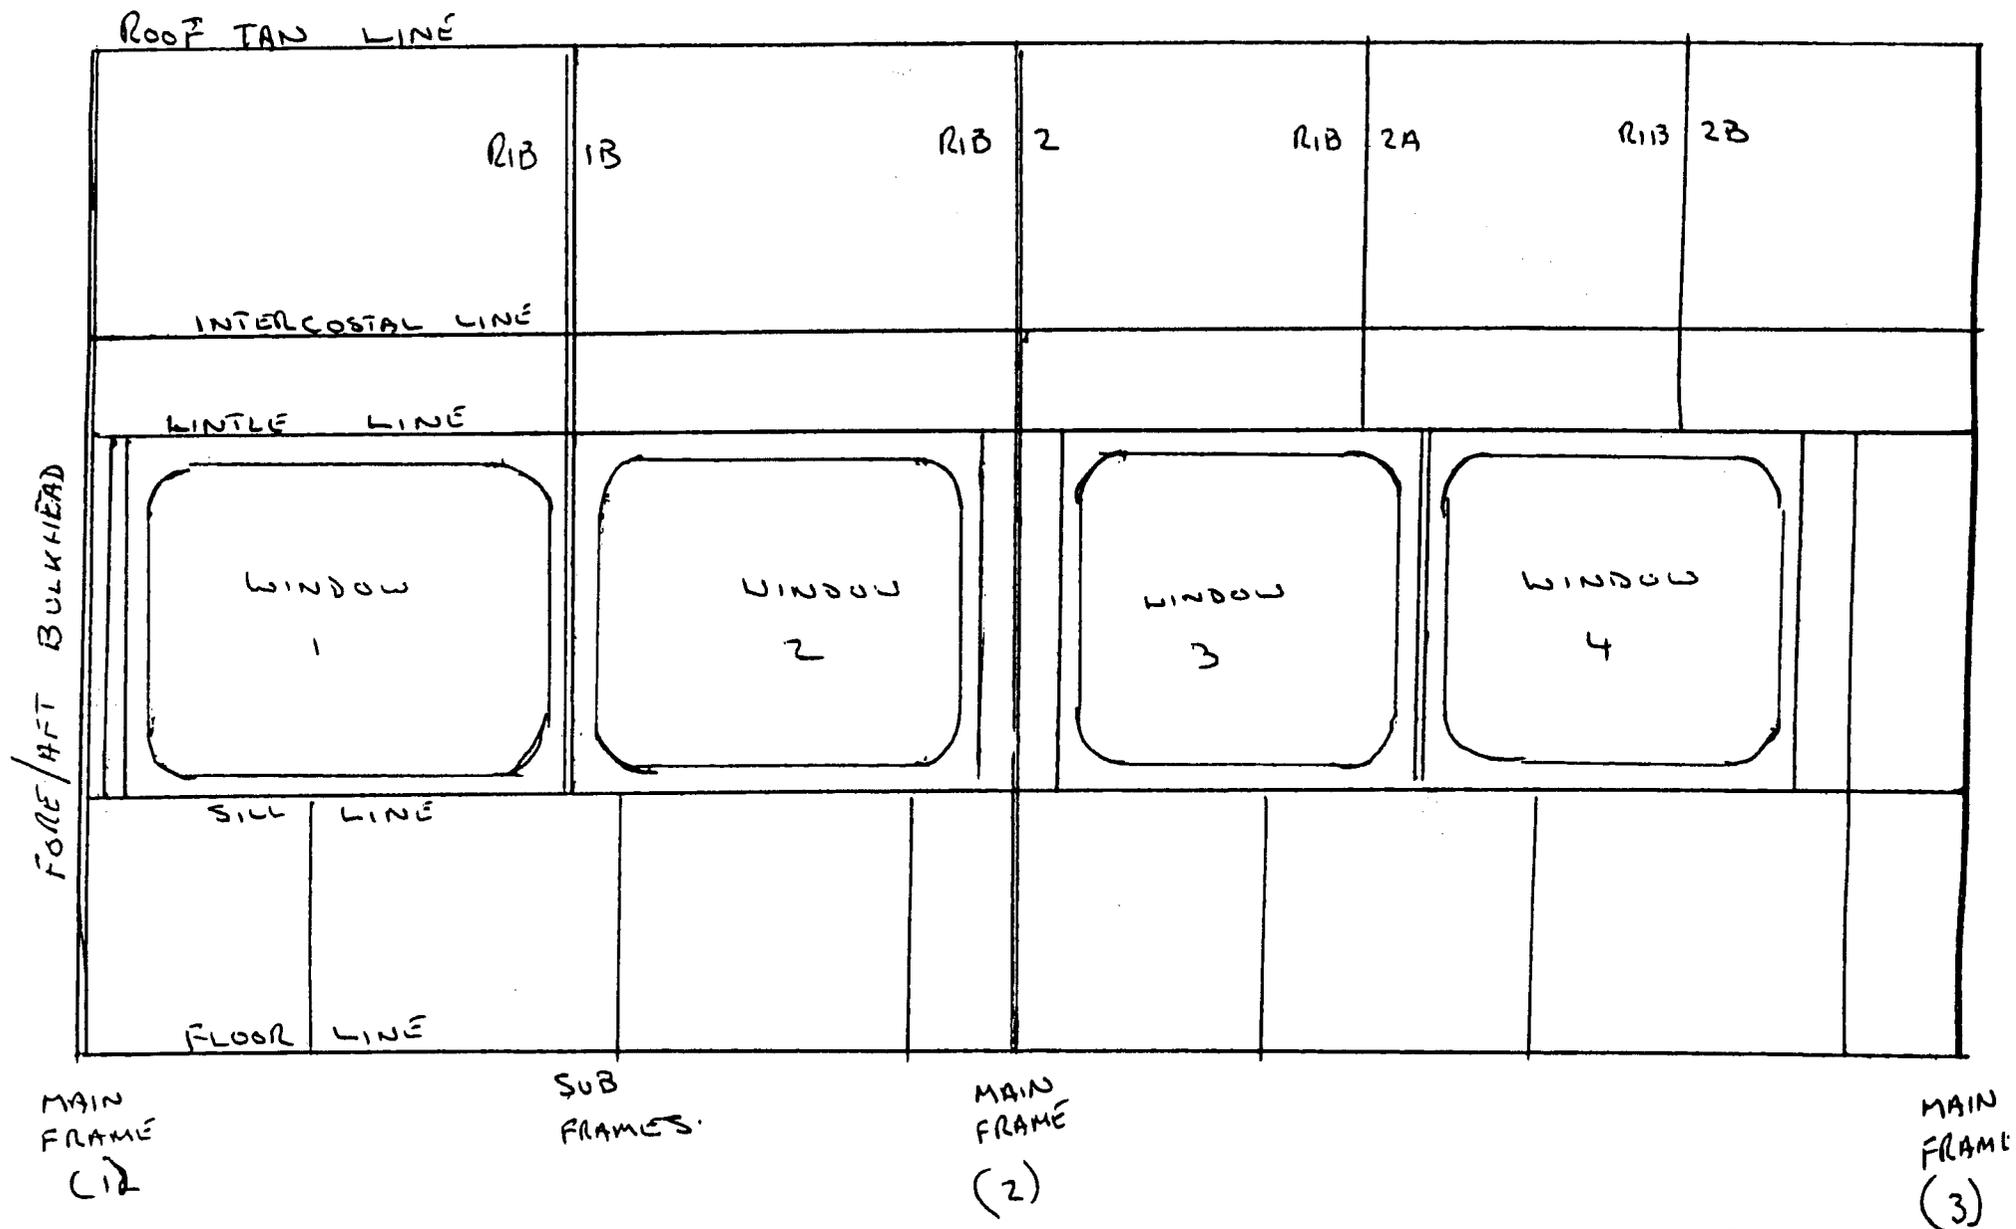
29-2-00

When *The Princess Anne* was taken out of service, the owners' technical management team visited the craft in Calais and carried out a full survey of the damaged area. The damage was very localised, affecting a number of roof ribs, the roof lining, the support structure above and below the windows between main frames 2 and 3, and water damage to carpets, seats, electrical items, and cabin fittings. A detailed list of the damage is in **Annex 1**.

GH2007 STBD FWD CABIN VIEWED FROM INSIDE LOOKING FWD.

The main forward window structure, roof ribs etc were replaced at the repair berth during the next two days. Protracted delivery times for other cabin linings and fittings prevented immediate completion of the repairs. With the craft fully operational apart from the starboard forward cabin space, she was allowed to re-enter service on Friday 10 March. When the other fittings arrived, repairs were completed during Friday and Saturday nights.

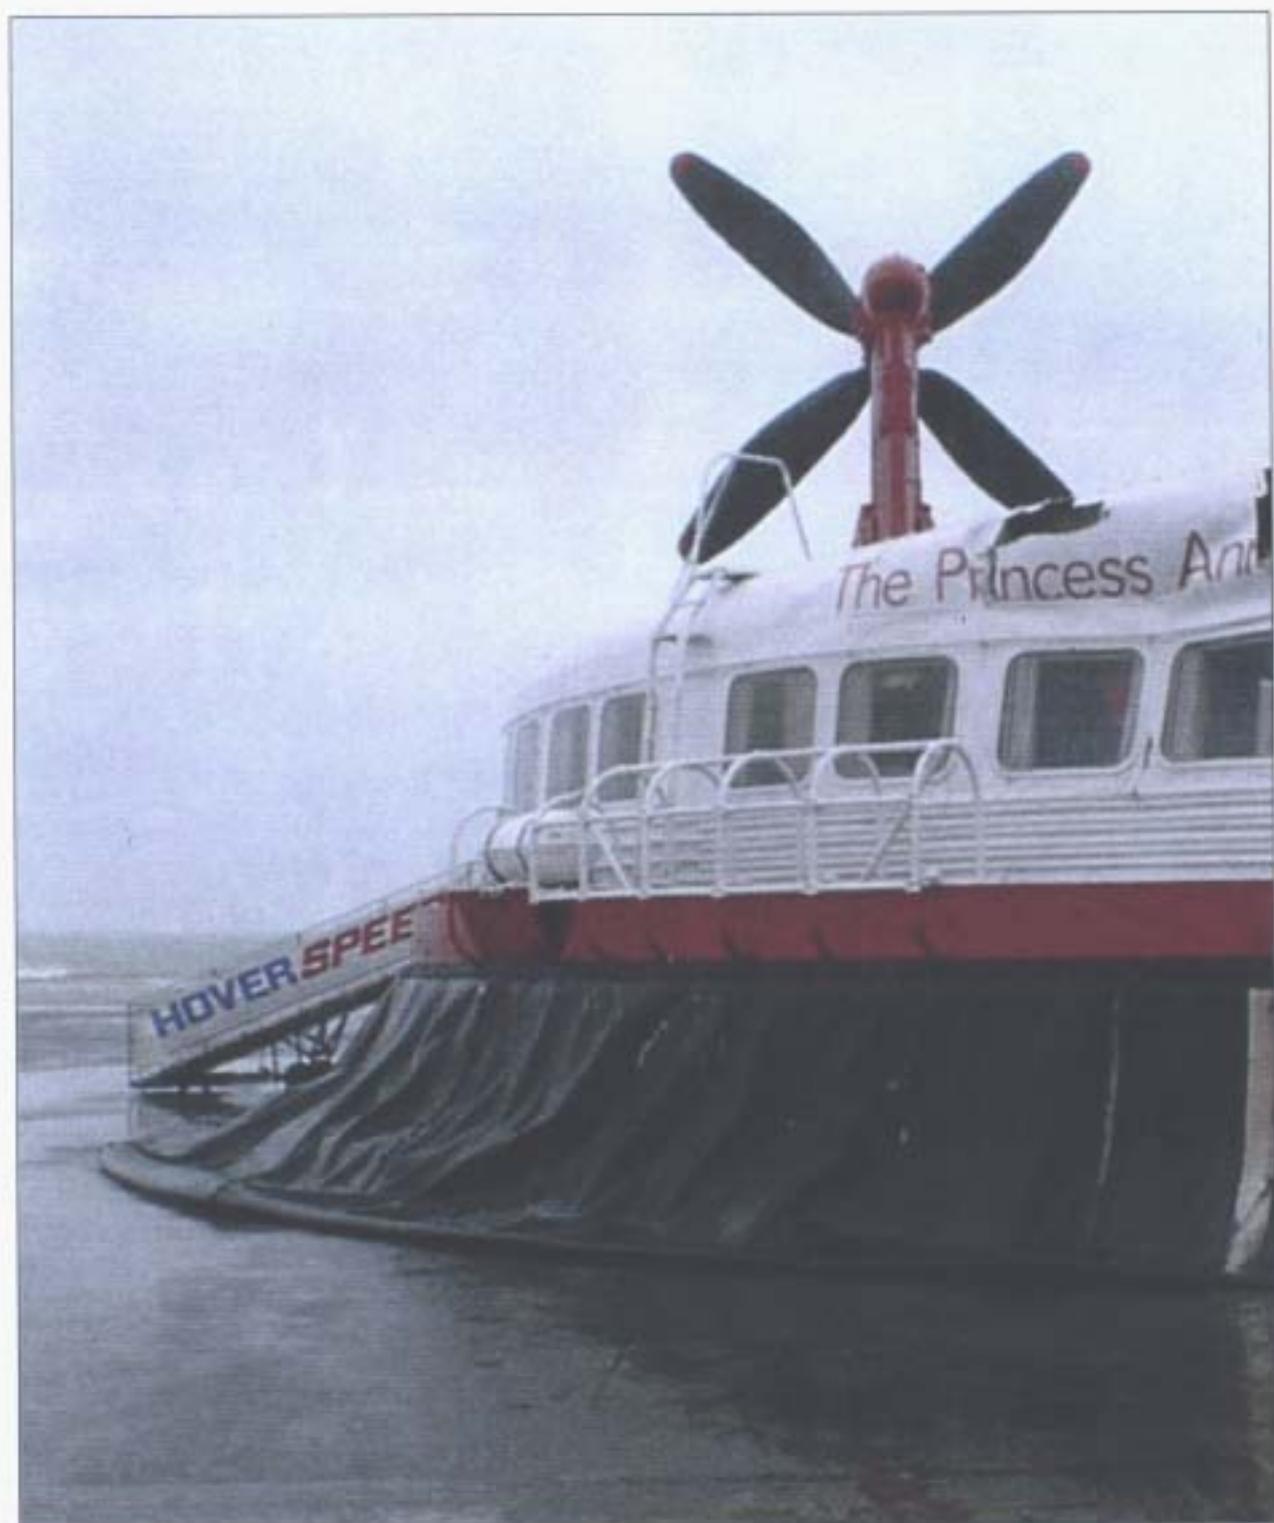
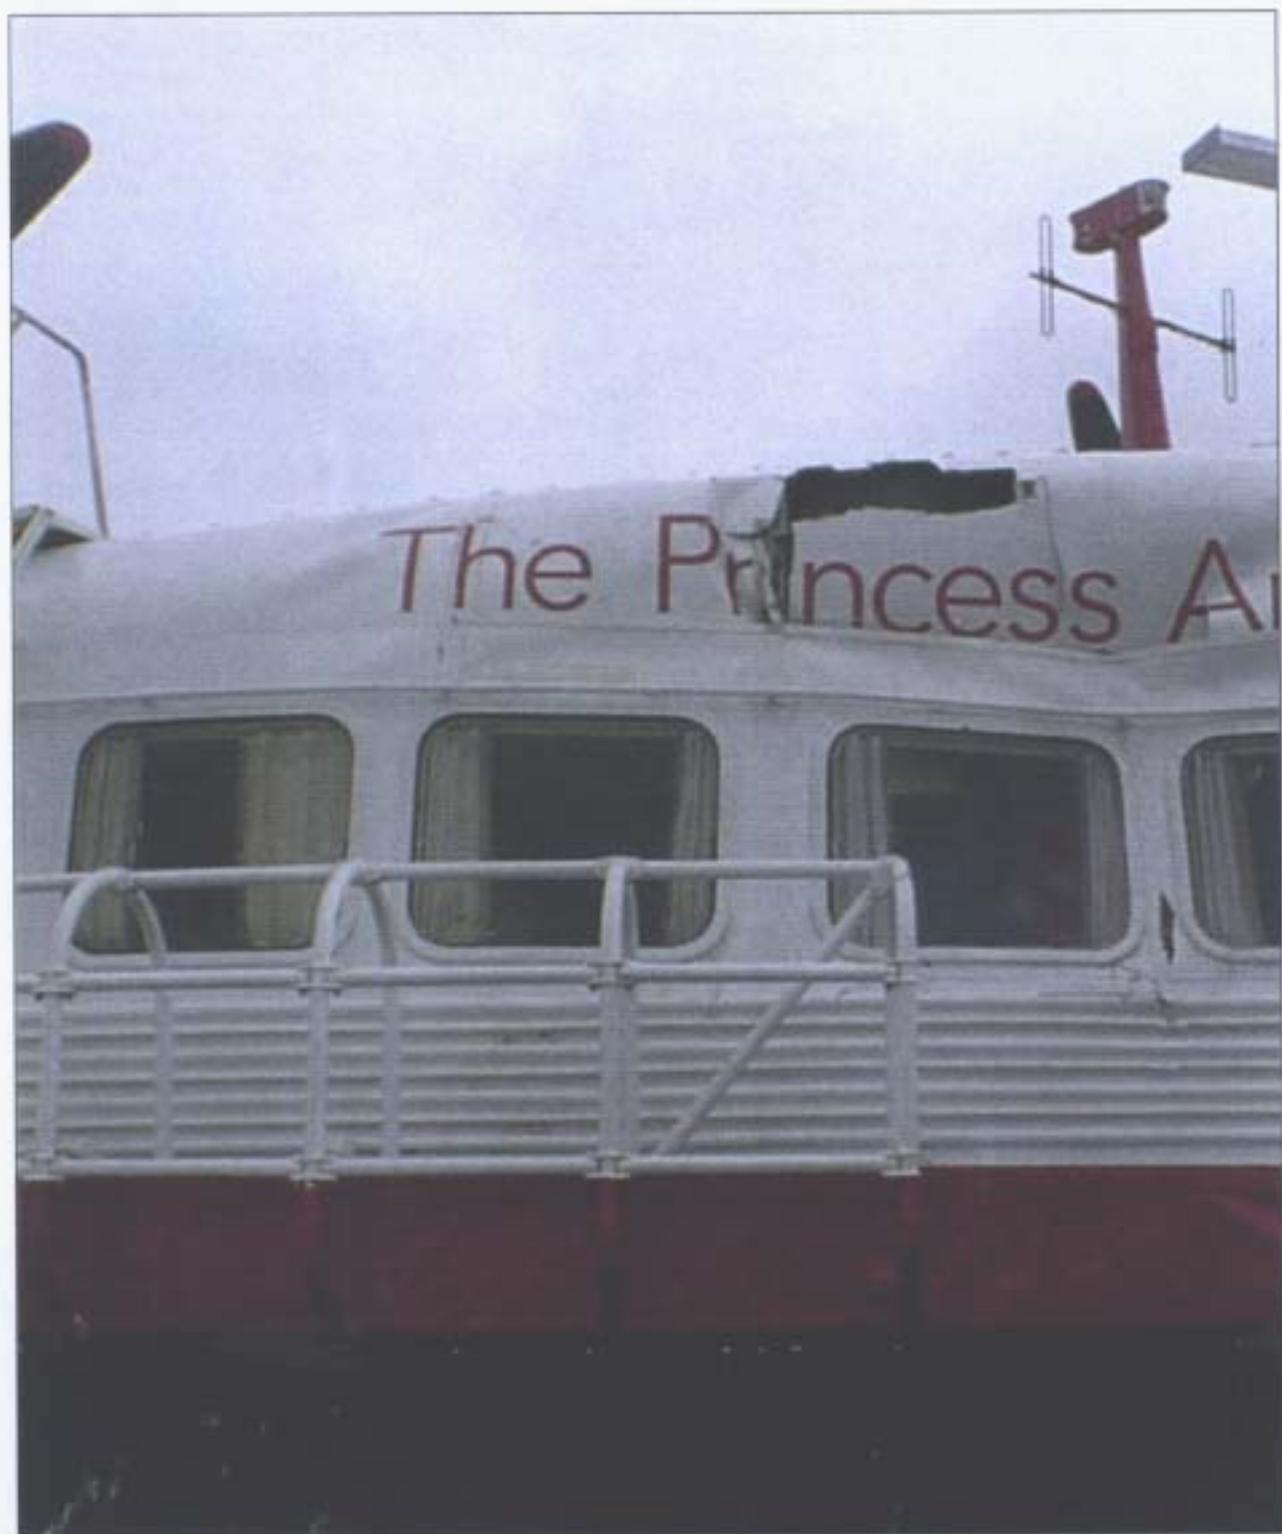
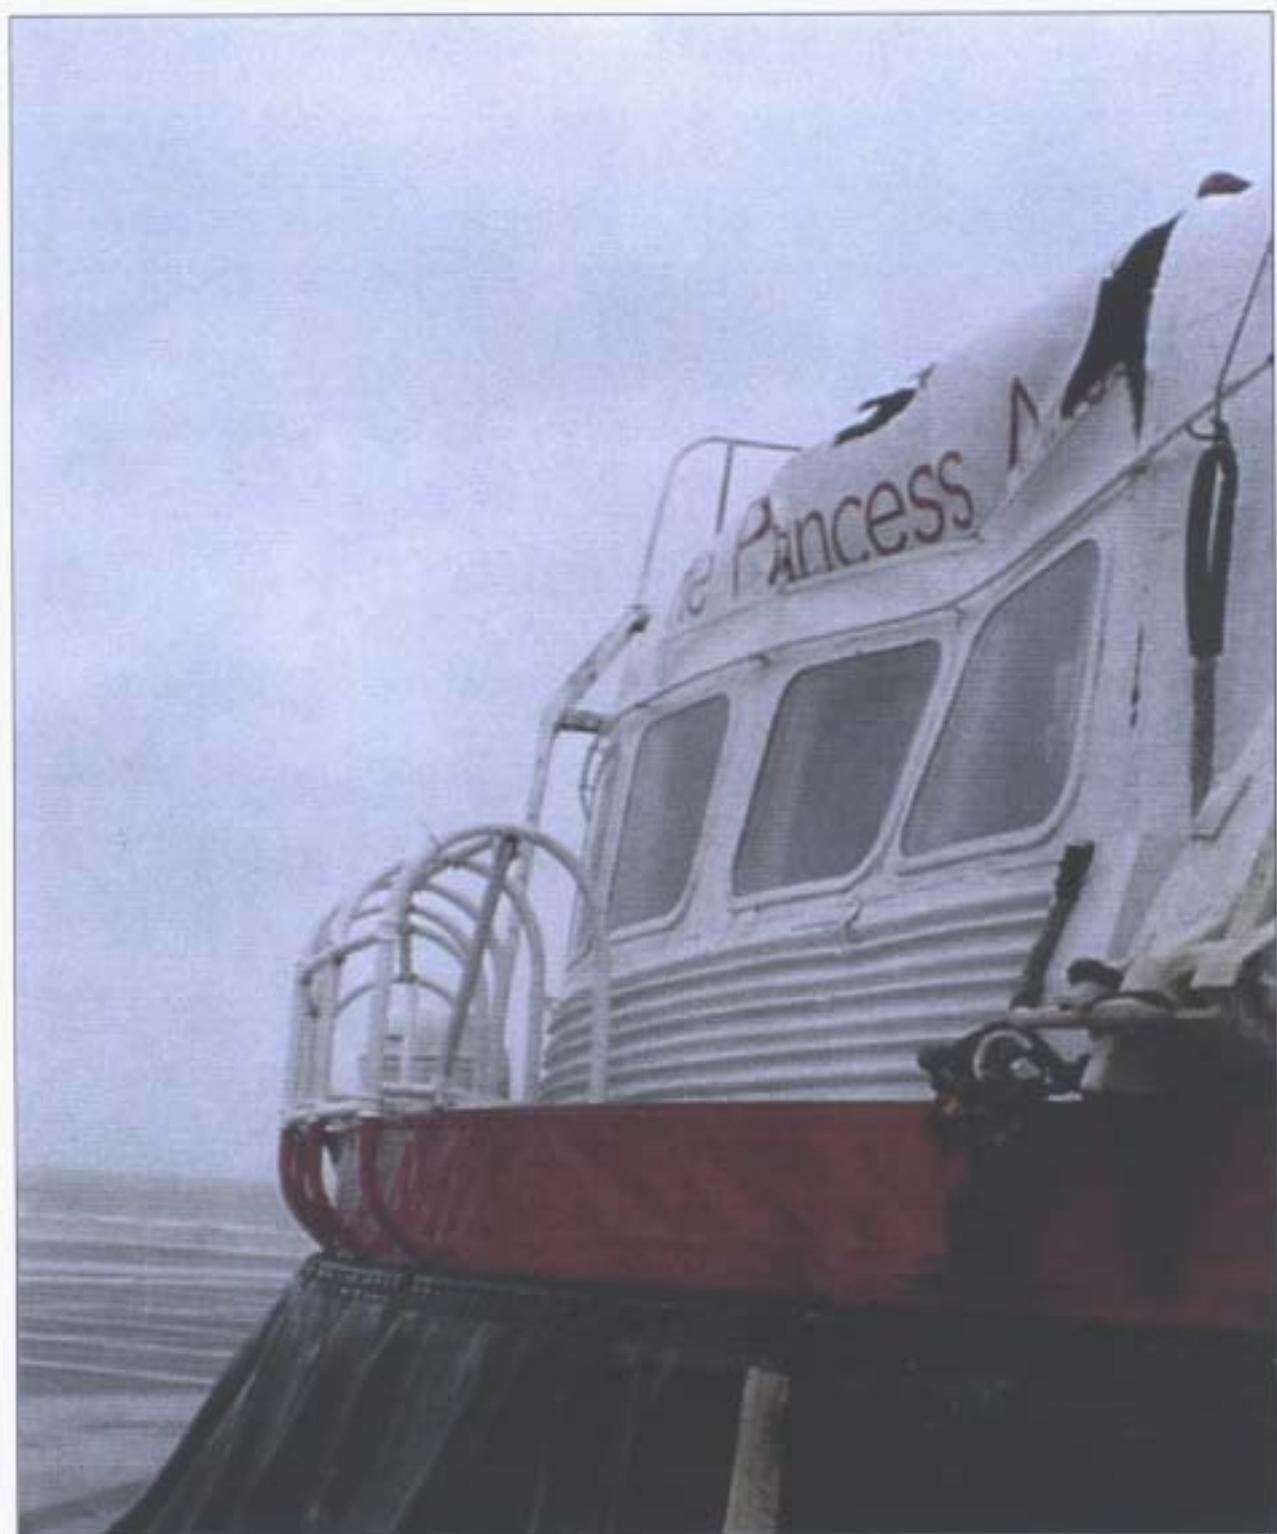
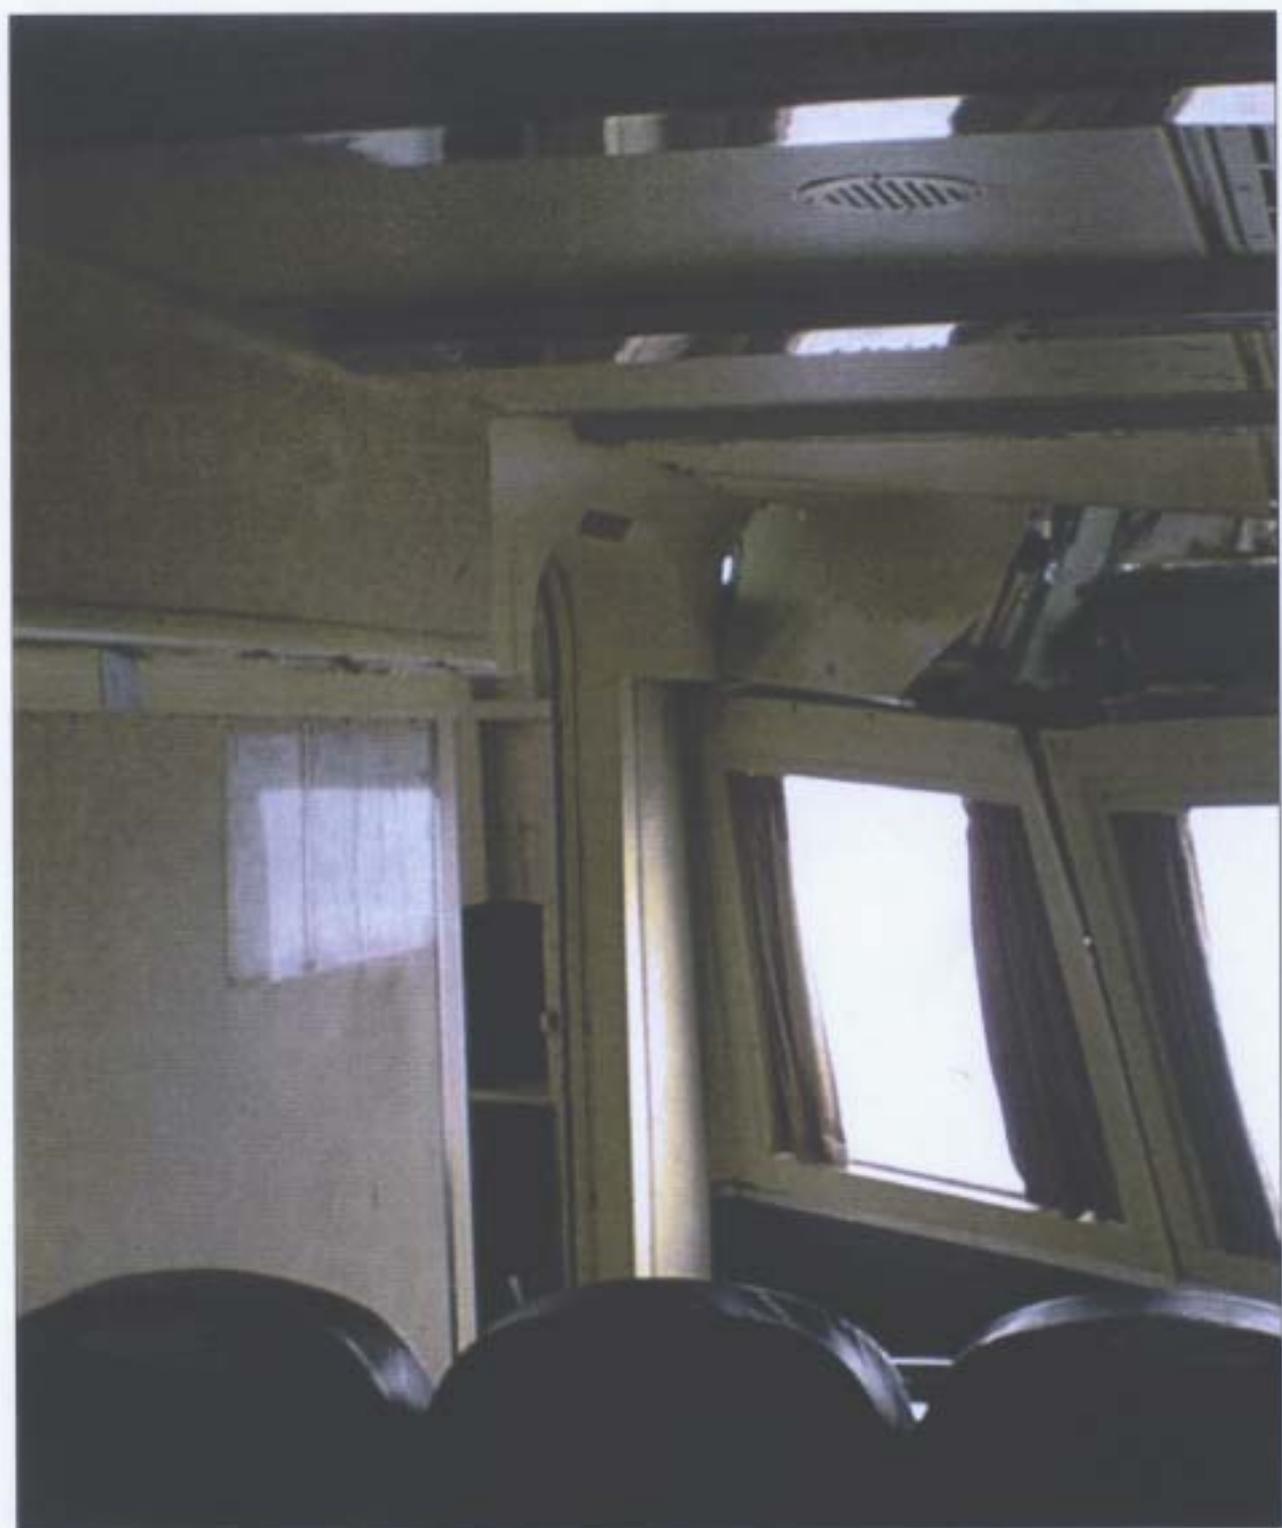
6. Photographs - damage to vessel

About 30 minutes later, when in mid-channel, the hovercraft dropped into a wave trough, resulting in a minor impact on the port forward side of the craft. The starboard bow sustained damage in the vicinity of the first three windows and above.

The vessel suffered damage as a result of a wave impact while moving at a relatively slow speed in an area of confused seas at the time. The hovercraft was operating within the designated operating limits.
