**Report on the investigation of the  
capsize and foundering of the fishing vessel  
*Angela*  
in the North Sea  
on 6 February 2000**

Marine Accident Investigation Branch  
First Floor, Carlton House  
Carlton Place  
Southampton  
SO15 2DZ

**Report No 14/2001**

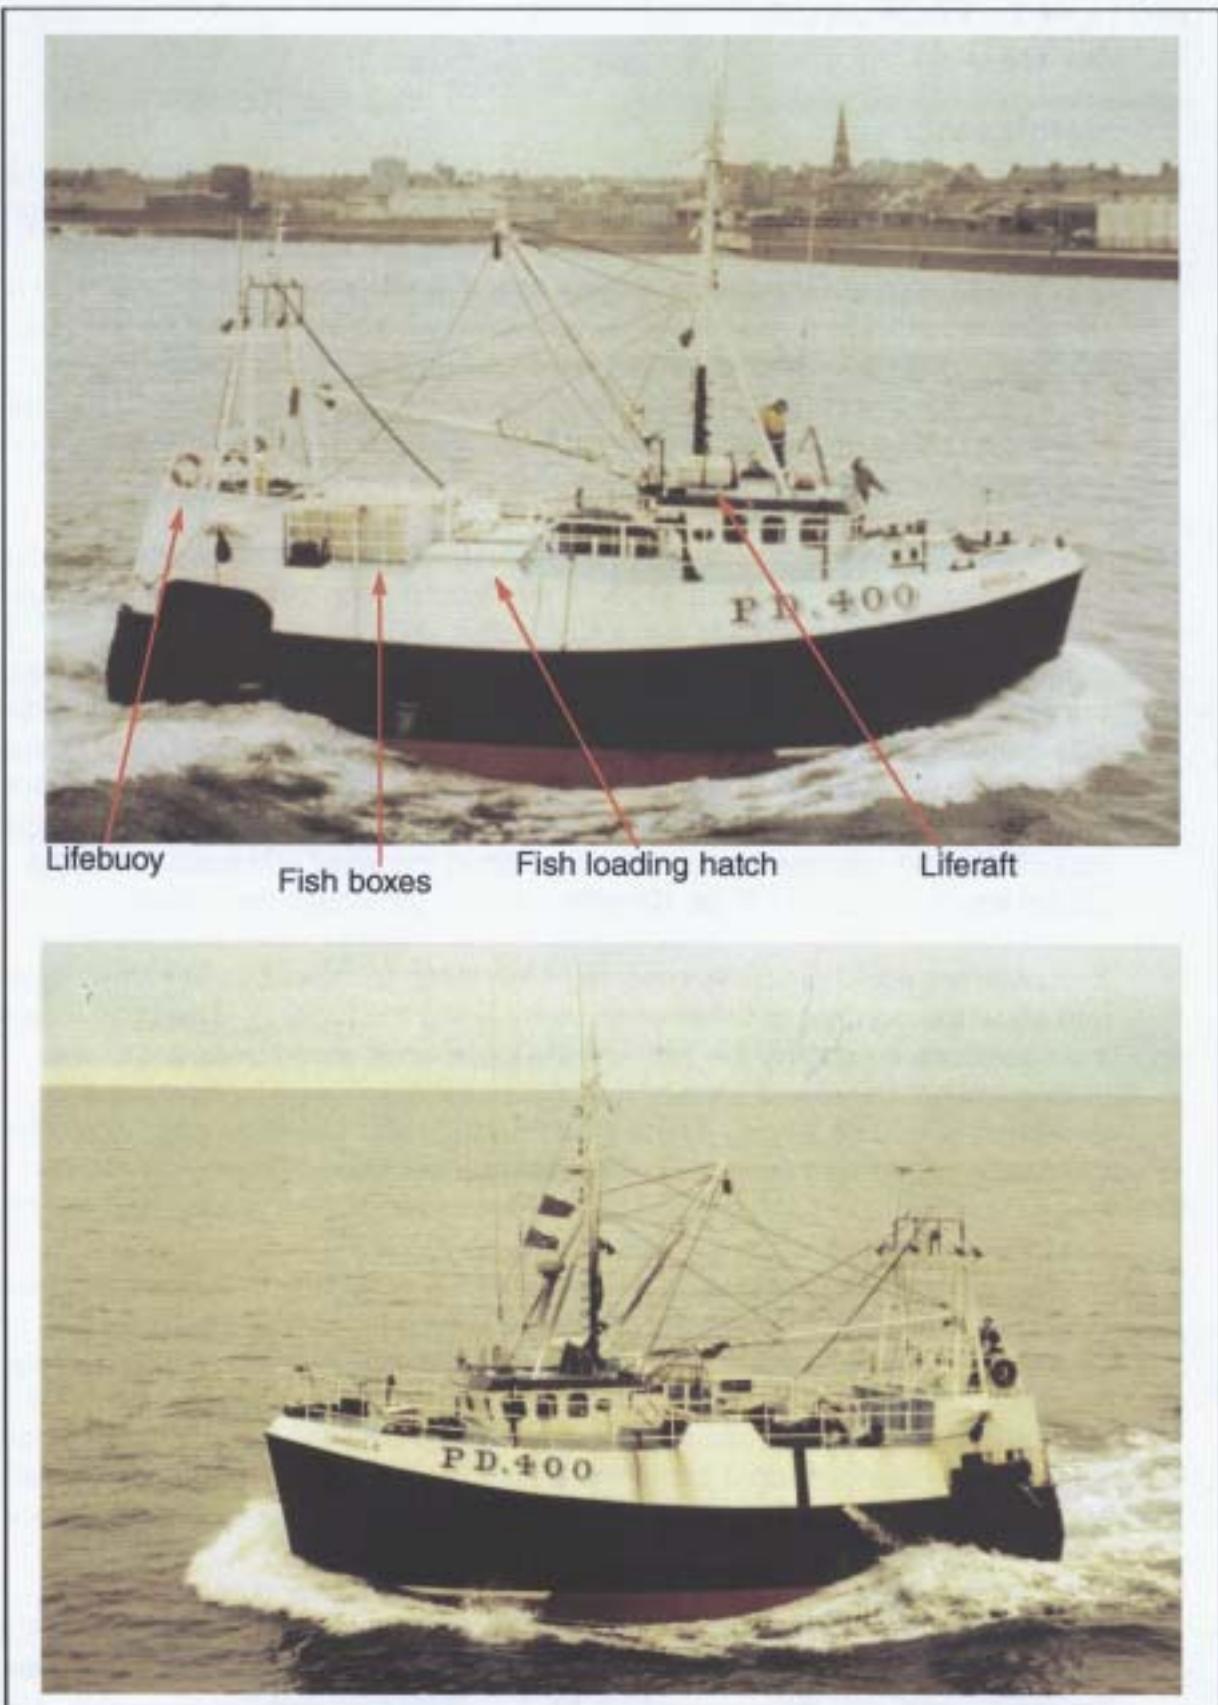
Figure 1

General views of *Angela*

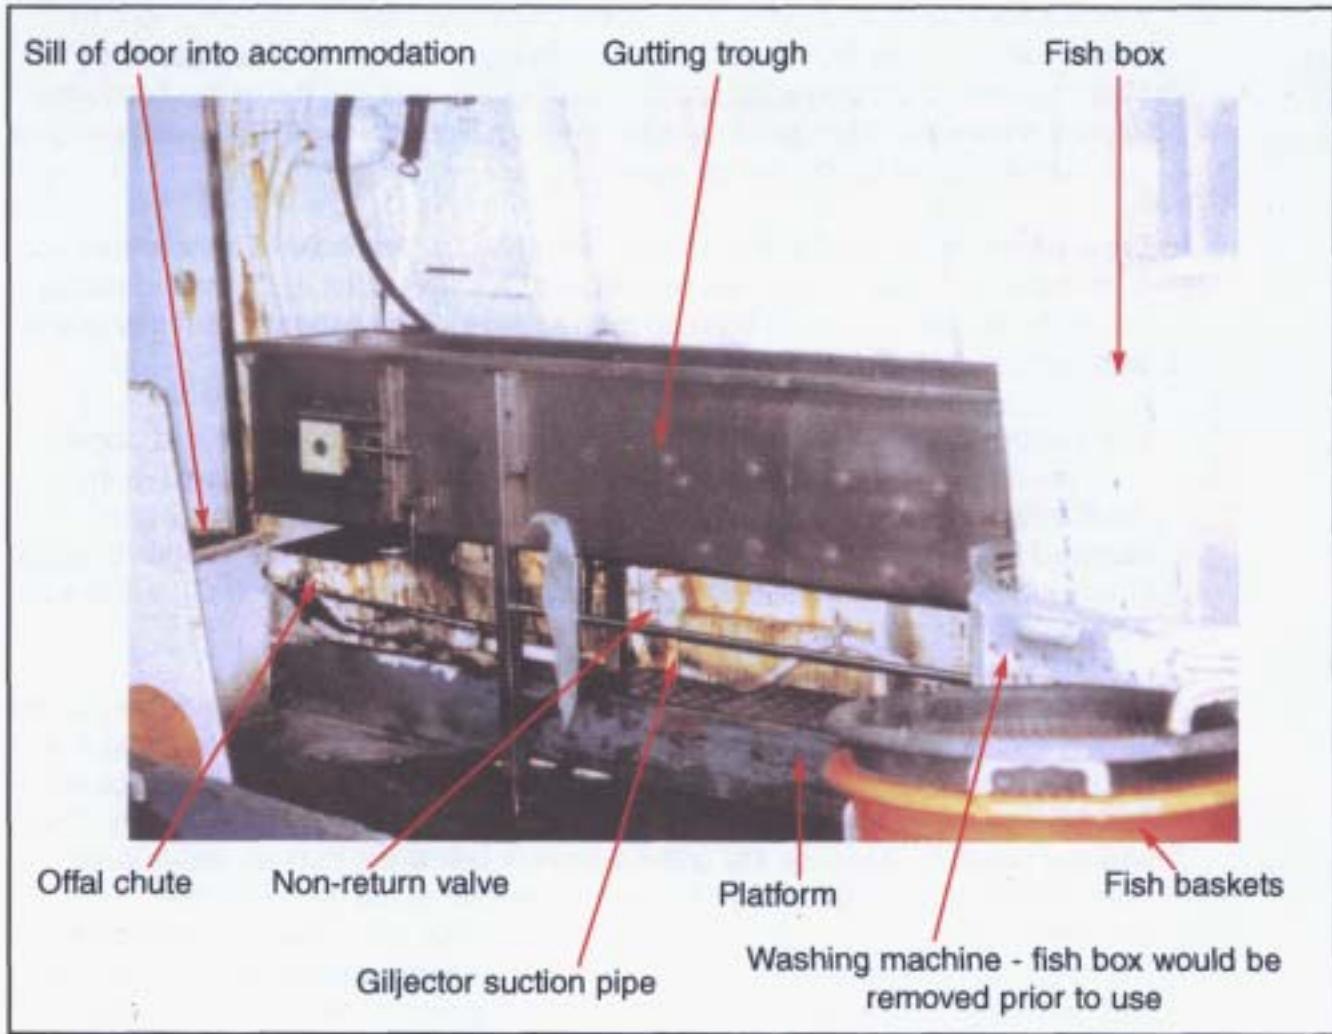
Figure 2

Gutting trough

A plan of the main deck, showing the internal arrangement of the shelter, is shown in (**Figure 6**). A photograph of the gutting trough can be seen in (**Figure 2**). While gutting the fish, the deckhands stood on a platform, outboard of the trough, which was about 250mm above the deck.

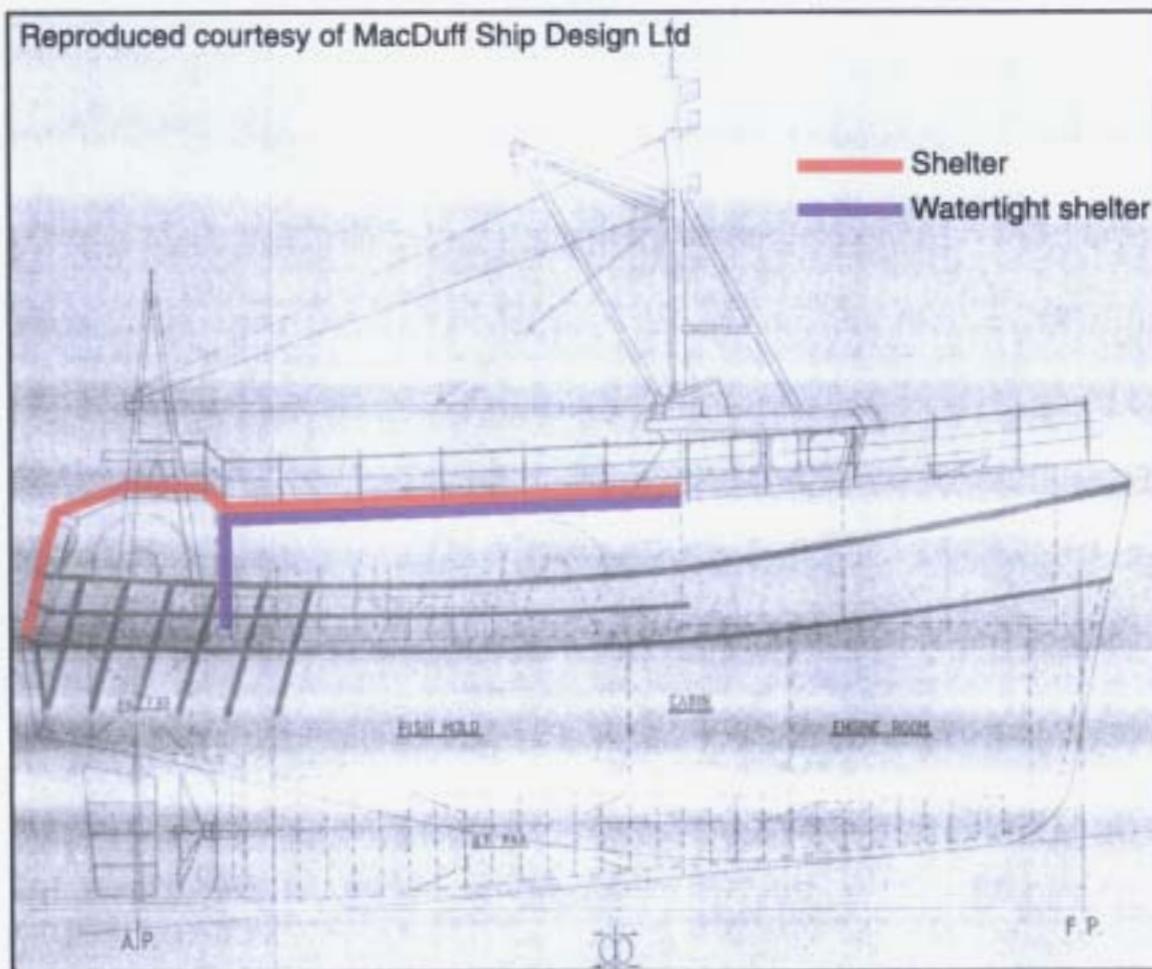
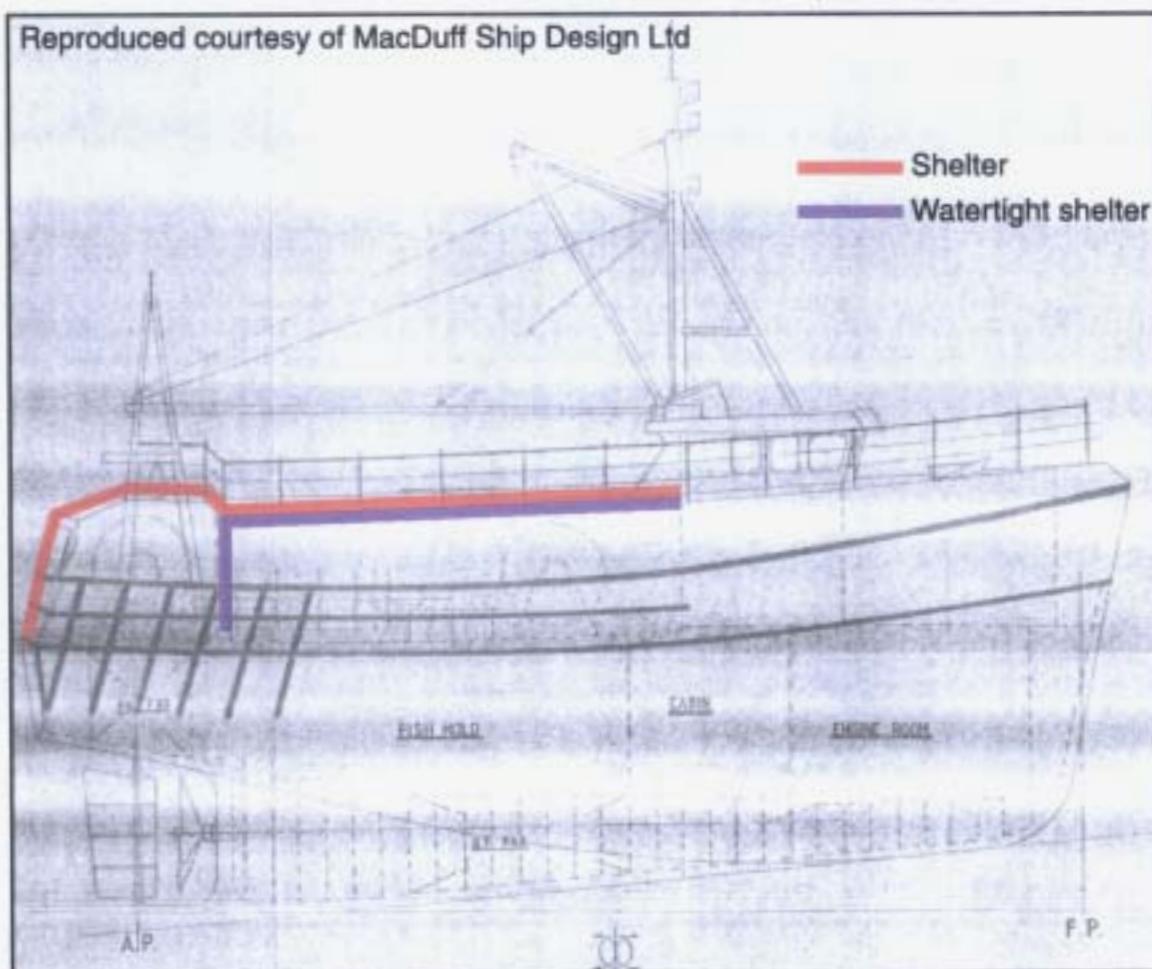
Figure 5

*Angela* was built in 1981 without a shelter. Two years later an aluminium shelter was fitted (**Figure 5**) to provide protection for the crew, particularly when processing the catch. Although it sheltered them from the weather, the structure was non-watertight and did not contribute to the vessel's buoyancy for stability purposes, because freeing ports were fitted at the level of the main deck.

Profile of *Angela*

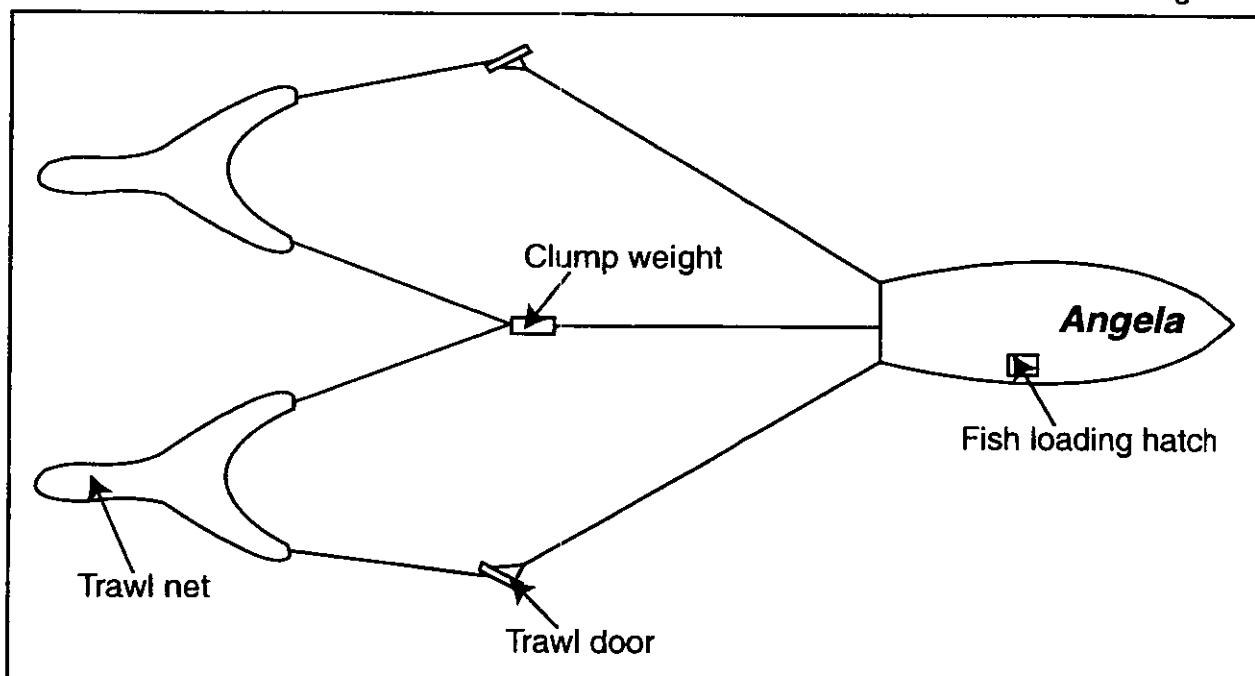
Figure 3

*Angela* used a twin trawl arrangement (Figure 3). A twin trawl tends to catch more fish than a single trawl. The arrangement was used for bottom trawling which was good for catching prawns, and fish such as saithe and cod.

Diagram of twin trawl arrangement

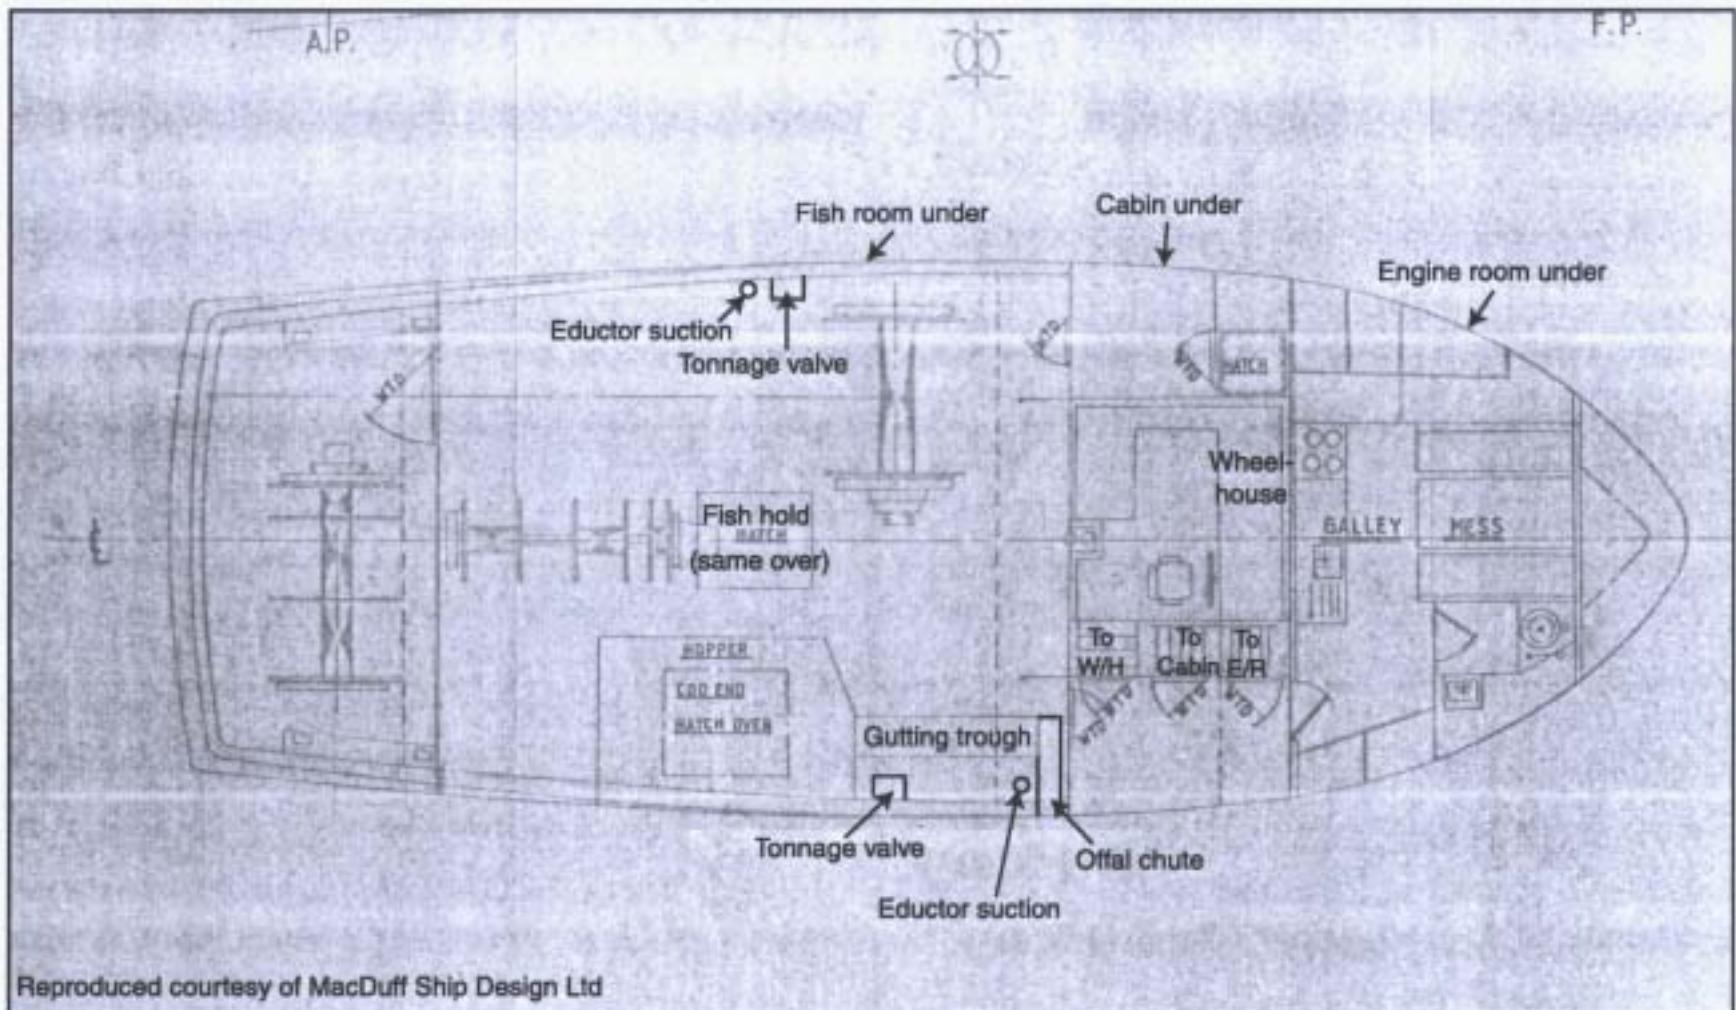
Figure 6

A plan of the main deck, showing the internal arrangement of the shelter, is shown in (**Figure 6**). A photograph of the gutting trough can be seen in (**Figure 2**). While gutting the fish, the deckhands stood on a platform, outboard of the trough, which was about 250mm above the deck.

Plan at main deck

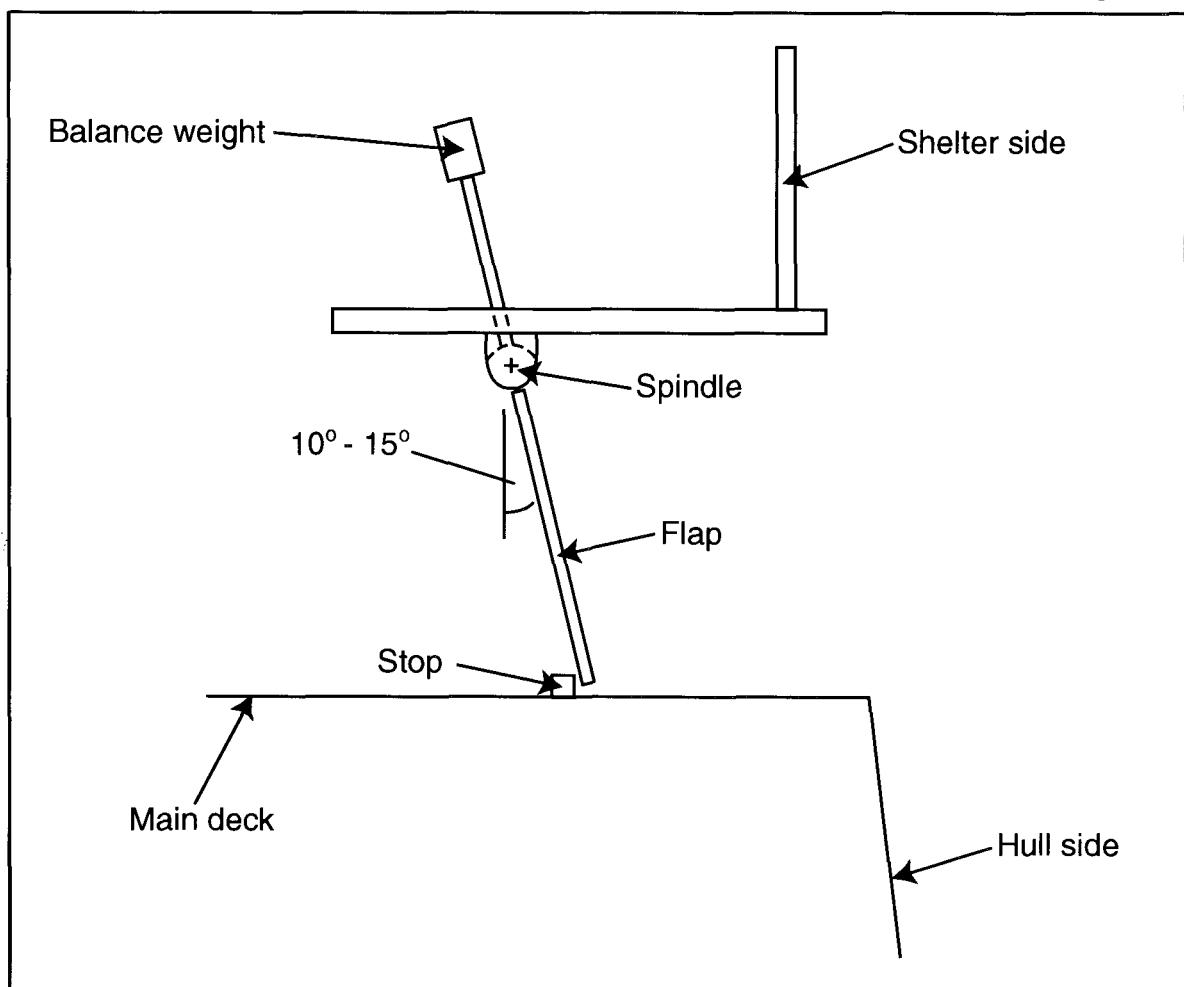
Figure 7

Tonnage valves perform a similar function to freeing ports, but they contain a weighted flap. This allows water to flow outboard, but not back in (**Figure 7**). During the latter part of processing of the catch the deckwash was kept running; the water and debris was evacuated mainly via the two tonnage valves. If the tonnage valves were working correctly, they ensured that the shelter provided buoyancy when the vessel rolled and the valves dipped under the water level, because the flaps in the valves prevented seawater entering the space. This meant that the shelter could be included in the stability calculations.

Section through tonnage valve

Had the starboard tonnage valve been jammed open, it could have allowed an ingress of seawater into the shelter, which could have capsized the vessel. It is considered that this is the most likely cause of the flooding. Alternatively, had this tonnage valve been jammed closed, flooding of the shelter could have come from the one of the Giljectors or the deckwash. Calculations have shown that *Angela* was fully capsized once 20 tonnes of floodwater had entered the shelter.

The most likely cause of the flooding is considered to be the starboard tonnage valve being jammed open, which could have allowed seawater to enter the shelter from the outside.

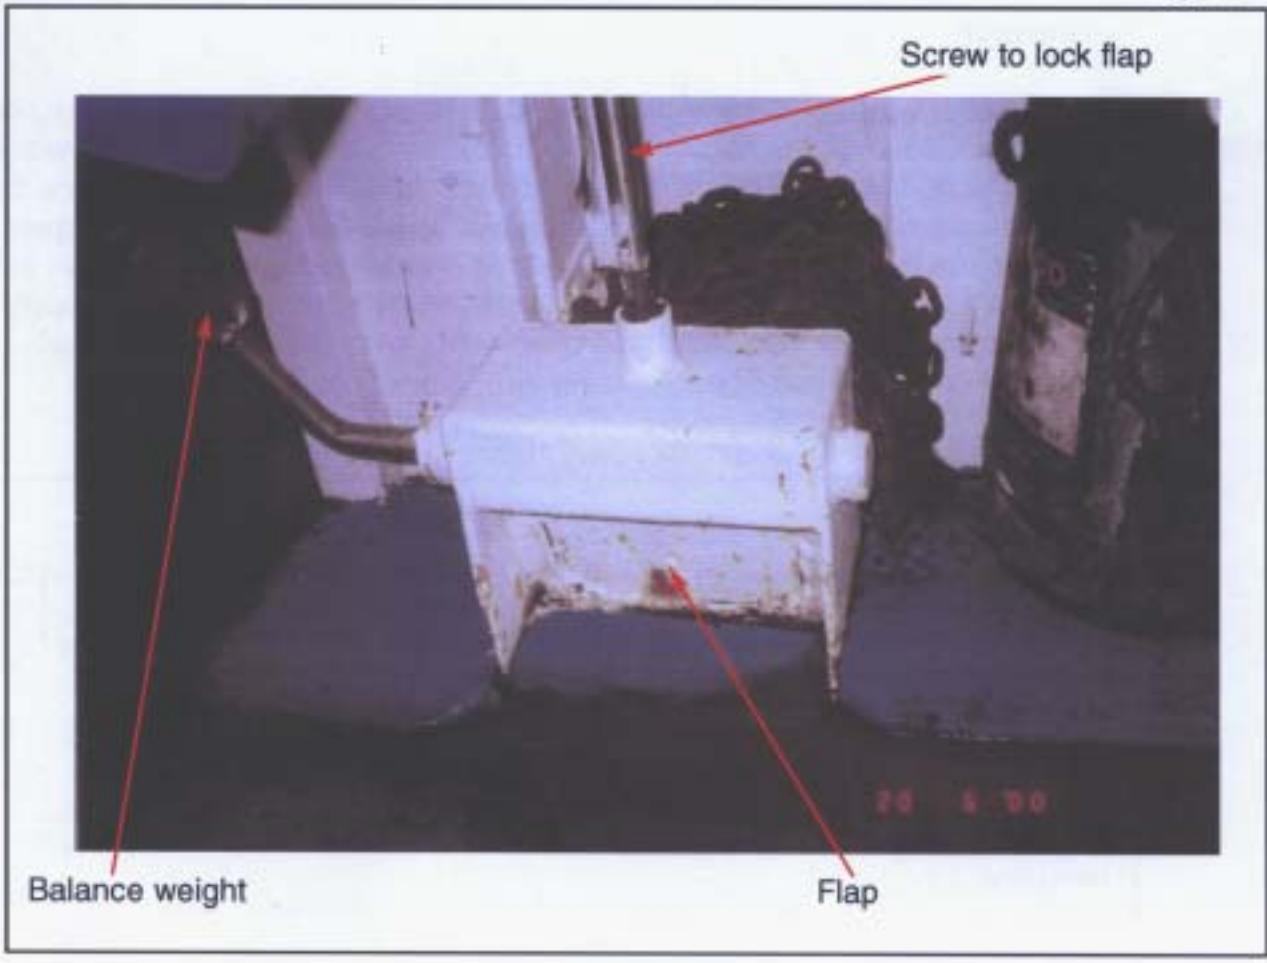
Figure 8

Tonnage valves are sometimes referred to as balance valves or weighted valves. Guidance on tonnage valves is contained in Survey Memorandum No 54 produced by the **MCA**. The tonnage valve on another fishing vessel is shown in (**Figure 8**); those on board *Angela* were similar, except that a balance weight was fitted on either side. The valve should be screwed shut when there is no fish washing taking place.

Tonnage valve on another vessel

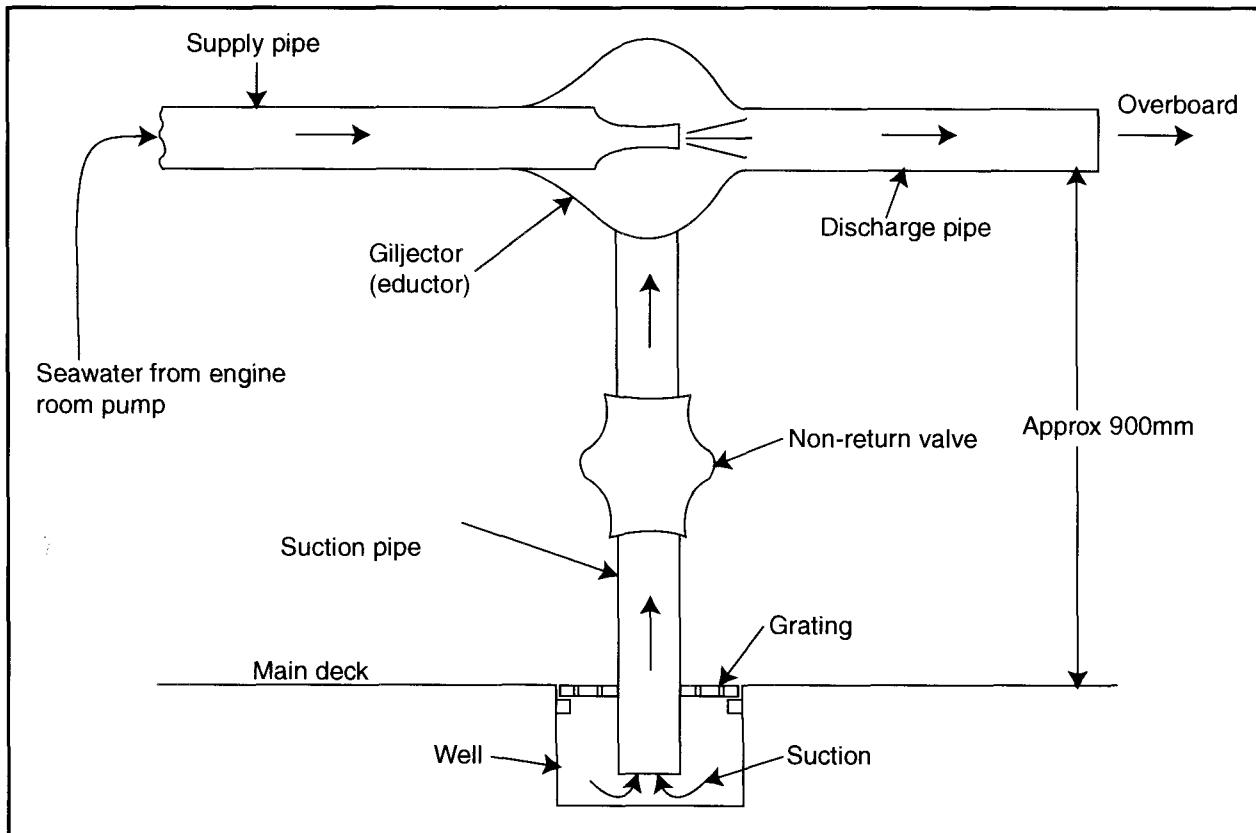
Figure 9

The shelter was also fitted with two suctions which could remove relatively clean water, but were not suitable for ejecting deck wash water contaminated with large pieces of fish offal and debris. The suctions were activated by eductors with the trade name Giljector. A sectional diagram of an eductor is shown in (**Figure 9**); the force of the water supplied by the pump creates a drop in pressure in the eductor which draws drain water up the suction pipe, so that both the supply water and the drain water are discharged overboard. The suctions were normally cleaned out at the end of each fishing trip.

Diagram of giljector

The floodwater built up on the starboard side of the shelter. The Giljector on this side could have been the cause, if the non-return valve was not working and the overboard discharge had become blocked. The non-return valve had not been checked for some time, and it could have become stuck open. This

defect would not have been readily apparent as the Giljector would still have pumped satisfactorily. However, if the overboard discharge became blocked, for instance, by a piece of fish offal, the supply to the Giljector would have been directed into the shelter. If so, the starboard Giljector would have been pumping water into the shelter, rather than extracting it, as it was supposed to.

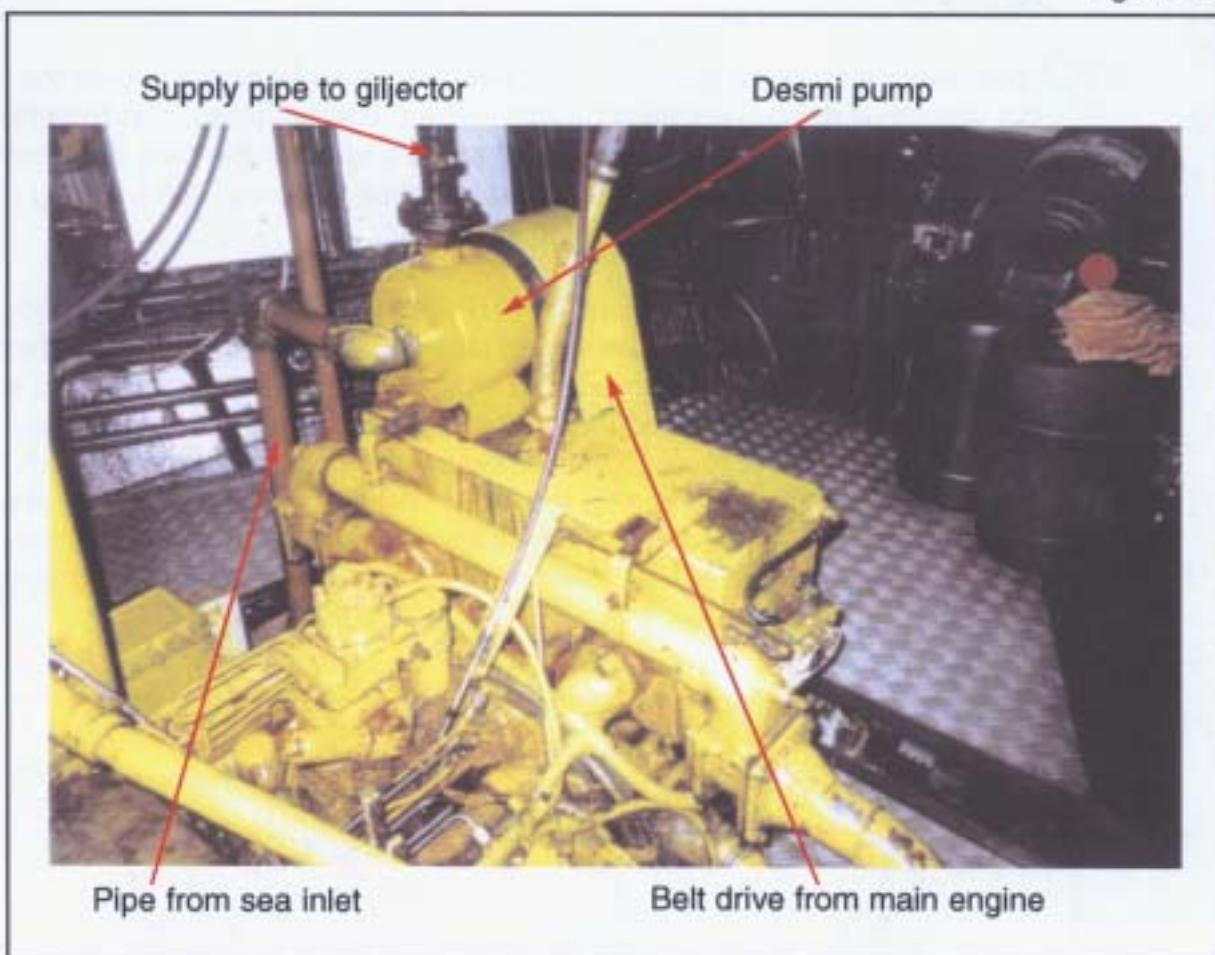
Figure 10

Seawater was supplied to the eductors from pumps in the engine room. An engine-driven Desmi pump (**Figure 10**) fed the starboard eductor. The amount of water which was supplied depended on the speed of the main engine. When *Angela* was stopped, and the main engine was on idle at about 1000 rpm, the amount of seawater supplied to the starboard eductor was about 14 tonnes per hour. When the main engine was on full power at about 1800 rpm, this eductor was supplied at about 25 tonnes per hour. The suction was fitted in a well with a grating over to stop large pieces of offal and other debris from entering. As both the pumps driving the eductors were belt-driven from the main engine, the eductors were being powered all the time the main engine was running, which was **24** hours a day when the vessel was at sea. The sea inlets to the pumps supplying the eductors were in the engine room.

Pump supplying giljector

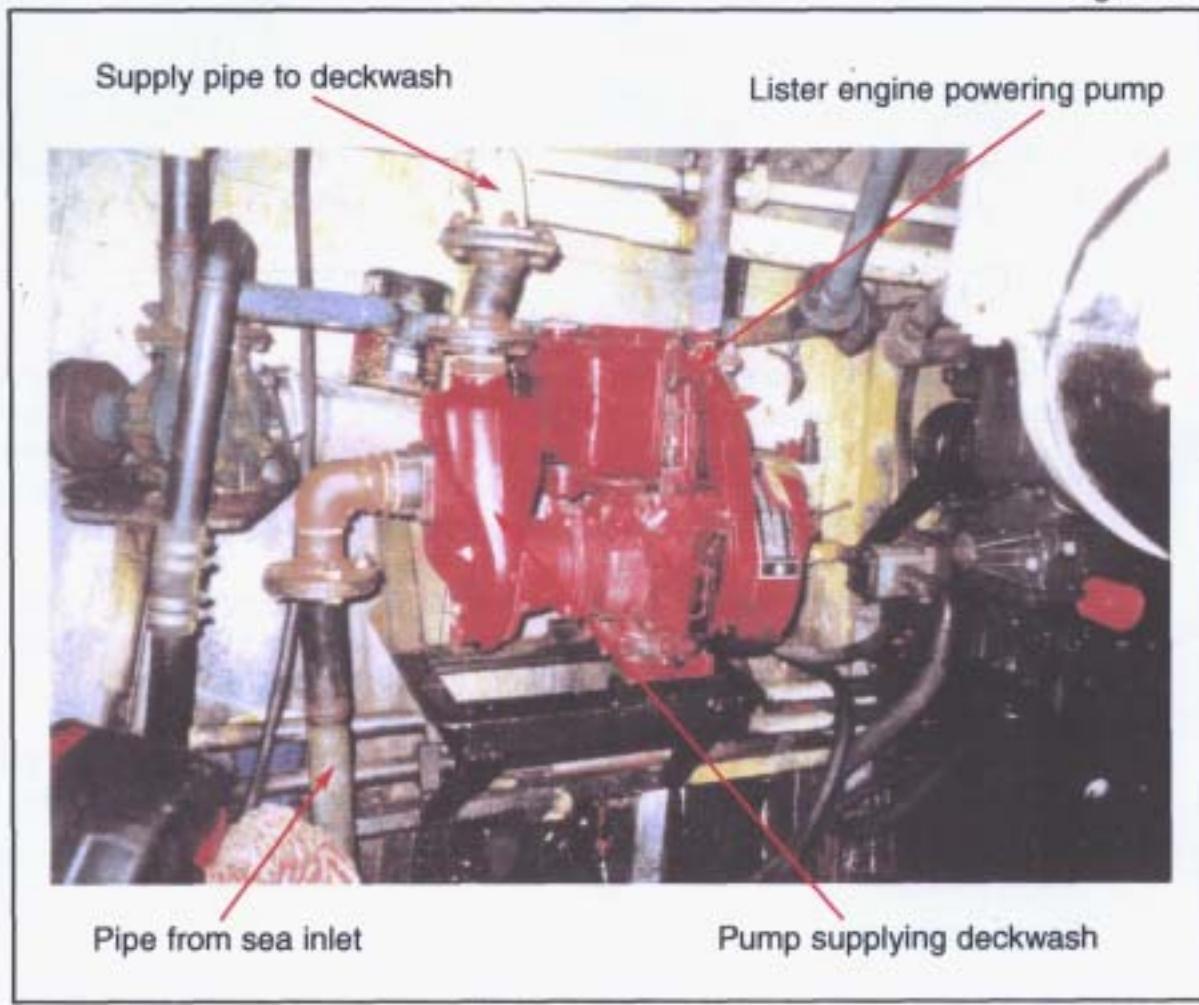
Figure 11

The pump in the engine room shown in (Figure 11) normally fed the deck wash. This pump had own power source, and supplied seawater at about 50 tonnes per hour. A deckwash with this capacity is typical for a fishing vessel of this size. The pipe to the deckwash was about 50mm in diameter. One of the crew needed to go down to the engine room to start and stop the deckwash pump, which was normally only kept running during the latter part of the fish processing operation. The diesel engine which drove the deckwash pump had its own tank, which contained about 9 litres of fuel; sufficient for about five to six hours running.
