Report on the investigation
of the fire on board the
fv *Ross Alcedo* (FH628)
while underway about 32 miles
north-west of the Isles of Scilly
on 16 January 2000

Marine Accident Investigation Branch
First Floor, Carlton House
Carlton Place
Southampton
SO15 2DZ

Report No 3/2001

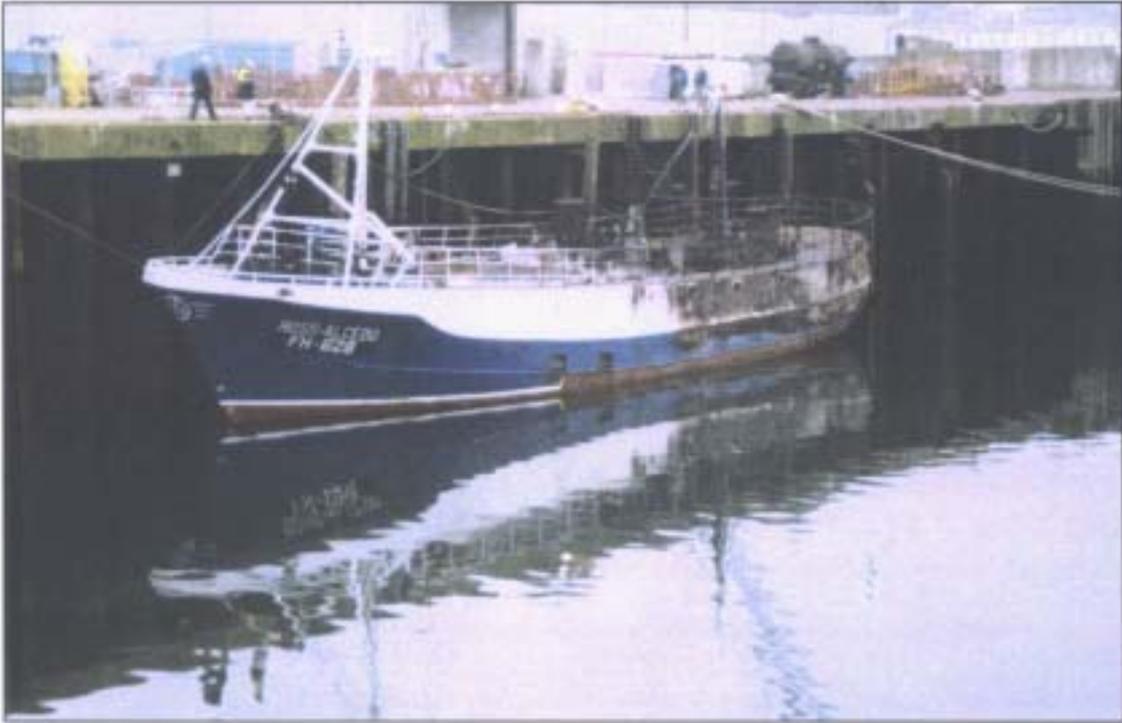
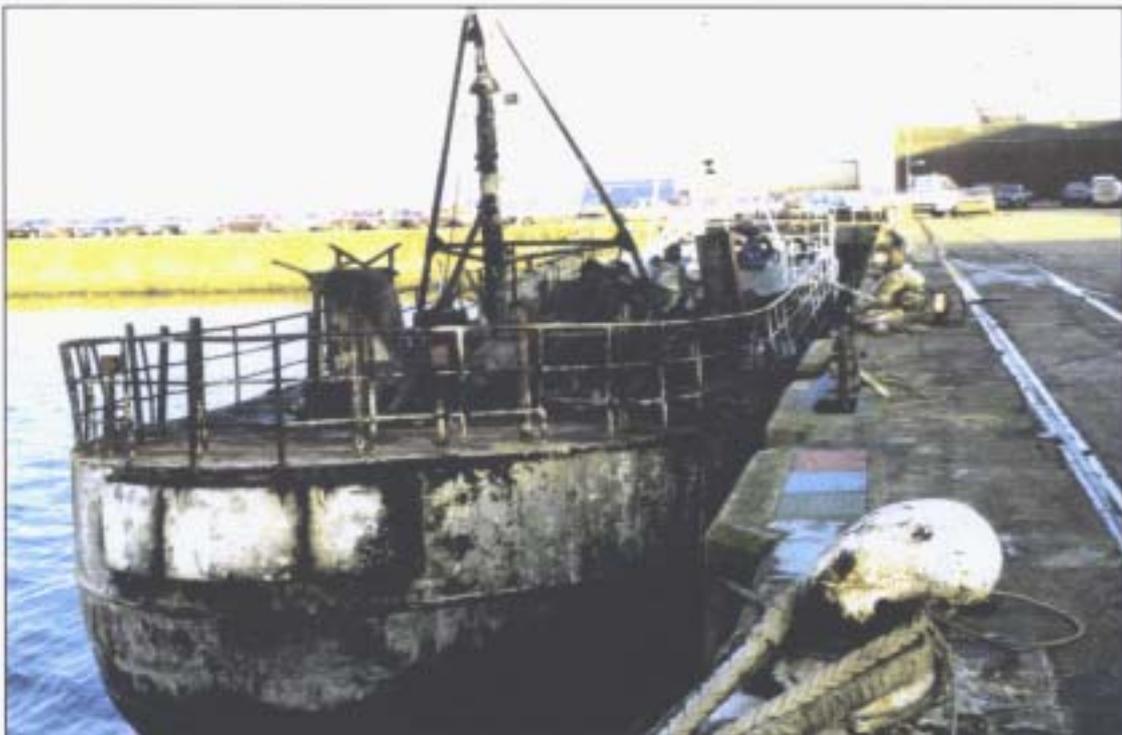
General views of vessel after return to Falmouth

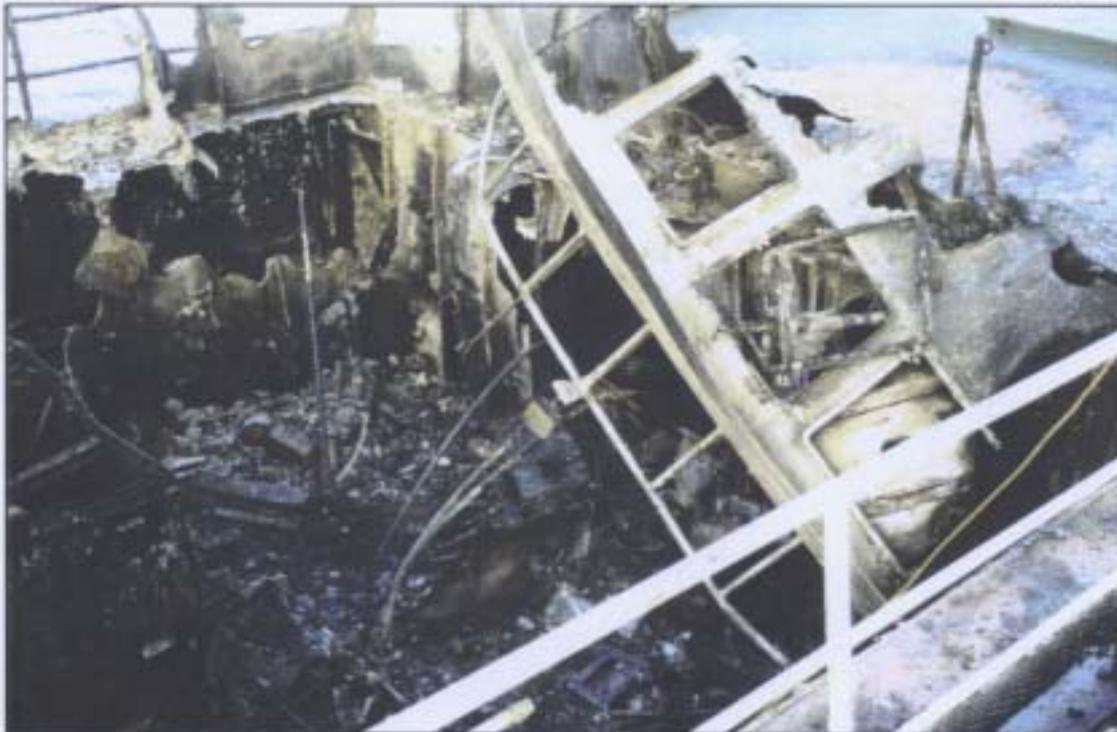
Figure 1

The aluminium wheelhouse had melted and burnt, with all wheelhouse equipment destroyed (**Figure 1**).

Fire damage to accommodation and wheelhouse

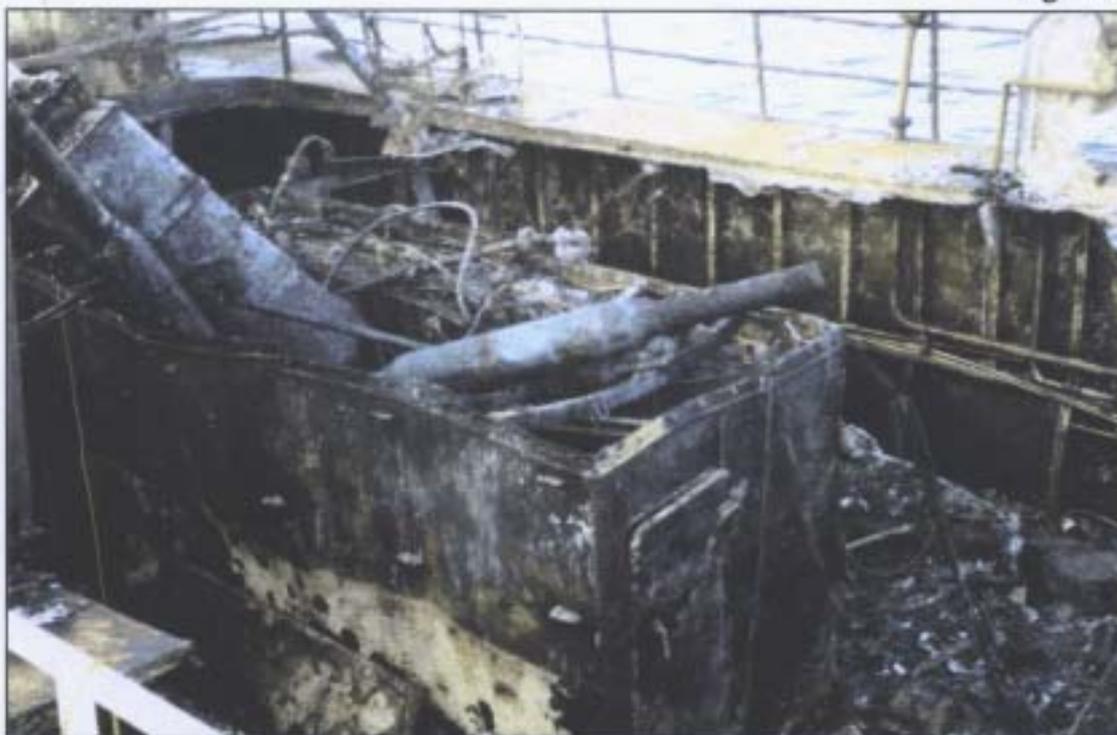
Figure 2

The steel bulkheads containing the upper section of the engine room (diesel oil tanks etc) were intact, although had buckled due to heat. The deckhead and skylights of the engine room had disappeared, although the steel exhaust pipes for both the main engine, and the generators, remained (**Figure 2**).

Remains of upper part of engine room showing complete collapse of the engine room crown

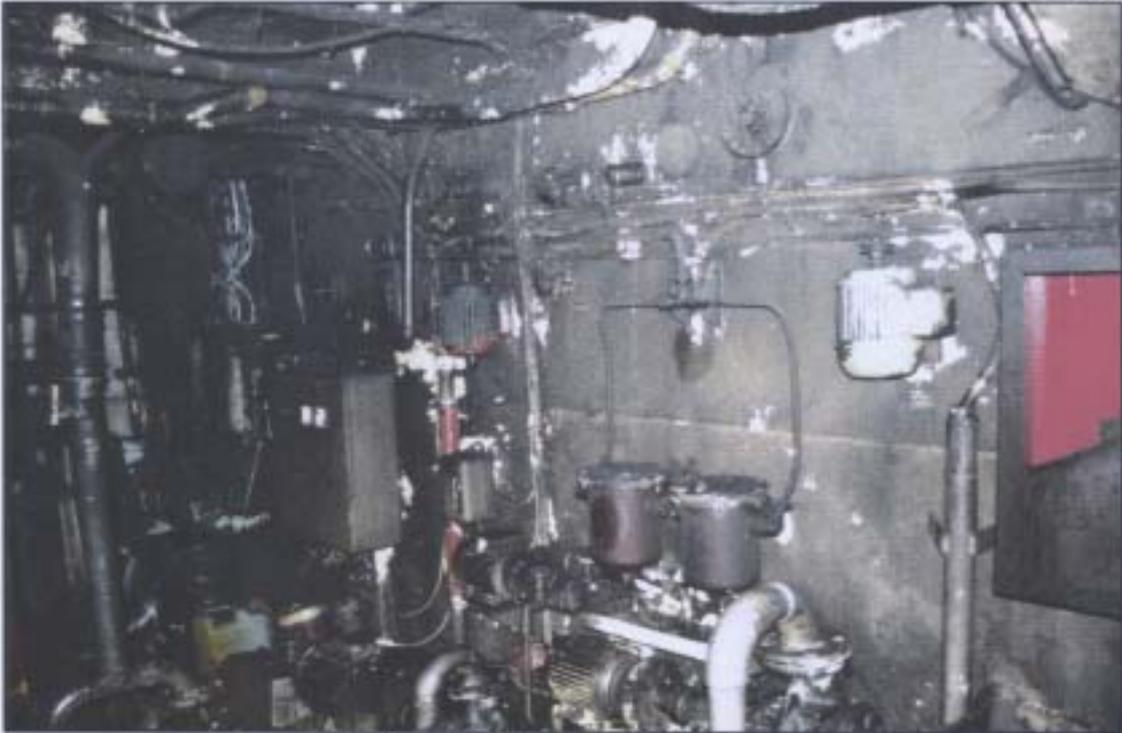
Figure 3

- 1.7.2 The engine room, below main deck level, had suffered less damage, although fittings and cables fitted to the deckhead were damaged by heat and smoke. The ventilation trunking supplying air to the engine room was blocked at the outlets with melted aluminium and general debris. The whole area was heavily sooted with debris from the accommodation above by lying over the main engine and machinery sited within the open area. Actual fire damage in the engine room was minimal (**Figures 3 - 8**).

Smoke and heat damage in engine room

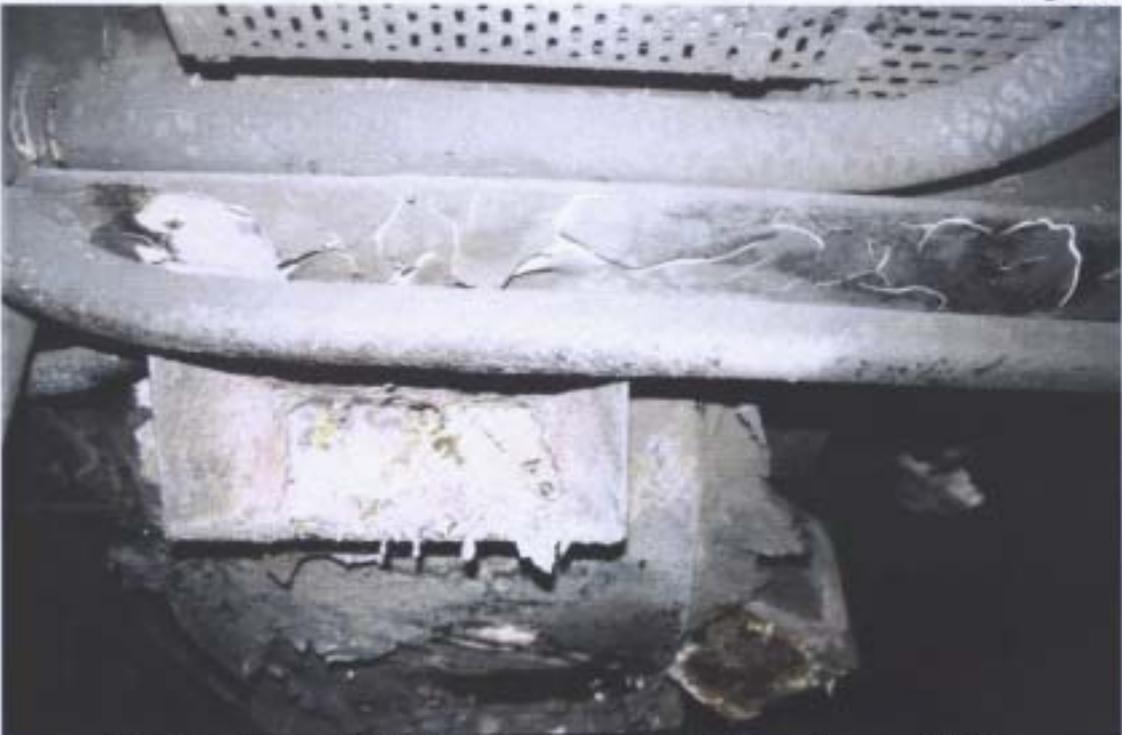
Figure 4

Vent trunking outlet blocked by melted aluminium and general debris

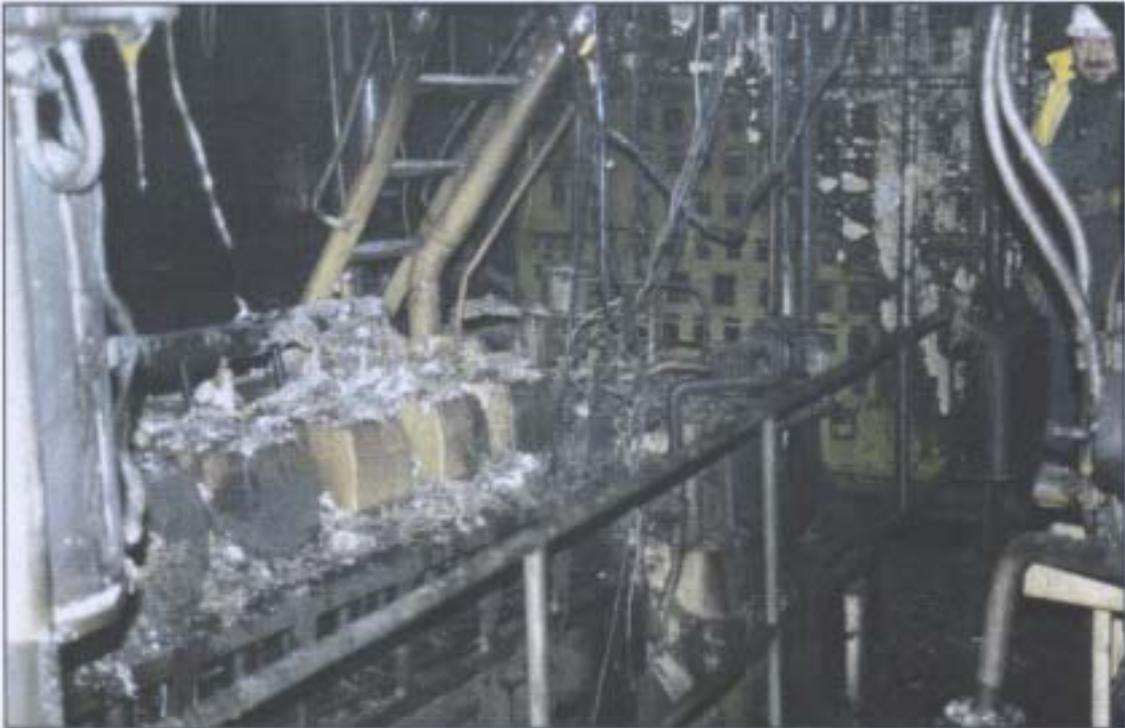
Figure 5

View across main engine showing debris from upper parts of engine room.
Note absence of fire damage

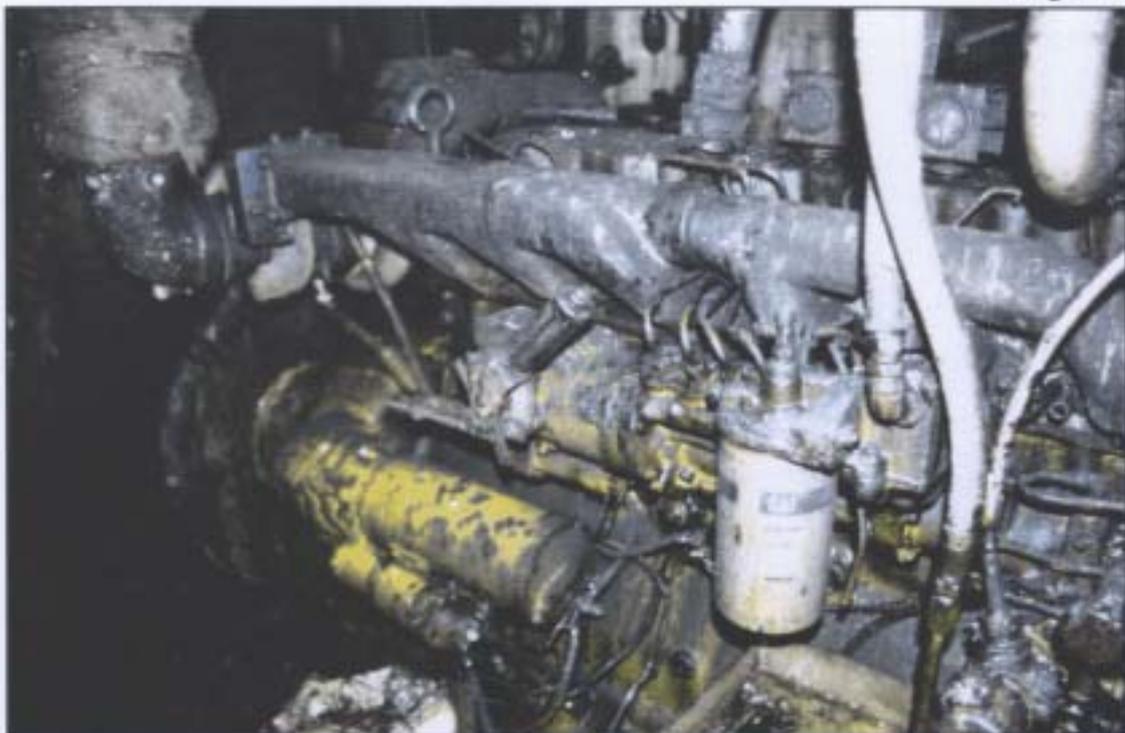
Figure 6

View of generator - covered in soot and debris but otherwise undamaged

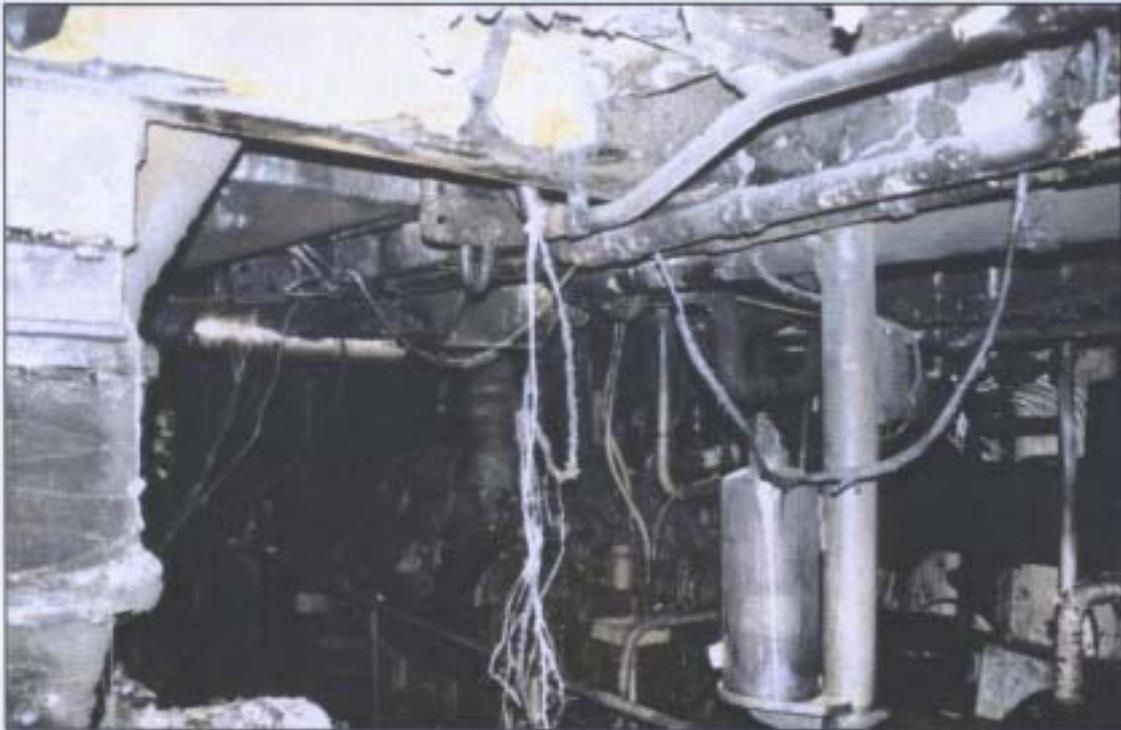
Figure 7

General view of engine room showing deckhead smoke and heat damage

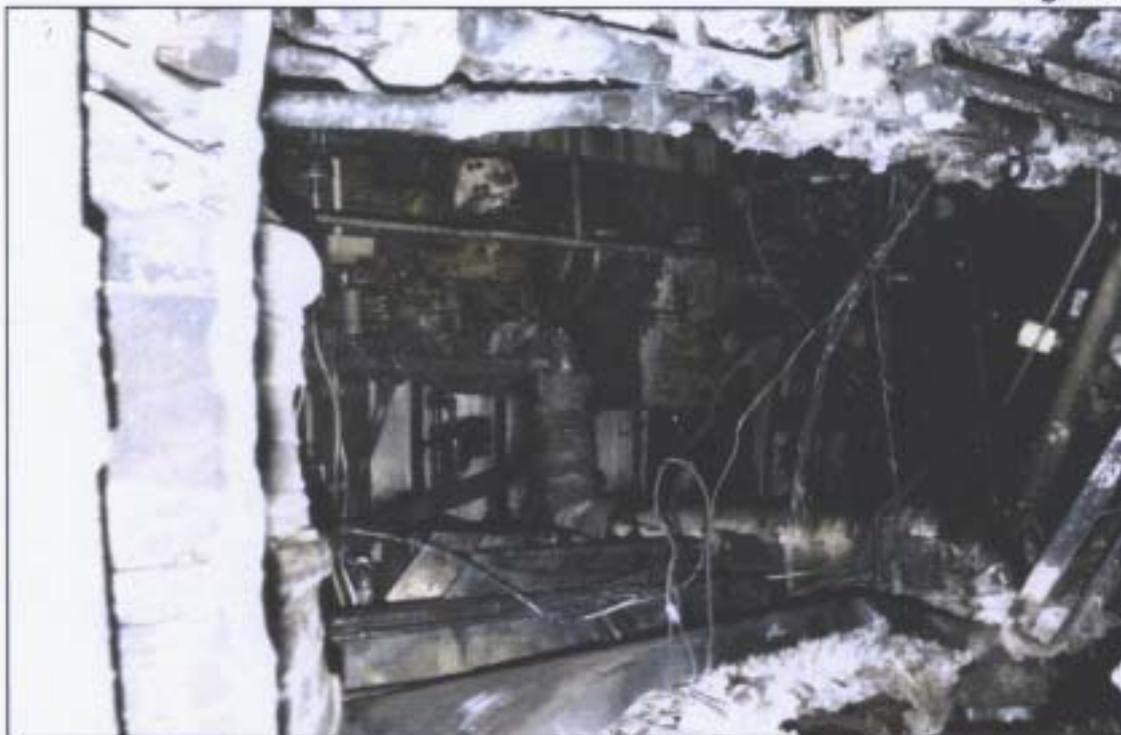
Figure 8

Heat and smoke damage to engine room deckhead

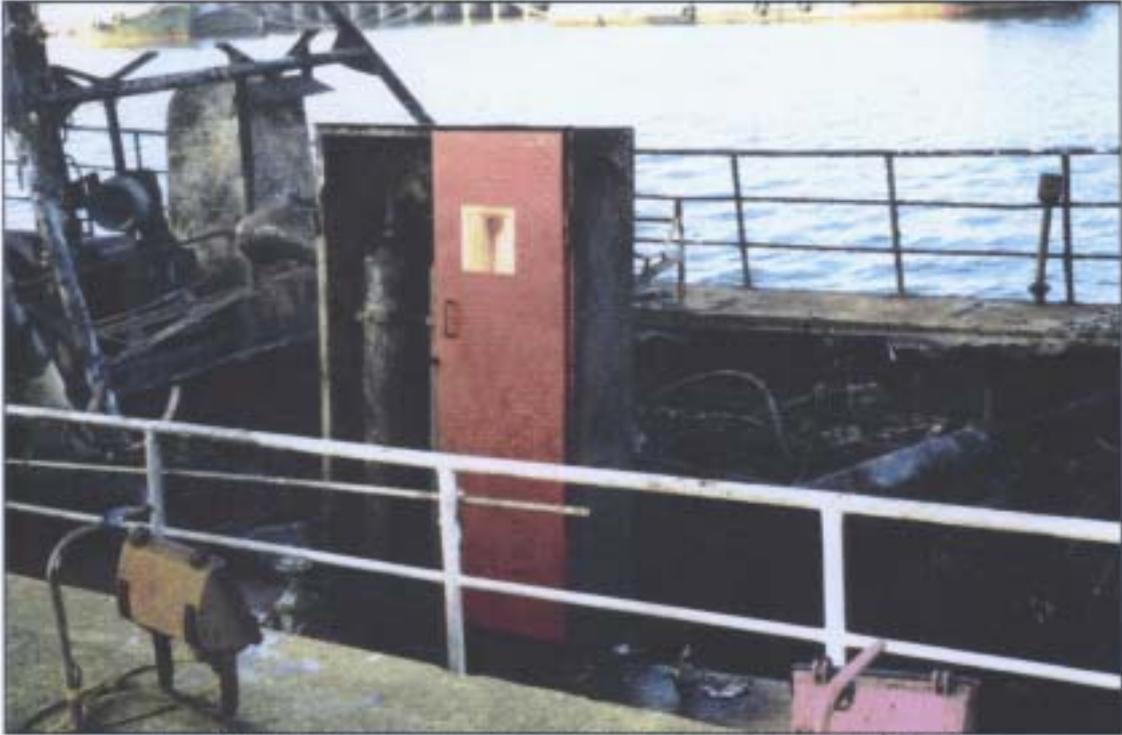
Figure 9

View of CO₂ station on top of shelter deck for engine room flooding

- d. The apparent speed with which the fire engulfed the messroom and starboard accommodation, preventing access to the CO₂ control station on the starboard side of the main deck, does raise the question as to how long the fire had been going before it was discovered. The aluminium deck house, although having poor resistance to heat, still requires some time before it collapses and burns. If the fire originated in the upper part of the engine room, it needed to reach, and pass through, the four-man cabin outboard of the engine casing before it would affect access to the CO₂ control station on the deck above.

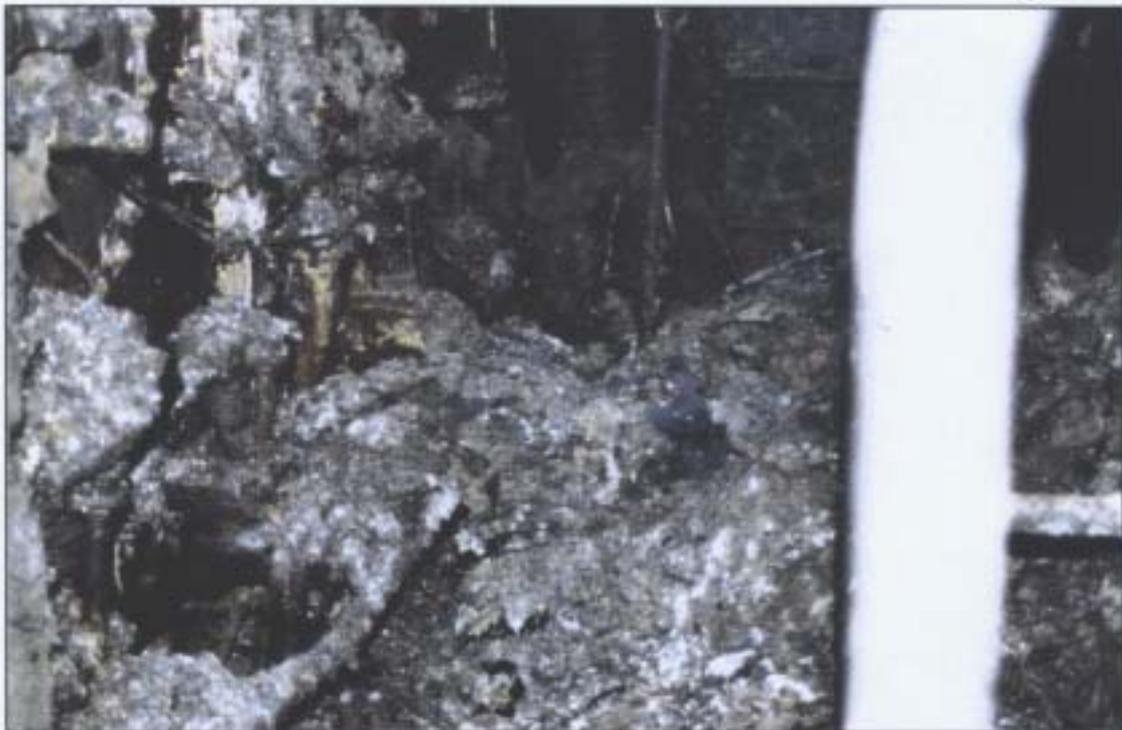
Figure 10

- b. The crown of the engine room, which comprised an aluminium funnel structure with, according to the drawings, a steel casing with skylights, had disappeared completely. It does raise the question as to whether, during the various conversion works, the steel had been replaced with an aluminium structure. It is likely that the steel work would have distorted rather than melted. The fire spread to the accommodation, either by heat transmission through steel bulkheads, or into the funnel space and through the accommodation deckheads (**Figure 10**).

Debris from aluminium deck structure and insulation at shelter deck level
in upper part of engine room
