**Report on the investigation of  
the loss of the fishing vessel  
*HARBOUR LIGHTS*  
off Polperro, Cornwall  
on 8 January 2000  
with the loss of one life**

**Report No 27/2000**

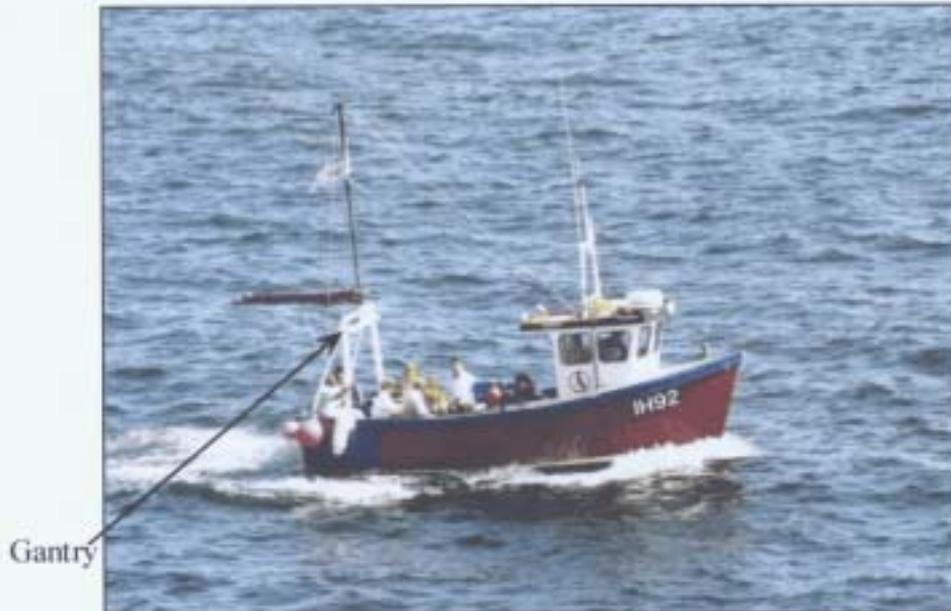
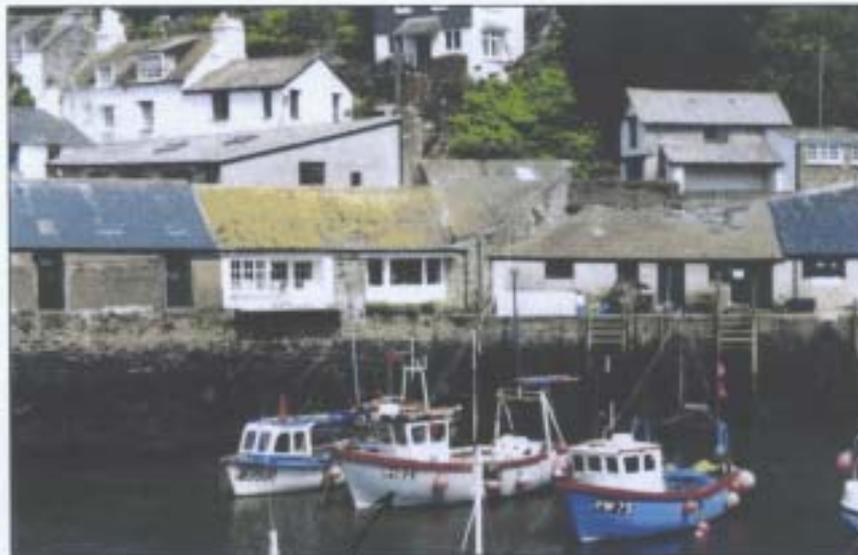
Figure 1 - General views of *Harbour Lights*

Colour scheme at time of accident

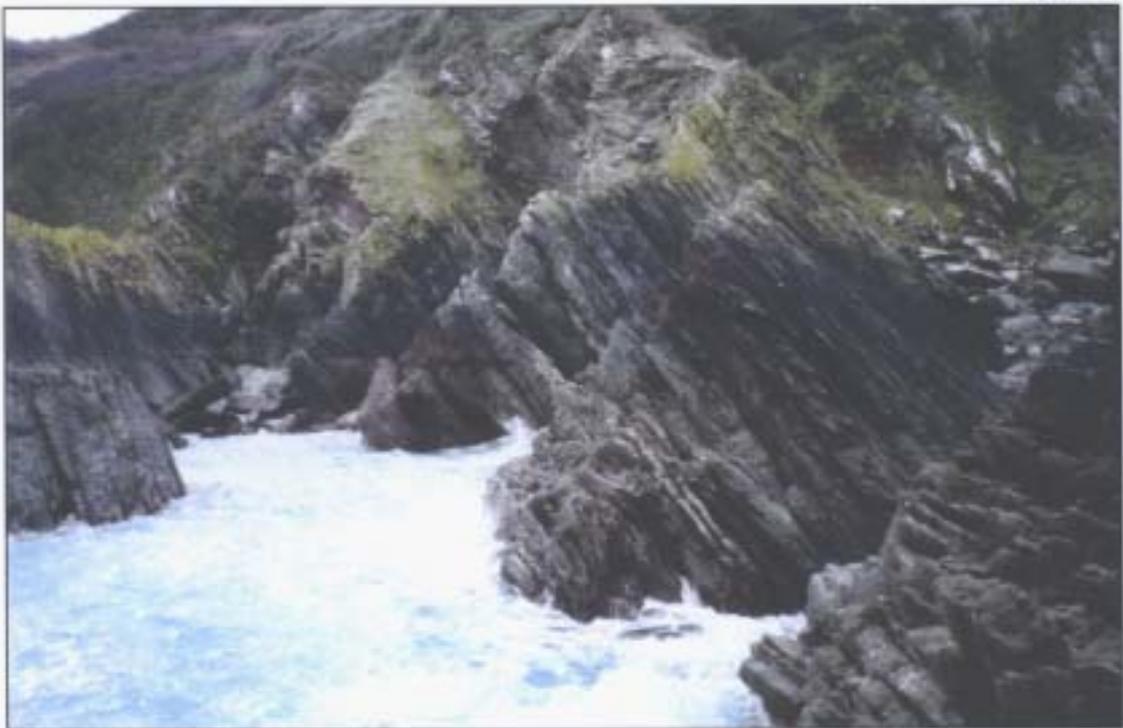
Figure 2

Mr Kebble then shot his last net. This was properly deployed, although the rope connecting the northerly dan had parted. *Harbour Lights* was on a northerly course, which was an extended line from where the last net was shot. At about 1600 another local fisherman, Mr Moore, saw from his house in Polperro, *Harbour Lights* heading close into shore in a northerly direction through Downend Shoals. He was fairly sure that the mizzen sail was down when he saw her. He had lost sight of the vessel by the time she passed the headland of Downend Point. *Harbour Lights* continued on this course until she hit the rocks and broke up just to the east of Downend Point (**Figure 2**).

Rocks where *Harbour Lights* came ashore

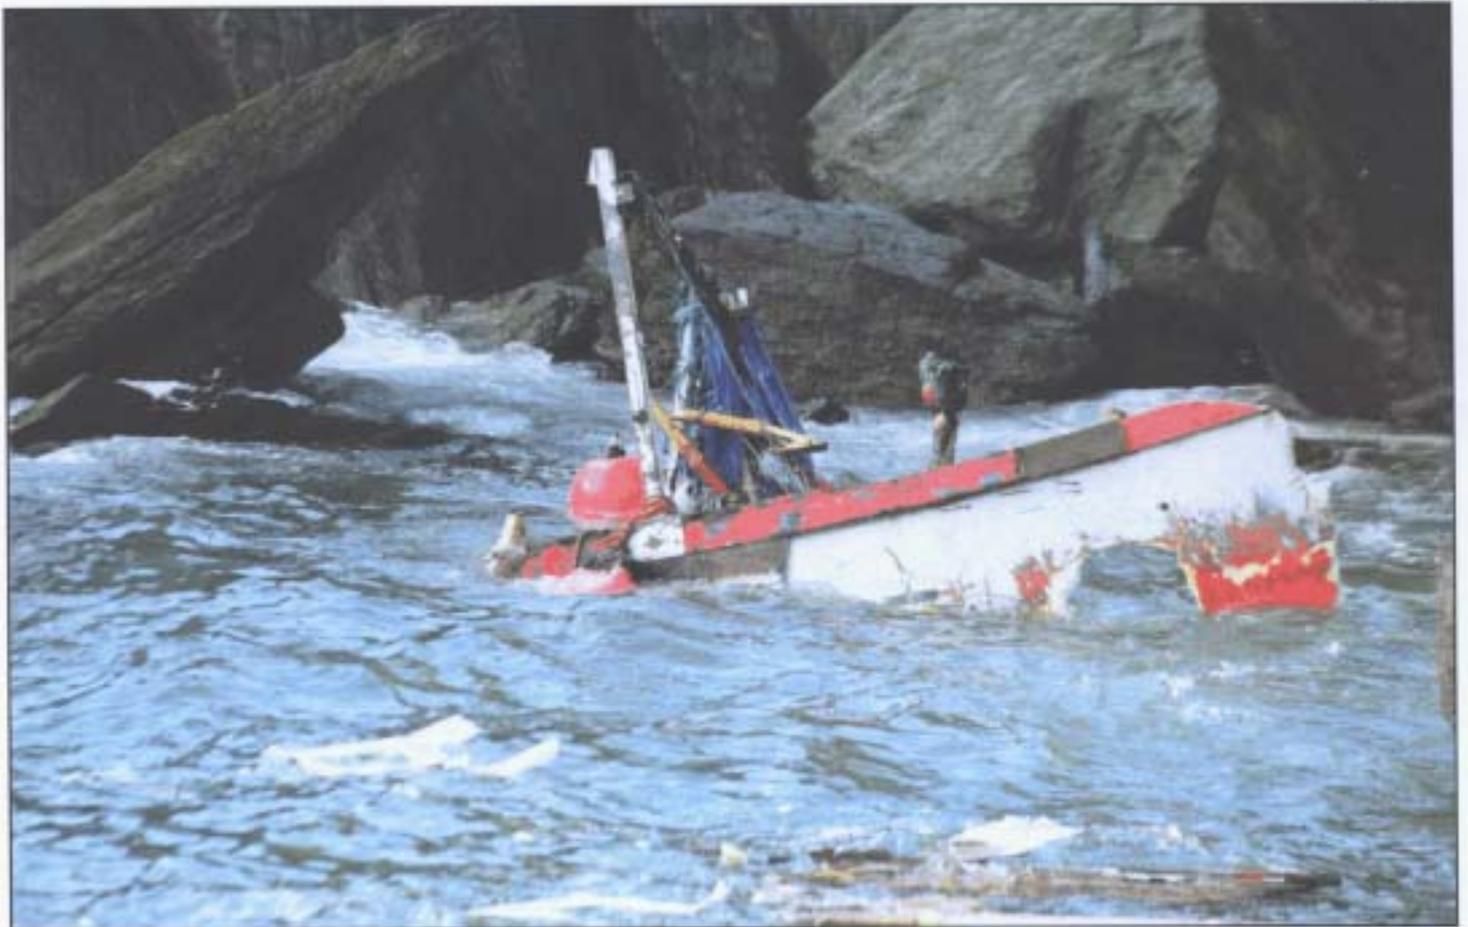
Figure 6

Wreckage from *Harbour Lights* was discovered at 2005 on 8 January between Looe and Polperro. The next day the wheelhouse top was photographed **(Figure 6)**. Dead ungutted fish, mainly cod, were found floating near the wreck. No nets were found at the wreck site.

Wreckage (wheelhouse top)

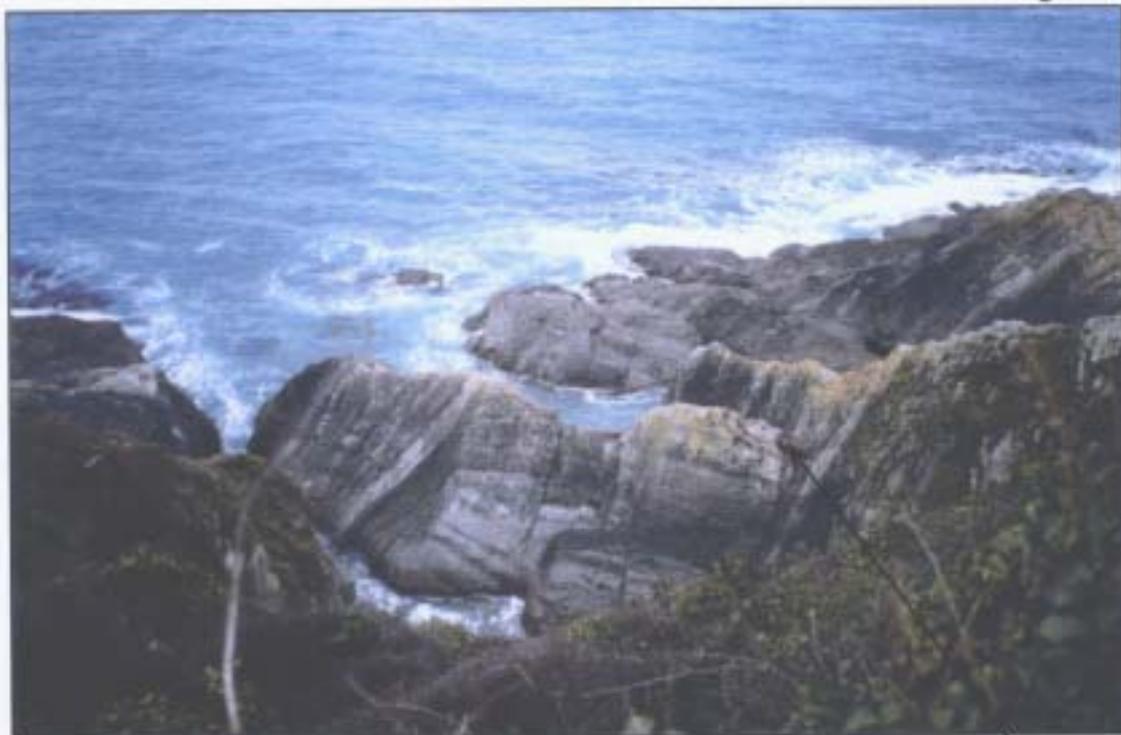
Figure 7

When the MAIB inspected the scene, part of the wreckage, including a lifejacket (**Figure 7**) was seen on the rocks. Difficulties in accessing the site, however, prevented a closer inspection. Pieces of wreckage, which were recovered during the days following the accident, were collected at a local boatyard (**Figure 8**).

Position of wreck

Lifejacket

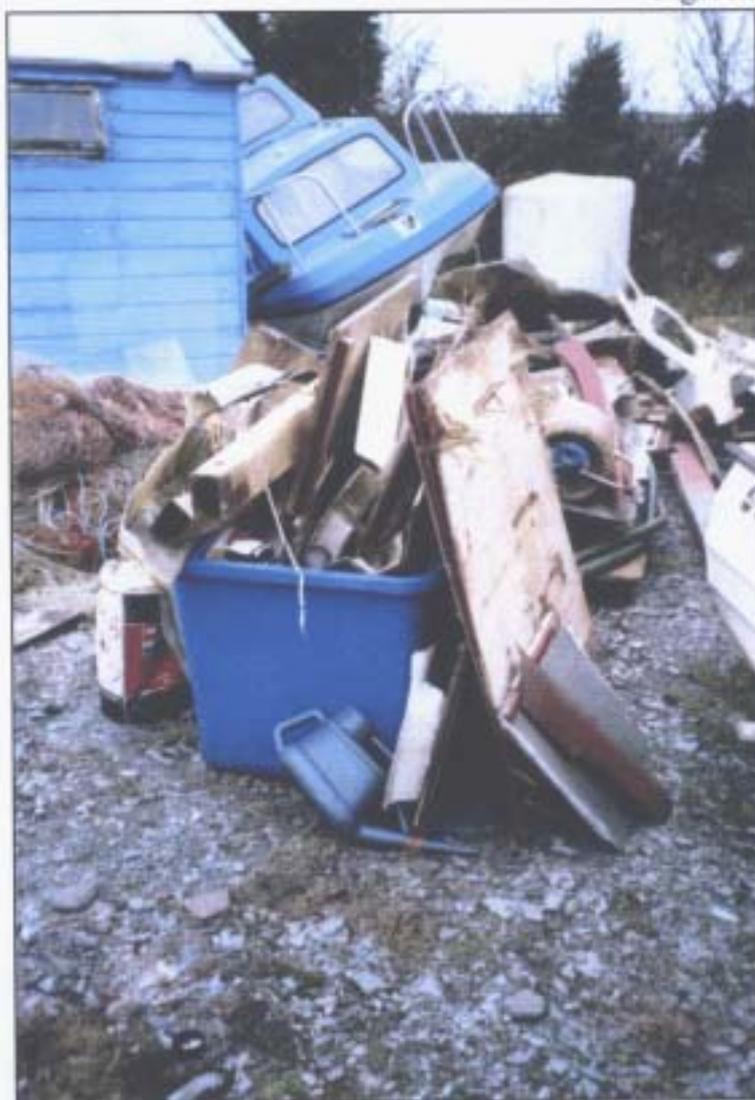
Figure 8

Wreckage collected at a local boatyard

When *Harbour Lights* hit the rocks, substantial damage occurred. The wreckage found was broken into many pieces and incomplete, making it of little use to the investigation.

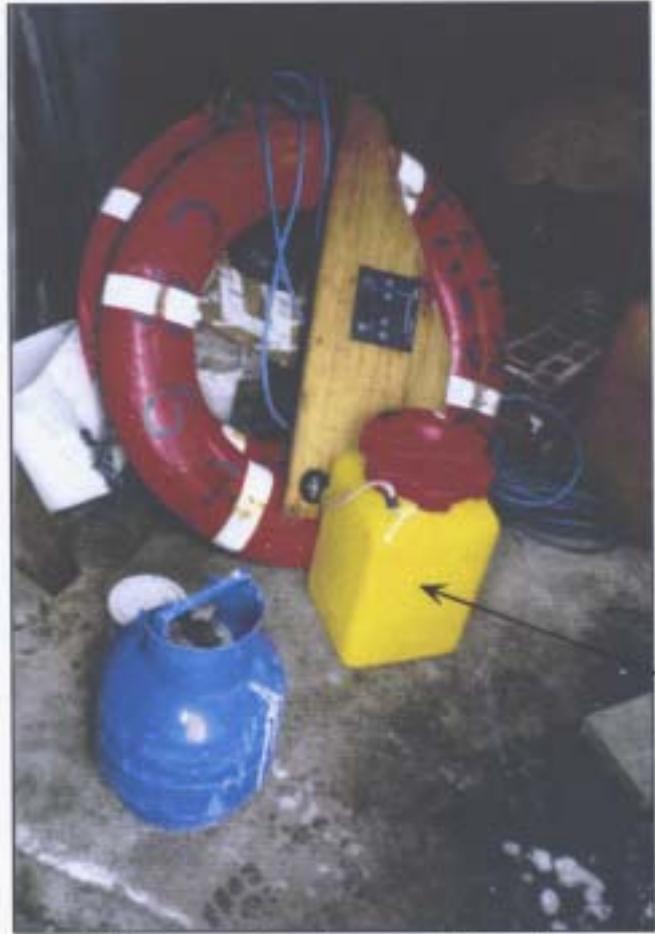
Figure 9

Flares  
canister

Lifebuoys and canister containing flares

Four parachute flares, plus four hand-held flares, and two smoke signals, all in date. Four out of date parachute flares were also on board (**Figure 9**).

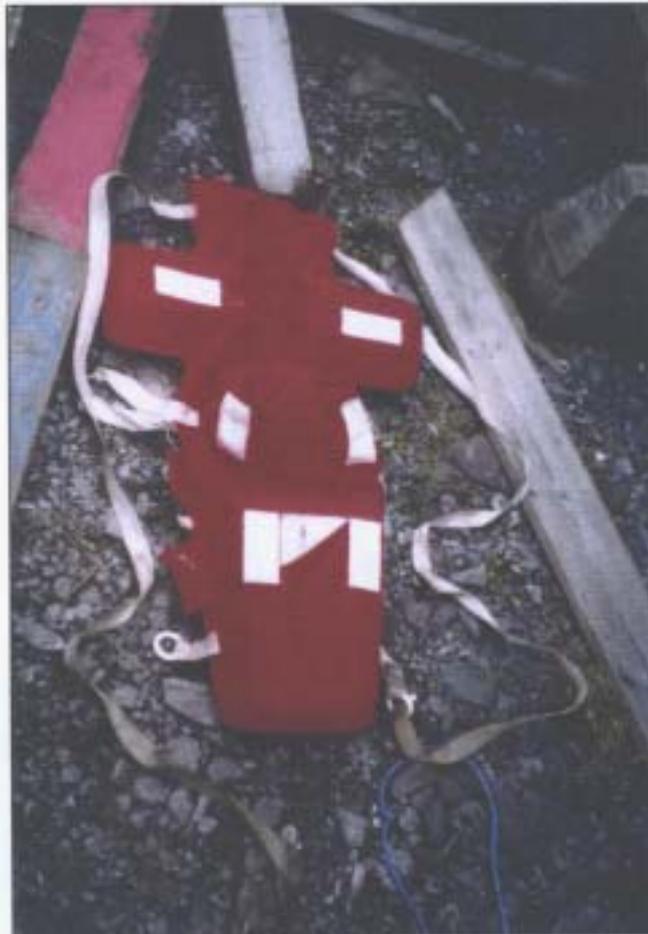
Figure 10

Lifejacket

At least twelve lifejackets, stowed on board for when the vessel was taking passengers on pleasure trips from Polperro, were carried. The lifejackets were of the inherently buoyant type (**Figure 10**) and unsuitable for constant use. Mr Kebble did not normally wear a lifejacket when fishing.

The safety equipment carried on board complied with legal requirements, although the only lifejacket seen by the MAIB inspector had no light attached. It is possible that one of the other lifejackets lost after the accident had been fitted with a light.

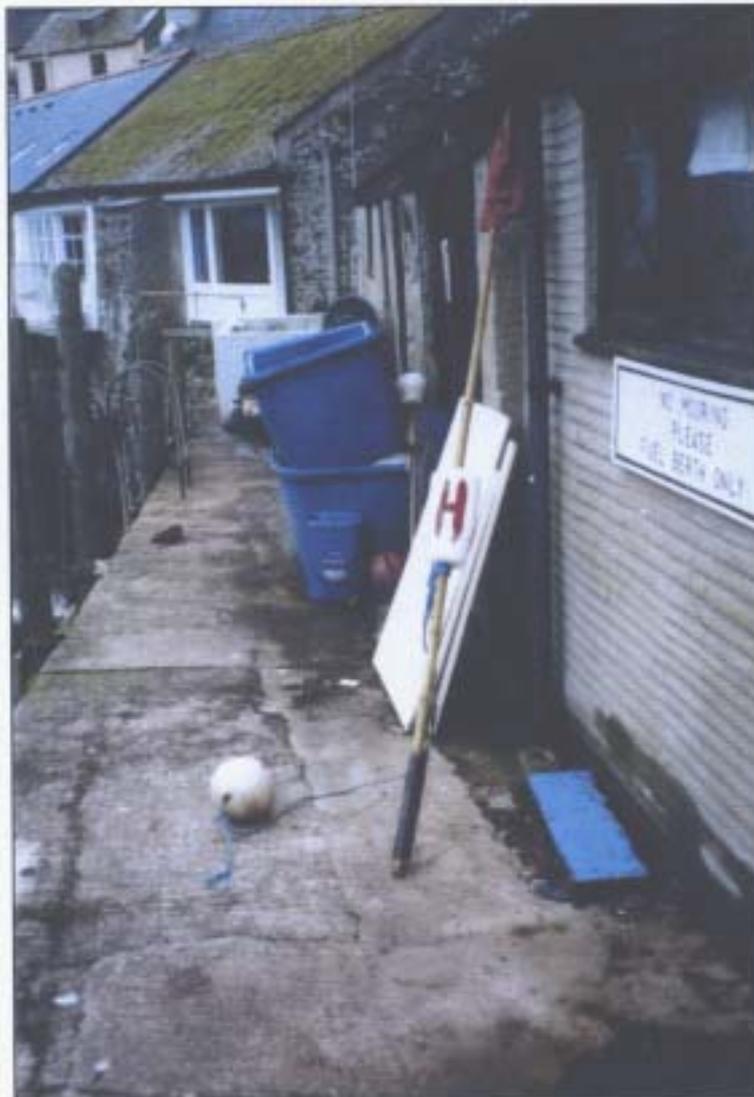
Figure 11

The dan buoy at the end of the net consists of a thick bamboo cane with some steel weights taped to the bottom, some flotation attached to the middle, and a flag at the top. A small buoy is also attached, making the whole unit easier to grapple (**Figure 11**). The rope to the dan had parted under strain (**Figure 12**); the break did not look like a clean cut made with a knife.

The dan

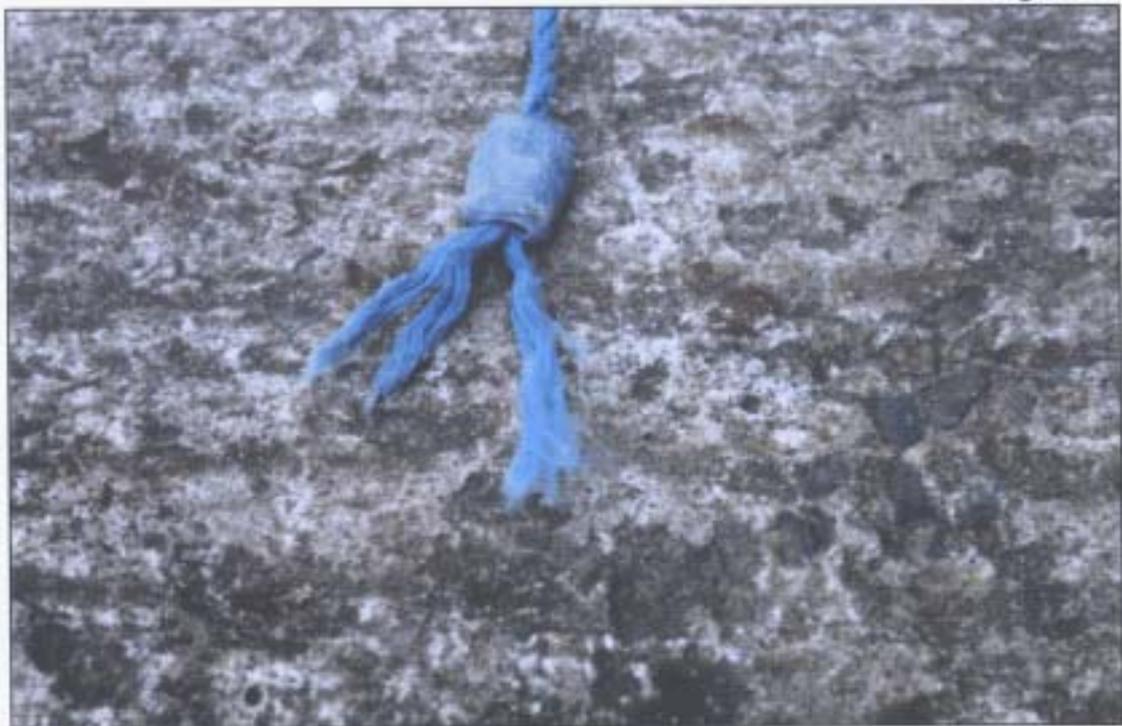
Figure 12

Three possible reasons for why the dan rope parted have been identified:

1. The dan buoy and its rope may have been thrown over immediately after the weight was deployed, as opposed to allowing the dan rope to be pulled over and then throwing the dan buoy in once this was near completion. Throwing the dan rope over in a bundle may have meant that it became tangled around the propeller shaft. If this had happened the rope would have wound around the shaft ever tighter until it parted under the strain. If this had been the case Mr Kebble would have stopped the vessel and then tried to release the rope from around the shaft. This scenario is considered to be unlikely, because if Mr Kebble fell overboard when trying to release the rope, he would probably have been able to climb back on board using the steps attached to the transom. This possibility is not consistent with the fact that at the last sighting of *Harbour Lights* she was heading towards the rocks well north of where the last net was deployed, and therefore is considered to be very unlikely.

Parted dan rope

2. The last net was deployed properly and the rope to the dan parted when it became tangled around the shaft of another vessel. This is considered to be unlikely as the search operation began only a couple of hours after *Harbour Lights* was last seen. There would have been few, if any, pleasure vessels out there on that winter's evening. There was no reason for a large vessel to be that close inshore. Had the break been caused by another fishing vessel, it would probably have been reported, as most of the local fishing boats were involved in searching for *Harbour Lights*.
3. Mr Kebble was no longer in control after the weight had been thrown over. If the dan was not thrown over, it is almost certain it would have been caught in the gantry (**Figure 1**) when the rope came tight. It is believed that the dan was not thrown over and hence the rope parted.
