Investigation of
the foundering of the 4.26m (14ft) dinghy

SAMPHIRE OF WELLS

on the North Norfolk Coast
with the loss of two lives on
16 December 1999

3/15/2000

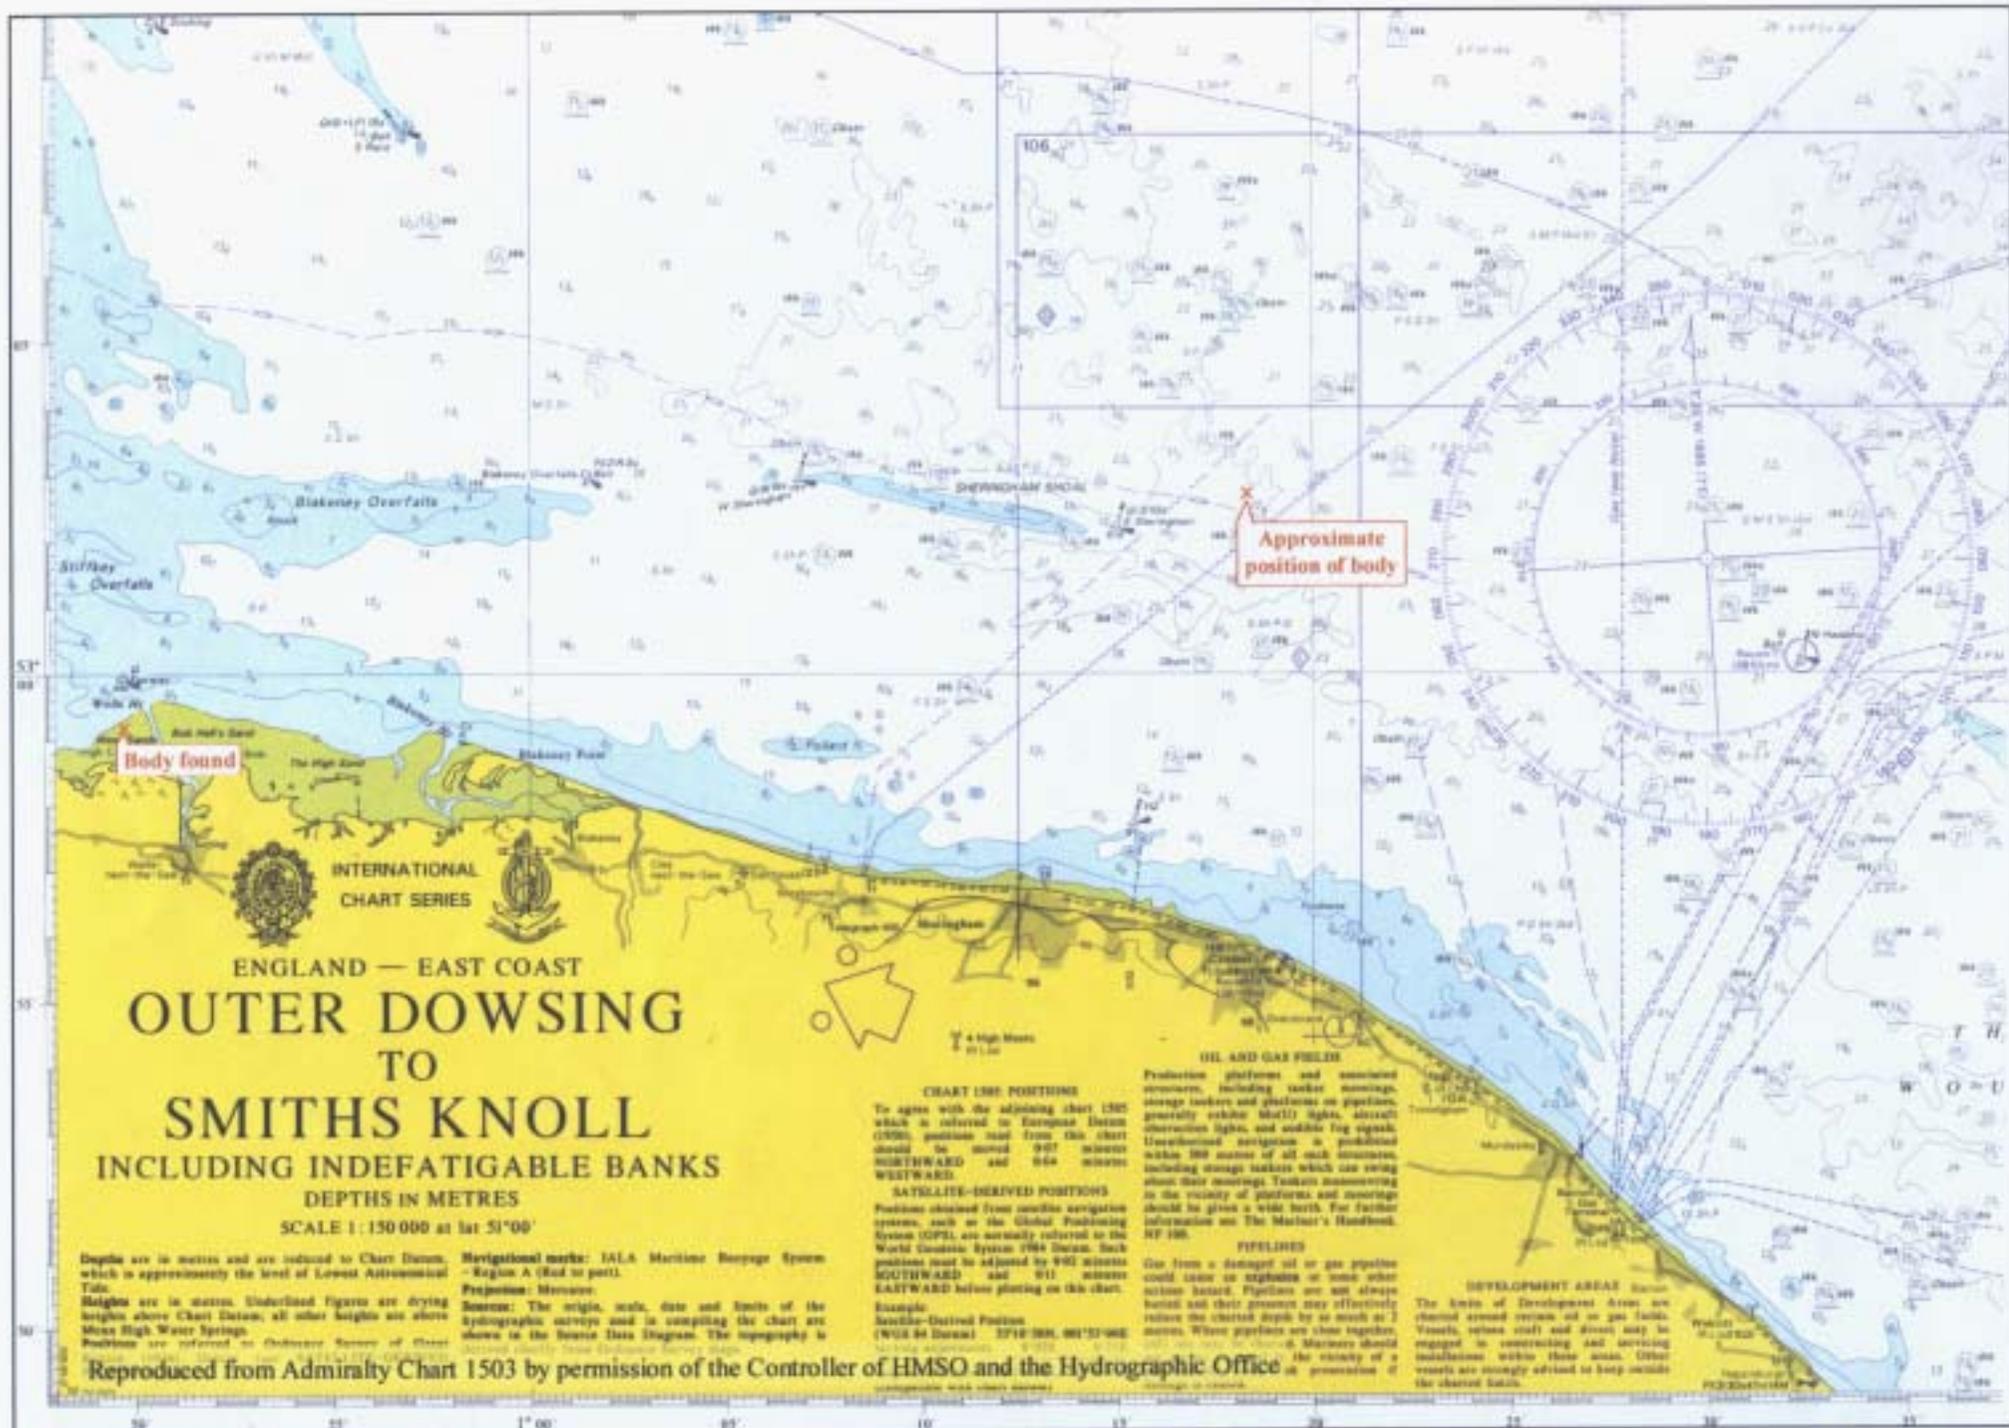
Body found

Approximate position of body
