**Report on the investigation
of the parting of a mooring line
while the Bahamian registered tanker
Alfa Britannia
was berthing at Tranmere oil terminal
causing injuries to crew on board a gig-boat
on 18 November 1999**

Marine Accident Investigation Branch
First Floor, Carlton House
Carlton Place
Southampton
SO15 2DZ

Report No 1/2001

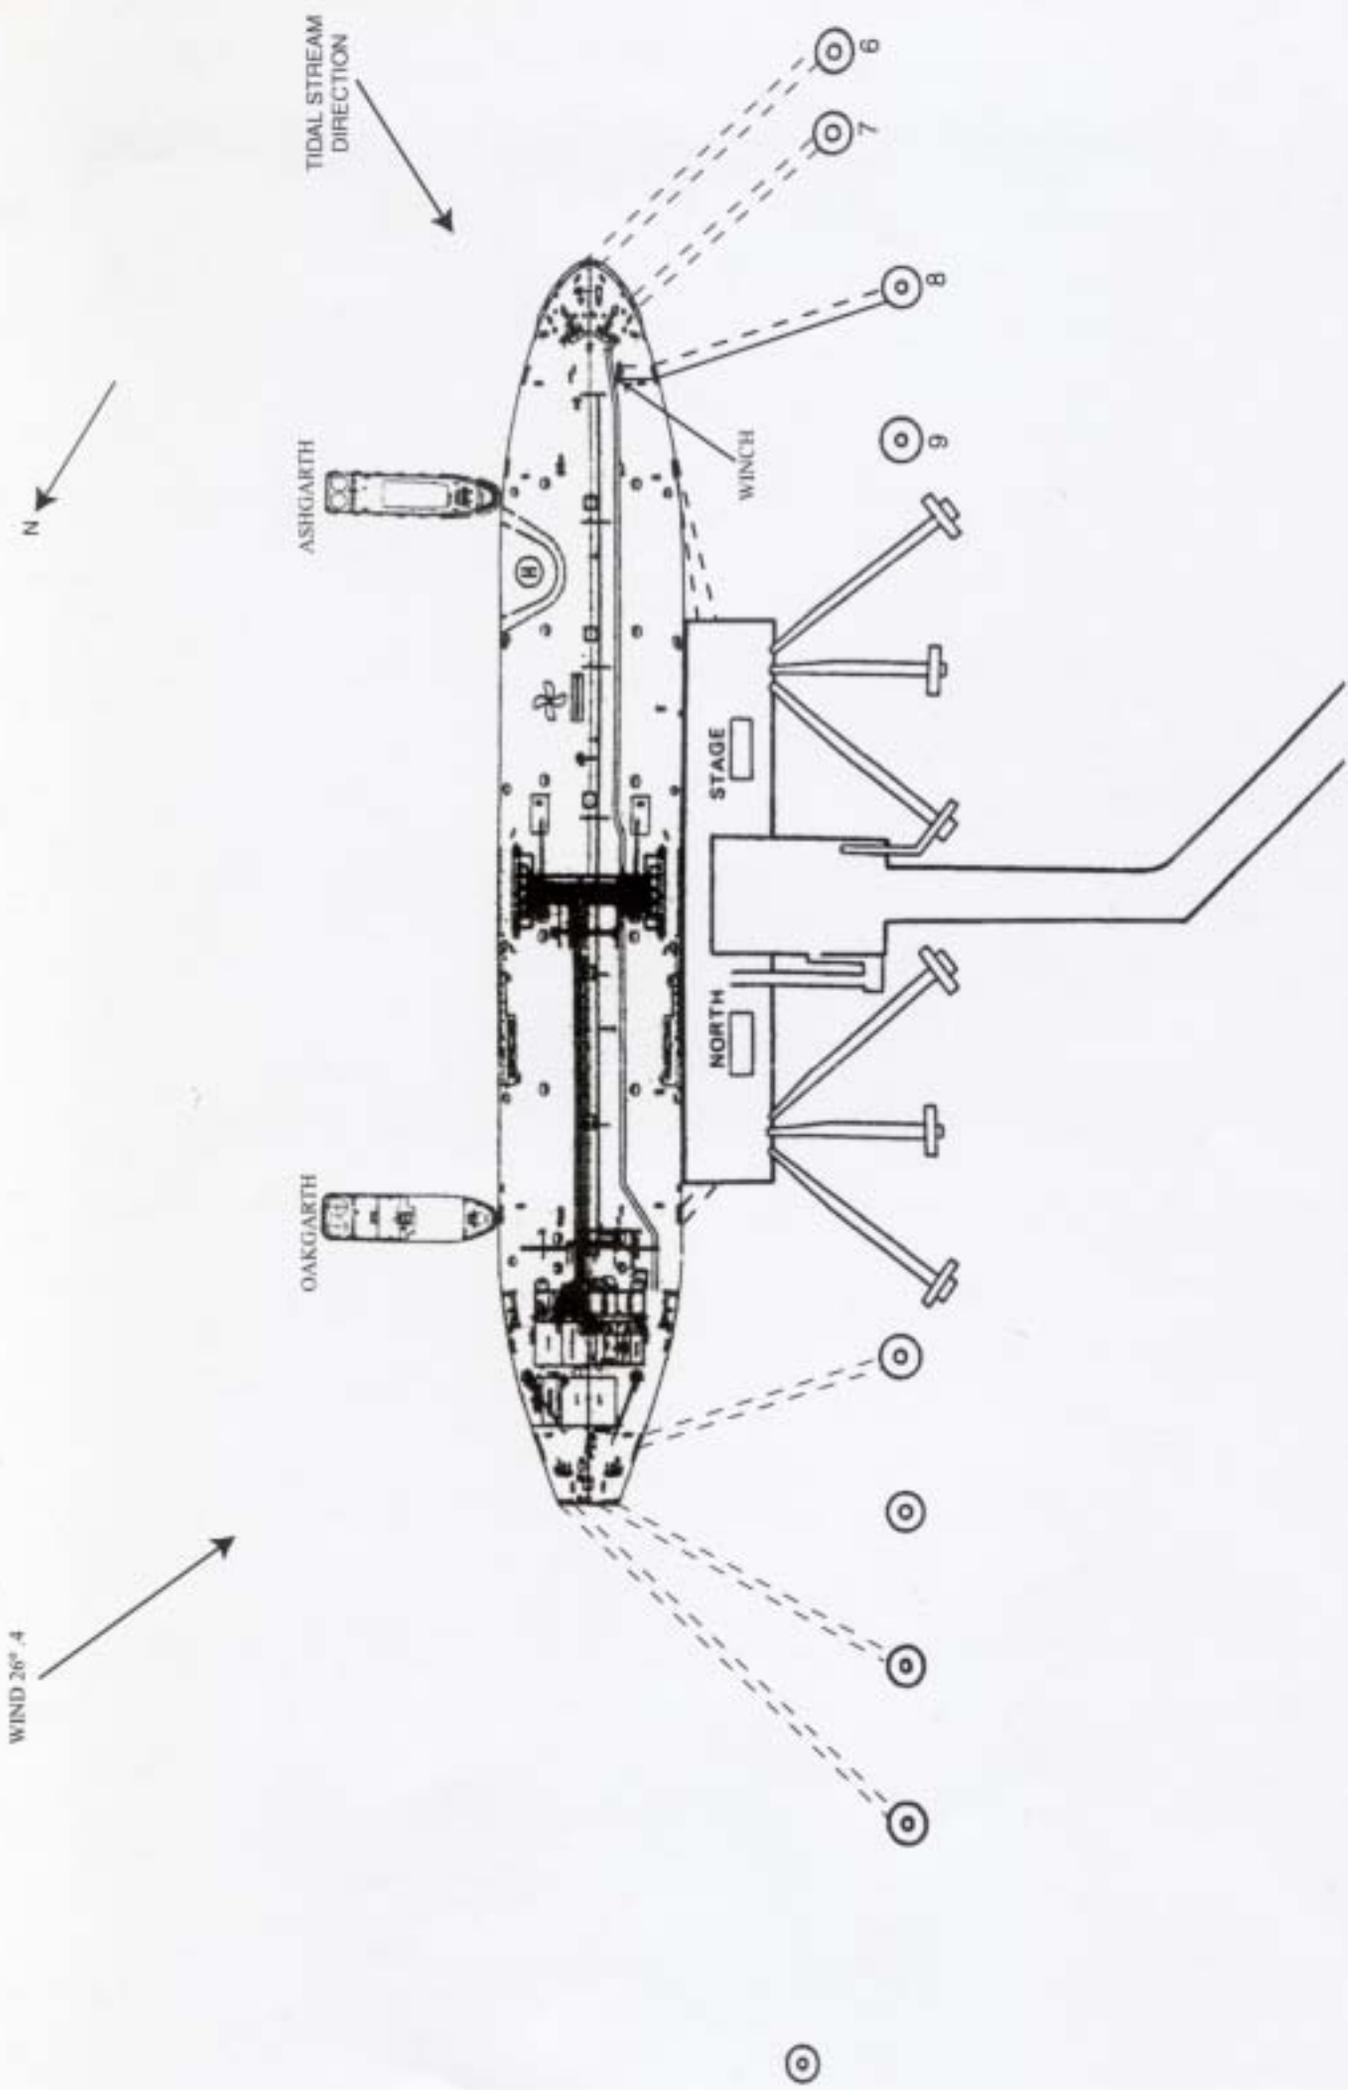
Intended mooring plan for *Alfa Britannia* showing environmental conditions and positions of the tugs at the time of the incident

1. Produce mooring guidelines, specific to the operational requirements and conditions for Tranmere oil terminal, and specific mooring plans for large ships, which can be sent to a ship before arrival.

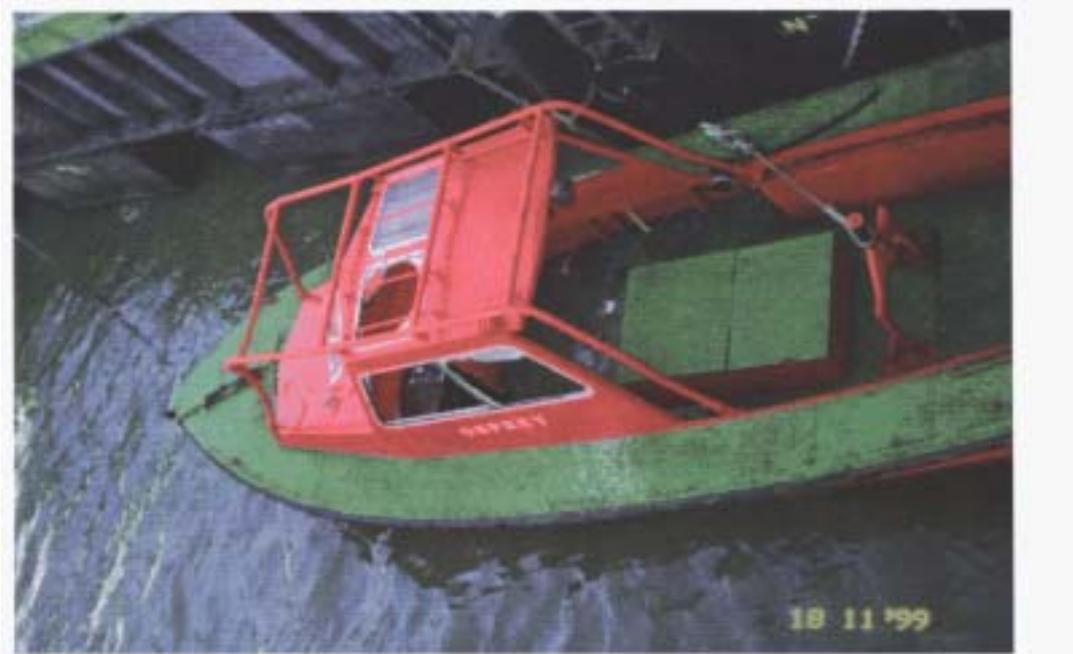
Photograph 2

Gig-boat *Osprey* at Tranmere oil terminal after the accident

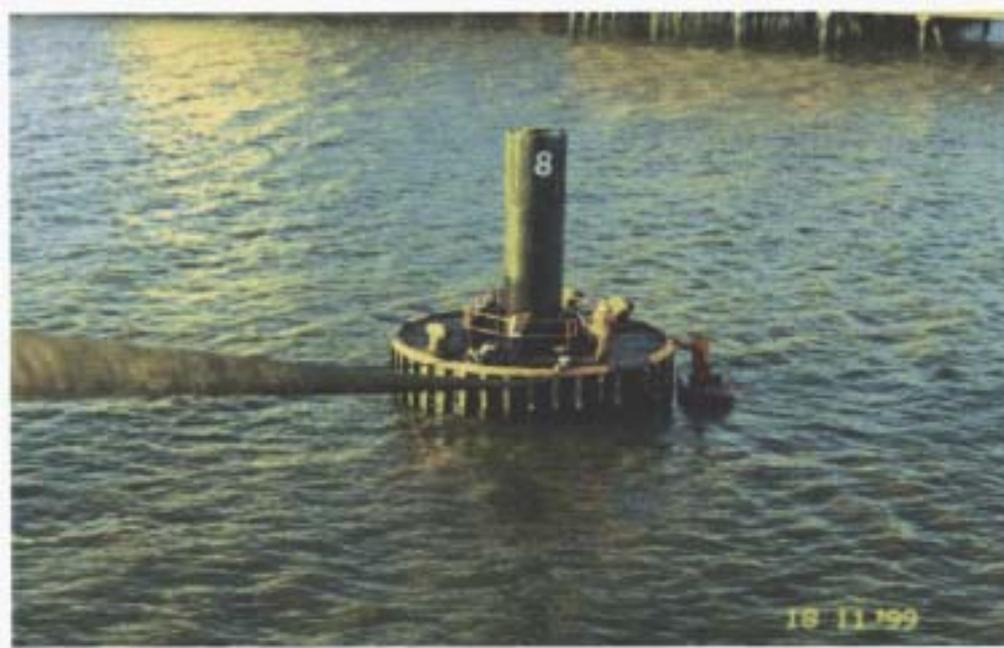
Photograph 3

A view of dolphin No 8 taken from *Alfa Britannia* showing the two breast lines

The dolphins consist of a round platform, which can revolve around a central post and move up and down with the rise and fall of the tide (**see Photograph 3**). There is a mixture of releasable hooks and bollards over which to place the eye of the mooring lines. The gig-boat crew members can place the eye of a mooring line over a hook without leaving the boat. This is not the case with the bollards. Because the hooks can be released in an emergency, and are more accessible to the gig-boat, they are preferred to the bollards.

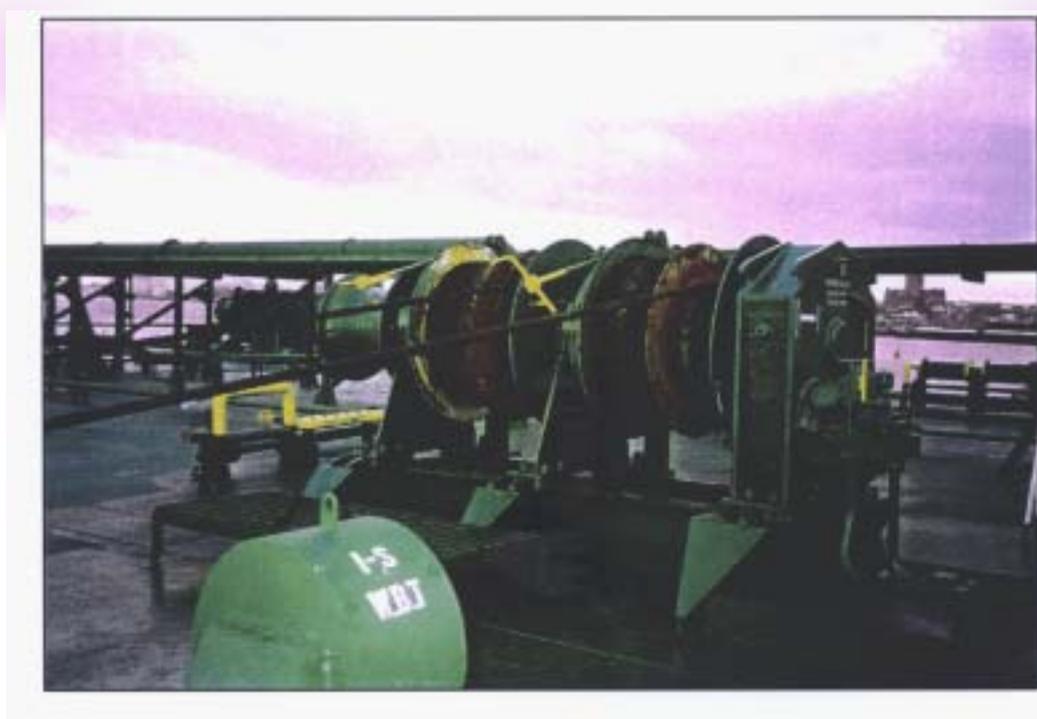
Photograph 4

The mooring drum had a nominal pull of 15 tonnes and, at this load, a hauling speed of 0-15m/minute. The brake holding load for the winch was 59 tonnes (see Annex, Section 4).

An overall picture of the starboard side forward deck-mooring winch

The brake holding load was tested on 28 September 1999, which confirmed that the manufacturer's force of 59 tonnes could still be met. The design of the winch was such that if the brake was applied harder than at the time of the test, the holding power could be increased to greater than 59 tonnes (see **Annex, Section 4**).

The realisation test estimated the strength of the nylon tail as 75 to 80 tonnes at the break point, which is greater than the tested brake holding load of the winch, but less than the breaking load for the wire section of the line. It is probable that the brake was tightened to an extent that its holding power was greater than the tested holding load such that it failed to render and so prevent the nylon tail parting.

The brake should be set to hold 60% of the mooring line's minimum breaking load, but since a brake deteriorates, it is recommended that it should be designed to hold 80% of the line's minimum breaking load. This higher figure allows the brake to adjust down to the 60%.

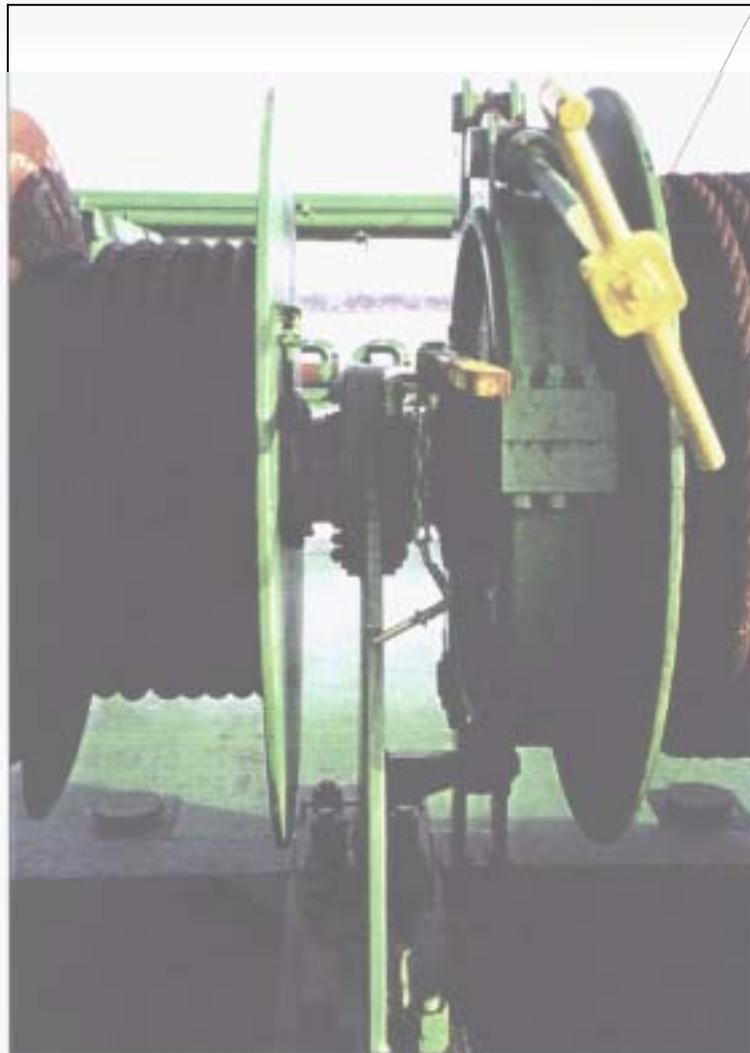
Photograph 5

Each deck-mooring winch had a single shaft to drive the two split drums (each with a tension and a storage drum) and the warping end. Normally, one drum was operated at a time. It had to be clutched into the shaft, by means of a lever, before the hand wheel brake was released. To change from one drum to the other, the hand wheel brake of the first drum had to be applied and the drum de-clutched before the second drum could be engaged. Both split drums could be operated at the same time but only in the same direction (heave or slack) (see **Photographs 4 and 5**).

The deck-mooring winch showing the brake and clutch mechanism

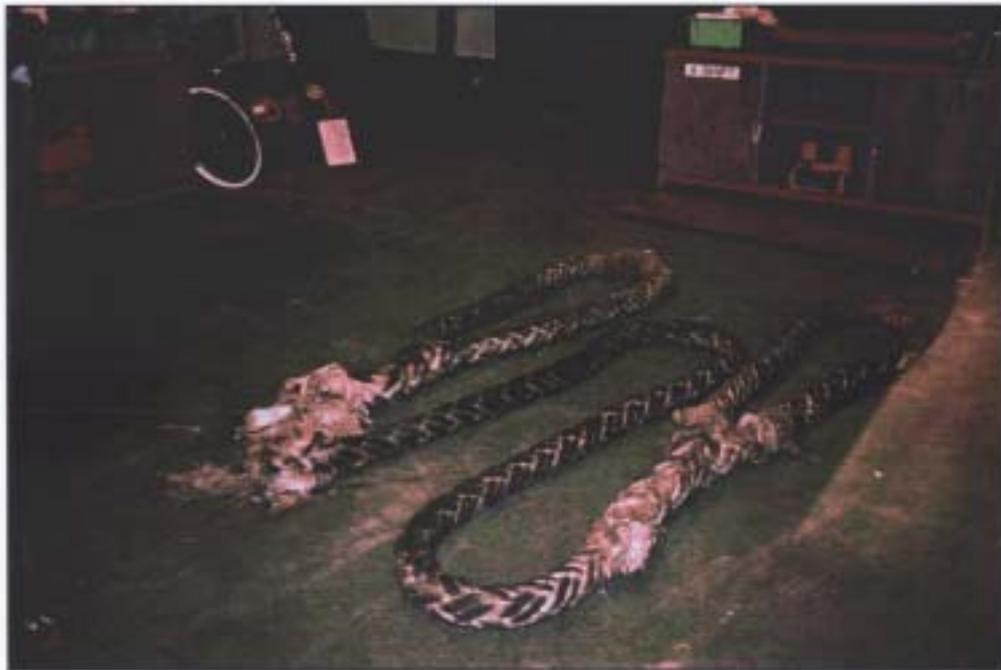
Photograph 6

The nylon rope tail section of mooring line parted cleanly close to the splice at the dolphin end. It was a multifilament eight-strand rope, 80mm in diameter, 11m long with a certified breaking load of 110tonnes.

The broken nylon tail

....., our overall inspection today suggests tensile overload failure. The form of failure, in which all strands have failed very close to each other and, adjacent to the 'Node' formed at the end of splice taper, is symptomatic of shock loading failure.

The final report by the Arbroath test house observed there were a number of broken outer yarns, especially in a region 2 to 3m from the intact splice end. This surface wear had resulted in the tail being under-strength before it failed. However, there was little evidence of surface wear and abrasion at the point of failure.

The realisation tests showed that the total strength of the rope was 65.5 tonnes. However, because there was less wear in the region of the failure (as well as for reasons due to test methodology and rope binding effects) the realisation figure was an underestimate. The report estimated that the strength of the rope at the broken region was about 75 to 80 tonnes.

The nature of the break in the nylon tail indicates that there was a sudden and dynamic load imposed on the line (see Section 1.6 and Annex, Section 2). However, due to its elasticity, the purpose of a nylon tail is to be a shock absorber for the stiff wire part of the mooring line. Nylon has good resistance to abrasion, is rot-proof and is not damaged by oils, gasoline, grease, marine growth or most chemicals. However, the range of design factors contains provision for very modest dynamic loads. This means that the load must be handled slowly and smoothly to minimise dynamic effects. The test reports state that the condition of the nylon tail was not a cause of the break.

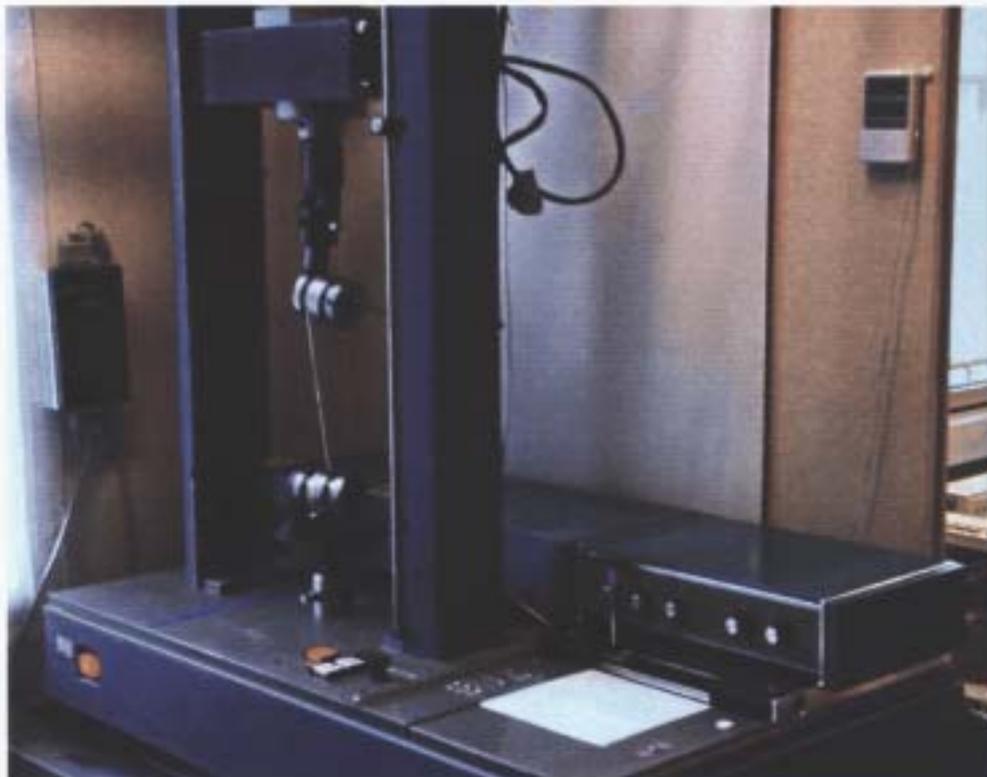
Photograph 7

A yarn from the nylon tail undergoing a realisation test in Preston

- a) determine mean yarn strength by test;
- b) multiply a) by the realisation factor of 0.66 in EN 919:1995;
- c) multiply b) by the number of unbroken yarns in this rope before failure.
