Report of an Investigation
of a steering failure and subsequent
collision with Lambeth Bridge of the
Class V passenger vessel

mv Symphony

on the River Thames
on 4 October 1999

Report No 18/2000

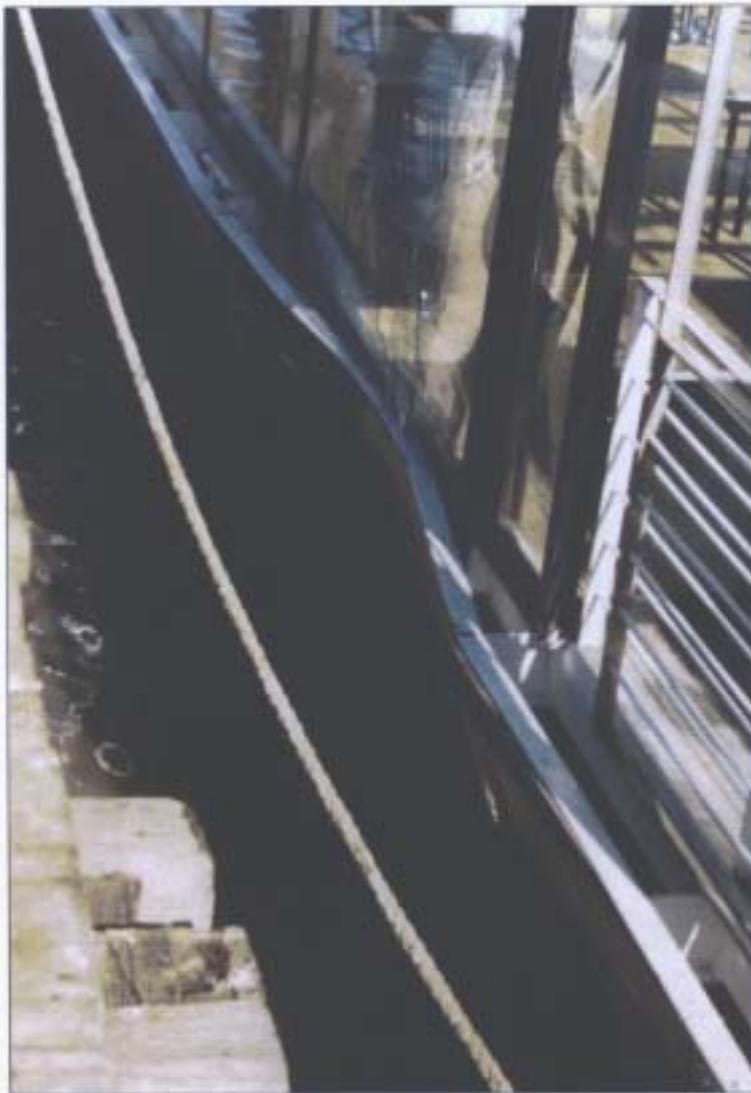
The first impact with the bridge caused damage to the starboard forward quarter at about frame 34. It is likely that this contact between the vessel and the bridge occurred when the vessel was still moving ahead and turning to port. This glancing blow was largely absorbed by the steel backed wooden fender and deck edge, but it did cause slight damage to the supporting framework of the glazing, and cracking of the glazing immediately above the impact area. A length of wooden fender, about 2m long, was lost with the steel backing pushed back to the deck edge in a smooth curve. There was no indication of a point of contact. With the main deck in this area overhanging the hull by some 1.5m, the hull was undamaged.

Damage to starboard forward quarter caused by first impact

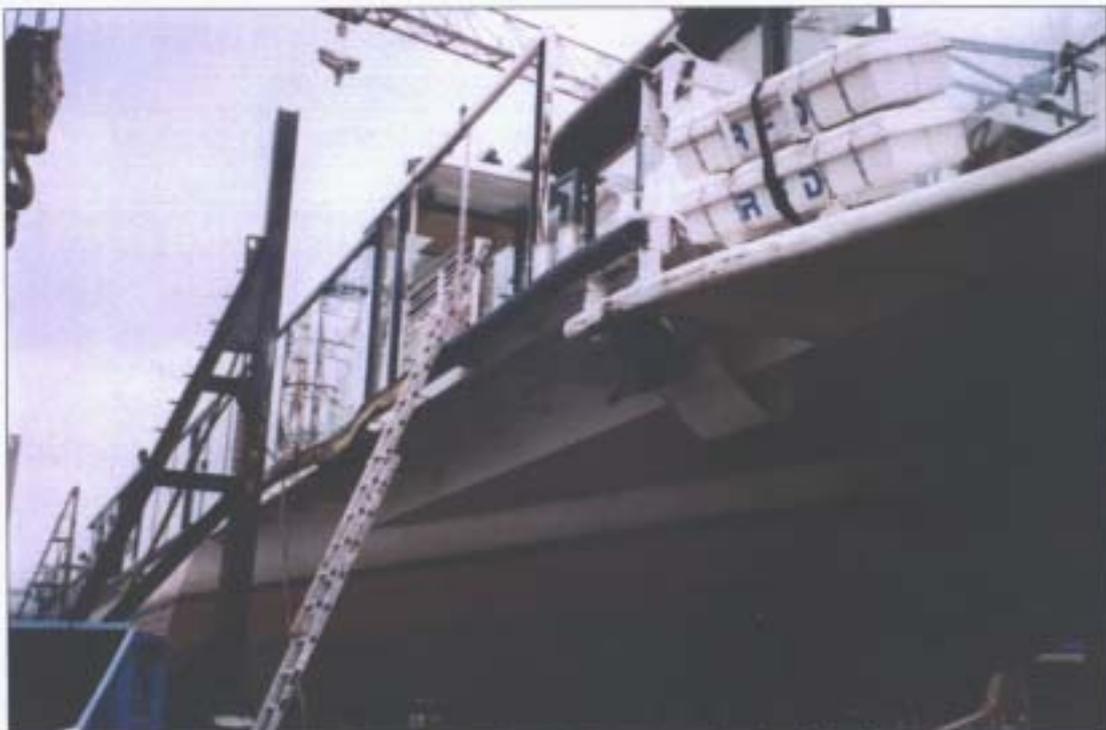
Figure 9

General view of starboard side showing localised extent of damage to steel and wooden fender

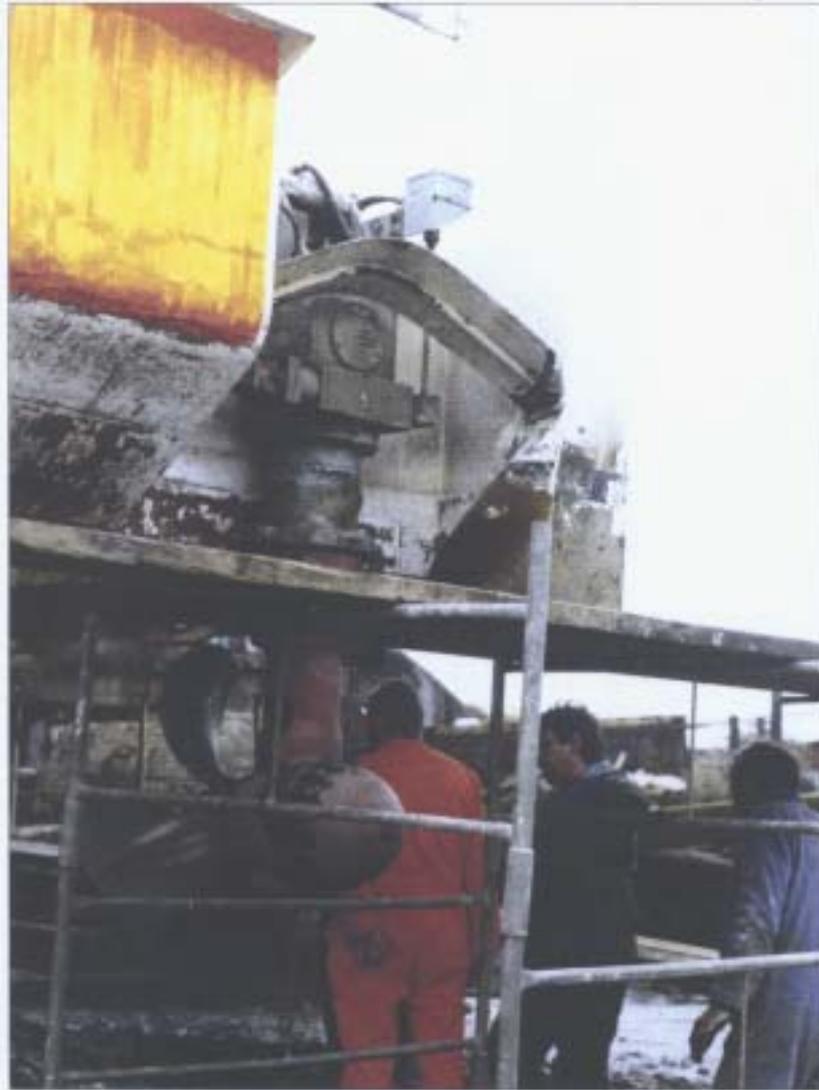
Figure 10

The second impact occurred when the stern swung under the influence of the flood tide and made contact with the bridge. A rectangular box-shaped section, forming part of the stern structure, was pushed inwards over the bottom half by about 100mm. Although causing local deformation to a footplate and guard-rails at deck level, the starboard Schottel unit was not damaged and remained free to rotate.

General view of stern - note starboard wing bent inwards causing foot plate to be pushed upwards

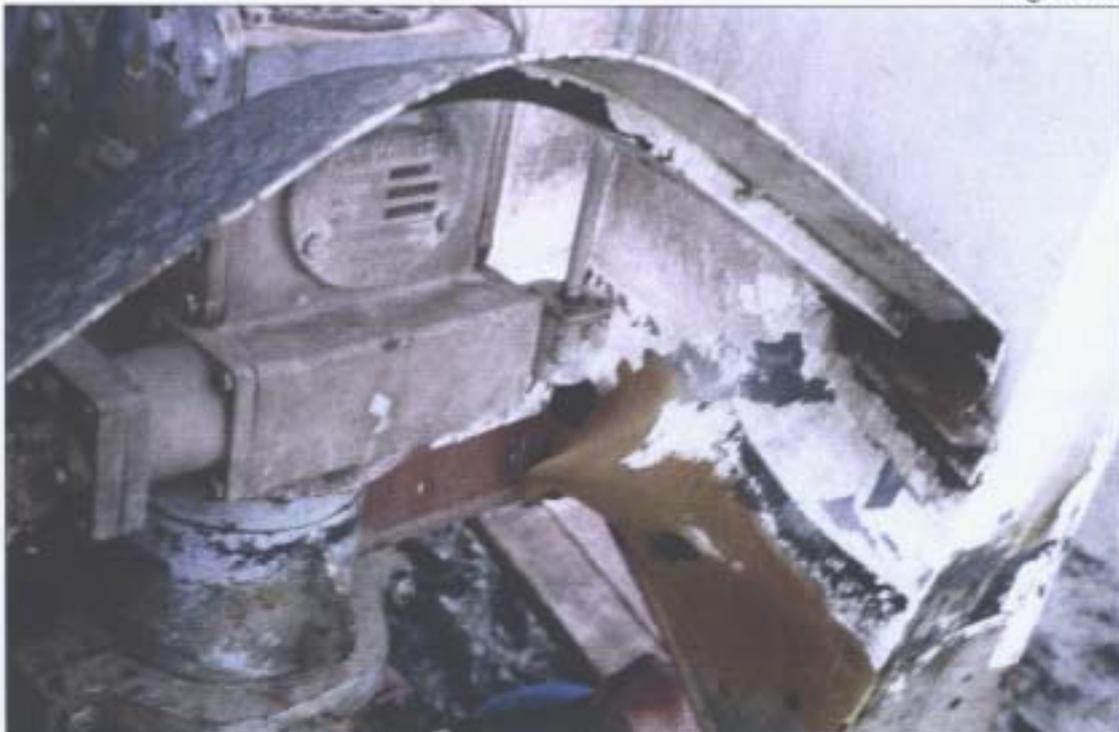
Close-up view of damage around around starboard schottel unit

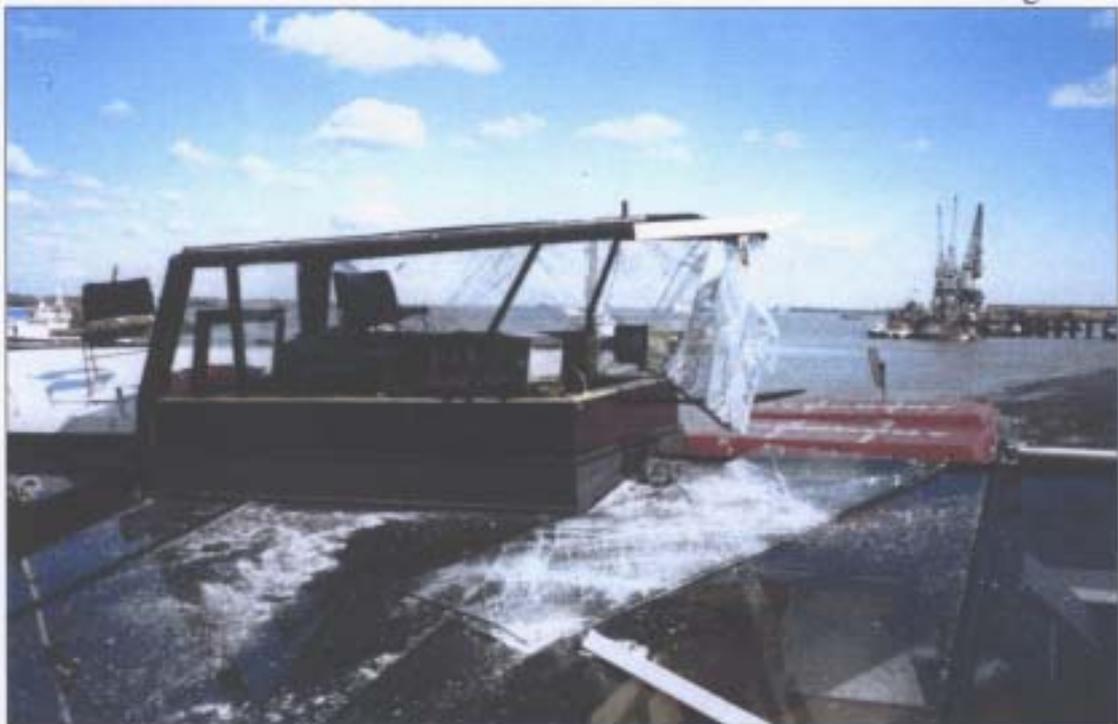
Figure 13

The third and last area of damage occurred as the vessel was passing under the bridge. With the vessel well off centre, the wheelhouse struck the curve of the arch causing the upper light structure to be pushed forward by about half a metre and slightly to port. This confirmed that the vessel came out of the bridge stern first and over to the south side of the bridge. The wheelhouse glazing had cracked throughout, with some panes dislodged when the light framing was bent forward. There was no damage to the control console or other equipment mounted on the lower half of the wheelhouse.

Damage to wheelhouse structure caused by contact
with underside of bridge while exiting

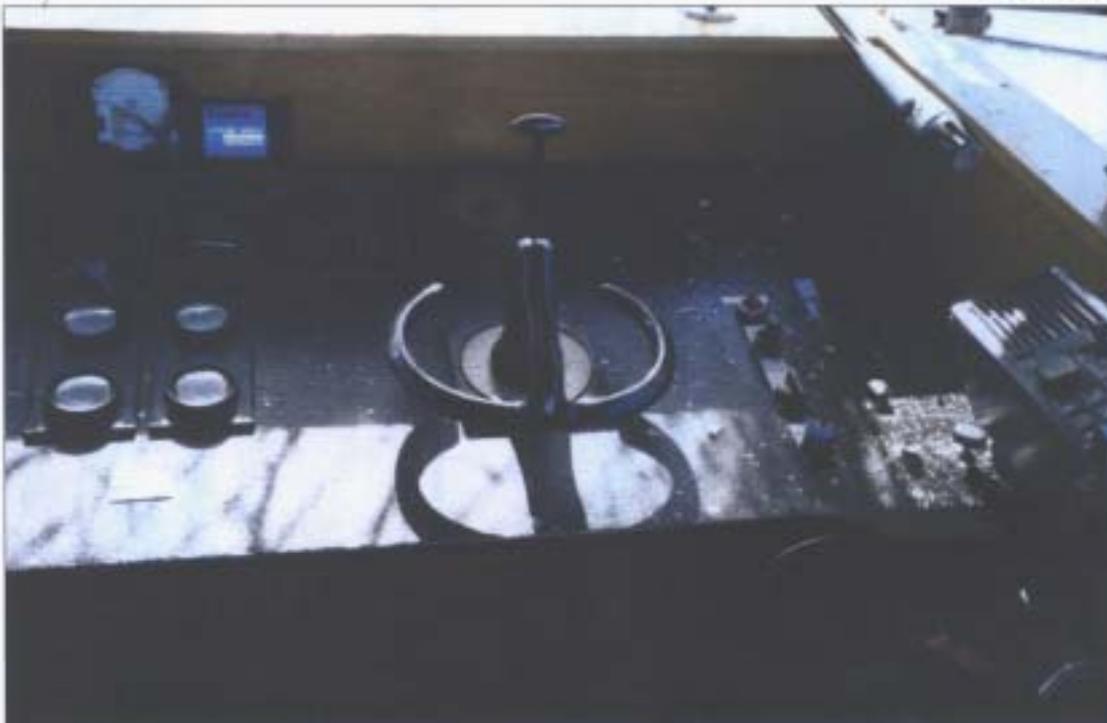
Figure 15

View of wheelhouse control console - note schottel direction indicator dial showing unit pointing in direction of between one and two o'clock

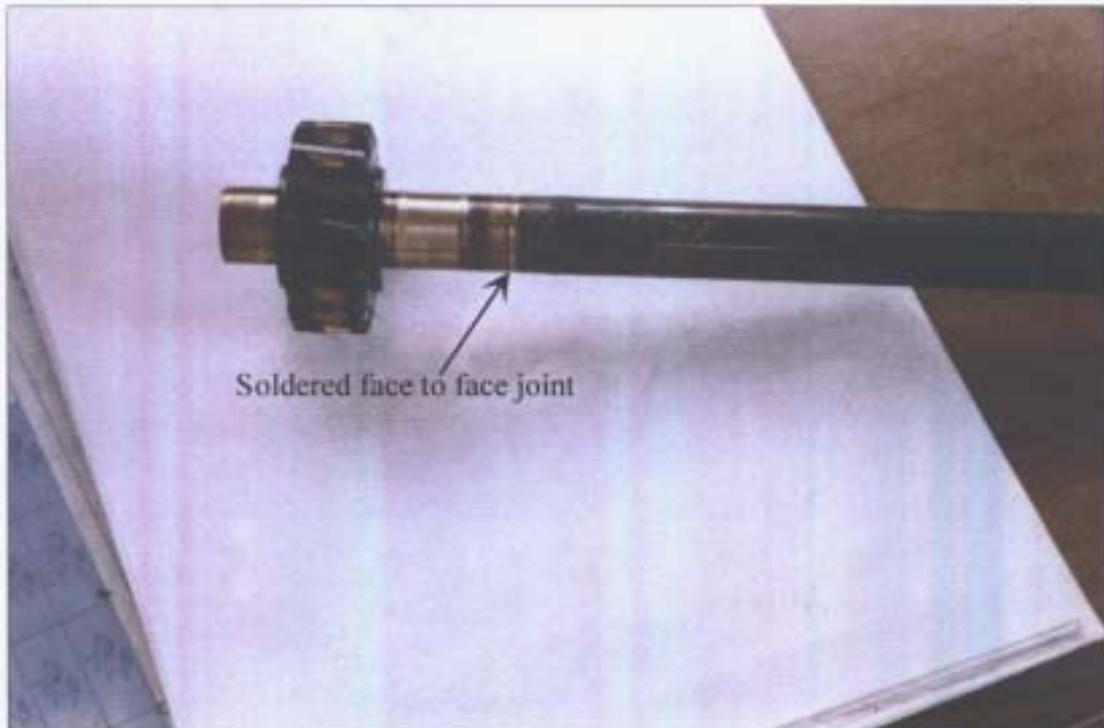
Figure 16

- 1.14.4 The feedback drive mechanism was then opened up, and it was found that the lower end of the shaft had separated from the extended drive shaft because a silver soldered spigot joint had fractured. No taper or split pin locking device had been fitted. Originally, both the drive mechanism and the potentiometer were in close proximity with the short stub drive shaft secured, direct to a similar stub shaft driving the feedback potentiometer, by means of a spigot joint and a split or taper pin.

Potentiometer drive shaft as fitted

- 2.1.1 The two technical investigations which took place at Dentons Slipway, Gravesend, between 5 and 11 October 1999 confirmed that the cause of the steering failure was the fracturing of a silver solder joint on the drive shaft of the starboard steering feedback potentiometer.

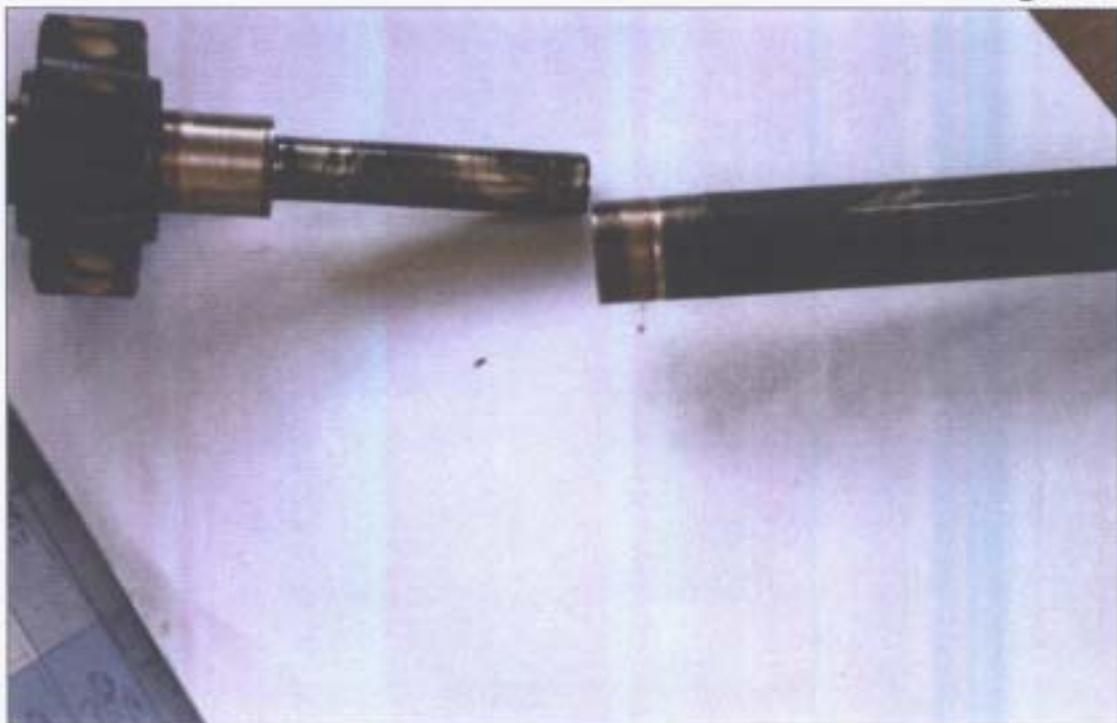
Figure 17

Potentiometer drive shaft showing extension shaft and absence of taper pin

The lack of a feedback control signal to the wheelhouse, did not only prevent the master knowing the position, and hence direction, of the engine thrust, but also caused the unit to continue to rotate as it was unable to sense a stop signal.
