Report on the investigation
of the Grounding and Loss
of the Fishing Vessel

RACHEL HARVEY

Peninnis Head, Isles of Scilly

Report No 23/2000

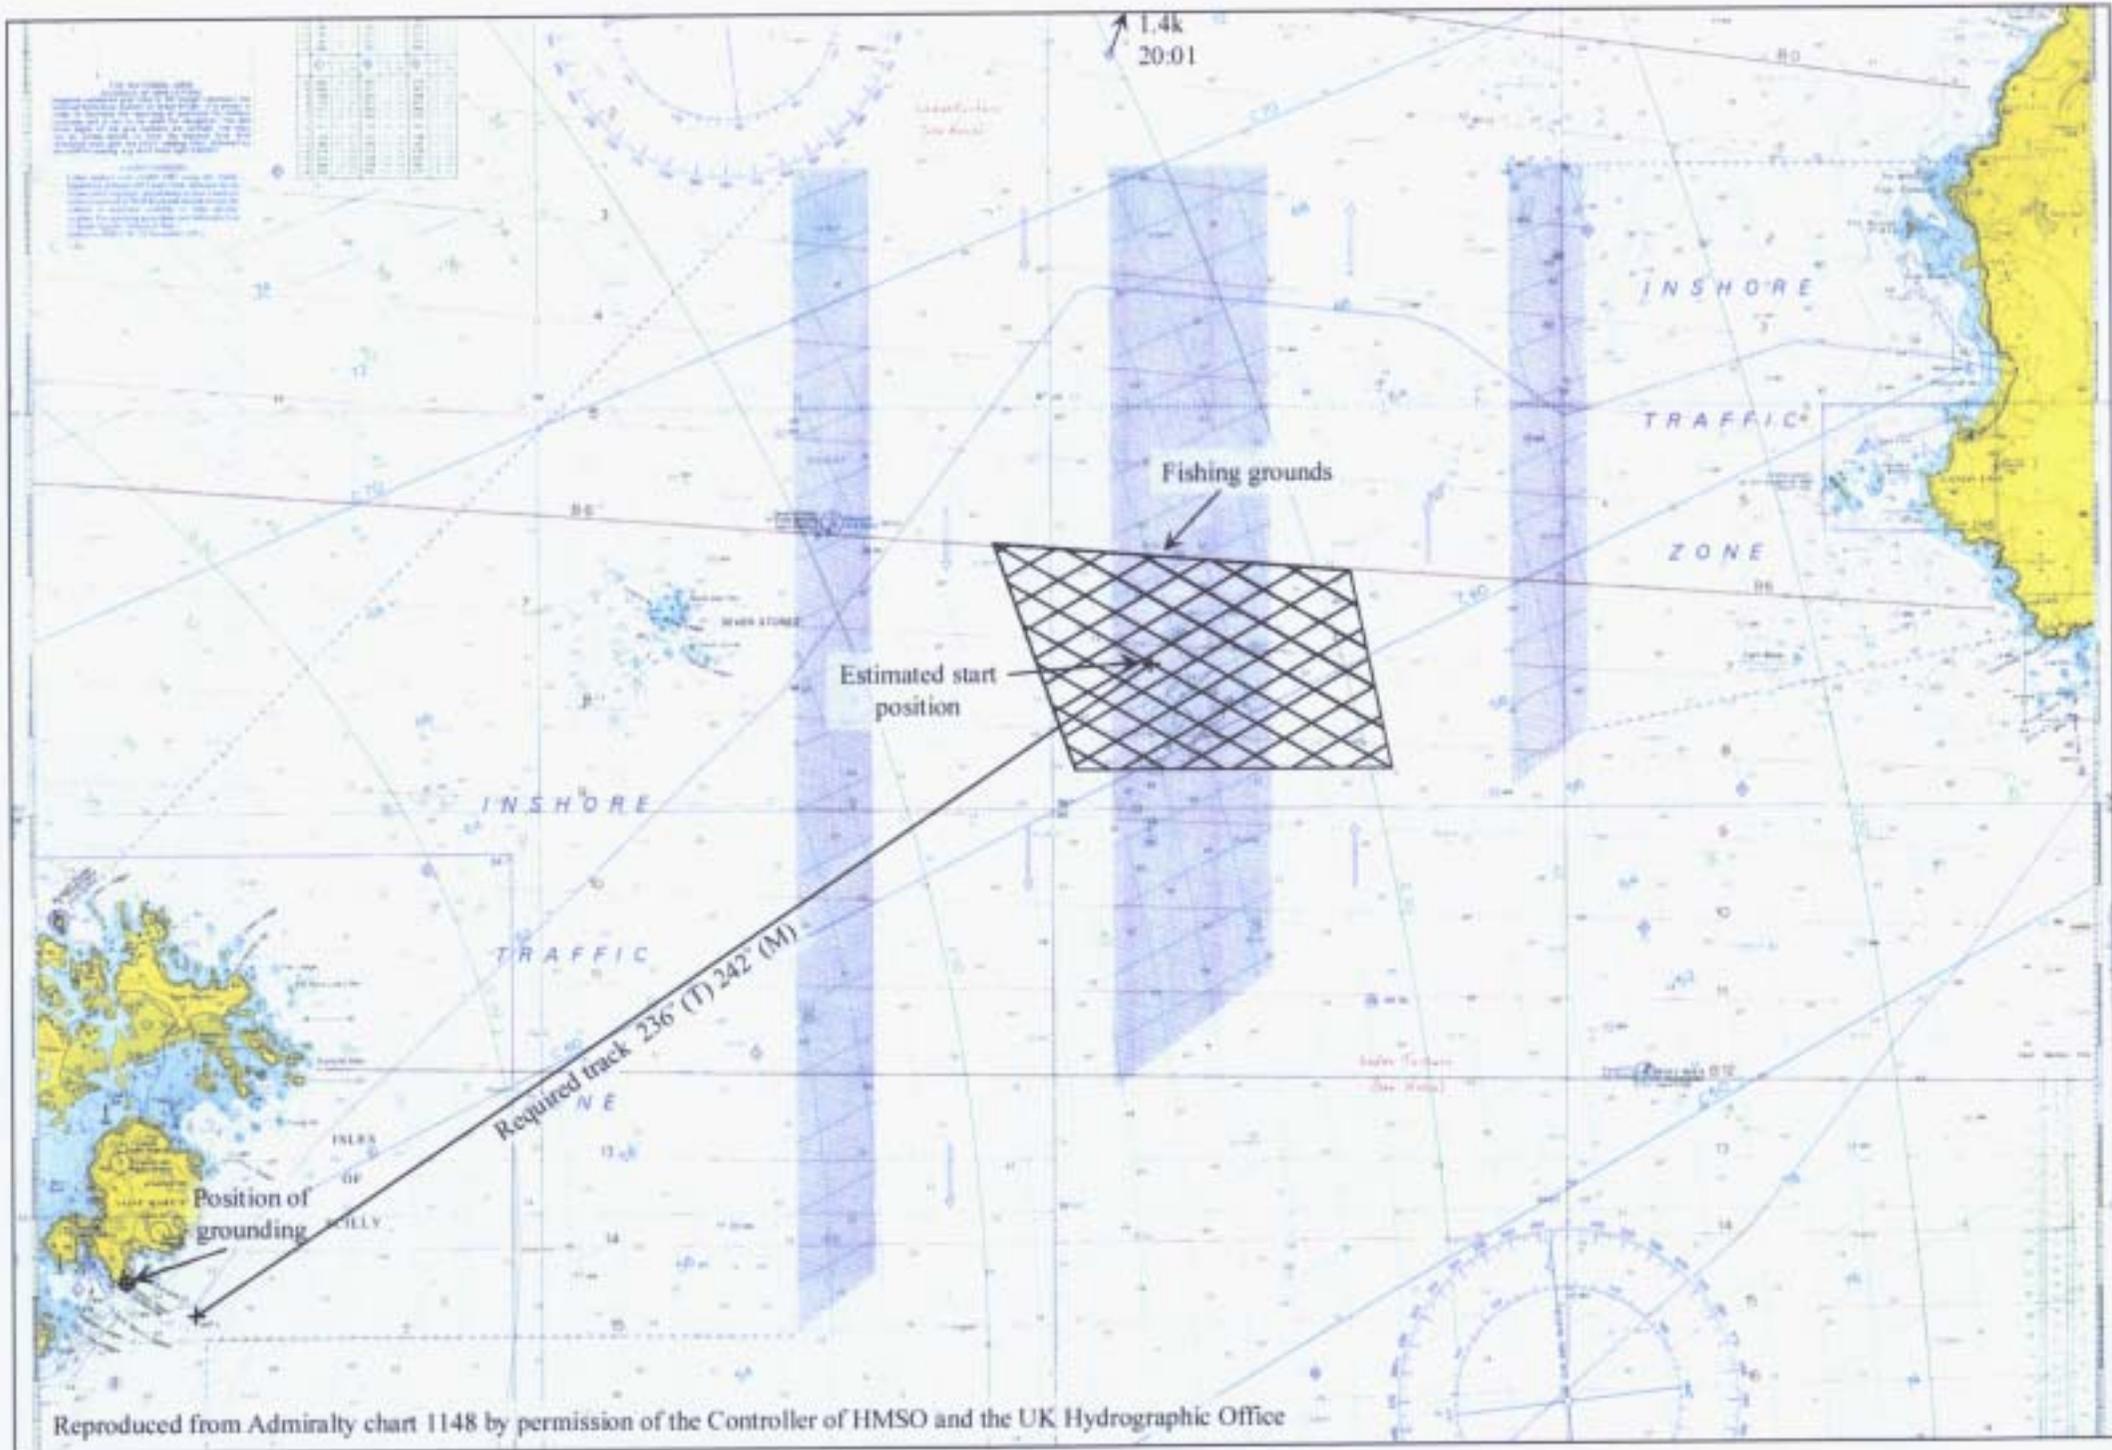
Figure 1

F2 could see Peninnis Head light on the starboard bow, but he was still concerned, so he adjusted the course setter control further to port. He did not want to disturb either F1 or the skipper unnecessarily. He had always intended to call the skipper when the vessel was off Peninnis Head, and she was nearing that point.

Soon afterwards something caused him to become very concerned, and he shouted to F1 to get the skipper. He looked out to starboard and saw breaking waves and rocks; a few seconds later the vessel was felt to judder as she grounded.

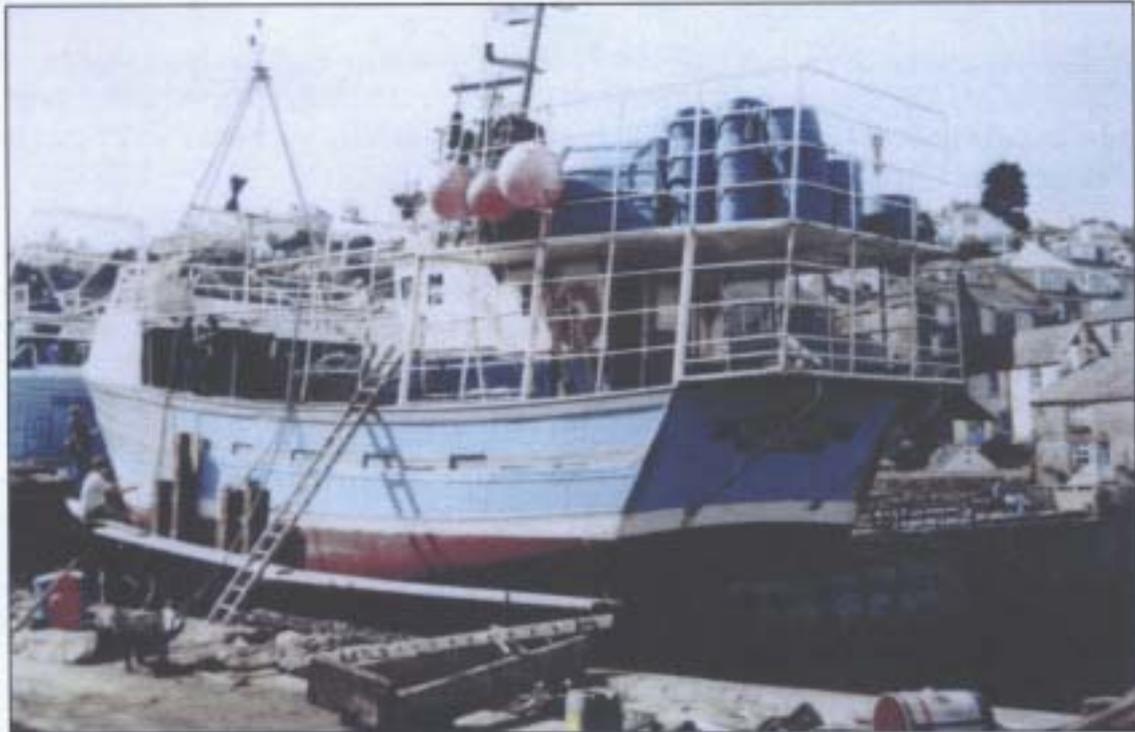
Photograph 2

Rachel Harvey was a wooden-hulled vessel of 16.25m registered length. She had a wheelhouse situated aft of mid-length, abaft which a platform (podium) was provided for storing empty pots and other equipment. To aid the security of the equipment, which was sometimes stowed on the podium and on the small after deck beneath, a tubular steel framework had been constructed (**photograph 2**).

25. The Navitron autopilot's operations manual was found to be poorly laid out and difficult to understand. [2.4]
26. The tubular steel framework, which surrounded the after deck, impeded the escape of crew members as the vessel was sinking. [2.7.1]

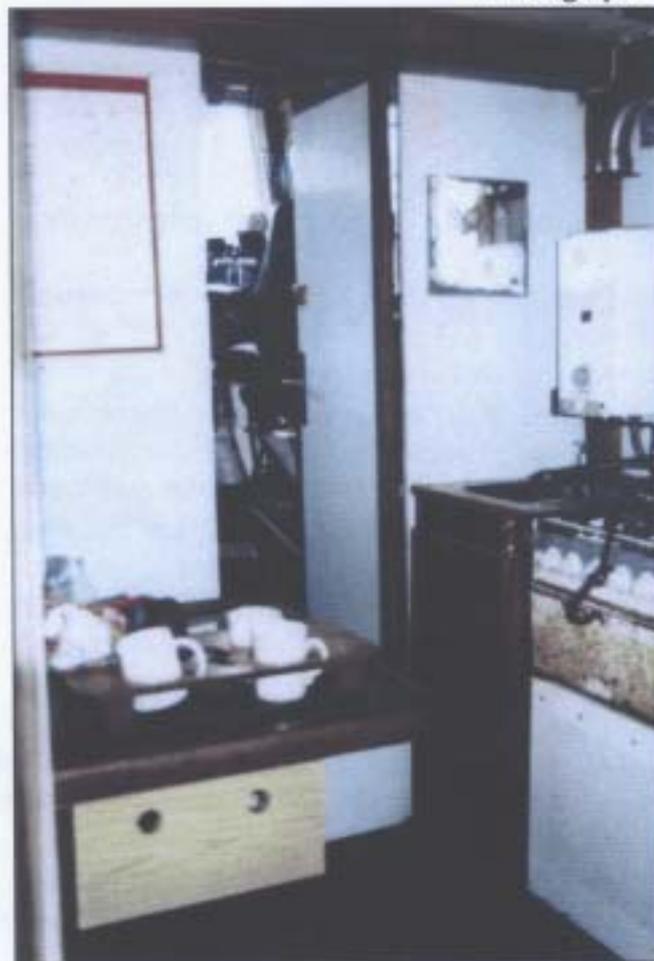
Photograph 3

The sleeping accommodation for the six crew was situated beneath the main deck aft of the wheelhouse. A ladder from the cabin led up to the galley area, which was immediately aft of the wheelhouse. A door from the galley led directly to the wheelhouse (**photograph 3**). Another door led aft on to the after deck.

Door from galley to wheelhouse

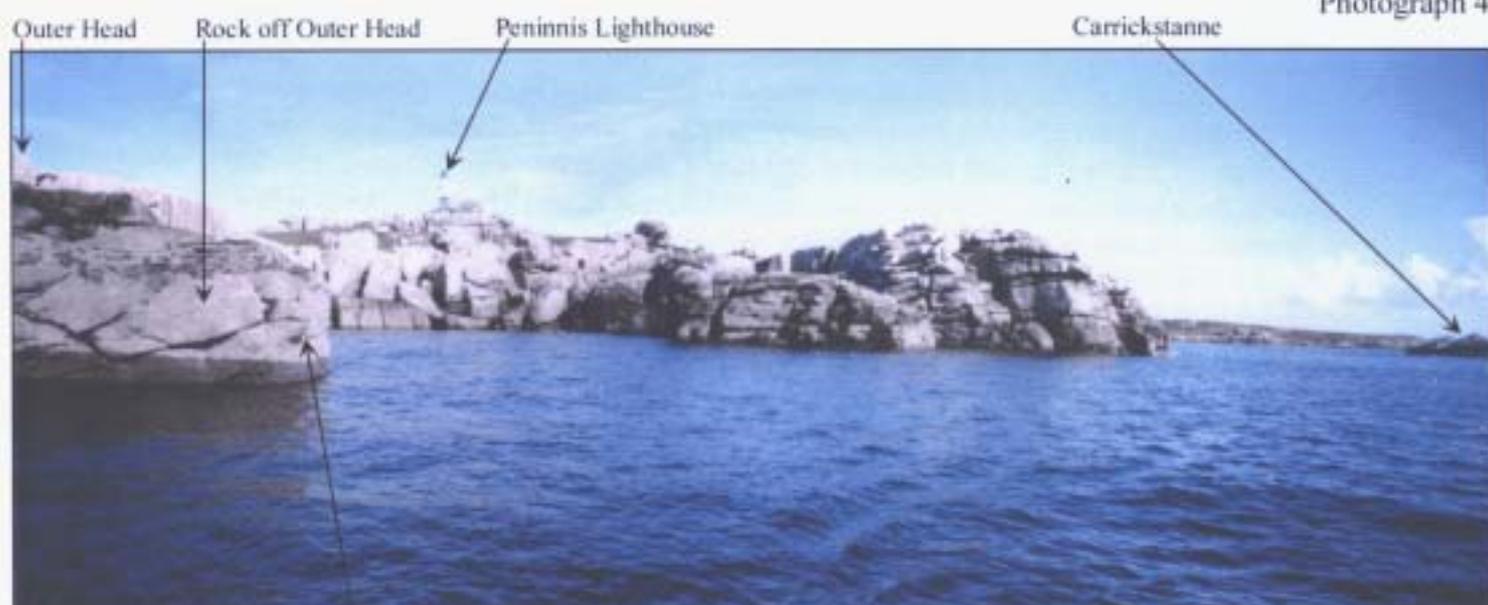
Photograph 4

Wreckage from *Rachel Harvey*

did not appear to work he tried to alter further to port, but each time the vessel appeared to come back to starboard. F2 put this down to the effect of the wind and tide, and continued to try to alter course to port. He became aware that the land was very close after he altered the range of one of the radars to 1.5 miles. He did not know where the vessel was at this time but he could see Peninnis Head light just on his starboard bow. The vessel was only a quarter of a mile from the coast. He then saw seas breaking on rocks to starboard. He shouted for the skipper to be called, and the vessel grounded soon afterwards (**photograph 4**).
