**Report of the investigation of
the capsize of a school boat
on Fountain Lake, Portsmouth
with the loss of one life
on 16 September 1999**

Marine Accident Investigation Branch
First Floor Carlton House
Carlton Place
Southampton
SO15 2DZ
Report No 6/2001

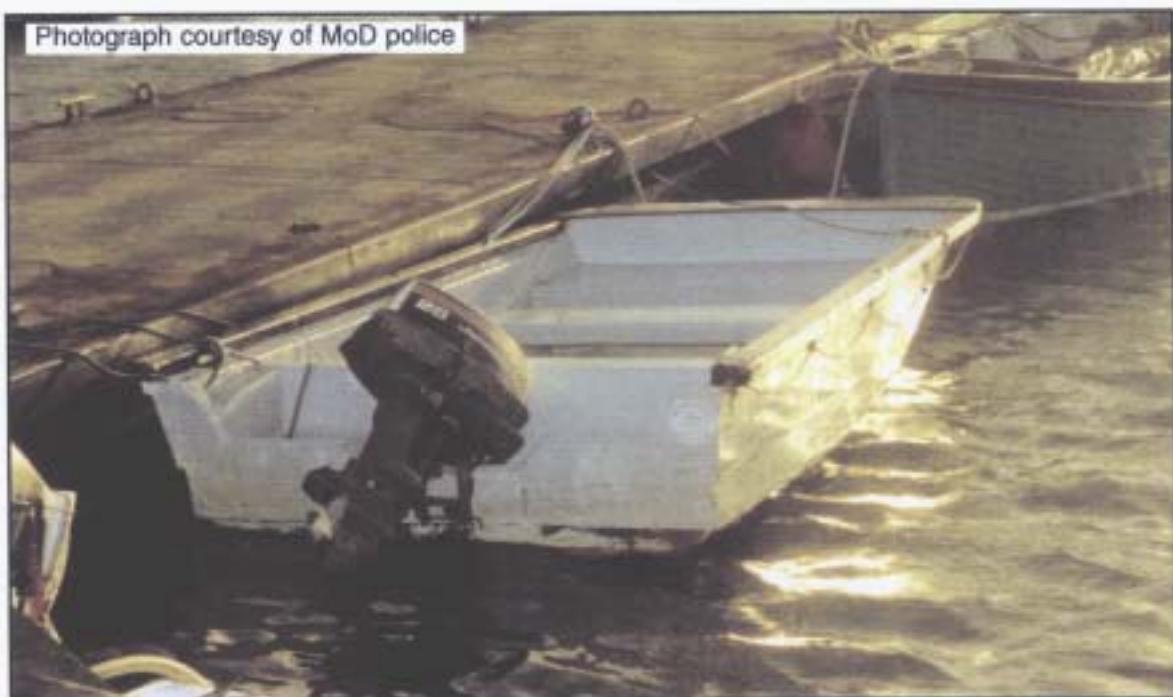
Figure 2

Following the accident the dory was examined in detail and found to contain a substantial amount of water trapped in the void between the inner and outer hulls below the floor.

Dory after recovery on 16 September 1999

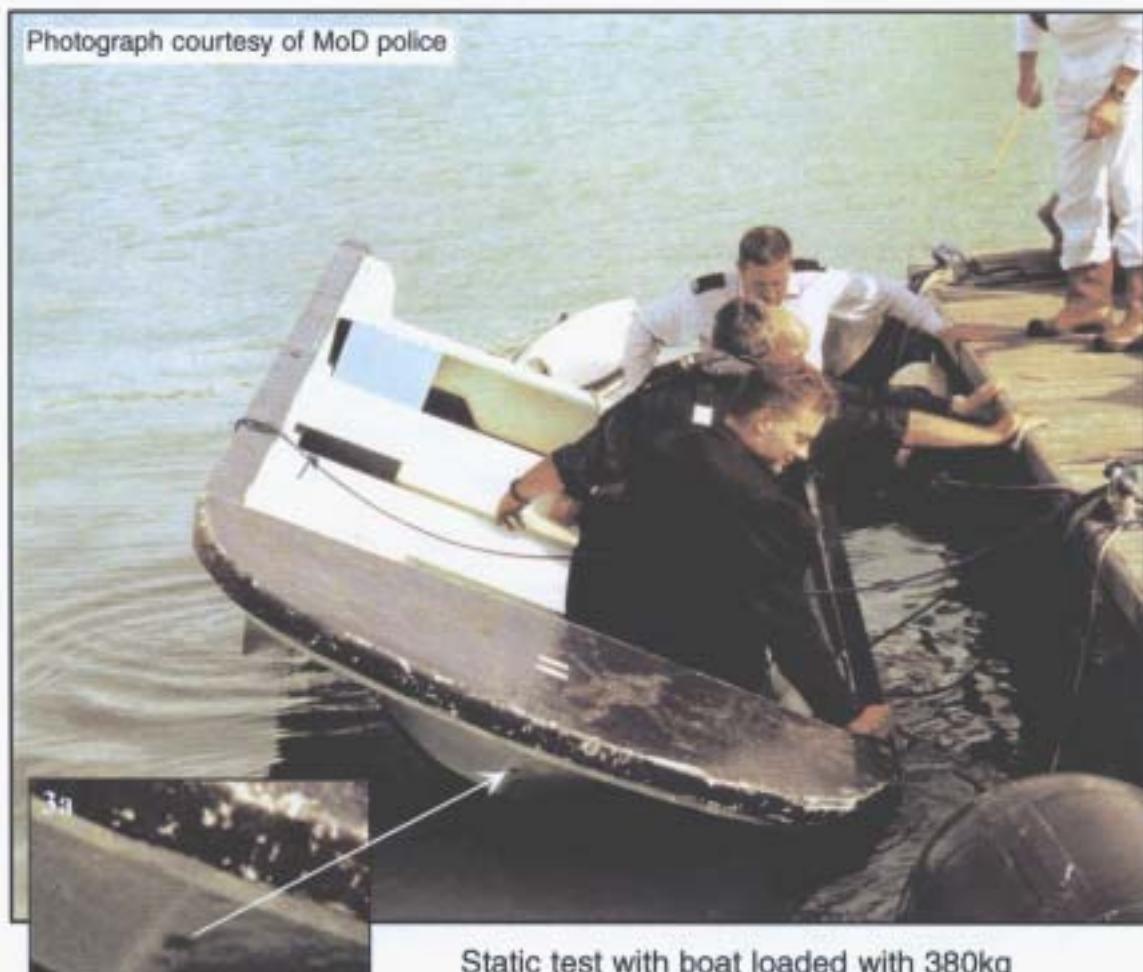
Figure 3

Enlargement showing holes to locate U-bolt

There were two 7mm-diameter holes vertically above each other in the stem and would have accommodated the stainless steel towing eye/U-bolt (**see Figure 5**). The position of this through-hull fitting was 254mm (10ins) below the top of the gunwale and clear of the waterline (**see Figure 3**). There was no sign of the towing eye that should have been secured through these holes.

The only possible way that water could enter the void was through the two small holes discovered on the stem where the missing U-bolt had been fastened.

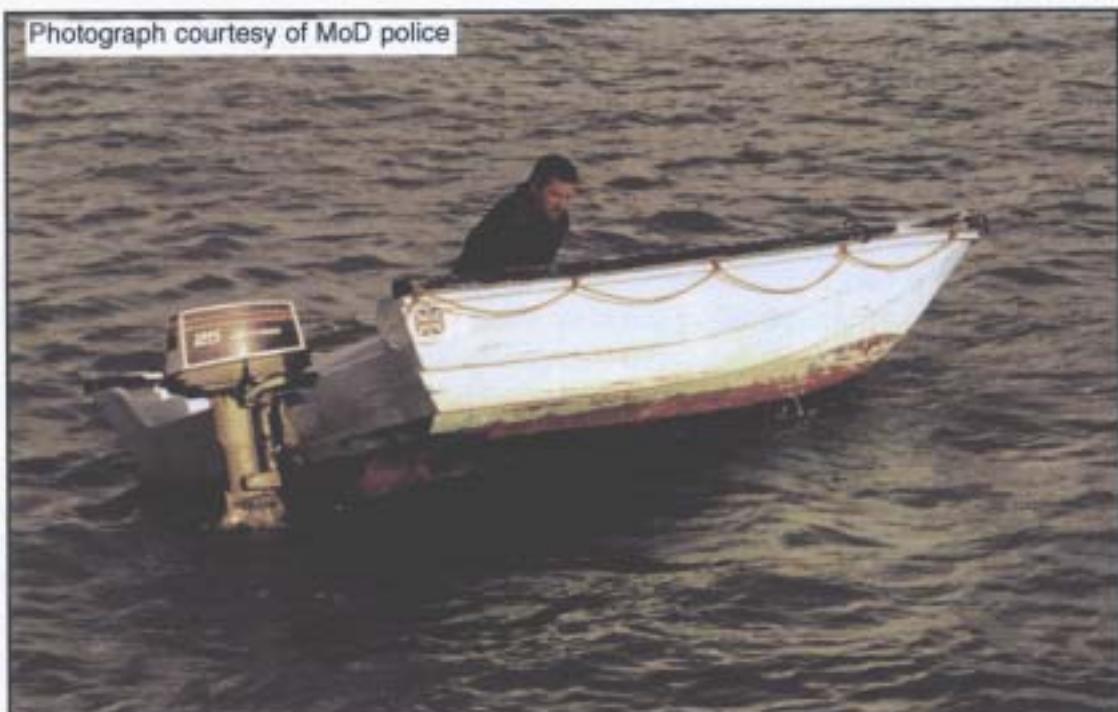
Figure 4

Once in position the boat was set adrift with the police officer on board. He started to move around and soon became concerned for his safety. He found that when seated on the port gunwale the boat was on the verge of capsizing (see Figure 4).

Reconstruction of incident

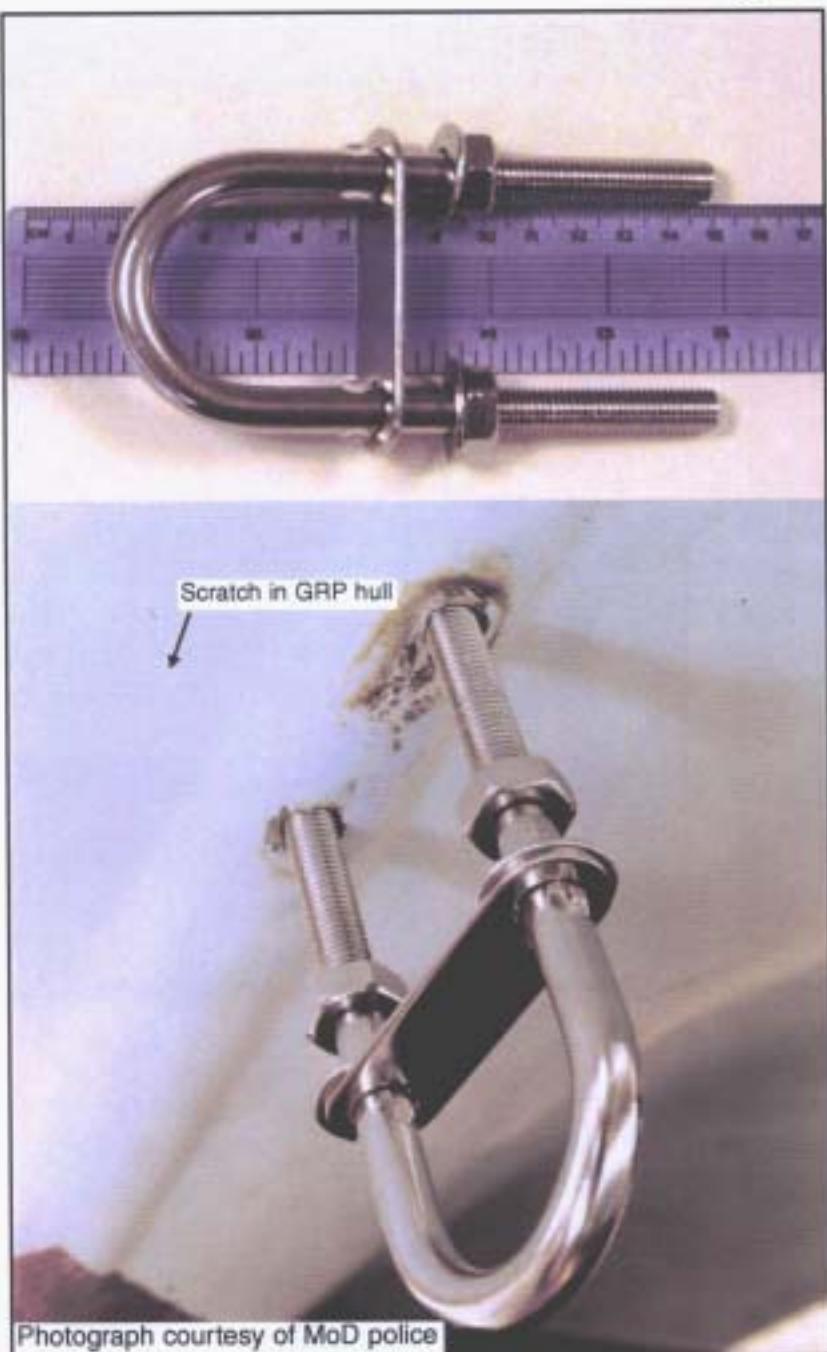
Figure 5

Typical U-bolts used as a towing eye

How and when it became detached is not known. The two nuts and a washer recovered from inside the foam in the bow void were in good condition, and the nuts had clear threads. This indicated they had dropped from the U-bolt by means other than excessive force or corrosion.

The nuts had, almost certainly, worked loose with vibration, with the lower nut falling off first. There was a score mark on the hull in line with the lower hole, to indicate that the lower part of the bolt became free first, leaving an exposed hole. For the nuts to work free, the process would have taken a long time, perhaps a year, as there was about 45mm of clear thread on a typical U-bolt (**see Figure 5**). To prevent the nuts working loose a nylon locknut or double nuts should have been fitted, but no evidence has been produced to show that this was done. On some GRP boats, this has been achieved by laminating over the nuts.

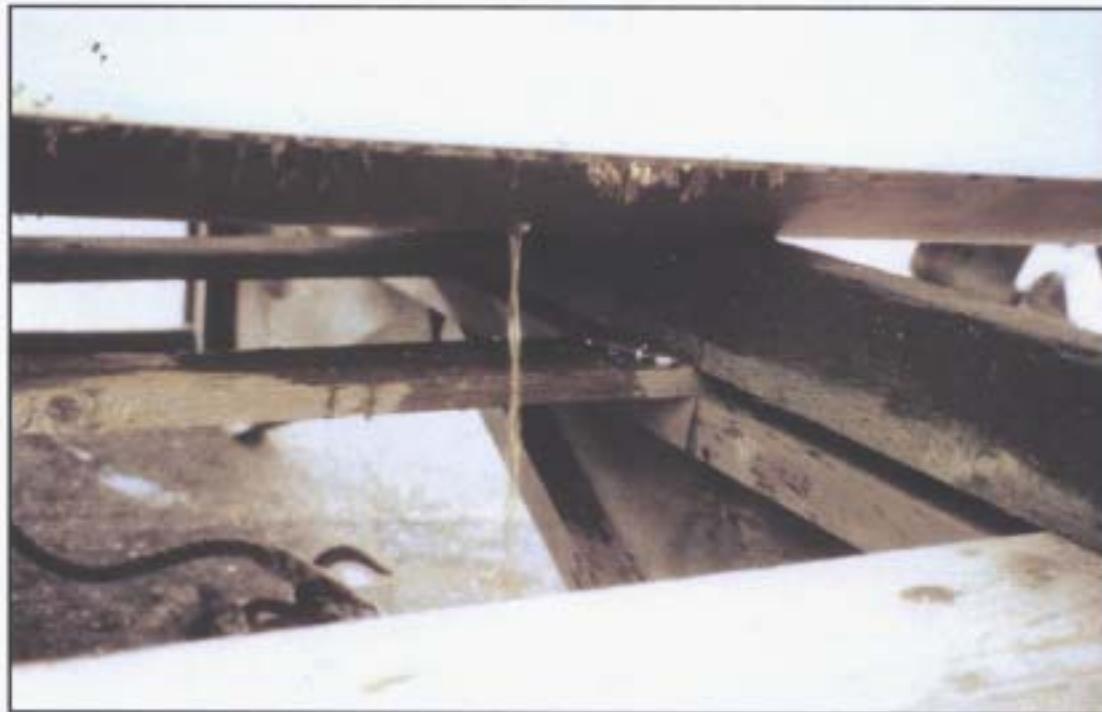
Figure 6

The void was found to be partially filled with open cell foam that had become saturated and was breaking up. 56.8 litres (12.5 gallons) of frothy water containing bits of foam was pumped out. In the opinion of those watching, the water gave the appearance of having been there a long time, but it was not possible to measure the amount that had been absorbed by the foam.

Boat lifted ashore - water draining from the void through a hole which had been drilled in the hull aft

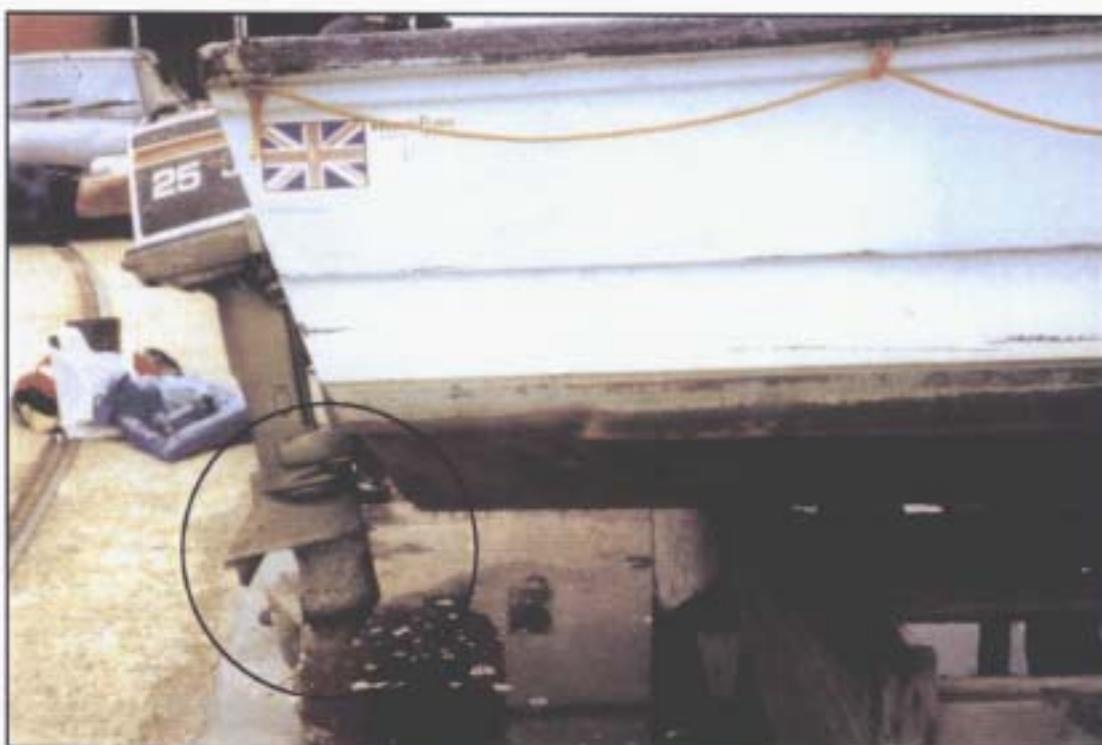
Figure 7

The angle of the outboard motor's cavitation plate to the underside of the boat was found to be at an angle of about [15°] (**see Figure 7**).

Boat ashore - aft end, note the angle of the cavitation plate on the outboard motor is not in-line with underside of the boat
(The starboard lifeline can be seen)
