Report on the investigation of

the Bahamian cargo ship

Union Arbo

Philomena

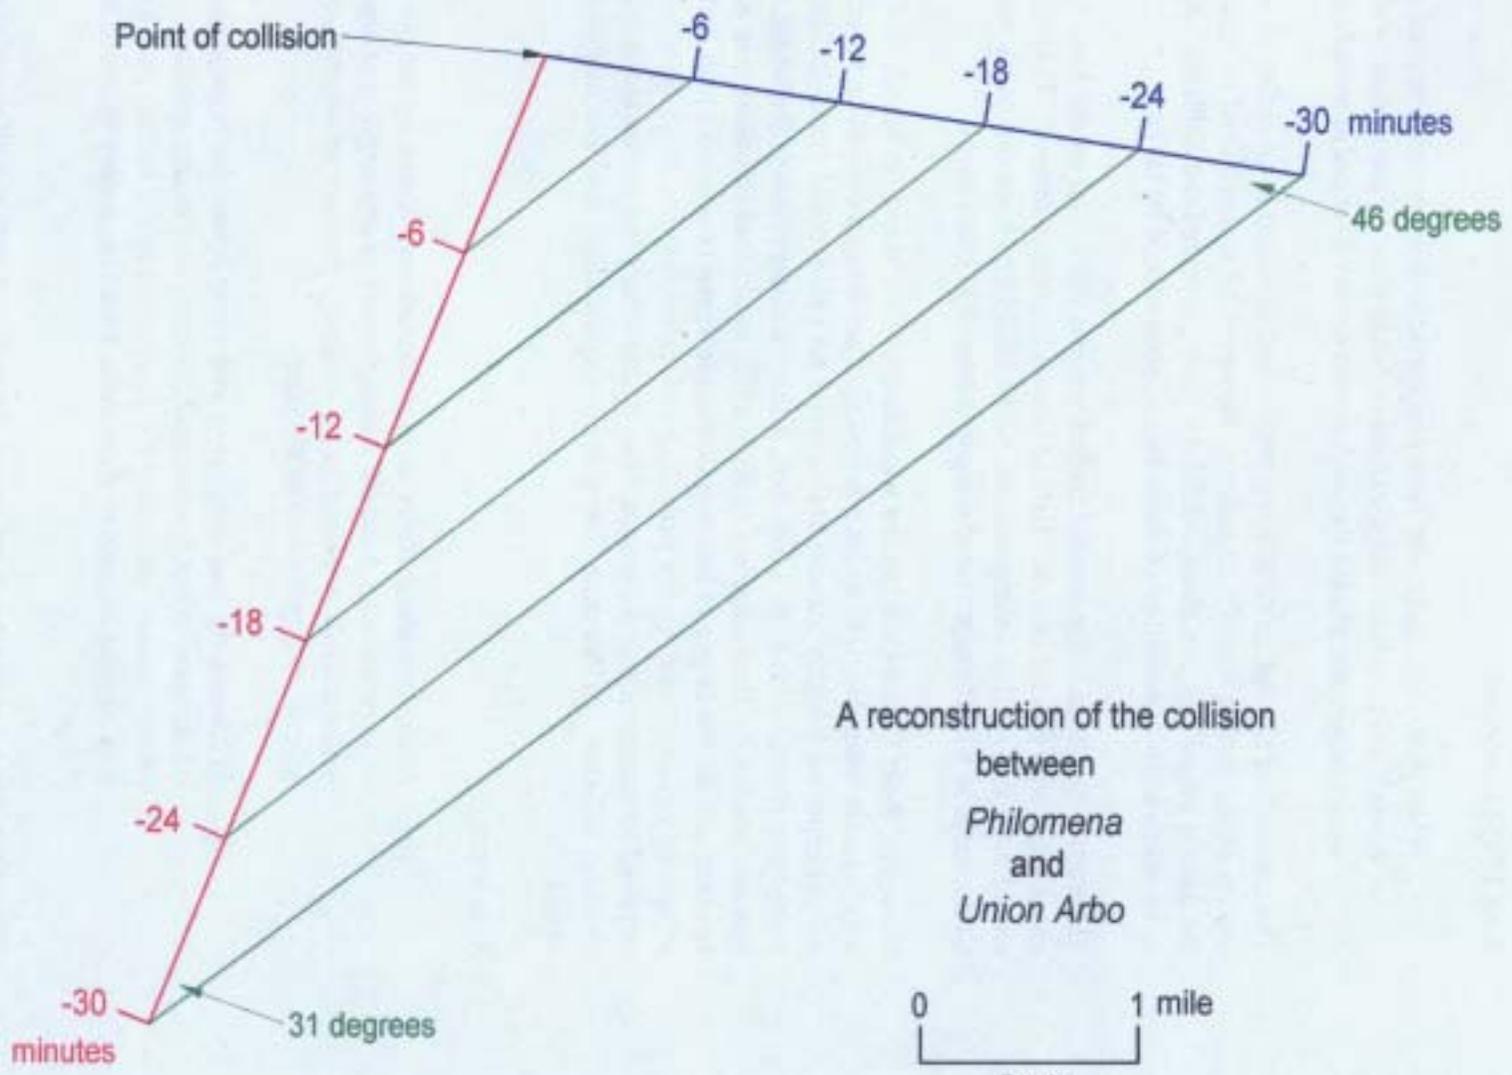
A reconstruction of the collision
between
Philomena
and
Union Arbo

The reconstruction of the collision (**see opposite**) shows that *Union Arbo* was about three points on the starboard bow of the fishing vessel. Because both vessels had not altered from their tracks and they eventually collided, the compass bearing remained steady. As stated in section 1.5 above, this was a crossing situation as defined by Rule 15, which states:

While he did not make a systematic appraisal to ascertain whether the two crossing vessels were on collision courses, he correctly assumed that they were. From the reconstruction of the collision, the fishing vessels were about four points on his port bow. He expected that, under the Collision Regulations, they would alter course for his ship; and the first vessel did so. Because the fishing vessels were relatively close to each other he also expected the second vessel to wait for the first vessel to alter course and then follow after a suitable interval so as not to get too close. However, the master of *Union Arbo* waited too long to take his own avoiding action and the collision occurred.

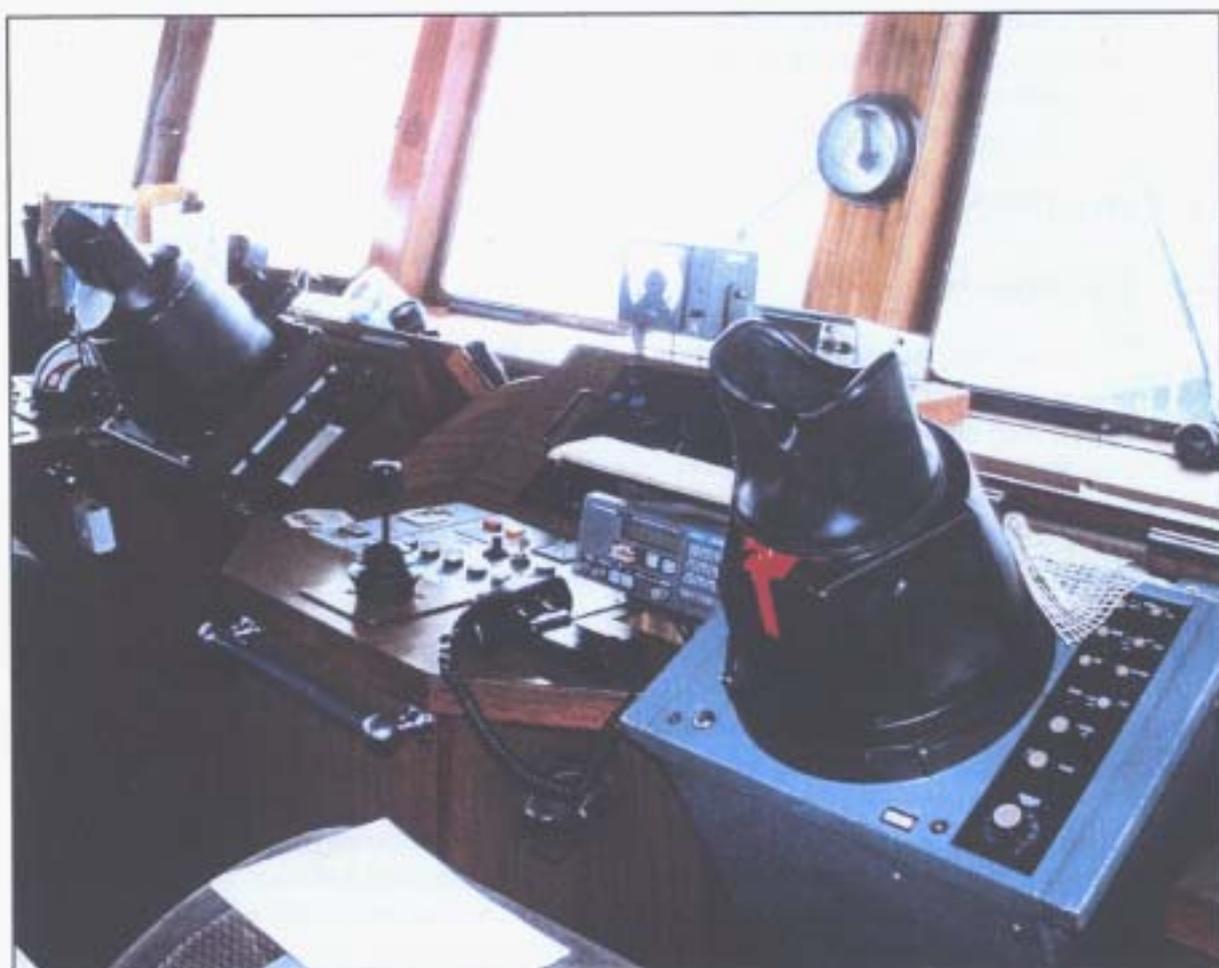
Ratheon radar operated in the unstabilised, ship's head up mode;

Union Arbo - navigation equipment and controls

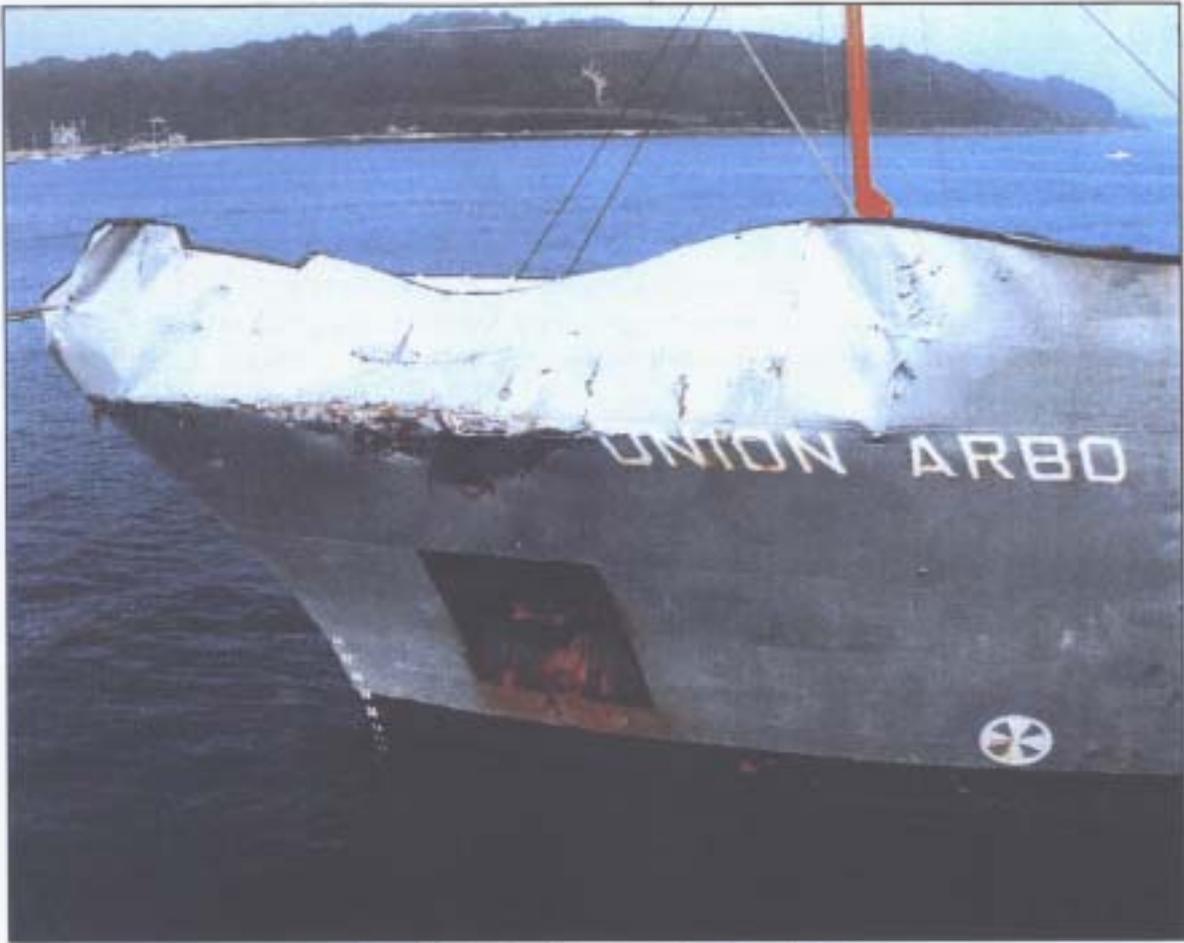
The bulwarks around the forecastle were crumpled, and there were dents in the port side hull plating below the forecastle deck, just above the anchor box. The hull amidships near the load waterline had a 2m long by 0.3m deep hole, in way of No 3 port ballast tank.

Detail of the damage to the port bow

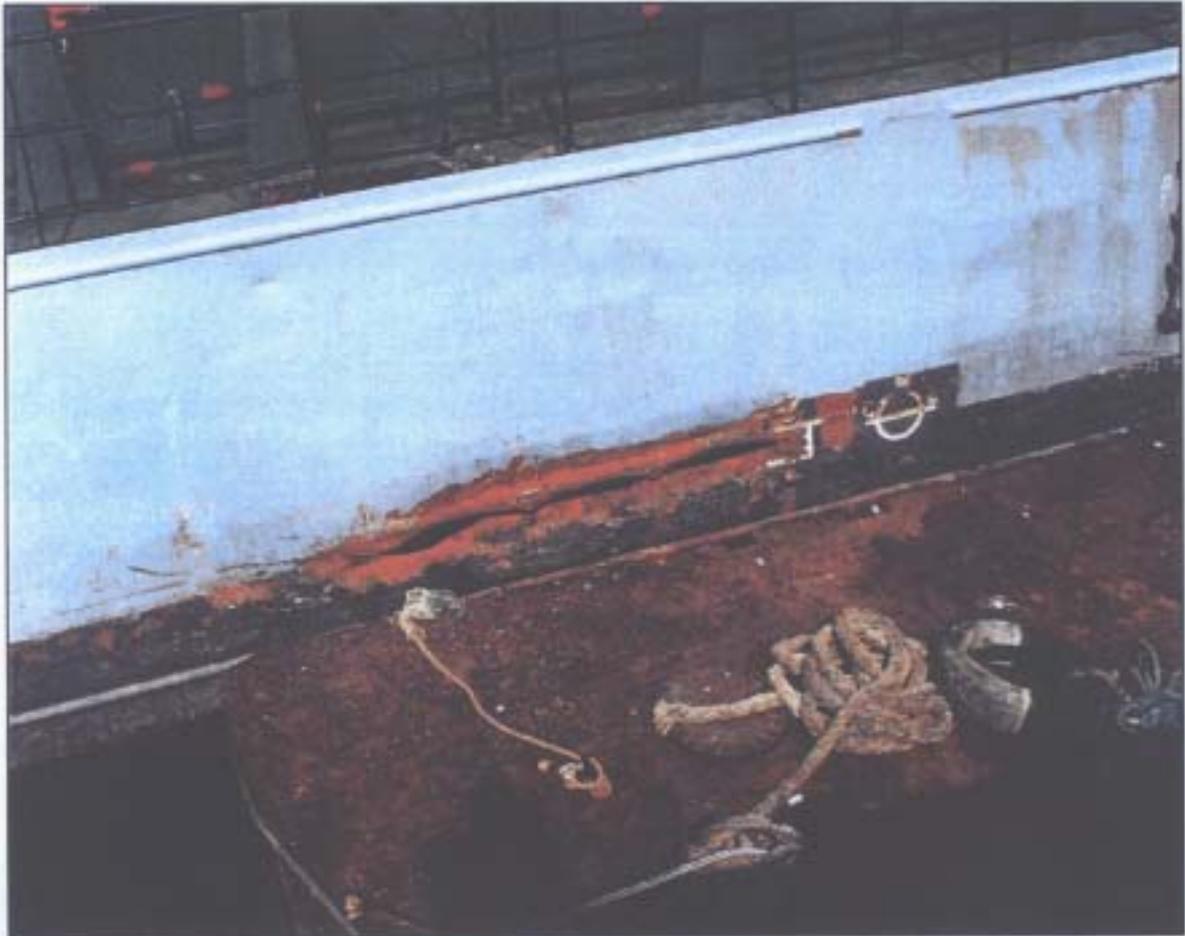
Detail of damage amidships

11. The latter damage allowed water to flood a ballast tank, which resulted in a port list. The list was rectified by pumping water ballast into the opposite side tank. [1.1, 1.3.4]

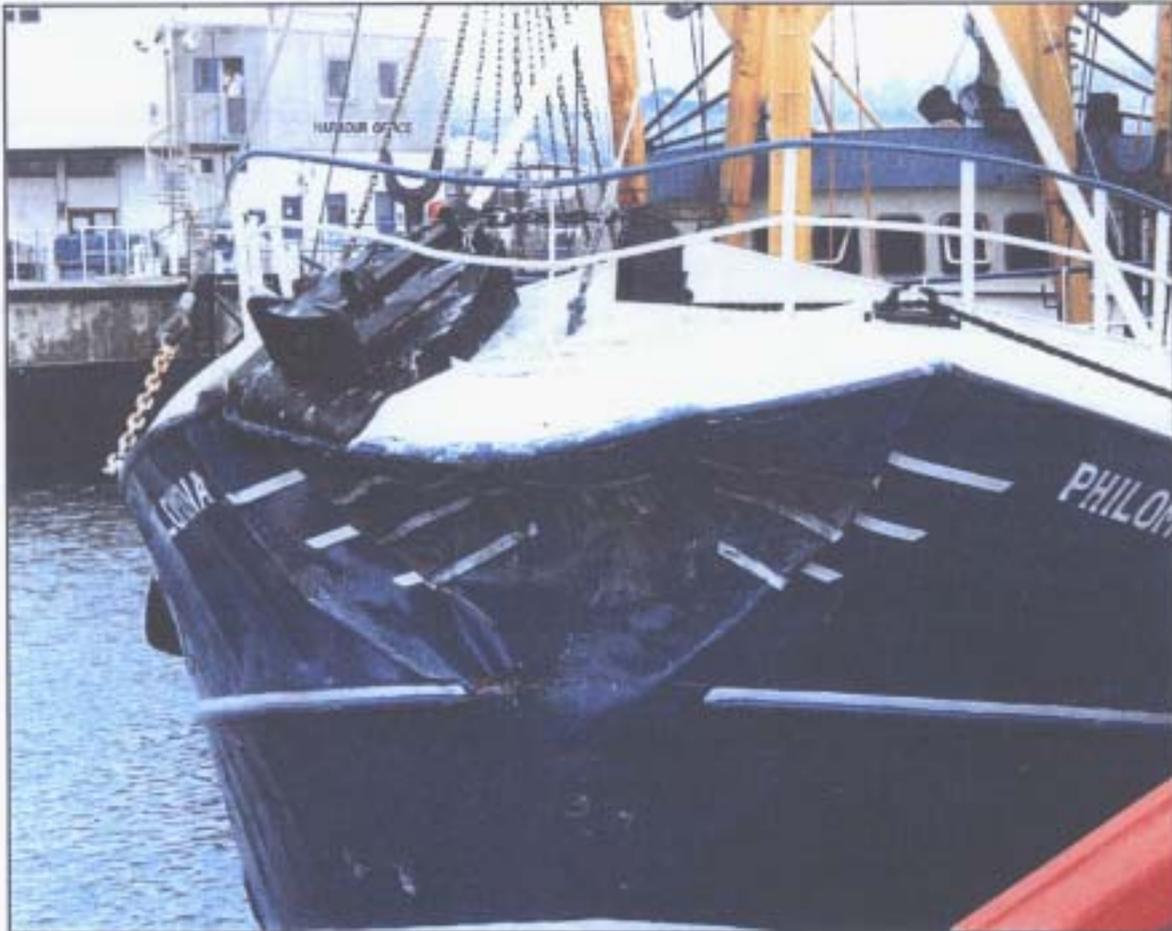
The extreme forward part of the whaleback, above the main deck, was crumpled towards aft for 1 - 2m.

Detail of damage to *Philomena*

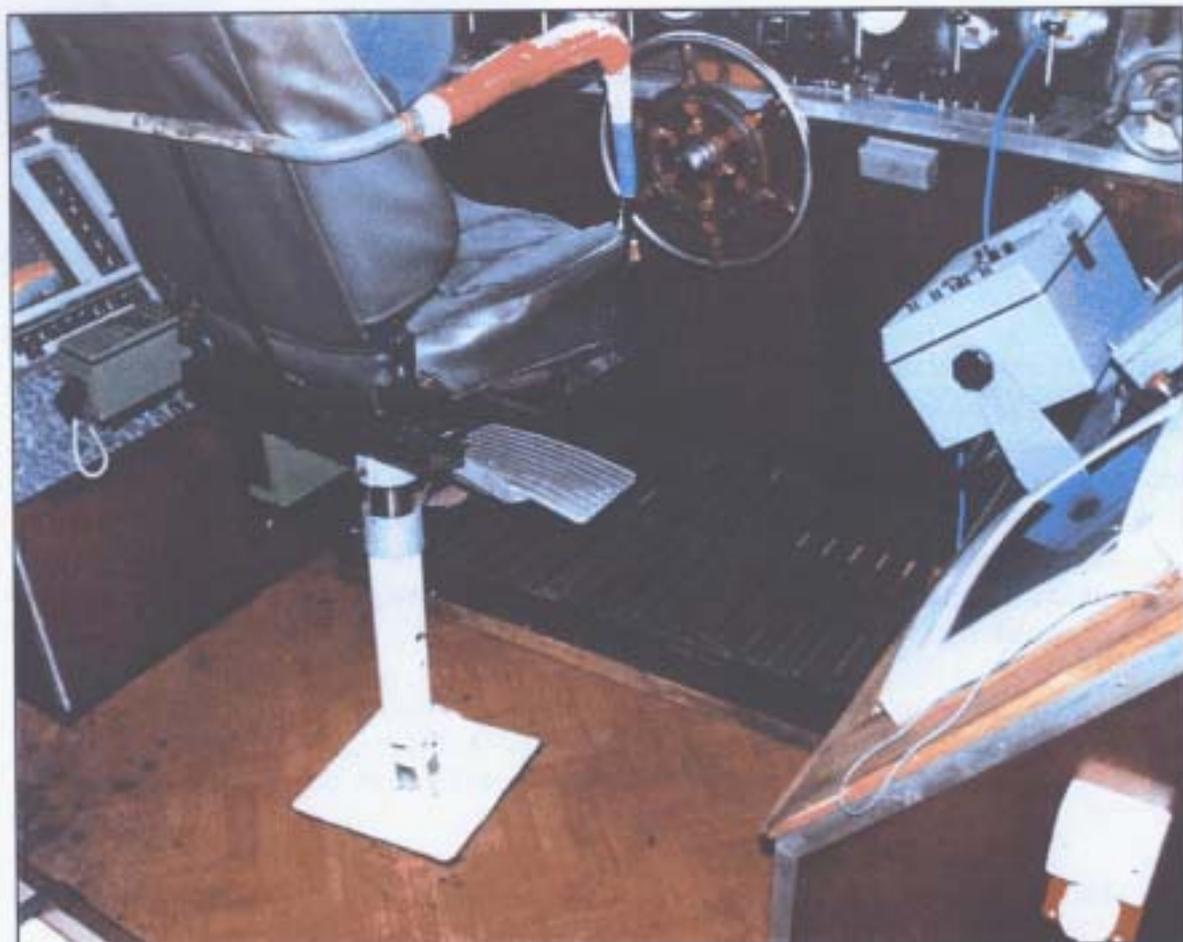
There was a duck-board in the deck space in front of the wheelhouse chair (**see first photograph opposite**).

The duck-board in front of the wheelhouse chair

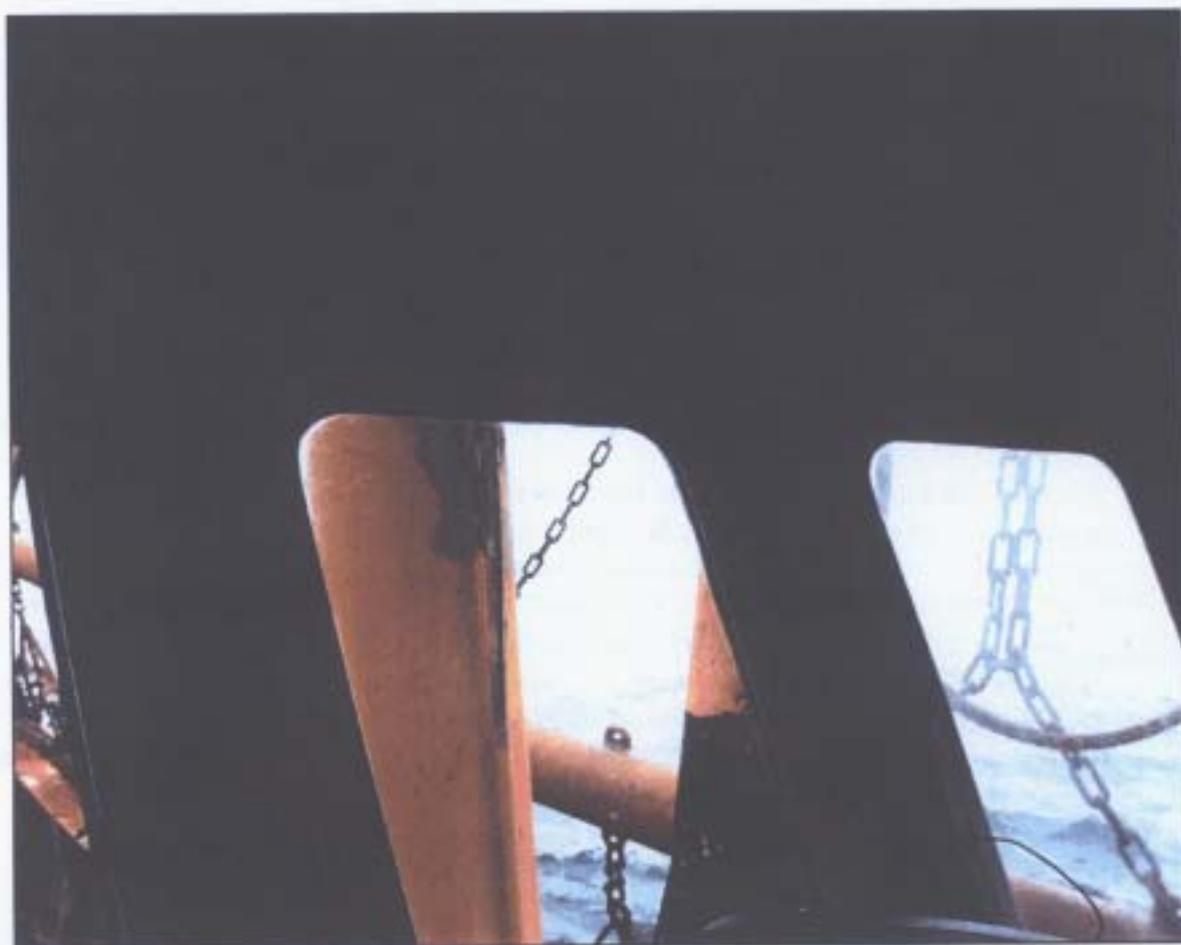
When standing on this, a watchkeeper is only just able to see the horizon through the wheelhouse windows (**see second photograph opposite**). He can see the horizon by sitting in the chair or standing aft of it. Periodically he should move around to see past the port and starboard samson posts, which slightly impede visibility.

The view to starboard when standing on the duck-board

7. While carrying out the latter job and standing on a duck-board, he would have only just been able to see the horizon. [1.1, 2.2.1]
8. It was not until the cargo ship was close to the fishing vessel, that the deckhand saw her visually. [1.1, 2.2.1]
