**Report on the investigation
of the foundering of the
fv Jasper III PD174
90 miles north-east of Fraserburgh
on 10 September 1999**

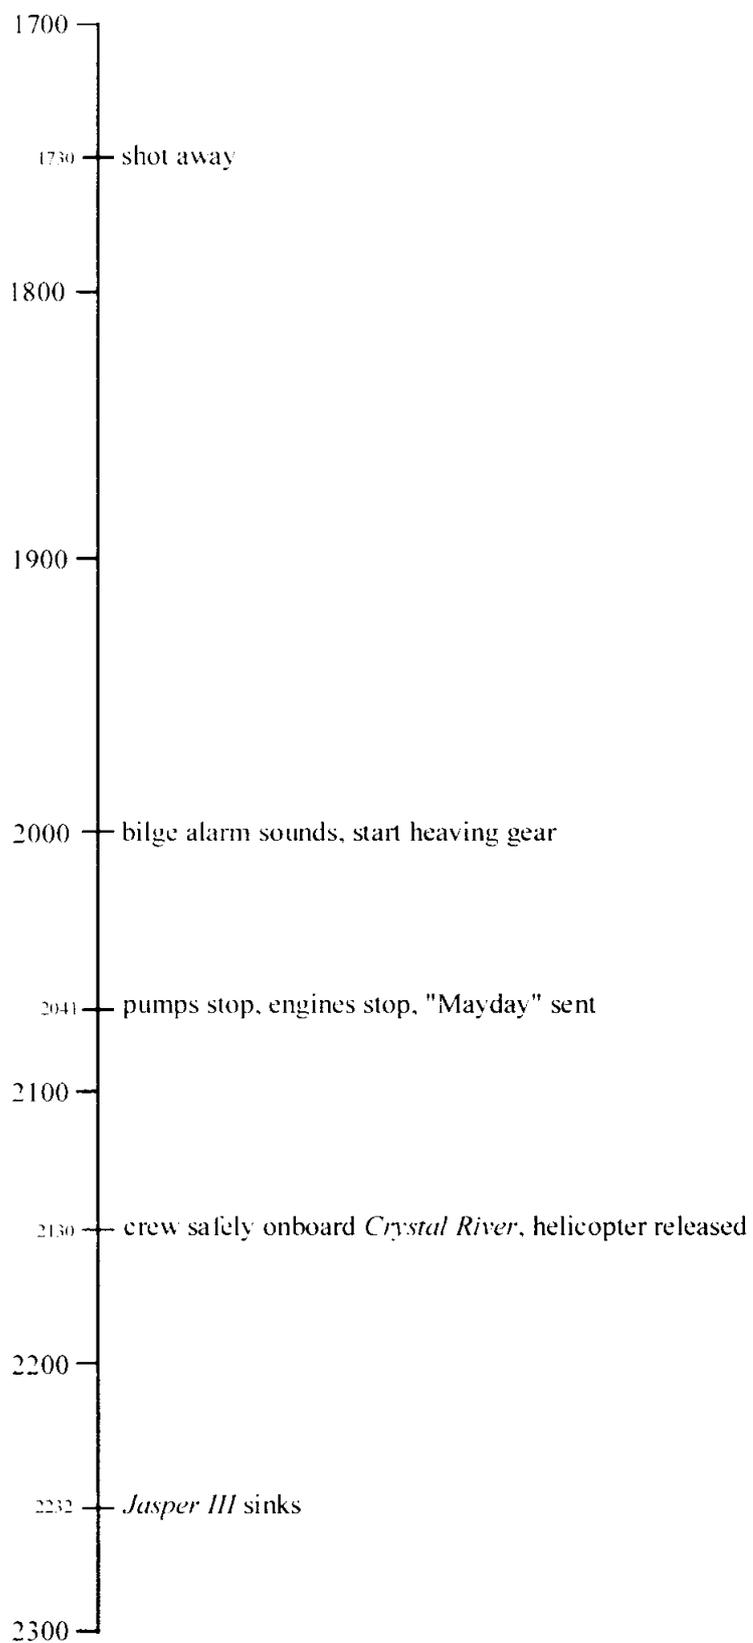
KEY EVENT TIMES

The estimated times for key events (see **Figure 3**) show that the vessel was abandoned between 2041, when the “Mayday” was received by the coastguard, and 2130, when the coastguard was informed that the survivors were safely onboard *Crystal River*. It was probably close to 2100, which allows 20 minutes for the crew to launch and board the liferafts and 30 minutes for *Crystal River* to recover the survivors.

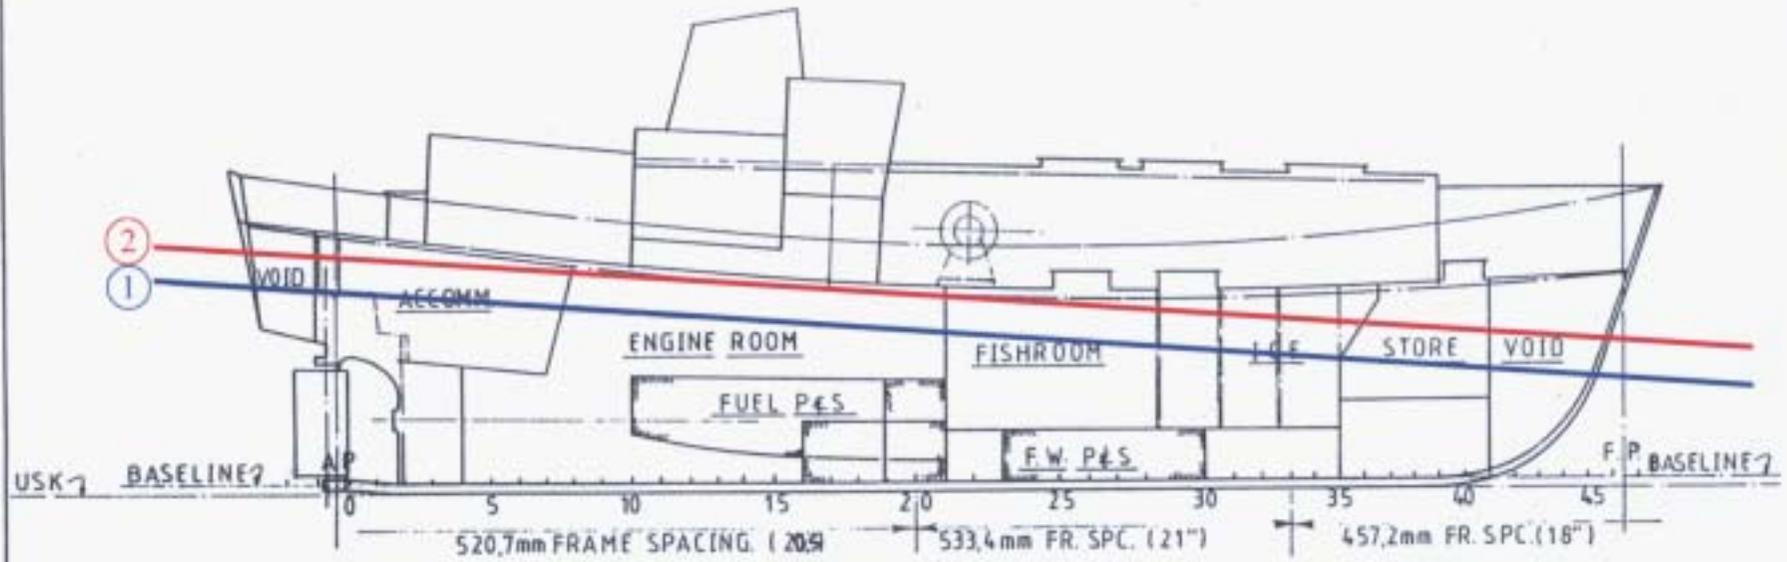
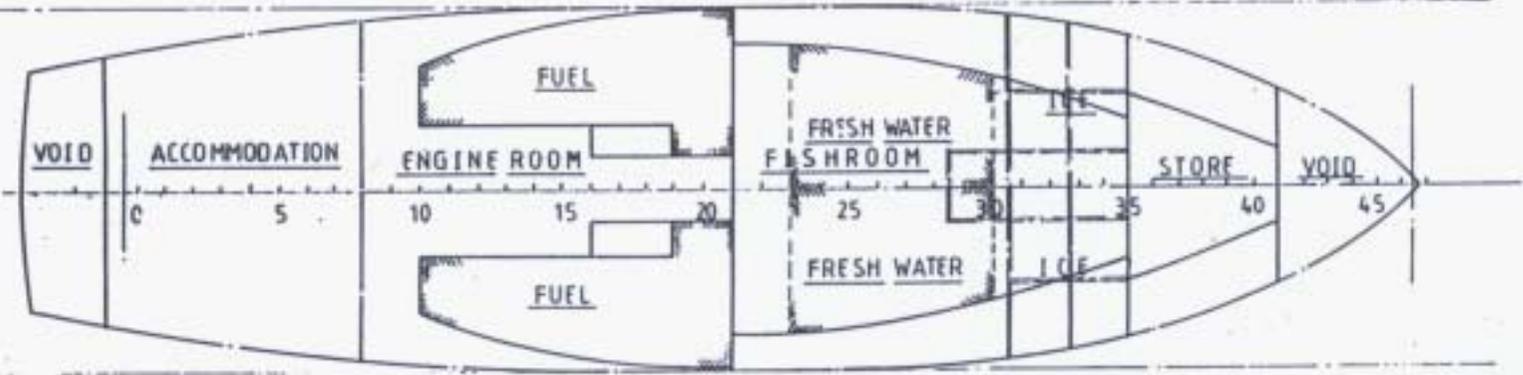
Figure 4

When the crew abandoned *Jasper III* the aft deck was awash, suggesting that it was very close to the waterline. A high estimate of the rate of flooding can be arrived at by assuming that the vessel sank bodily, without trimming, until the waterline was just level with the deck edge (**Figure 4**). The weight of floodwater to produce this effect is about 56 tonnes.

The 29 tonnes of water discharged by the bilge pumps between about 2000 and 2041, must be added to this 56 tonnes, indicating that, between the start of the flooding and 2100, about 85 tonnes of water flooded into the vessel. (This estimate would be substantially less if it was assumed that the vessel had trimmed further by the stern, as likely with the engine room flooding). Although it is not known when the flooding started, the skipper and driver saw water up to the shaft when they first investigated the problem at about 2000. At that depth, the engine room already contained about 27 tonnes of water, so, between 2000 and 2100, approximately 58 tonnes of water flooded the vessel.

The draught at the mid-length of the engine room was about 3.1m, giving the initial head of water acting at the leak probably greater than 2m.

- ① Waterline before flooding
- ② Approximate w.l. when crew abandoned ship

Collating this information indicates that the hole causing the leak was probably no bigger than 80mm in diameter. The leak was either in the hull plating, or from a fractured pipe, probably starting less than 30 minutes before the bilge alarm sounded.
