Report of an Investigation
of the flooding to the
engine room of the cargo vessel

mv Sonia

off Sandown Bay, Isle of Wight
on 1 September 1999

Report No 29/2000

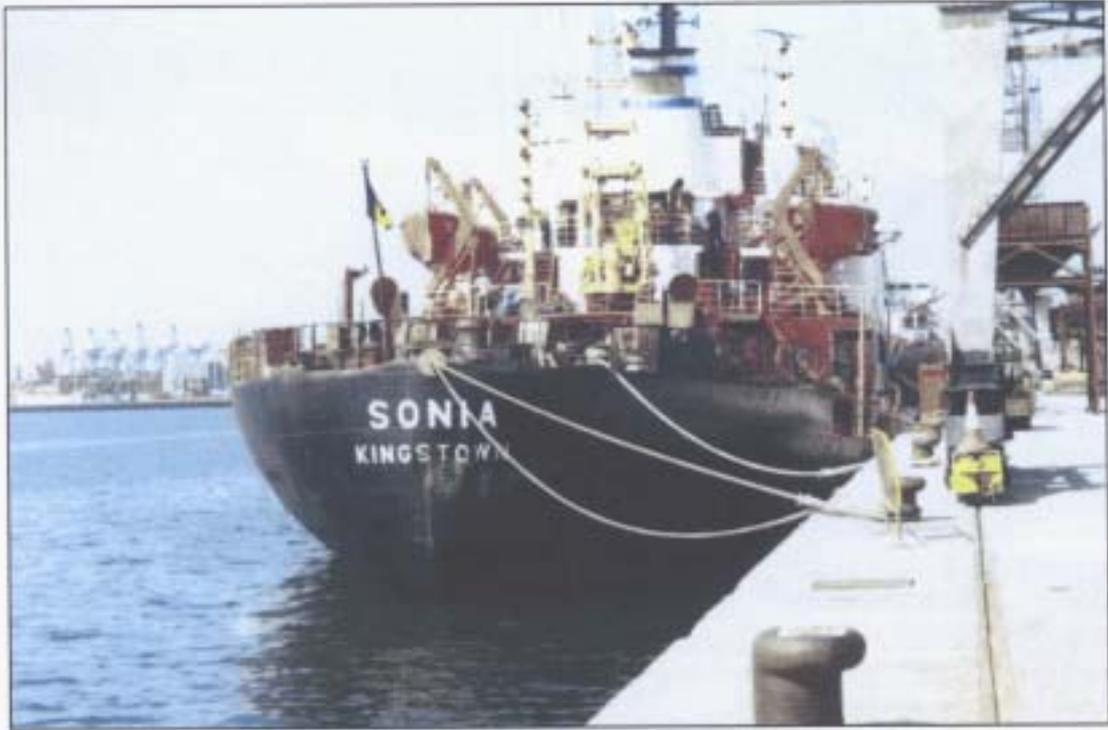
Photograph 1

General view of vessel alongside at Southampton after salvage

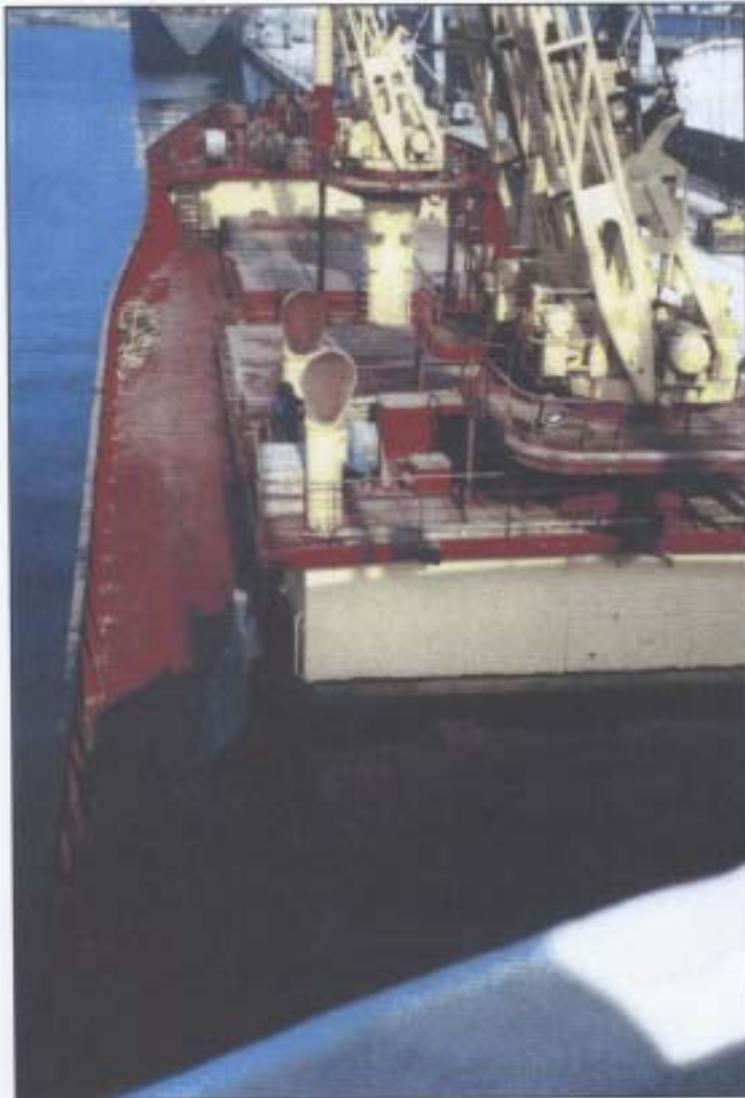
Photograph 2

General view forward from bridge

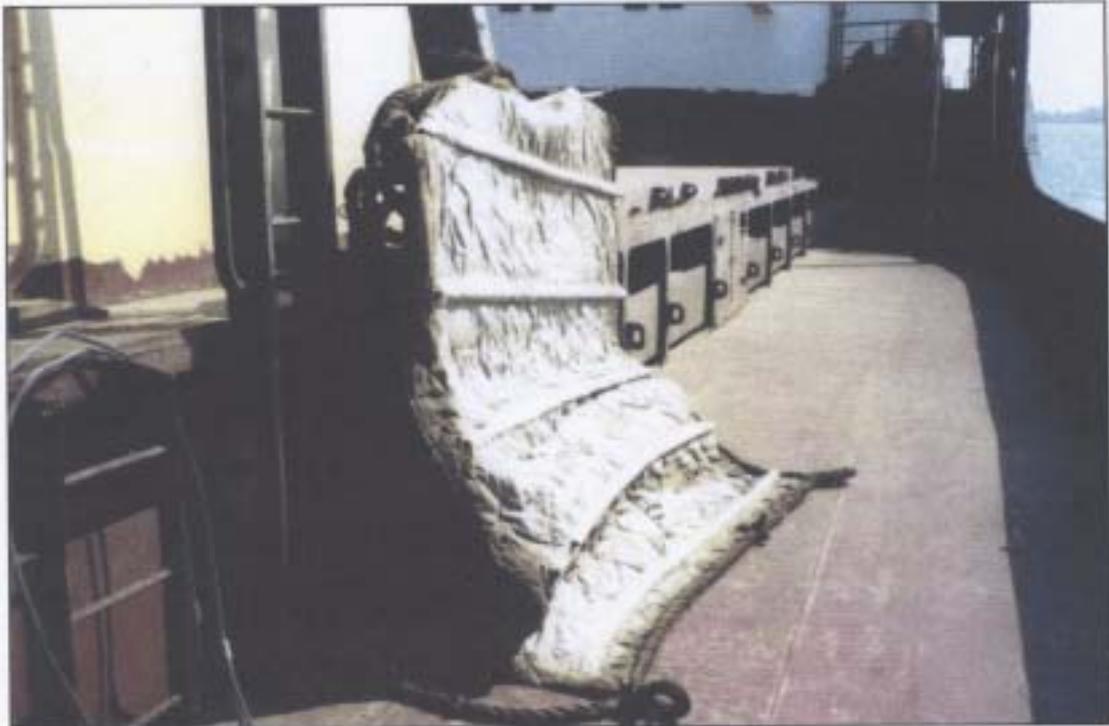
Photograph 3

Collision mat

Immediately the leak was discovered, the chief engineer was called and the potential effects of the leak conveyed to the master. Repairs were attempted, but it rapidly became apparent that the leak was more serious than at first thought. Although the engineers fitted a deflector in place and sought to build a seal, the water pressure was too great. Attempts were made to seal the sea chest using a collision mat, but were unsuccessful.

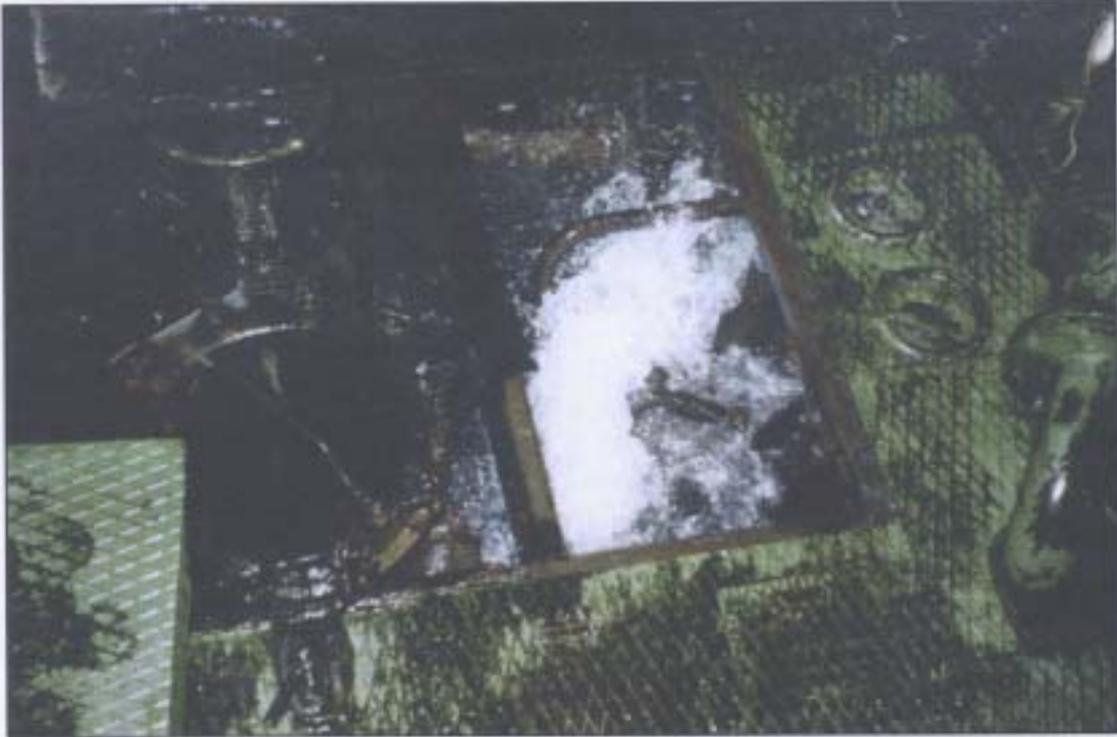
Photograph 4

General view of inlet pipe showing S.W. pipe leaking even with temporary seal fitted externally

- 1.3.12 At 1900, a diving team boarded *Sonia*, and started sealing operations, which continued over the next few days. A plywood-backed patch was fitted over the seawater inlet to the sea chest. At 1000 on Sunday 5 September, the inlet had been sealed and work to remove the corroded sea valve pipe began. By 1745 that day, the pipe had been removed and a steel sheet welded in place. Work then started on cleaning the engine room and recovering the machinery (**Photographs 4 and 5**).

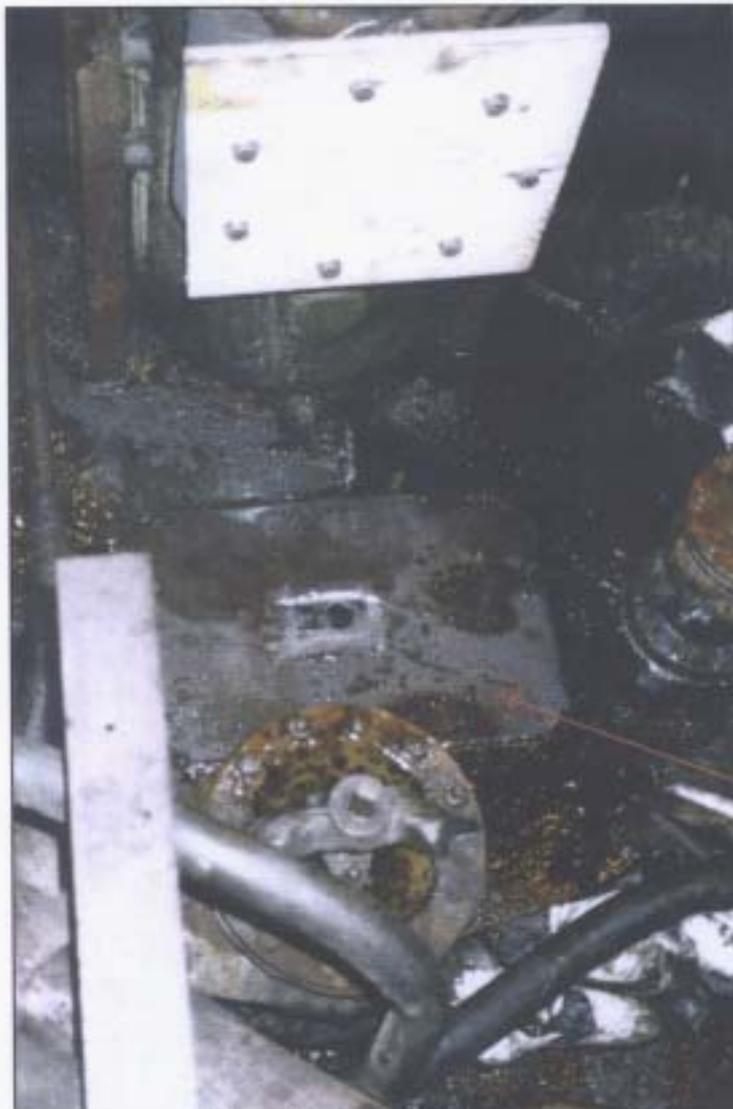
Photograph 5

Steel plate welded on top of plate

View of 'sealed' S.W. inlet.
Wooden seal covers inlet to filter

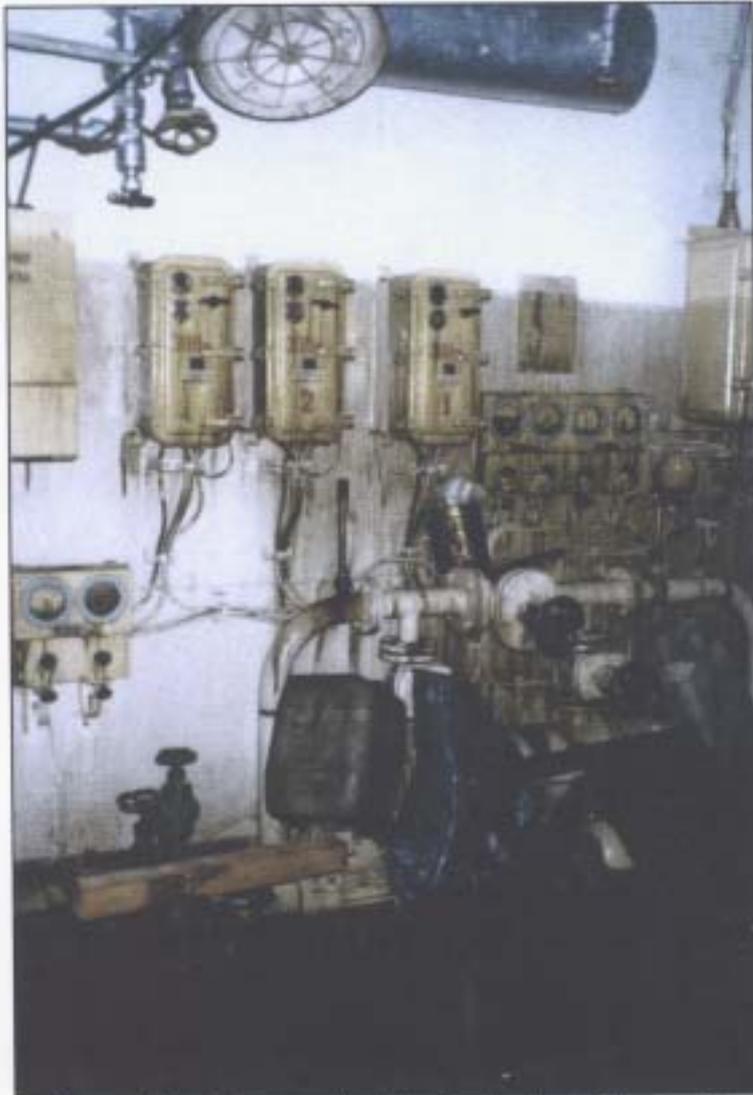
Photograph 6

Forward engine room bulkhead showing 'tide mark' of flooding above floor plates

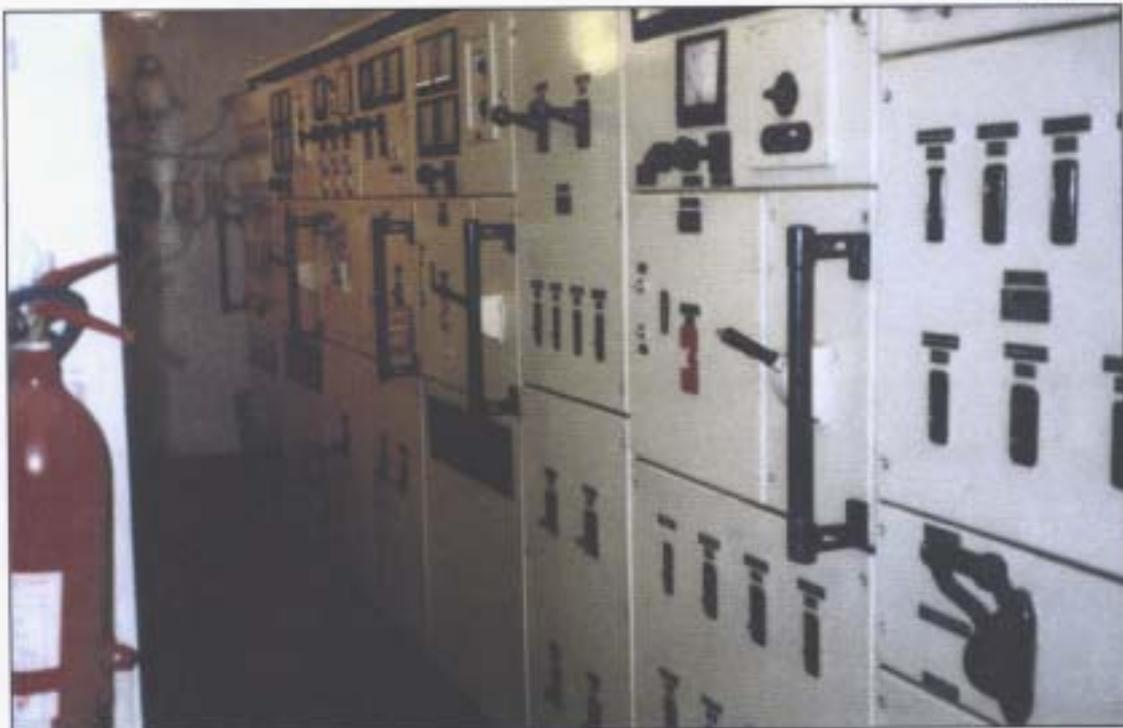
Photograph 7

Main switchboard

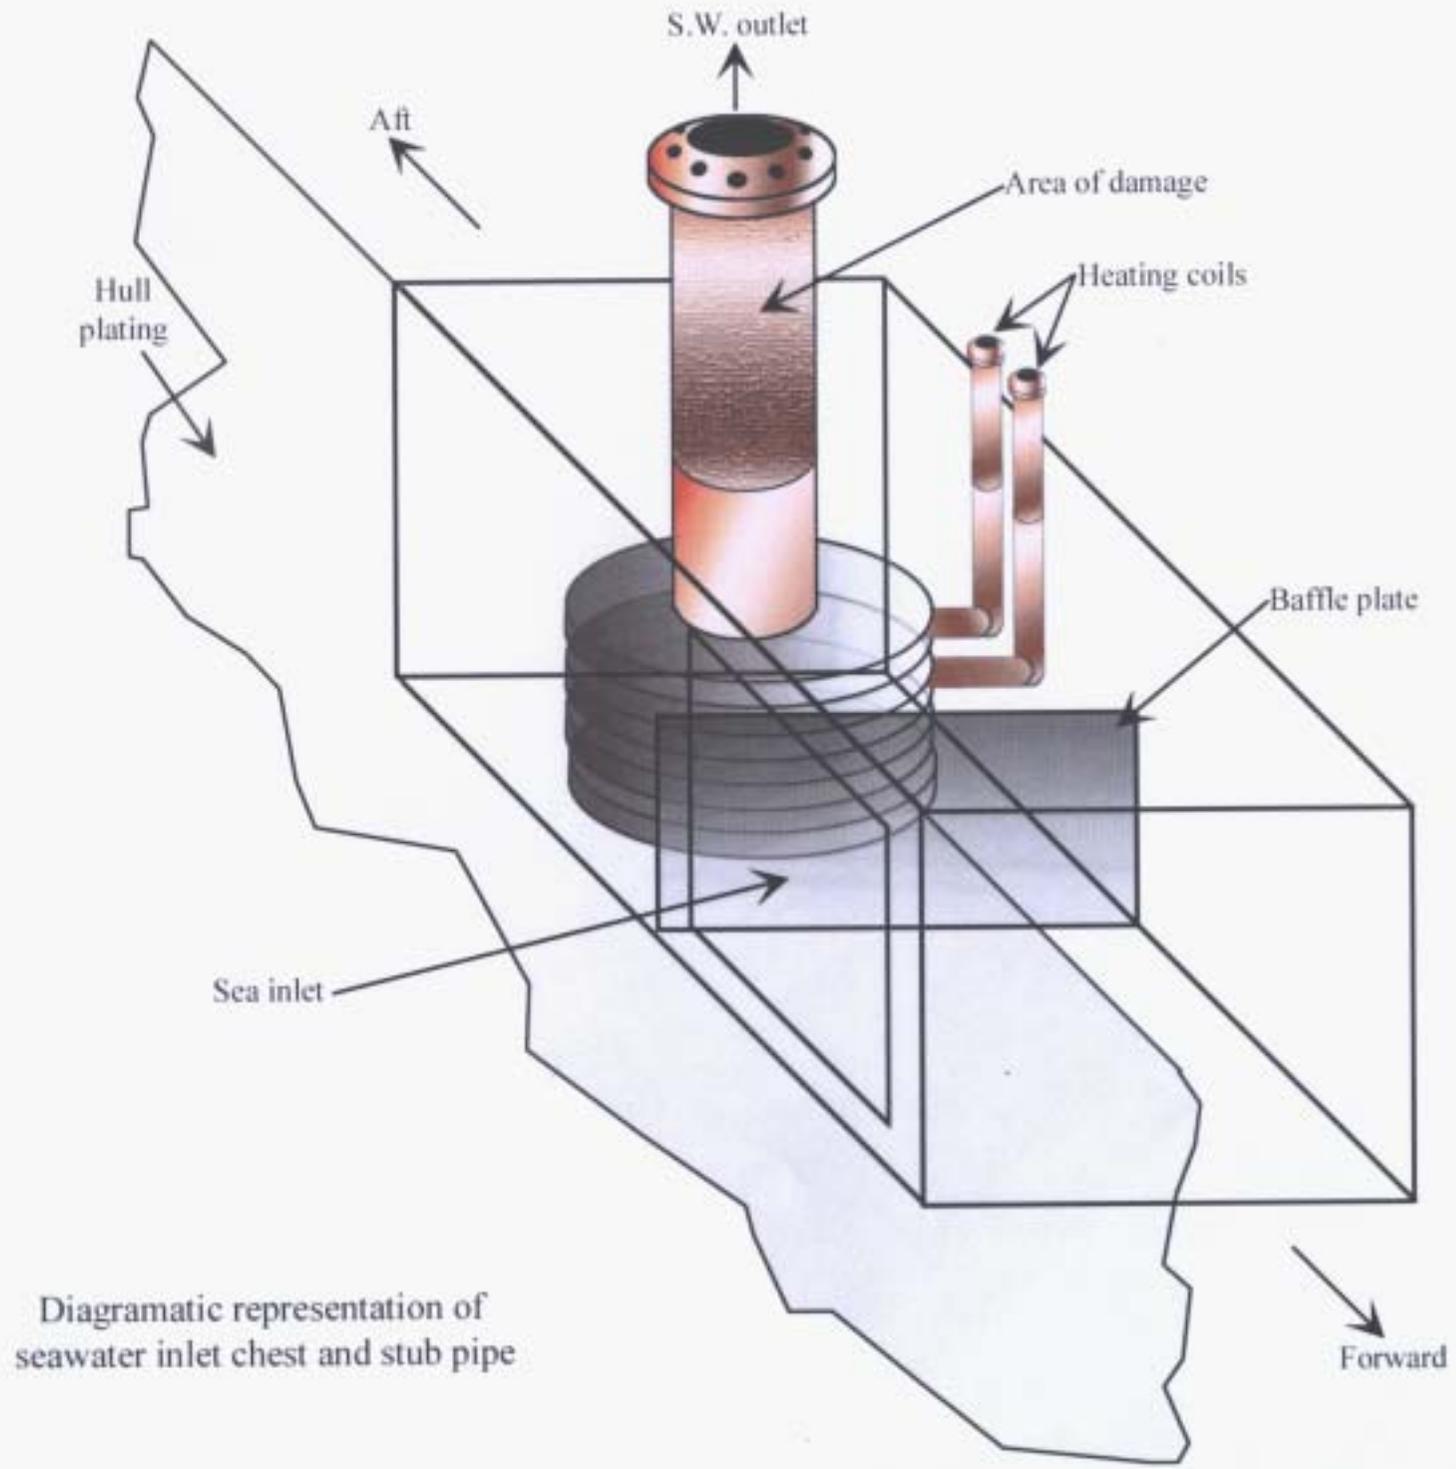
Figure 1

The seawater inlet chest, to which the corroded seawater inlet pipe was connected, was constructed on the port forward side of the engine room between frames 124 and 126. The rectangular chest was constructed from 14.7mm thick steel plating and was built into the hull. It consisted of two chambers separated by a swash plate which extended upwards from the bottom of the box to about two-thirds of the box height. The first chamber had direct access to the sea via a grid fitted on to the hull, while the second or inner chamber, had a number of stub pipes welded on the inboard side of the chest to provide connections to various inboard cooling systems.

1.6.2 The corroded stub pipe to which an engine room seawater cooling line had been attached, consisted of 440mm high, 262 bore, steel pipe, 7mm thick, welded on to the top of the sea chest. Three support knees, 7mm thick, and at 120° to each other, were welded to the stub pipe to provide additional vertical support. The top flange, 38mm outside diameter and drilled to receive 14 fitted bolts, provided the attachment for the right-angled isolating valve.

Diagrammatic representation of seawater inlet chest and stub pipe

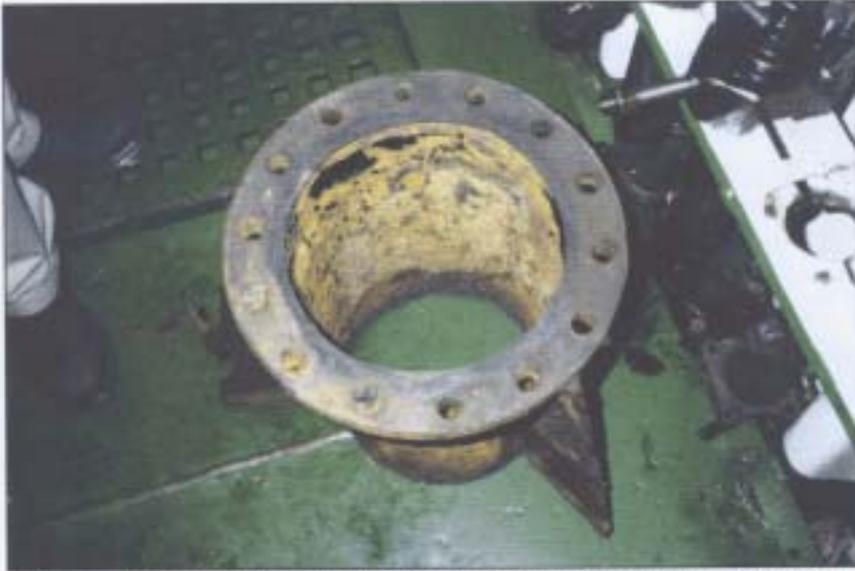
Photograph 8

- 2.1.1 The flooding of the engine room was caused by the failure of a stub pipe forming part of the forward port sea chest. The steel stub pipe, shown on a sketch, subsequently prepared by the Russian shipyard as originally being 10mm thick, was measured as about 7mm thick at the time of the incident. The pipe had suffered corrosion throughout its length with particularly severe corrosion at the top end, some 5 to 6mm below the bolted flange. The material had corroded away round almost two-thirds of the circumference, and it was only the flange and vertical knees that prevented a total collapse of the stub pipe (**Photographs 8 to 10 and Figure 2**).

General view of pipe after being removed from top of sea chest

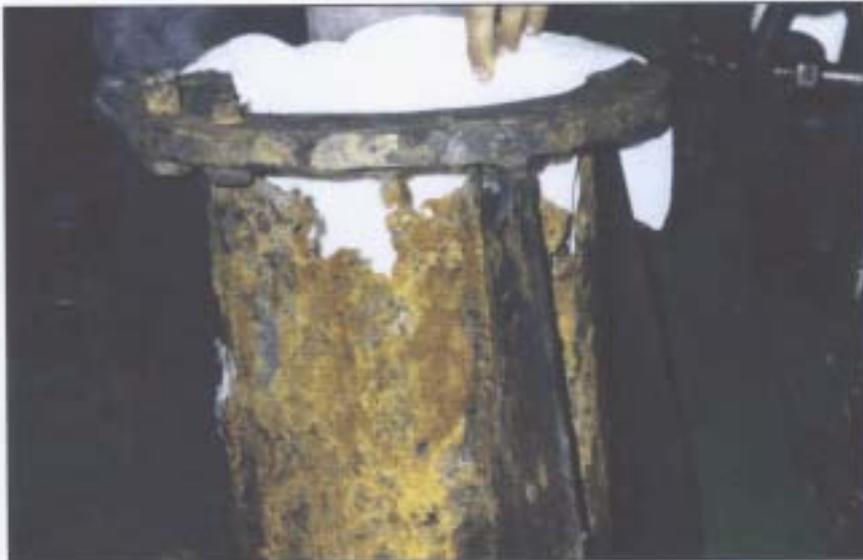
Photograph 9

- 2.1.2 This level of corrosion indicates that the protection afforded by galvanisation of the steel pipe had long since been lost, with any galvanic protection offered by anodes within the sea chest being ineffective. An examination of the stub pipe, after it had been removed from the sea chest, showed no evidence of a protective paint either inside the pipe or externally. Further metallurgical analysis carried out on behalf of the owners and the P&I Club, established that the severe corrosion found adjacent to the valve flange was the result of galvanic action. This occurred because a bronze alloy isolation valve was fitted directly on to a mild steel stub pipe.

Extent of corrosion

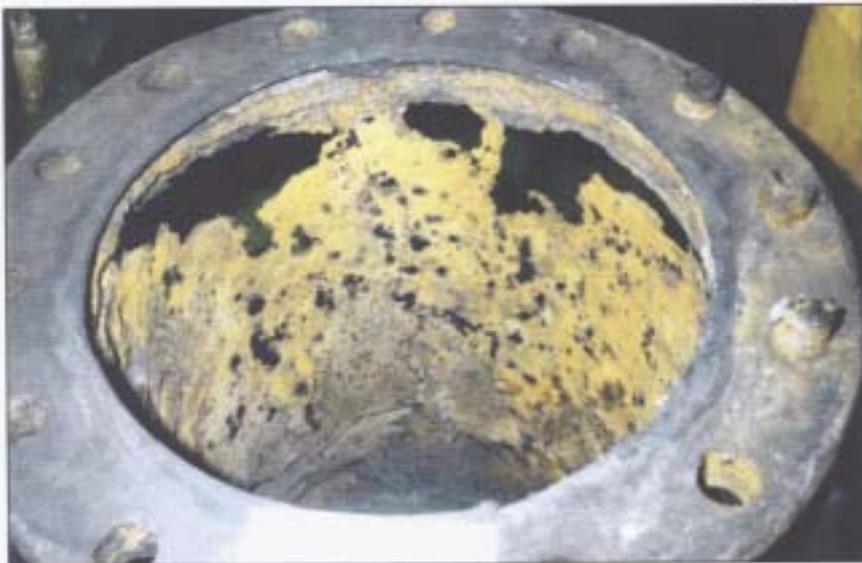
Photograph 10

Extent of corrosion on sea inlet pipe.
Isolating valve sat on flange.

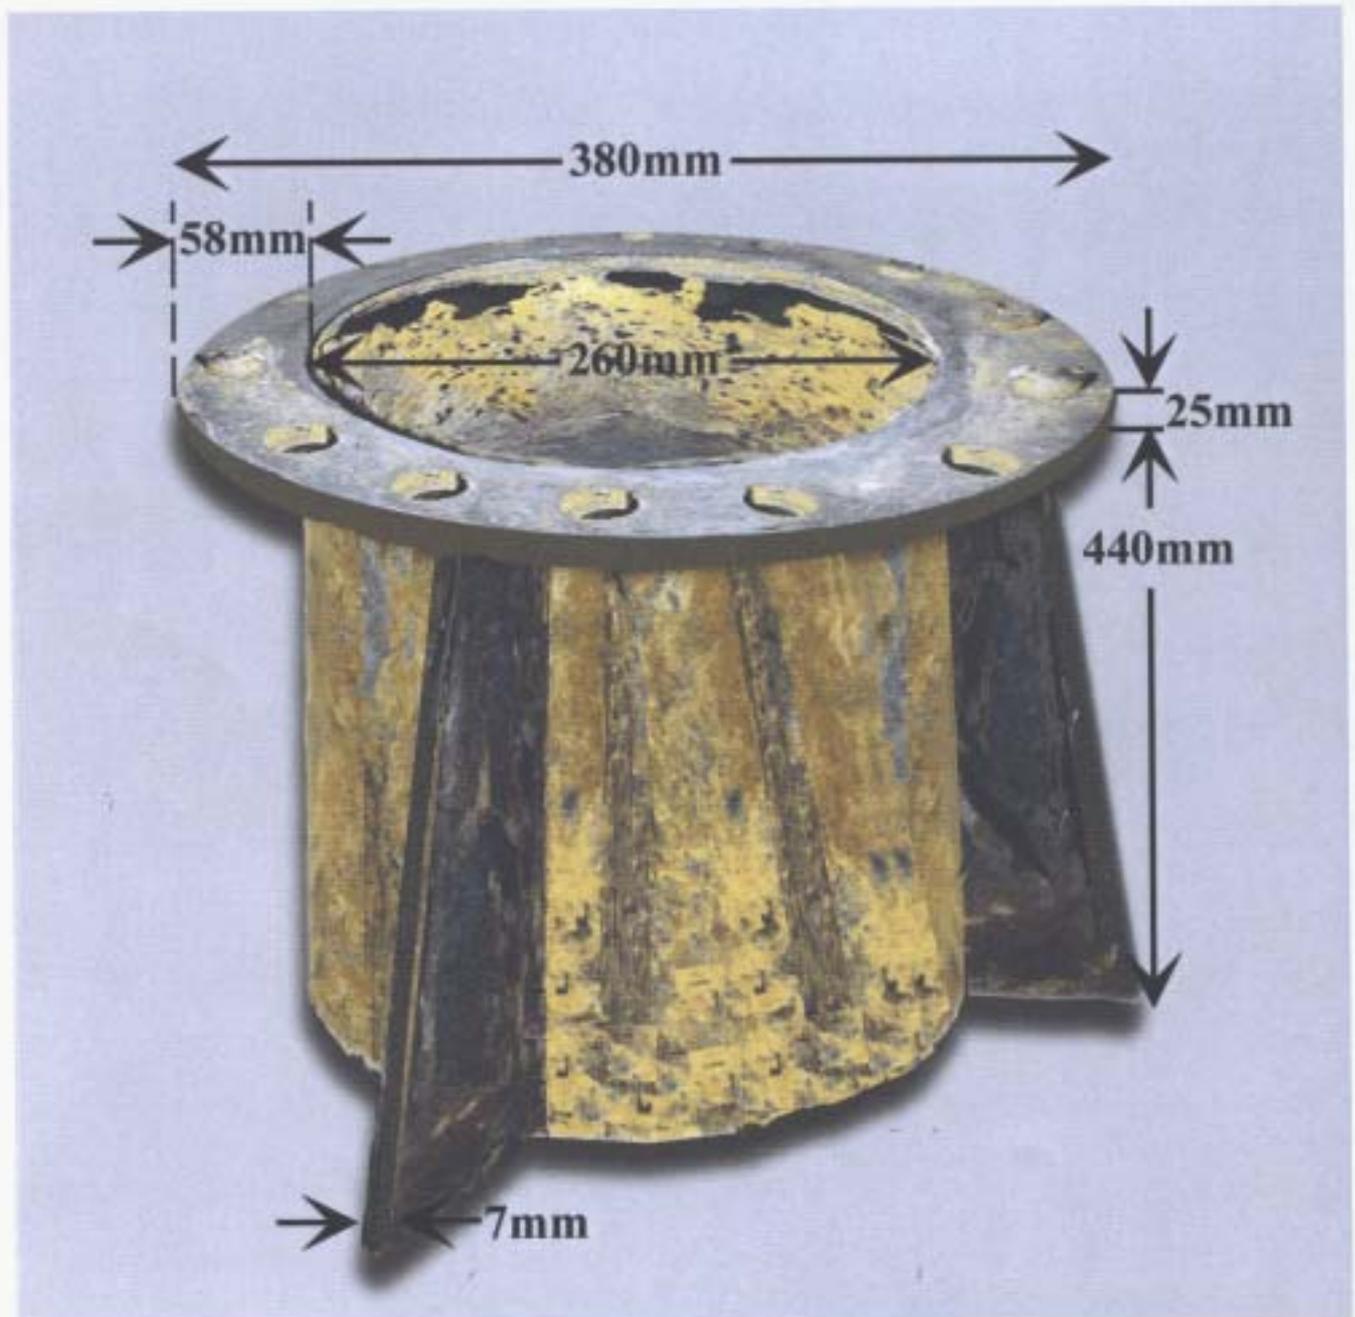
Diagram showing the sea water inlet pipe (not to scale)

5.6mm and 6.8mm. If this stub pipe was originally 10mm thick, a uniform loss of thickness of between 3.2mm and 4.4mm from corrosion is very unusual. The accelerated galvanic corrosion at the top, near the flange is not disputed, but a general uniform loss of material over the rest of the pipe cannot be explained by corrosion alone. It is more likely that the pipe had been replaced since the vessel was built, and that the replacement pipe was in the order of 7mm thick. The stub pipe should have been of similar thickness to the hull plating around 10-12.5mm thick (the top plate of the sea chest was 14.5mm). Although a new owner would probably not have been aware of the history of this particular piece of pipe, it is technically an extension of the hull, and an area that requires special attention during surveys.
