Report on the investigation of
a collision between the yacht
Bluebell of Warsash
and an unidentified ship
about 23 miles south of the Needles, Isle of Wight

7 August 1999

Report No 20/2000

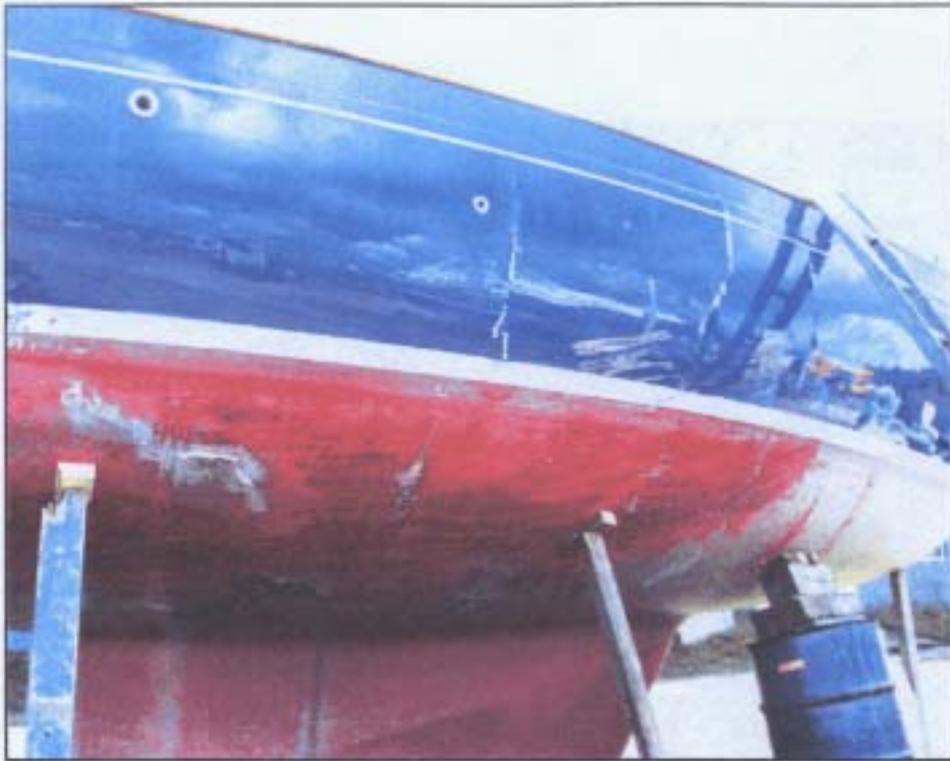
Photograph 2

The hull amidships had three major vertical splits from near deck level to the waterline. There were external scrape marks in this area and various small splits, some below the waterline.

A view of the external damage to the starboard side of the hull

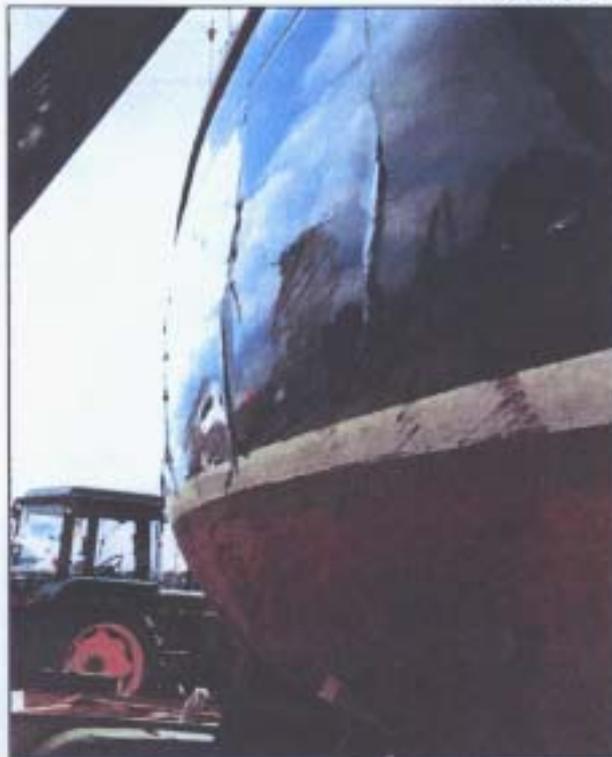
Photograph 3

Another view of the splits, looking aft

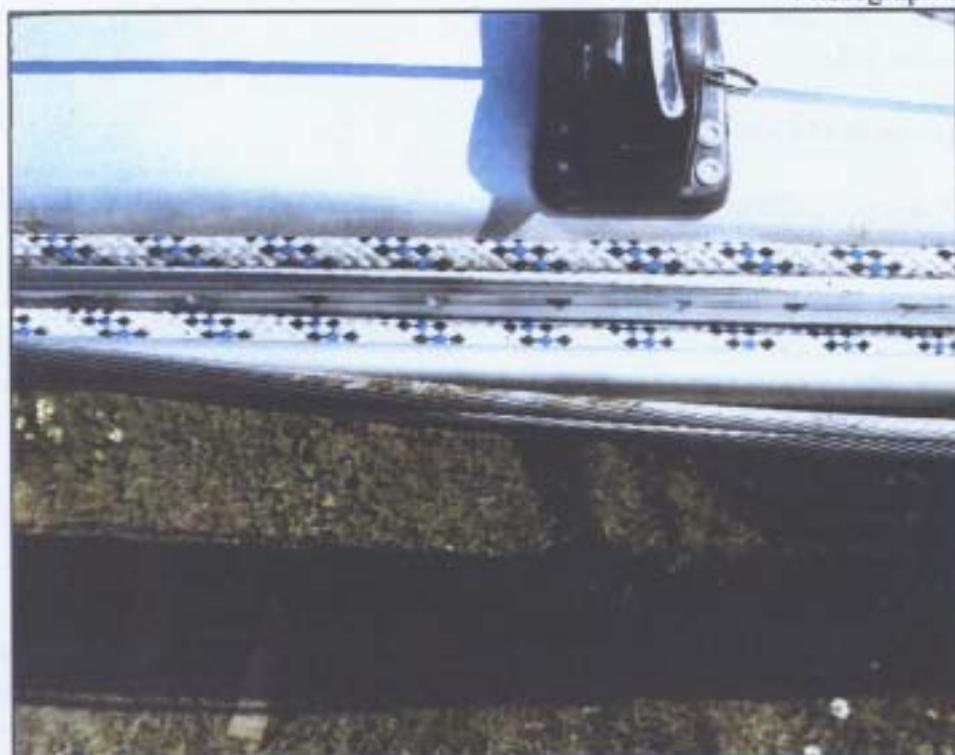
Photograph 6

The spreader bracket (above) and the cap shroud (centre)
both of which had pale blue paint deposits on them

The starboard side spreader had been snapped off and lost overboard, leaving the bracket, on which there were pale blue deposits. Similar coloured deposits were also found embedded in the starboard cap shroud wire and on the mast itself.

The pale blue paint deposits were located high up on the yacht's mast. They were probably left there by the upper section of the bow of the ship, when the yacht heeled over on impact. The Forensic Science Services could not match the darker blue paint samples from ship 1 with the pale blue deposits from the yacht. However, the red paint on the wooden strake looks similar to that of the boot topping of ship 1.

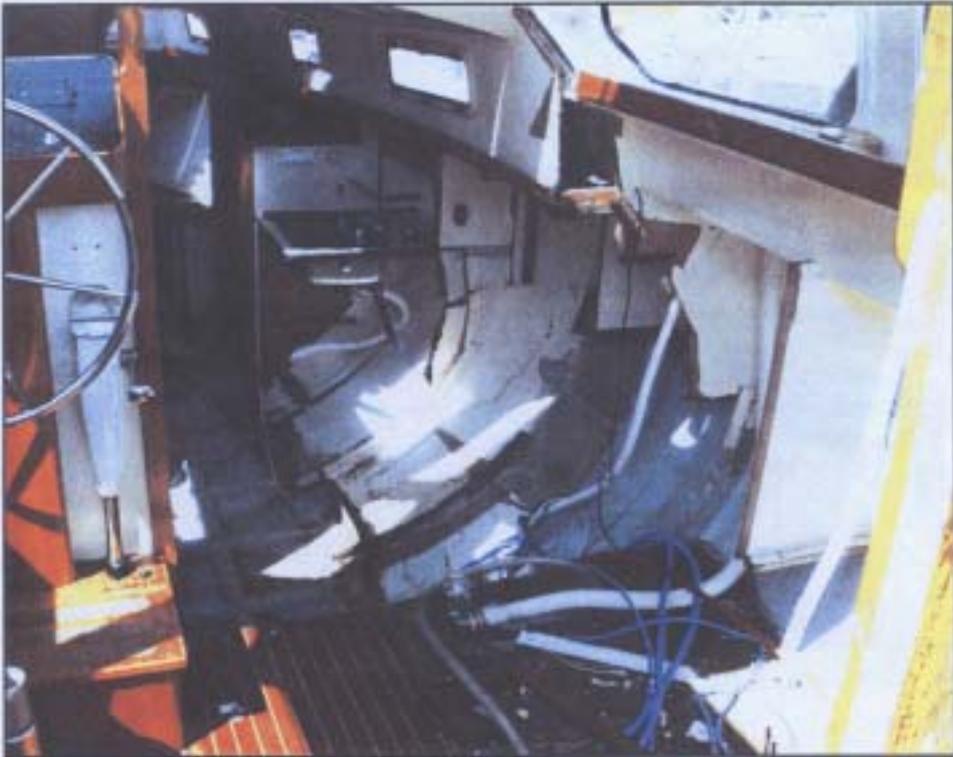
Photograph 4

The internal damage was extensive; transverse bulkheads had been compressed and distorted. A through-hole fitting from the sink had been displaced.

A general view of the interior damage to the starboard side

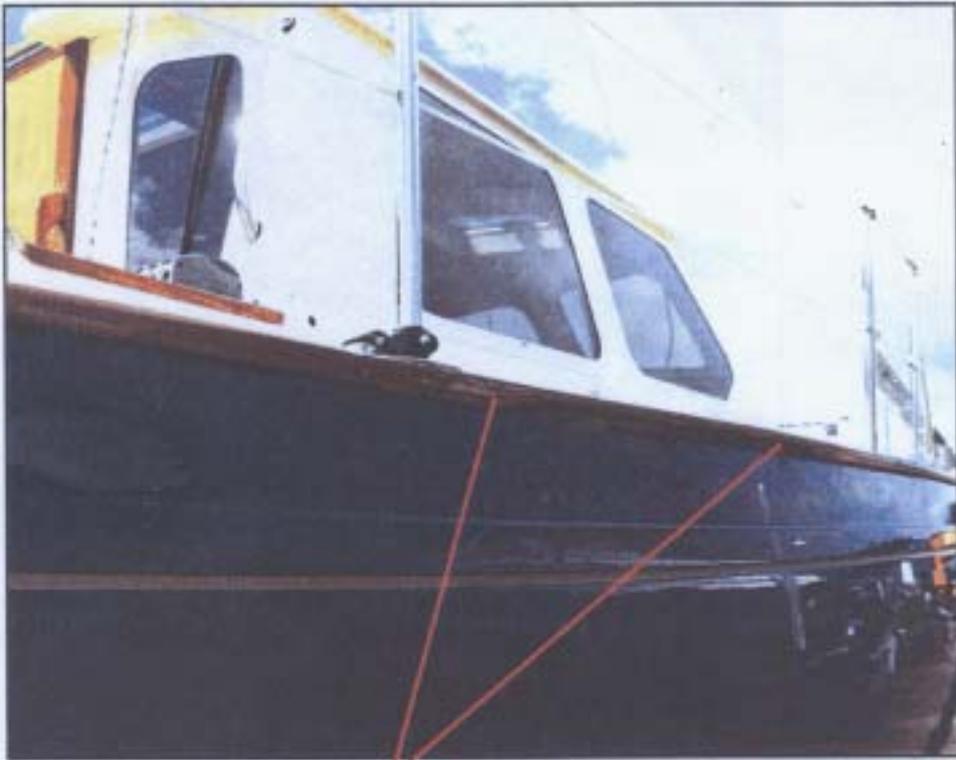
Photograph 5

On the starboard side, at the after end of the pilothouse, the wooden rubbing strake was split, with deposits of red paint on it (see Sections 1.4 and 2.2).

Damage to the wooden strake with red paint deposits

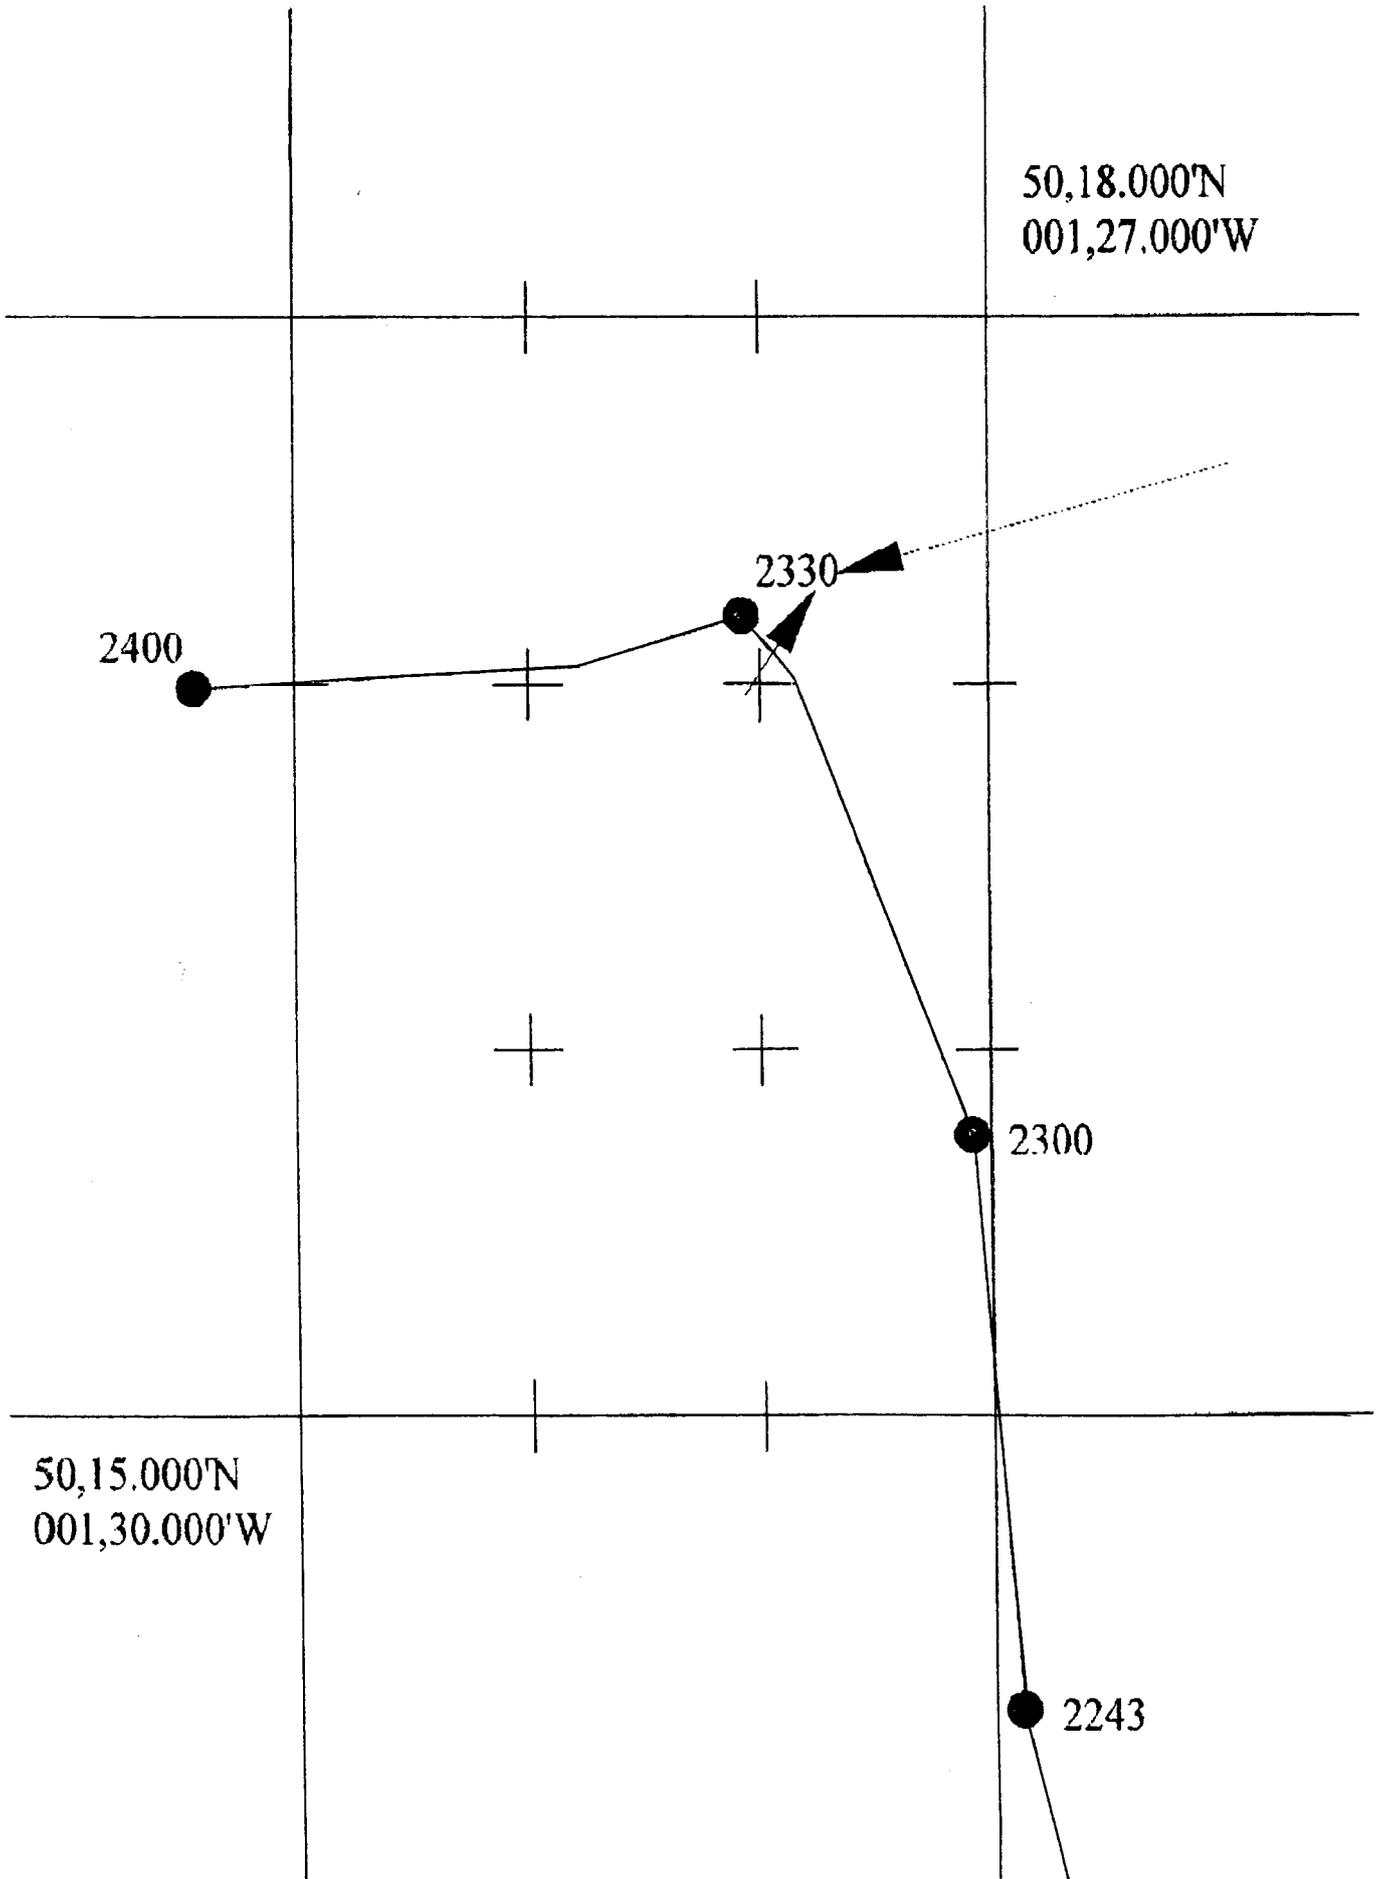
View from yacht's plotter

The yacht's course made good over the ground, was about 336° during the 30 minutes before the collision (see **Figure 2 overleaf**). A reconstruction of the collision has been made (see **Figure 3 overleaf**). It has been assumed that the bearing of the ship did not alter. A relative bearing line of 15° has been drawn from the 2300 position and a course line of 252° (the recommended direction of the traffic flow) has been assumed for the ship. These two lines cross at A. The distance between 2330 and A is about 5.5 miles, which makes the speed of the ship about 11 knots.
