**Report of the investigation of  
the flooding and  
foundering of**

***mfv Sharona (PD185)***

**80 miles north-east of Peterhead  
on 3 August 1999**

**Report No 25/2000**

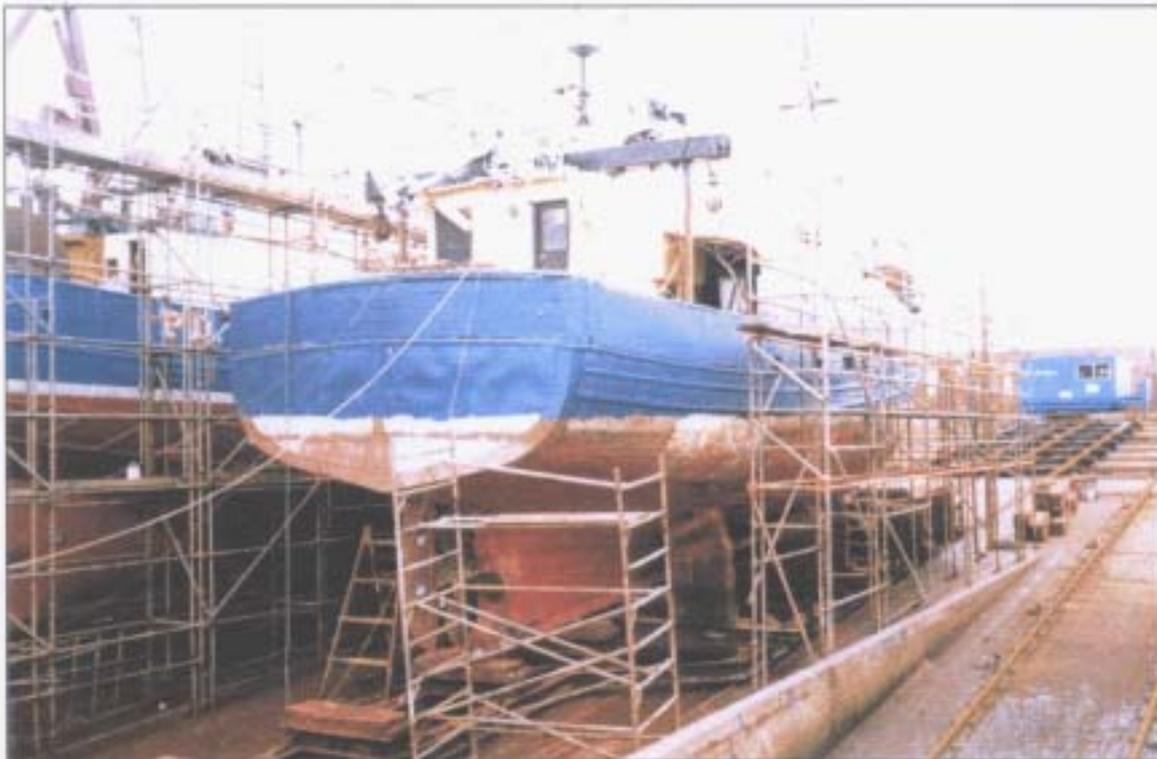
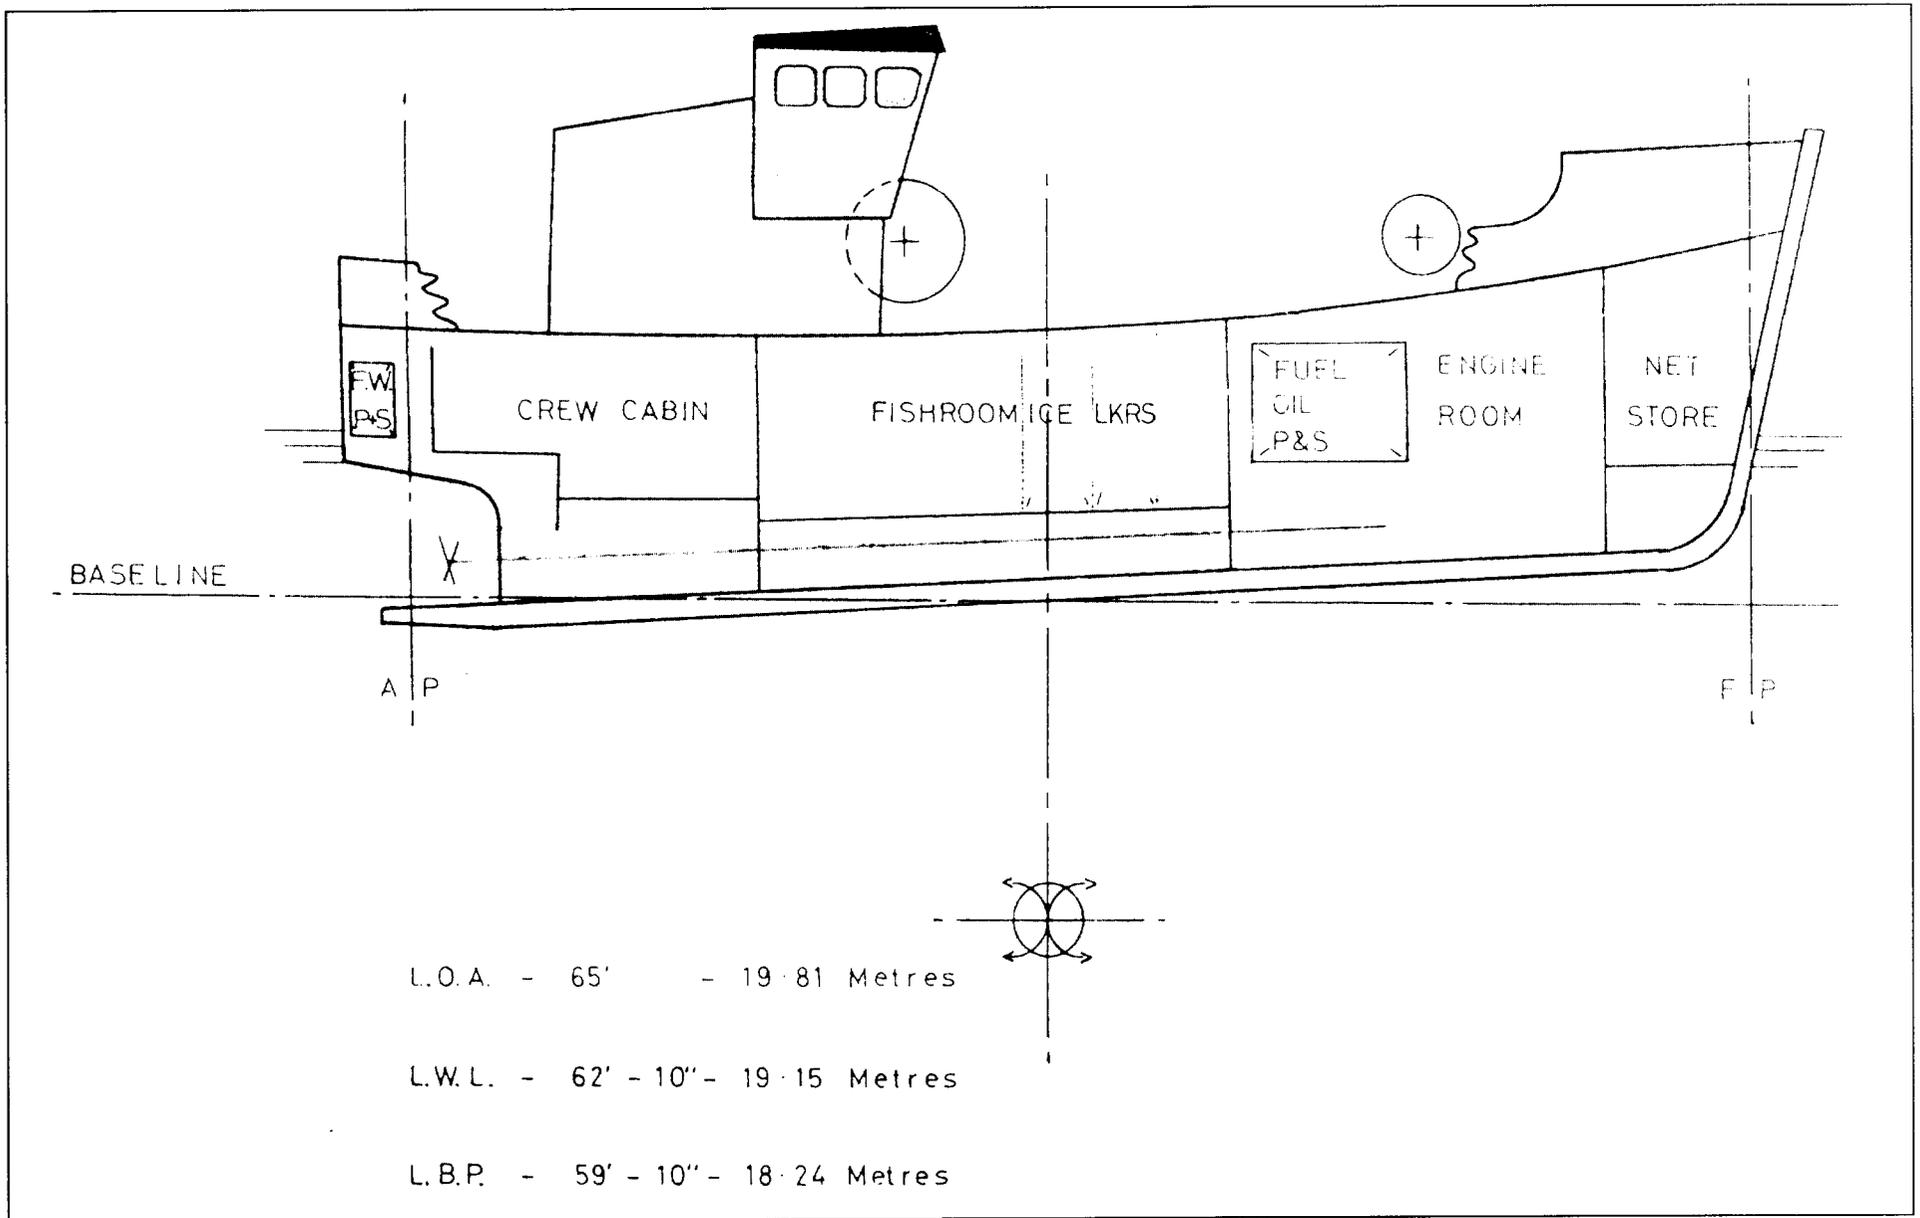
Figure 2 - General arrangement

Under deck, the accommodation was situated aft. Forward of the accommodation was the fish room, and forward of this was the engine room. They were separated by a non-watertight bulkhead. A CCTV camera was located in the engine room with a monitor in the wheelhouse. This enabled the watchkeeper to keep a constant view of the engine room.

Had a watertight bulkhead been in place, separating the fish room from the engine room, progressive flooding into other spaces would have been avoided and *Sharona* might not have foundered.

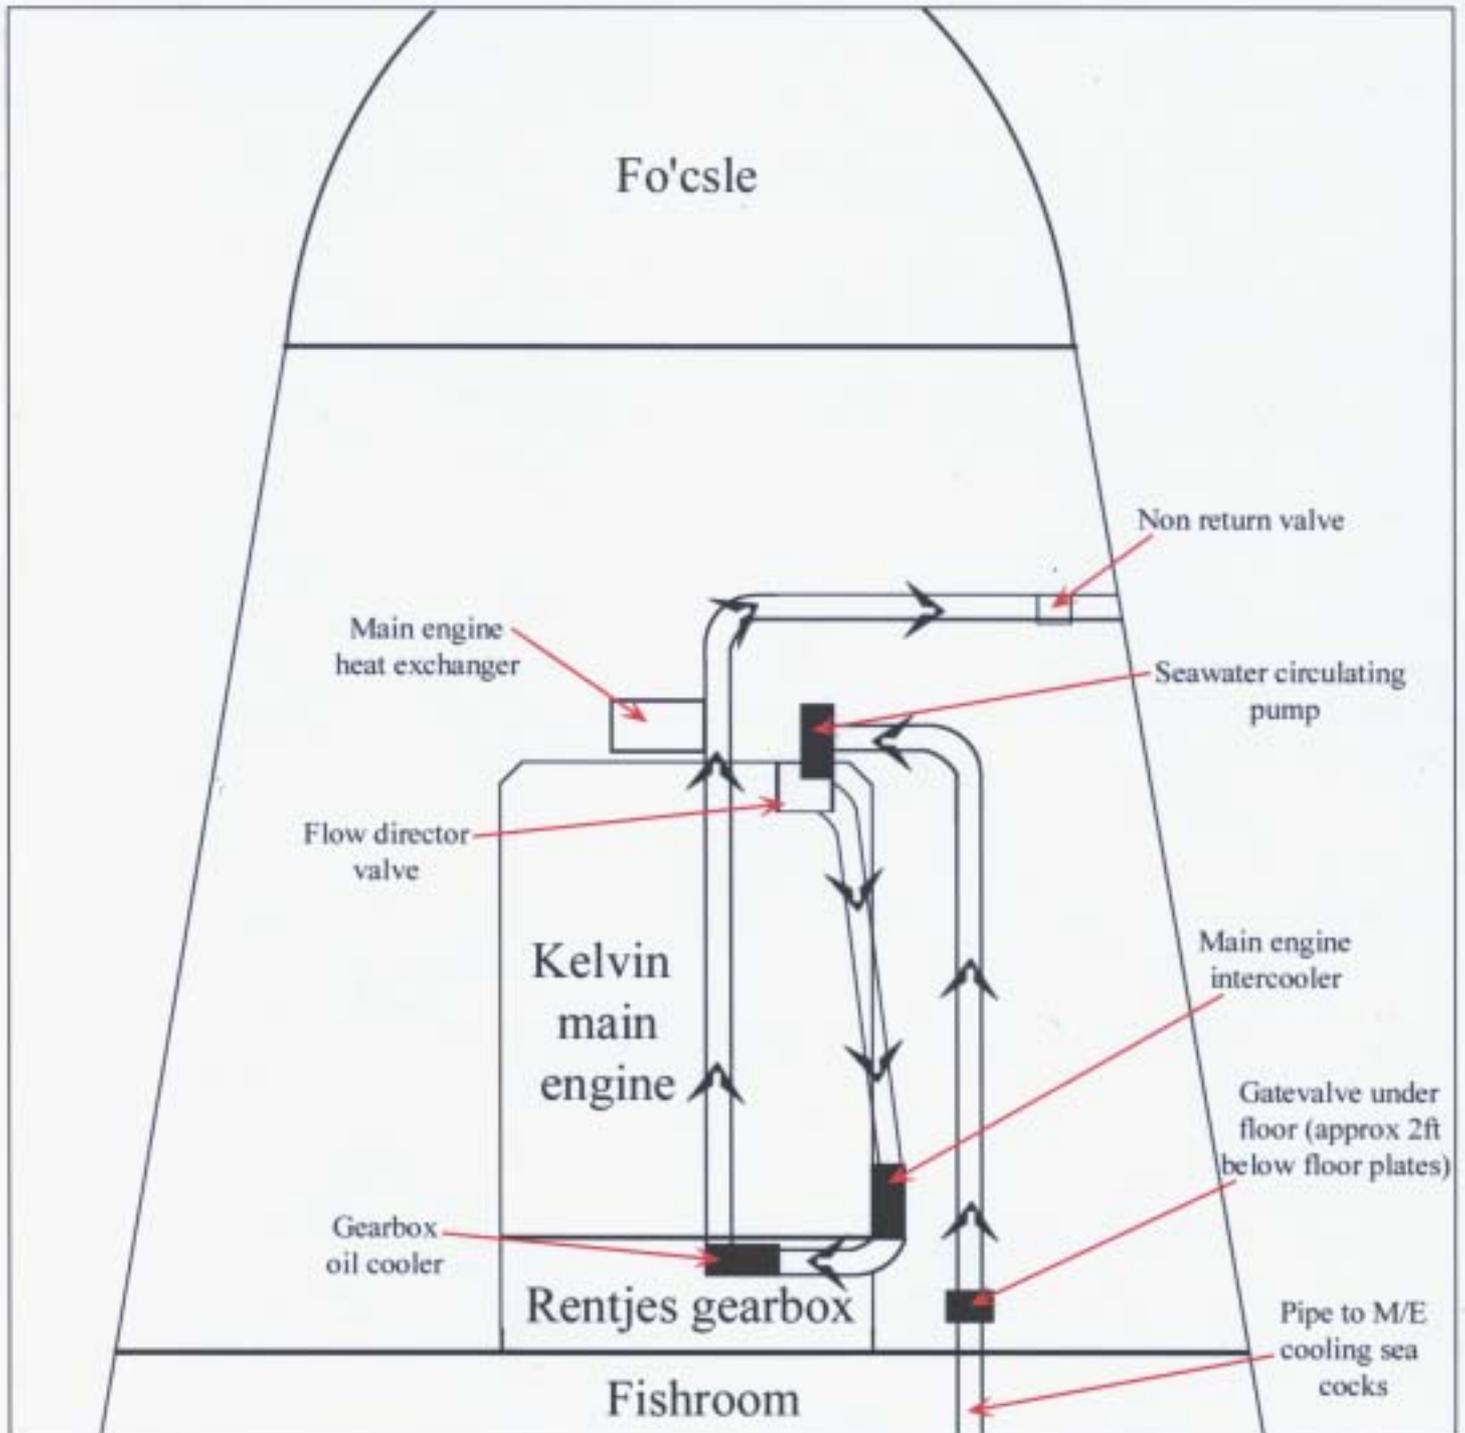
Figure 3 - Main engine and gearbox cooling system

The main engine, a 336kW Kelvin diesel was sea water cooled by means of a fresh water heat exchanger. Cooling water was supplied through one of two main sea water valves situated in the fish room. The sea water was fed into the engine room and pumped via a two-way valve into the main engine heat exchanger and into an inter-cooler for the main engine gearbox. The sea cooling water was then pumped overboard through a 50mm diameter copper pipe. This pipe was approximately 2 to 3mm thick. The discharge outlet, which was fitted with a non-return valve, was situated 0.6m above the waterline forward on the starboard side of the hull.

Once in the engine room, he discovered that the overboard discharge pipe for the main engine cooling water, on the starboard side of the engine room, was fractured. The cooling water pump, driven by the main engine, was pumping cooling water into the bilges instead of overboard, while the main engine was running.

Further flooding while under tow had occurred due to back-flooding through the fractured overboard discharge outlet. The skipper confirmed this when he inspected the engine room.

The non-return valve fitted behind the discharge outlet failed to prevent back-flooding. Unfortunately this valve was not checked during the recent condition survey carried out by the vessel's insurers. This again raises concerns as to whether non-return valves fitted on *Sharona* had been regularly checked and maintained in accordance with *Marine Guidance Note MGN 49(F)*. Had the non-return valve been fully operational, it would have prevented further flooding into the engine room and the vessel could have been saved.

*Sharona's* loss was caused by uncontrolled flooding to the engine room through a fractured main engine cooling water pipe because of erosion/corrosion or work-hardening of the copper pipework.

For this reason a recommendation will be made to the MCA to update its advice given in *Merchant Shipping Notice M 631*, and to include reference on work-hardening of copper piping.
