Report on the investigation of the
man overboard fatality from
the angling boat

PURDY

at Shipwash Bank, off Harwich
on 17 July 1999

Report No 17/2000

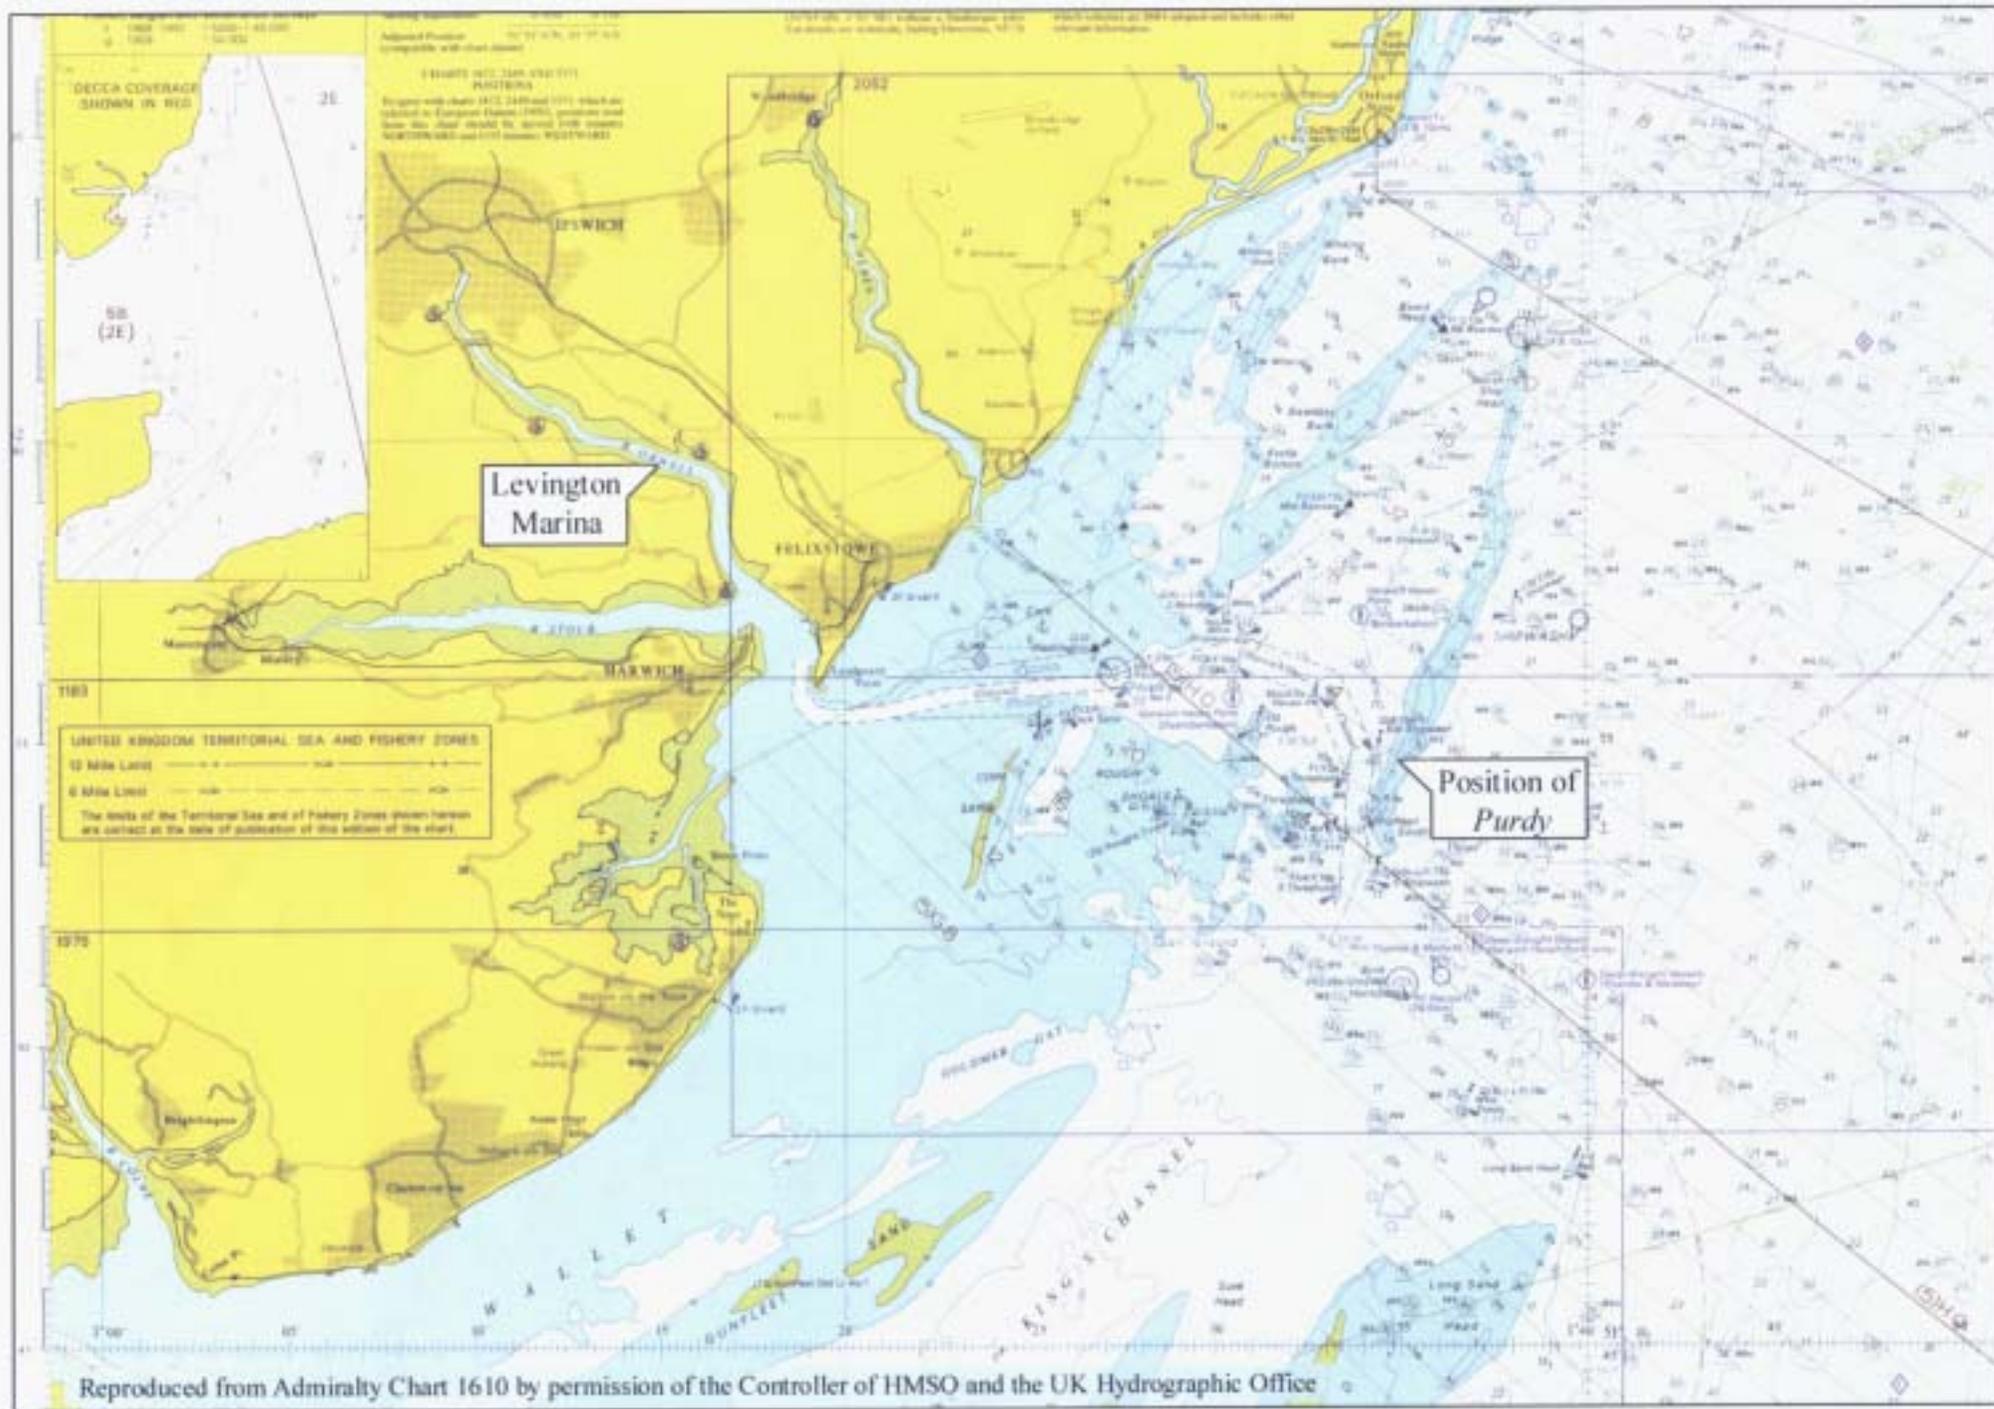
Figure 1

Purdy's owner regularly took friends and acquaintances on fishing expeditions off the entrance to Harwich Haven. On 17 July, he and one acquaintance, Mr Sibley, were out for a day's fishing expedition. They had left Levington Marina at about 0730, and having had no success at their first choice of fishing ground off Rough Tower, at about 0900 they had moved to the vicinity of another regular fishing position off the southern end of the Shipwash Bank. It was close to low water and the shape of the shallower parts of the bank could be seen in the slight sea conditions (**Figure 1 - Chart extract**).

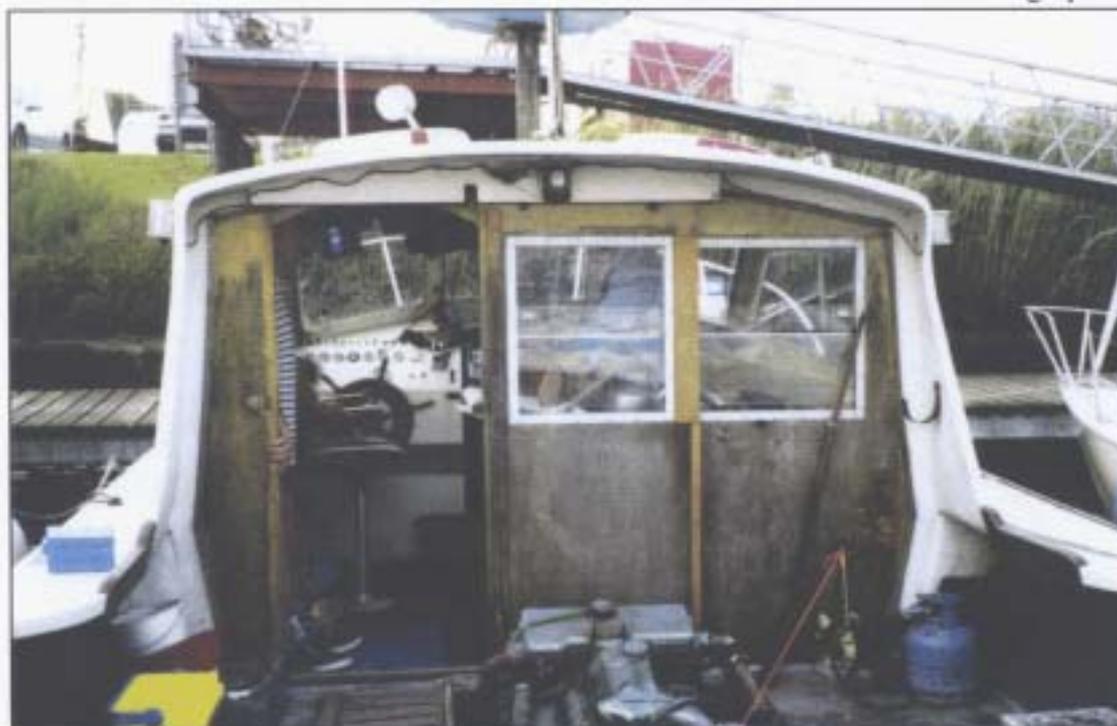
Photograph 5

Whale hand pump

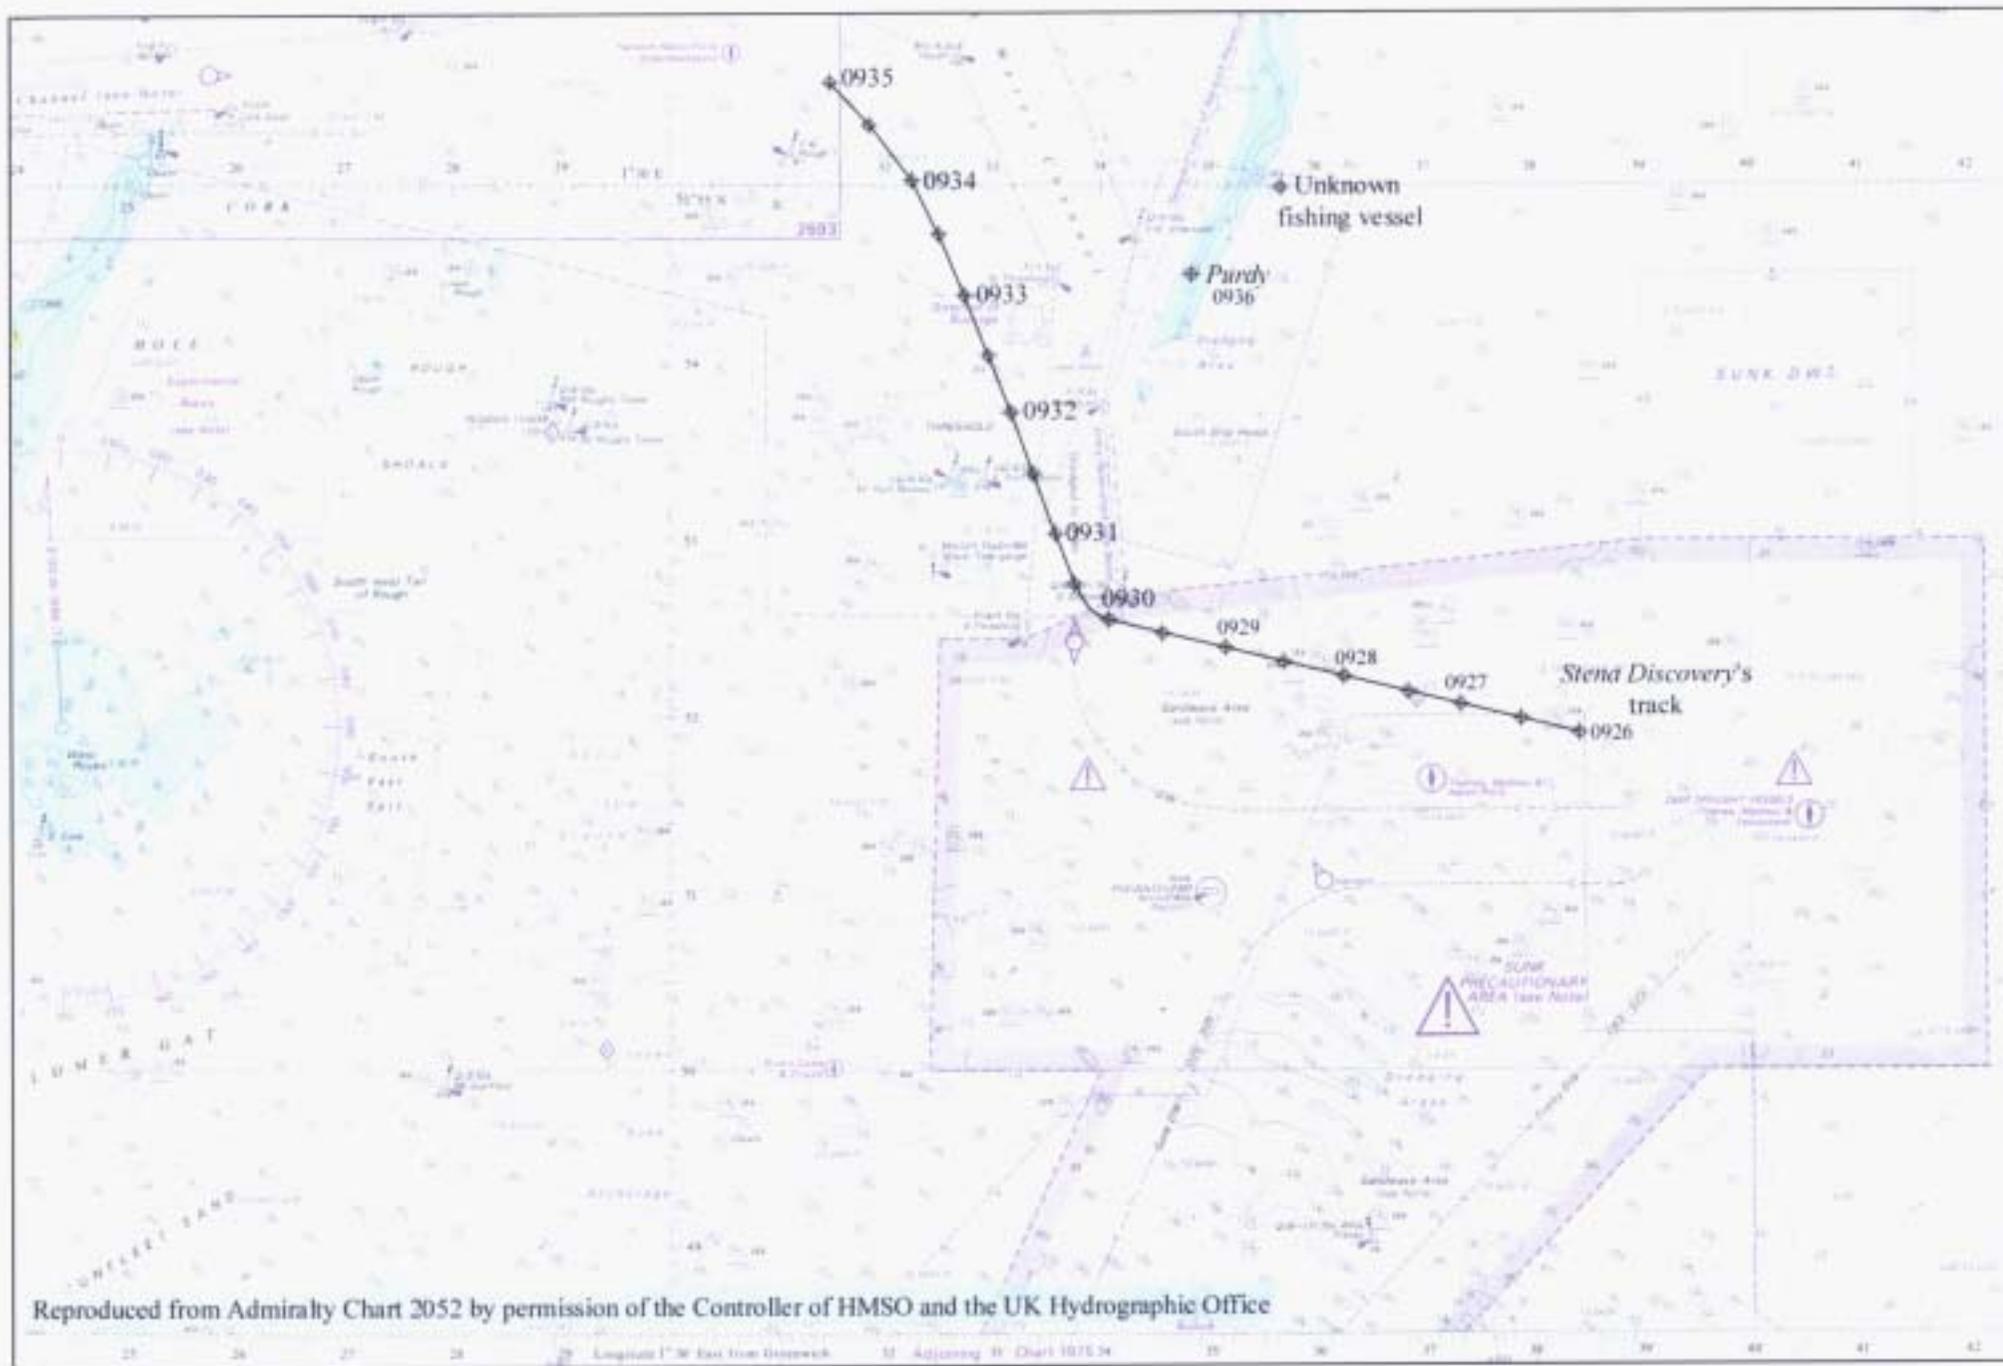
Figure 2

The track and speed information indicated on the chart extract was taken from *Stena Discovery's* electronic chart display by the master after the incident. The chart display system does not permanently record historical track information. The most recent four tracks are retained in the memory, with heading and speed information at 30 second intervals. No means are provided to print-off, or otherwise permanently store, a record of all the track information. On this occasion, before it was overwritten by another track record, the position, course and speed information was read-off and noted by the master.

It can be seen from the table and from the chart extract that *Stena Discovery* slowed considerably during her 54° course alteration made to the south of South Shipwash buoy, just after 0930. The lowest speed recorded is 33.1 knots at 093030 in a position where the water depth was approximately 17.5m. Because the speed information was recorded at discrete 30 second intervals the actual lowest speed reached during the turn was probably less than 33 knots.

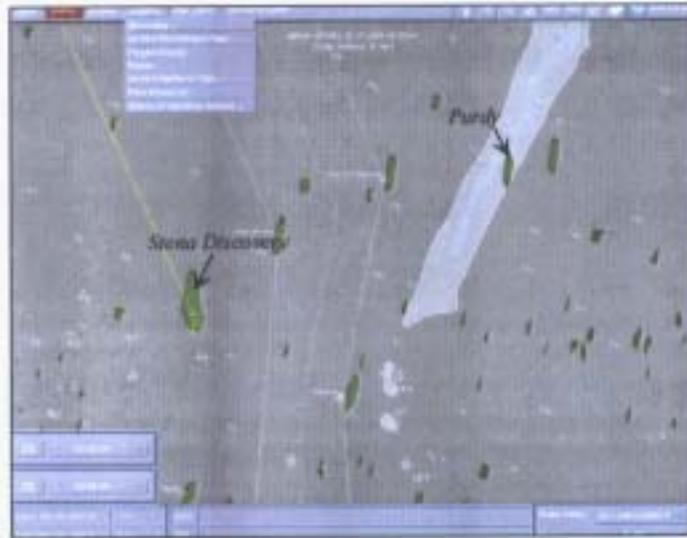
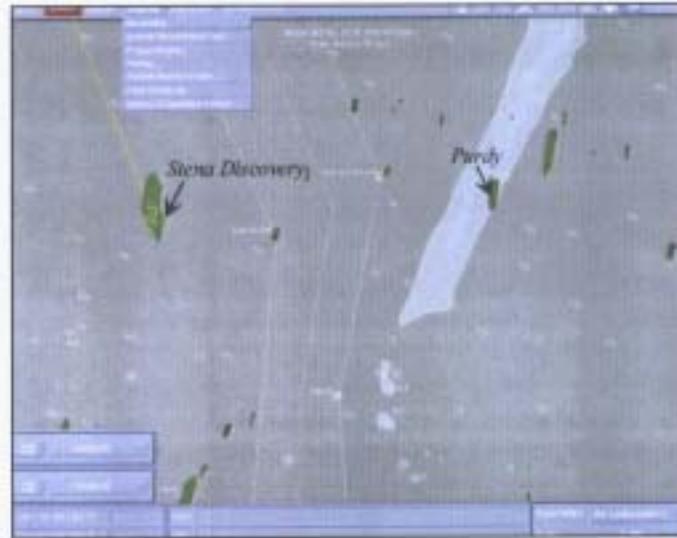
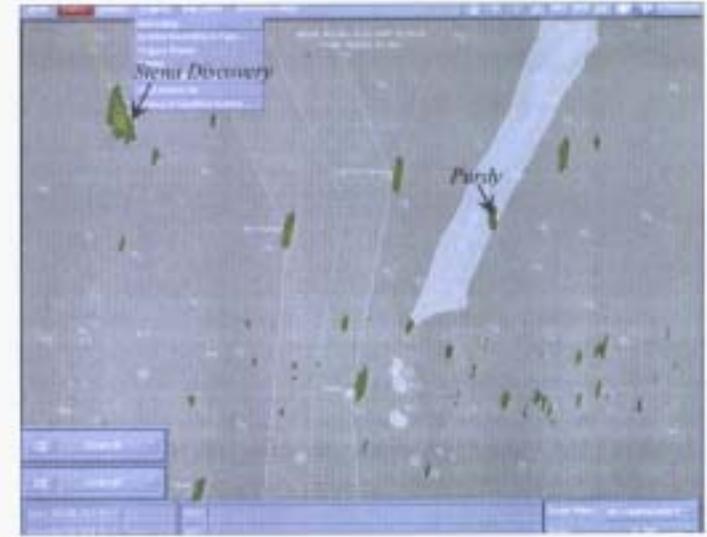
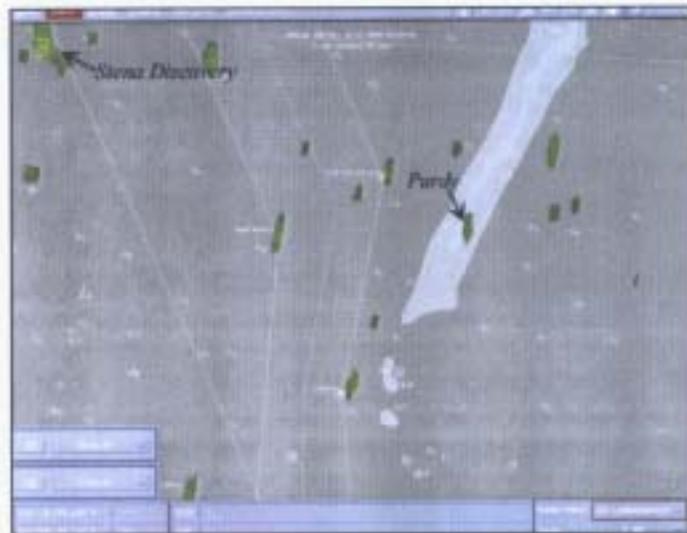
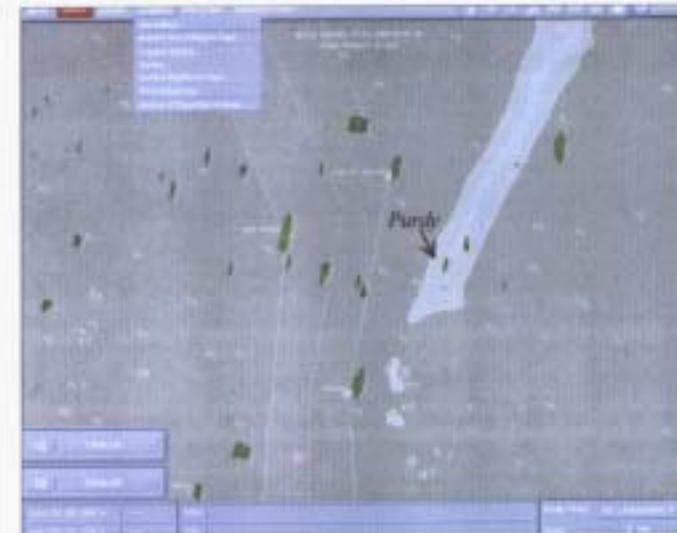
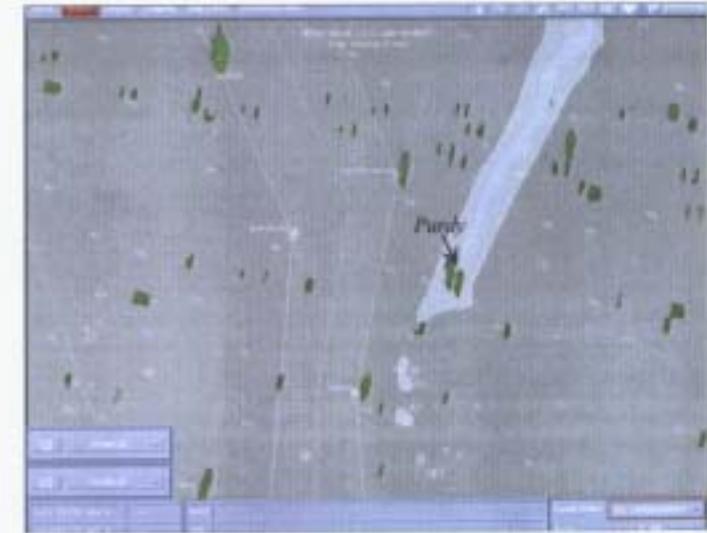
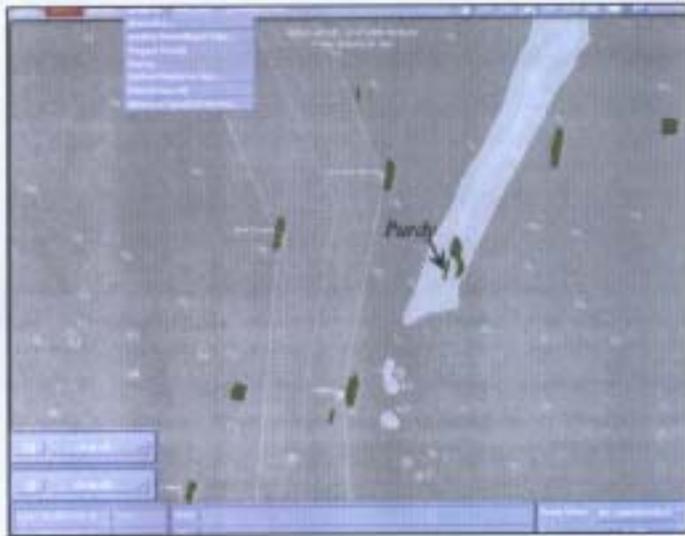
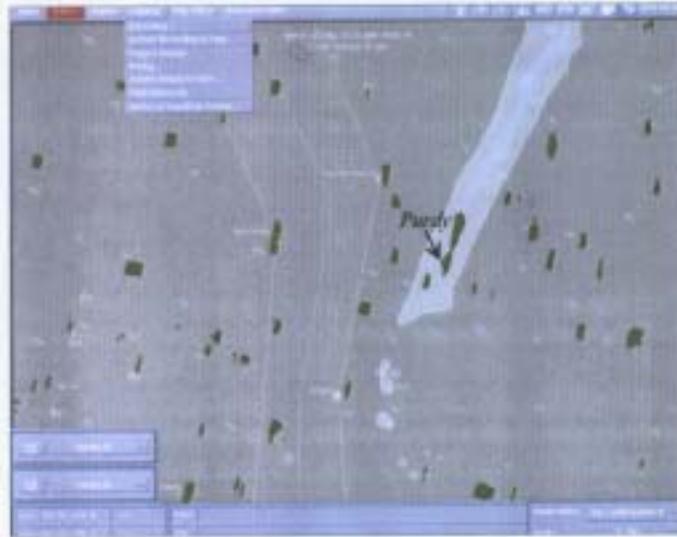
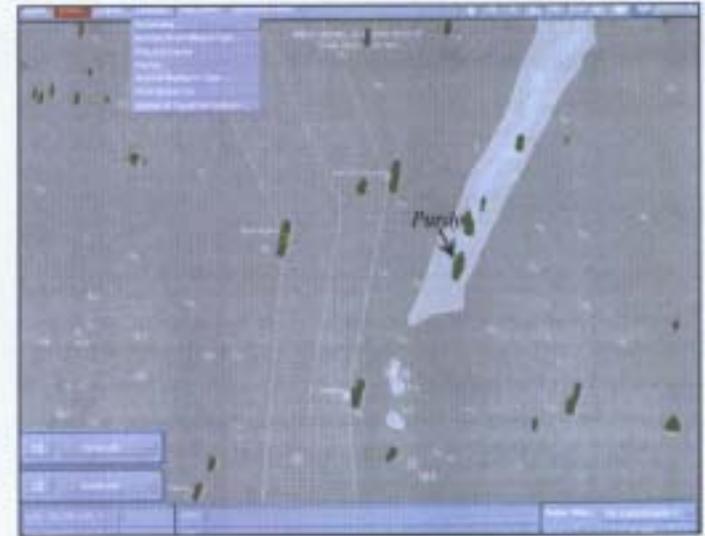
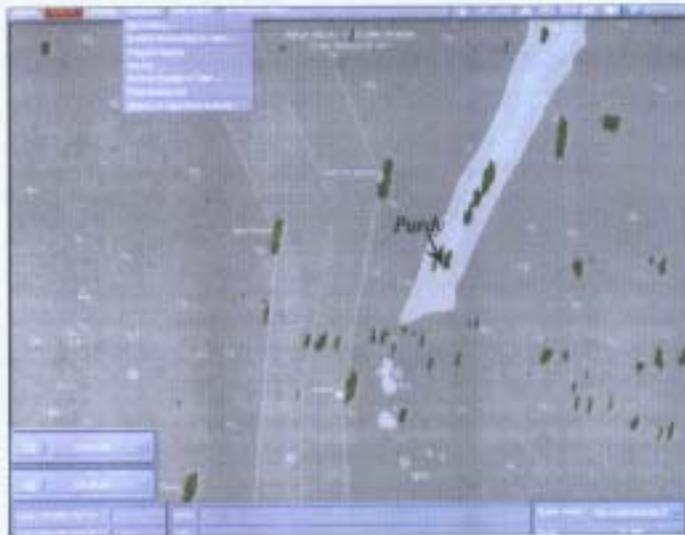
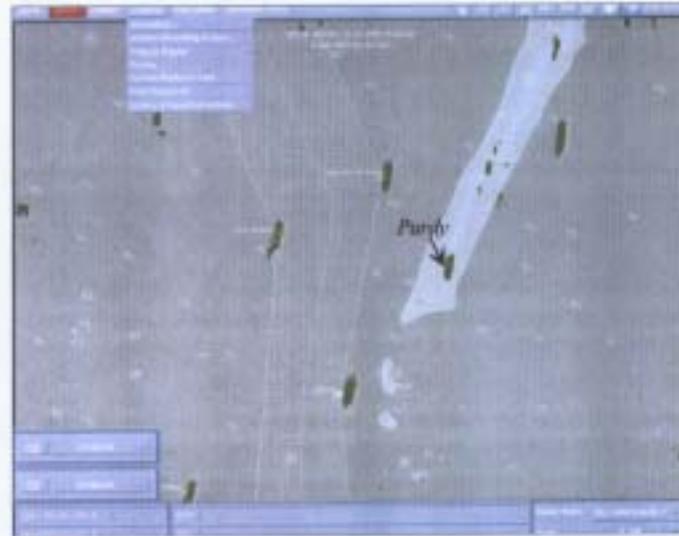
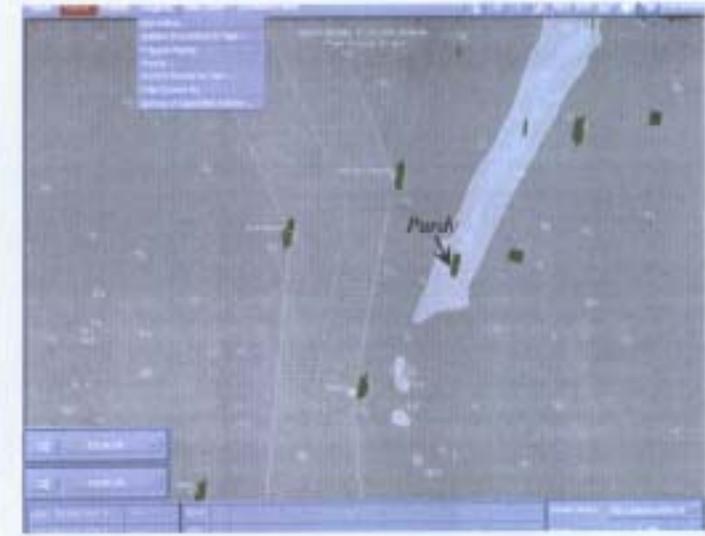
Series of radar snapshots

The event was also recorded by the VTS radar. The radar recording confirms the accuracy of the information supplied by Stena Line BV and also indicates the precise position of *Purdy* which is shown on the chart extract.

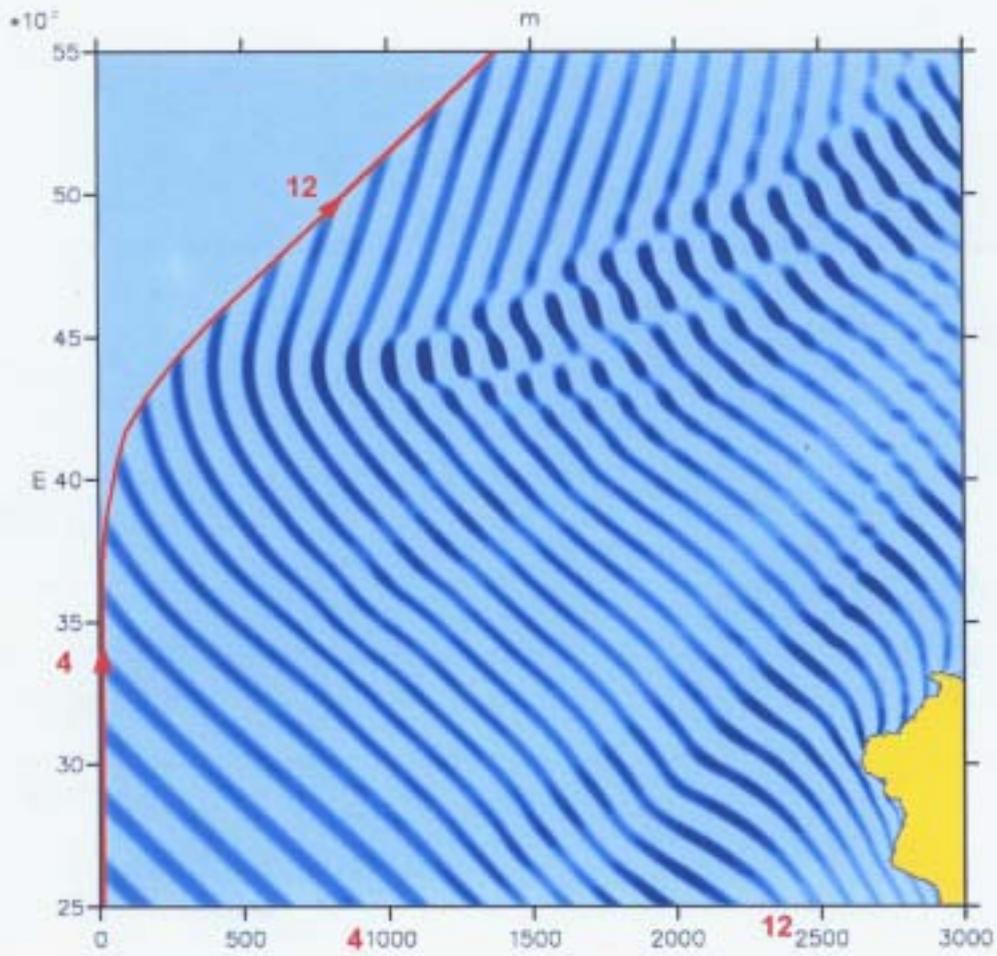
Figure 4

Stena Discovery was travelling at supercritical speeds before and after the alteration of course south of South Shipwash buoy. The alteration of course was 54°. Evidence from trials carried out on the HSS 1500 routes in the Irish Sea² have shown that diverging waves, created before a sharp turn, can combine with those created after, to form larger waves by superposition (**Figure 4**). Additionally refraction effects caused by the bathymetry and shallow water might have focussed the wave energy in the area of the Shipwash Bank (**Figure 5**). If superposition and/or focussing of the diverging waves created before and after the turn occurred, breaking waves of the height described by the skipper could have resulted.

Showing superposition of diverging waves on the inside of an alteration of course

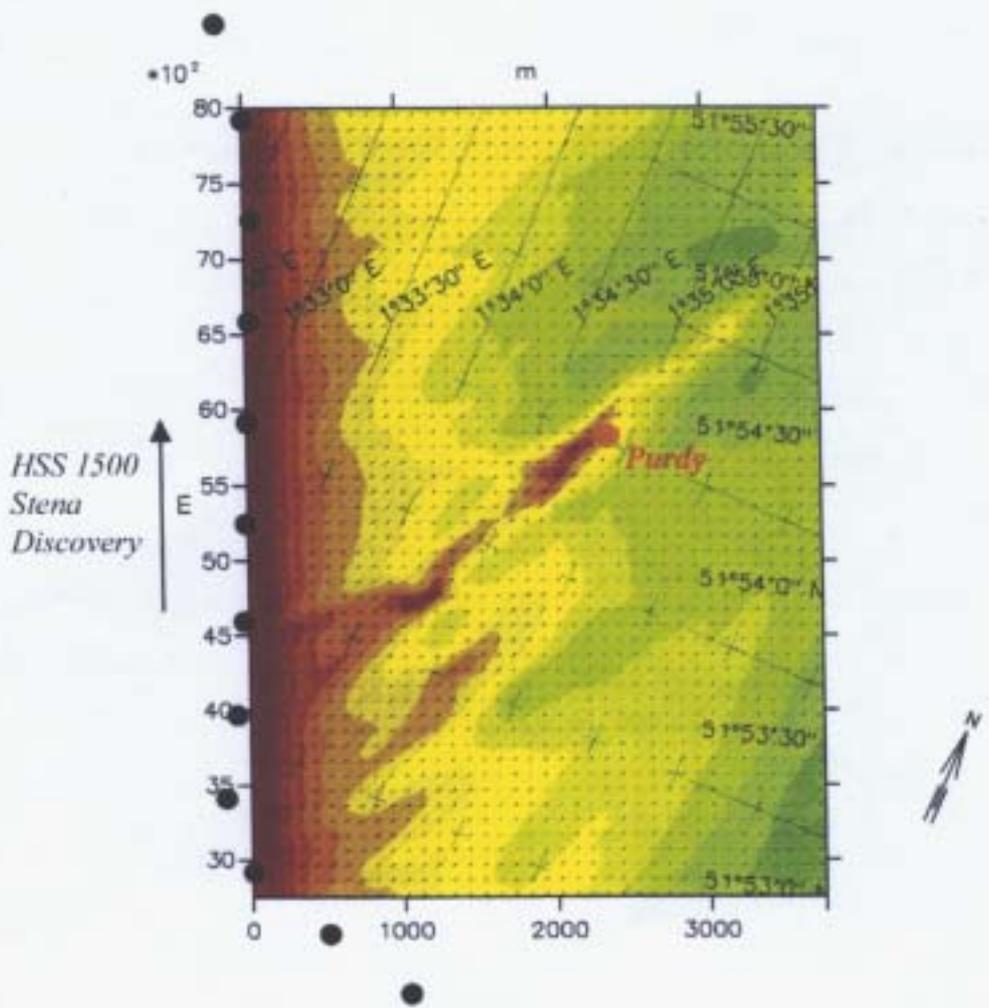
Figure 5

Example of predicted wave field on the Shipwash Bank. The figure shows the maximum wave height for the ship course 337°.
