Report on Investigation

of explosion on

Lord Trenchard

in Poole Harbour on 30 June 1999

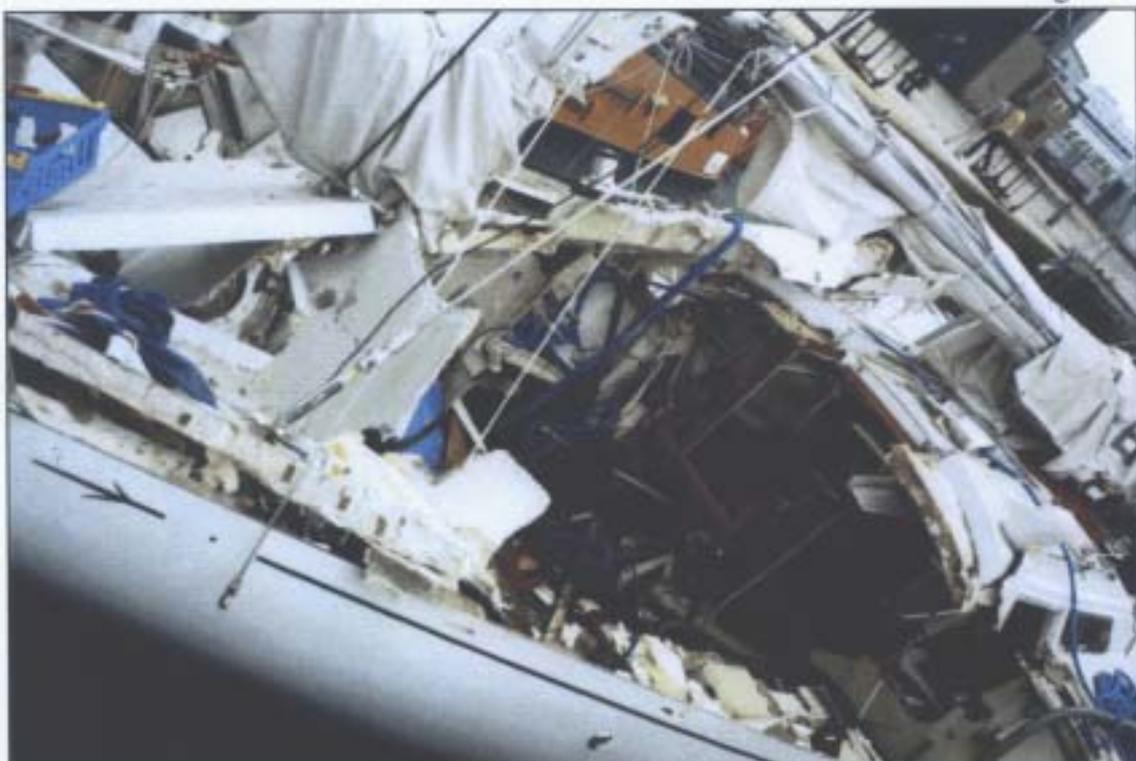
Figure 3

All structure, fittings and decking over and aft of the main cabin were severely damaged and displaced (see **Figure 3 photo taken in Poole**).

Port and starboard parts of the main hull skin were vertically fractured down to the waterline, abeam of the cockpit. As the extent of this hull damage could not be fully assessed with the vessel afloat, safety considerations prevented any detailed examination until the vessel was lifted from the water.

Aft end of *Lord Trenchard* shortly after the explosion

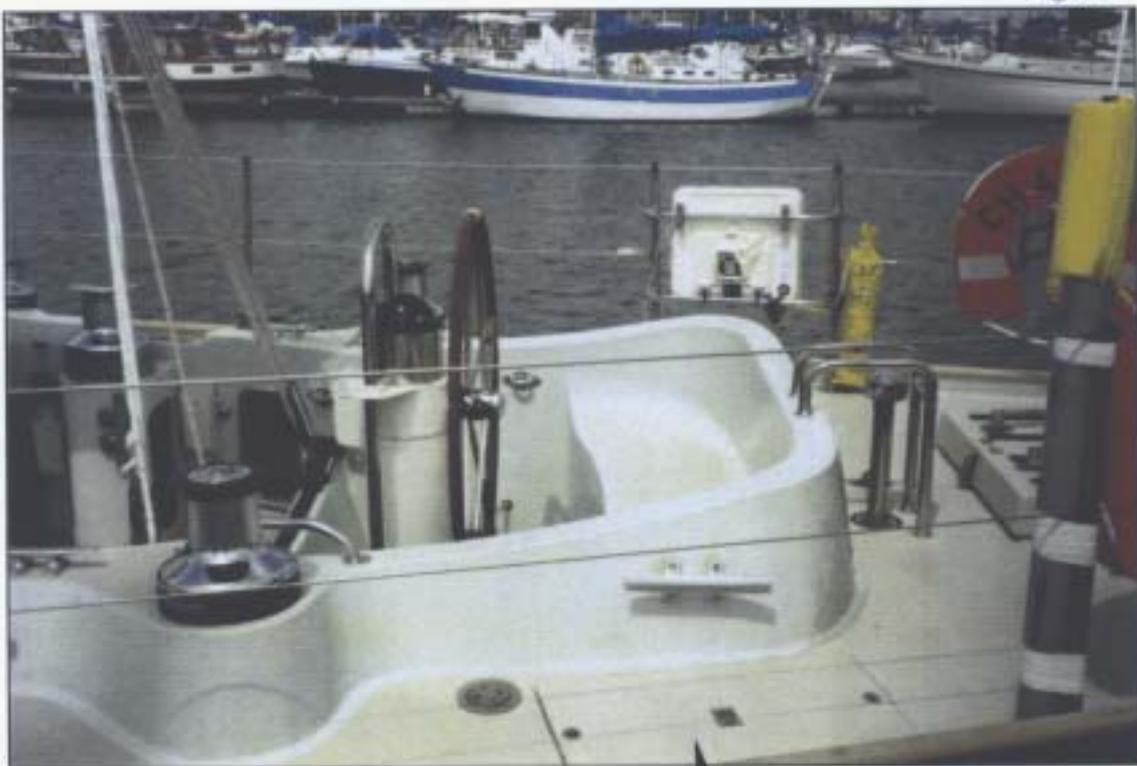
Figure 7

Cover to ready-use gas bottle locker

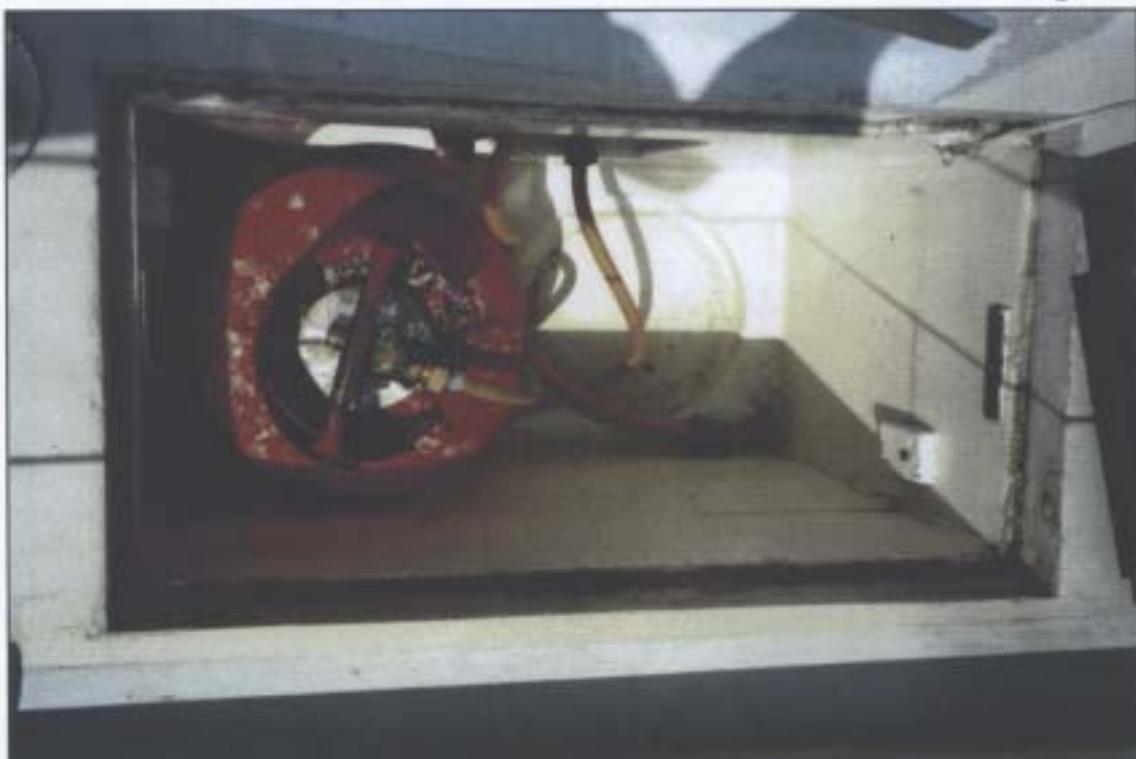
Figure 8

Interior of ready-use gas bottle locker with one bottle
and the bottles' securing arrangement removed

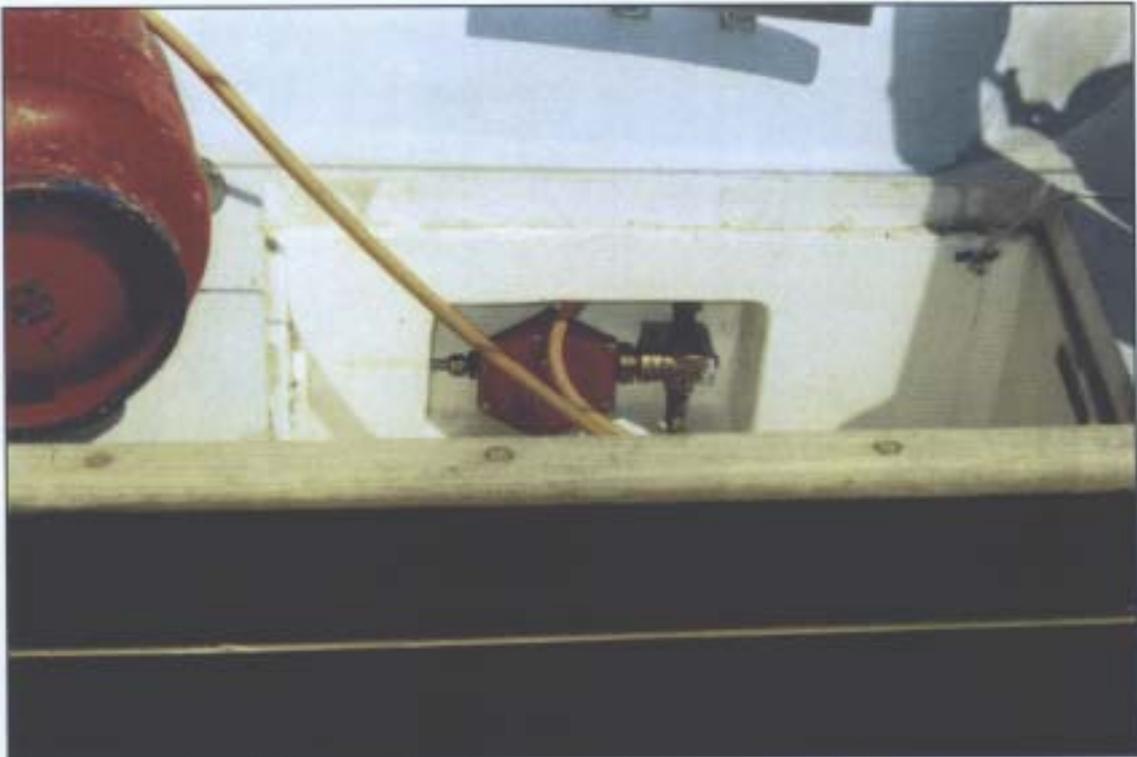
Figure 10

Moulded recess in ready-use gas locker accommodating
'T' piece wallblock and pressure regulator

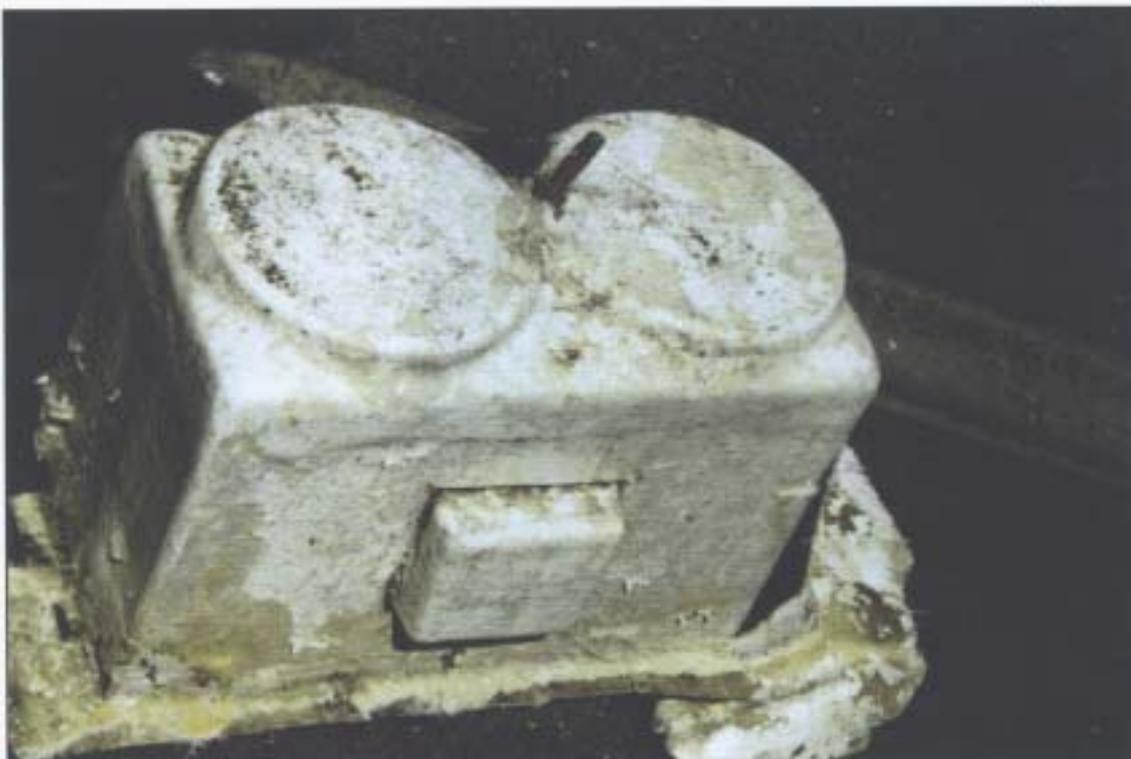
Figure 11

The ready-use gas bottle locker was found torn from the surrounding deck structure (see **Figures 11 & 12**). It did not contain bottles or regulator, but the 'T' connector wall block was in place, with one length of flexible hose to the forward bottle, remaining connected. The separately moulded recess, which had accommodated the regulator, was totally displaced. No securing screws, or any significant amount of sealant, remained in place on the joint surfaces between the recess and locker's wall. The locker's drain connection was in place and unobstructed, but unattached to its flexible hose leading overboard (see **Figure 11**).

No copper gas piping remained in the locker, but the position of the pipe's penetration of the locker was identified. Mastic type sealant was partially attached to this penetration.

Ready-use gas bottle locker moulding following accident

Other penetrations of the ready-use gas locker were for sliding bolts of the bottle securing arrangements (2) and latches for cover's locks (2). None of these penetrations was sealed, and each connected the interior of the ready-use locker to the vessel's hold space.

Several penetrations of the ready-use gas locker clearly breached its integrity as a gas-tight division, between the gas bottles and the vessel's hold space. The female elements of the securing arrangements for the locker cover and bottle securing device, generated clear passages for gas leakage into the hold space. In addition, the fixing and sealing of the locker's recess moulding, and the sealing arrangement for the gas outlet pipe, were probably not effective as gas-tight barriers.

Some, or all, of these penetrations would have allowed gas from inside the locker to migrate into the hold space of the vessel. However, what proportion of the total quantity of gas which leaked from the aft gas bottle escaped to atmosphere, via the drain pipe, and how much entered the hold, is unknown. What is clear, is that there were several gas leakage paths from the ready-use gas locker into the hold space. It is concluded that gas entered the hold space by one or more of these routes.

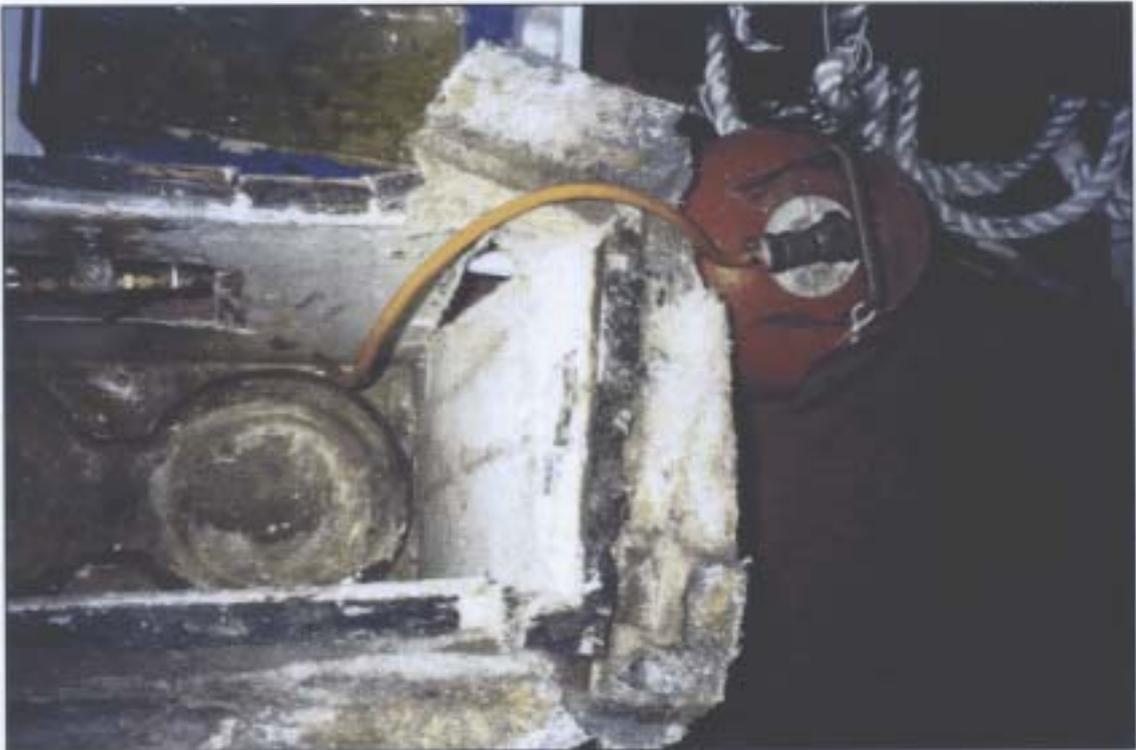
Figure 12

Ready-use gas bottle locker moulding following accident

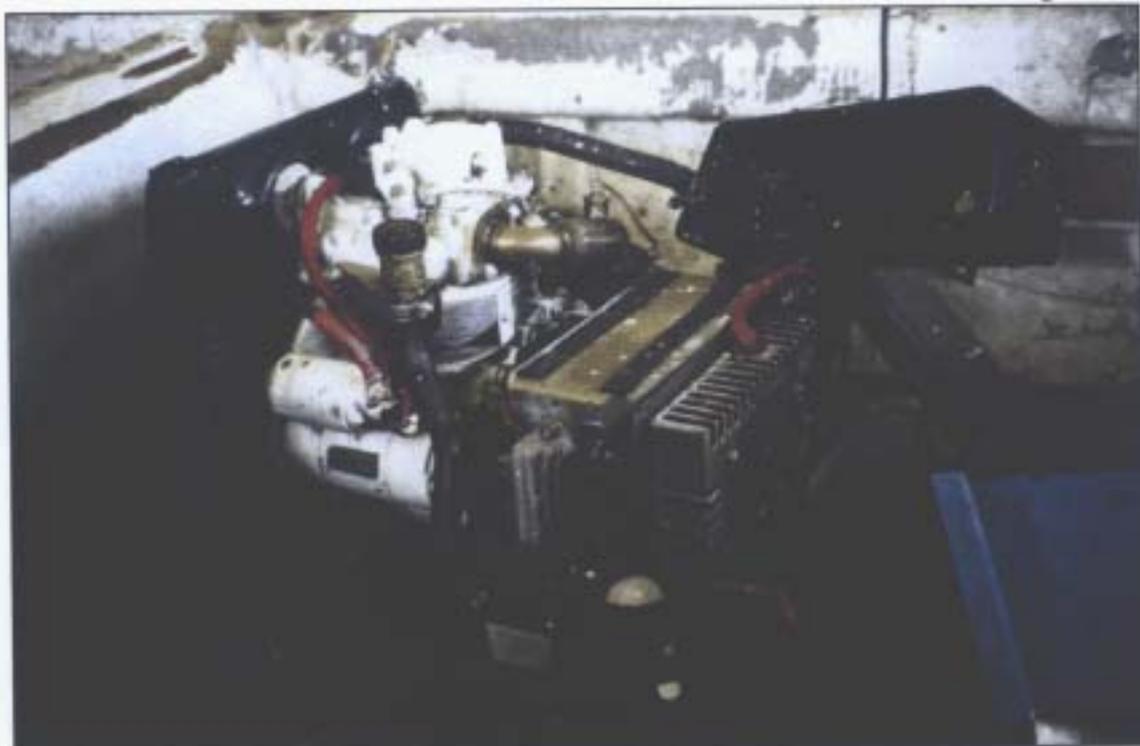
Figure 13

No part of the generator's upper acoustic enclosure was in place. A large but badly damaged portion was adjacent to the generator. Other smaller parts were found on the quayside at Poole and on the deck of *Royalist* immediately following the accident.

The sea water cooled air cooler of the generator had come away from its mountings, but remained attached to the water hoses. A small end cover on the starter motor was displaced, as was a single electrical spade connector on the starter motor's solenoid. Various other small electrical components attached to the aft end of the alternator housing were also displaced and damaged.

The generator
