Report of the Investigation
into the injury of a
crew member on board
mfv Purbeck II (SU 461)
on 7 June 1999

SYNOPSIS

A crew member from the 11.03m potting vessel *Purbeck II* was dragged overboard when a bight of back rope caught round his neck.

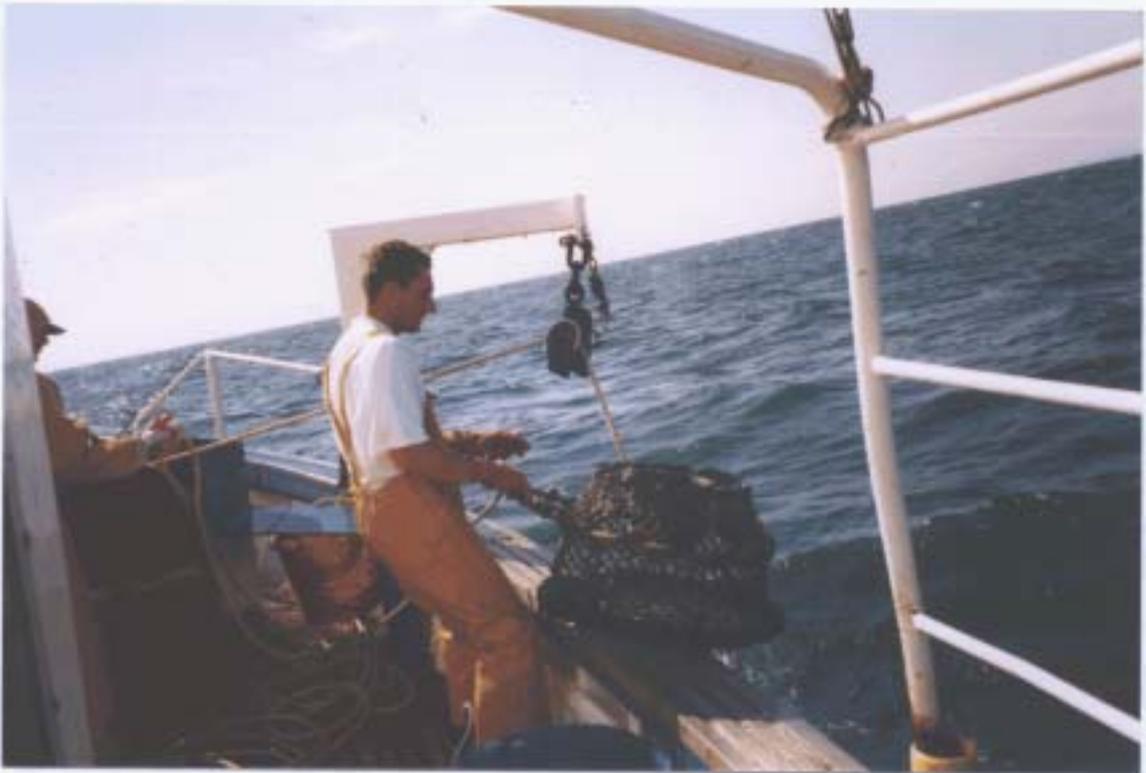
Figure 3

The back rope is then taken around the hauler and lifting of the pots begins (**see Figure 3**). As the rope is heaved on board, it piles up next to the hauler.

Hauling - *Purbeck II*

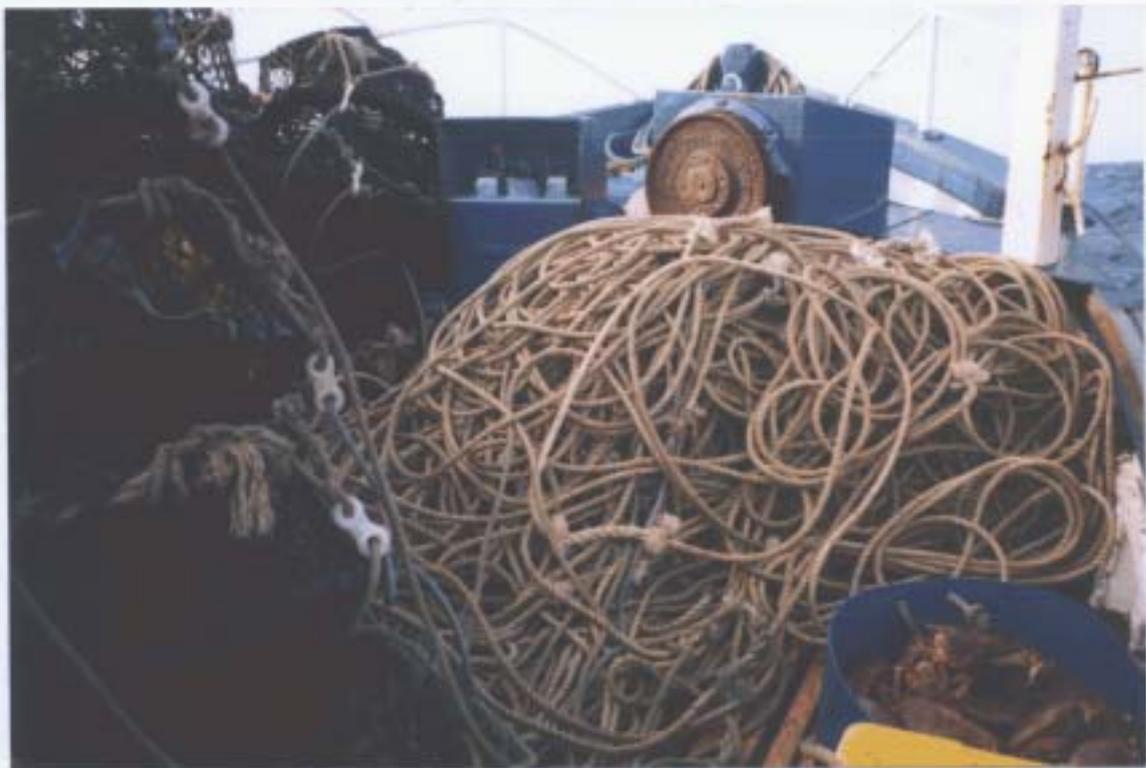
Figure 4

By the time all the pots in the fleet have been hauled there is very little free space remaining on deck. The back rope has now accumulated in a large pile next to the hauler (see **Figure 4**). Preparations are then made for the shooting operation.

Back rope pile on deck, after hauling - *Purbeck II*

During the shooting operation, the back rope, which was piled on deck after hauling, was allowed to run free across the deck often whipping and snaking as the pots were shot. No safety measure was in place to prevent the crew coming into contact with the back rope, making them, and in particular the crewman positioned at the shooting pole, vulnerable to being caught in any snags or bights which might form.

Separating the back rope from the crew will reduce the danger of crew becoming snagged in the rope when shooting, and would probably have prevented this accident.

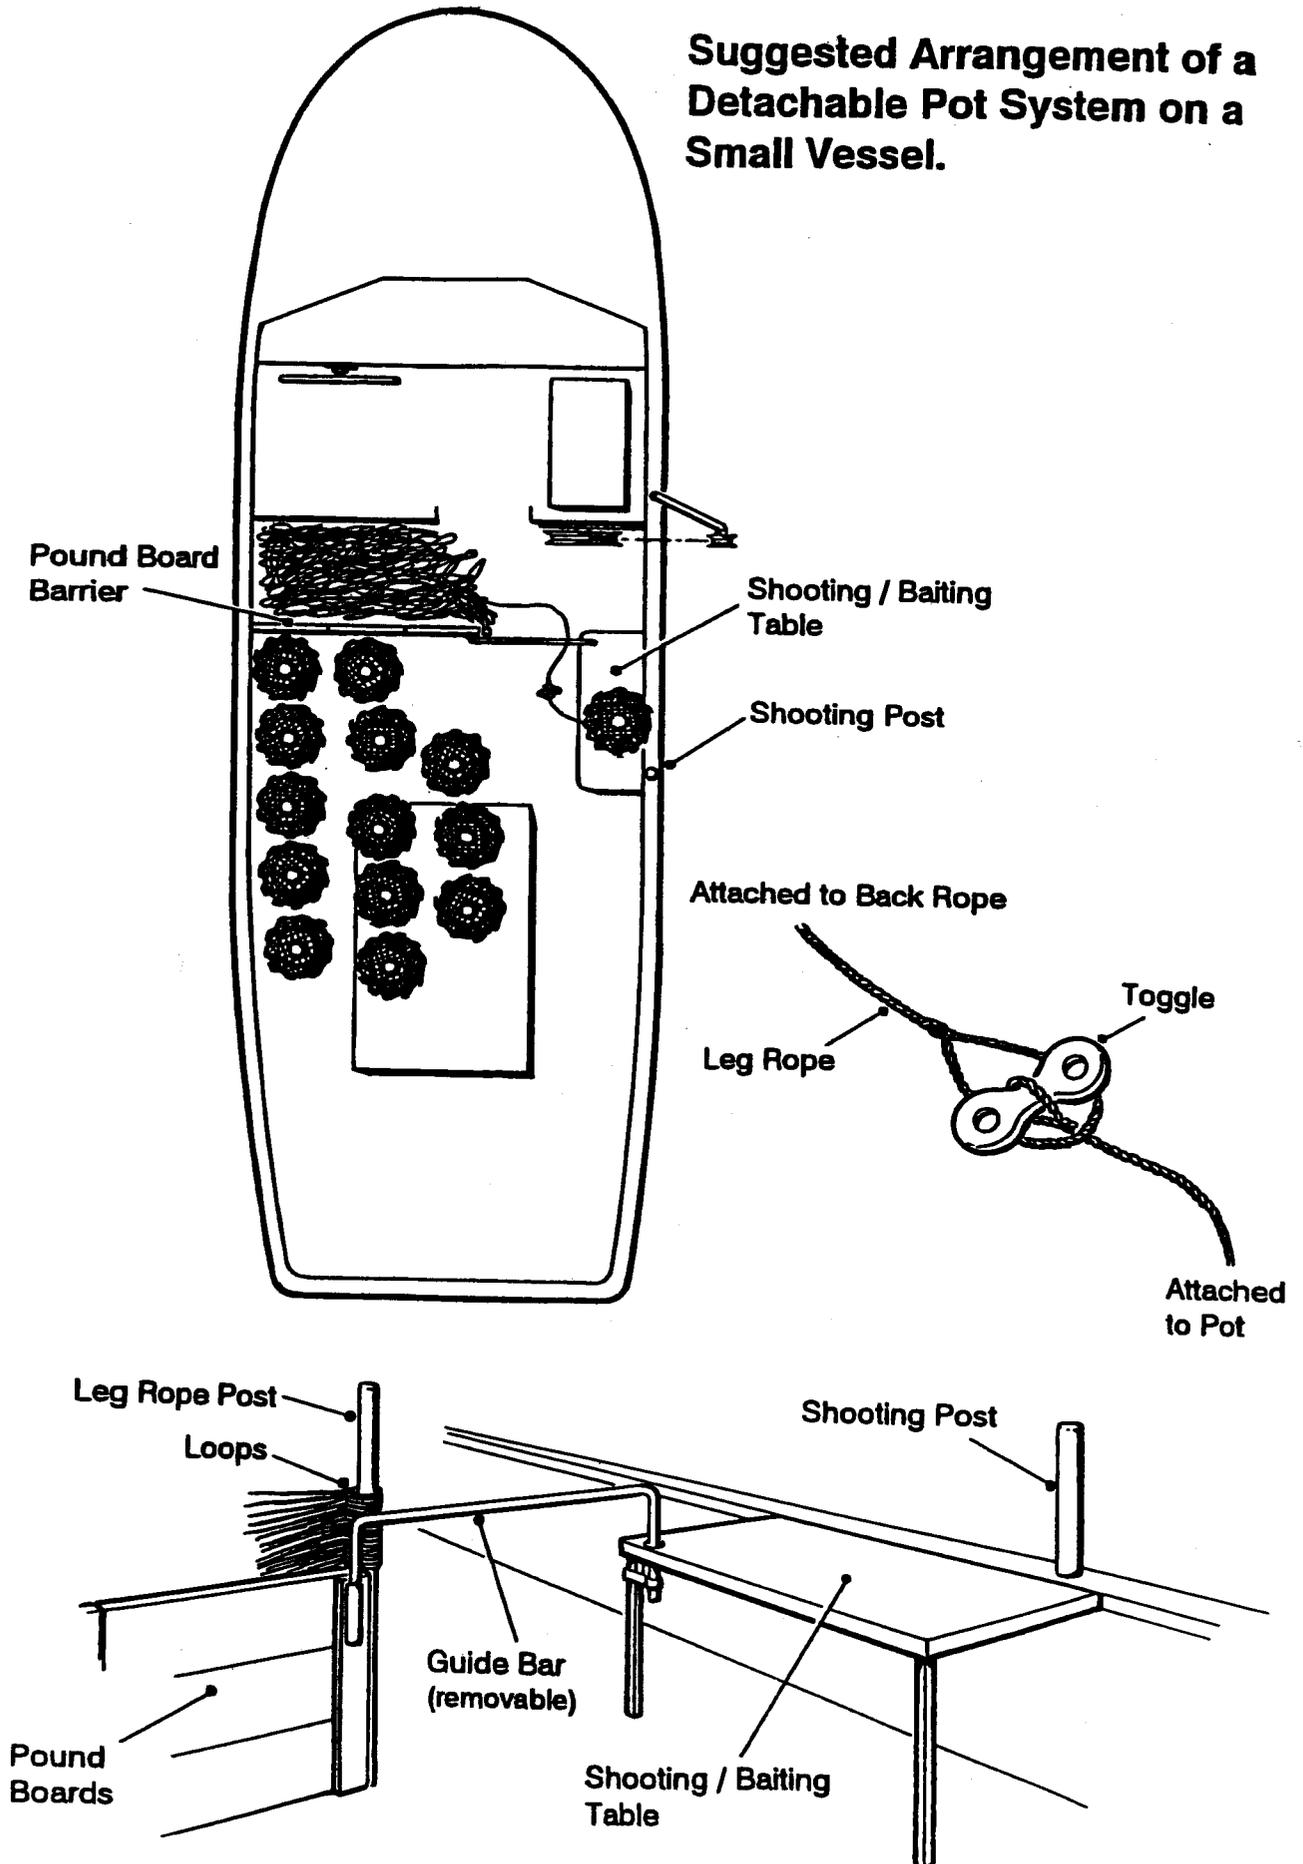
Figure 5

The key to this system is a toggle clip which connects into a loop to join together the two-piece leg rope at a point quite close to the pot. During hauling each pot is detached from the back rope, which allows the pot to be stored independently of the rope.

The loops on the leg rope are placed, in order, over a vertical pole. When the pots are shot, the toggle is connected back to the loop and the pot is allowed to go over the side of the vessel.

Apart from the ability to stack the pots out of sequence, the system gives more compact storage of the back rope, which allows a division to be constructed, separating the rope from the deck area where the crew handle the pots (**see Figure 5**).

Suggested Arrangement of a Detachable Pot System on a Small Vessel.

Adopt an alternative deck system, such as a detachable pot - toggle system which would prevent the crew from coming into contact with the back rope during shooting operations.

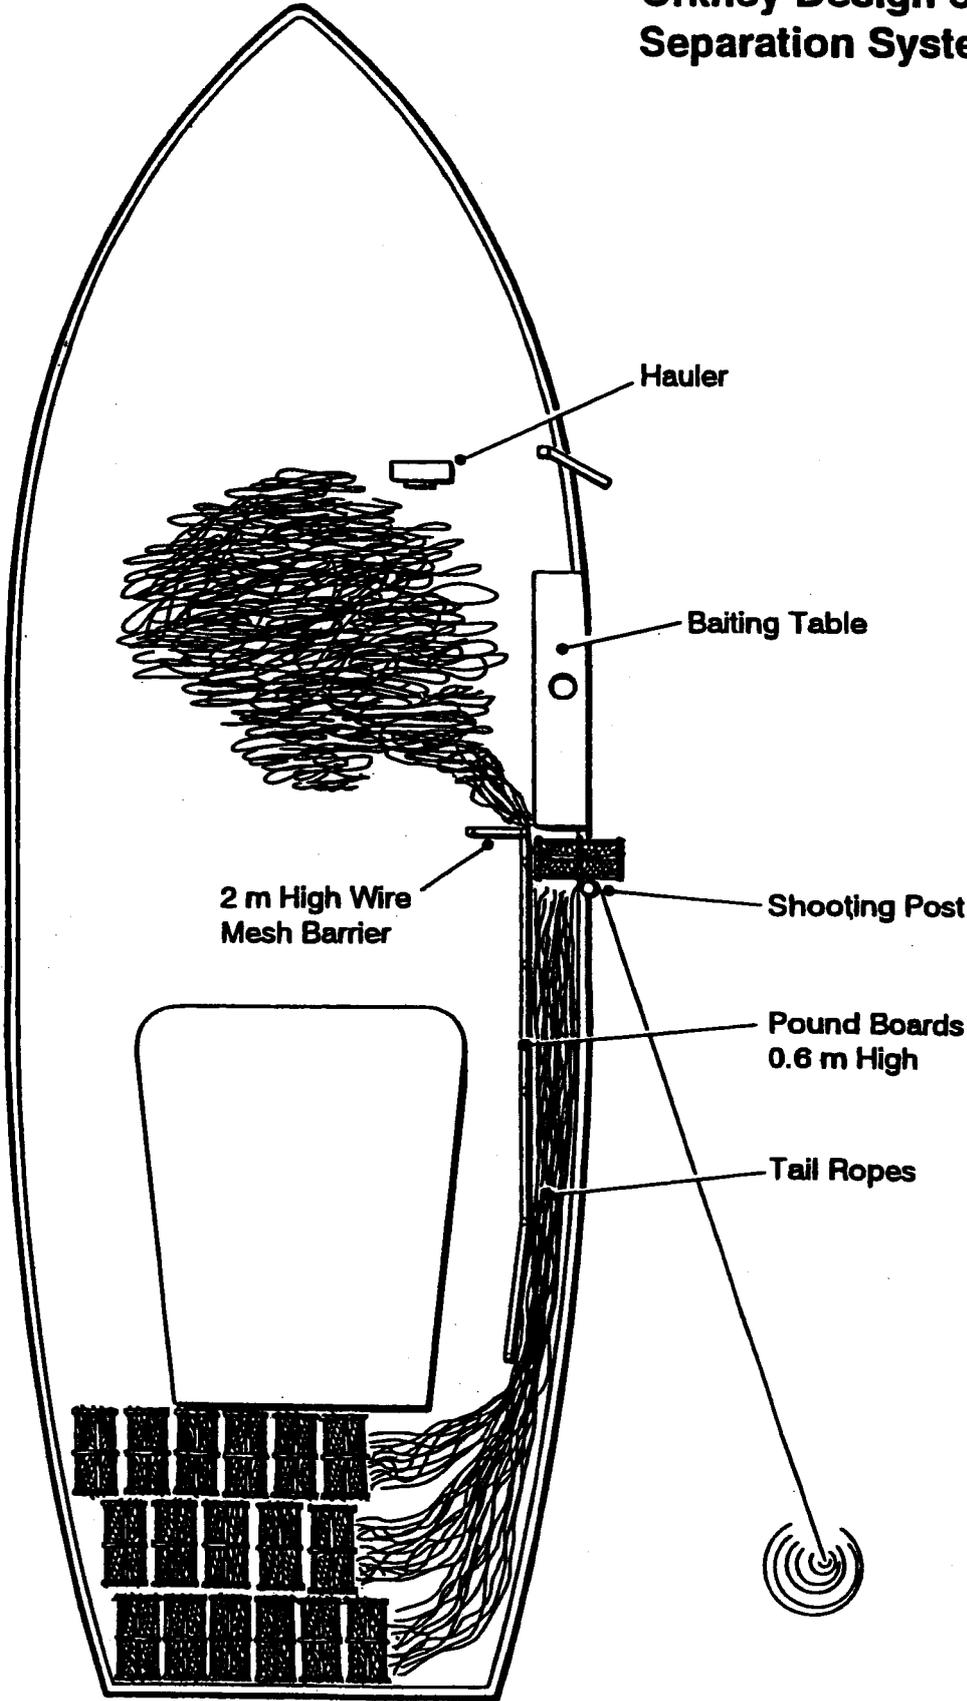
A method of separating the back rope and leg ropes from the crew is to use pound boards or divisions. The design of the barrier will depend on the layout of the vessel and the stacking of the pots.

Figure 6 shows a separation system devised by an Orkney skipper who introduced it after one of his crewmen, who had become snagged in the back rope while shooting, was killed.

Orkney Design of a Separation System
