Report on the investigation of the fatal accident to
a motorman on board the ro-ro cargo ship
Sea Centurion
at the Portsmouth Naval Base
on 18 May 1999

Marine Accident Investigation Branch
First Floor
Carlton House
Carlton Place
Southampton
SO15 2DZ

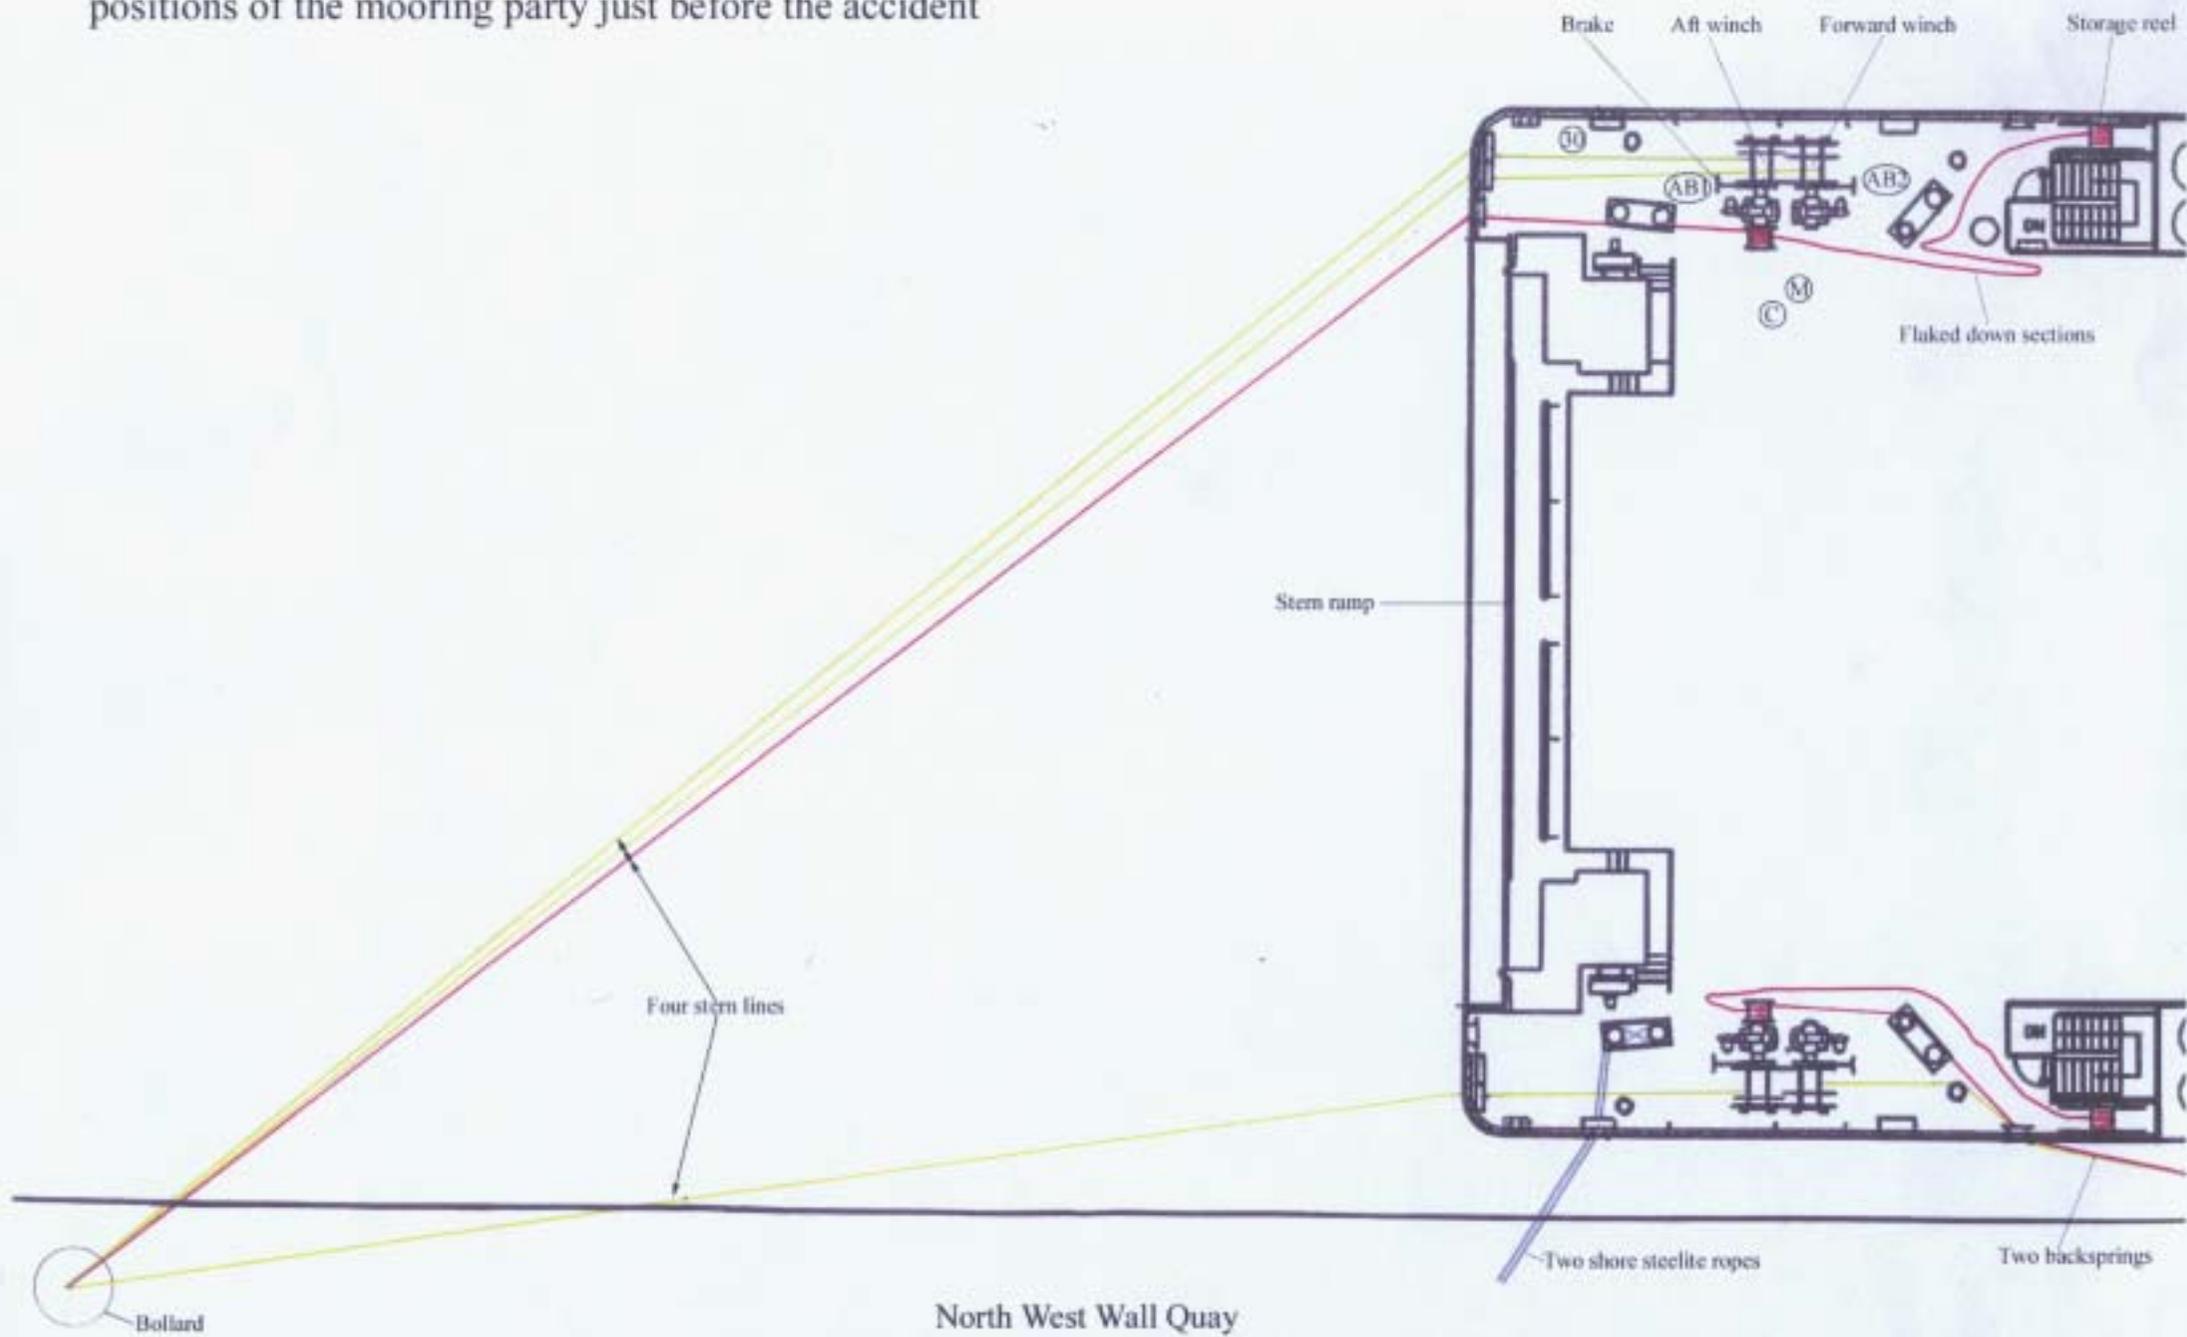
Mooring and afterdeck arrangement for *Sea Centurion* with positions of the mooring party just before the accident

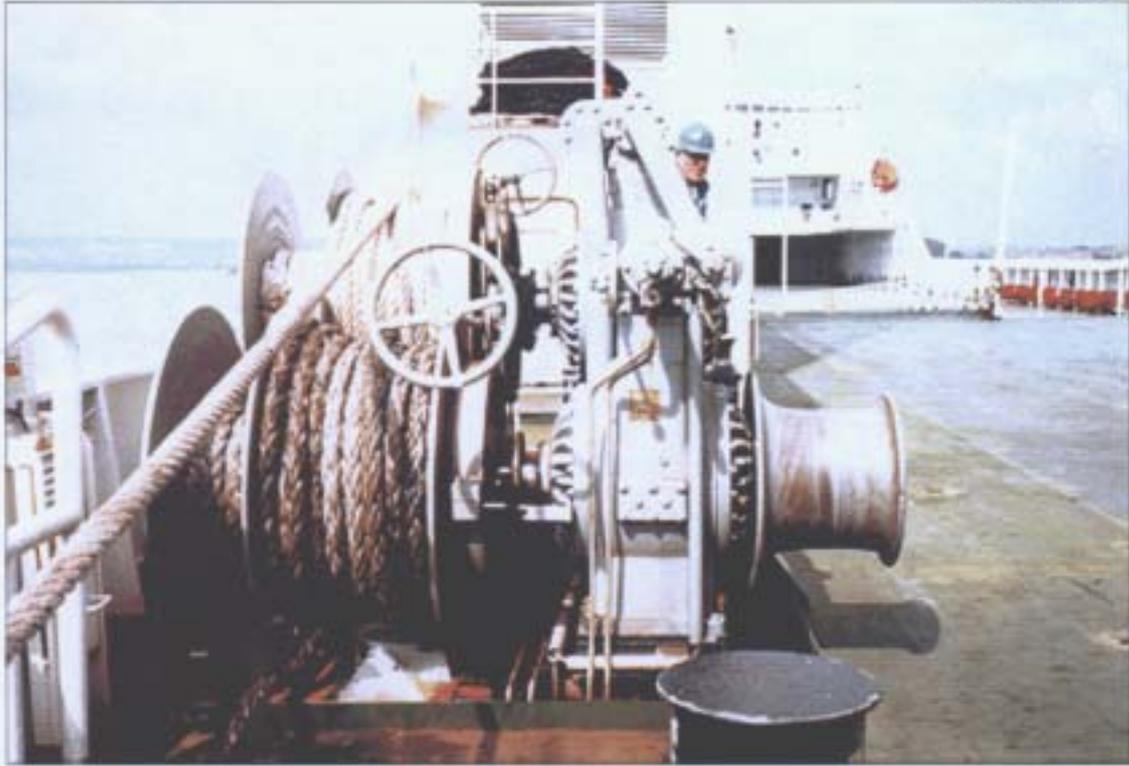
Photograph 1

Port side self-tensioning mooring winches

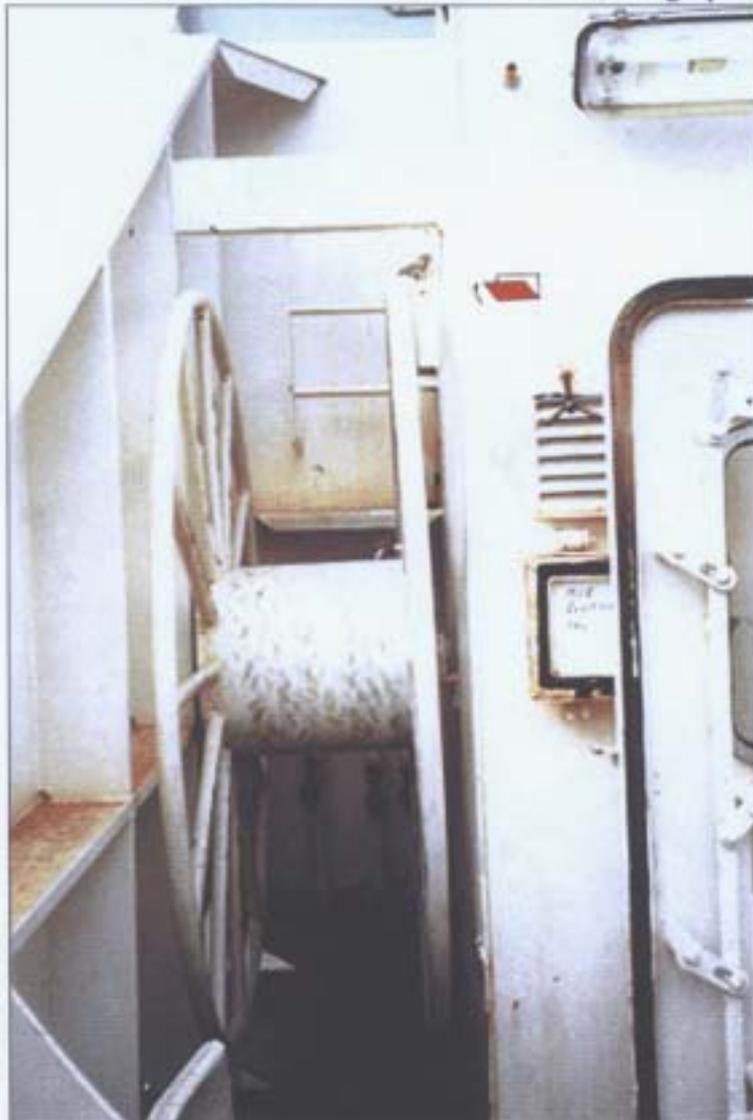
Photograph 2

Port side rope storage reel

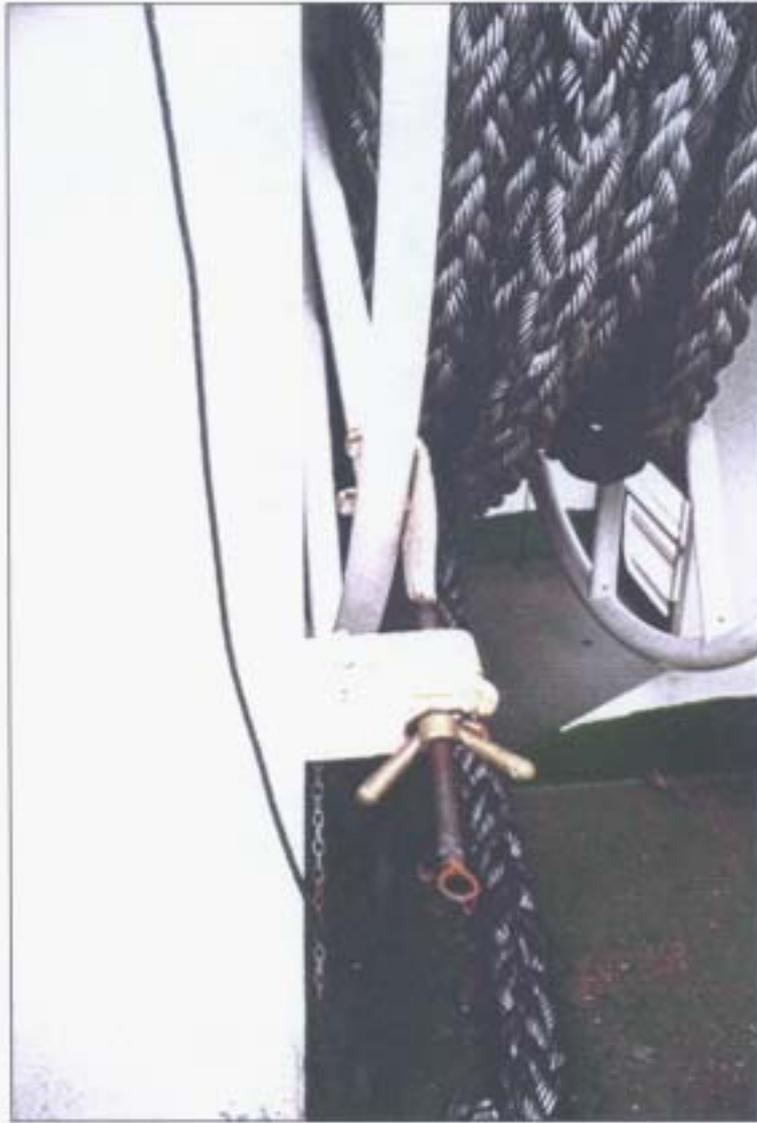
Photograph 3

Casualty	:	One fatality
Damage to ship	:	Broken rope reel restraining clamp
Pollution	:	None
Location of incident	:	North West Wall in the Portsmouth Naval Base
Date and time of accident	:	18 May 1999 at 1446 (UTC + 1)

Starboard side storage reel and retaining clamp

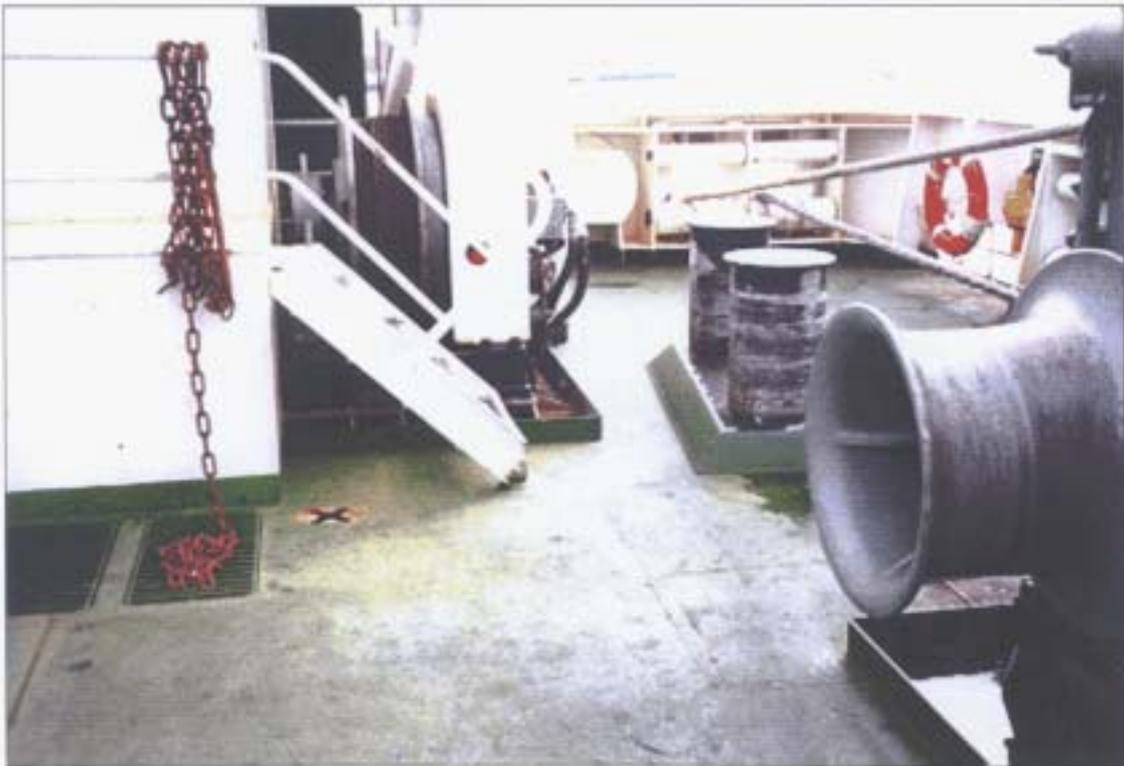
Photograph 4

Sea Centurion's port side, aft mooring station

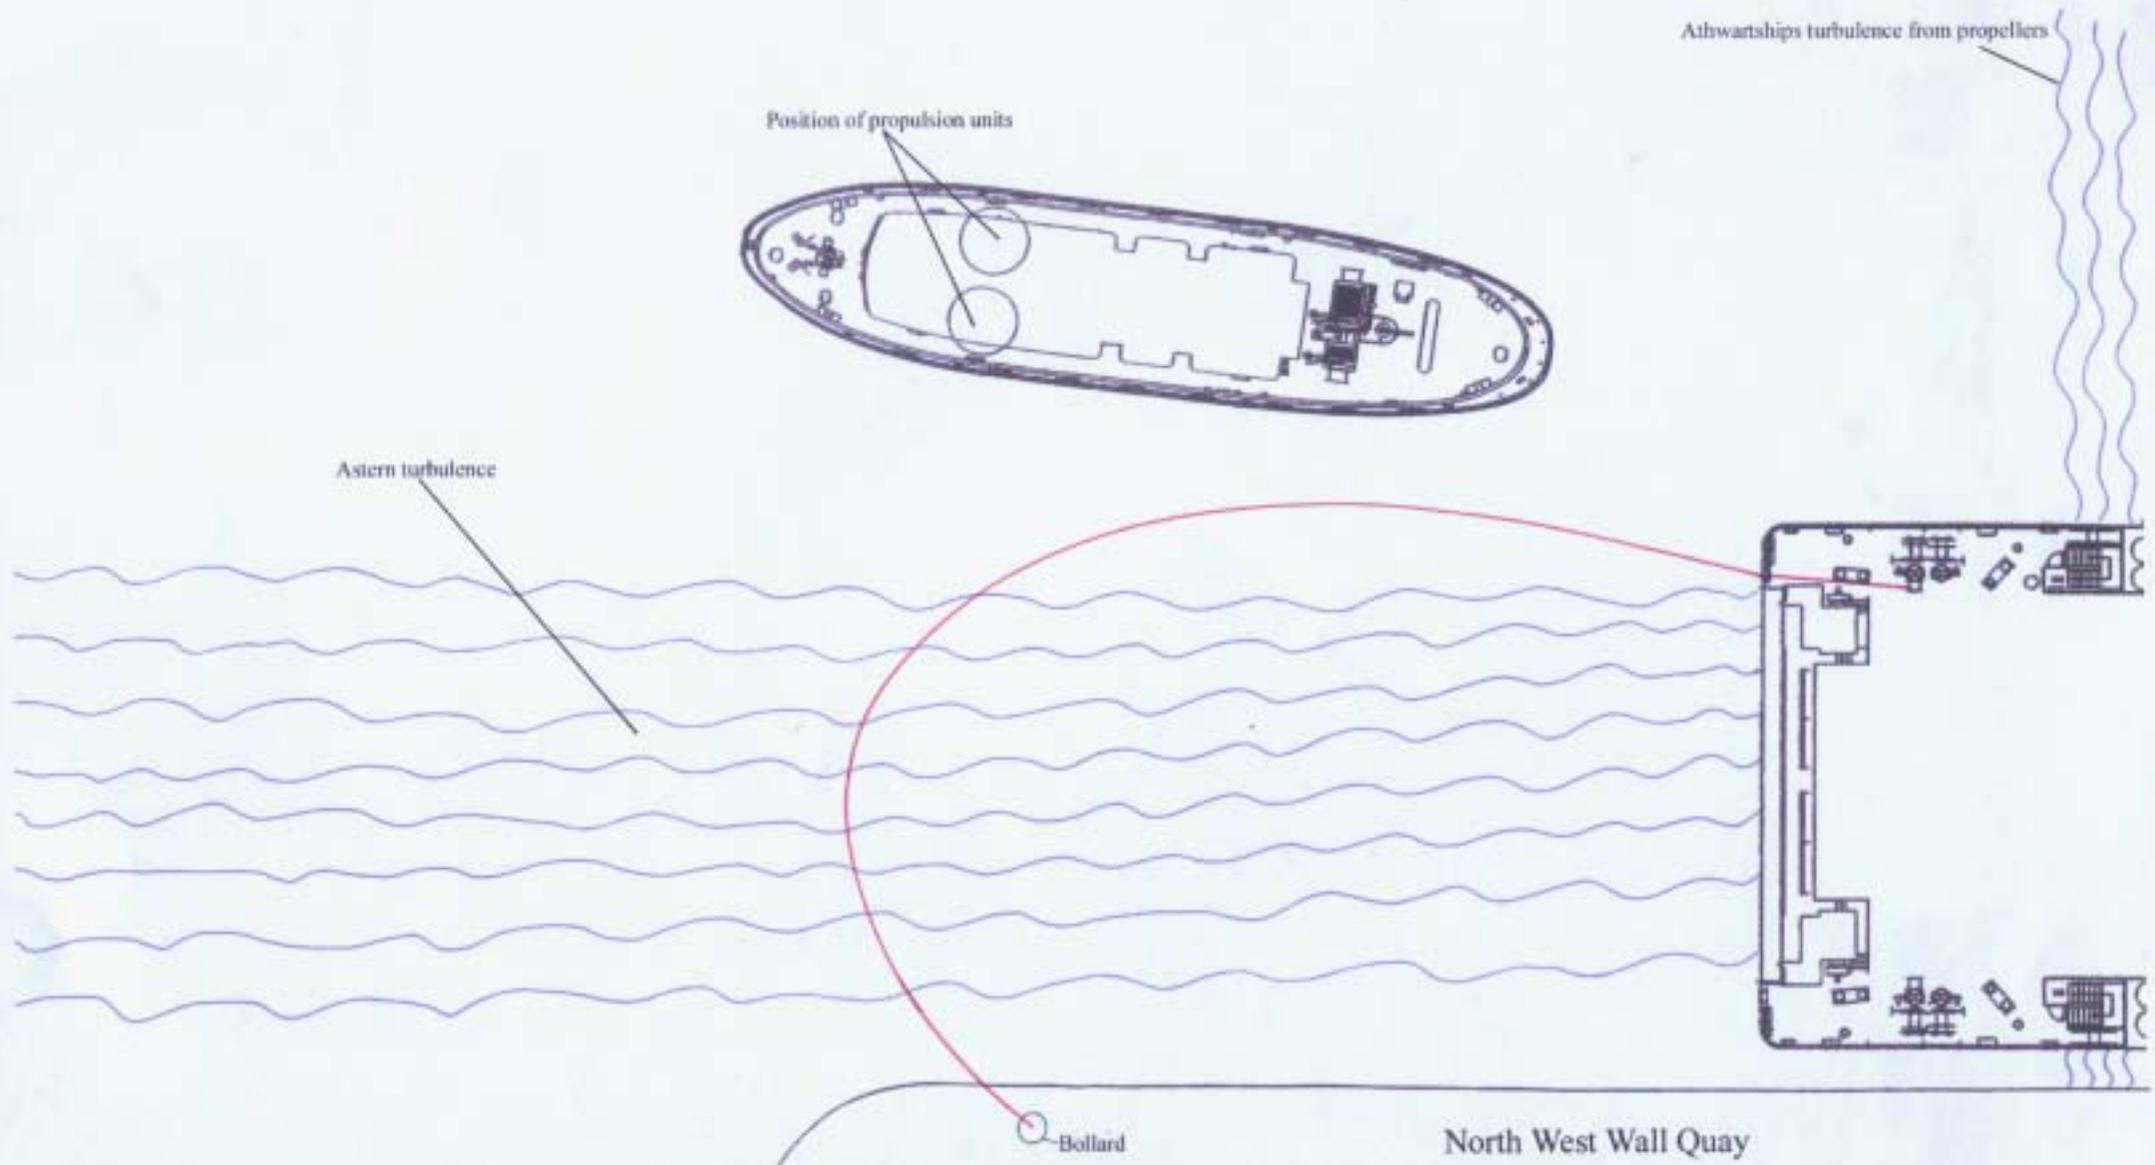
A reconstruction of the snagging of the mooring rope

1. Rope slacked off, but still fast ashore

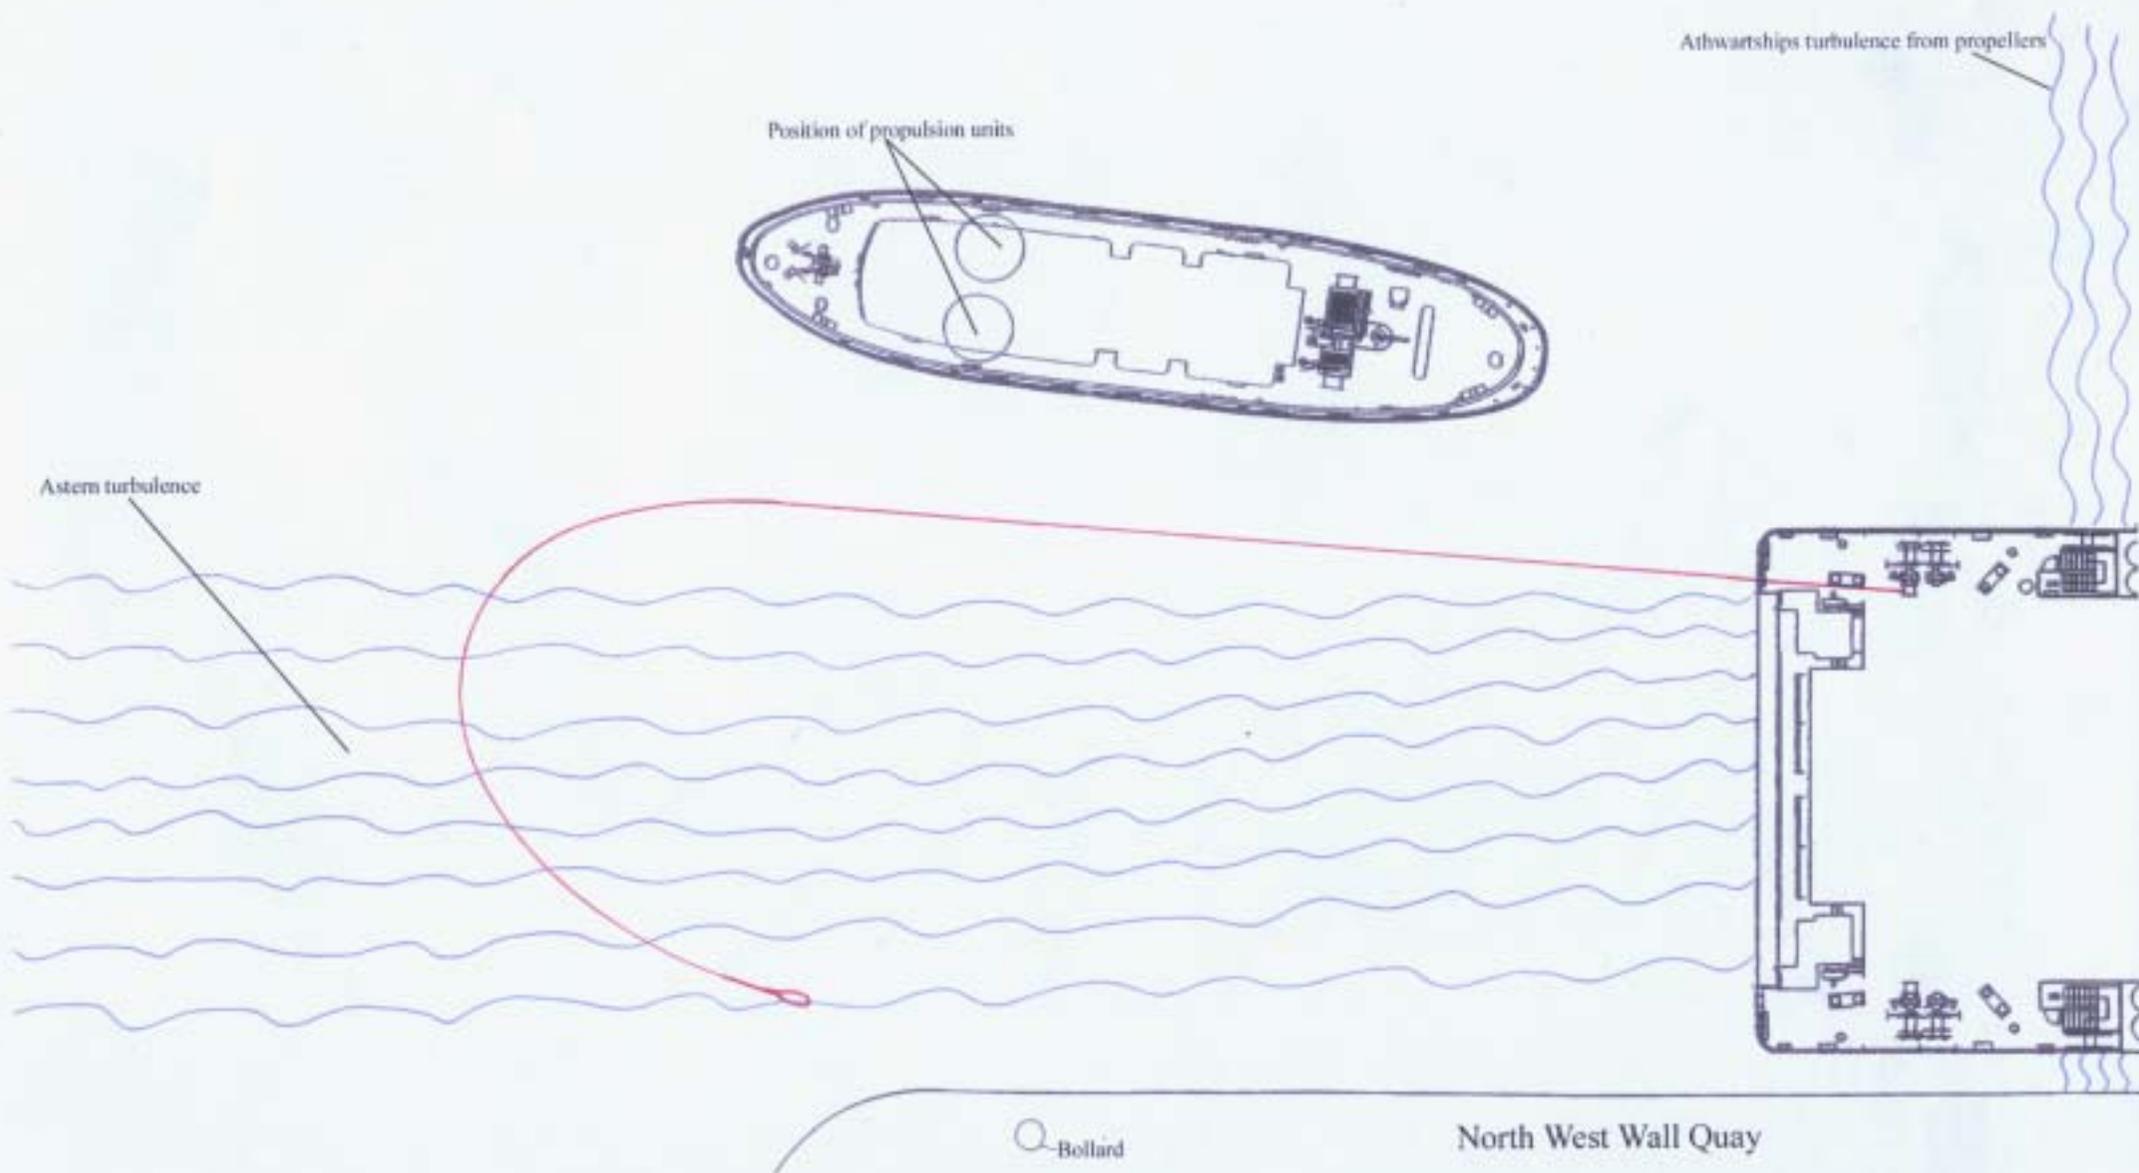
A reconstruction of the snagging of the mooring rope

2. The mooring rope clear of the bollard

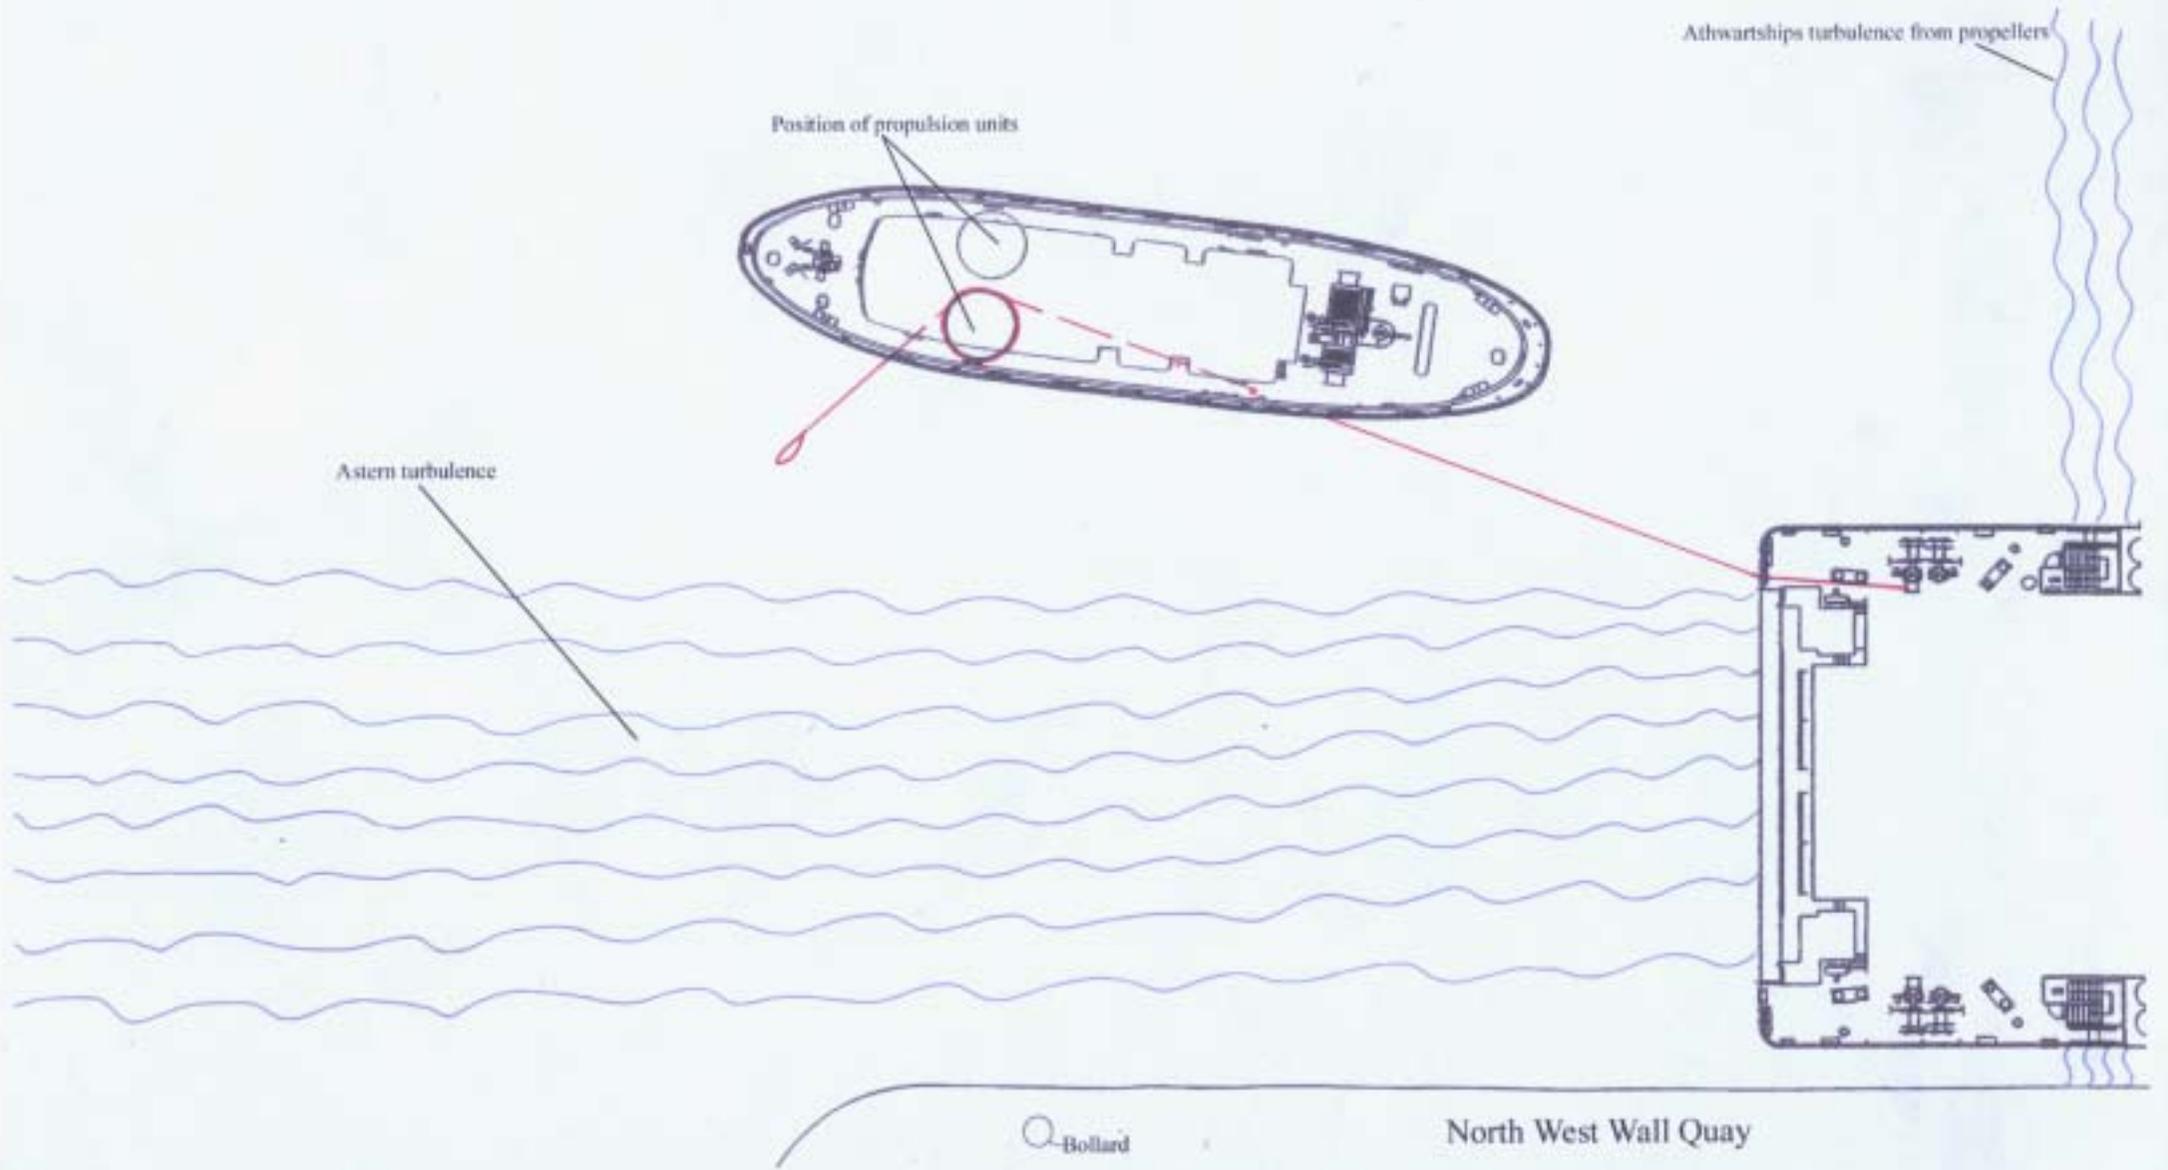
A reconstruction of the snagging of the mooring rope

3. The mooring rope caught in the port propulsion unit

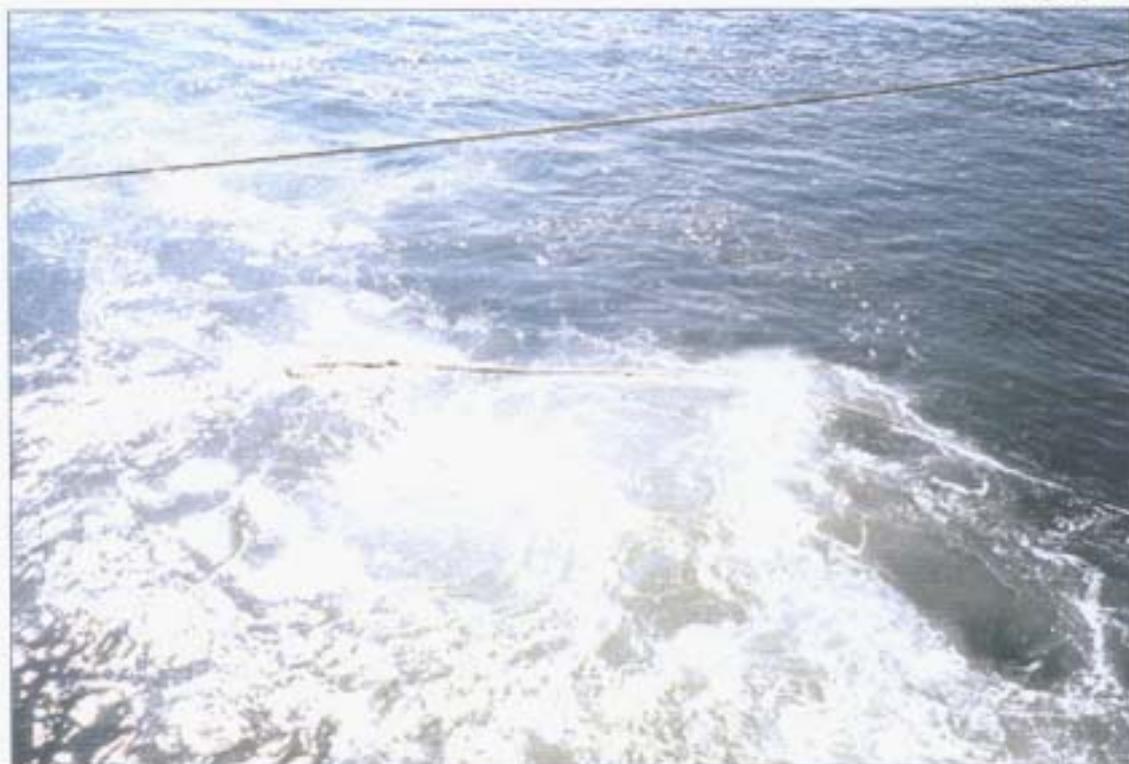
Photograph 6

zero. In this condition, the revolving propellers will produce turbulence athwartships or at right angles to the fore and aft line of the ship. However, on the day of the accident, there was significant turbulence directly astern of the ship. The likely explanation is that, despite the controls being set to zero, the propellers had a slight positive pitch and would have needed some small adjustment to stop the turbulence. It would have been a sensible precautionary measure for the third officer to have contacted the bridge and commented on the significant stern turbulence from the propellers.

Mooring rope pushed away by astern propeller turbulence

3. The failure of the motorman to comply with AB1's warning and instruction. [2.4]
4. The turbulence from *Sea Centurion's* propellers, which swept the mooring rope out towards *Powerful*. [2.3]

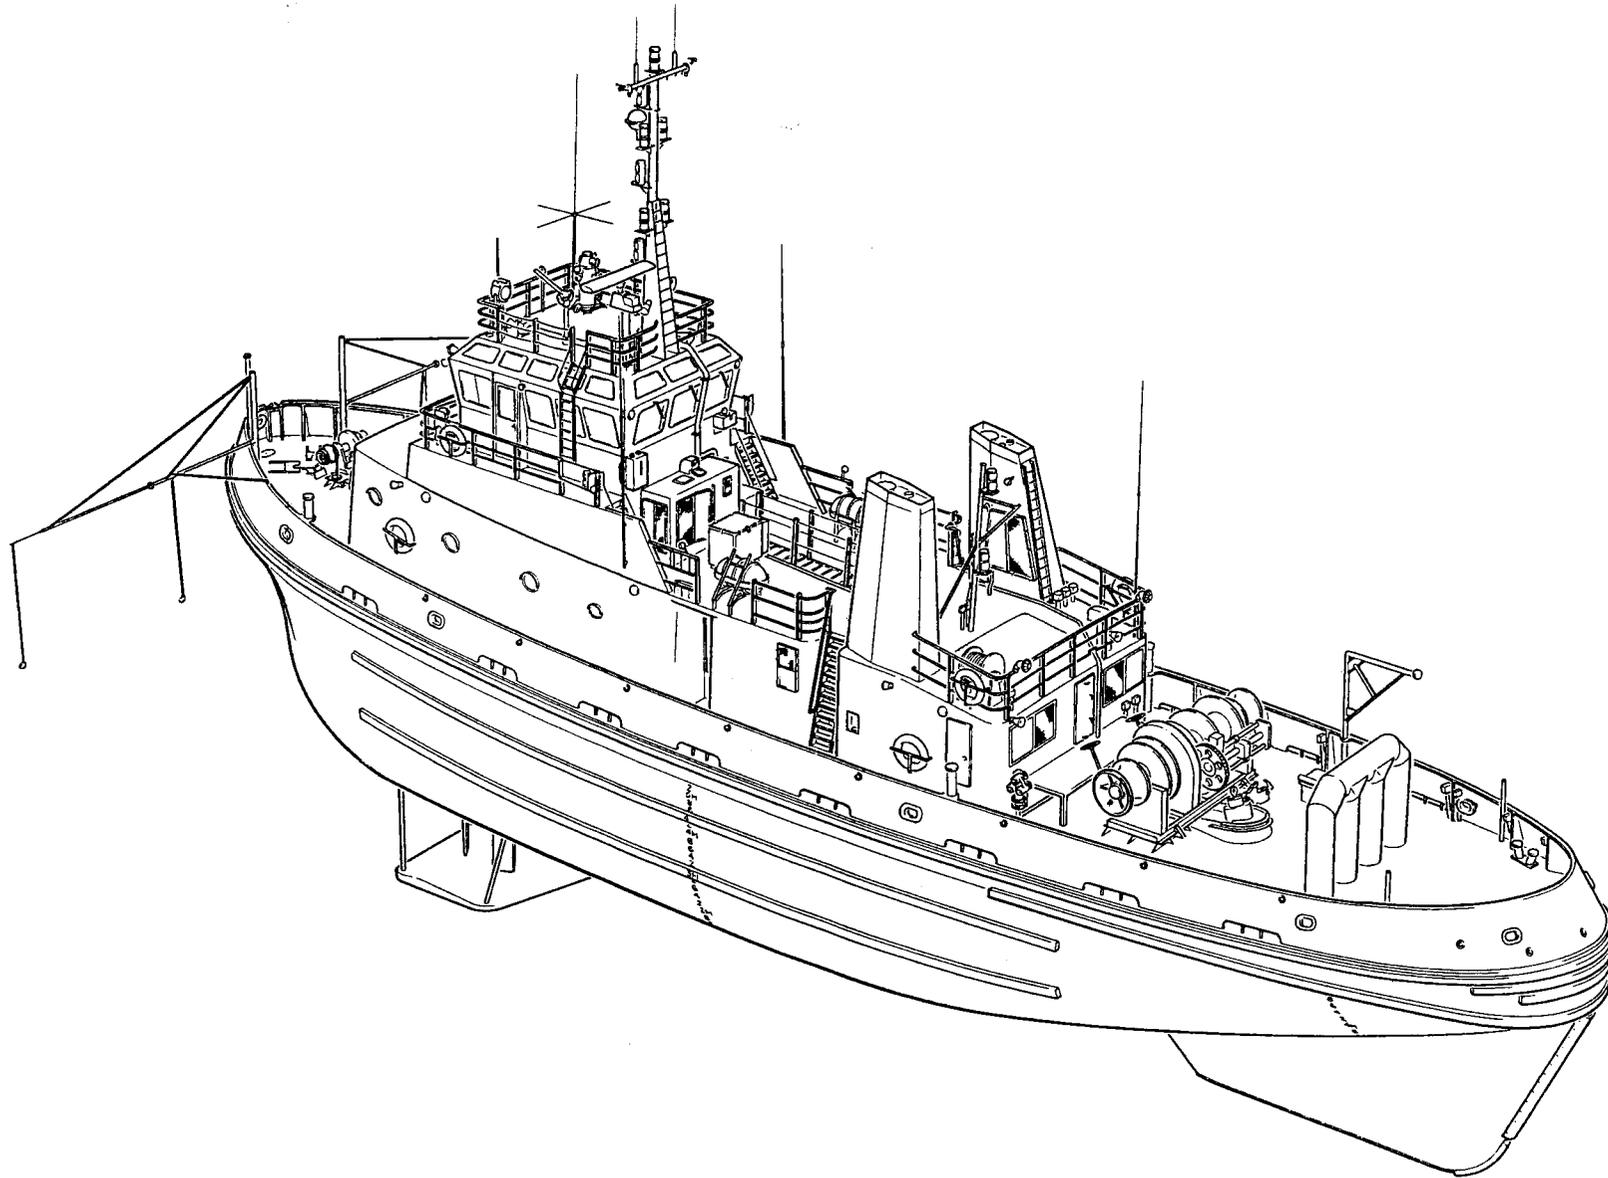
Tug *Powerful*, showing her port propulsion unit and the large aft skeg
