Report on the investigation of the collision

Beverley Ann II

Cypress Pass

on 9 March 1999

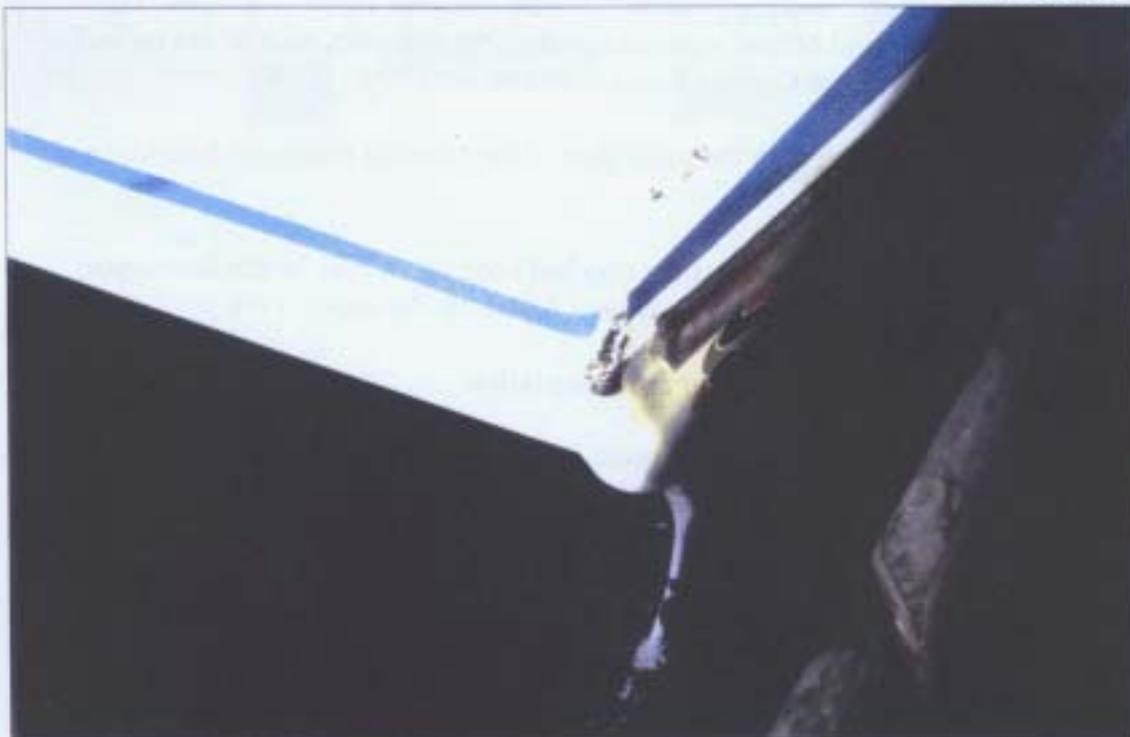
Photograph 1

There were scrape marks to the GRP and traces of black paint on the port bow corner. The mast, on top of the wheelhouse, was bent and a number of aerials had become detached from it (see photographs opposite).

A view of the port bow corner of *Beverley Ann II* showing the slight damage to the GRP and the paint traces

The port bow corner of the fishing vessel had been damaged slightly and there were black marks on it. A small piece of GRP was taken from this area. On 18 May, a representative of the Liberian authorities took paint samples from various locations on the port side of *Cypress Pass* (see **photograph overleaf**).

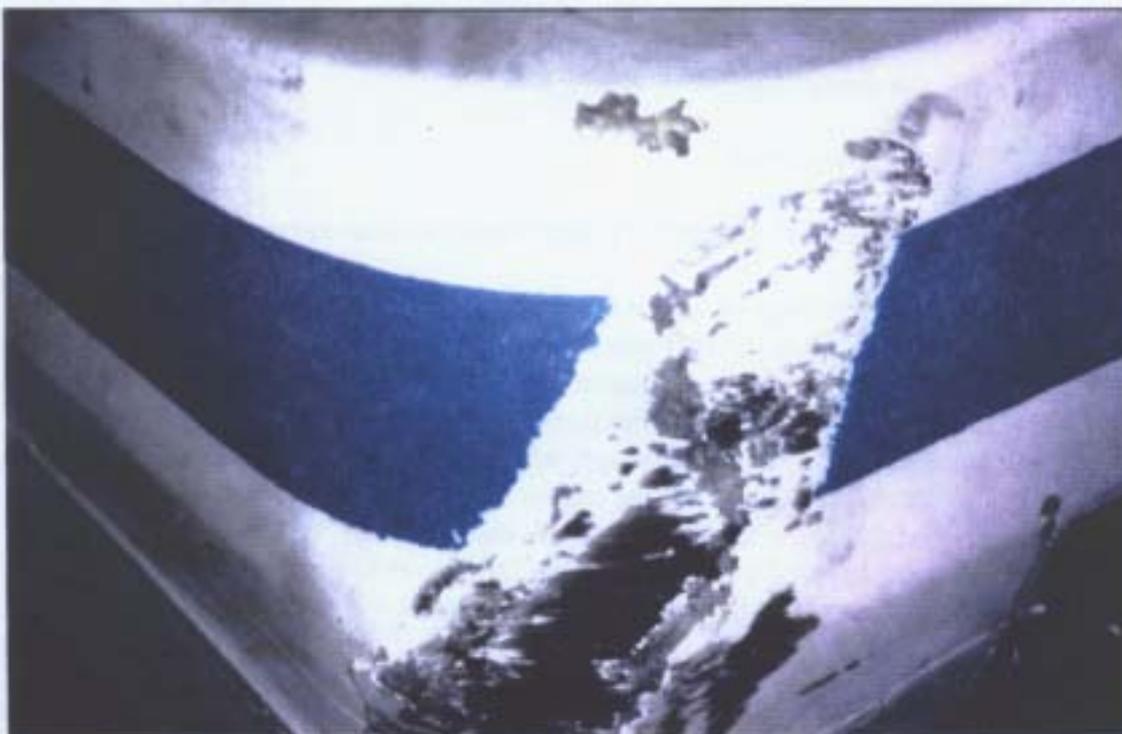
Photograph 2

A close view of the damage from which a sample of paint was taken for forensic analysis

The sample from the Beverley Ann II was a small piece of white fibreglass with a smear of black paint on it. Part of this smeared black paint was removed and examined microscopically. This showed that it consisted of a single layer with translucent particles dispersed throughout it together with a few orange particles. This paint was indistinguishable microscopically from the topcoat of the Cypress Pass.

In the forensic scientist's opinion, the findings of the analysis provided moderate support for the proposition that the two vessels were in collision with each other. The level of support was based on a scale of none, limited, moderate, strong, very strong, or conclusive. The moderate rating was given on the presumption that there were other ships in the immediate area with the same paint.

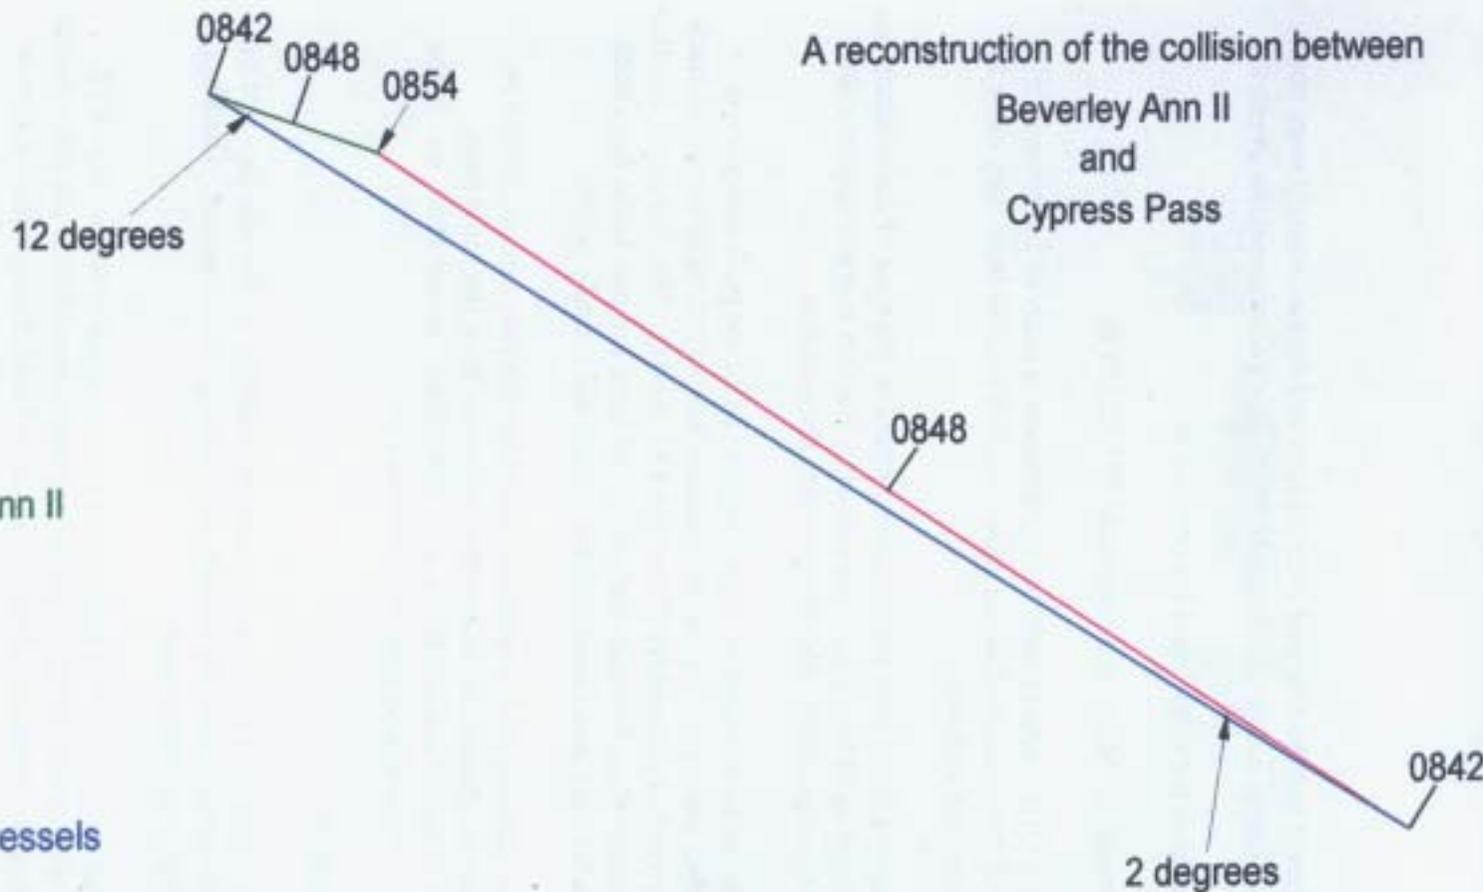
A reconstruction of the collision between
Beverley Ann II
and
Cypress Pass

Between *Cypress Pass*'s positions plotted at 0843 and 0900, she covered a distance over the ground of 4.45 miles, which gave a speed of 15.7 knots. As

Beverley Ann II was making just over 2 knots and the two vessels were nearly end-on, the closing speed was about 18 knots (see reconstruction overleaf).

Given the speed of the ship and the above position, the time of the collision has been calculated as 0854. This is supported by the fact that the skipper called Tyne Tees Coastguard at 0855, shortly after the collision.

A track line has been drawn through the mean of all the positions plotted between 0843 and 0930. The above position lies very close to this mean track line (see extract of Admiralty Chart No 152 above). This indicator, together with the results of the forensic analysis[^] of the paint samples taken from both vessels, leads to the conclusion that the vessels did actually collide.
