Investigation into the fire
on board the UK registered trawler
DE KAPER (GY 269)
off Hanstholm, Denmark
on 12 February 1999

FILE:MAIB 1/2/131

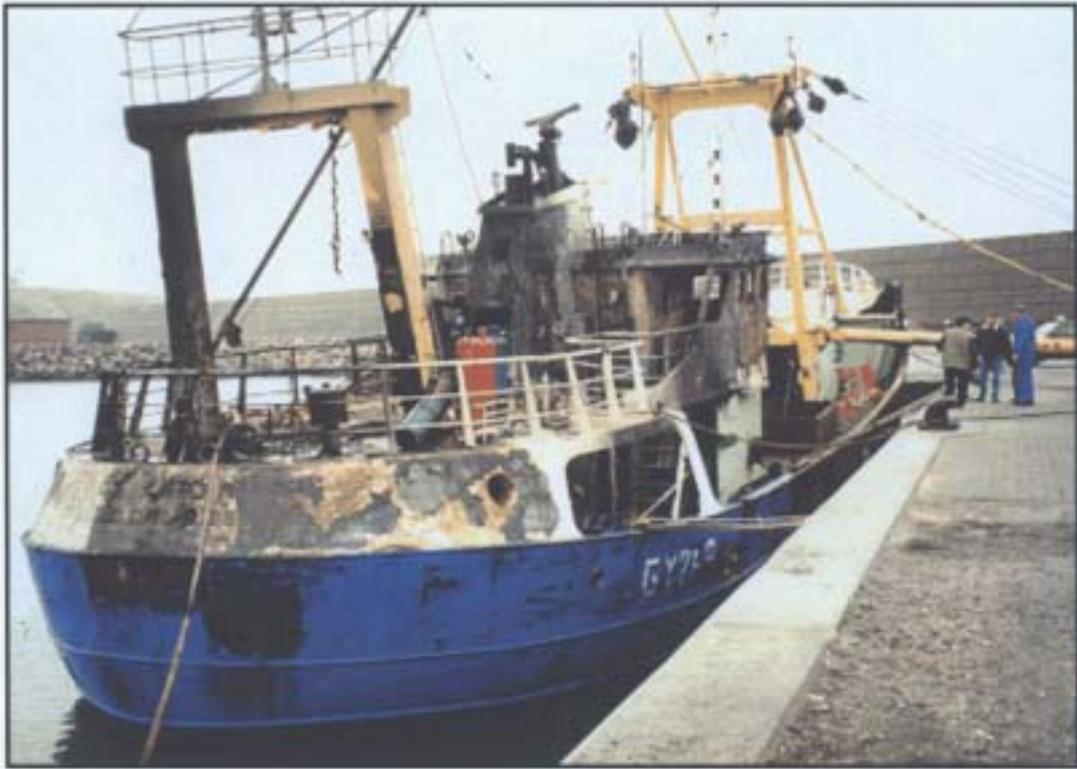
Photograph 1

De Kaper in Hanstholm

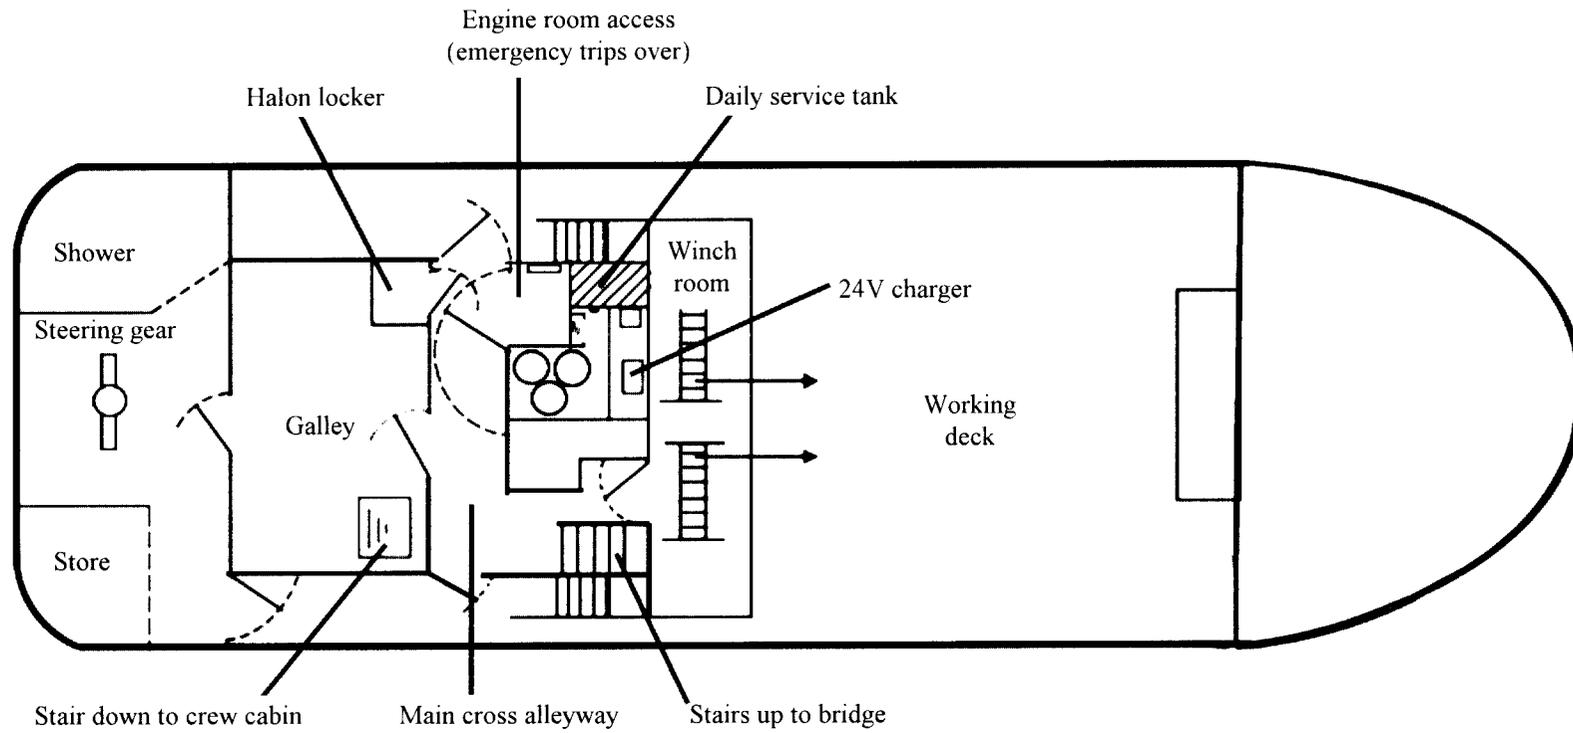
***De Kaper* main deck arrangement
(not to scale)**

Access to the engine room was by a single steel door situated within the accommodation cross alleyway on the main deck level. From the cross alleyway a passage led forward to the winch room and, by a stairway and wooden door, up to the bridge, which was located one deck higher. Another wooden door led from the cross alleyway directly aft into the galley which extended the whole width of the housing. The crew cabin was beneath the galley. The area aft of the galley on the main deck contained a shower room, the steering gear and a storeroom. The main cross alleyway could be entered directly from outside by steel doors on the port and starboard sides.

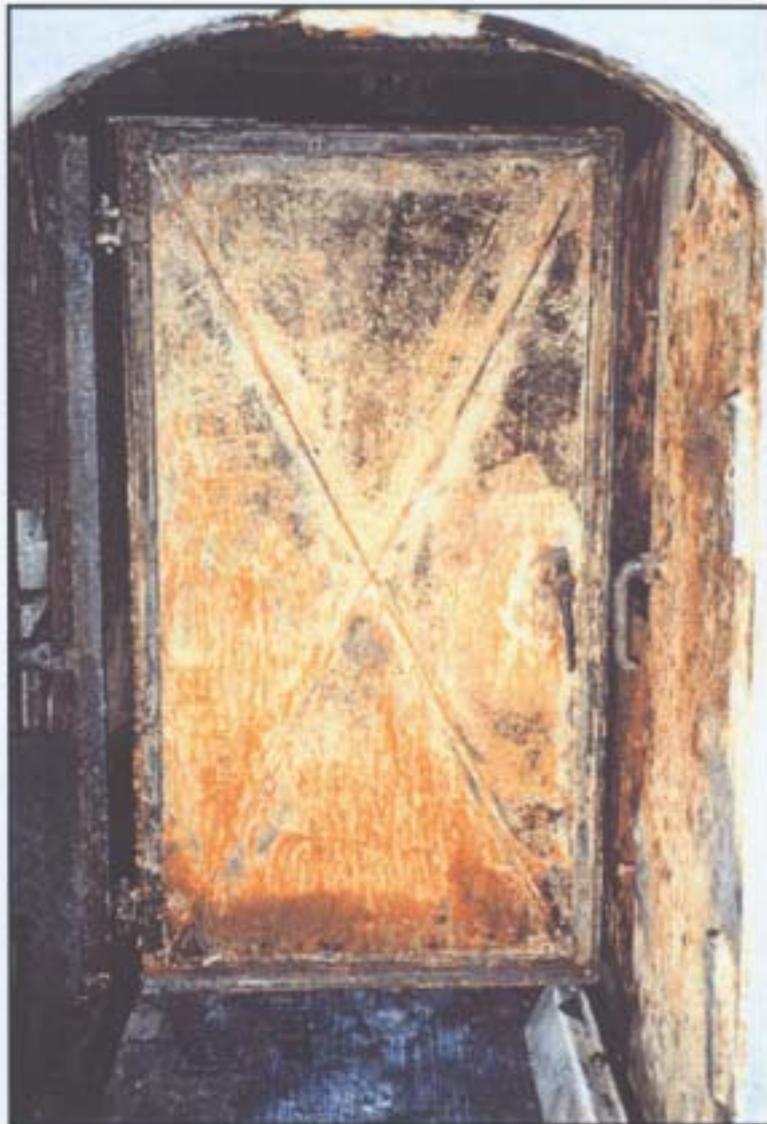
Photograph 2

The steel engine room door hinged into the port side of the cross alleyway. The alleyway was only just wide enough for this heavy door to swing through 90° so that it could be hooked back against the forward bulkhead (see **Photograph 2**). The lack of space made it awkward to handle the door, so it was usually left hooked open. Opposite the engine room entrance, on the after bulkhead of the cross alleyway there was a locker containing halon fire smothering equipment serving the engine room. Eight wire operated emergency valve trips connected to port and starboard bunker tanks, port and starboard tunnel tanks, the

The engine room door open at 90°

Poor design led to the practice of leaving the engine room door hooked open using a hook and eye arrangement. The door was heavy and awkward to manage, especially when the vessel was moving in a seaway. To hook the door back it needed to be swung through 180°, just scraping the opposite bulkhead as it swung through 90°. If the doors of the halon store or other storage locker on the opposite bulkhead were not properly closed or even hooked open the engine room door would foul them.

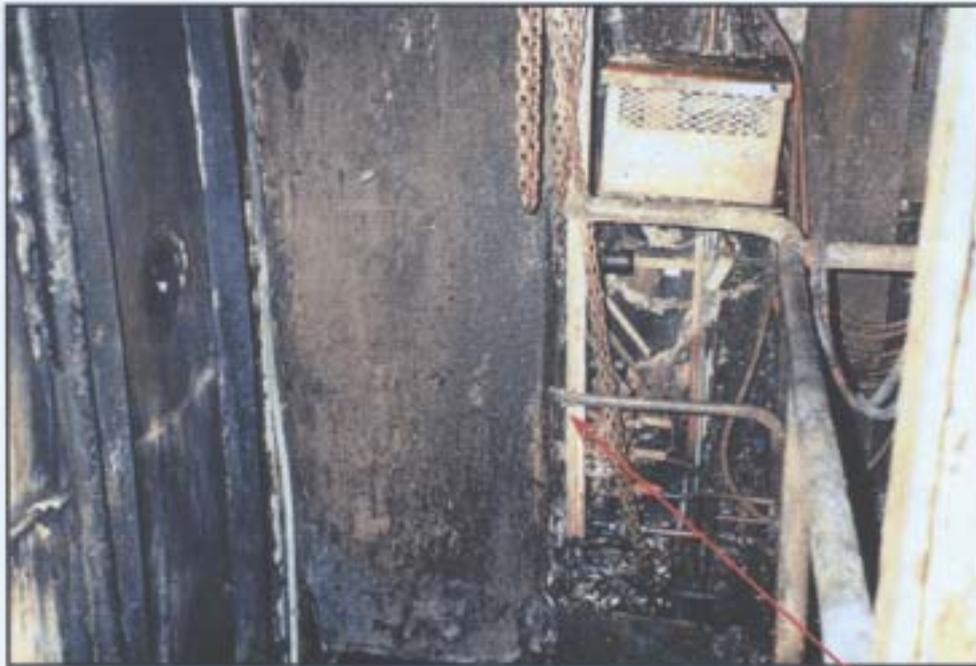
Photograph 3

Daily service Tank

Sight contents gauge

The fire was out of control within seconds. It was fed by an inexhaustible supply of fresh air through the open engine room access door and the adjacent open external door and through open ventilators on the bridge deck. The instantaneous ferocity of the fire indicated a ready source of fuel. This was probably fuel oil from the daily service tank situated in the immediate area of the seat of the fire.

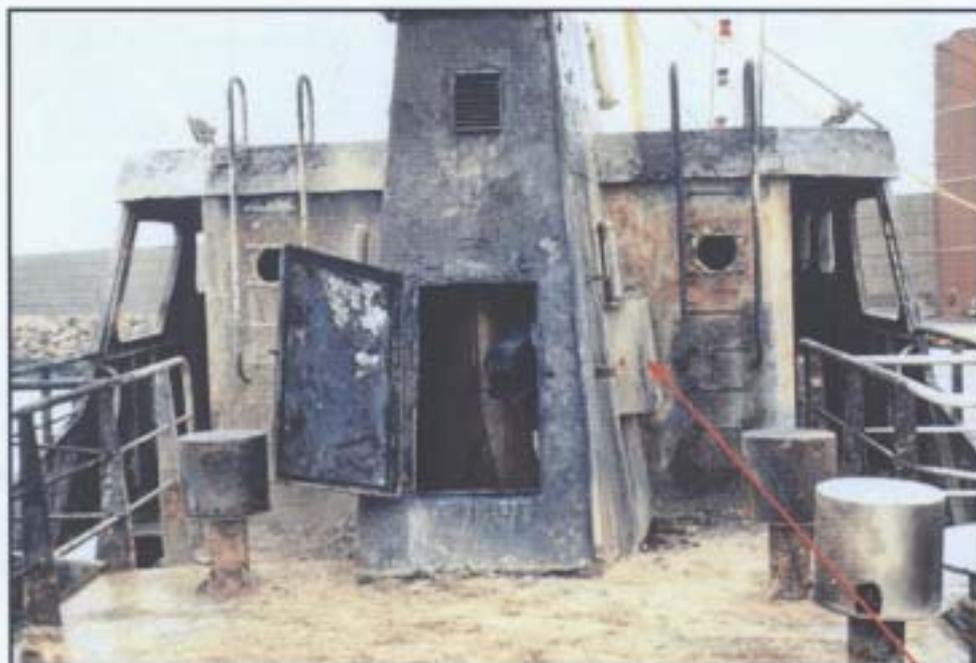
Photograph 4

The main engine room air intakes were sited on bridge deck level either side of the funnel casing (**see Photograph 4**). In the event of a fire they were designed to be closed using steel sliders which were stored in a nearby locker located in the funnel casing on bridge deck level. The locker door was open at the time of the fire.

Bridge Deck

Engine room ventilators

On the external bridge deck, one liferaft had been burnt in its rack, the deck was buckled but the after "A" frame appeared undamaged. The funnel casing and after bulkhead of the bridge were buckled. The storeroom in the funnel casing was burnt out (see **Photograph 4**).

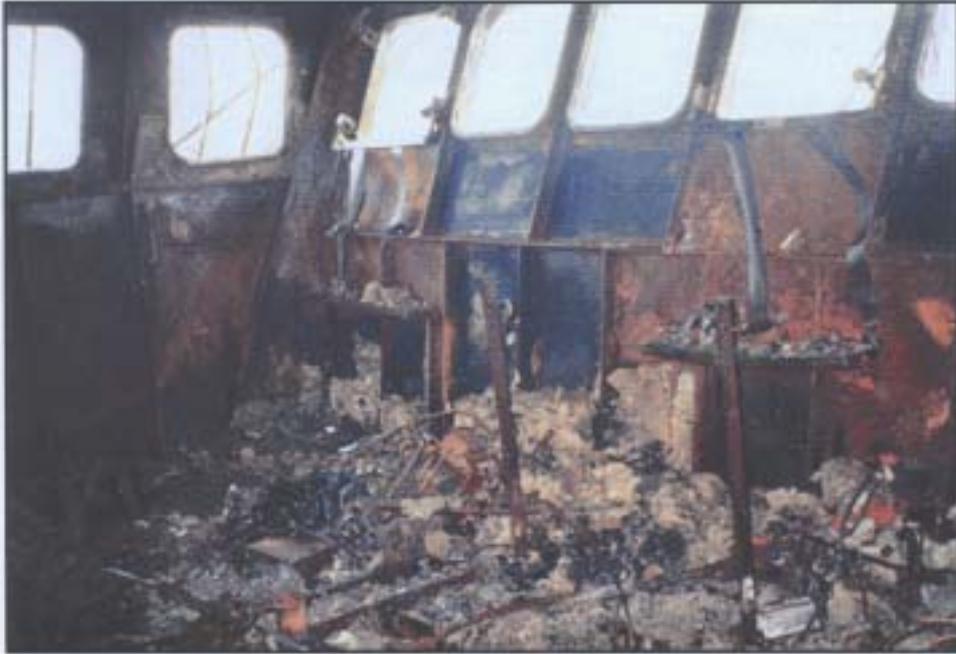
Photograph 5

The bridge, galley and cross alleyway had been completely gutted by fire (see **Photograph 5**). No fittings or linings remained intact in these spaces. The steelwork of the housing had been deformed by the heat. Although the crew cabin was damaged by fire and smoke, some lining and fittings remained. Personal effects belonging to the crew which had been left in this space, were retrieved after her arrival in Hanstholm.

The bridge

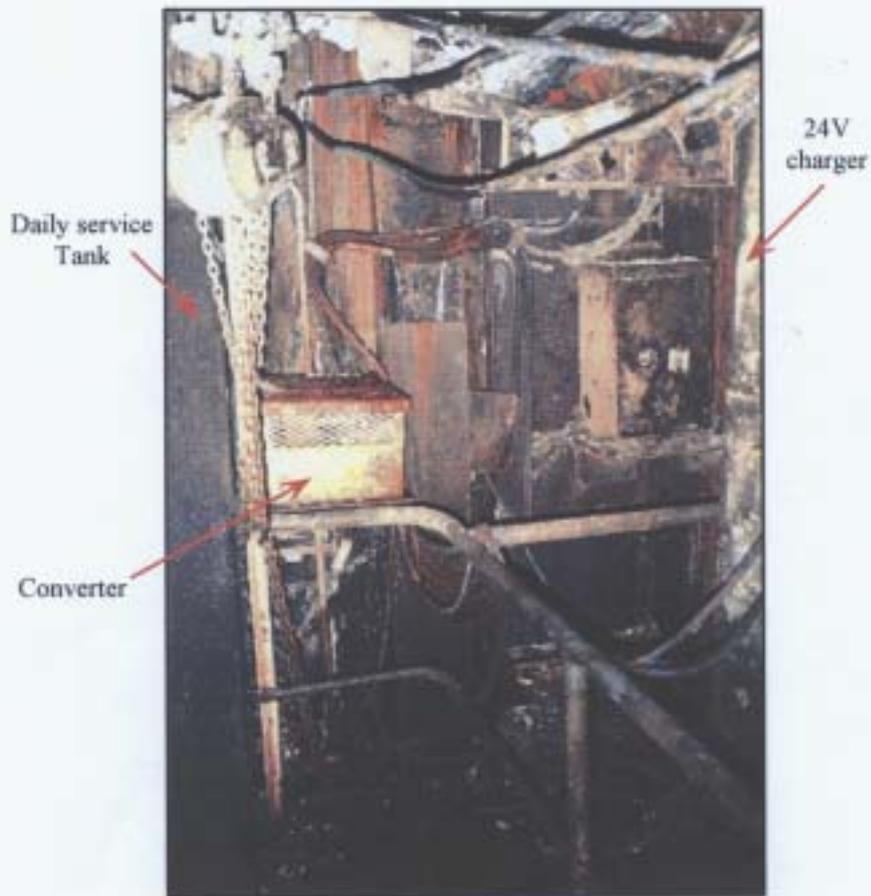
Photograph 6

The equipment and machinery located in the area of the engine room inside the access door at main deck level were severely damaged (see **Photograph 6**). Aluminium exhaust trunk sheathing and platform fittings had melted. The daily service tank was empty; its sight gauge was missing. Examination of the tank gauge automatic closing valve could not establish whether it had operated correctly (see **Photograph 7**). The copper plates within the 24V charger unit had melted and fused and all electrical wiring in the vicinity had been destroyed.

Engine room entrance

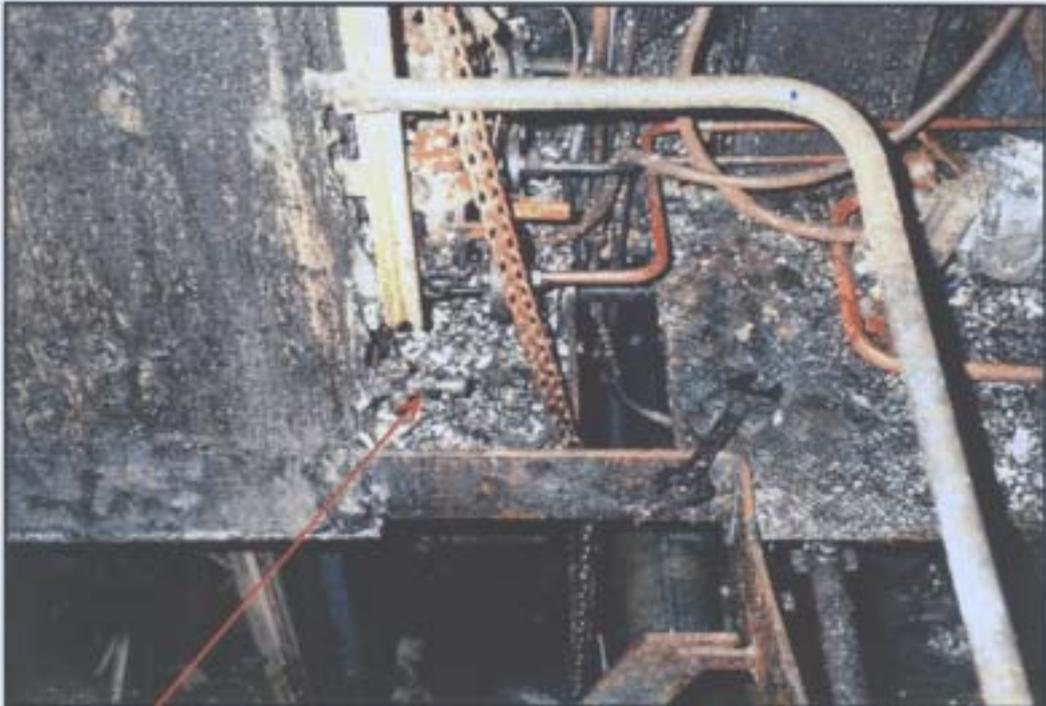
Photograph 7

Automatic closing valve

Tank contents gauge

The immediate cause of the fire cannot be identified positively, but is likely to have been a fault in the 24V battery charger. A small initial fire quickly escalated when the contents of the daily service fuel tank emptied, due to a faulty closing valve in the tank's contents sight gauge. [2.1]

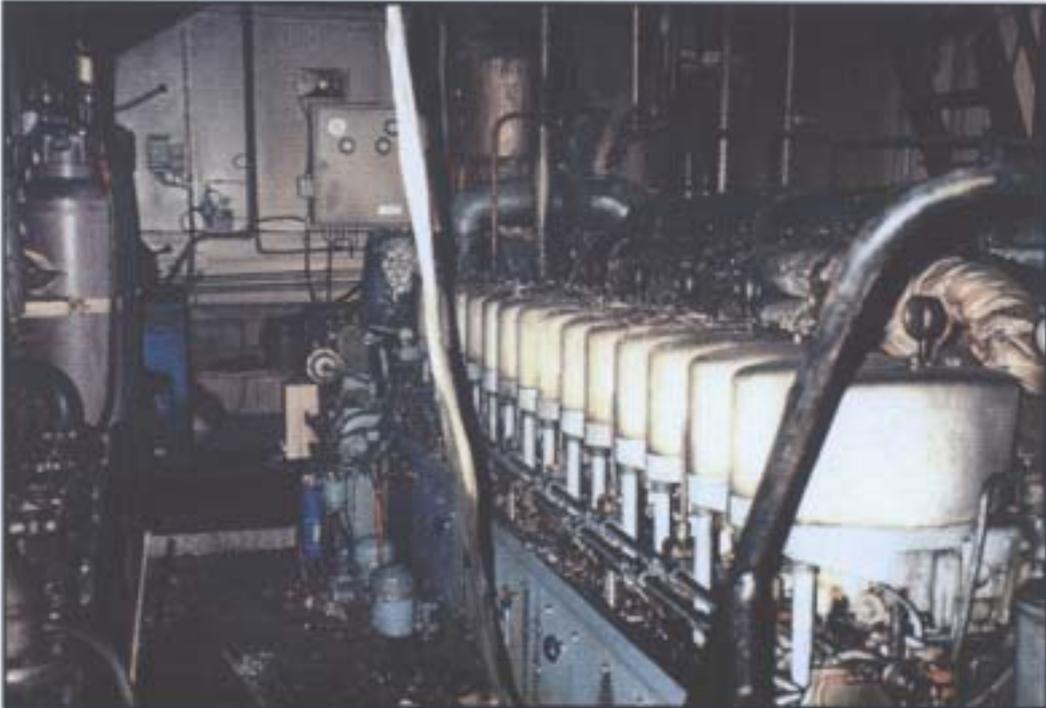
Photograph 8

Although the engine space below the main deck access point was smoke blackened in places, it did not appear to be substantially damaged. Some plastic deckhead fittings had been severely affected by the heat (see **Photograph 8**).

The Engine space below main deck
