**Report of an investigation of
the grounding of**

Baltic Champ

**off Kirkwall
on 4 February 1999**

**Marine Accident Investigation Branch
MAIB 1/6/109**

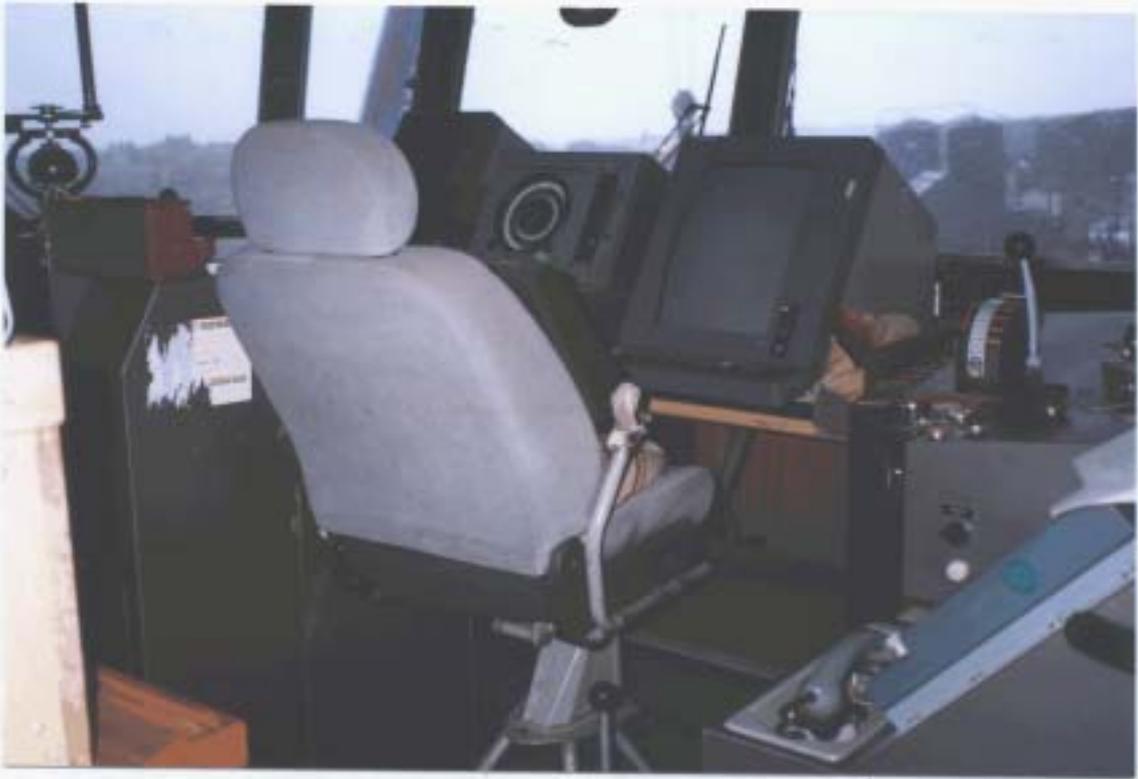
Wheelhouse

At 0130 on 4 February, the master relieved the chief officer on watch and checked the vessel's position by radar and GPS navigator. The radar was operating on the 0.75 mile range scale with two variable range markers; one was set on the echo of Helliær Holm lighthouse, and the other on the conspicuous echo of a house, in a direction about 90° from the lighthouse. The master was alone in the wheelhouse with a stand-by crewman stationed in the messroom. A watch alarm was not fitted on the vessel.

The close proximity of the leeshore rendered it essential that any drift, caused by the anchor dragging, was immediately identified. Monitoring the vessel's position on radar by means of two variable range markers was appropriate, but required frequent observation. When the drift was first detected, the vessel was already moving quickly, which suggests the interval between radar observations was inadequate.

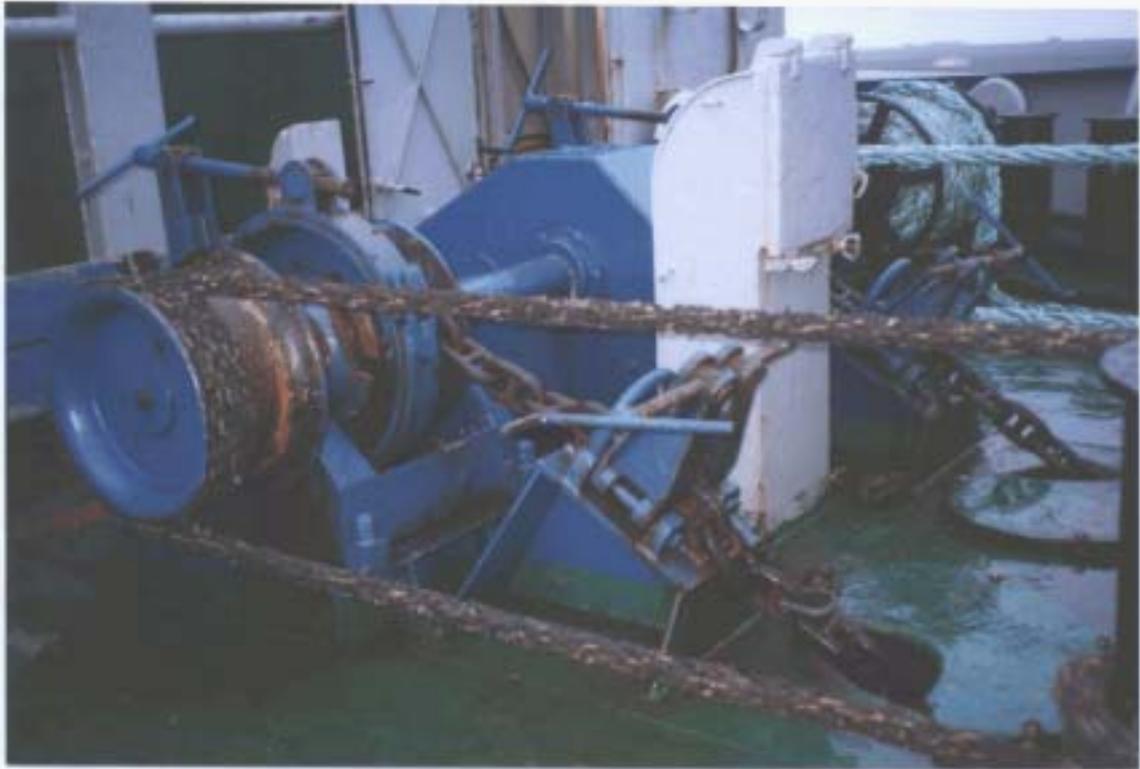
Windlass

The vessel grounded on her starboard side aft, in position Latitude 59°01.803'N, Longitude 002°51.805'W, approximately 0.65 mile from the anchorage position. The anchor cable was leading about 5° on the port bow with 3 shackles in the water. The windlass was unable to heave any more cable, and so the master instructed the chief officer and crewman to stop. The vessel was heading 240° at this time.

At 1100, while *Havila Chieftain* was manoeuvring towards *Baltic Champ* in a further attempt to pass a line, *Baltic Champ* floated free of the ground and swung to port. The master then manoeuvred his vessel ahead and about 90° to starboard, before applying astern propulsion and bow thrust to port. During the manoeuvre, the anchor cable parted at about two shackles from the anchor.
