**Report of an Investigation  
into an engine room fire on  
the UK registered merchant vessel**

***Toisa Gryphon***

**150 miles west-south-west of the Isles of Scilly**

**on 2 February 1999**

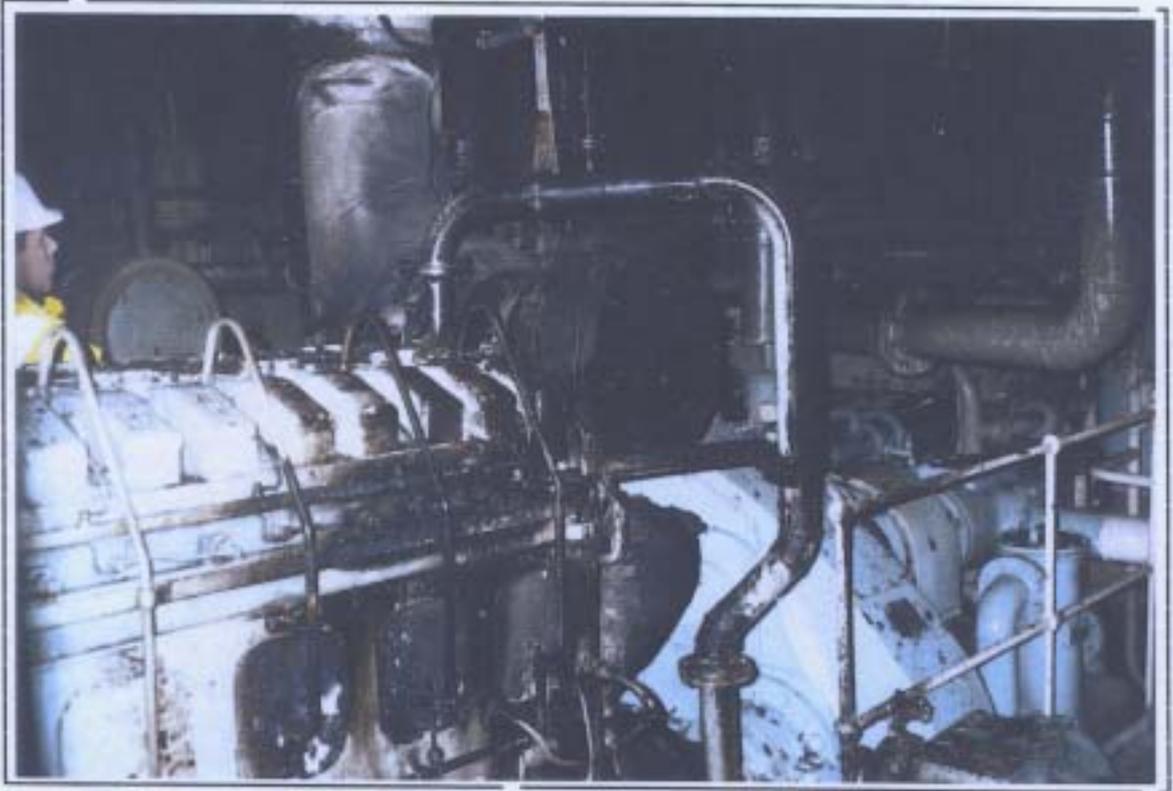
- 1.6.1 Direct fire damage was fairly localised but the effect from heat and soot was much more widespread. The origin of the fire centred on the starboard gearbox and the inner of the two starboard main engines, in particular, the engine turbo-charger. The aft area of the engine room, particularly at deckhead level, was heavily affected by heat with considerable damage to electrical cabling and plastic fittings. Deckhead paint blistering in two areas suggested local secondary fires had occurred.

Fig 3 View of starboard inner main engine showing extent of heat and smoke marking on engine crankcase and turbo-charger.

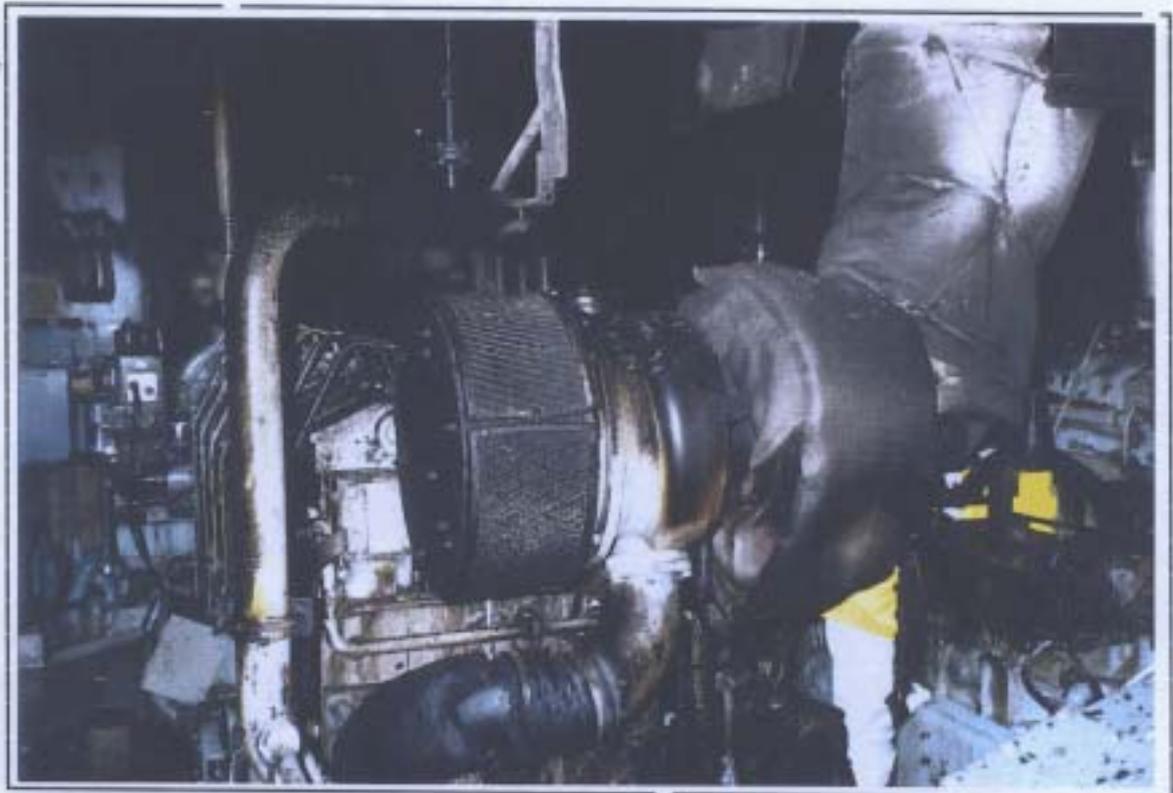
The cause of the fire was the presence of lubricating oil from the starboard main engine gearbox on the turbo-charger and exhaust trunking of No 3 main engine.

Fig 4 View starboard inner main engine turbo-charger showing localised nature of oil burning at lower levels.

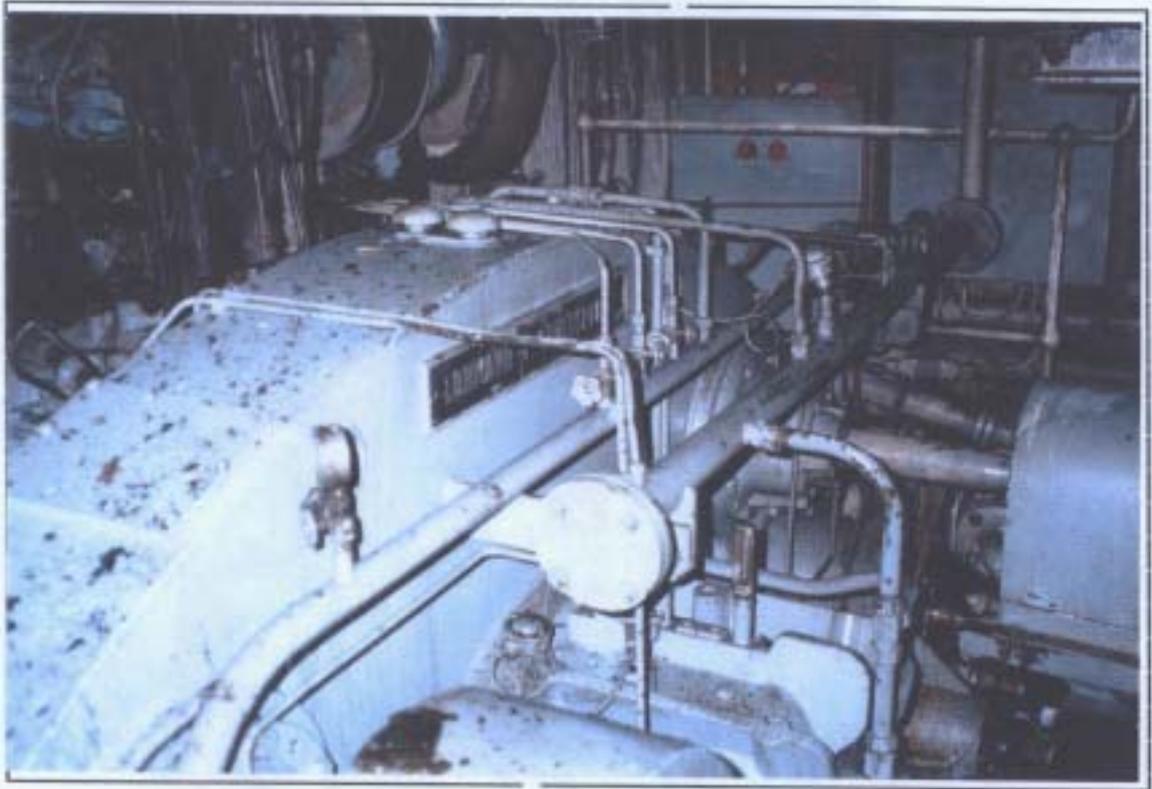
The gearbox itself was not fire damaged, but was covered in sooty oil deposits. Initial investigations showed no obvious signs of split or broken lub oil pipes but the soot pattern showed that oil had sprayed across the forward side of the

Fig 5 View of starboard gear box from aft. Note lack of discolouration or smoke damage.

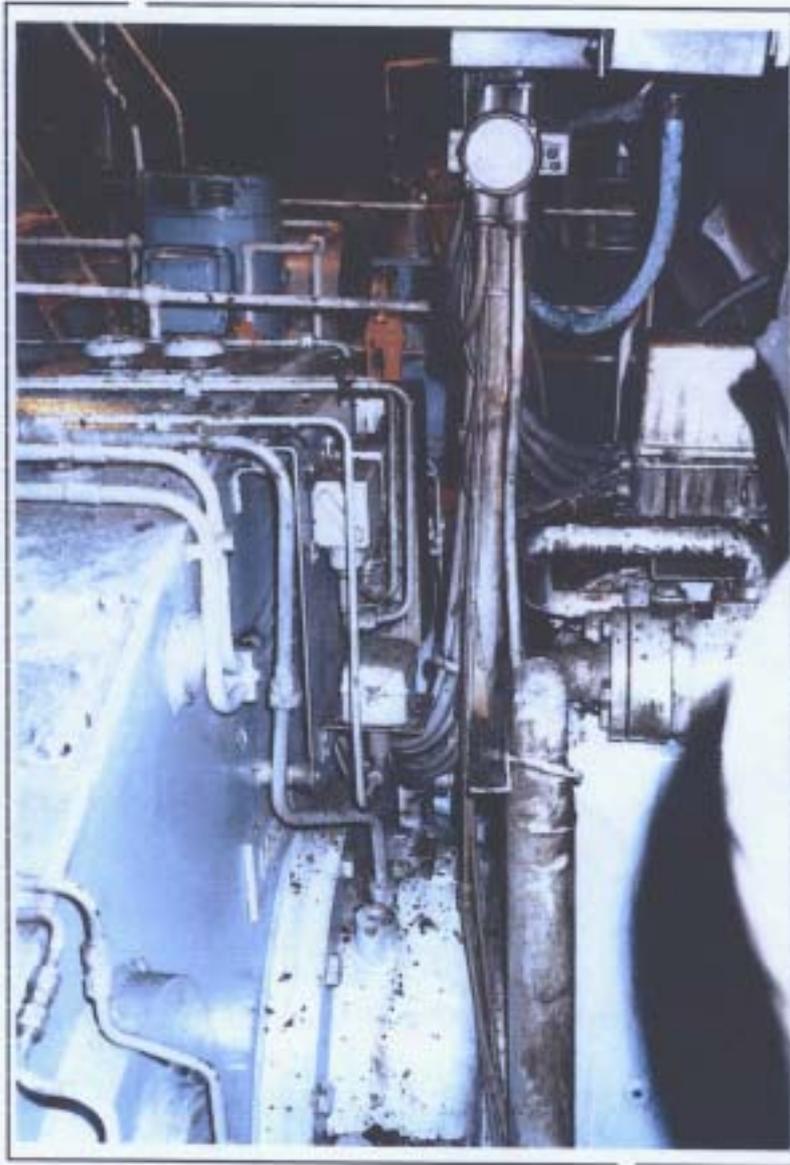
- 2.1.2 Shortly before 2215, a flange seal ring on the CPP high pressure oil line on the forward side of the starboard gearbox failed. High pressure lub oil sprayed towards the port side of the engine room covering the deckhead and aft part of No 3 generator, including the turbo-charger and exhaust trunking. On contact with a hot surface, the oil rapidly rises in temperature and evaporates into a mist or vapour. A further increase in the temperature would likely lead this vapour to smoulder and eventually ignite. With the engine room atmosphere contaminated with a fine lub oil spray, it is probable that sudden ignition of the oil vapour cloud would follow.

Fig 6 View of starboard gear box, forward side, looking from starboard to port.

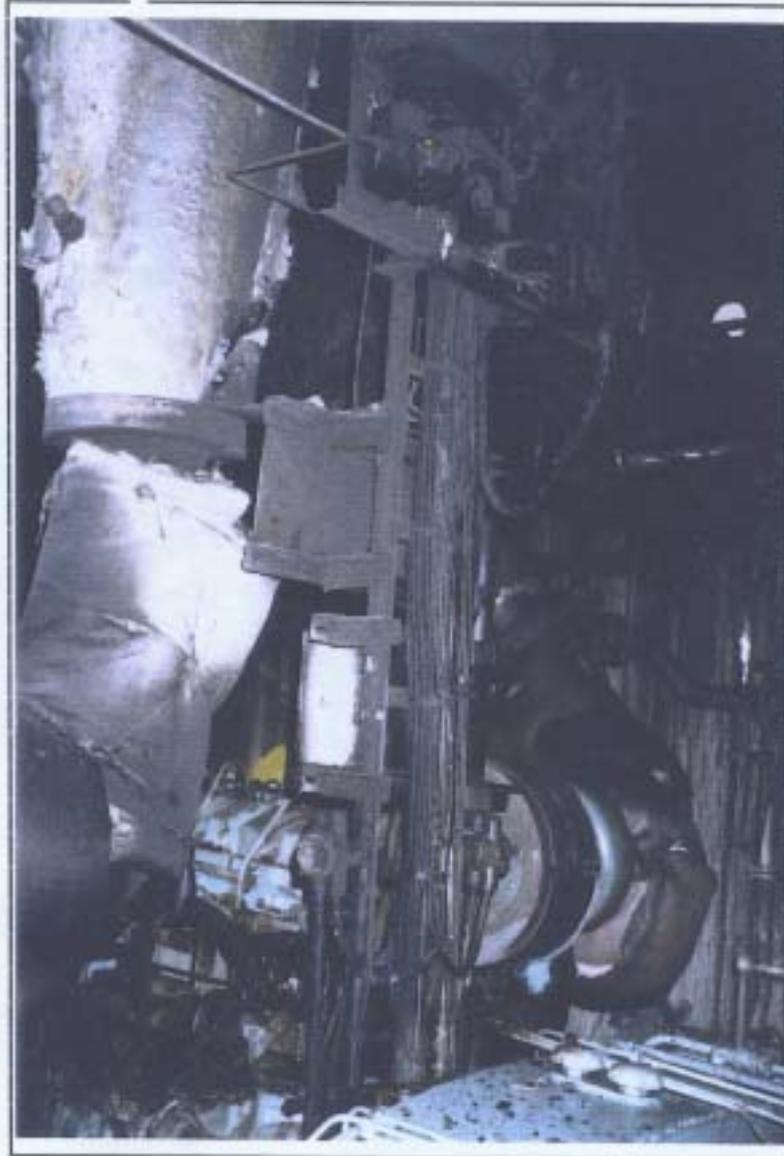
Fig 7 View of alarm and signal actuator panel above starboard gear box showing increasing damage towards the deckhead.

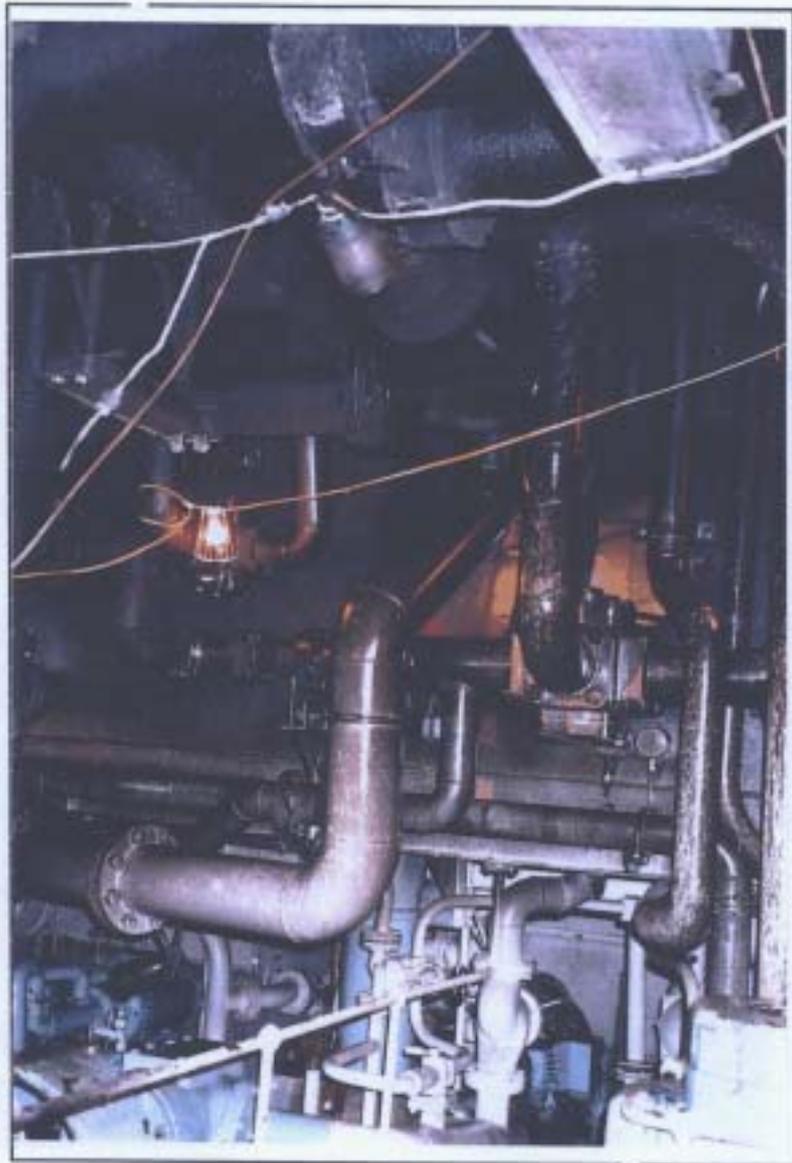
Fig 8 View of deck machinery hydraulic pipework at deckhead, starboard side, aft. Note heat blistering of paintwork.

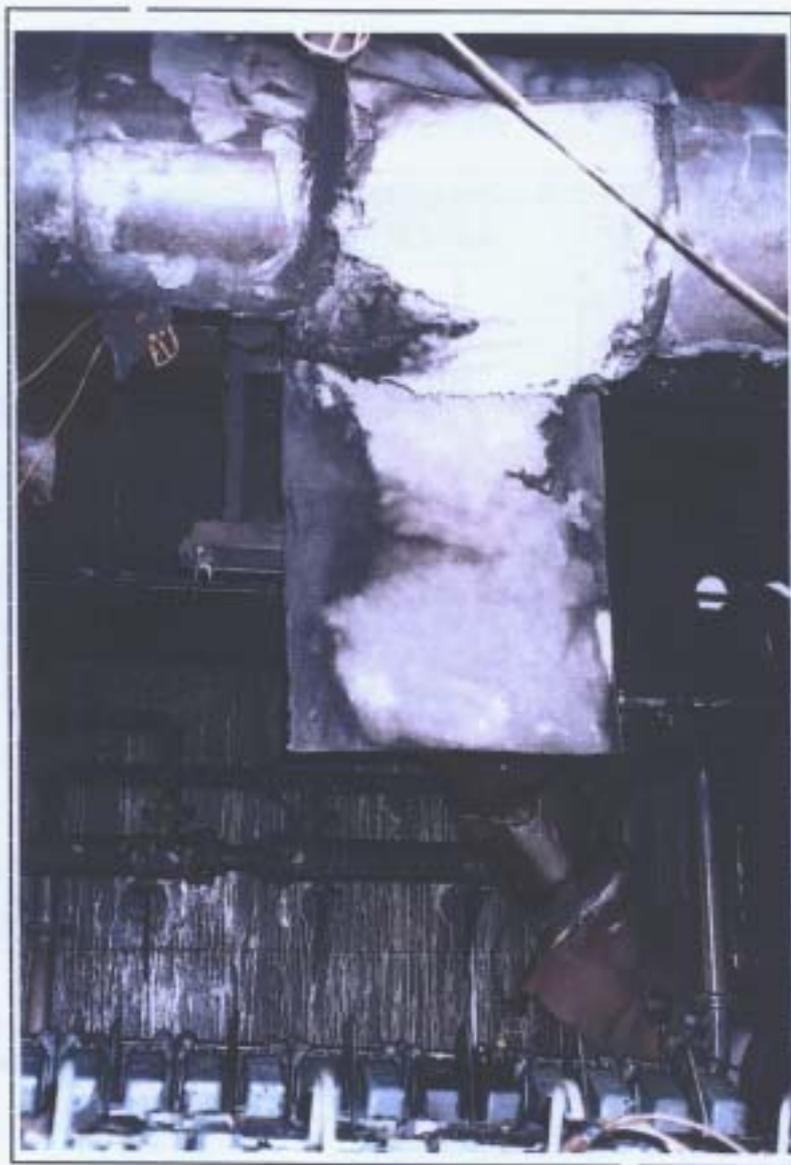
Fig 9 View of starboard side deckhead and bulkhead interface showing soot and oil runs as well as failure of lagging clips.

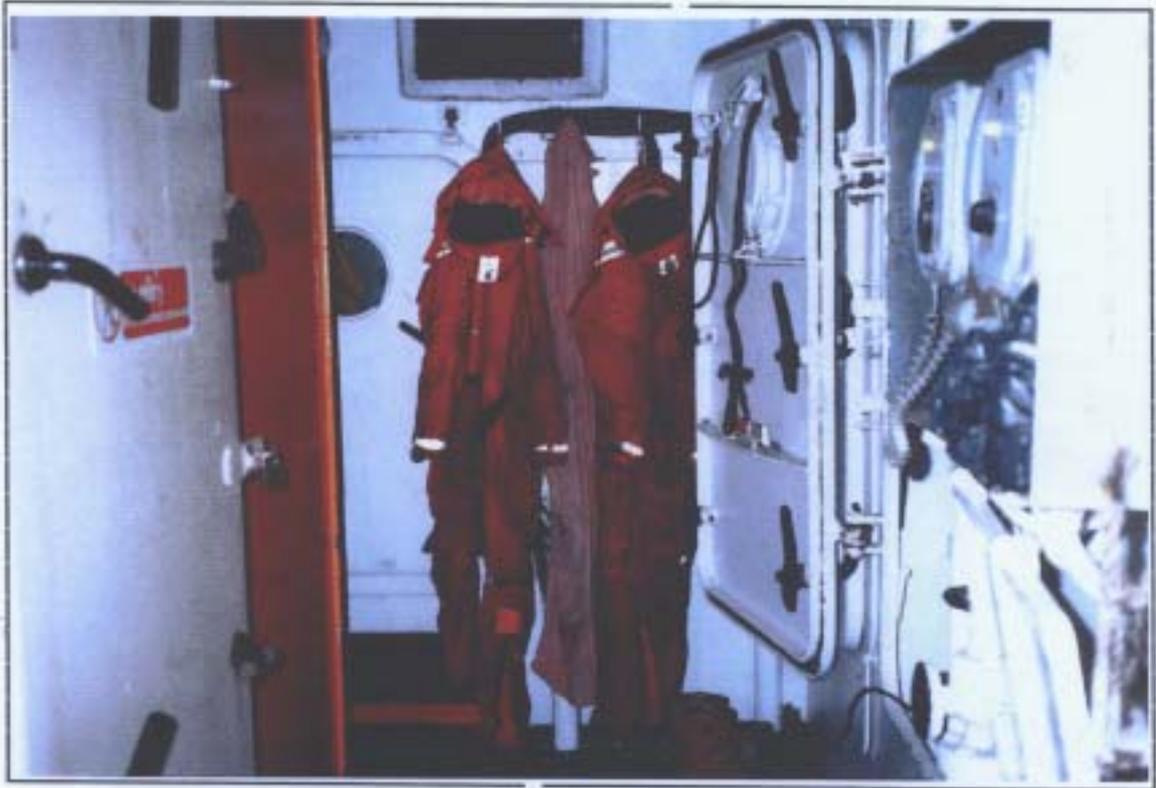
Fig 10 View of aft cross alleyway outside of accommodation block. This gives access to both port and starboard engine room entrances. Note outer accommodation door in normal open position.

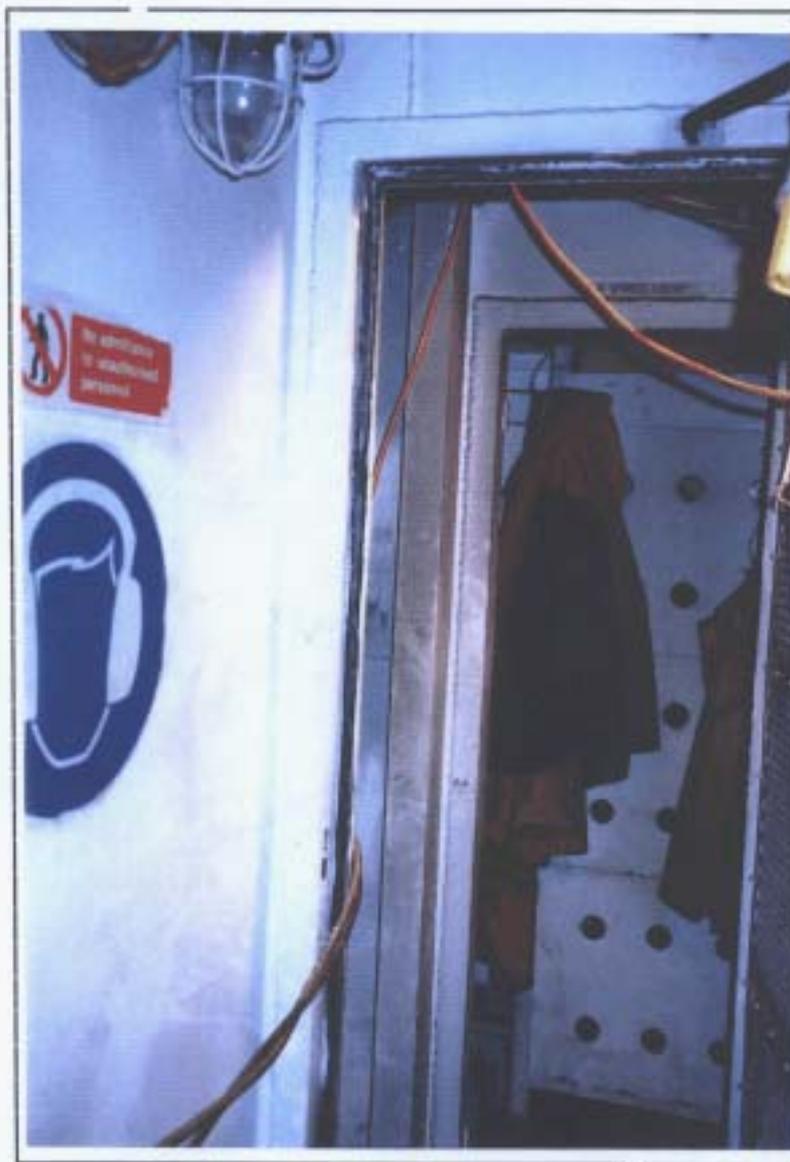
Fig 11 View looking to port from outer entrance door of engine room, through inner door to lobby showing open stores locker. Entrance to engine room is to the left where cables are passing down stairway.

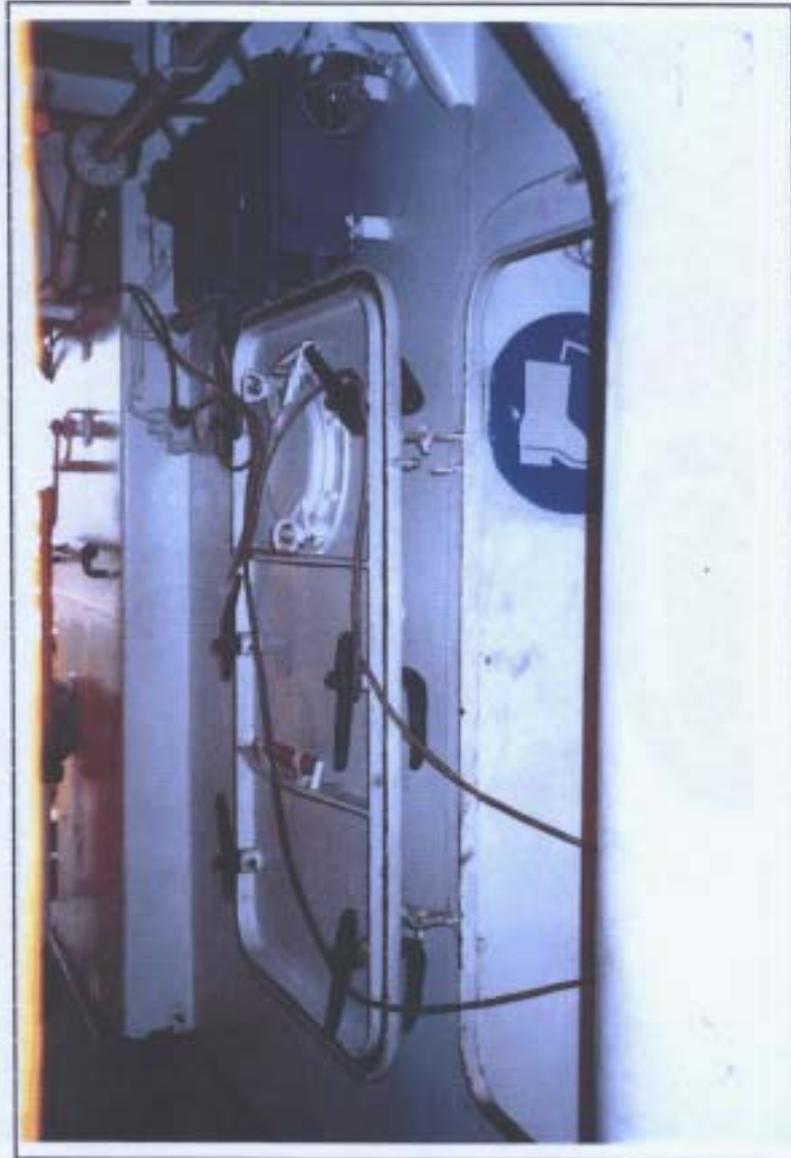
Fig 12 View looking aft through port alleyway showing outer engine door flat against funnel casing. This is not as shown on GA.

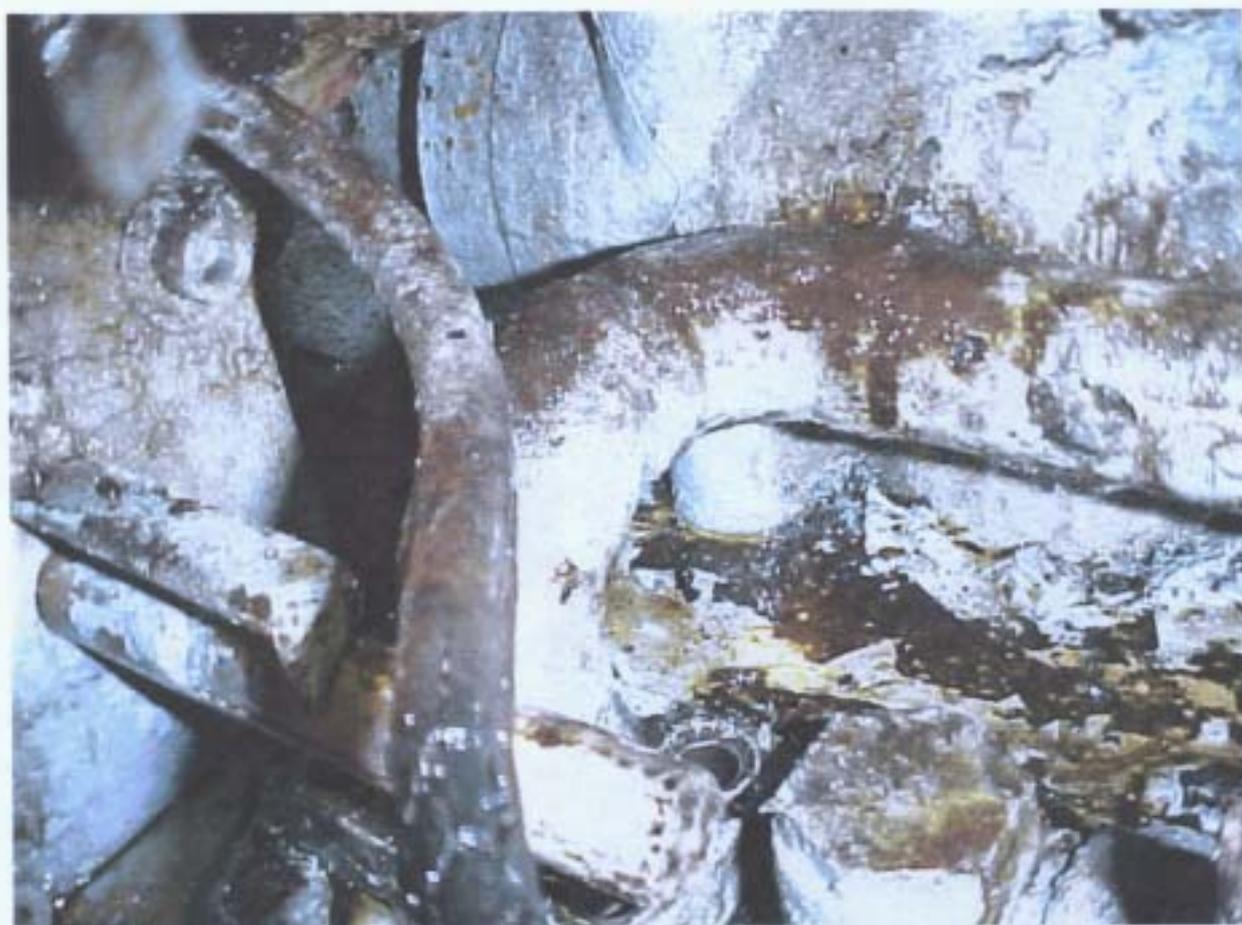
Close up view of O/D box after fire

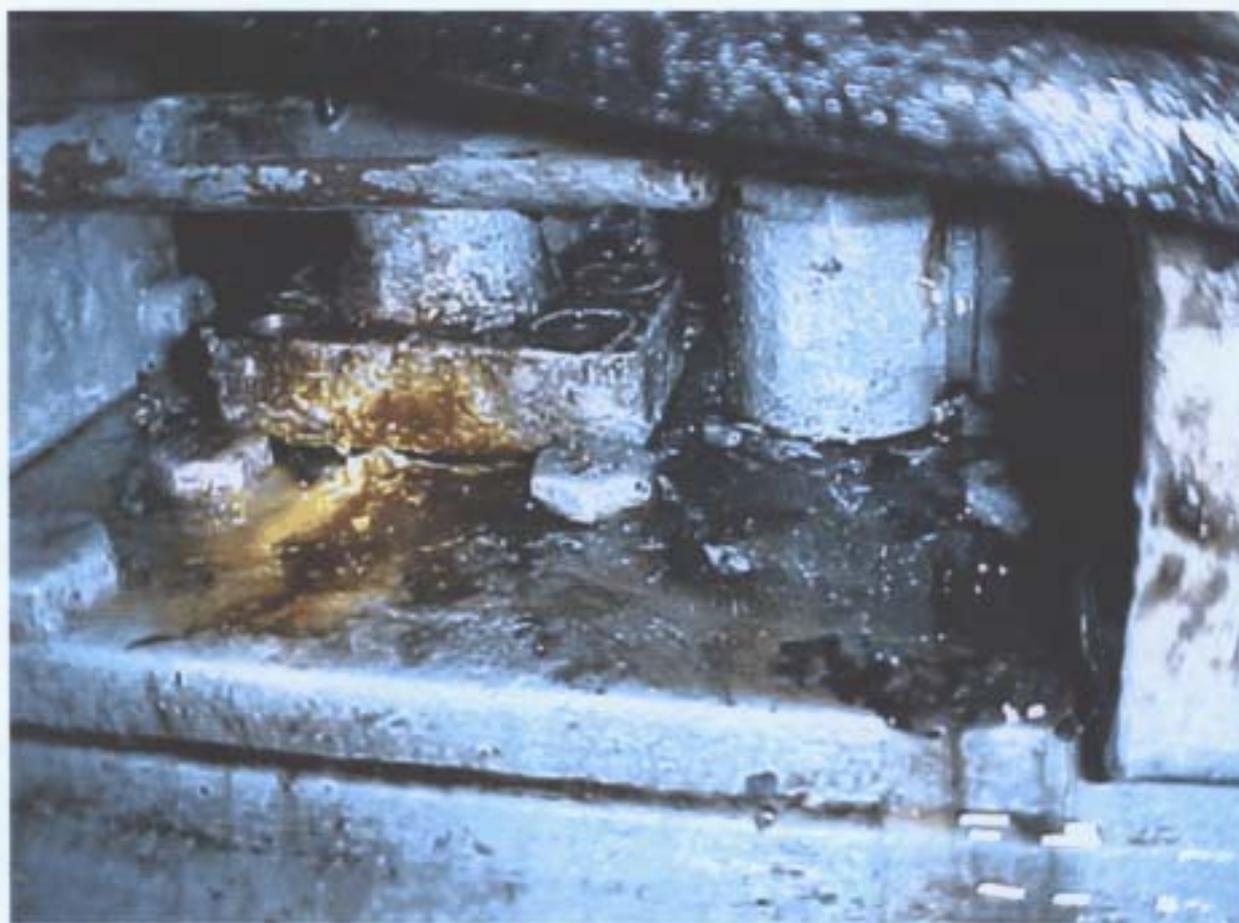
- 1.8.3 Once the source of the lub oil leak had been located, the standby pump was stopped and the pressure allowed to drain down. The pipe flange was dismantled and the cause of the leak found to be a broken seal ring. When the flange bolts were removed, it was discovered that the individual tension on each of the four bolts varied. This suggested that at some time in the past, either they had not been tensioned evenly in the first place, that they had “worked” loose, or that the loss of part of the seal ring resulted in uneven tension in the bolts. Chisel marks on the bolt faces suggested that with access being very restricted, difficulty had been experienced in the past in tightening the bolts to an even and correct tension. Available records suggested that the flange had last been touched some three to five years before.

- 2.3.4 The tight arrangement of pipe connections on the O/D box suggests that the original design envisaged assemble/dismantling on a total overhaul basis, i.e. the pipes being fitted or dismantled in order. This design concept would involve replacing nitrile seal rings on a strict time based maintenance schedule. However, the chisel marks suggest that either the seal had been replaced outside the normal unit overhaul schedule, or that a leak had developed and attempts had been made to tighten the bolts without disturbing the complete unit. There is also the possibility that the bolts were not tightened correctly at the time of the last scheduled overhaul and had become loose during service.

Close up of leaking HP flange connection (bolts removed)

Bearing in mind access difficulty, the chisel marks, and the seal failure, the fitting of locking devices on the flange bolts should be considered at the next overhaul. It would not prevent a seal failure, but it would remove the possibility of bolt slackening during service.

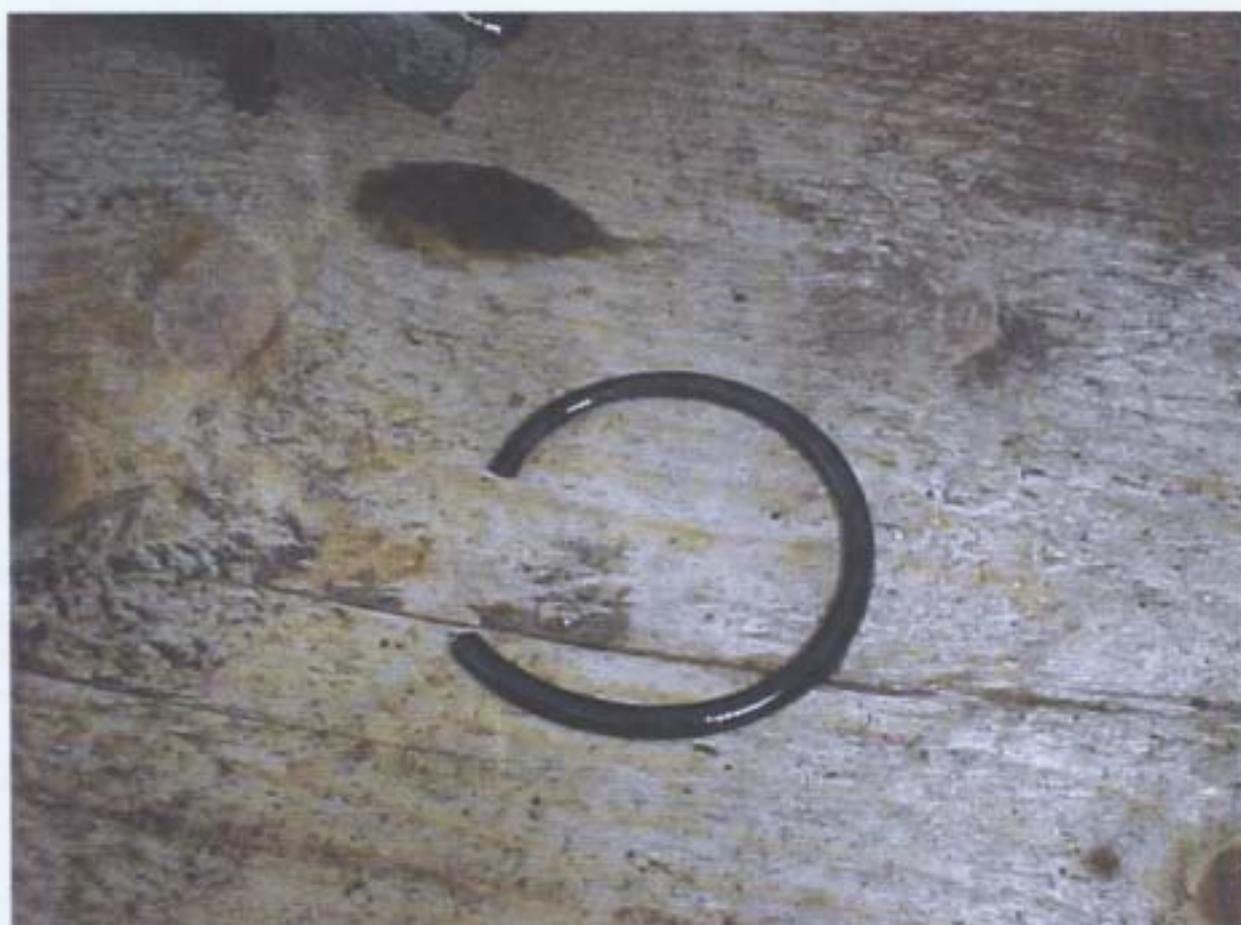
The failure of a nitride rubber seal ring in a pipe flange on the high pressure side of the CPP pump allowed lubricating oil at high pressure to be sprayed over the aft centre and port sides of the engine room. This oil spray also covered the aft part of No 3 main engine and in particular the turbo-charger and exhaust trunking of that engine.

Broken seal ring

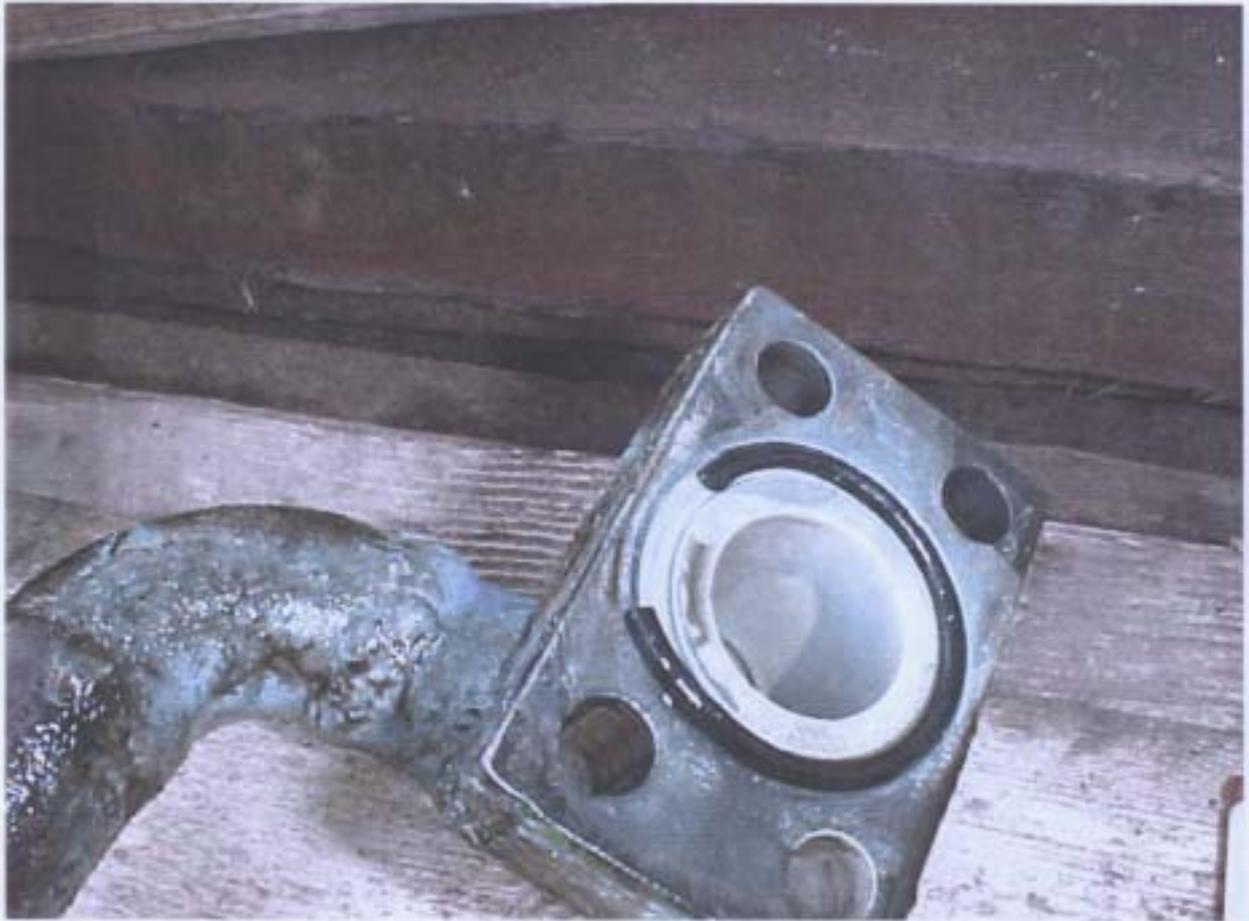
Pipe flange showing missing section of seal ring
