**Report of the Inspector's Investigation into
the death of one person on the fishing vessel**

***GEESKE* BM140**

while fishing off Beachy Head

on 9 December 1998

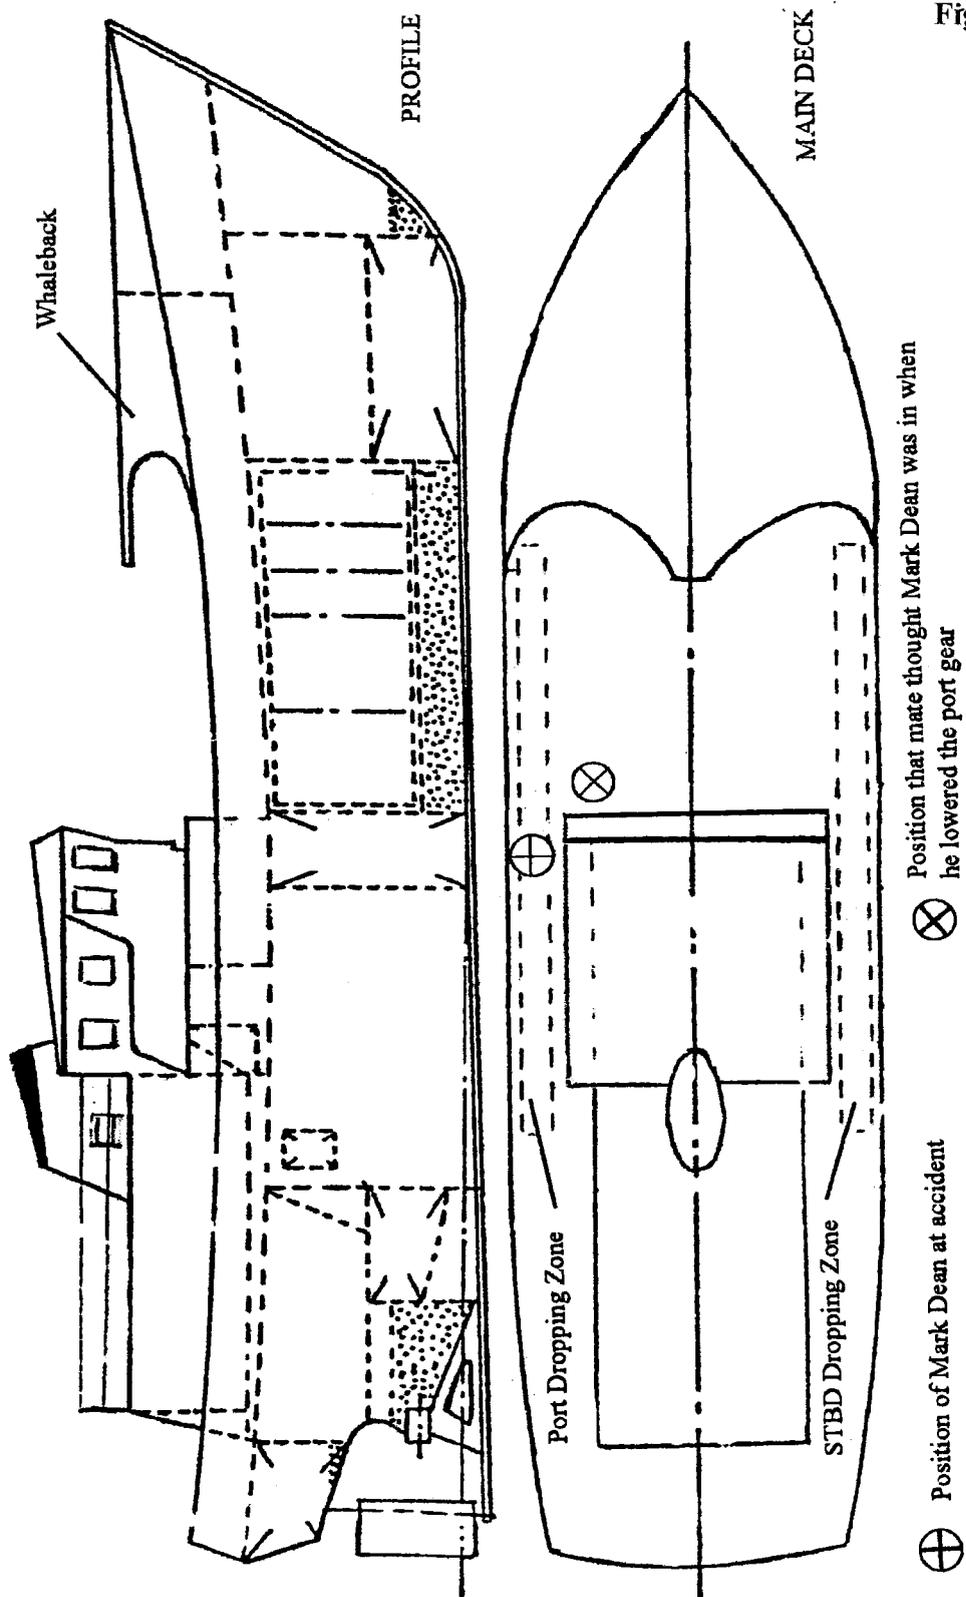
Figure 2

ready"? or "All clear?" and deckhand A replied "All clear". Just after making this observation and hearing the call he moved back slightly and operated the winch controls to drop the port gear. It is evident that Mark Dean was under the gear at the time (Figure 2).

Profile and plan of fv *Geeske* BM140 (not to scale)

Deckhand A has made no mention of giving the “All clear”; also his recollection is that the gear dropped on Mark Dean as he was taking the last turn off the whipping drum. In this position he would have been on the port side of the deckhouse in the dropping zone of the port gear (**Figure 2**).

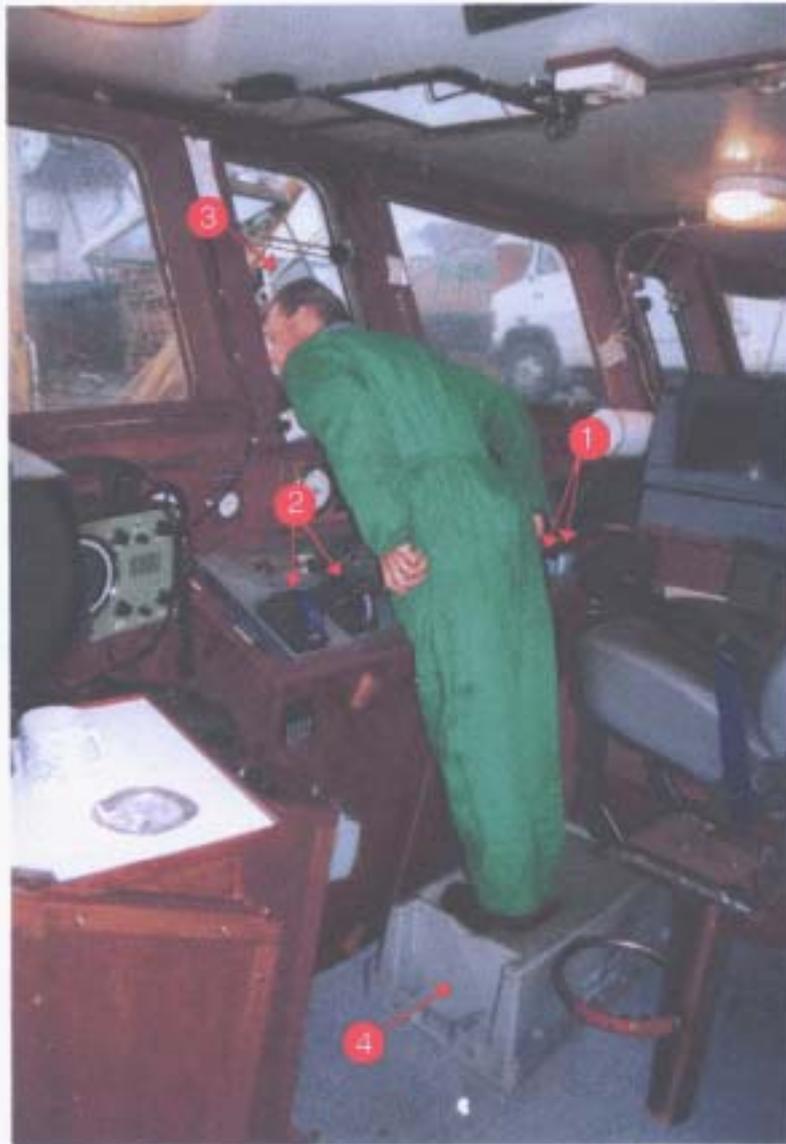
Figure 3

View of the winch control position in the wheelhouse

1. Starboard winch control levers
2. Port winch control levers
3. Open window
4. Fish box used as a standing platform

The skipper of *Geeske* was 1.83m (6'0"), and the mate was 1.55m (5'1") tall. The person at the winch control in (Figure 3) is 1.7m (5'2") tall and can see some of the working deck by leaning out of the window. An MAIB inspector 1.72m (5'8") tall, also looked out from this position and found his view of the deck restricted. This was with the vessel alongside in calm water. A typical view from the open window of the dropping zone is shown in (Figure 4). It was difficult to view the working deck from the wheelhouse, especially for a short person. The fish box was being used as a standing platform at the time of the accident.

1. Change the wheelhouse arrangement/equipment so that the winch operator has a clear view of the whole of the dropping zone for each set of fishing gear. [2.1, 3.1.3]
2. Undertake a risk assessment of the hauling operation on *Geeske*; a written procedure should be developed from this exercise. The owner should ensure that the procedure is followed by the crew. [2.2, 3.1.4]

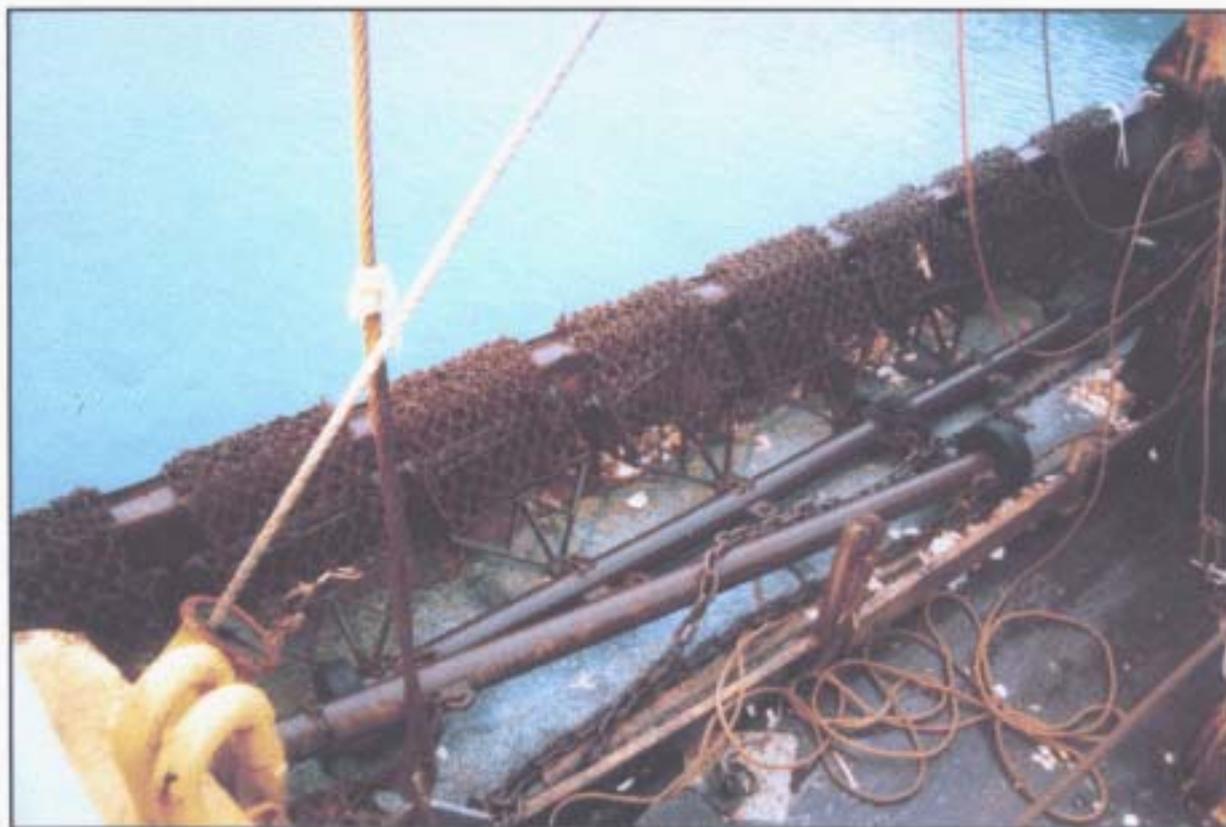
Figure 4

General view of the port dropping zone from the open window in the wheelhouse

- 2.1.1 The whole of the dropping zone for the fishing gear could not be seen from the winch control position in the wheelhouse. The area at the side of the deckhouse could not be viewed at all, and the area just forward of this could only be viewed with difficulty. The upturned fish box used as a standing platform is not acceptable on a permanent basis.
- 2.1.2 The view could be improved by having a winch control position at each bridge wing or by covering each dropping zone with closed circuit television. A raised floor could be installed rather than a temporary standing platform.

3. The winch operator, from his position in the wheelhouse, could not see the whole of the deck on to which the fishing gear was to be dropped. The area at the side of the deckhouse could not be viewed at all; the area just forward of this could only be viewed with difficulty. [2.1]

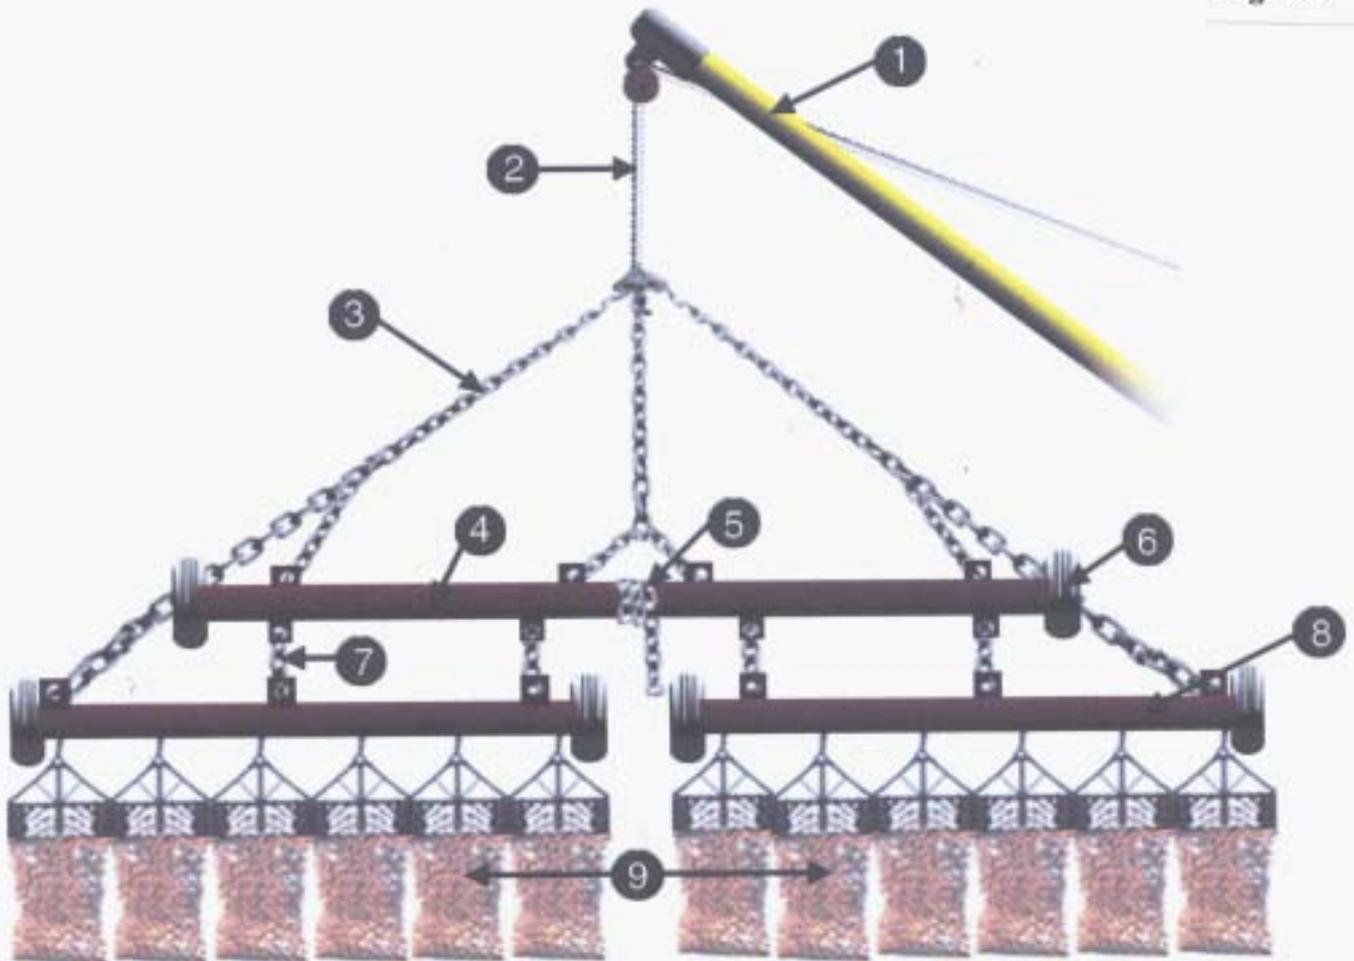
Figure 5

Typical scallop dredge arrangement

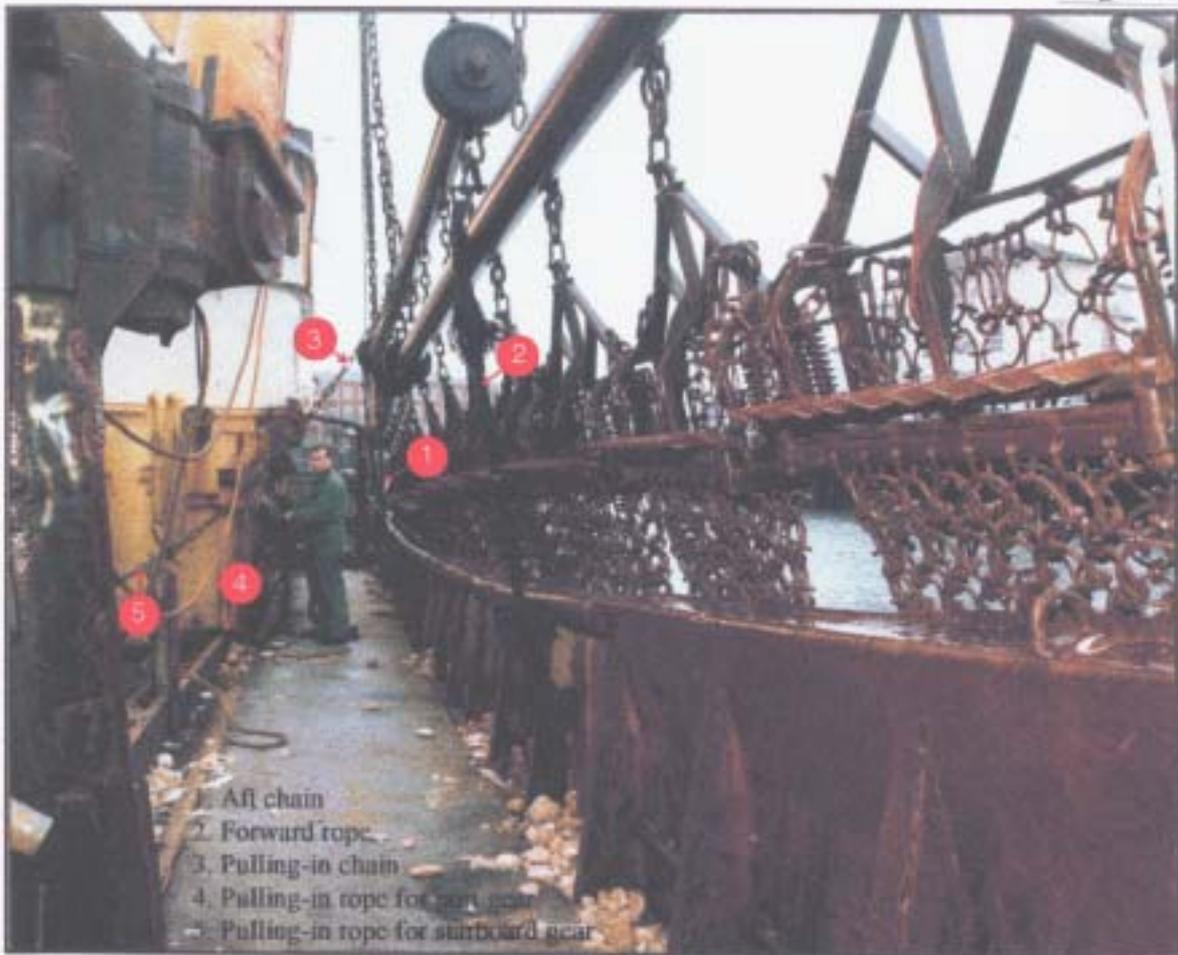
Figure 7

Fishing gear hauled tight

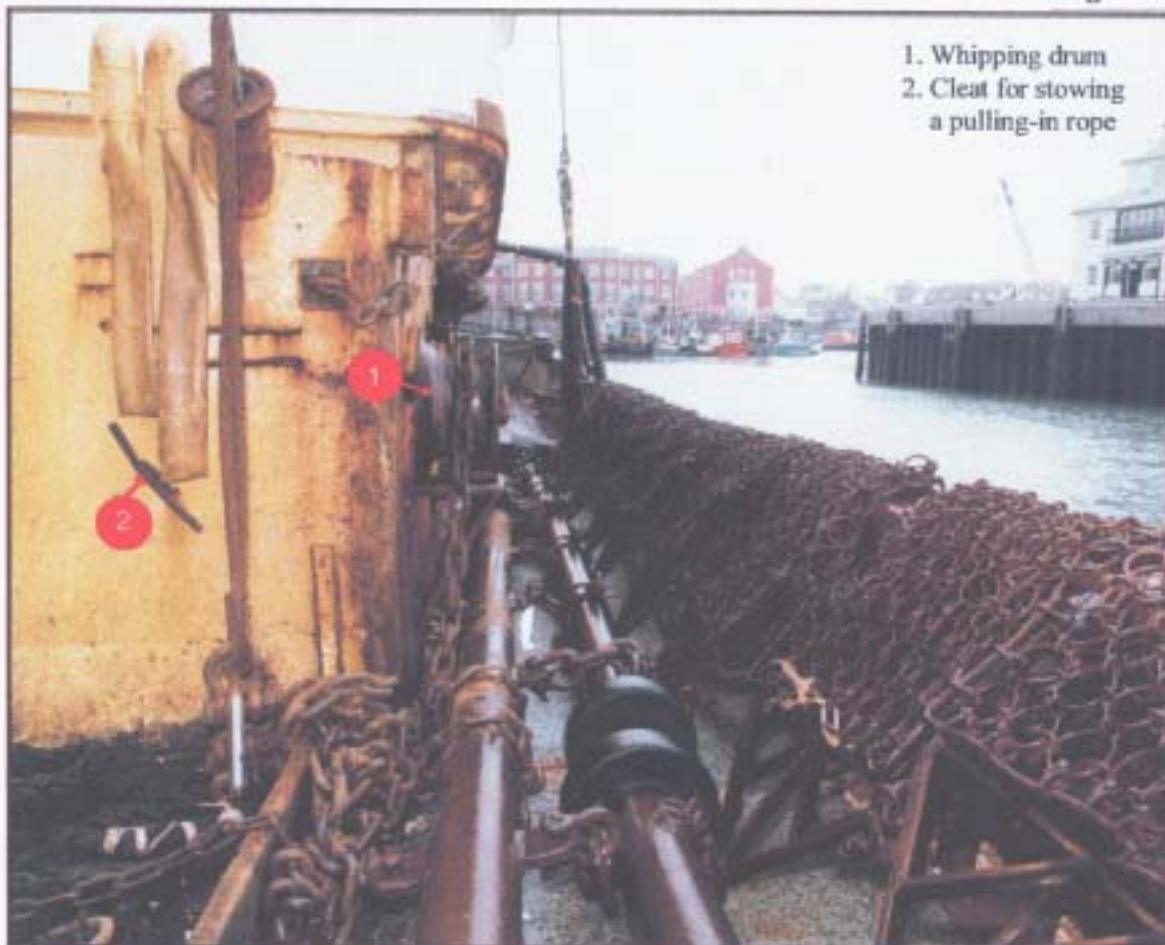
Figure 8

The port whipping drum and the cleat used for stowing a pulling-in rope is shown (**Figure 8**).

Whipping drum and cleat

2.3.2 The blunt wound which Mark Dean received to the lower left side of his head, was probably caused by the lip of the whipping drum. If the wound was caused in this way, Mark Dean was standing, and facing aft, when the poles of the port side fishing gear were dropped on him. Another possibility was that Mark Dean finished stowing the pulling-in rope and then attempted to get to the galley before the port side gear was dropped. He normally left the open deck early in order to prepare food for the watch. If this was the case he would have been walking by the whipping drum.
