Report of an Investigation
into the death of a donkeyman on
mv *P&OSL KENT*
on 10 November 1998
off the Port of Dover

MAIB 1/10/186

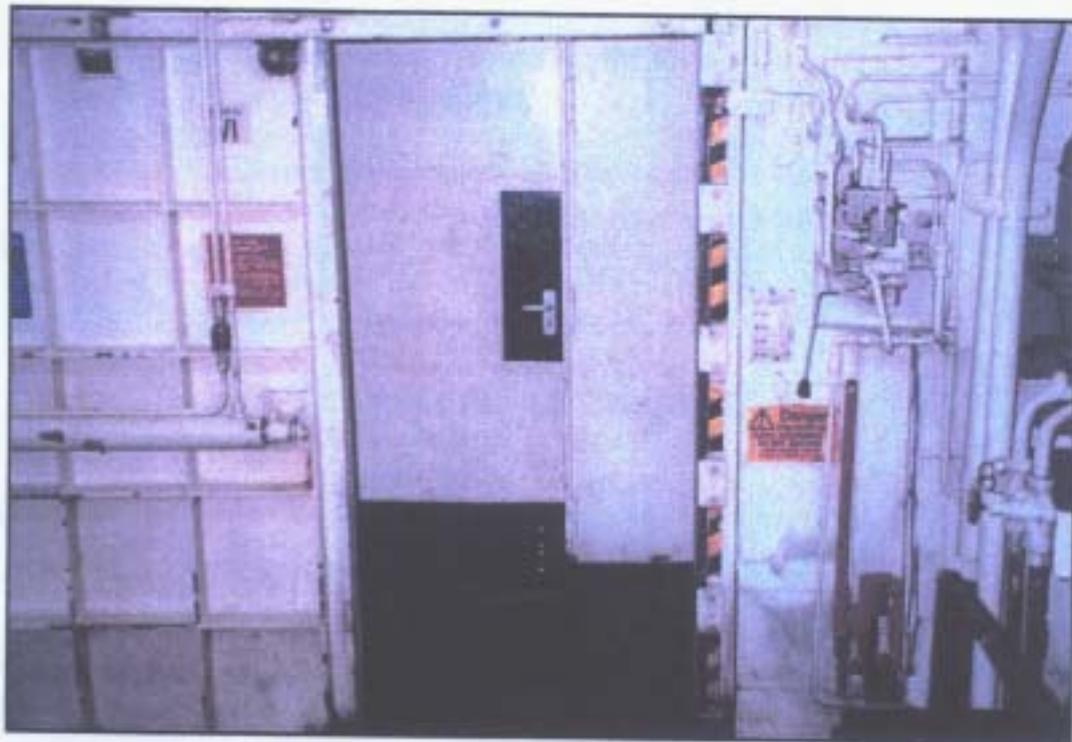
Photograph 1

At about 1800 on 10 November 1998, he was found by the fourth engineer found him trapped in No 6 watertight door. He was released from the doorway by normal operation of the door controls and laid on the floorplates in the generator room. The fourth engineer noticed at that time that he had a red mark running diagonally across his body from the left shoulder downwards.

Watertight door No.6 viewed from generator room.

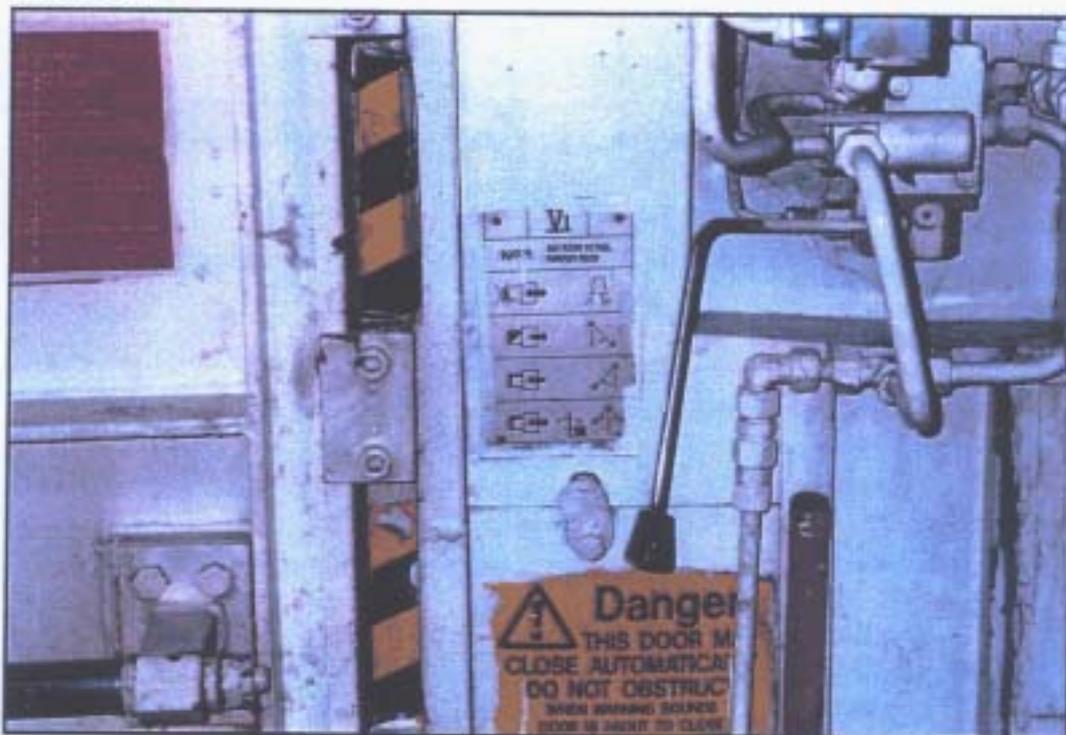
Photograph 5

"Cranked" operating lever on separator room side of watertight door No.6.

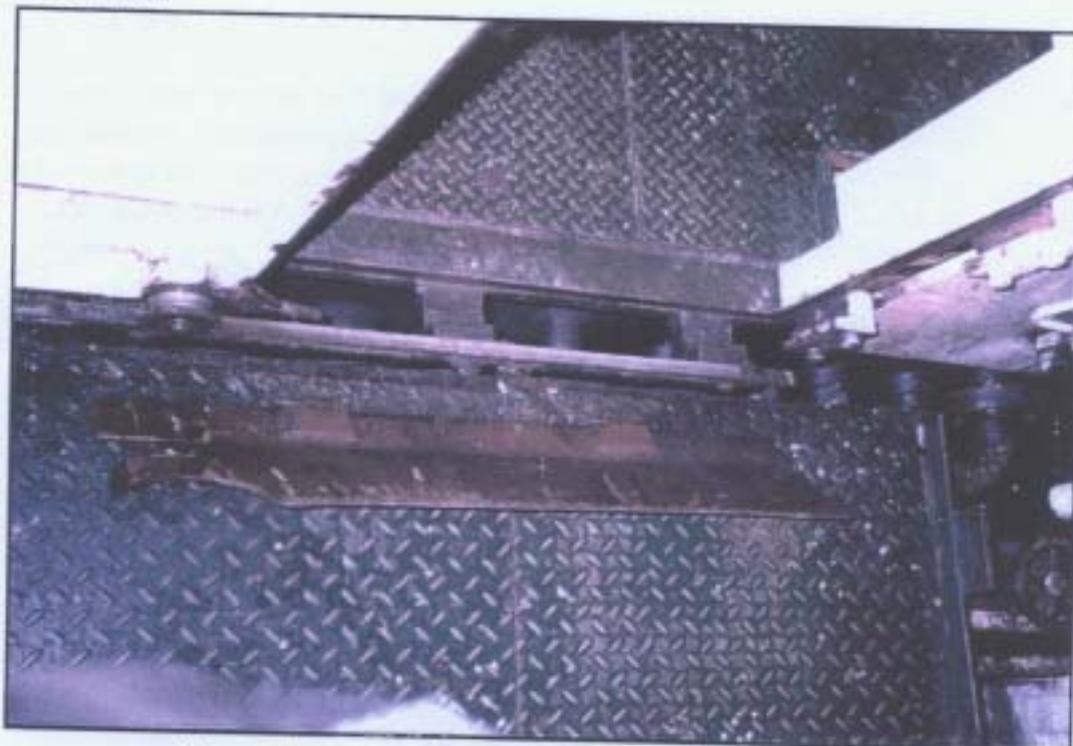
Photograph 7

View of raised floorplate when watertight door is partially open.

With the watertight door only partly open, and a bag of salt on his right shoulder, Mr Williams would not only have had to ease his way round the door, but would have found it necessary to step over the raised floorplate. It may be that with his sight partially obstructed by the bag of salt on his shoulder and, when concentrating on easing through the doorway, he caught his leading foot on the raised floorplate. With the weight of the bag on his right, and leading shoulder, he could have stumbled and fallen towards the door jamb.

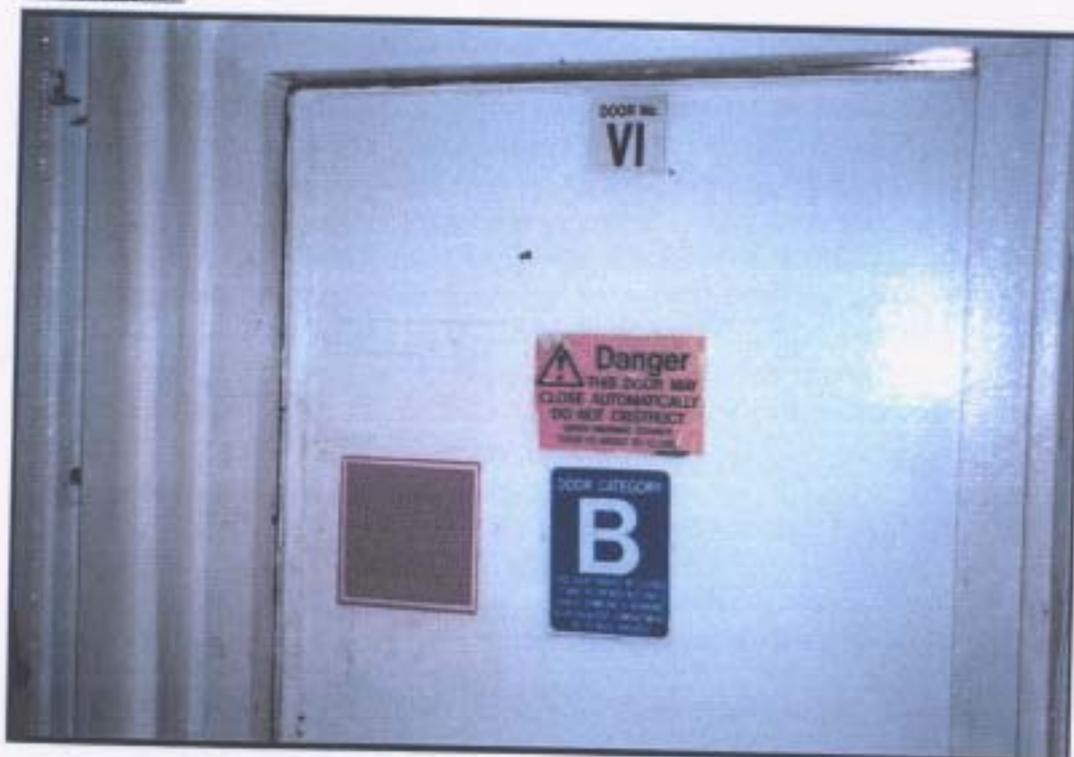
Photograph 9

Warning and Instructional signs on watertight door No.6.

All instruction and warning notices were fixed to the doors or adjacent parts and were in a good and readable condition.

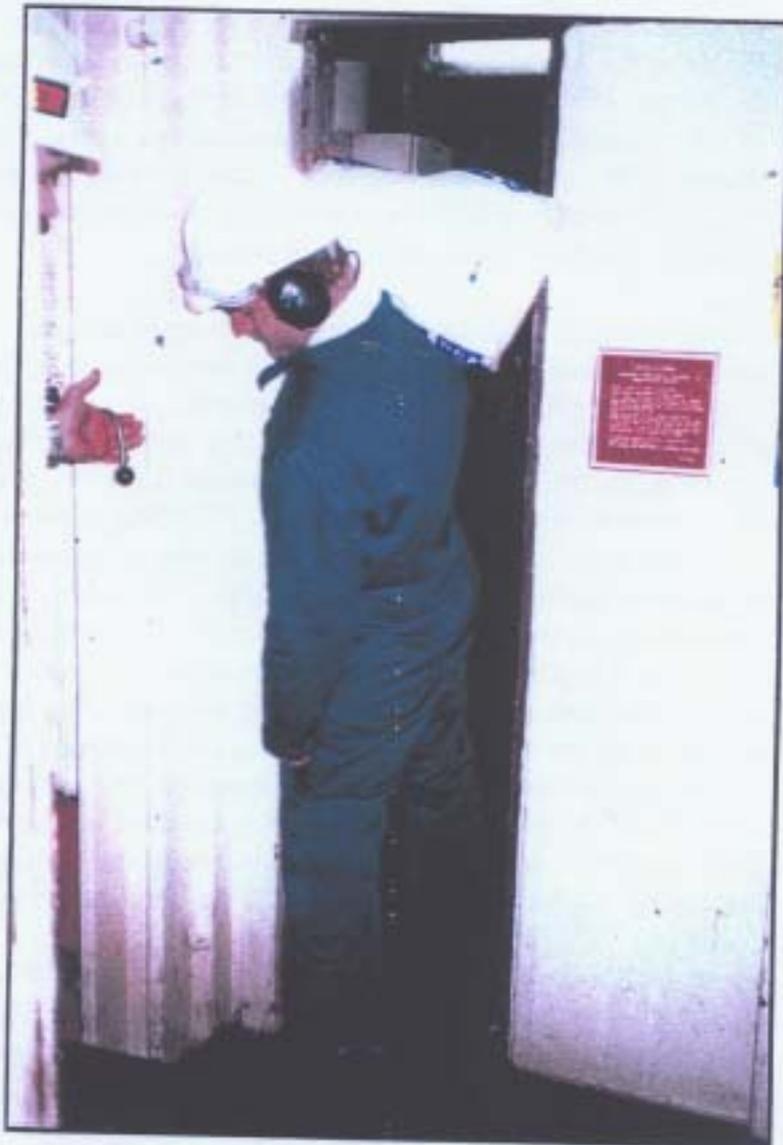
Photograph 10

Illustration of possible position of donkeyman
immediatly prior to accident.

Trying to regain his footing, he may have banged his head on the door jamb (this would account for the bruises seen in the vicinity of his right eye when the police examined him on arrival Dover) and become momentarily dazed. It is also possible, that while negotiating the doorway, his free left hand retained a grip on the door operating handle on the separator room side of the door. On falling forward, given the shape and position of the operating handle relative to his height, he would have pushed the handle downwards. This downward action would have caused the door to start to close. In a slightly dazed condition, it is possible that he did not realise that the door was closing until it started to grip him. At that point, undoubtedly a degree of panic would set in, and it may be that he mistakenly continued to hold the handle downwards. On becoming unconscious, it is probable that his hand fell off the operating handle causing the door movement to stop. The door would have remained in that position until the fourth engineer discovered the donkeyman and operated the handle to release him.

- 2.2.3 The donkeyman was 1778mm (5ft 10") in height and with the watertight door having a clear height of 1900mm (6ft 3") he would have clear headroom to pass through the doorway. His normal hand height when upright would have been about 800mm (2ft 7"). The operating handle on the separator room is at a height of 1150mm (3ft 9"). This means that when grasping the operating handle, his arm would have been bent up to about or just above waist height. In this position, any stumble forward is likely to cause hand/arm movement downwards. With the operating handle requiring a minimum applied force of 850g (1lb 14oz) to move, such a downward movement will result in the door closing.

2. Re-assess the procedure for the use and operation of type “B” watertight doors when operating in “Local Control”.
3. Emphasise to all its sea staff, that until such time as the re-assessment recommended above has been completed, current procedures for operating watertight doors must be followed and that watchkeepers should exercise supervision over any work requiring the movement of tools, parts or materials through a watertight door.
4. Remind personnel that, under current “Local Control” instructions, two men should be in attendance during the transfer of salt between the separator room and the generator room.
