Report of the investigation
of the grounding of the
Romanian registered ro-ro cargo vessel
Octogon 3
two cables south-east of Spurn Head
at the entrance to the River Humber
on 22 October 1998

Marine Accident Investigation Branch
First Floor
Carlton House
Carlton Place
Southampton
SO15 2DZ

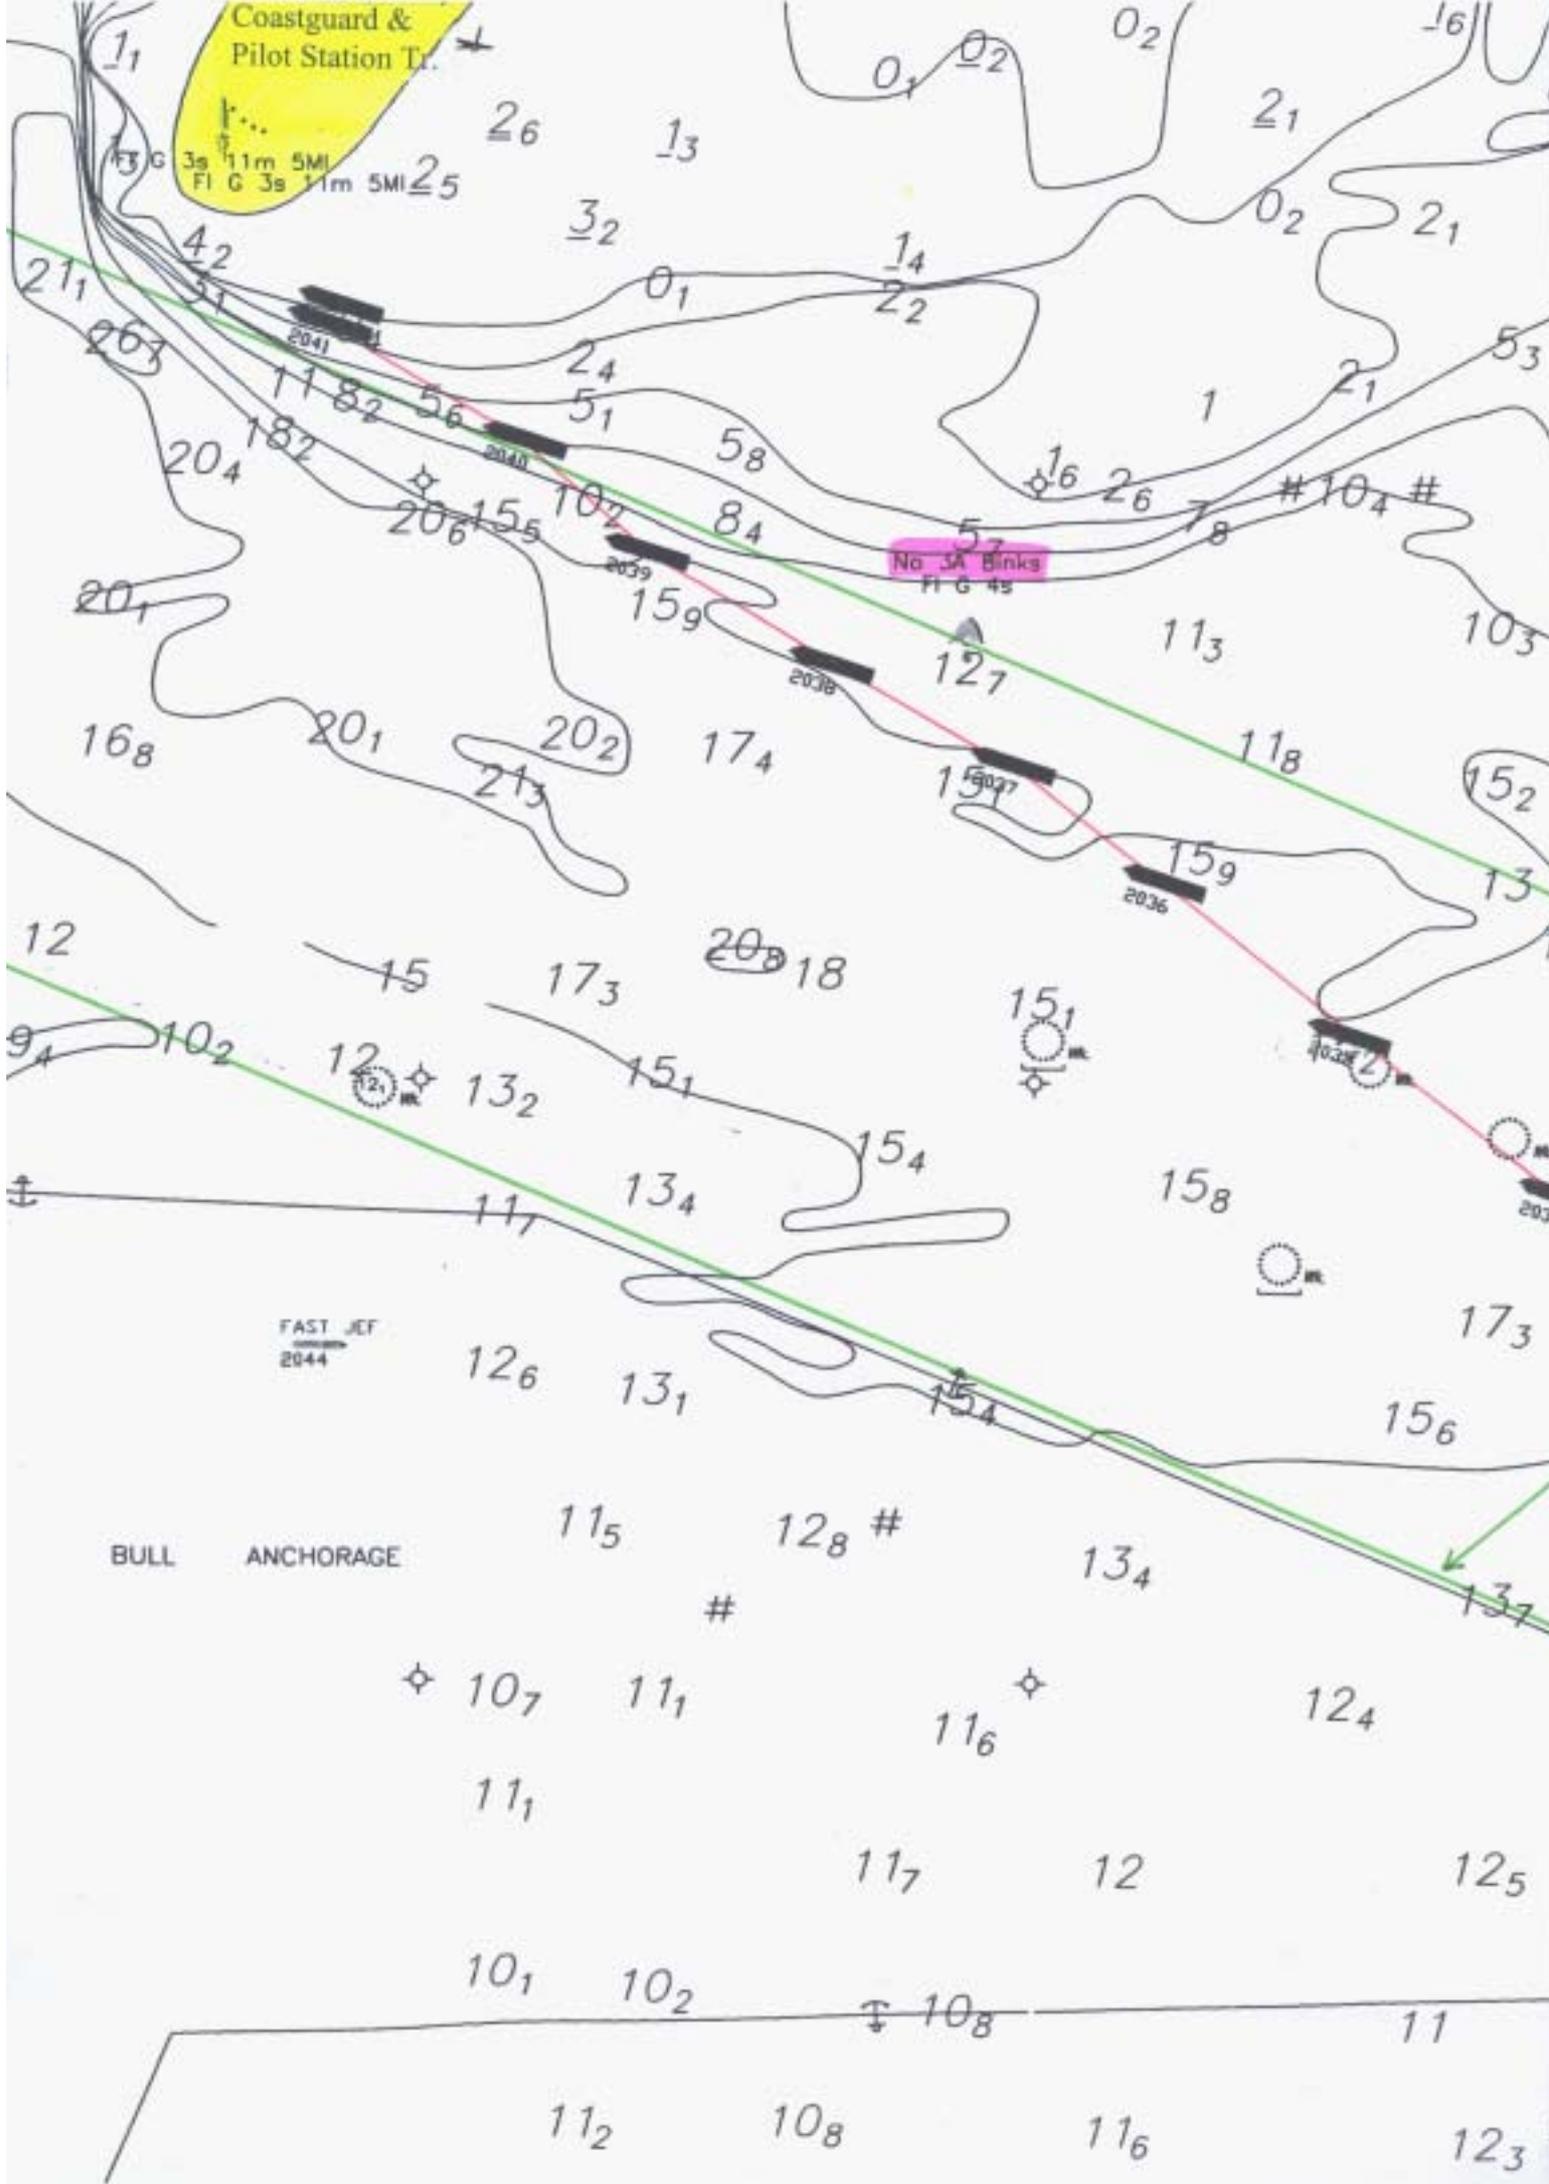
Octogon 3 passed 5.8 cables to the south of Chequer No 3 buoy and altered course to 295°. She was well to the south, or port side, of the channel as she did so. She was on course by 2029 and making good 16.4 knots with the first of two outbound ferries fine on her port bow. She passed the first at 2033 and the second at 2039. At 2036 the pilot launch *Rover* instructed *Octogon 3* to change to VHF radio channel 13 and, shortly afterwards, to reduce speed to dead slow ahead to enable the pilot to embark. Throughout the time she was on a heading of 295° wind and tide had been setting her steadily to starboard and her course made over the ground was 308° (see chart over leaf).

As speed was reduced the master realised he was being set down too close to Binks No 3A buoy on his starboard bow and altered course 7° to port to 288°. He cleared the buoy at a range of 1.2 cables while making good 9.3 knots but this new heading was insufficient to prevent *Octogon 3* drifting to starboard.

The pilot boarded at 2039 but as the launch pulled away, her coxswain asked *Octogon 3* for her ship's head since it appeared she was getting too close to Spurn Head, which was now only 5 cables away on her starboard bow. The master replied that, because he had been told to reduce speed, he had come too close to Binks No 3A buoy but was now heading more to port. The engines were put to full ahead.

As soon as the pilot reached the bridge he realised *Octogon 3* was very close to Spurn Head, was informed the ship's head was 301° and immediately ordered hard-a-port. However, the drift to starboard continued and the vessel

grounded on Spurn Head about 2 cables south-east of the beacon making the seaward end at 2041.

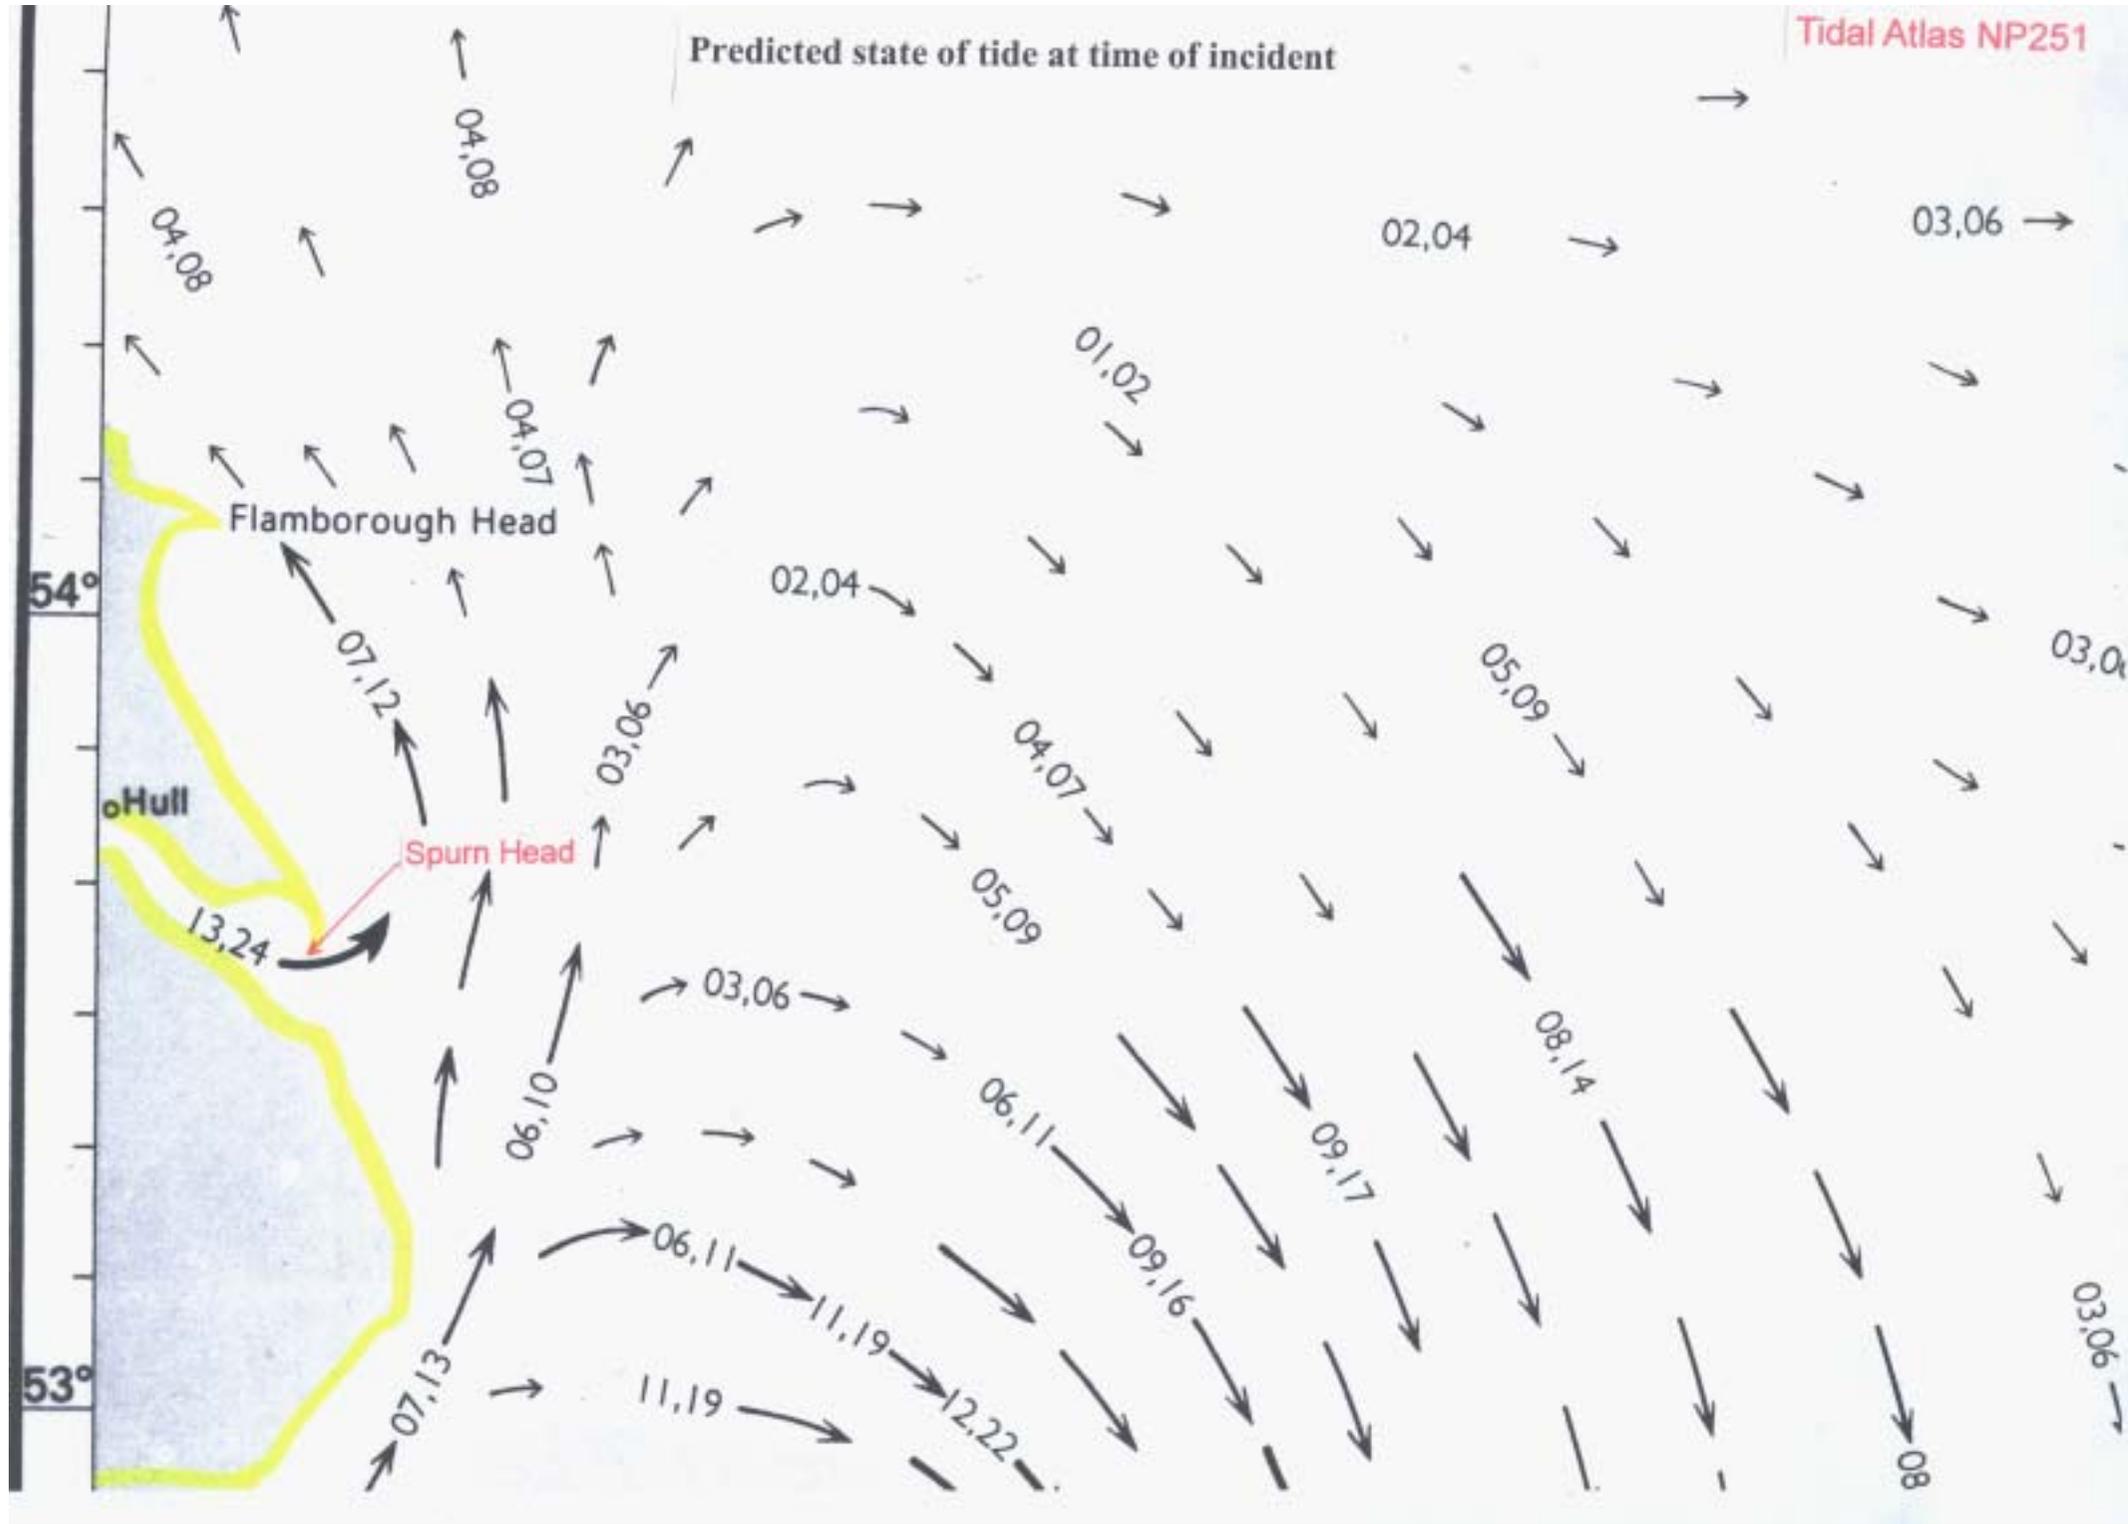
Predicted state of tide at time of incident

Between Chequer Shoal and Spurn Head the tidal streams run strongly in the direction of the channel. However, for the first two hours after high water the tidal stream has a north-easterly component, which is across the channel at over 2 knots. This was the case at the time of the incident (**see extract from the Admiralty Tidal Stream Atlas opposite**).

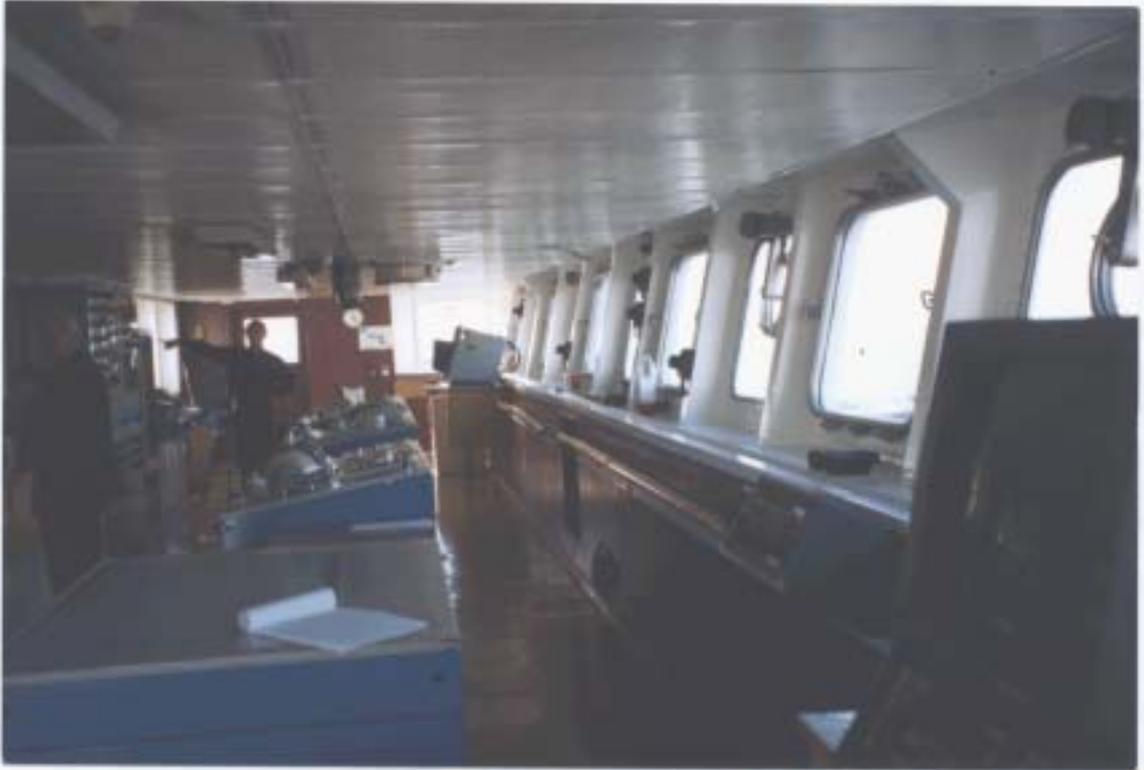
Octagon 3 - Bridge Layout

The ship had two radars - a Racal Decca BT501 sited on the port side of the bridge and a Kelvin Hughes 1700R on the starboard side (see **photograph overleaf**). Both radars had ARPA capabilities. There was a GPS Shipmate RS5700 and two echo sounders. The chart room was aft of the wheelhouse but there was a plotting table behind and close to the starboard radar. There were gyro repeater compasses, with azimuth mirrors, on each bridge wing.

Once in pilotage waters, the master took charge of the navigation of the ship. The chief and third officers, with a helmsman, were on the bridge to assist the master. However, the helmsman was dispatched to attend to the pilot ladder and the chief officer took over the wheel. The master navigated the ship by eye, using the port radar and judging navigational marks by sight to make decisions on courses to steer. The third officer was using the starboard radar to give the master distances and bearings of navigational marks. The master acknowledged and verified the information given to him by his officer.
