Report of the investigation
of the grounding of the
Romanian registered ro-ro cargo vessel
Octogon 3
two cables south-east of Spurn Head
at the entrance to the River Humber
on 22 October 1998

Marine Accident Investigation Branch
First Floor
Carlton House
Carlton Place
Southampton
SO15 2DZ

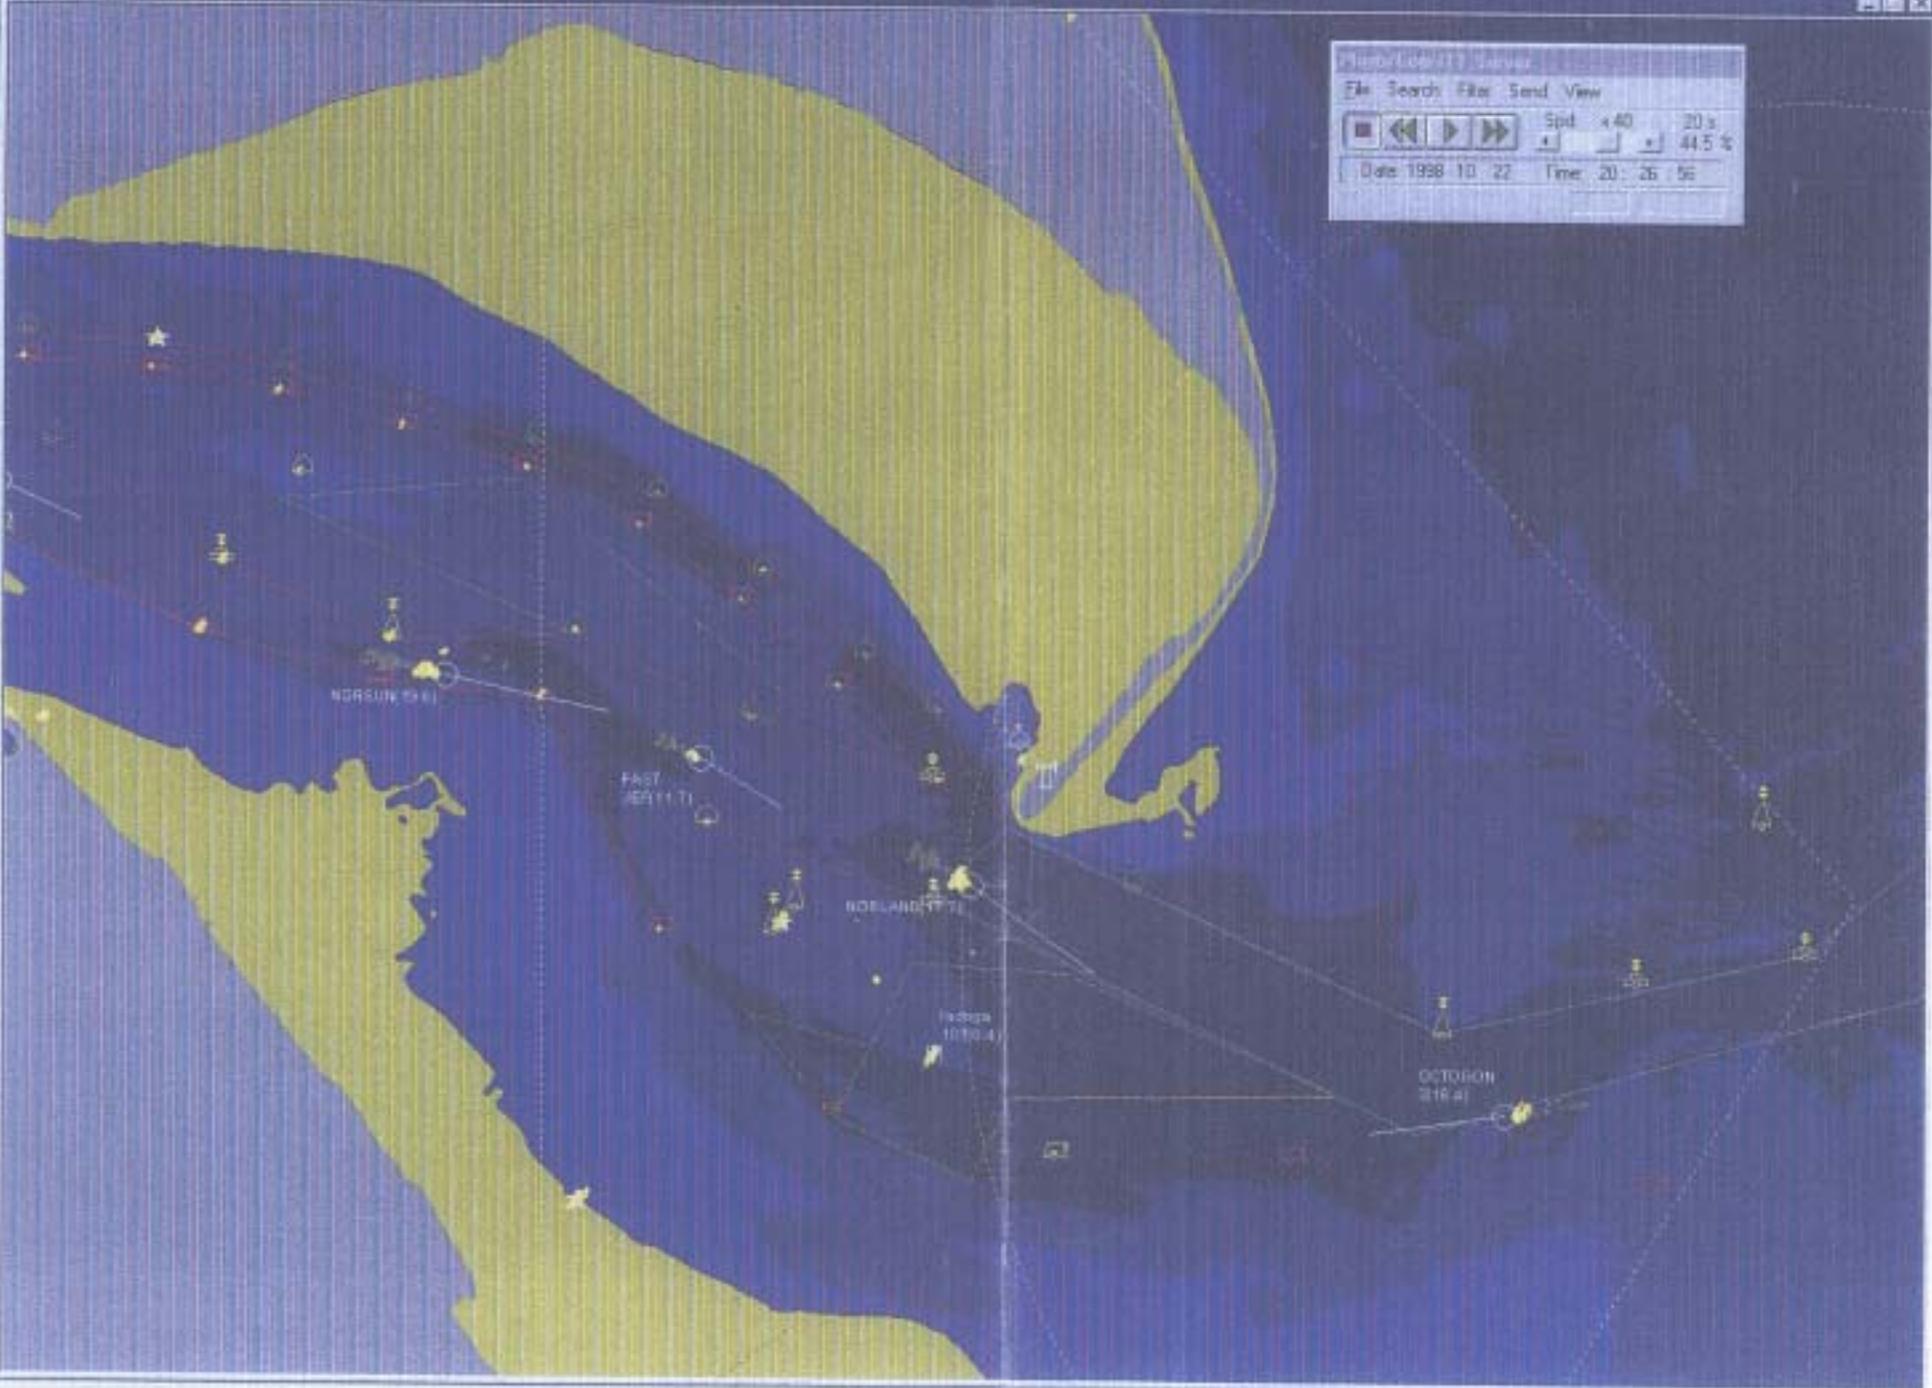
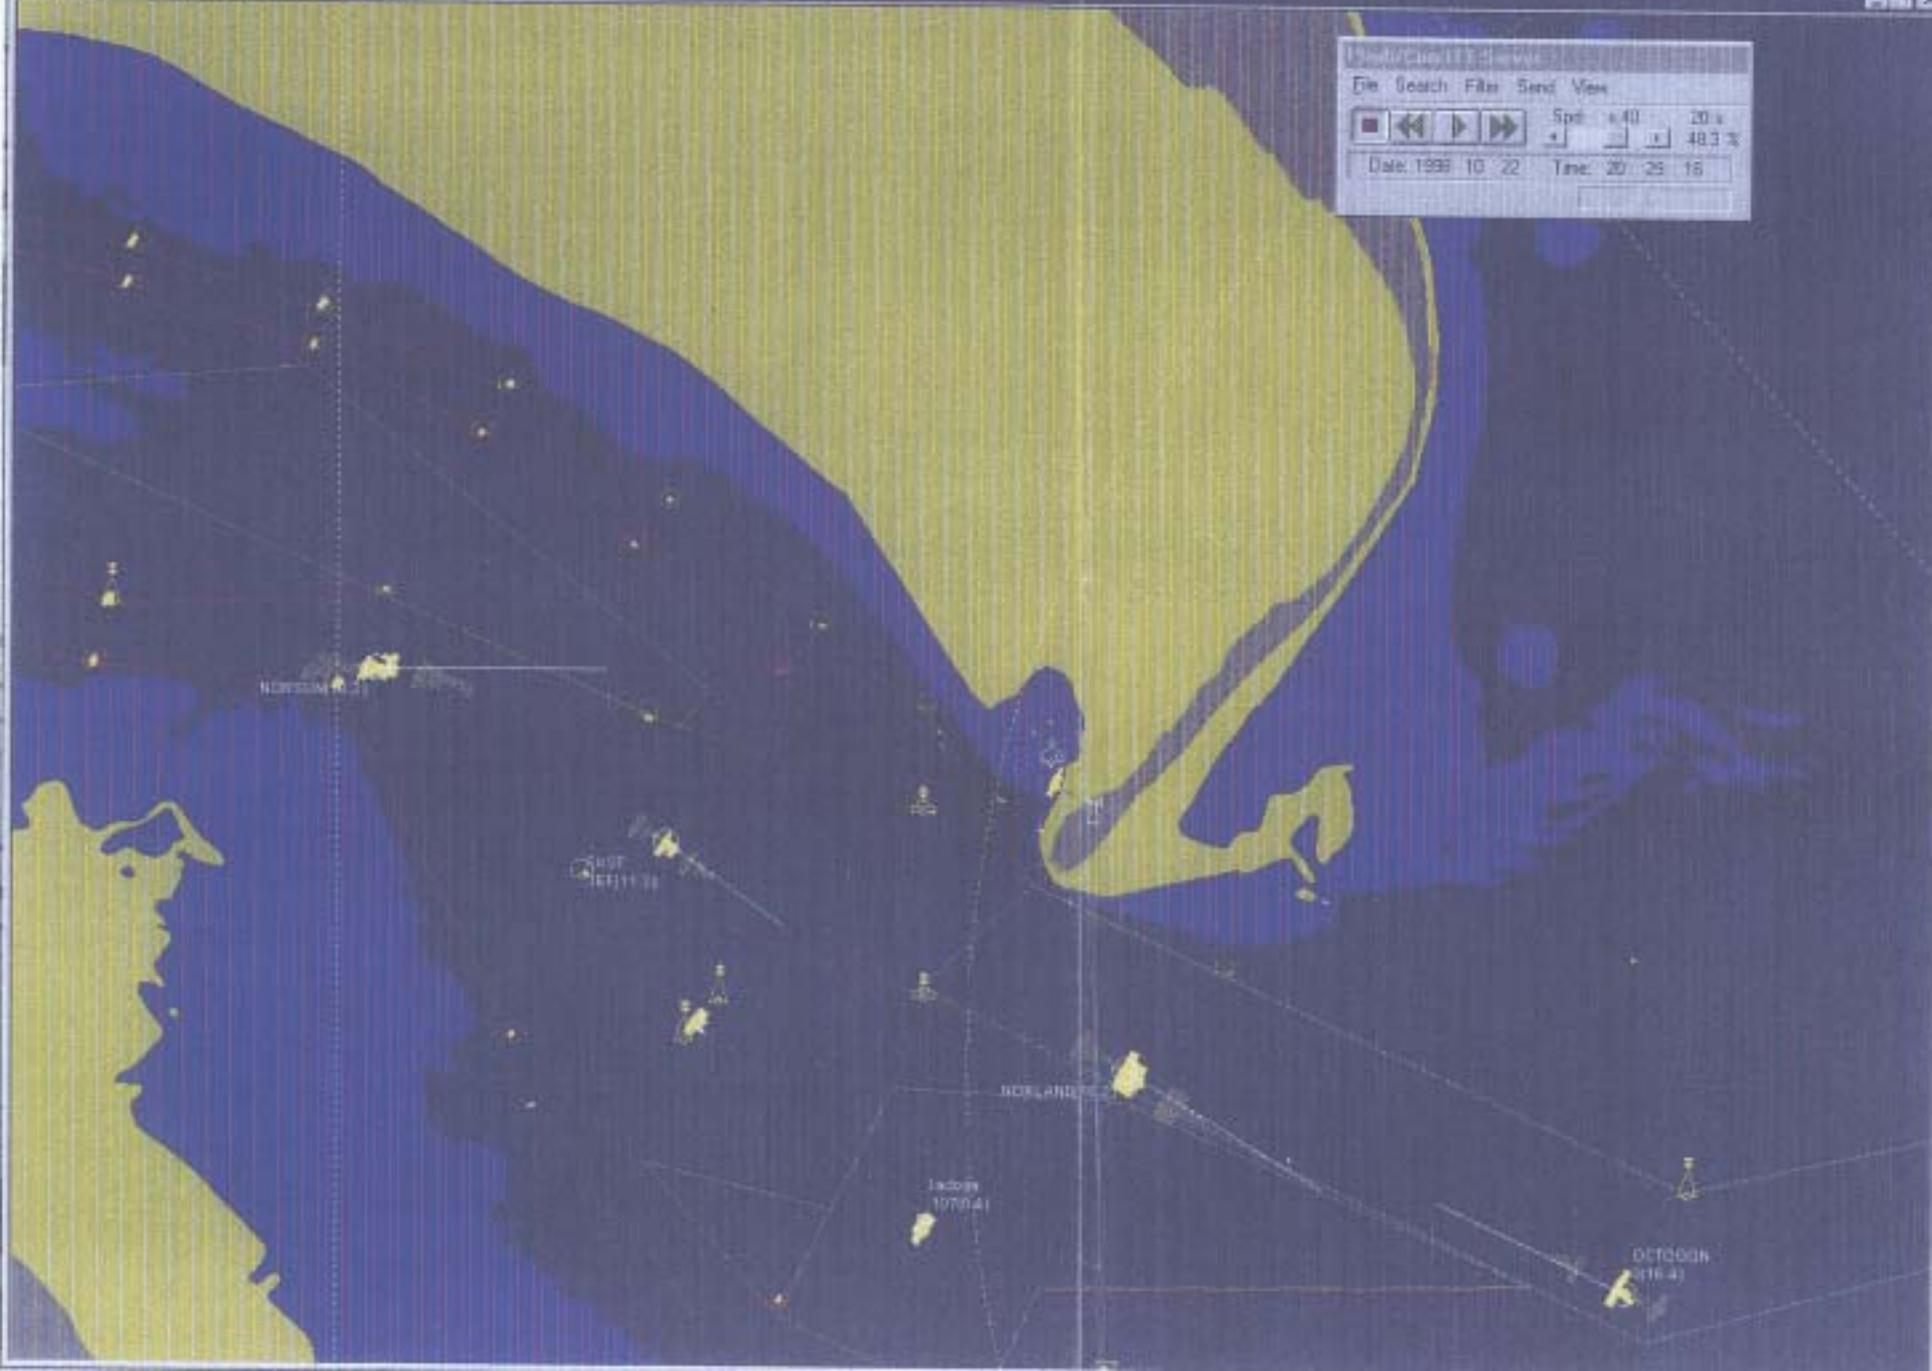
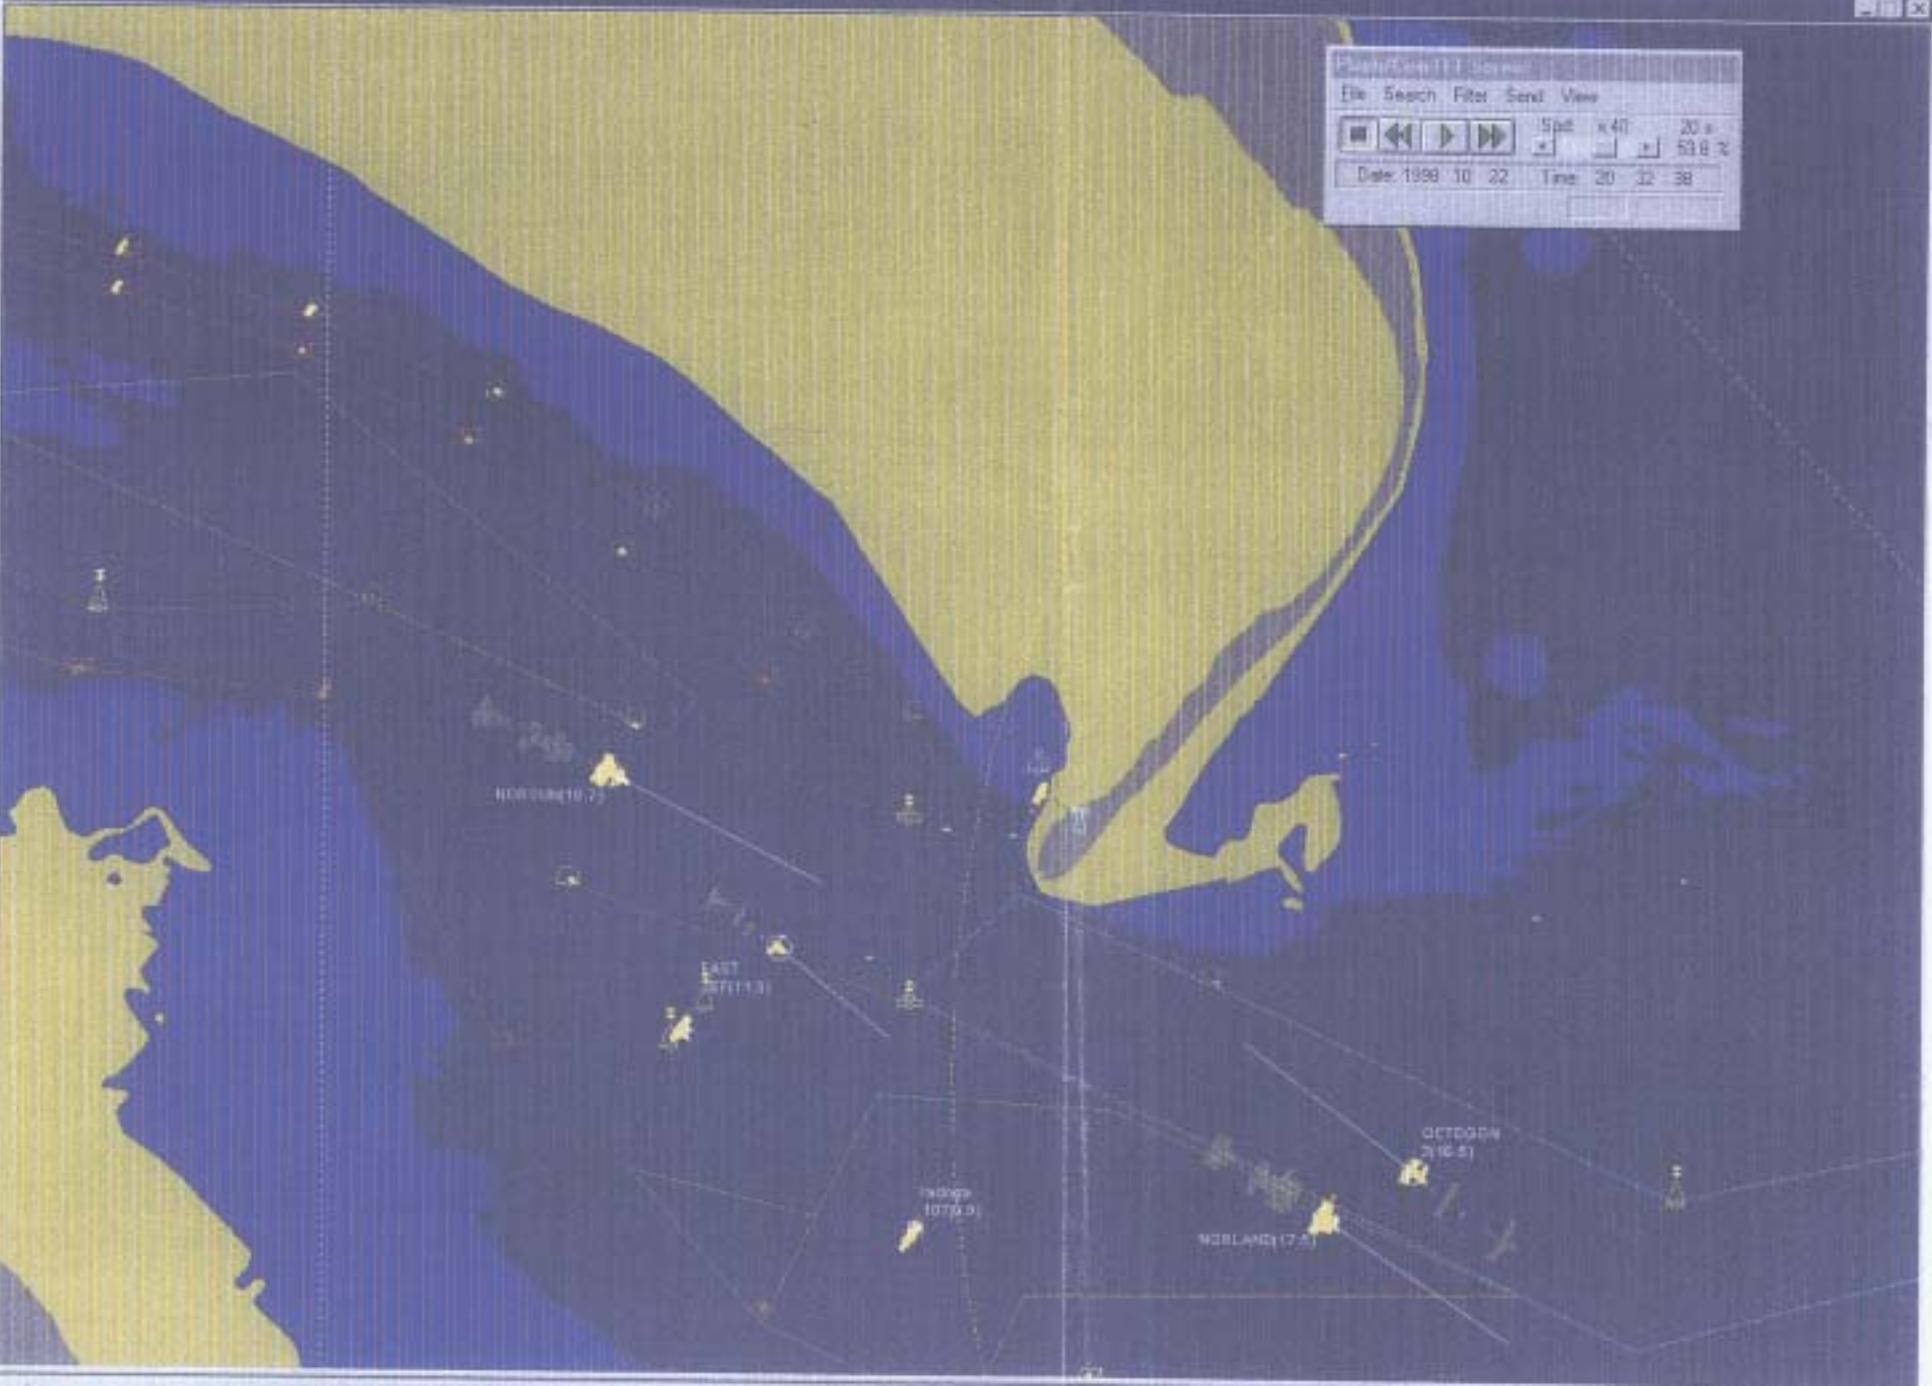
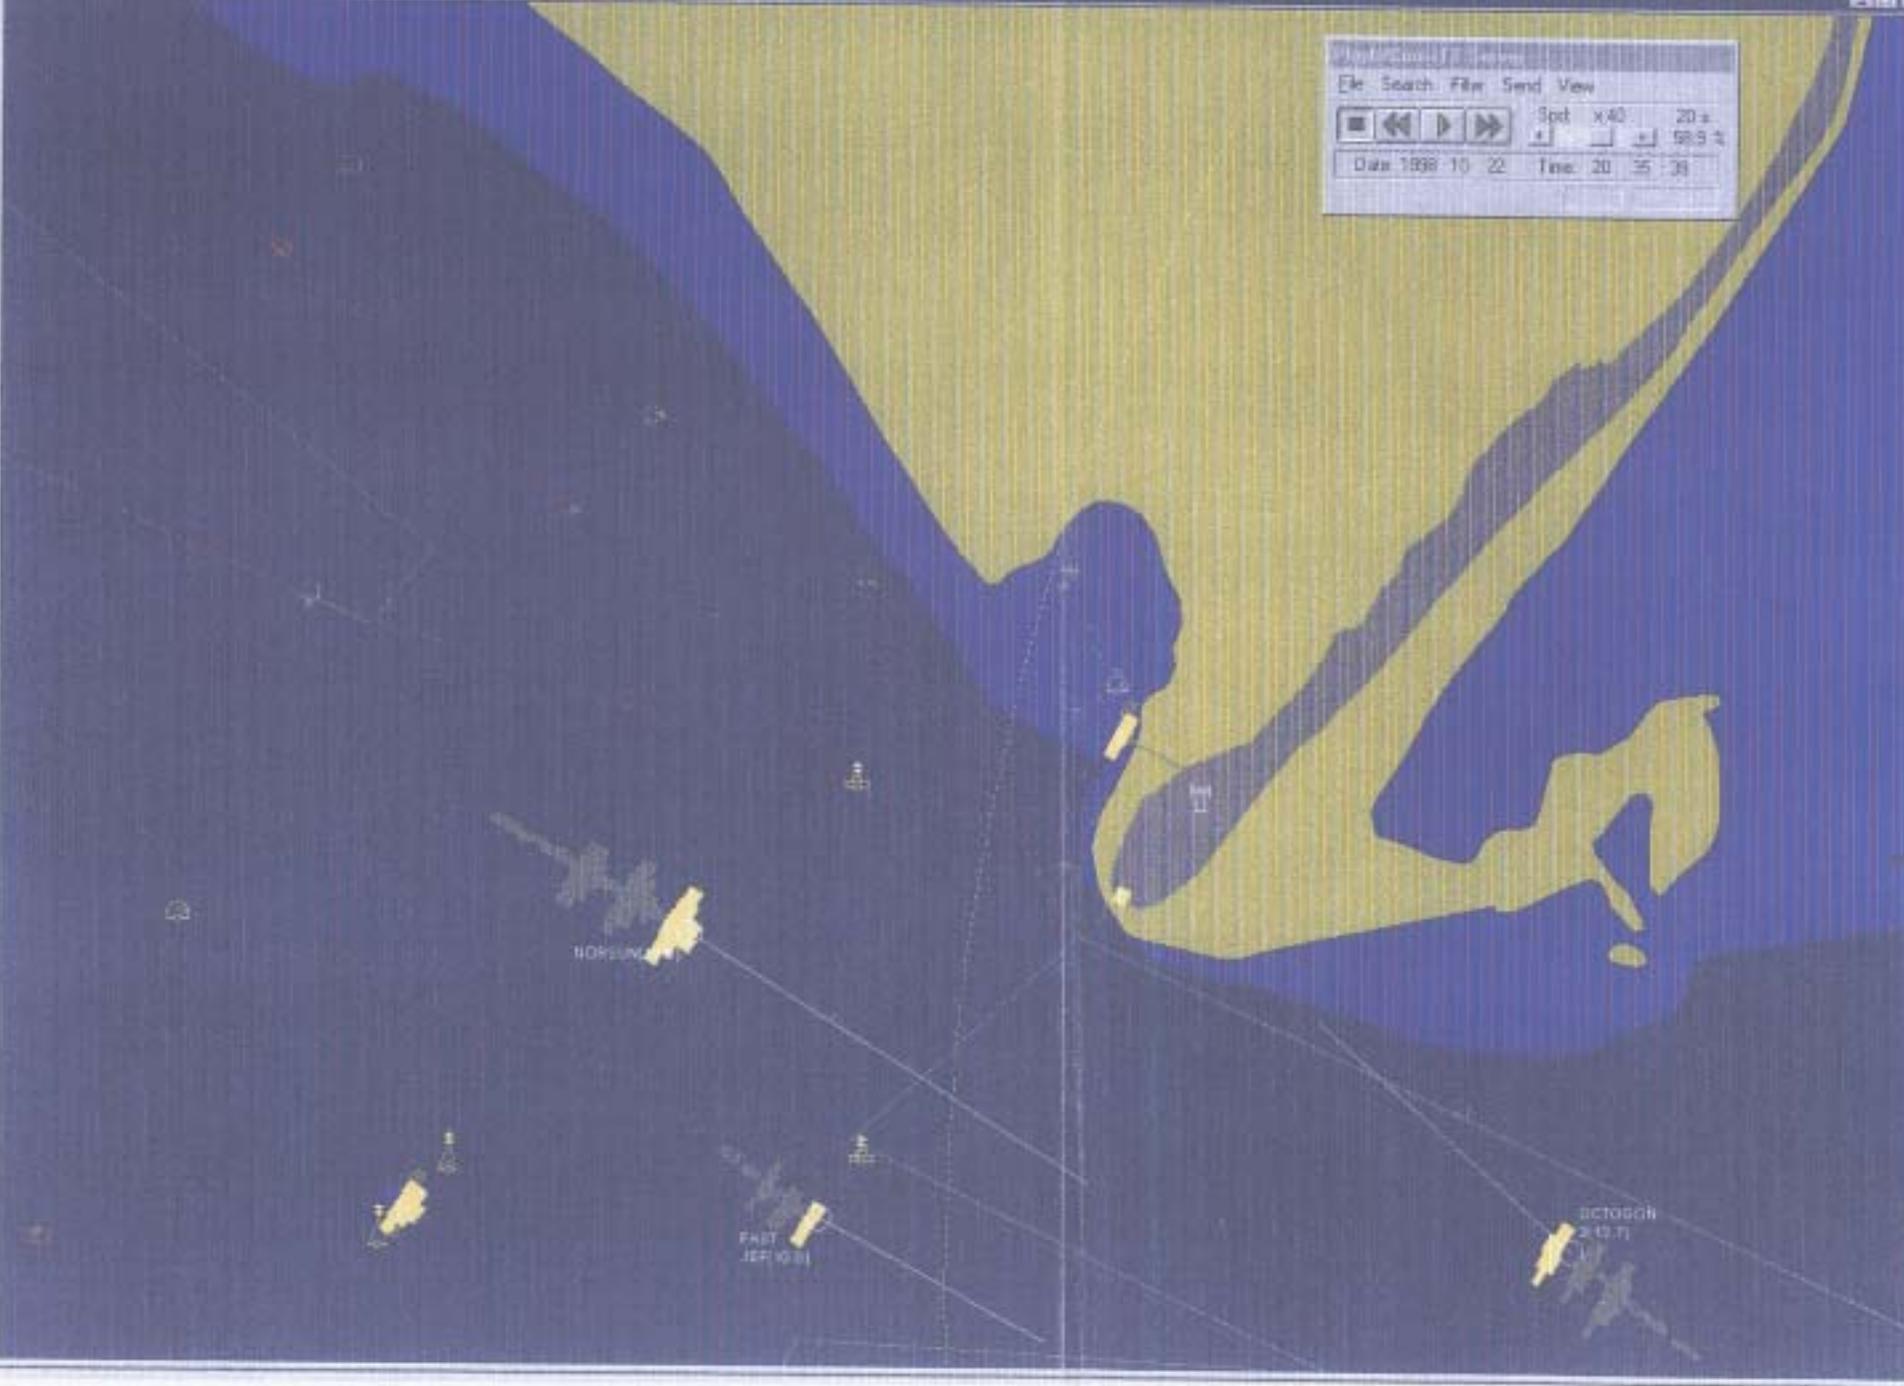
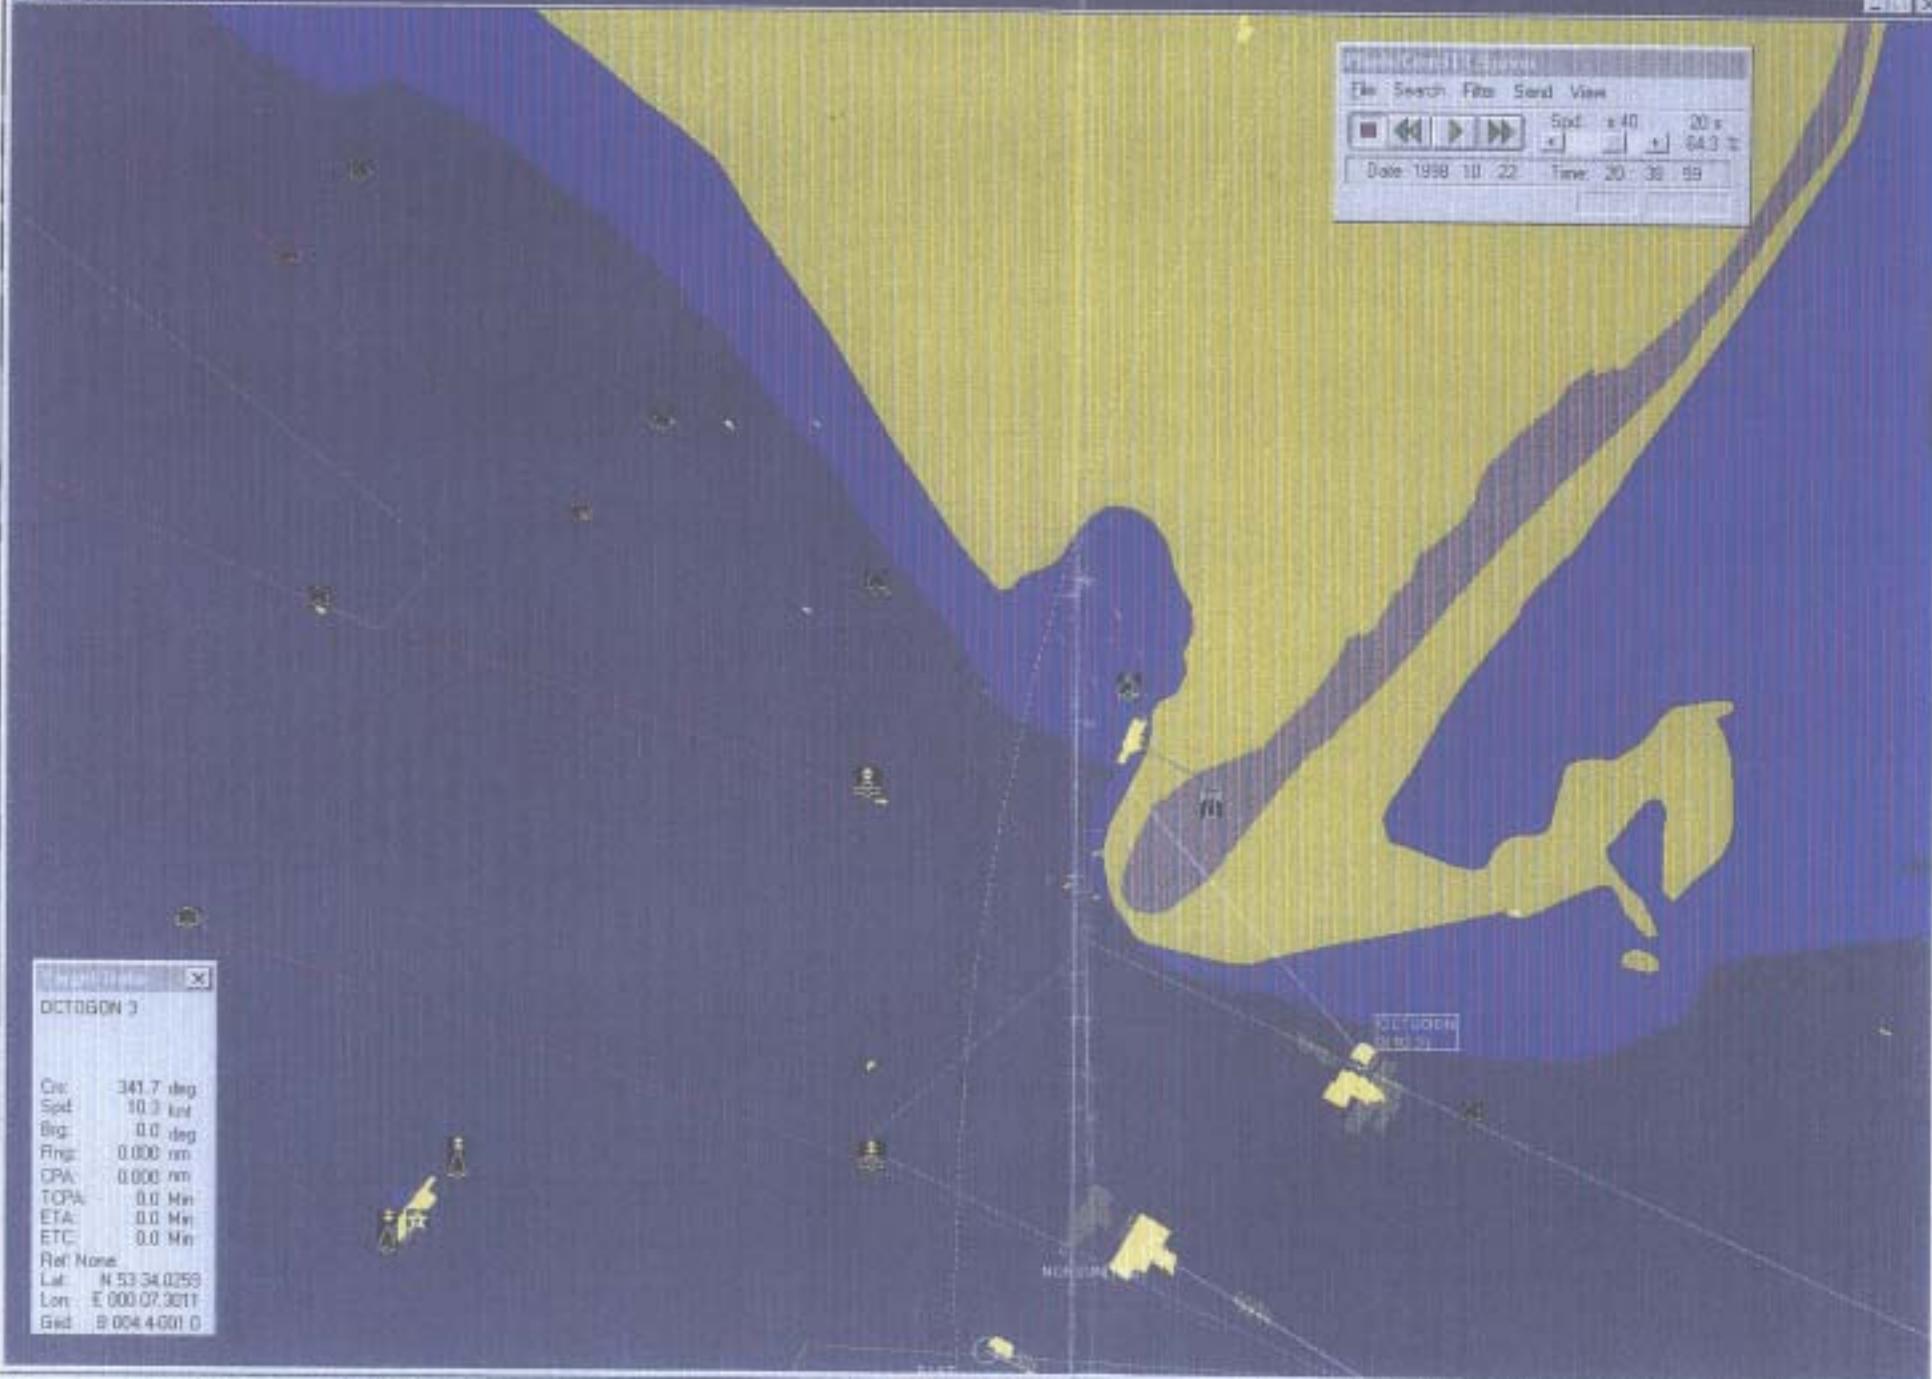
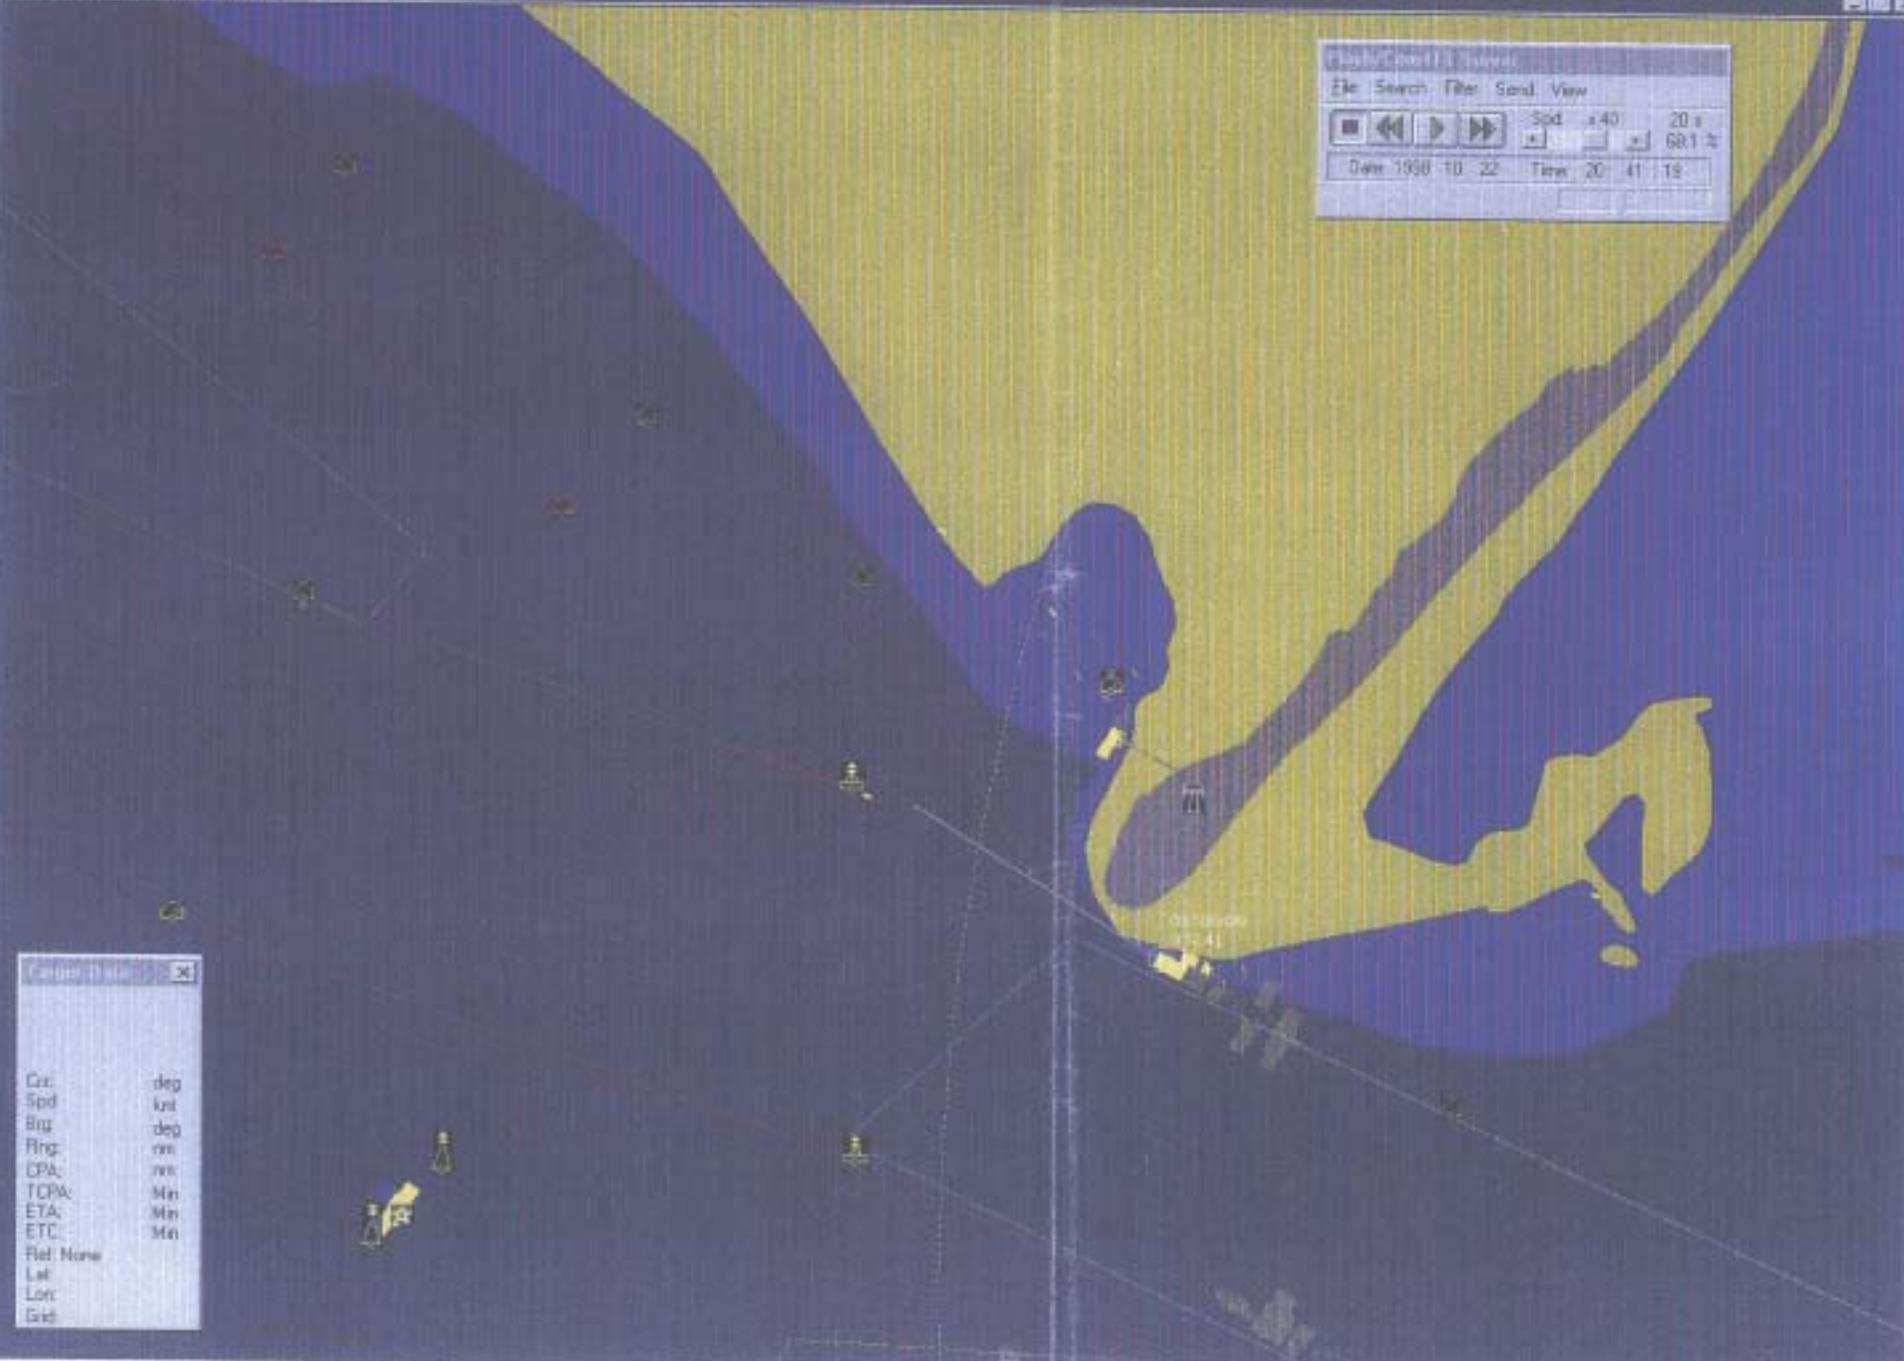
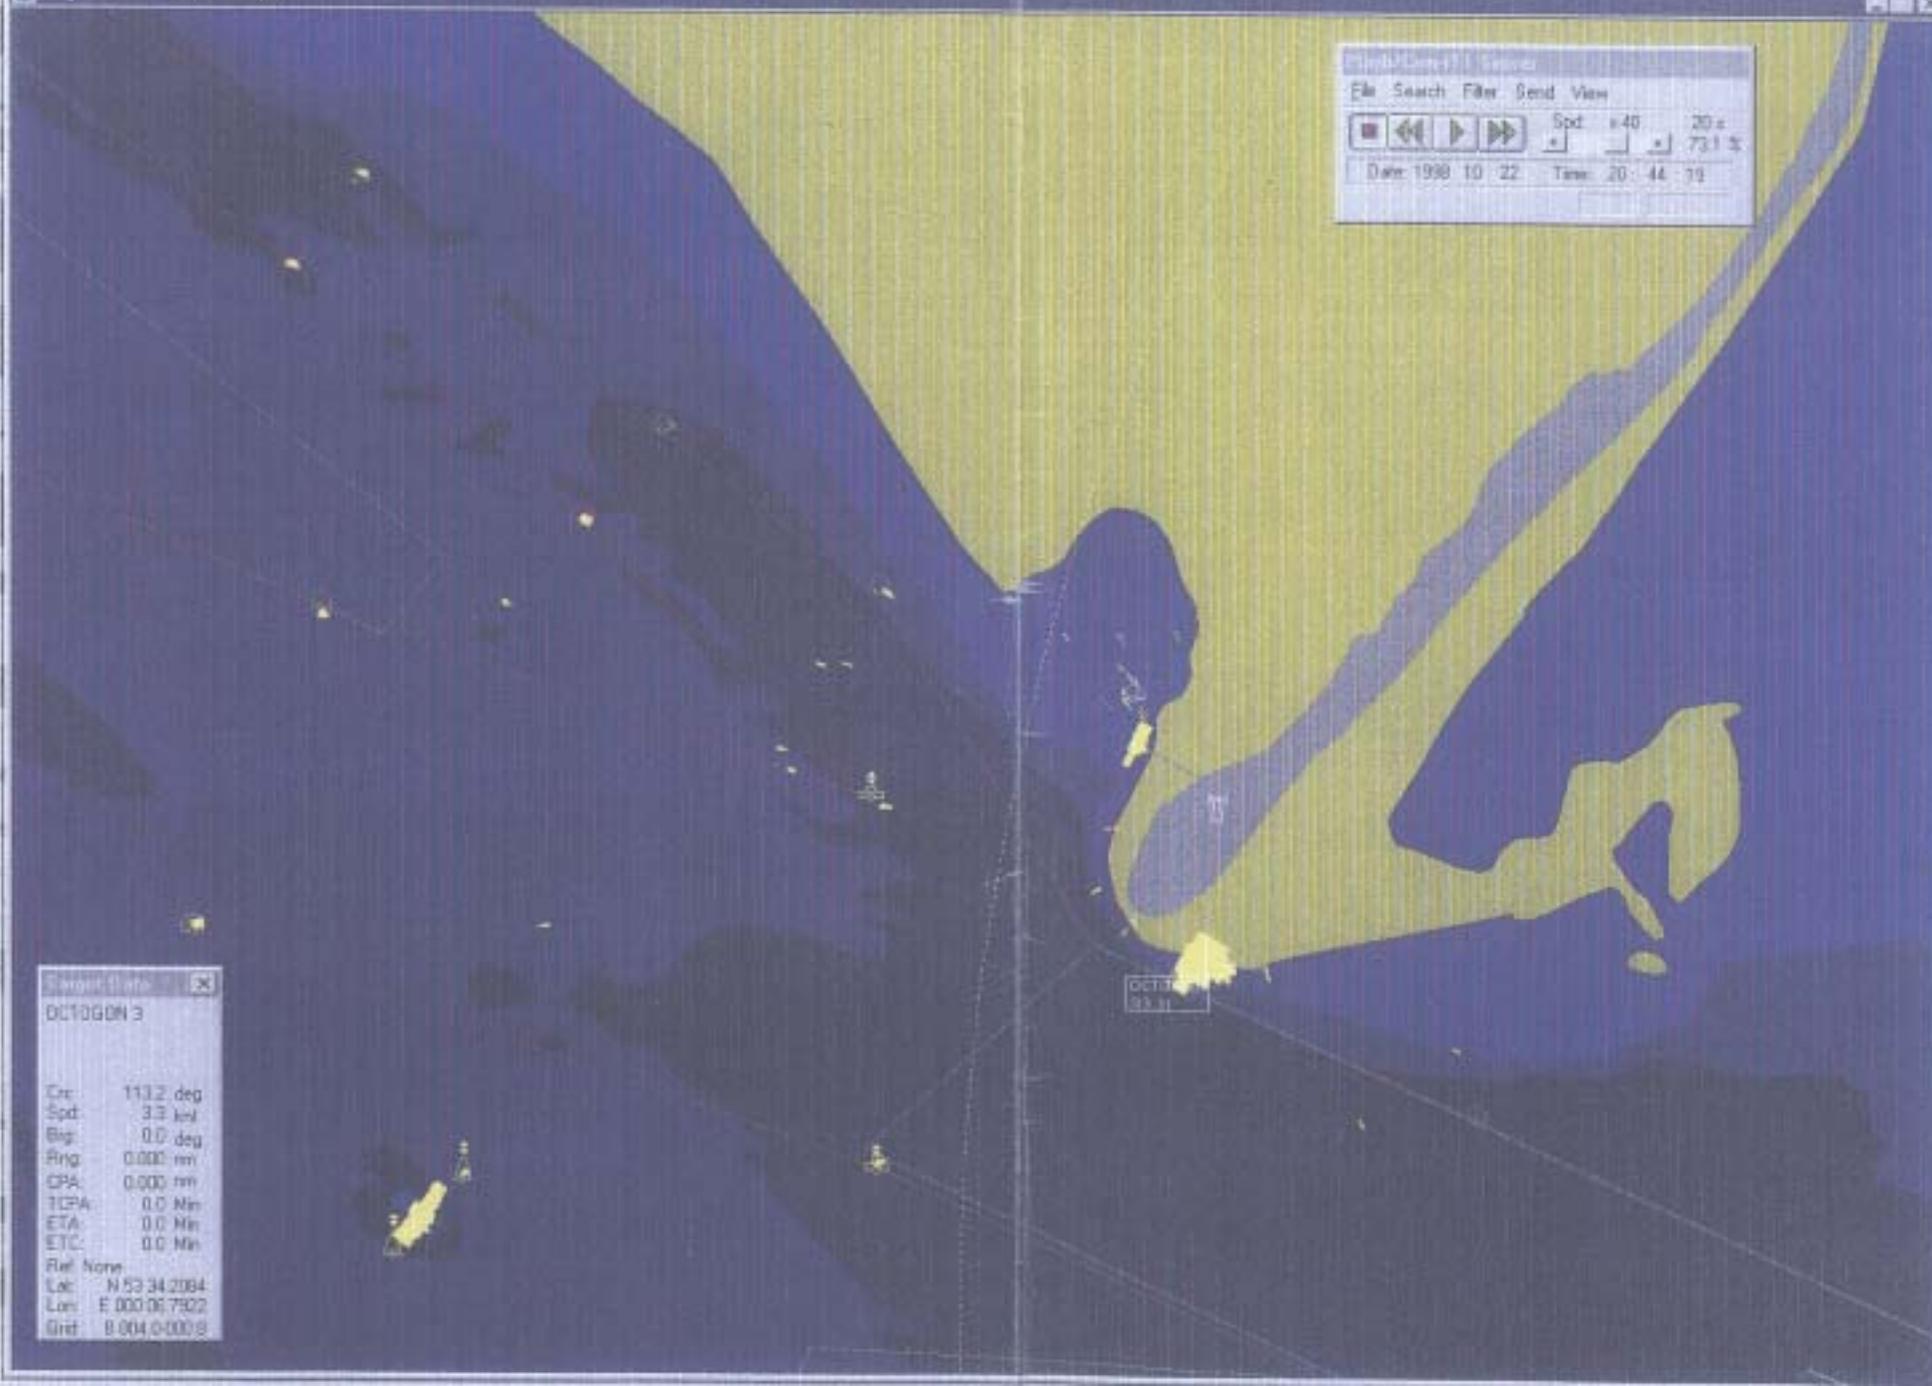
VTS radar print-outs

Analysis of the VTS radar tapes and the courses steered by the ship, show that from 2029 until picking up the pilot, *Octogon 3* was closing Spurn Head on a steady bearing and unless something was done to offset the drift, grounding

was inevitable. Had this very basic information, clearly available to him throughout, been interpreted correctly the master would have had every opportunity to make an allowance for the drift. It required an early and substantial alteration of course to port to offset the drift to starboard particularly in view of the probability that he would have to reduce speed to embark the pilot. The grounding would have been averted. He did not do so.

1. consider introducing the implementation of designated traffic lanes for the approaches to the River Humber within the limits of its jurisdiction;
2. investigate alternative types of pilot launches and consider their all-weather suitability for pilotage operations to seaward of the River Humber; and
3. encourage VTS operators to be more proactive, under the guidance of IMO Resolution A.857(20), to provide timely warnings to vessels acting in an unsafe manner.
