Report on the Investigation
on the Capsize of the
UK Registered Fishing Vessel
CATRINA NN194
South of Newhaven
on 13 October 1998

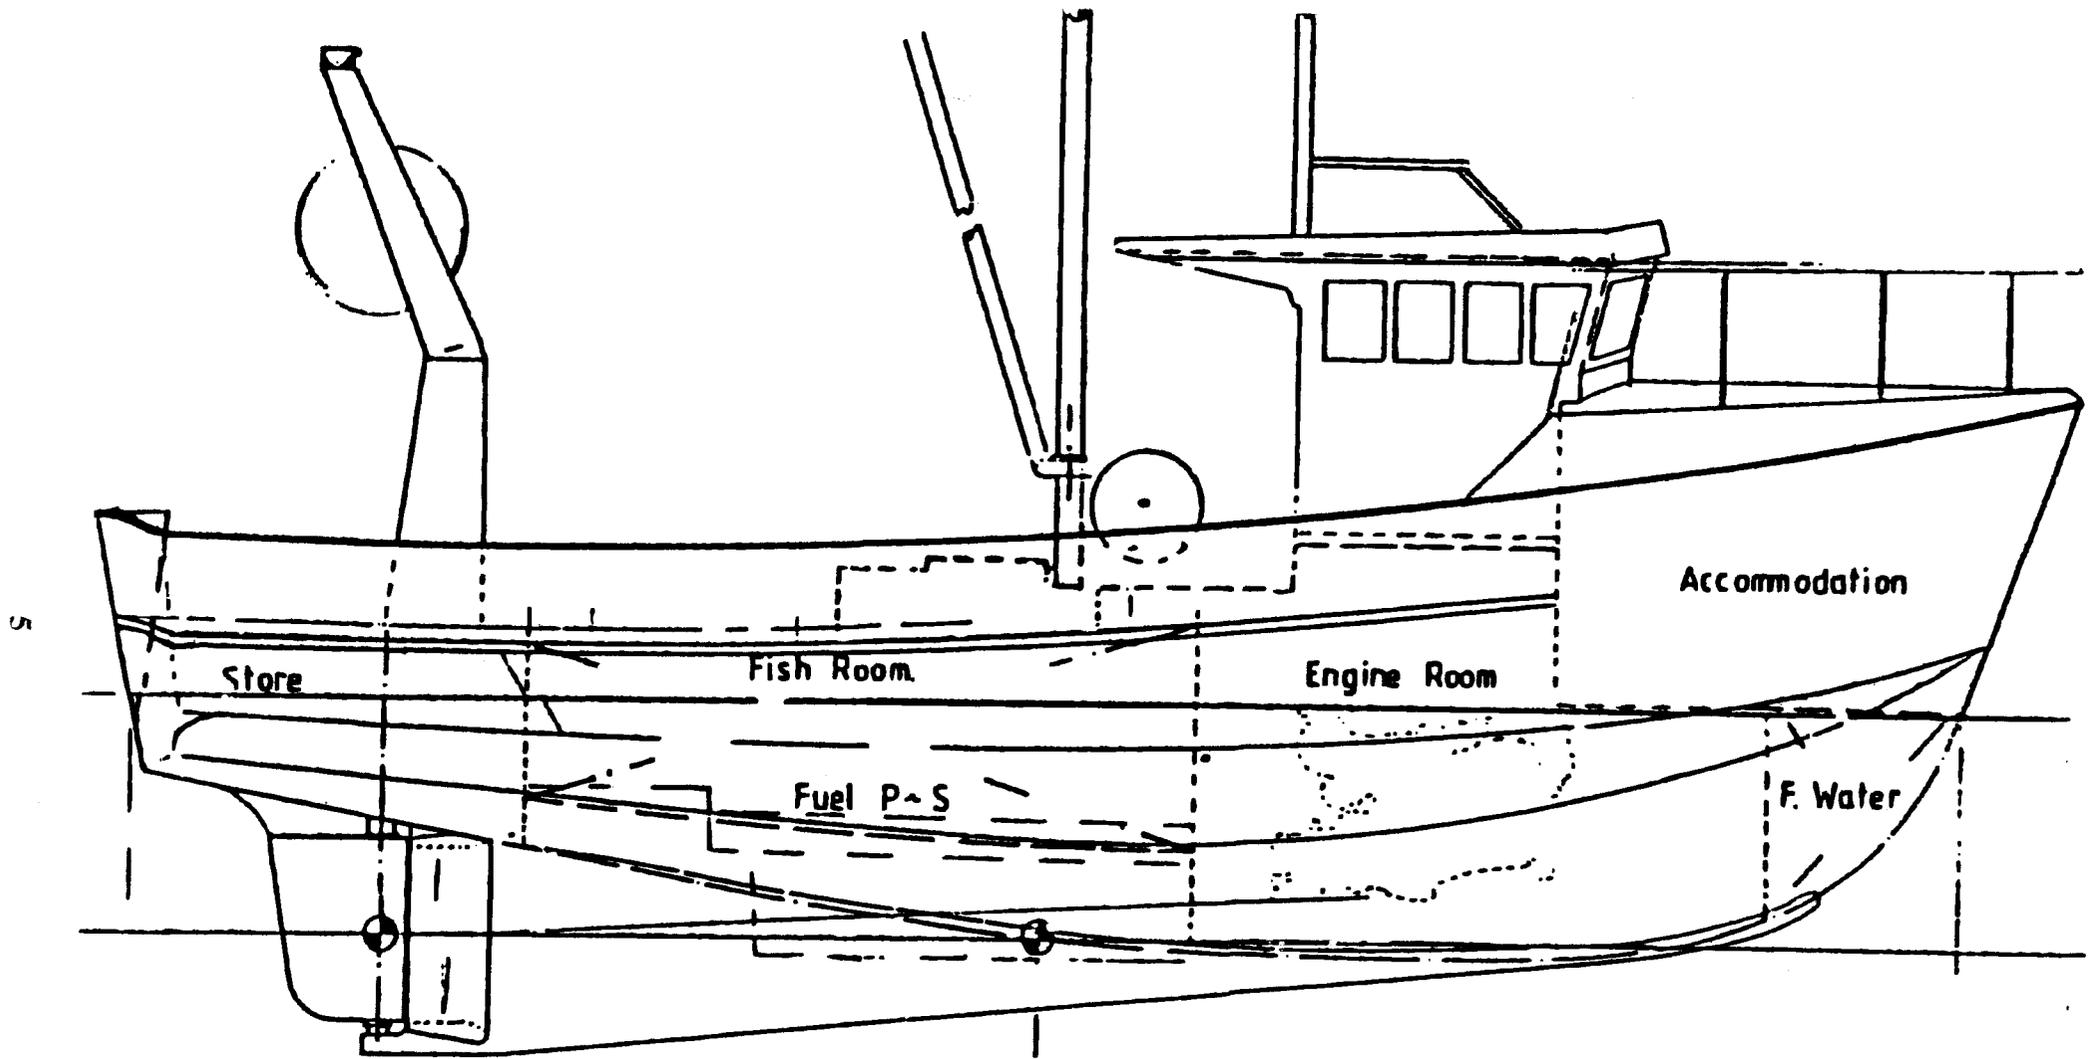
Catrina was one of four identical sister vessels in service with the same company. She was manufactured to a design developed by the shipyard for the owner, and had proved very successful in service. The transverse stability of the design was not assessed, but the skipper had every confidence in the vessel which he had found very seaworthy during his 6½ years as skipper. On many occasions he had sailed in far worse conditions than generally prevailed on 13 October and did not expect problems on that day, particularly with a lightly loaded vessel.

Layout of *Catrina*

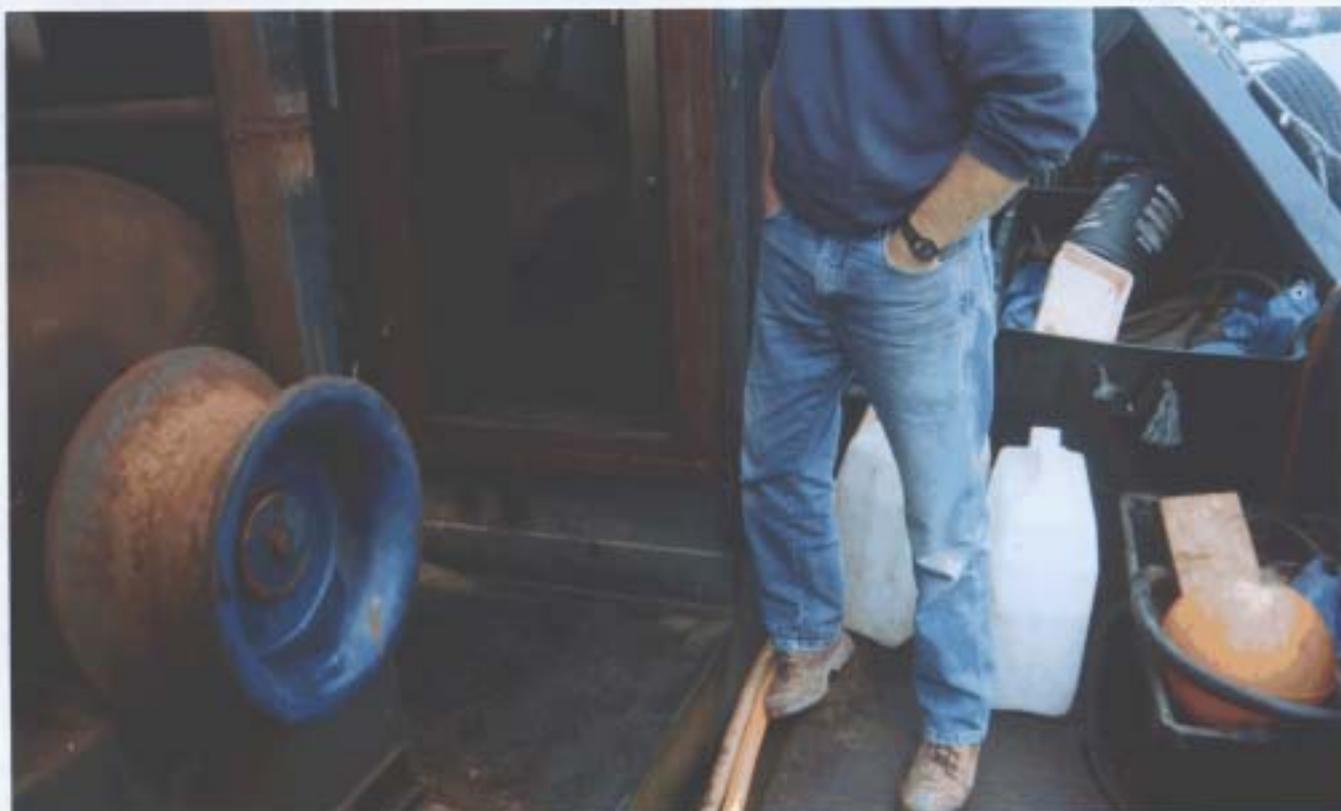
FIGURE 3

She was fitted with a forward wheelhouse (**Figure 2**). Access to the wheelhouse was through a wooden door in the starboard side of the aft bulkhead (**Figure 3**). Forward of the wheelhouse was the accommodation, which was connected to the wheelhouse by an opening in the bulkhead on the starboard side (**Figure 4**).

Wheelhouse Door

It is particularly important on small vessels that no openings are immersed before the angle of vanishing stability is reached. On *Catrina* two substantial openings were immersed, well before she had heeled to the 50° angle of vanishing stability. This caused rapid and extensive flooding of the interior of the vessel and possibly prevented her survival. At about 38° the door to the wheelhouse was immersed, flooding both the wheelhouse and forward cabin. At about 33° the starboard ventilator to the engine room was submerged, flooding that space (**Figure 10**).

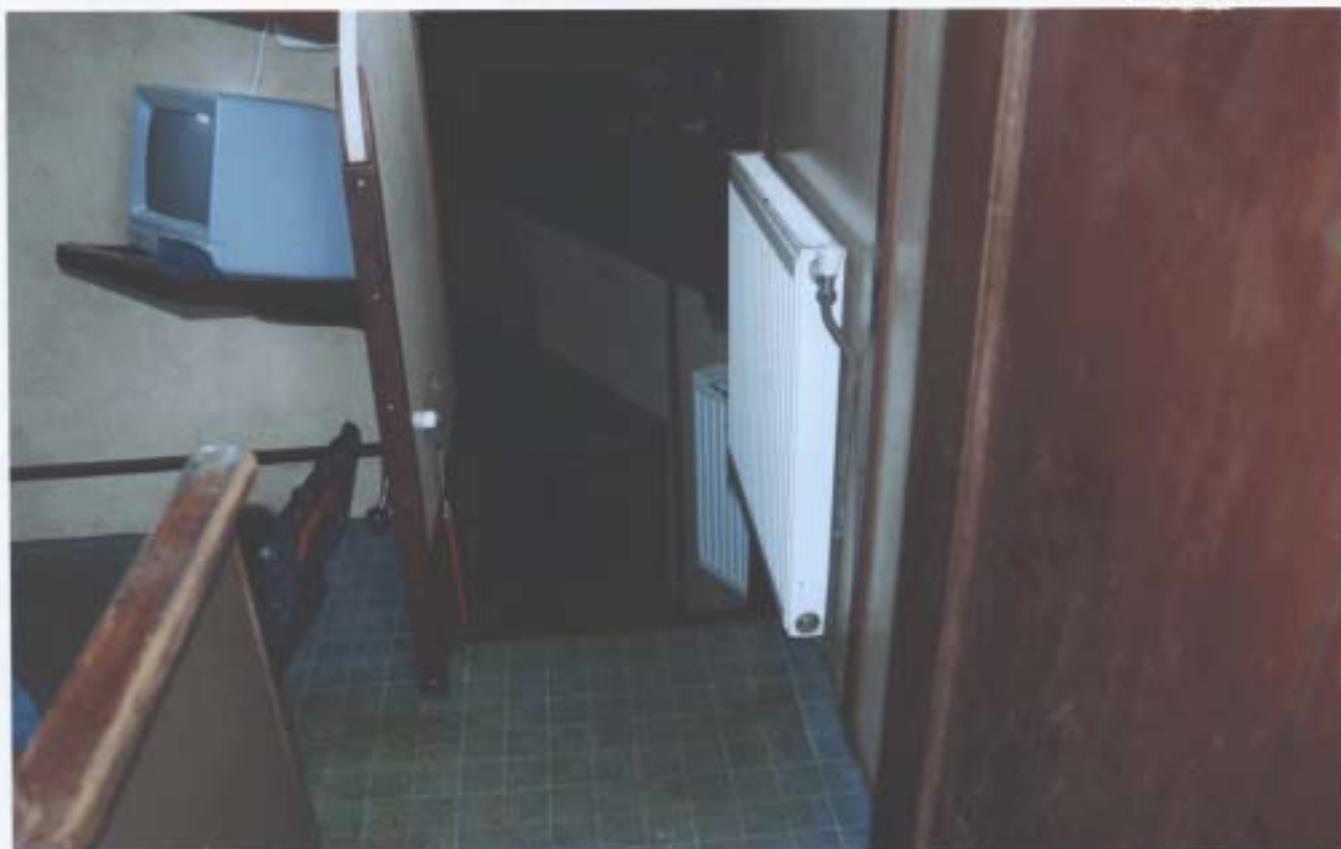
FIGURE 4

Access to Forward Accommodation from Wheelhouse

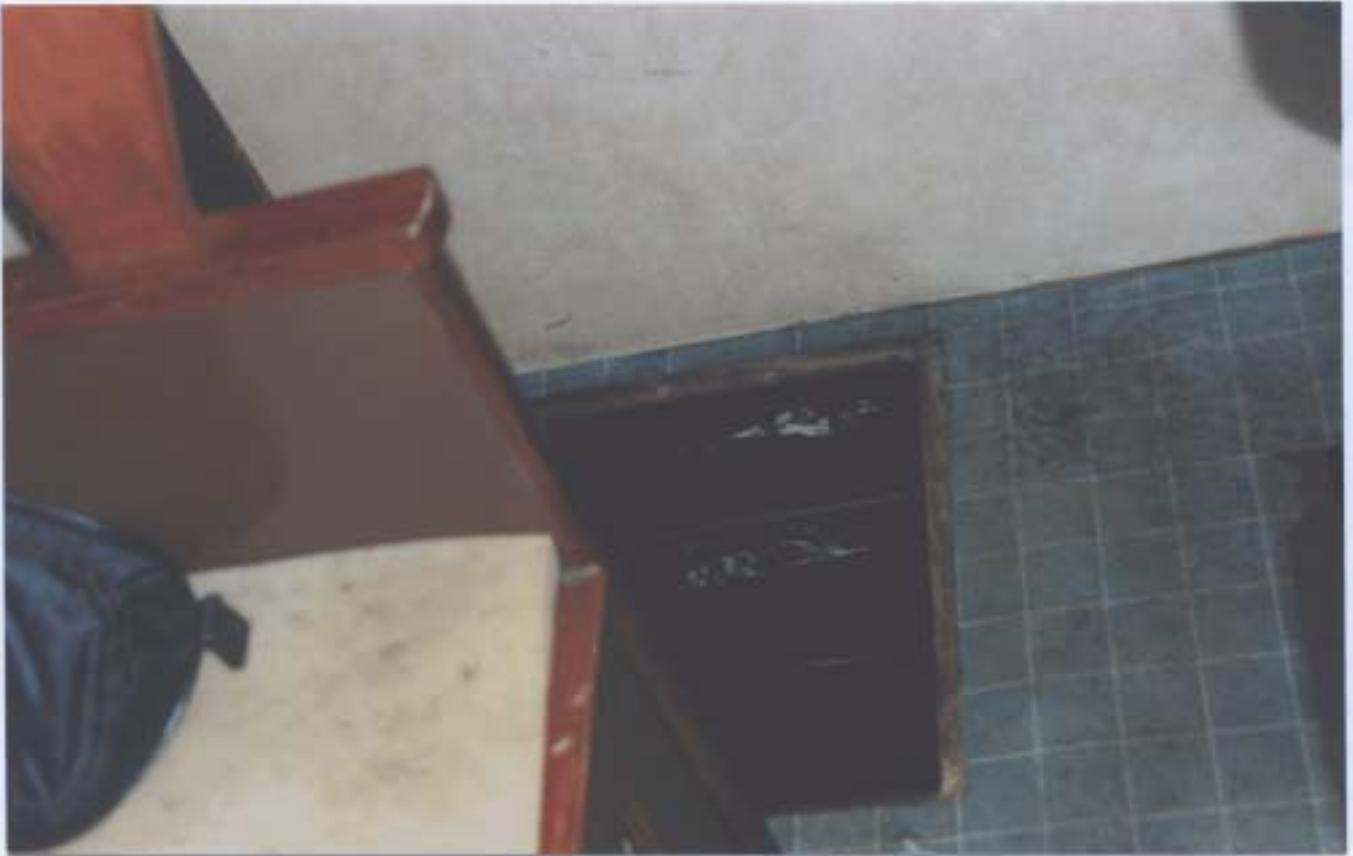
FIGURE 5

The fish hold was amidships between watertight bulkheads, and forward of this was the engine room. Access to the engine room was through a non-watertight hatch in the wheelhouse sole (**Figure 5**). Ventilators to the engine room were fitted on both sides just inboard of the bulwarks and against the aft face of the foc'sle bulkhead (**Figure 6**). The ventilators were 150mm x 200mm in section and stood 840mm above the weather deck.

Engine Room Hatch in Wheelhouse

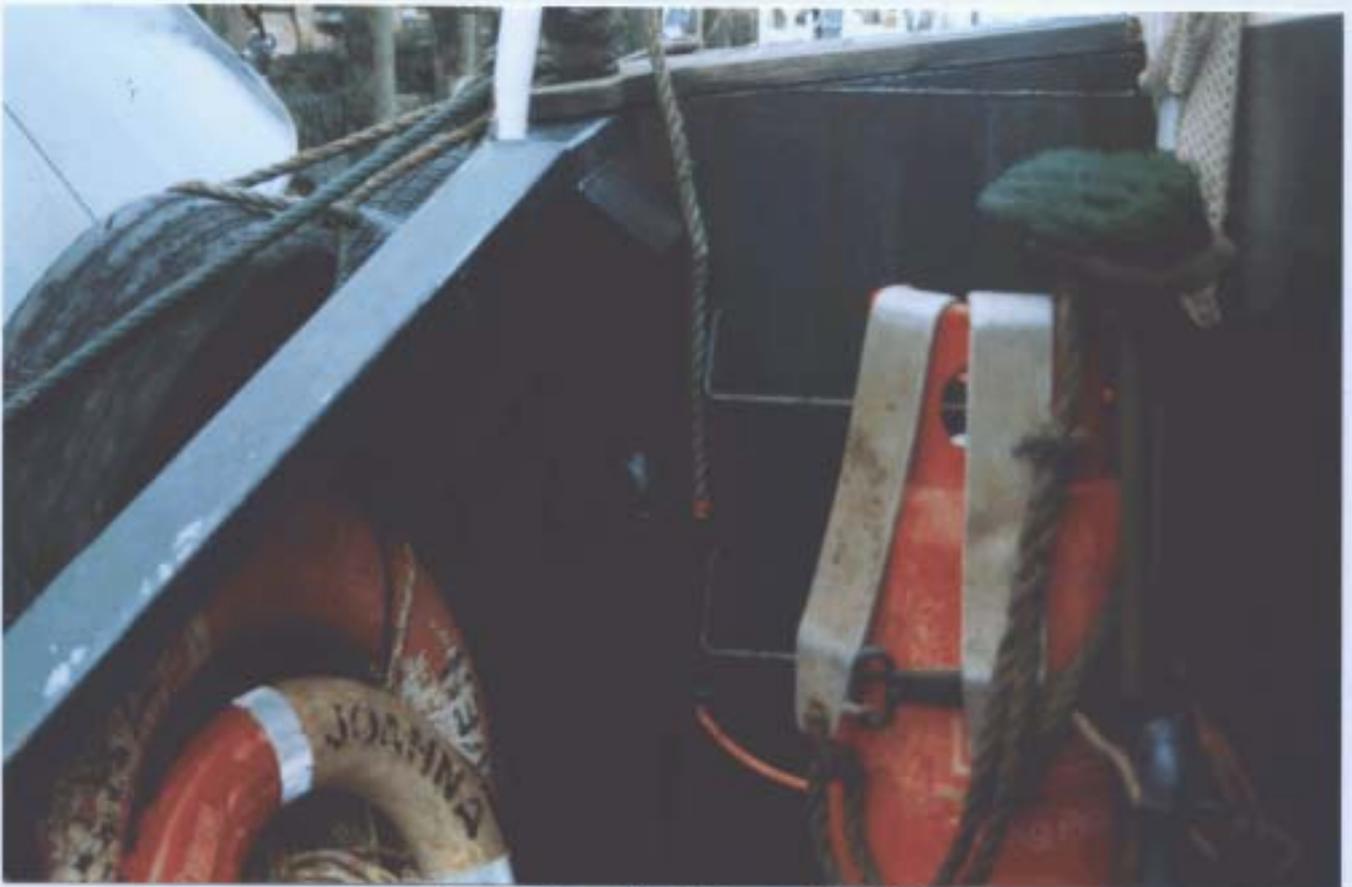
FIGURE 6

Engine Room Ventilator on Port Side

Openings essential to the working of the vessel should be placed on the centre-line, wherever possible, to ensure that maximum advantage is taken of the available range of stability. For the same reason the locations and heights of ventilators should also be carefully considered.

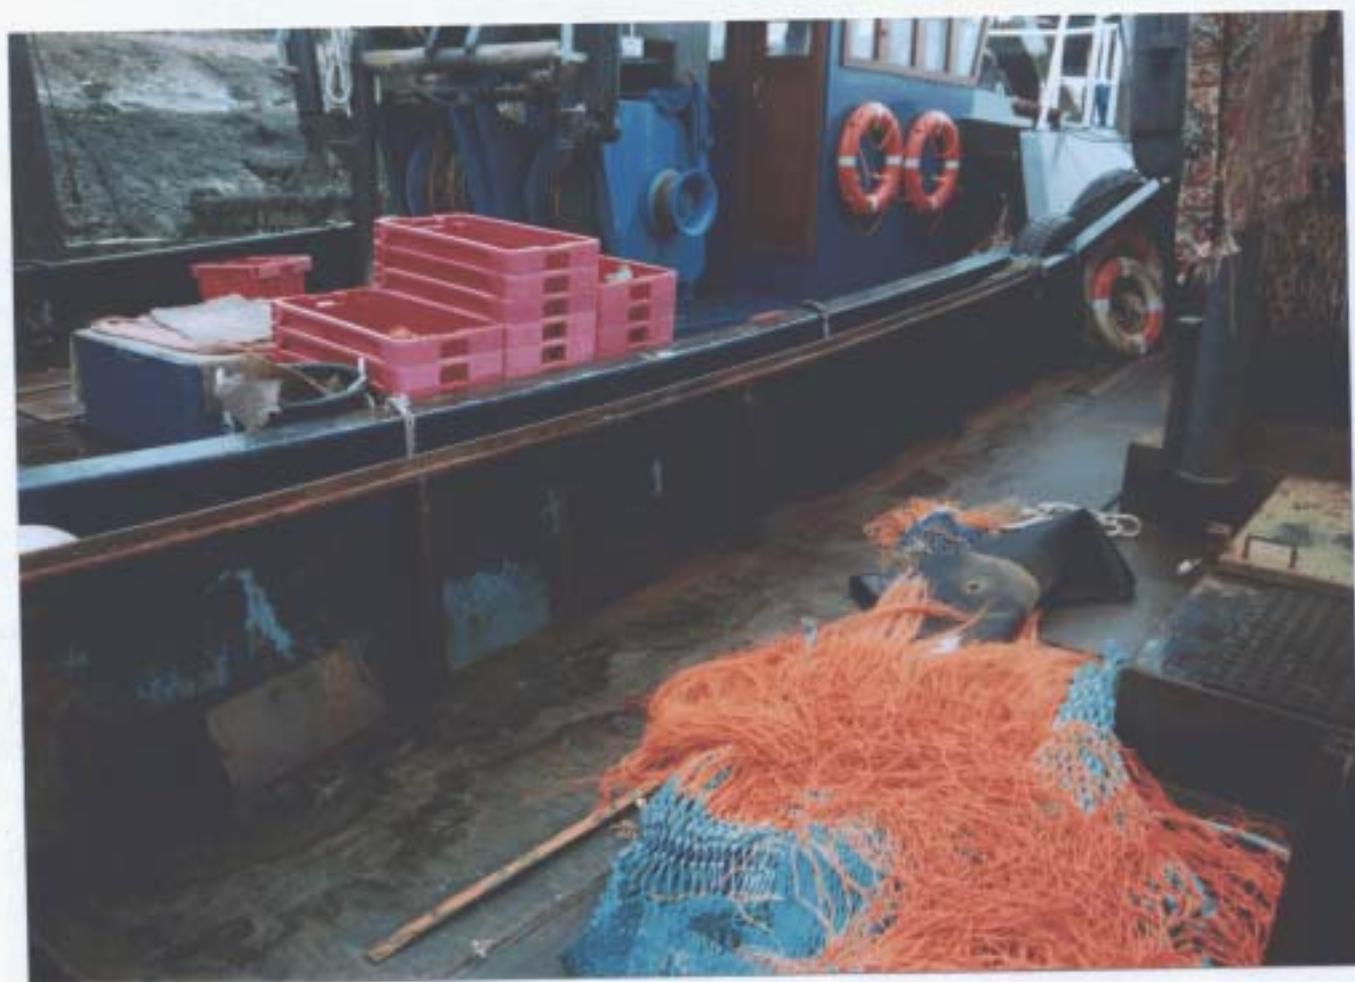
FIGURE 7

The working deck was bounded by bulwarks fitted with three freeing ports on each side and two across the transom. The total area of the freeing ports on each side was about 0.35 m², some 30% greater than the area specified in the Sea Fish Industry Authority (SFIA) *Rules for the construction of steel fishing vessels of less than 24.4 metres registered length*. The freeing ports could be closed by vertical plates (**Figure 7**).

Freeing ports

She was well provided with freeing ports, the total area of which was well in excess of SFIA requirements. However, an inspection of the vessel showed that the freeing ports were concentrated amidships and there was a large area of the deck forward where water could be trapped inside the bulwarks. This could be improved by fitting an additional freeing port just aft of the foc'sle bulkhead.

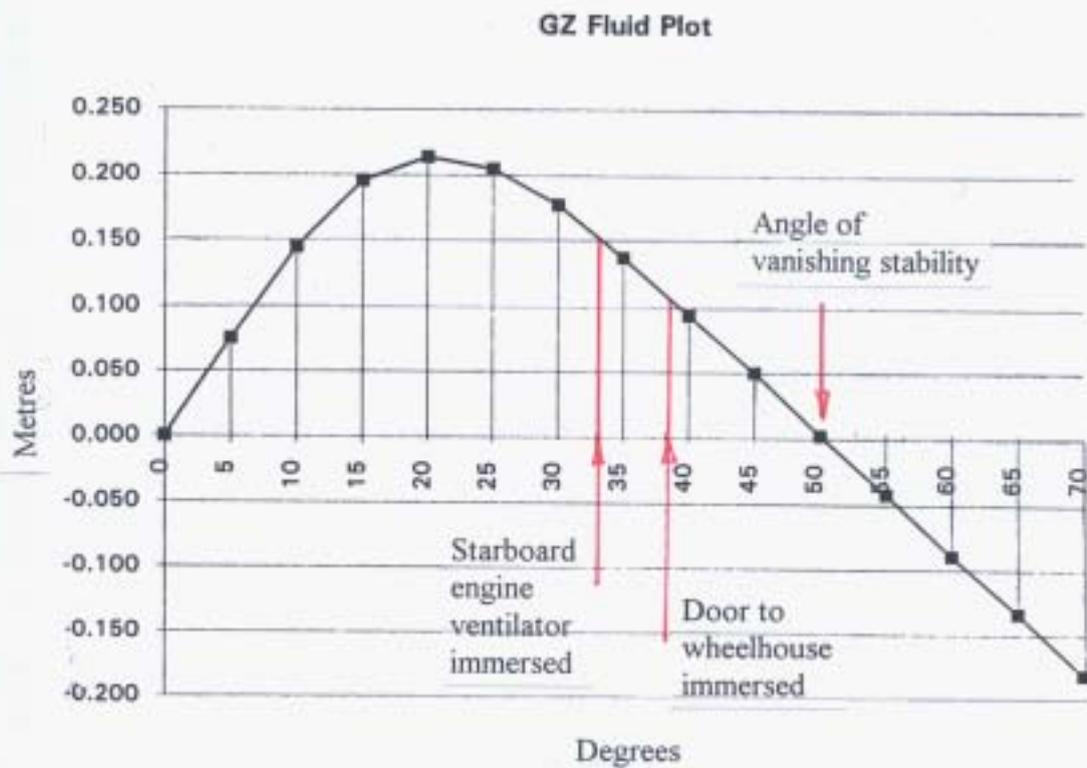
FIGURE 10

Catrina's Stability Curve Showing Downflooding Points

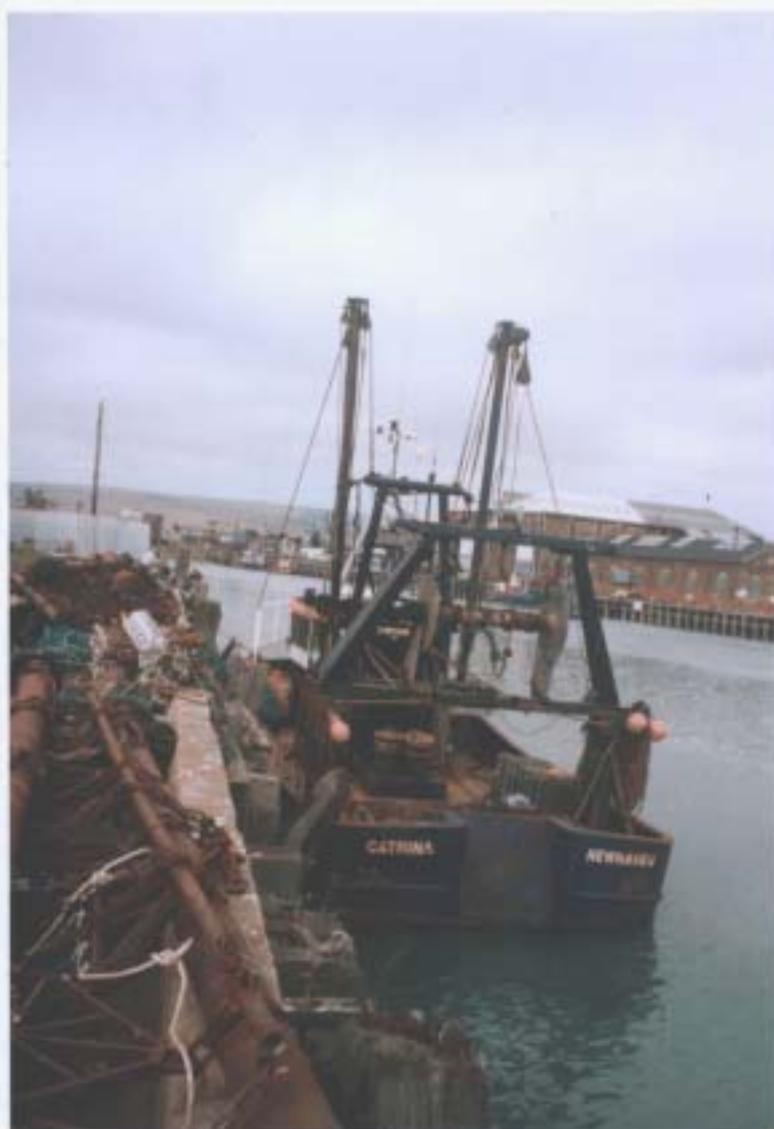
FIGURE 11

Catrina in Port, Showing Obstructions to Freeing Ports

The MAIB was also concerned that gear on deck, such as pound boards and stowed scallop bars, could have obstructed the freeing ports and prevented the deck from draining rapidly. Photographs of *Catrina* in harbour showed that pound boards were obstructing

the flow of water through the freeing ports in the transom, and fishing boxes were stowed in front of some of the freeing ports on the starboard side (**Figure 11**).

It is essential that freeing ports are unobstructed when the vessel is at sea. The owner is recommended to draw this important matter to the attention of his skippers.

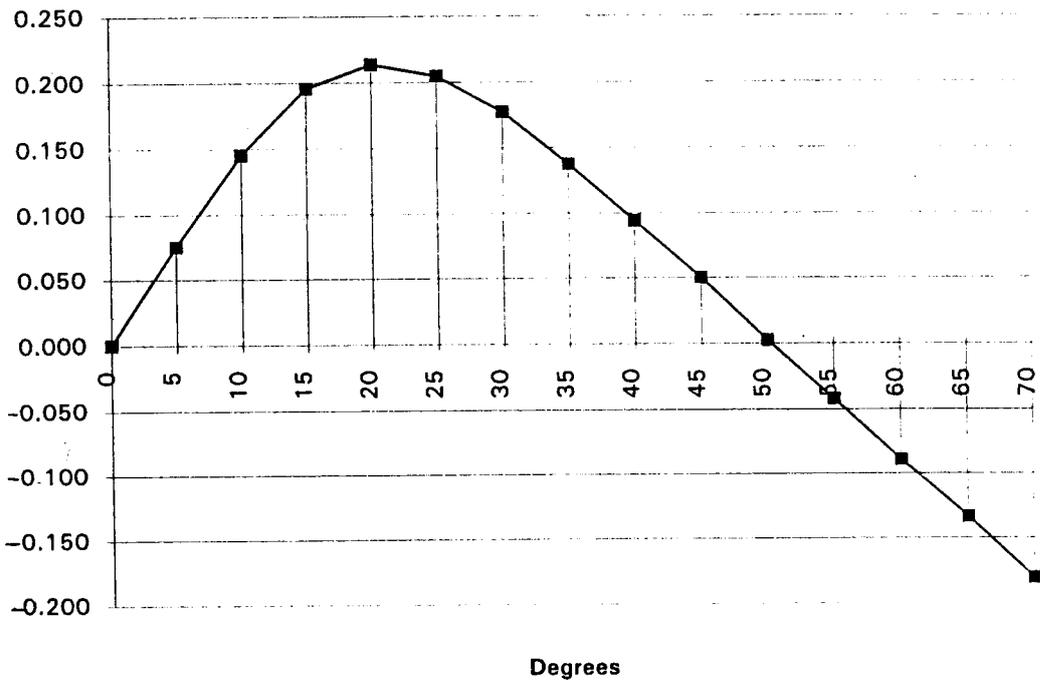
GZ Fluid Plot

STABILITY	SUMMARY	MINIMUM	ACTUAL
		BEAM TRAWL	
AREA UNDER GZ CURVE	UP TO 30 DEG	METRE RAD	0.066
AREA UNDER GZ CURVE	UP TO 40 DEG	METRE RAD	0.108
AREA UNDER GZ CURVE	BETWEEN 30-40		0.036
MAXIMUM GZ		METRES	0.213
ANGLE OF HEEL AT WHICH	MAX GZ OCCURS	DEGREES	25
MAXIMUM GZ BETWEEN	30 - 90	DEGREES	0.24
GM SOLID			0.871
FREE SURFACE CORRECTION			0.002
GM FLUID			0.42
			0.869
