Report of investigation into

Fire in main galley of

Edinburgh Castle

on 21 August 1998

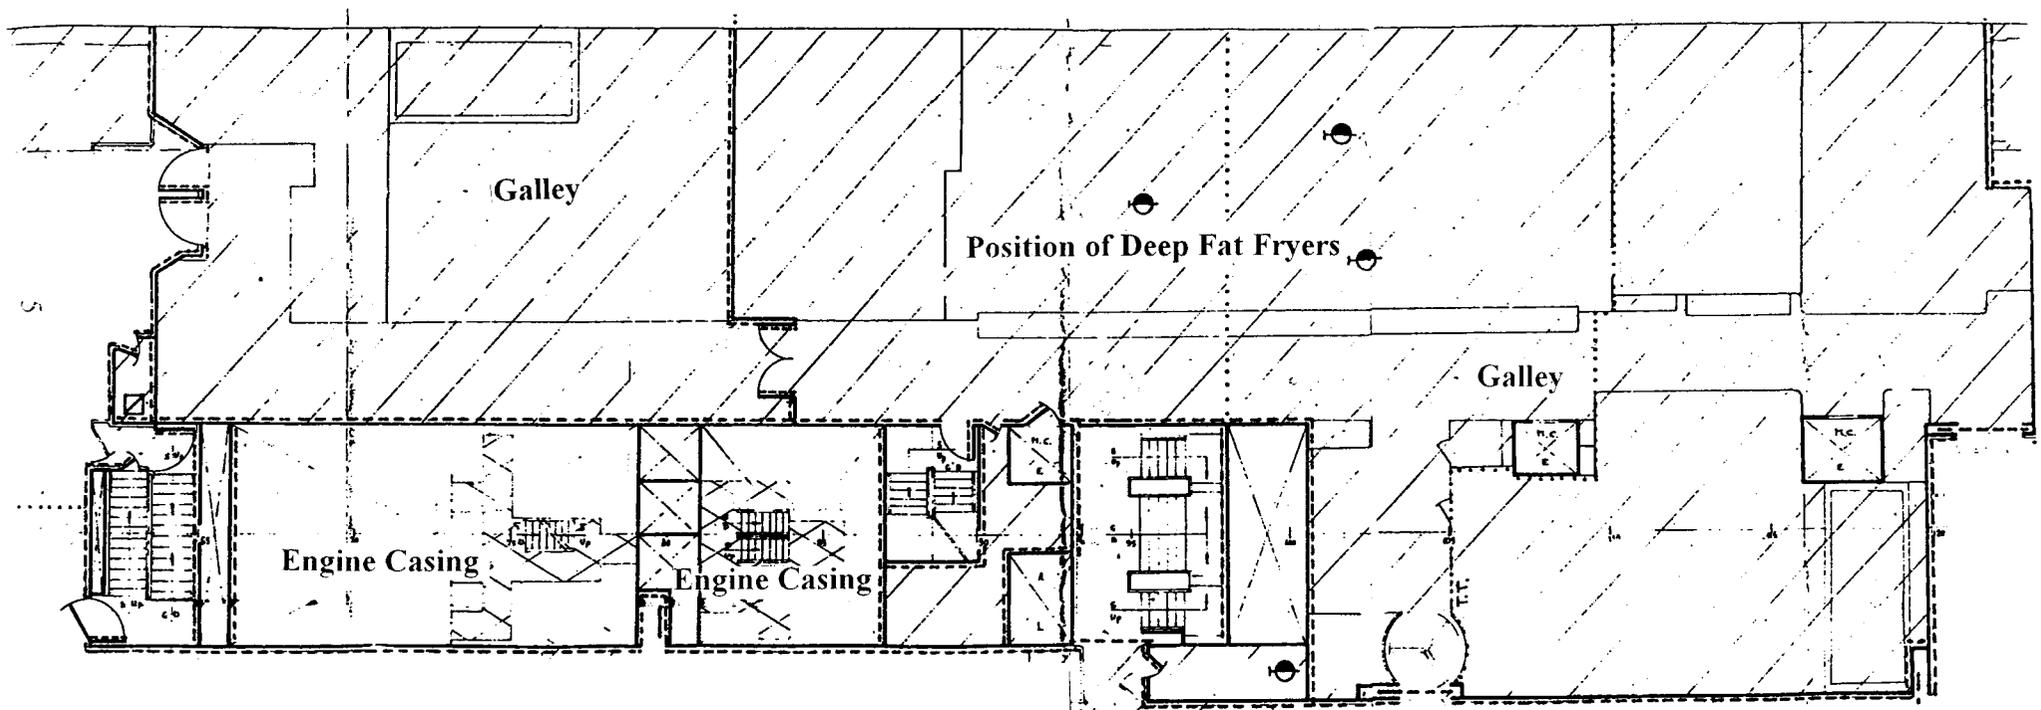
Figure 2. Extract from vessel's Emergency Fire Plan covering Deck 7 and Main Galley

The vessel's emergency fire plan showed three dampers in the main galley (**Figure 2**). No identification labels or other marking were shown, either on the emergency fire plan or other drawings of the ventilation system (**Figure 7**).

The vessel's fire plan, for example, showed three fire dampers within the main galley (**Figure 2**). However, the position and function of these was not clear from an inspection of the galley or from other documents.

There is a need for the crew to have information which is clear and accurate. The owners have indicated that they recognise this and stated they are to improve identification of these dampers and crew training on this subject.

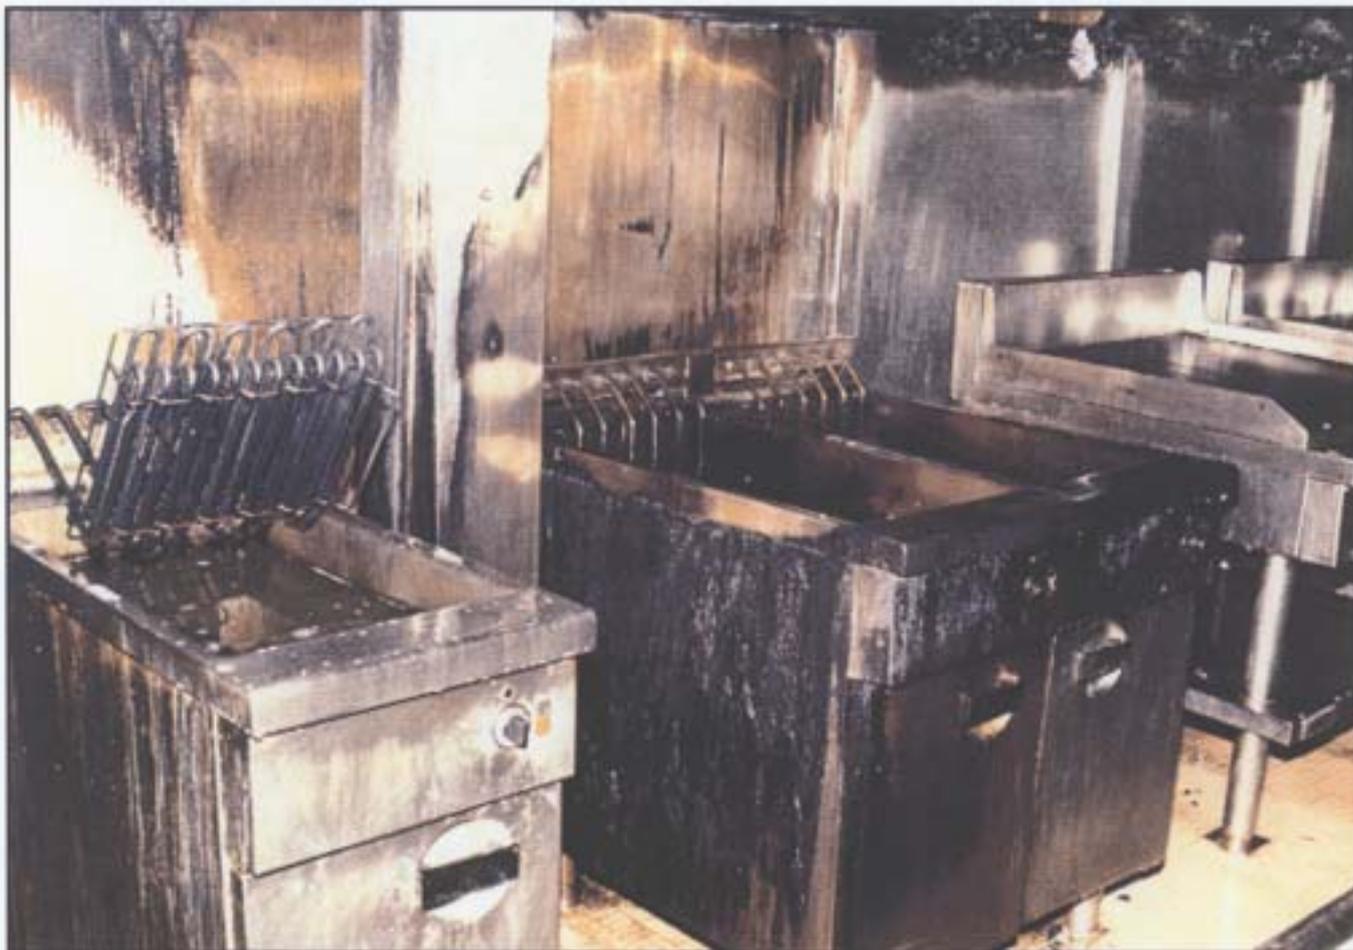
Figure 3. Two coupled deep fat fryers in centre of picture, independent unit to the left.

At the aft end of the centre island of the main galley were three deep fat fryers. The forward pair of these units was coupled. The third, aftermost unit, was independent (**Figure 3**).

Fire damage was limited to the immediate area around and above the deep fat fryers (**Figures 3 & 4**). Smoke damage extended over a larger area but was confined to the galley. No injuries were reported.

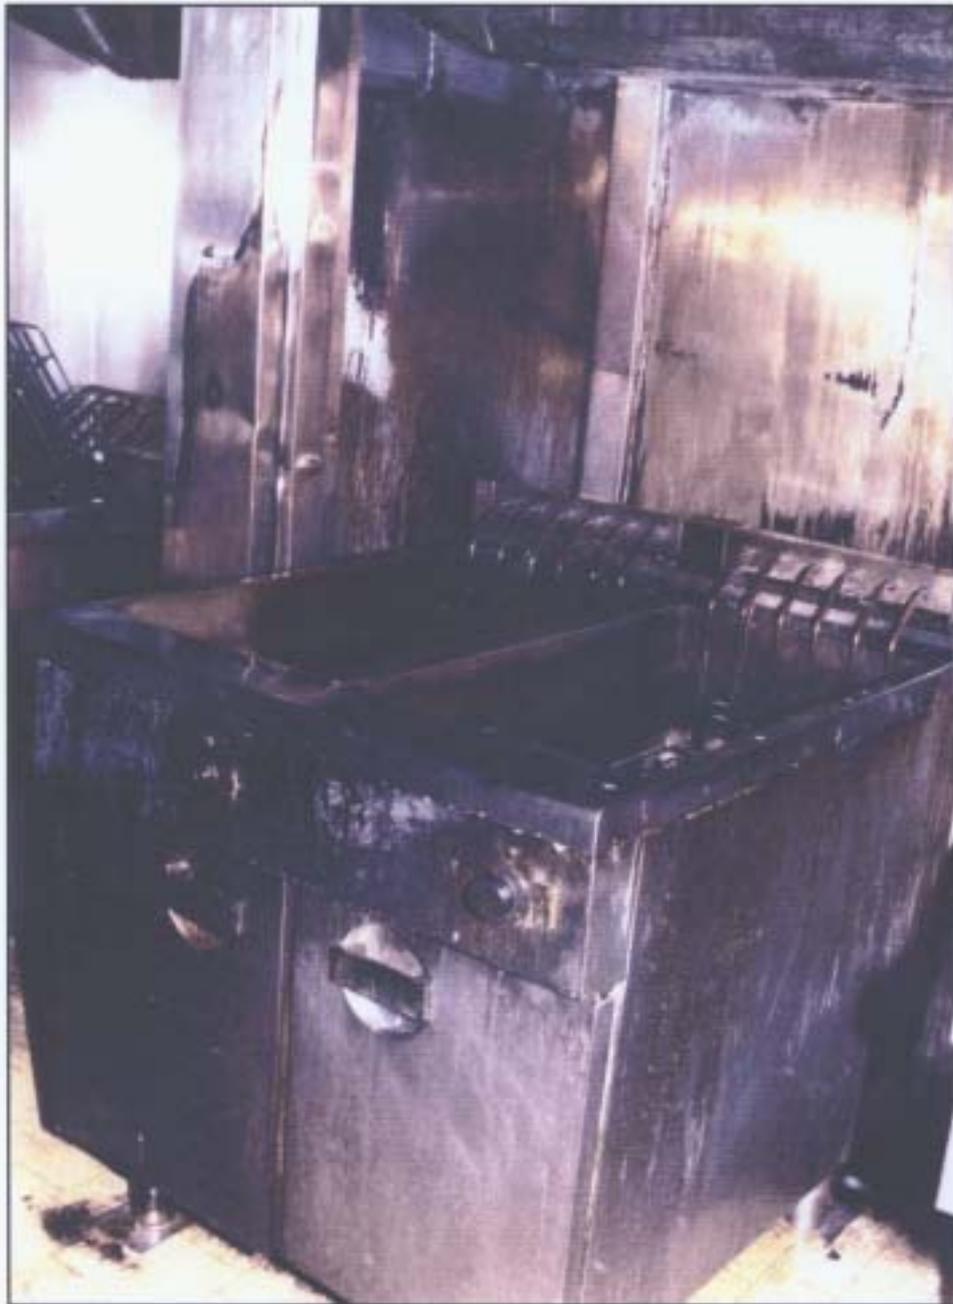
Figure 4. The coupled deep fat fryers. The unit on the left is the aft unit in which the fire occurred.

The damaged deep fat fryers were the coupled pair. They were of a type fitted with two thermostats, each operating a common circuit breaker (**Figure 4**).

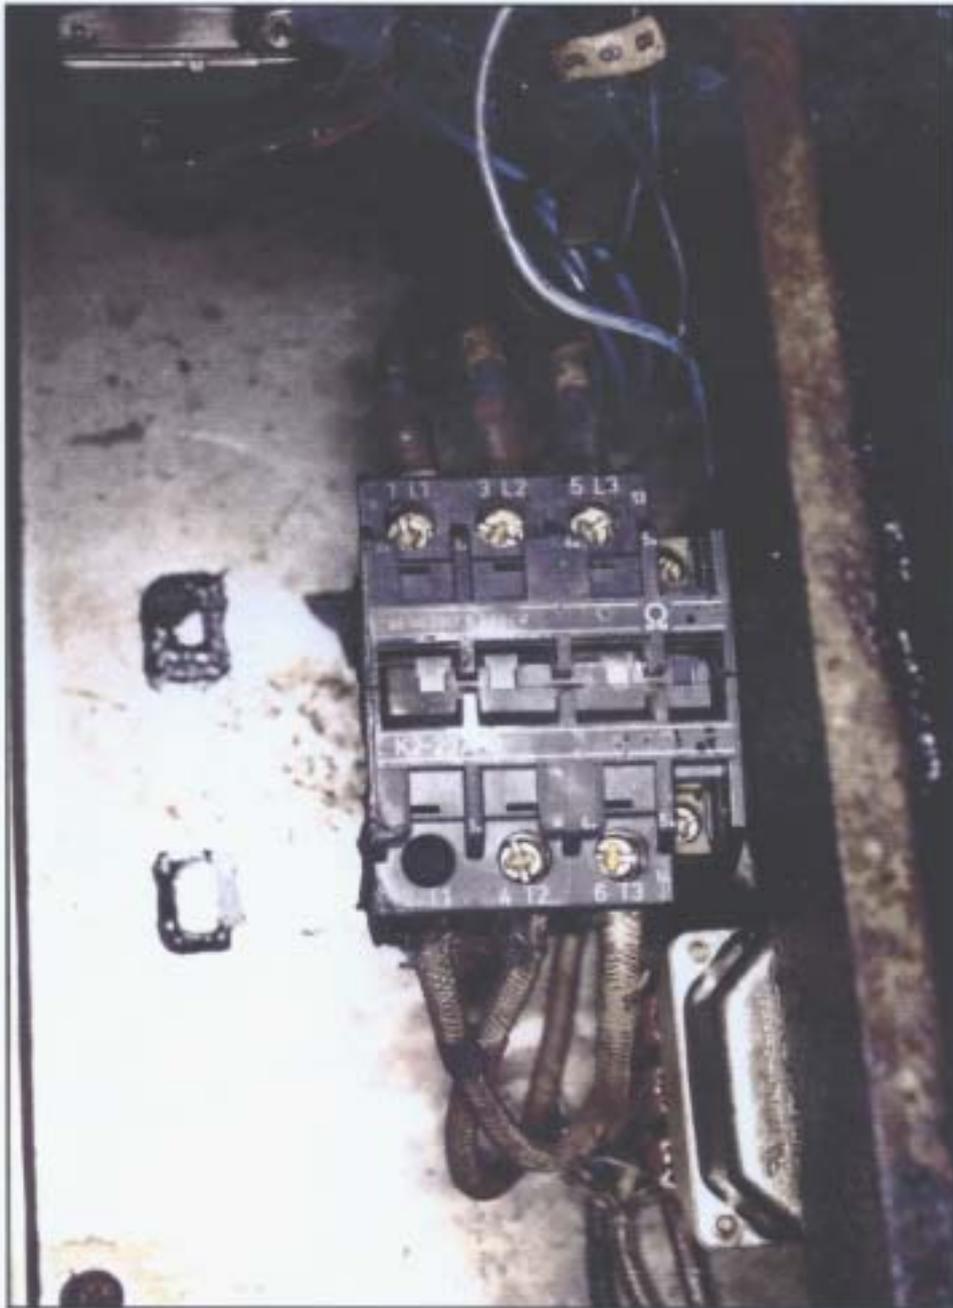
Figure 5. The contactor of the affected deep fat fryer.

Following the fire, ship's staff examined the breaker on the aft damaged deep fat fryer and found the main contactor welded closed. This was taken as an indication that the breaker had been unable to open under the control of the thermostats (**Figure 5**).

An inspection by the ship's electrical officer of the thermostat controlled breaker on the aft coupled fat fryer found the contactor welded in the closed position. It is reasonable to presume that once the unit had been switched on by galley staff, coming on duty to prepare breakfast, this defect resulted in the power supply remaining on until the fat's temperature reached ignition point.

The cause of the contactor welding closed is less certain. However, ship's staff reported that an adjacent power cable connection was loose and showed signs of overheating (**Figure 5**). It is possible that the heat generated by this poor connection caused the contactor to weld closed, or at least adversely affect the working of the contactor. In the absence of any other reported defect this possibility is accepted as most likely.

The reason for having a second thermostat and breaker fitted to these units is to protect against the failure of the primary thermostat and breaker. This incident demonstrates the value of a second independent thermostat as set out in Merchant Shipping Notice M.1022. Assuming the cause set out above is correct, a second thermostat and breaker is likely to have prevented this accident.

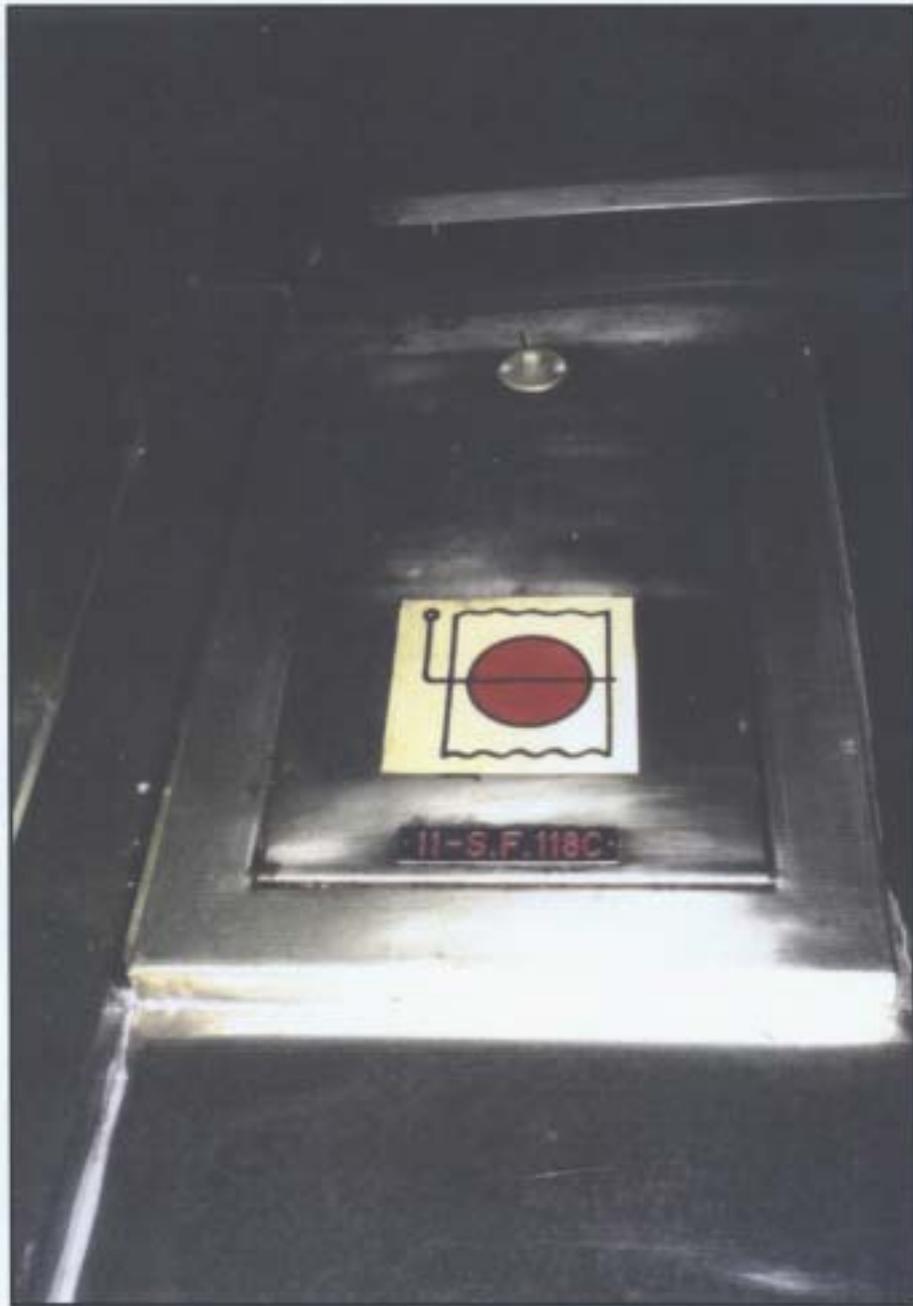
Damper control levers within the galley were enclosed by deckhead linings. Symbols, code letters and numbers were marked on the hinged covers (**Figure 8**). None of the codes could be related to information contained in ship's drawings or other documentation.

Figure 8. A galley damper cover, with label.

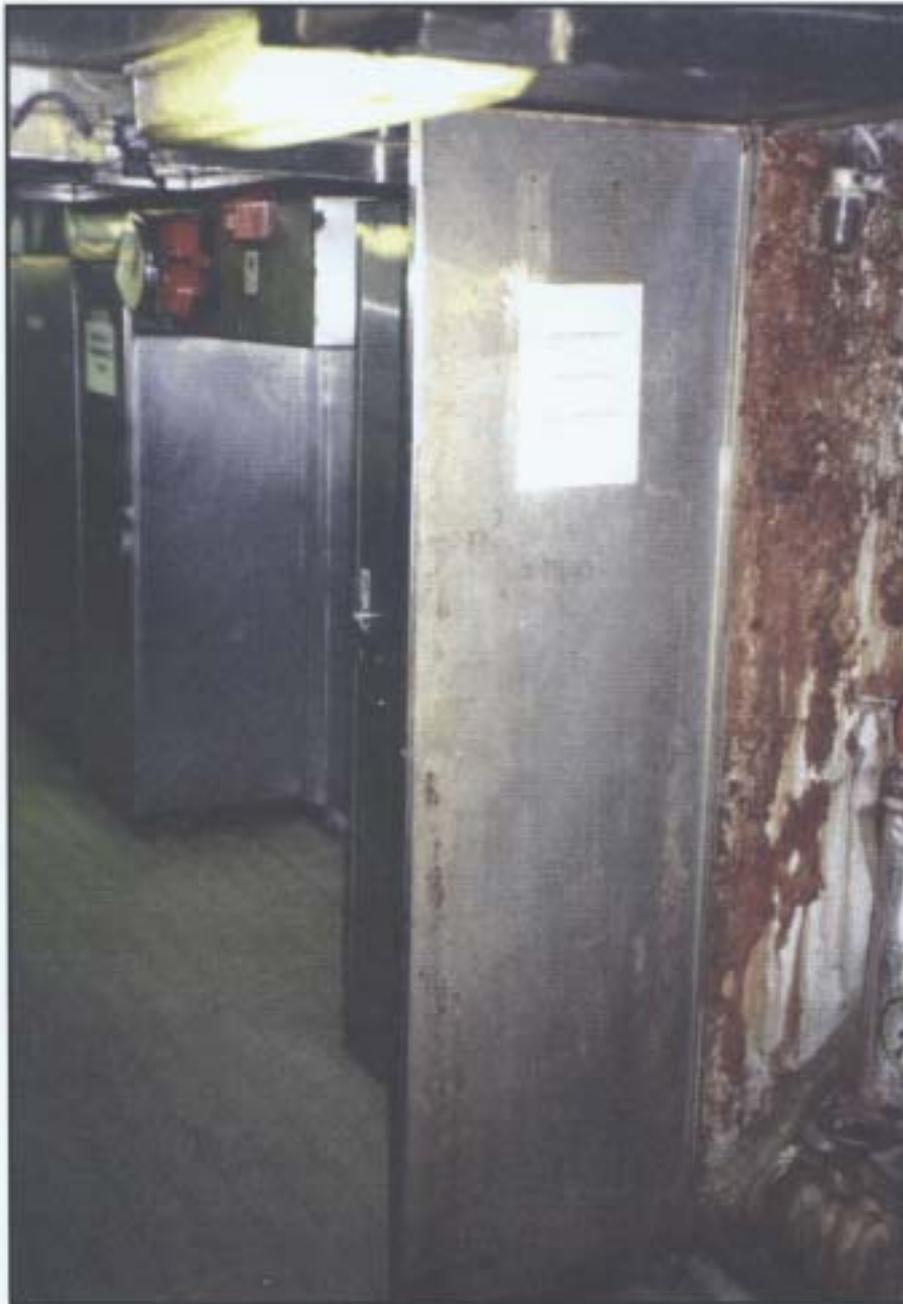
Control valves for this system were positioned within a cabinet set into the engine casing, just forward of the door separating the forward and aft sections of the galley's service corridor (**Figure 9**).

Figure 9. Control cabinet for steam smothering system to left of picture. Working passage within galley leading off to the right.

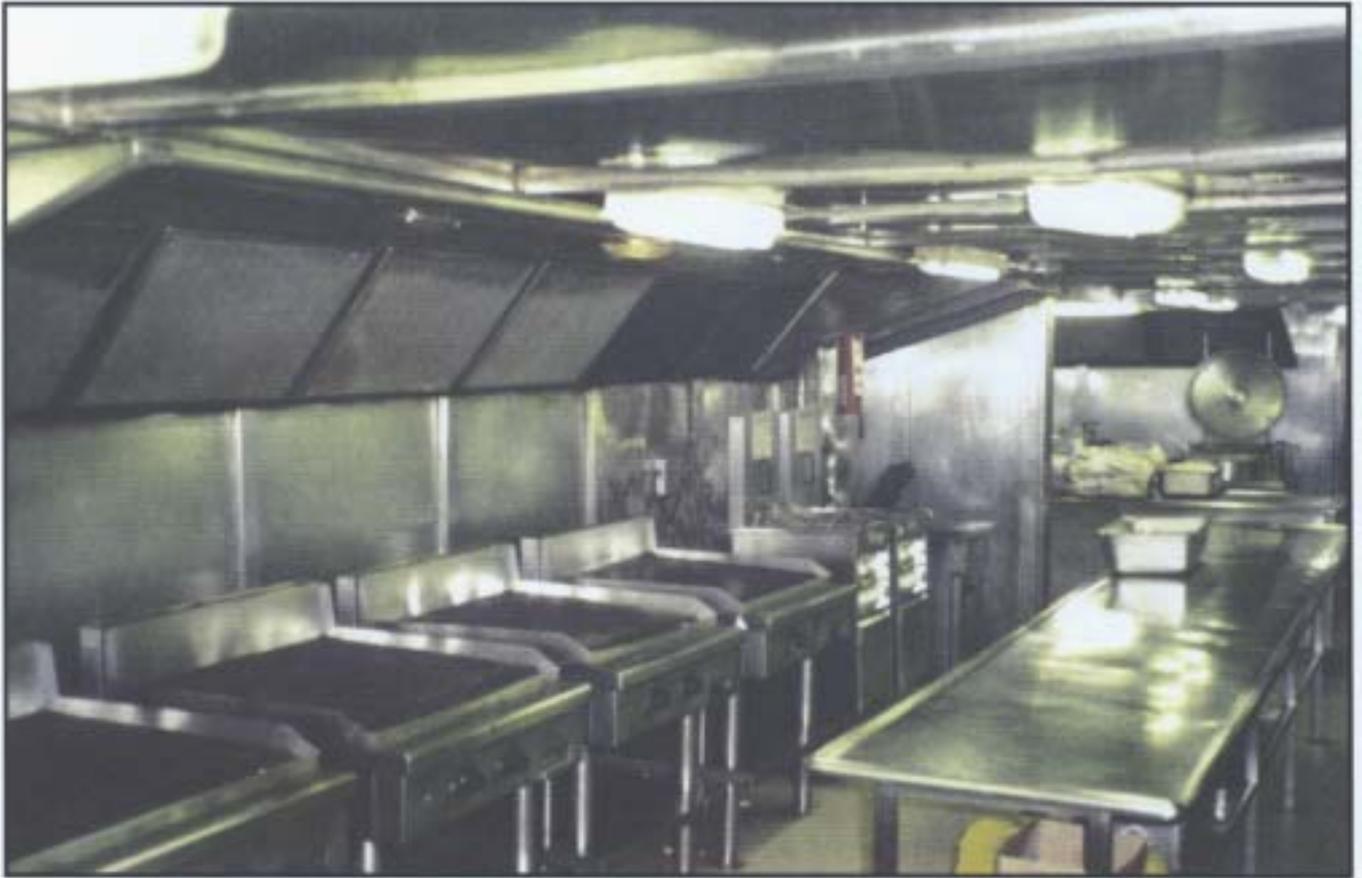
Figure 10. New deep fat fryers to left of centre of picture.

Following this accident, the vessel's owners removed the fire damaged deep fat fryers and replaced them with two new units (**Figure 10**). These were confirmed by the owners as complying with the contents of Merchant Shipping Notice M.1022.
