**Report on the investigation
of the foundering of the narrow boat
Drum Major
with the loss of four lives at Steg Neck lock
near Gargrave, North Yorkshire
on 19 August 1998**

Marine Accident Investigation Branch
First Floor
Carlton House
Carlton Place
Southampton
SO15 2DZ

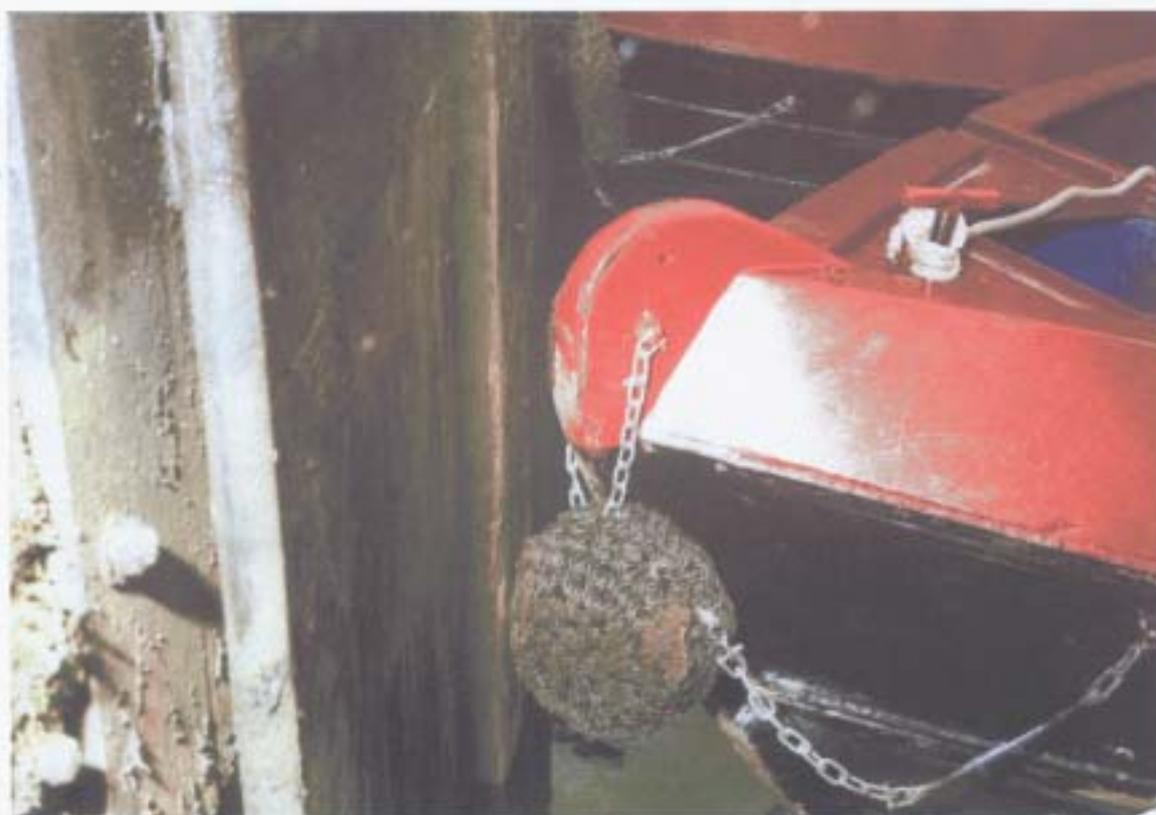
A view of the stem of DRUM MAJOR, showing the securing points for the fender chains

On *Drum Major* there were four chains; two leading vertically down from securing points on either side of the snub nose, and two lower ones leading horizontally aft to securing points on the hull, with connection bolts as little as 5mm in diameter. The lower chains were of unequal length, allowing the fender to swing to starboard of the stem. The fender arrangement was designed to take loads in the horizontal plane, not the vertical.

1. Require all owners of boats using canals and navigations under its control to inform British Waterways of all accidents and hazardous incidents.
2. Consider modifying lock gates/narrow boat bow fendering arrangements to prevent similar accidents in the future if database trend and risk analyses so indicate.
3. Review the adequacy of existing emergency escape routes on board narrow boats, with particular regard to the carriage of disabled, elderly and young persons.
4. Encourage boat owners to fit weak securing arrangements to bow fenders of the type fitted to *Drum Major*.

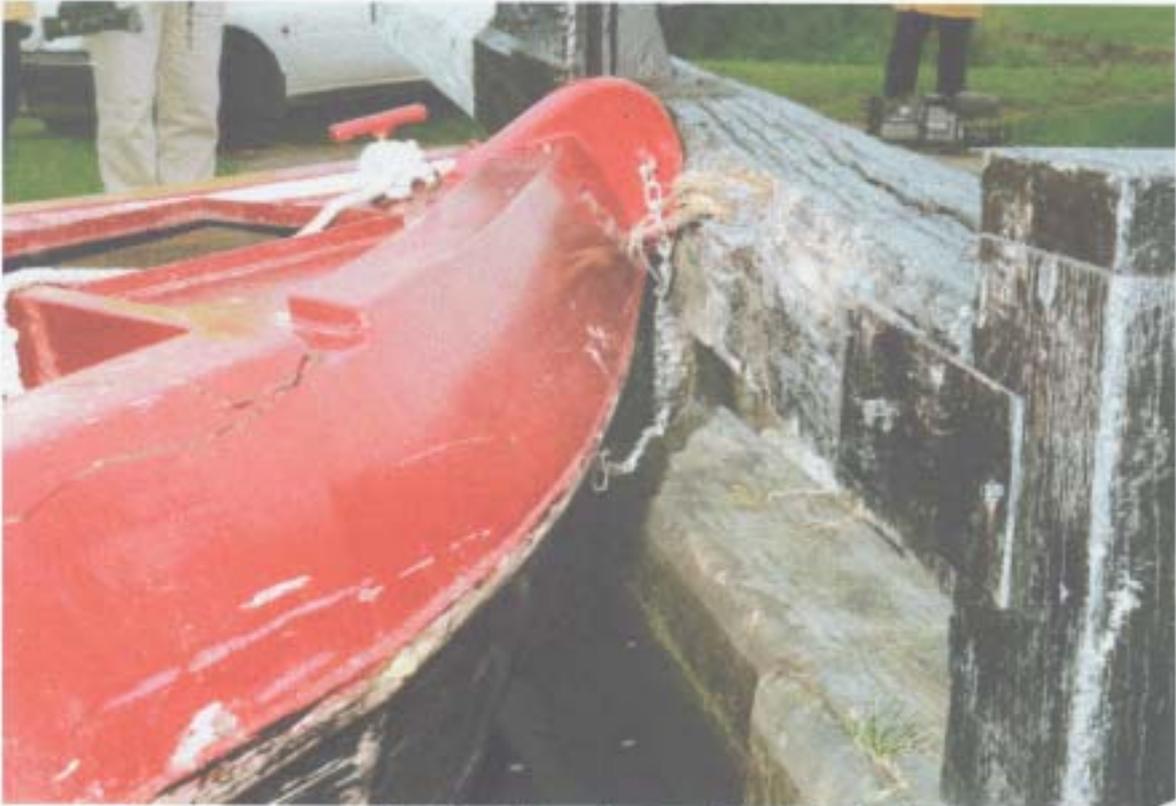
Fresh damage was observed on the coping stonework at the top edge of the lock and there was a large splinter on the balance beam of the bottom left-hand gate.

The snub nose against the balance beam with the fender in the gap.

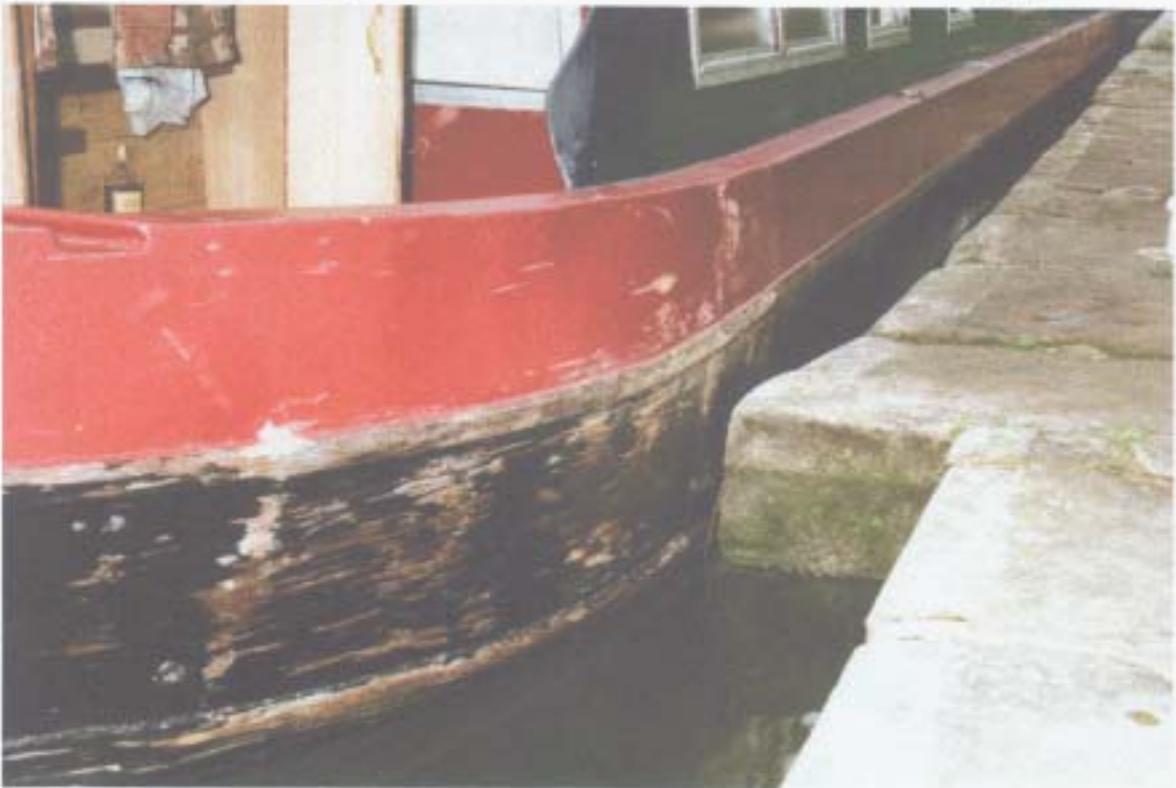
A view showing the port side rubbing bands in relation to the coping stones when the lock was full.

The water in the lock was slowly drained in a controlled manner and it became evident that the top rubbing band coincided with the fresh damage marks on the lock edge coping. It was also noticed that the splinter on the balance beam matched the position of the snub nose.

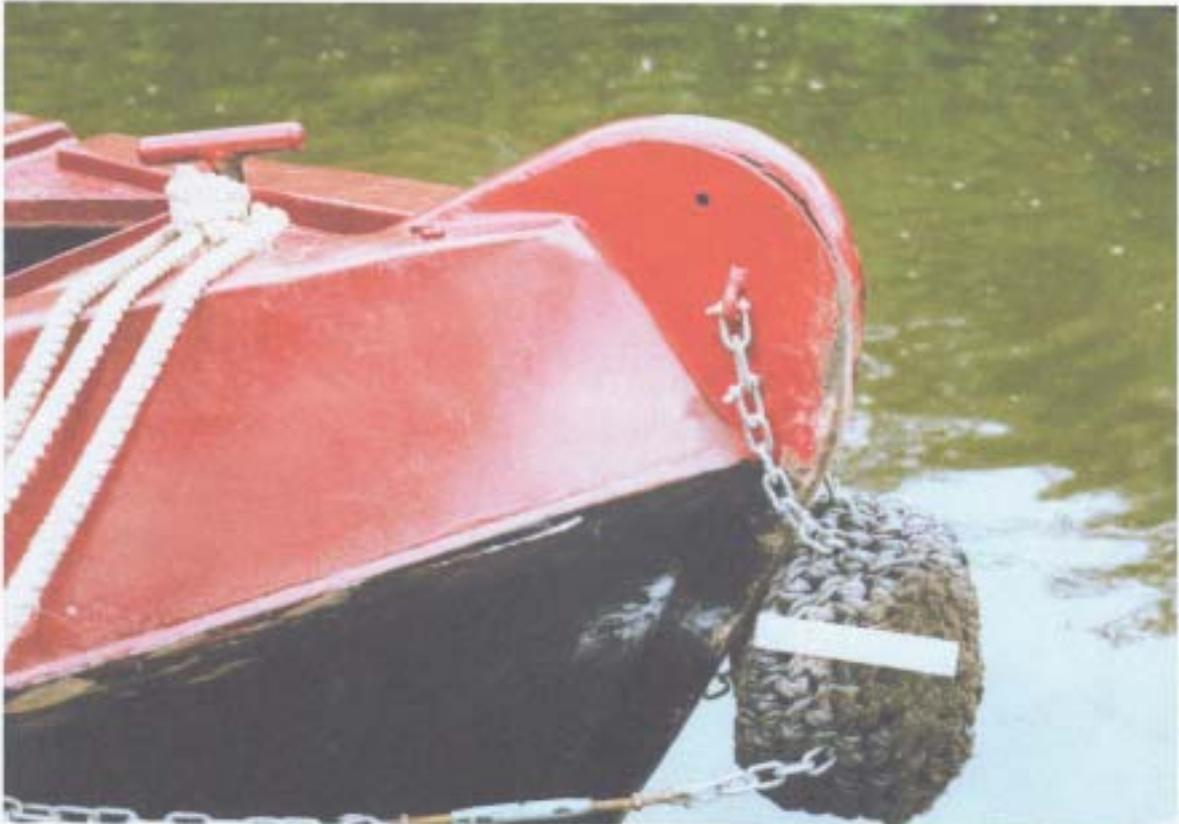
An inspection of *Drum Major* revealed scrape marks on the starboard face of the snub nose. No visible signs of strain were found in respect of the fender securing arrangement.

The Damage to the starboard side of the snub nose, which probably caused the splinter to the balance beam.

As the descent began to accelerate the rubbing band slipped off the coping stone to cause the bow to move to starboard and splinter the balance beam. This interpretation is supported by the fresh damage found on the coping stonework and the scrape marks found on the starboard face of the snub nose of *Drum Major*.

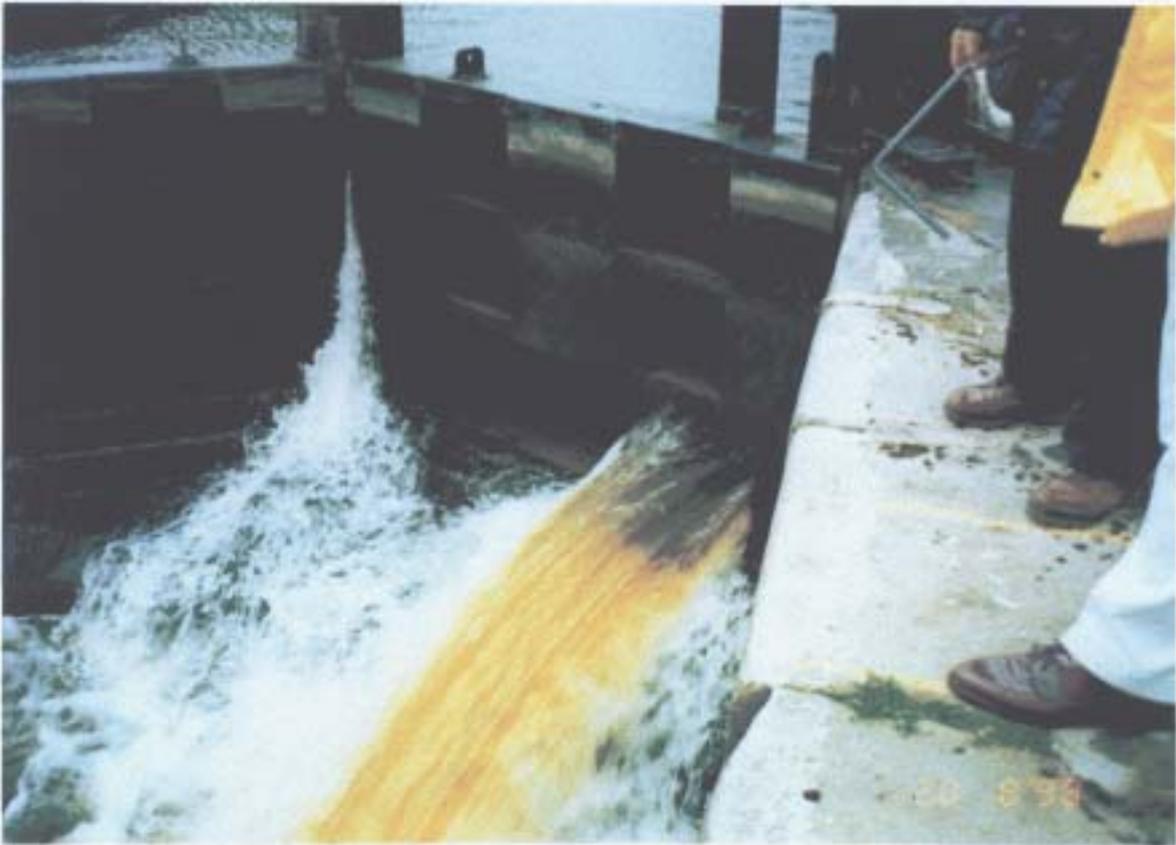
The top paddle gate was opened to show the force of the water entering into the lock. Note the cill beneath and the police yellow chalk marks on the coping stones to the right.

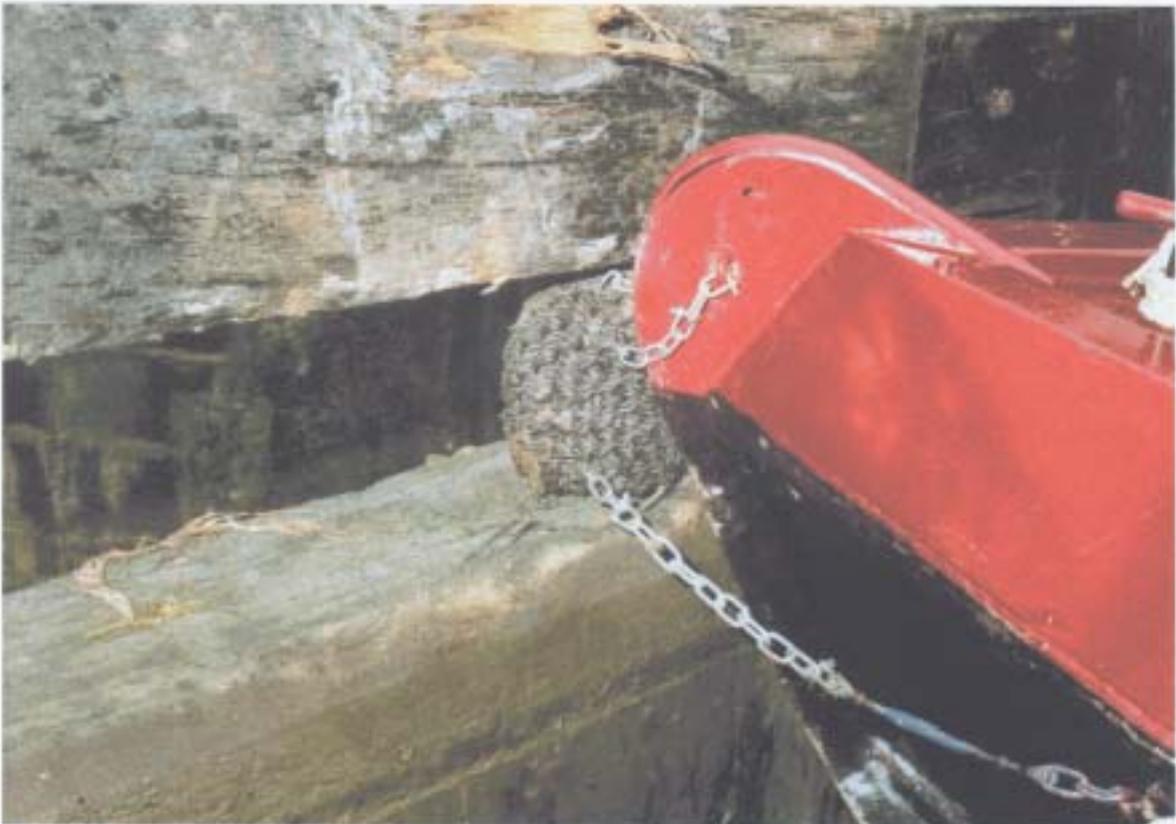
As the water continued to drain away, weight came onto both the fender and the snub nose resting on top of the gate.

The water level in the lock was dropped and the fender was allowed to become caught in the gap between the balance beam (top) and the top of the gate (below).
