Report
into the sinking of
fv *Constancy* BCK 371
on 30 July 1998
with the loss of one life

Constancy BCK371

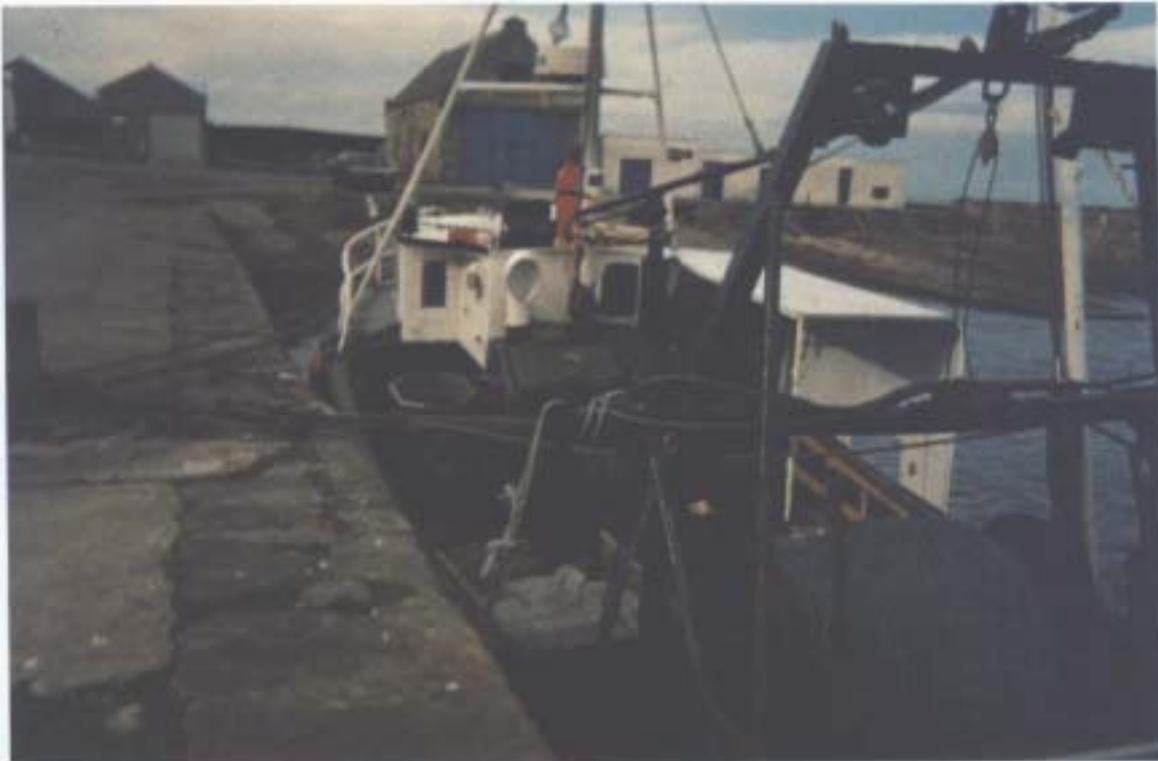
Figure 2 - Working deck of *Constancy*

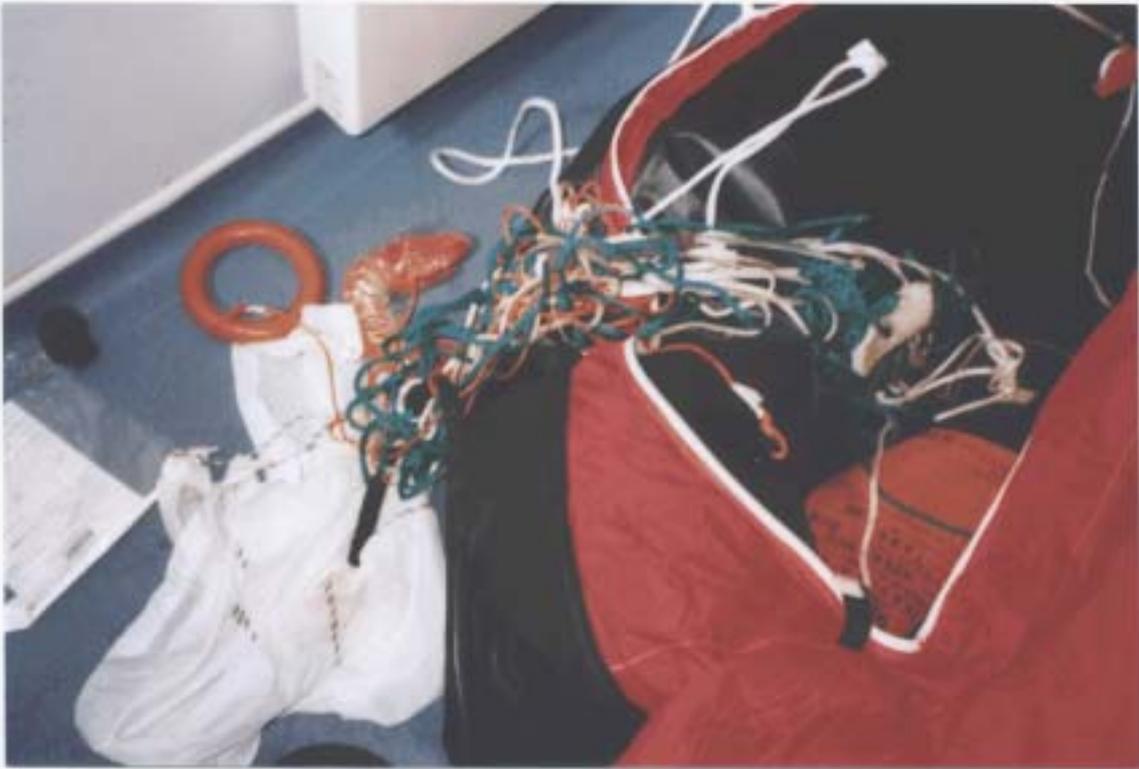
Figure 3 - Liferaft's quoit and line entangled with other equipment

Once the skipper had boarded the liferaft, he found it drifting away from the crewman. He recognised that he should throw the quoit and buoyant line to the crewman in order to pull the two together. However, the buoyant line close to the quoit had become tangled with other items, such as the boarding ladder, drogue and painter. This prevented easy deployment of the quoit.

However, the liferaft was equipped with a knife, which the skipper had already used to cut the painter and other lines, and this was available to cut the tangled line from the quoit allowing it to be re-tied. A substantial proportion of untangled buoyant line was still available in the stowage pouch. This course of action was not followed.

1. Advise liferaft manufacturers and packing stations that, for liferafts not equipped to MCA standards and which are to be carried on fishing vessels, a list of a liferaft's equipment should be supplied to the purchaser or hirer at the time of purchase or hire and at each service. The list should not be stowed within the liferaft's container. This advice should also be made known to the fishing industry so that owners, skippers and crews become aware of the provision.

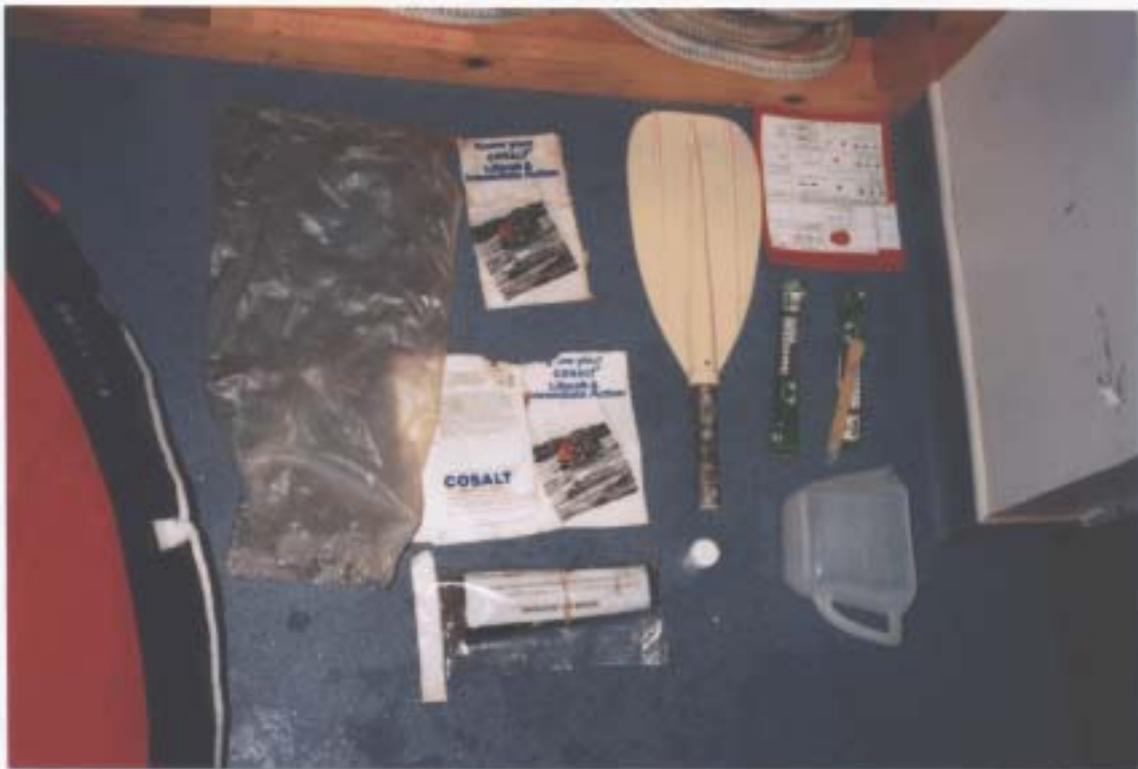
This liferaft floated free from the sinking vessel and was used by the skipper. It was later recovered during SAR operations and inspected. It showed no defect and was complete with all manufacturer's listed equipment, except for flares (**Figures 3 & 4**).

Figure 4 - Remainder of liferaft's equipment

1. Fishing vessels of less than 12m registered length are not required to carry liferafts.
2. The liferaft carried by *Constancy* was equipped to a standard intended for use in the leisure market, not to MCA or SOLAS (International Safety of Life at Sea Convention) standards (**Figures 3 & 4**).

5. The liferafts on which the skipper had undertaken his survival training had been equipped to MSA/SOLAS standards.
6. Inspection of the recovered liferaft identified no defect. With the exception of the three smoke flares, which had been thrown away by the skipper after use, the equipment carried was in accordance with the records supplied by the packing station. In particular the knife was in its pocket and there was a substantial proportion of the quoit's line untangled and neatly stowed in its pouch.
