INSPECTOR'S REPORT
ON THE CAPSIZE OF THE
fv SALLY JANE SM74
ON 27 JULY 1998

Sally Jane, a twin beam trawler of 11m registered length, capsized at about 1300 on 27 July 1998 while alongside in the Aldrington Basin of Shoreham harbour. At the time the crew were repairing both sets of fishing gear which had been hauled up to the derrick heads. The crew of three abandoned the vessel when they saw it was going to capsize. Weather conditions were good and were not a factor in the accident. No one was injured.

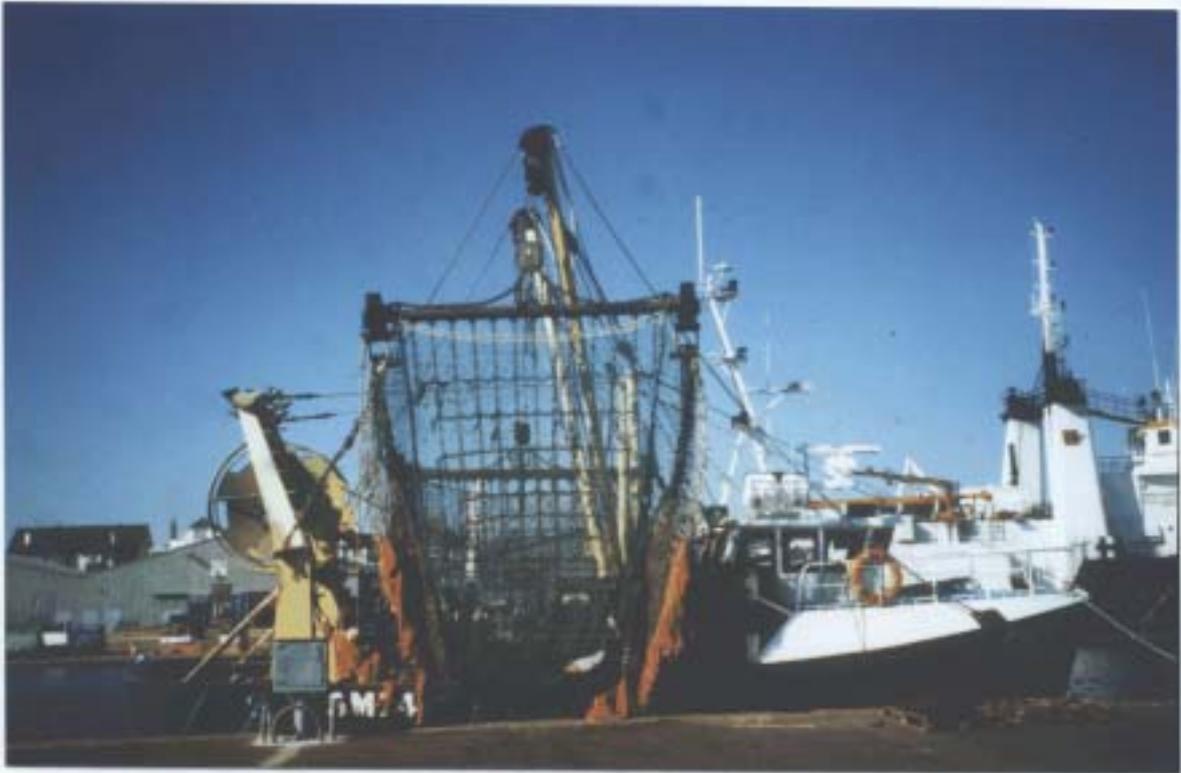
Figure 2

As part of the preparations the twin beam fishing gear was examined and repaired. Both sets of gear, each weighing 1.8 tonne with a 4.5m long beam, were lifted off the deck and hauled to the heads of the derrick, which were about 8.5m above the deck. The bridle chains attached to the beams had been shortened so that the chain mats were fully extended (**Figure 2**).

Trawl gear hauled aloft for repair

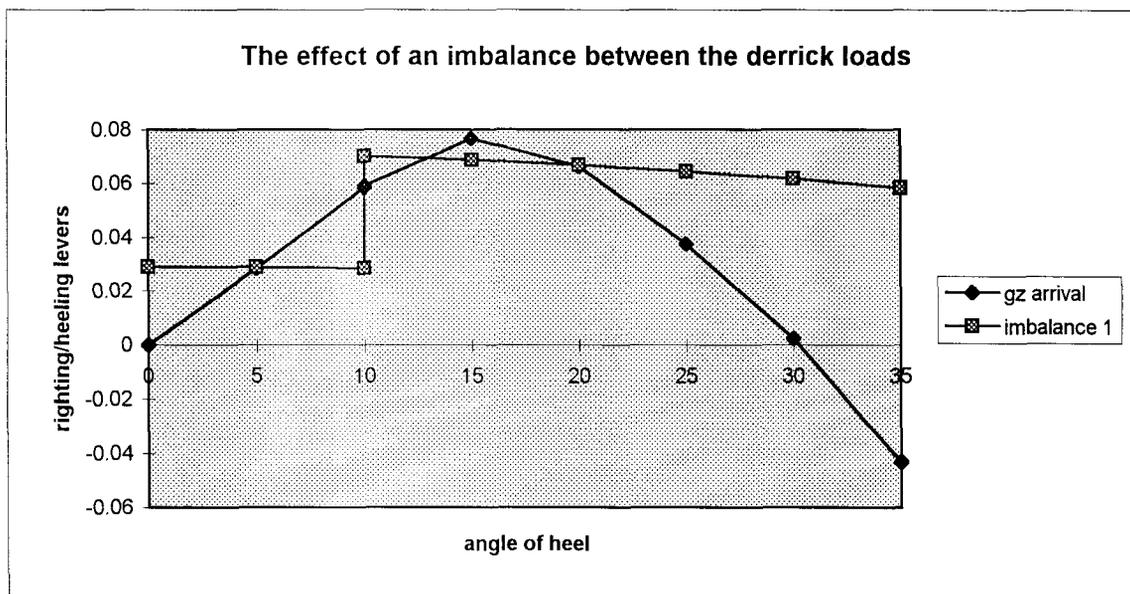
Stability with both sets of trawl gear aloft

Hauling both trawl beams to the derrick heads is the established position in which gear is repaired in port. Consequently, a twin beam trawler must have adequate transverse stability for this operation to be carried out. An examination of the vessel's stability, based upon the data in the trim and stability book, indicates that this is now the case if both sets of gear and derricks are kept in balance about the centre-line (**Figure 4**).

- 1 The curve "imbalance 1" represents the limiting heeling lever from the derricks. It is assumed that both derricks are initially 10 degrees off the vertical. One derrick is then lowered slightly so that the derrick head moves outboard. This causes the vessel to roll in the direction of the derrick movement and as the roll passes 10 degrees the other derrick falls in towards the centre-line, causing a step change in the heeling lever curve.

- 2 It is assumed that the second derrick is restrained by a wire **from** falling in past the vertical, that is it can only **fall 10** degrees towards the centre-line before **it** is stopped.

- 3 The curve shown corresponds to an outboard movement of the first derrick head of 2.3 metres, which is equivalent to a 16 degree rotation of the derrick from its original position. Any greater movement could capsize the vessel.

- 4 No account has been taken of the slight lowering in vertical centre of gravity which would accompany the rotation of the first derrick.
 - 5 The vessel's loading condition is arrival port, less catch, but full of fuel and water, and no ice. Displacement 63.17 tonne and VCG 2.254m above base.
-

1. Engage a naval architect to produce a condition for the trim and stability book to cover the operation of repairing gear in port, clearly setting out the required loading of the vessel and including limitations on the movement of the derricks. The skipper should be instructed in the use of the information by the naval architect. [3.1.7]

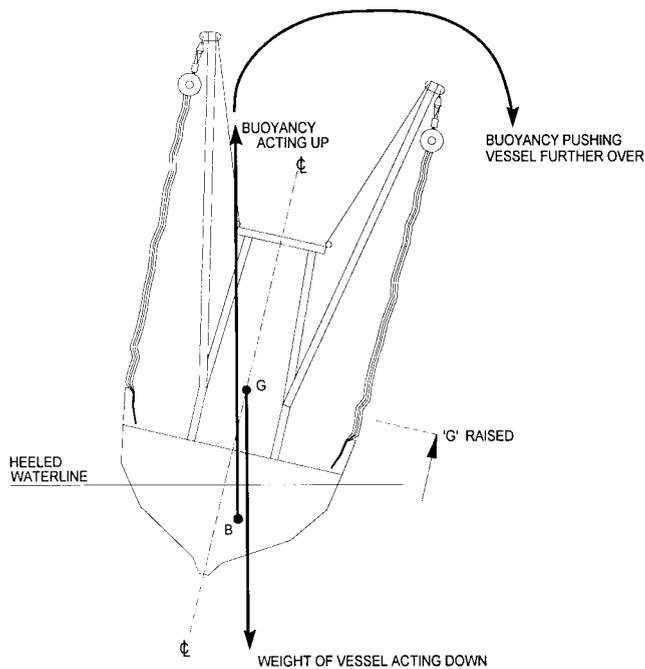
The vessel had operated without incident for eight years and during this time the crew hauled both trawl beams to the derrick heads hundreds of times without mishap. This strongly indicated that the capsize was a result of changed circumstances; either the stability of the vessel had changed as a result of the refit, or there was an imbalance between the derrick loads while the crew worked on the suspended trawl gear. No other possibility has been identified, and there was insufficient data on the condition of the vessel before she capsized to determine which was the underlying cause of the accident.

'G' WAS HIGHER AFTER THE REFIT

CAPSIZE

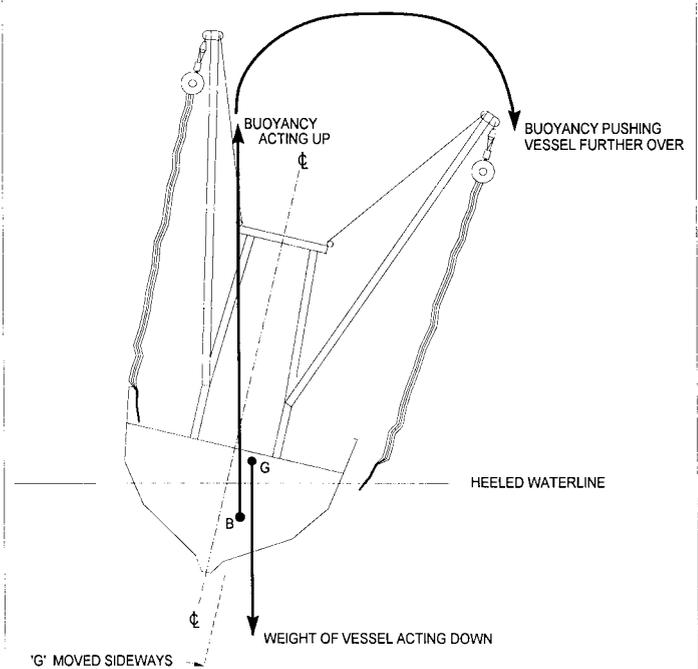
THE DERRICK LOADS WERE OUT OF BALANCE

CAPSIZE
