NAME OF VESSEL
REMA

At 0221 the Belize registered MV Rema broadcast a Mayday on VHF ch16 its position approximately 22 miles NE of Whitby. A search of the area using RNLI lifeboats, RAF helicopters and several Merchant vessels located the wreck of the vessel but its 4 crew were not found and considered to have perished with the vessel.

The purpose of this investigation was to perform calculations to explore the extent of flooding that would be necessary to sink the "Rema" in a manner that was consistent with the known circumstances of the casualty and the evidence available from the wreck. If possible, the investigation was to attempt to narrow in on the position and extent of damage that, at least on the balance of probabilities, is likely to have been involved.

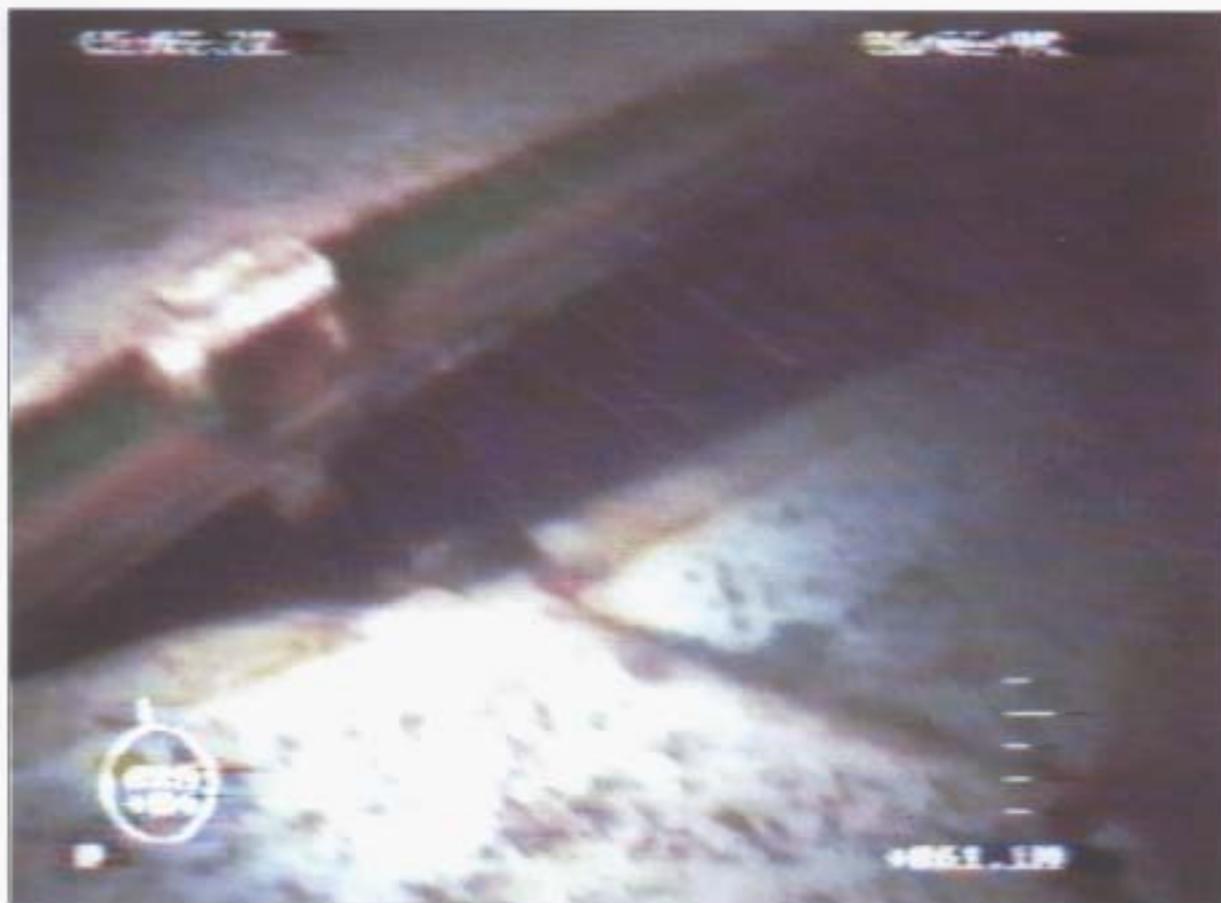
Access hatch to forecastle storeroom — note deformation of hatch sides and hatch cover forced into hatch space by water pressure

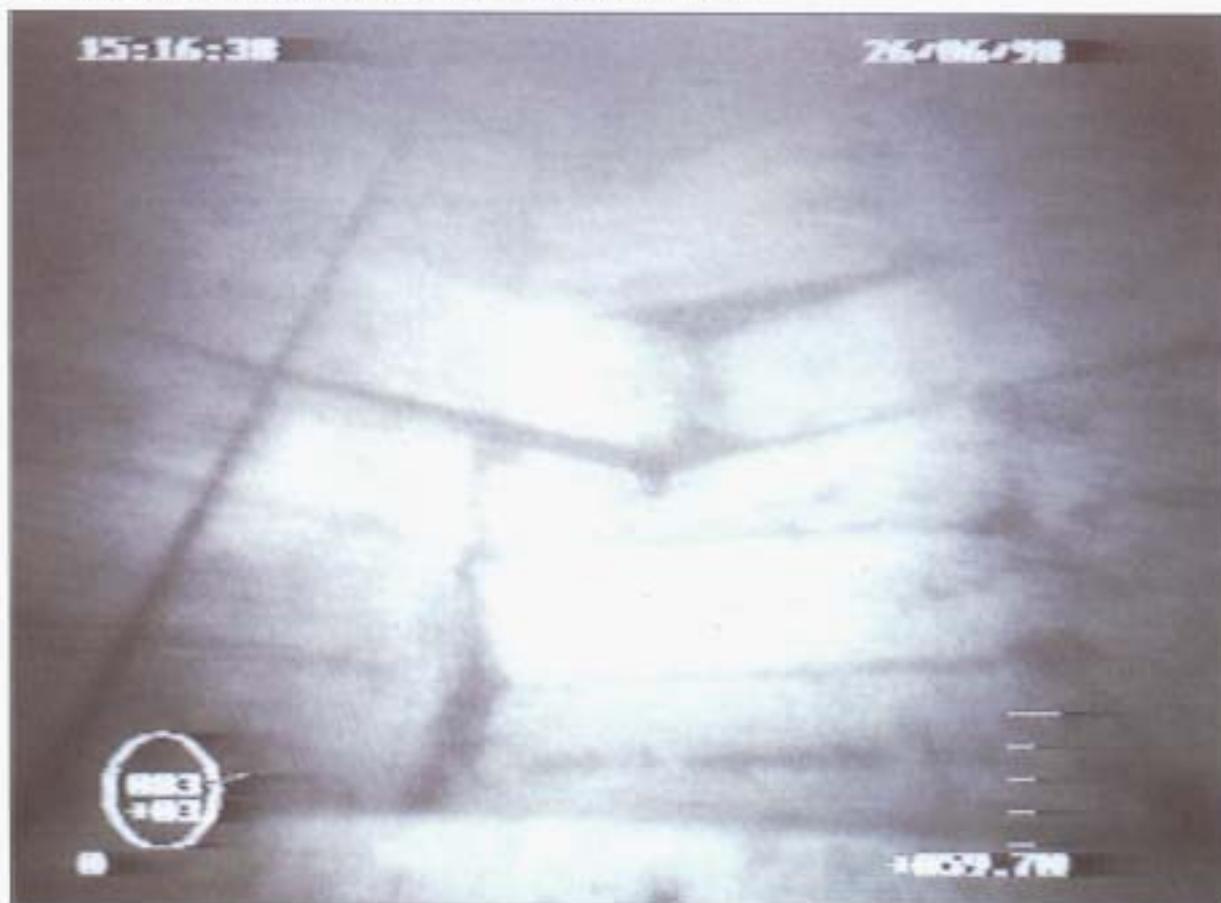
Close-up of fractured and distorted hatch cover beams due to water pressure

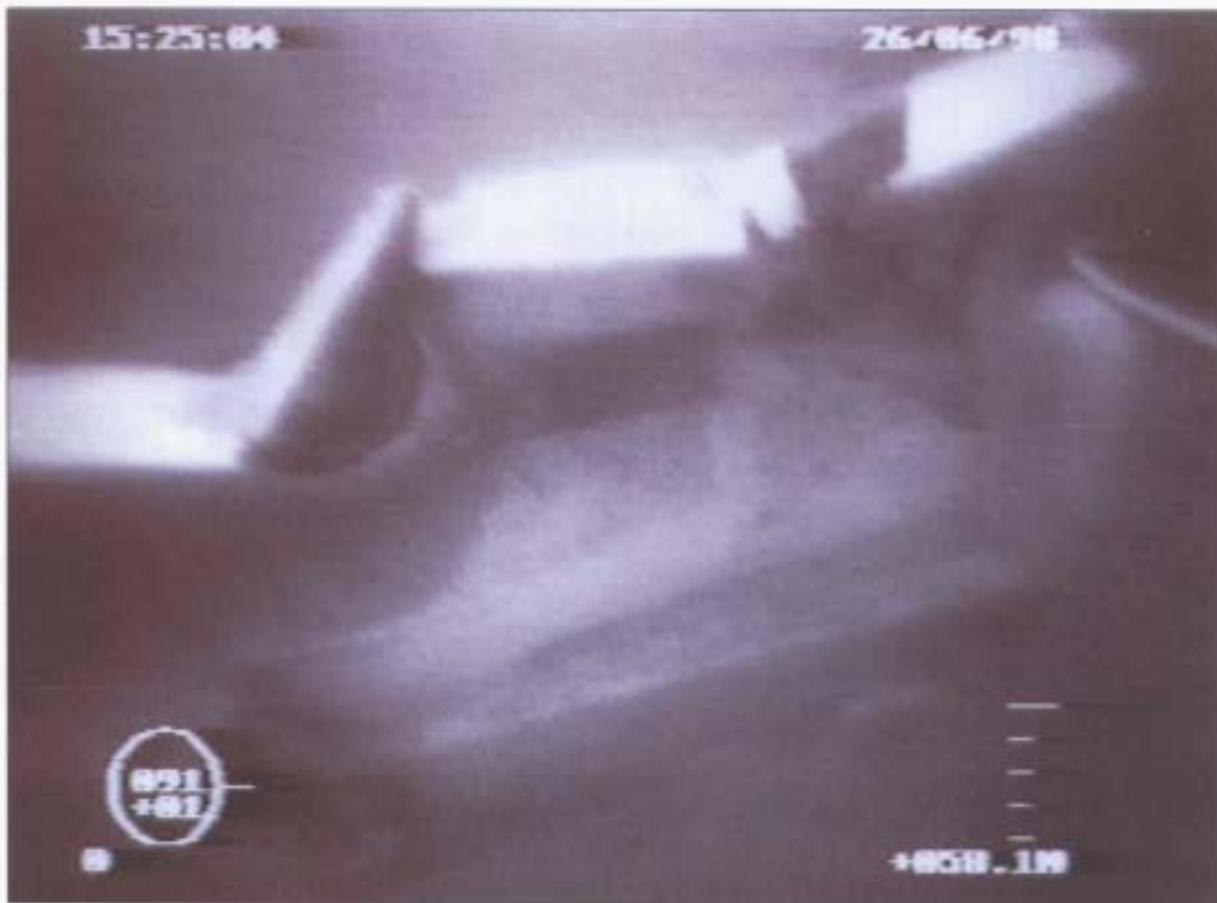
View of hatch covers looking forward from wheelhouse front — note fractures due to water pressure

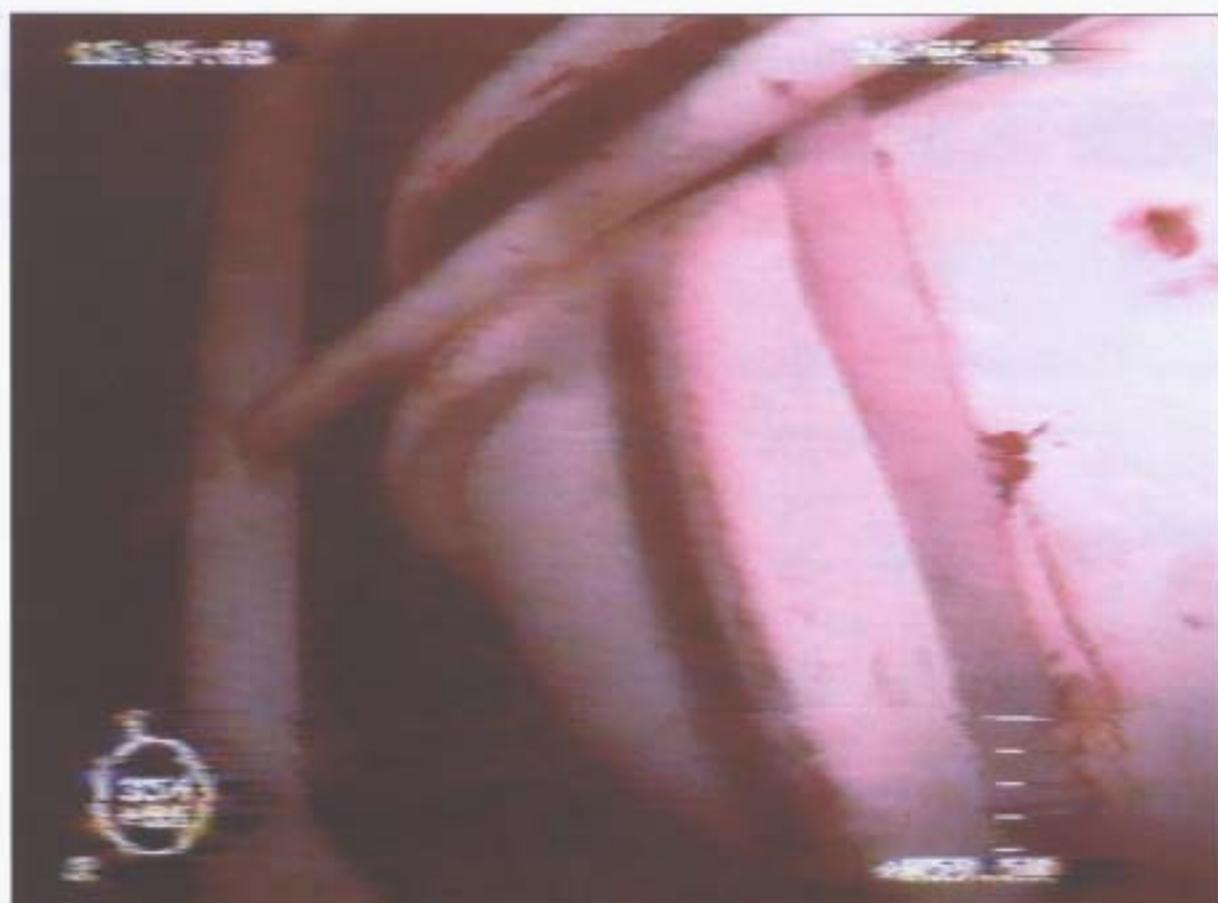
View of port aft poop deck showing damaged hatch and air vent due to implosion of store and fresh water tank below

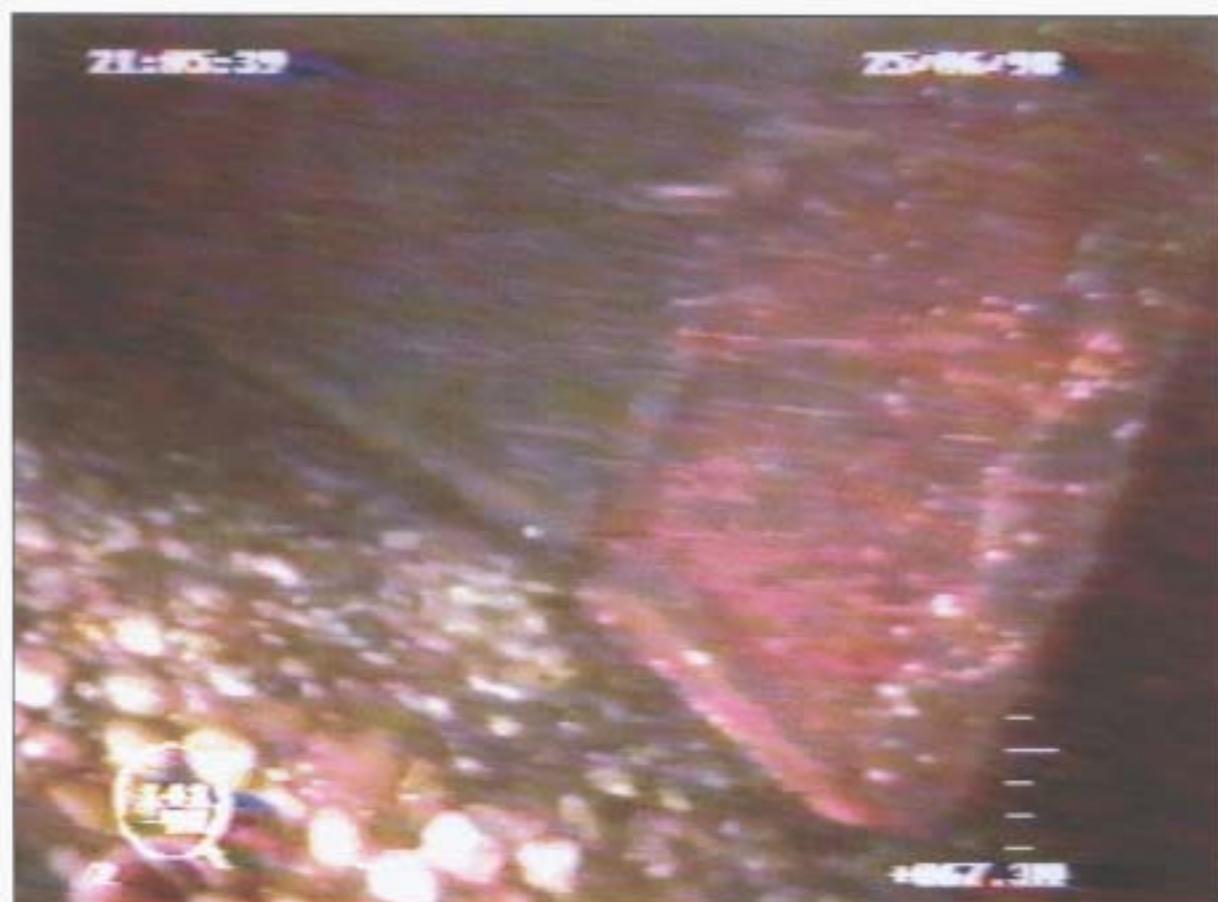
View of port liferaft trapped under ships rails aft of liferaft cradle

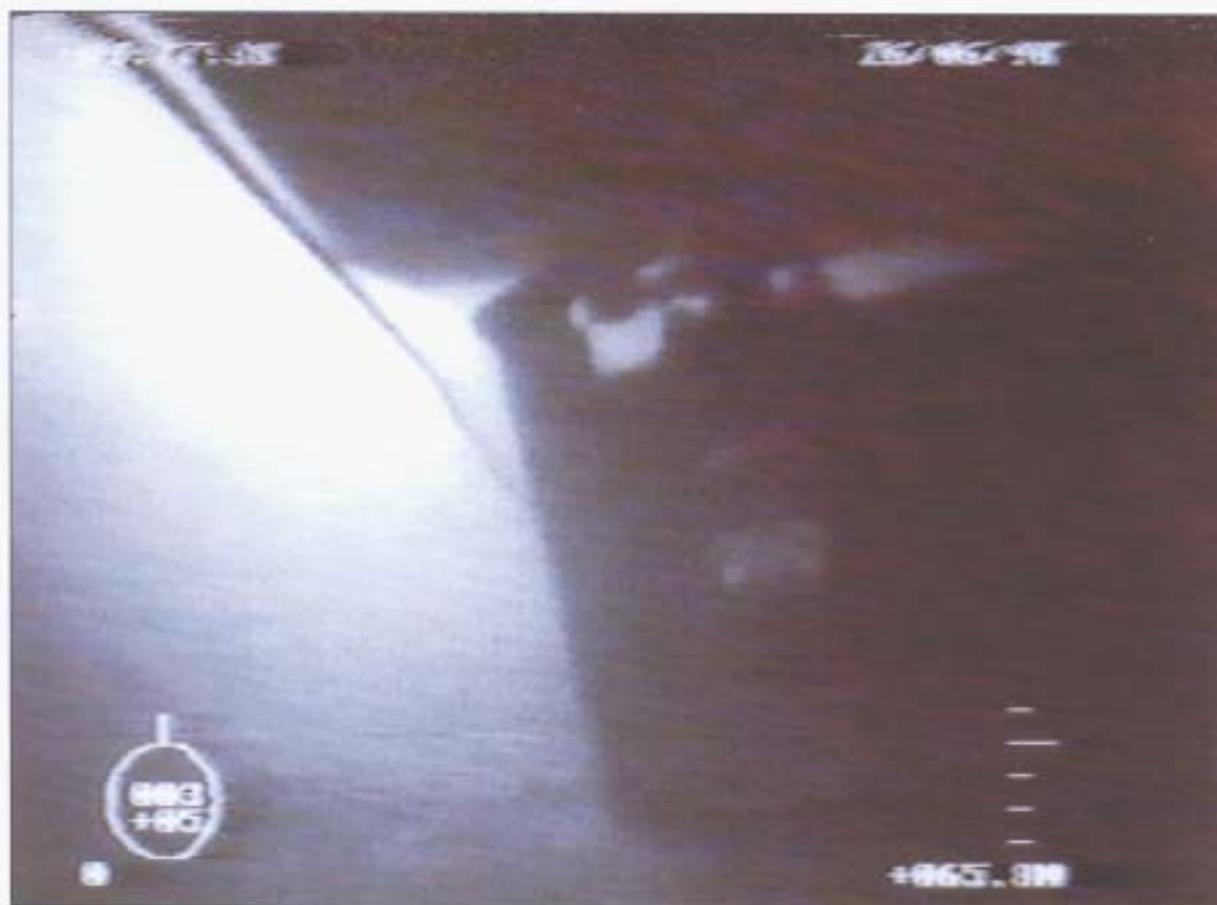
Close-up of lower part of Bekker rudder showing absence of grounding damage

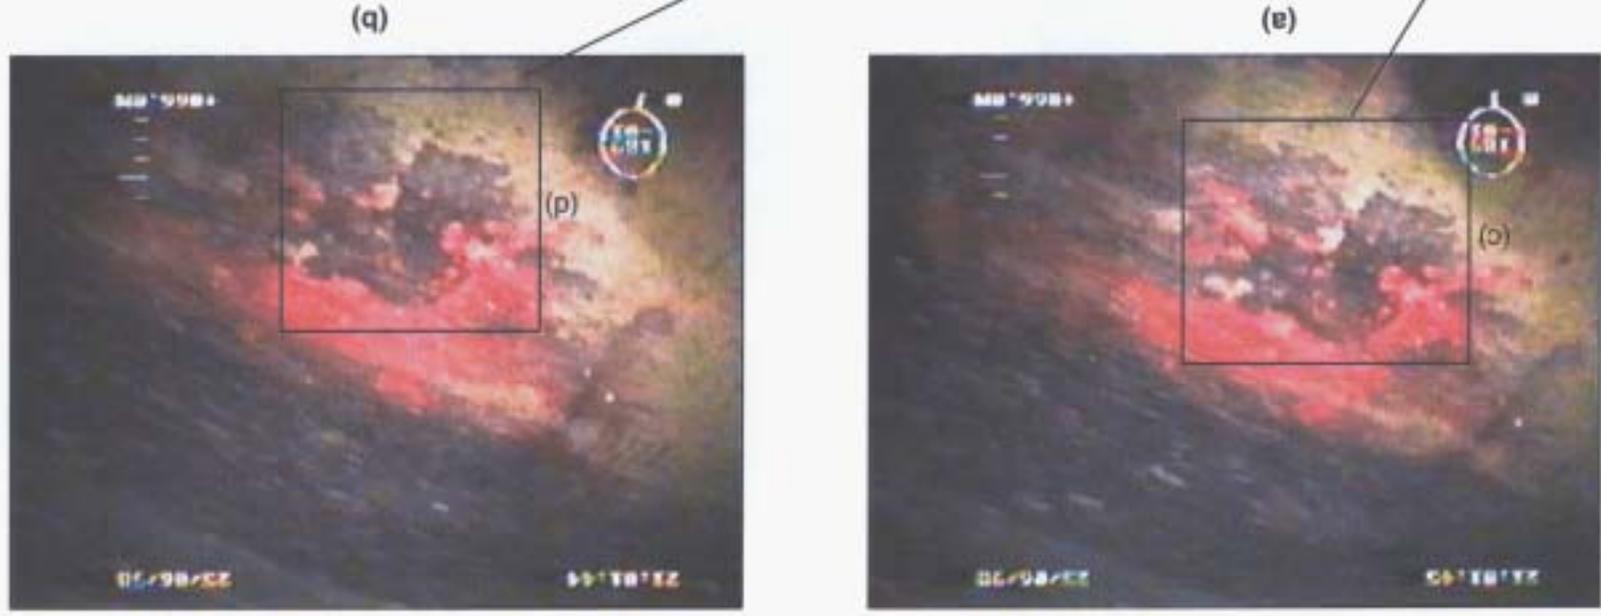
View of damaged area and possible "vertical crack". Image (a) is viewed and illuminated from the right, image (b) is viewed and illuminated from the left. Small images (c) and (d) are details of the "vertical crack", at the same scale and orientation, taken from (a) and (b) respectively. Image (e) is a colour-scale inverted version of (d). Image (f) shows the result of combining (c) and (e): if the vertical feature was a "crack" in the hull casting a shadow, then it would not appear equally, or simultaneously, in both left and right illuminated views. Image (f) shows the "vertical crack" is cancelled out by combining the inverted left view with the right view. This means the "vertical crack" is not a shadow cast by a parting in the plates, but a dark colouration of the hull, and probably damaged paint-work.

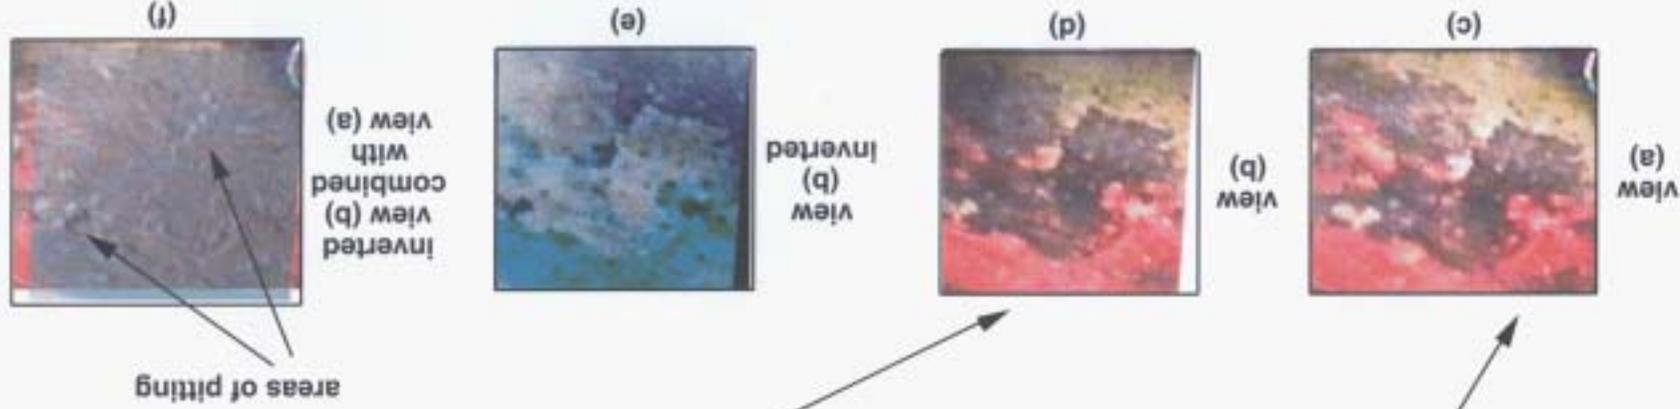
View of possible "corrosion wastage". Compared with image (a), image (b) is viewed and illuminated from ~50-100cm further to the right. Small images (c) and (d) are details of the "corrosion wastage", taken from (a) and (b) respectively. Image (e) is a colour-scale inverted version of (d). Image (f) shows the result of combining (c) and (e): if the "corrosion wastage" included pitting of the hull, casting shadows, then they would not be cancelled out when the inverted and positive images are combined. Image (f) shows two areas where small circular features remain, indicating vertical relief in the hull plating consistent with pitting damage. However, there is no evidence that these pits have penetrated the hull.

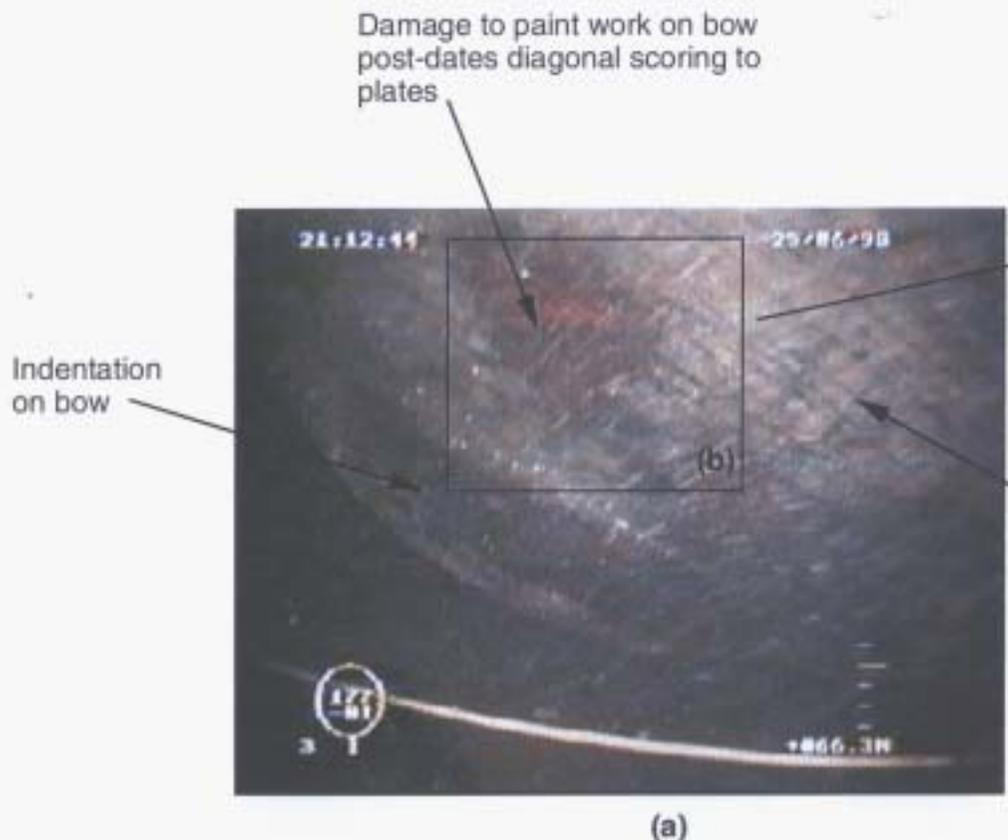
Area underside of bow where a damaged area has exposed red paintwork and where diagonal scores cross the plates.

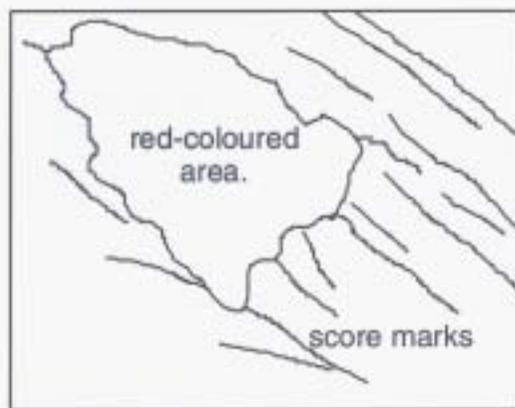
Score marks are clearly truncated by red-coloured area of damaged paint work.

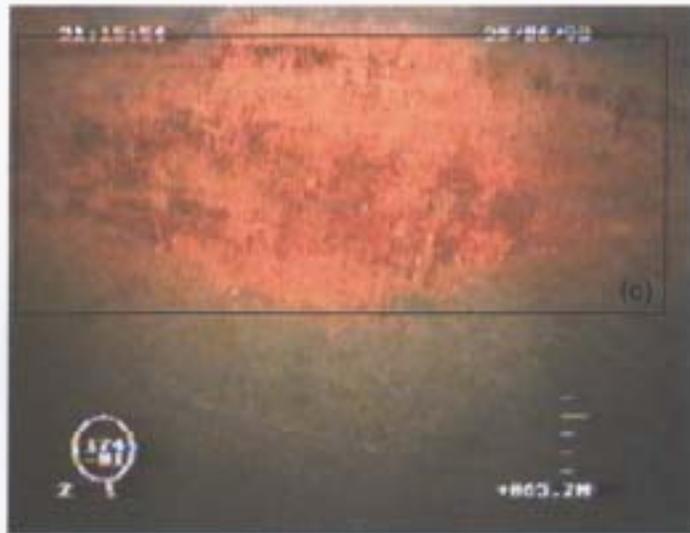
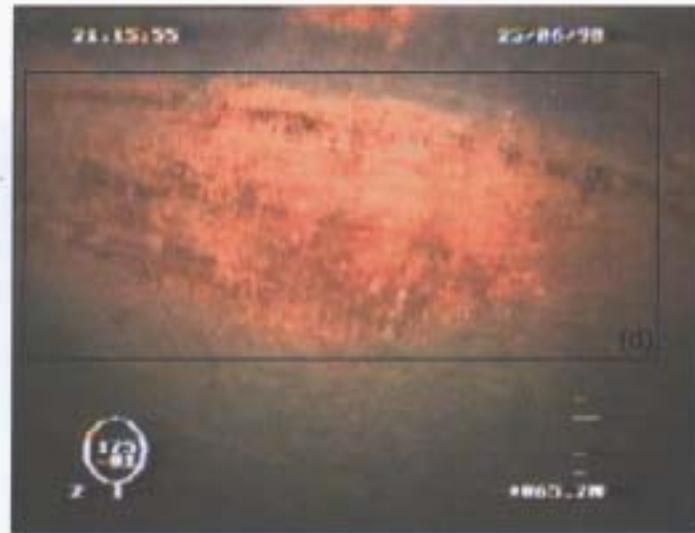
Different images (a) and (b), one second apart and taken from different positions, showing a general area of possible corrosion or damage to the hull.

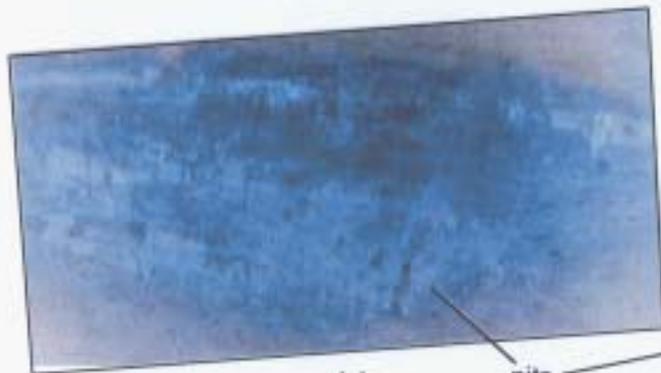
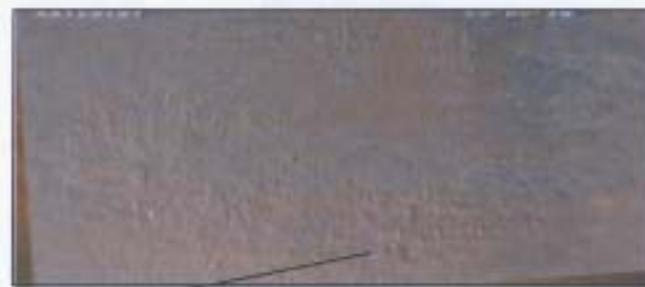
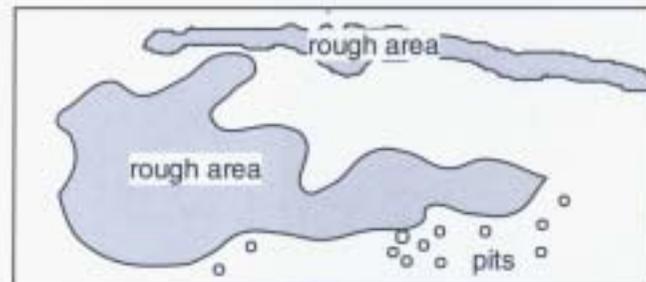
Inverted, rotated and scaled image (d) detail of possible corrosion area shown on (b).

Difference image: comparison between (c) and (e). Rough and smooth areas (shown in sketch (g)) correspond to areas with more or less corrosion respectively. Small spots remain in difference image and are evidence of pitting of surface. But there is no evidence these pits penetrate the hull.

Interpretation and summary of corrosion area, showing rough and smooth areas and pits.

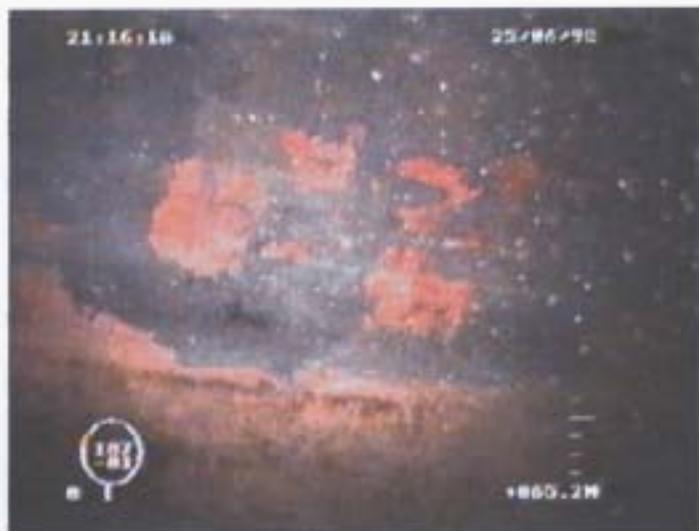
(a)

Area of general "corrosion", red paint exposed under black paint, plus linear, sub-horizontal marks.

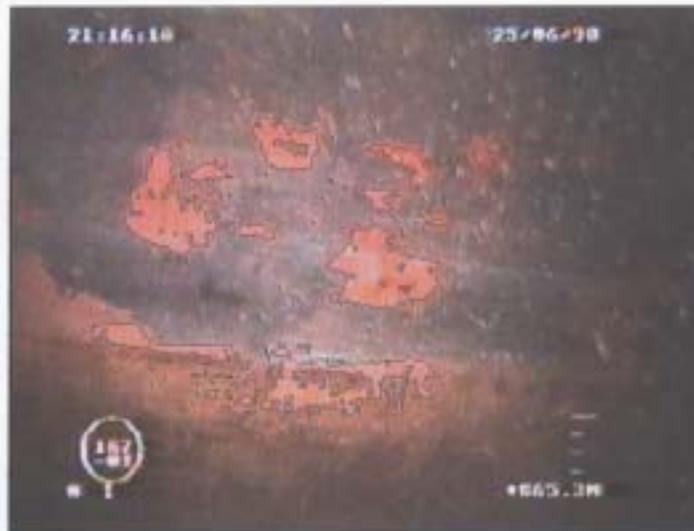
(b)

Area of general "corrosion", outlined by contours of significant colour gradients.

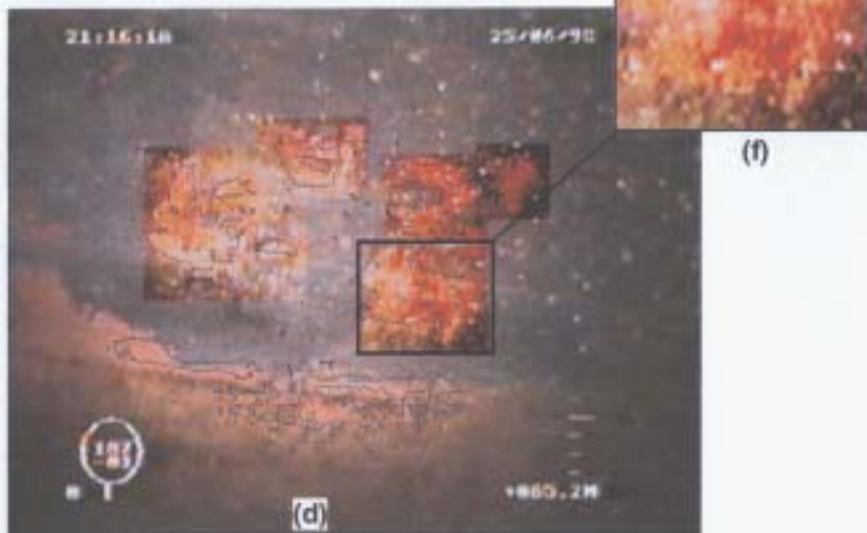
(d)

Areas of general "corrosion", enhanced by contrast equalisation (including inset detail (f)). Equalisation shows variations in paint colour, but no perforations in the plating which would otherwise appear homogeneous.

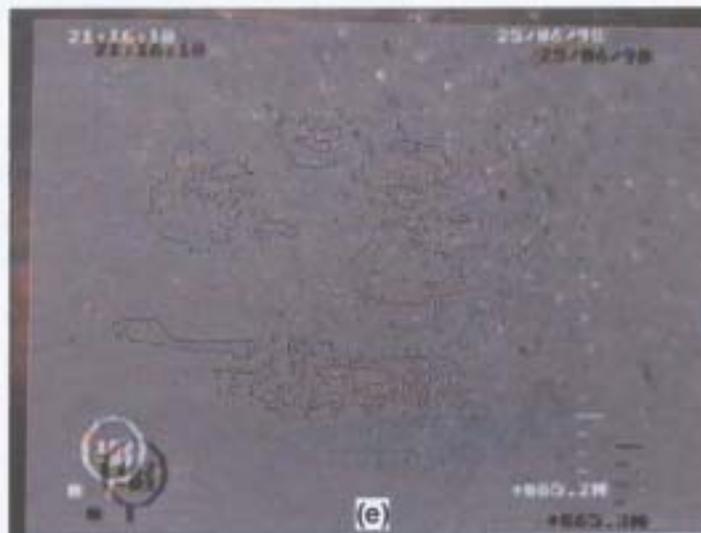
(e)

Difference between two images of the same area, offset by 10-20cm. The image does not show any significant textural differences coinciding with the areas of "corrosion" (outlined) indicating little irregularity of the surface

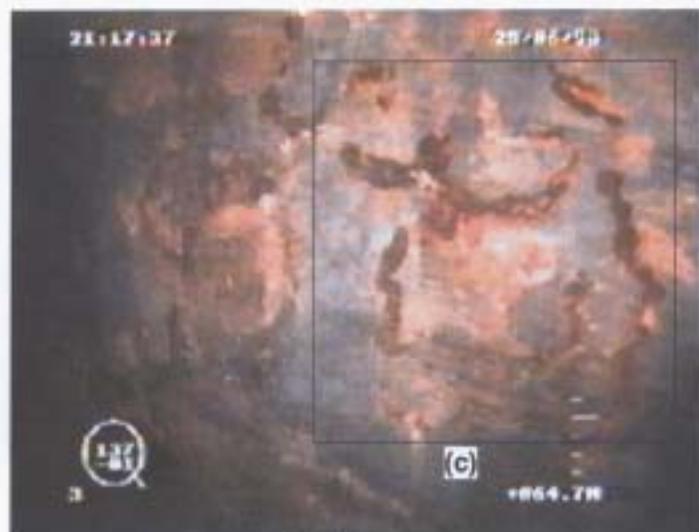
(a)

Areas of "corrosion" on plating. Inset (c) is area of more significant changes in colouration and possible depth of wasting.

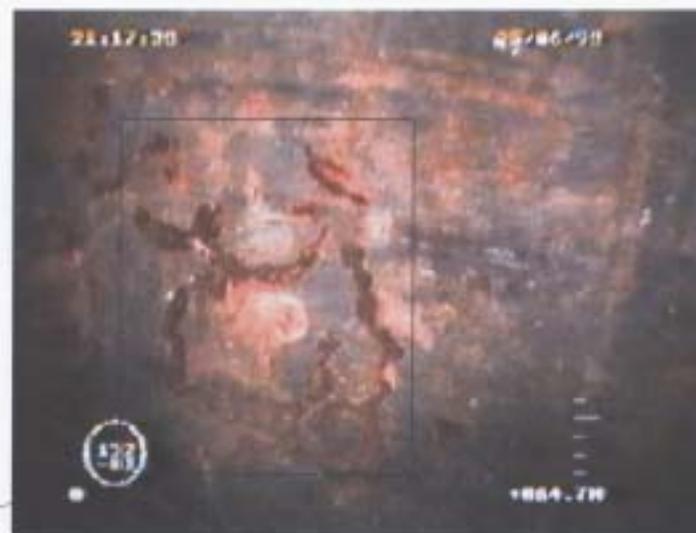
(b)

Areas of "corrosion" on plating imaged from a position ~50 cm to the left of (a)..

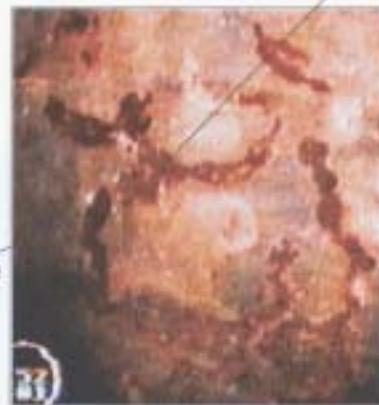
(e)

Details of areas of "corrosion". Equalisation of the image shows areas of darker discolouration bordered by dark and lighter edges, indicating surface relief.

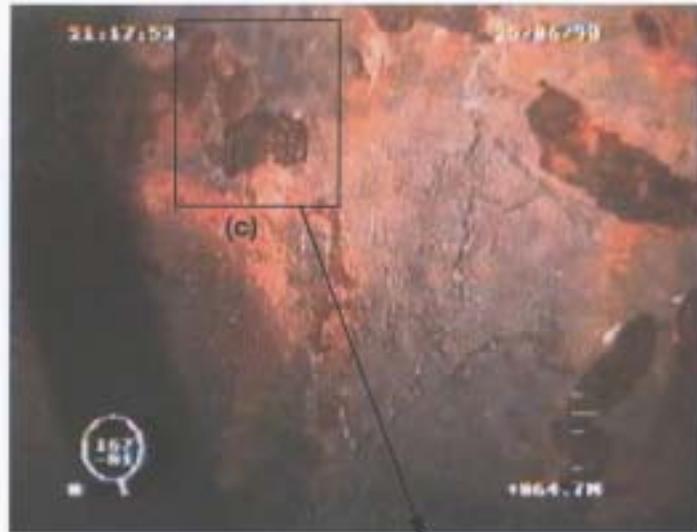
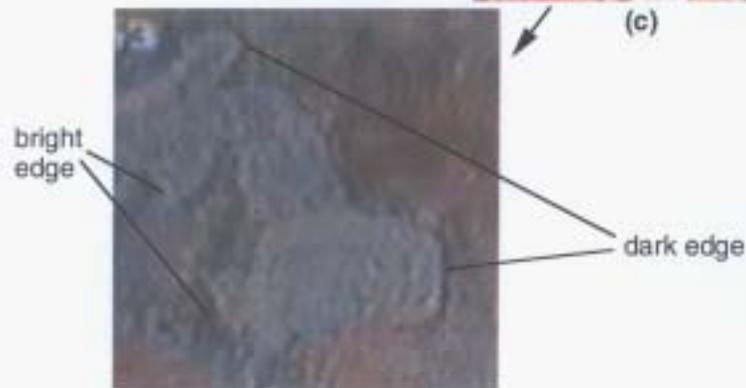
Areas of "general corrosion", (a) and (b) are views from different positions and perspectives. Views (c) and (d) are details, contrast optimised to show variations in illumination. The dark regions in views (c) and (d) are generally bordered by light rims to the left (reflective edges) and dark rims to the right (shadowed edges). Illumination is from the right, therefore the rims show relief between the dark and light areas such that the darker areas are depressed relative to the lighter areas. This difference in relief is demonstrated by the difference between the detailed areas (f) (after correction for perspective and scale) showing dark rims (i.e. shadow) on the right edge of the dark regions and light rims (i.e. reflective) on the left rims. This suggests the darker regions have lower relief compared with the lighter areas and are probably areas of general wasting of the plates.

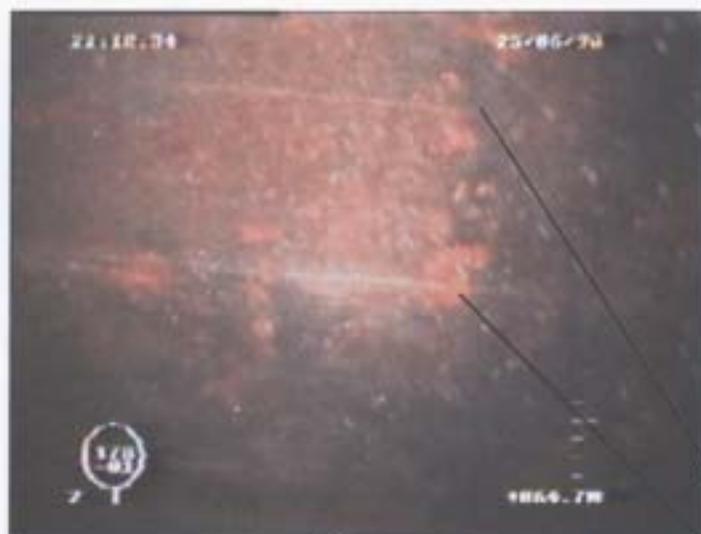
(a)

Image of parallel scratches on side of hull

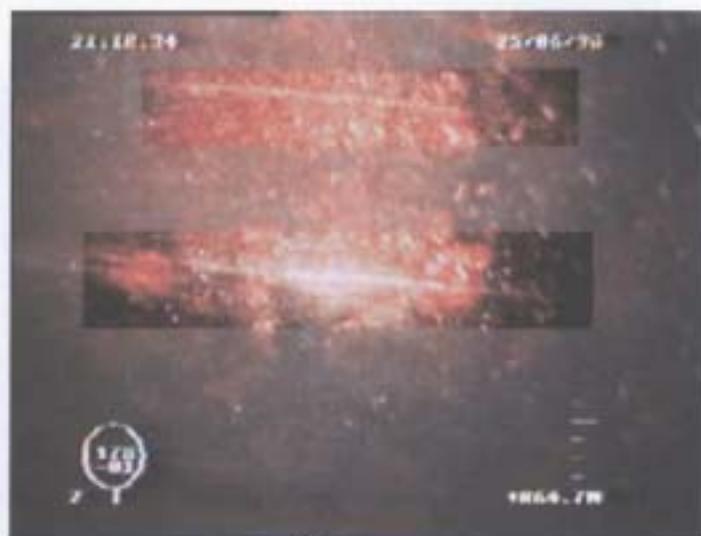
(b)

Image of parallel scratches, contrast equalised, showing lighter colouration, and hence no evidence of penetration of plate surface.

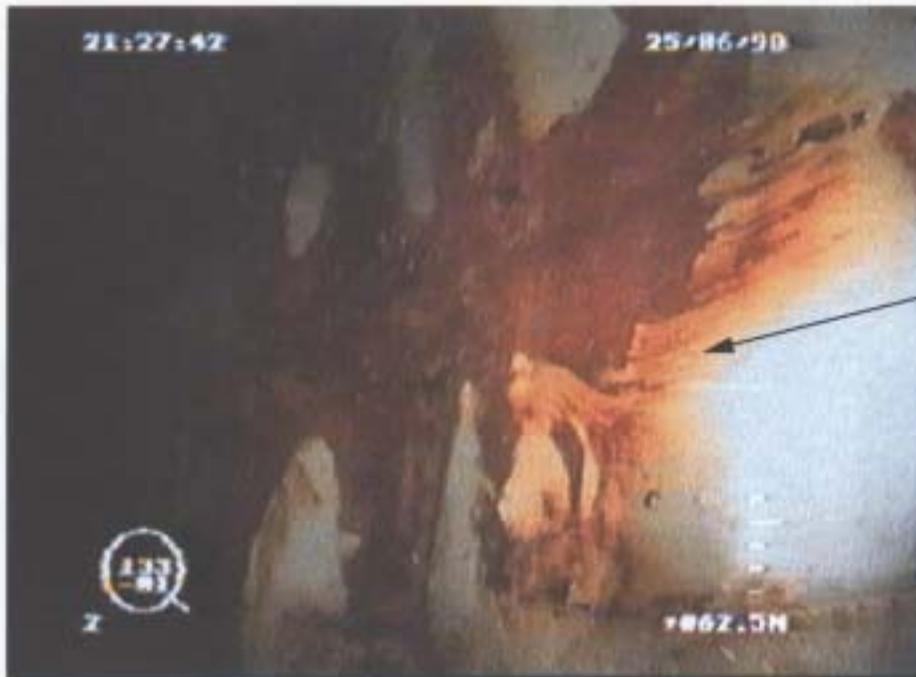
STARBOARD SIDE BOW DAMAGE

Parallel and sub-horizontal scratches truncated by large area of damaged paint work revealing red surface below white.

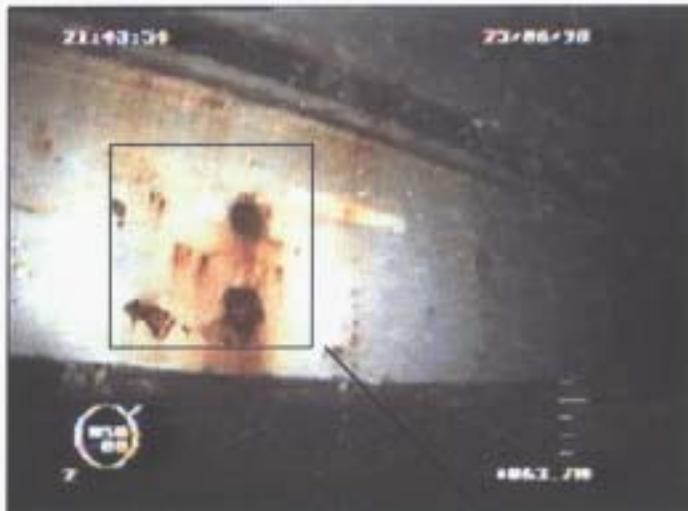
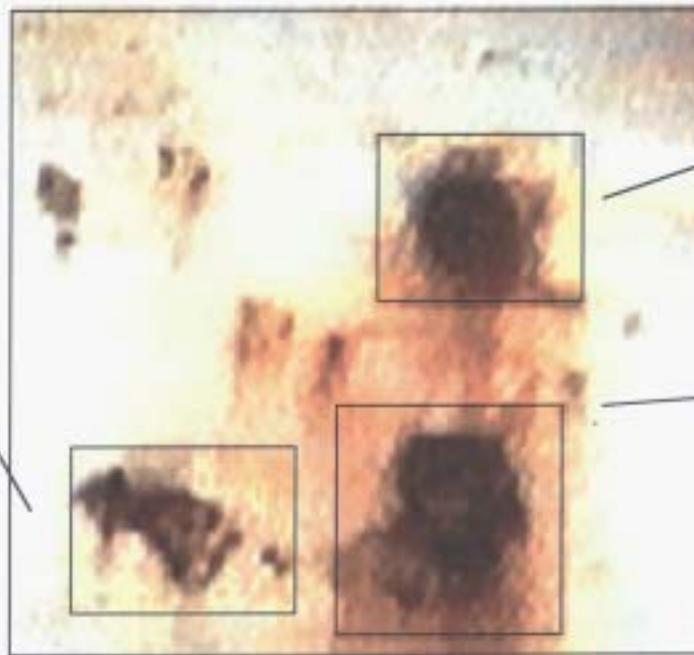
THREE RUST SPOTS ON TOP SIDE FORWARD AND MIDSHIPS

Inset details of rust spots including contoured contrast gradients (i.e. edges) showing details inside rust spots. Variations in contrast within the spots is evidence that the rust patches are regions of variable corrosion. Small dark spots within the rust patches are possible perforations of the plate surface.

Three rust spots, contrast equalised, and details

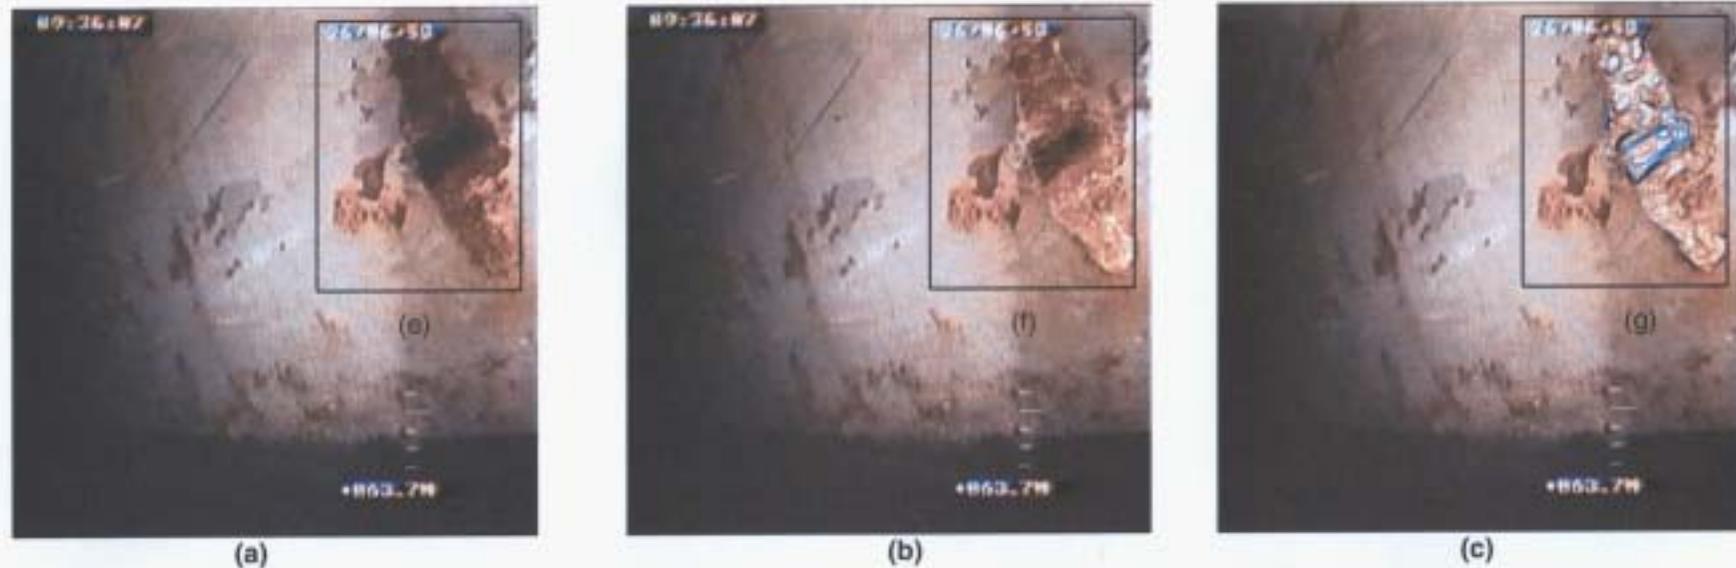
POSSIBLE INDENTATION, RUST PATCH AND PERFORATION OF PLATES

Images of possible "indentation, rust patch and perforation" of plates on top side forward amidships. Image (a) is the image of the area of interest, (b) is the area after contrast equalisation, and (c) is contoured for edges (second order differential). Both (b) and (c) show complex structure in the area, with several concentric zones of increasing dark colouration. The darkest colouration is roughly rectangular in shape and elongated sub-horizontally and parallel to the length of the vessel.

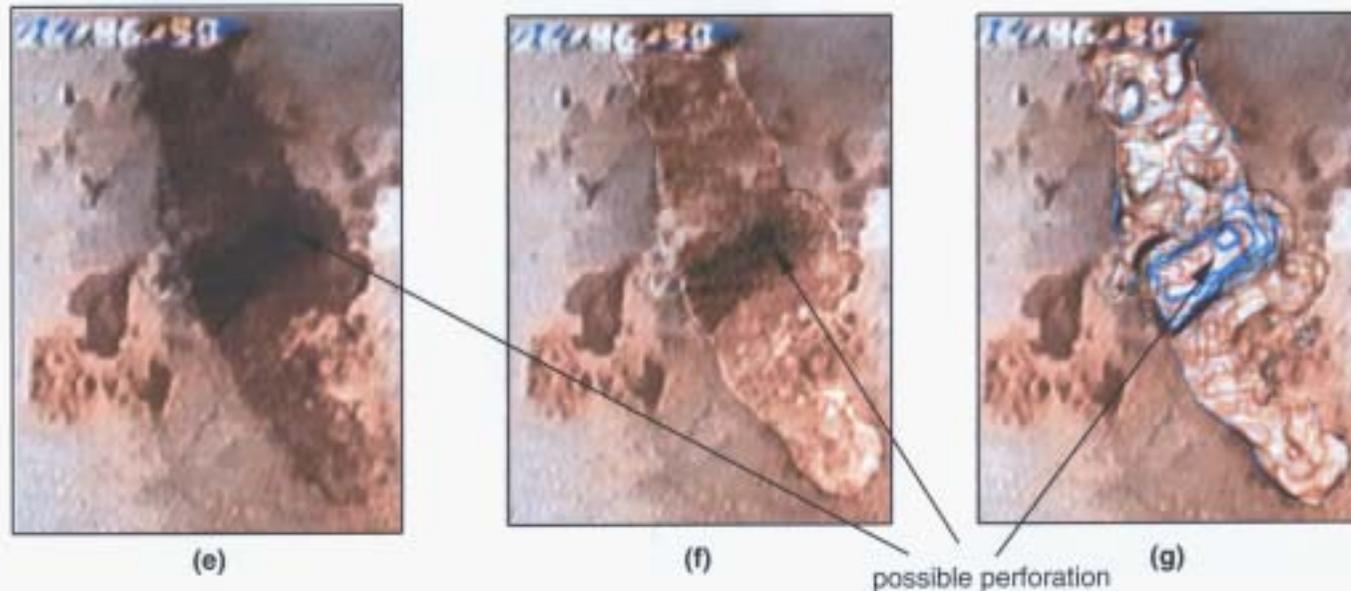
Details of the rust patch: (e) after contrast optimisation, (f) after contrast equalisation and (g) after contouring of edges of different contrast within the area of interest. The darkest discolouration forms a rectangular shape, with several further concentric rectangular boundaries inside. The innermost and darkest rectangular patch contrasts with the red rust patch to the left, which is consistent with the presence of a perforation in the plate work.

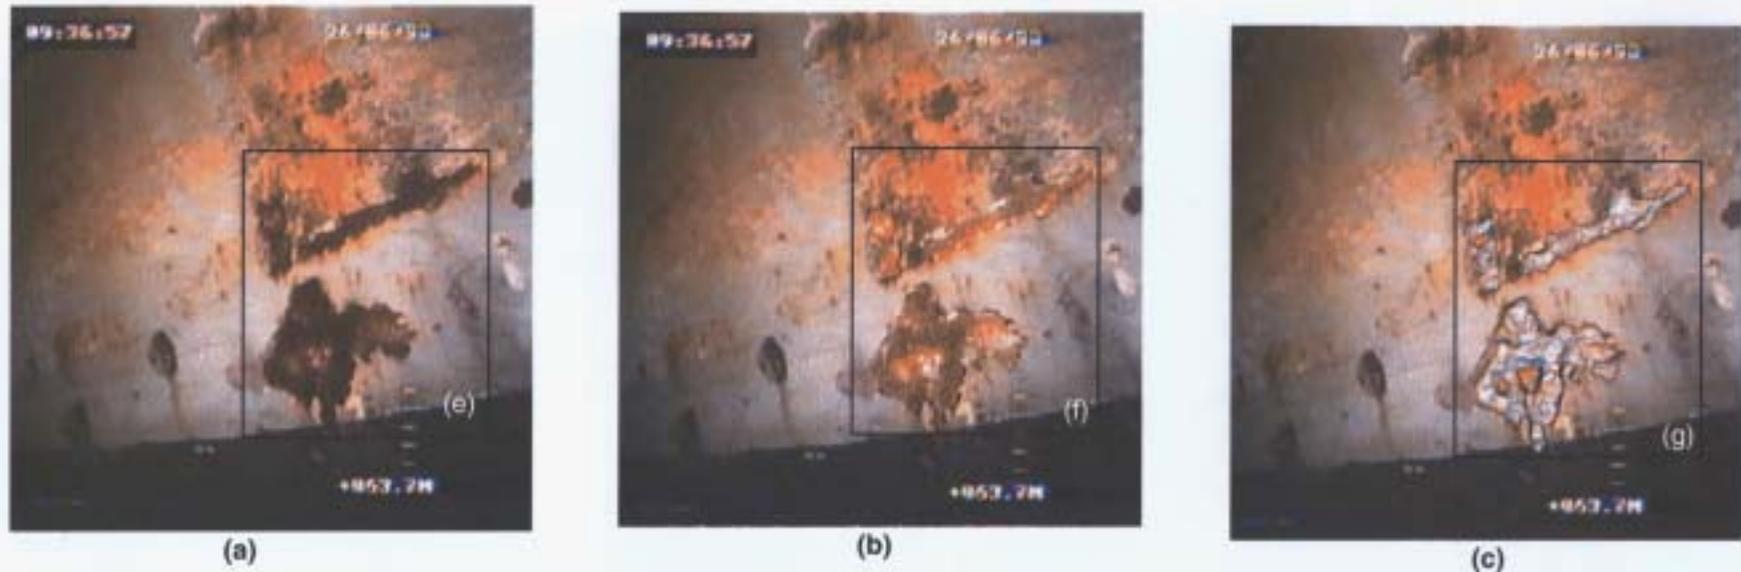
POSSIBLE INDENTATION, RUST PATCH AND PERFORATION OF PLATES

Images of possible indentation, rust patch and perforation of plates. Image (a) is the image of the area of interest, (b) is the area after contrast equalisation, and (c) is contoured for edges (second order differential). Both (b) and (c) show complex variations in discolouration within the rust patches, indicating wasting, but not perforation, of the plate.

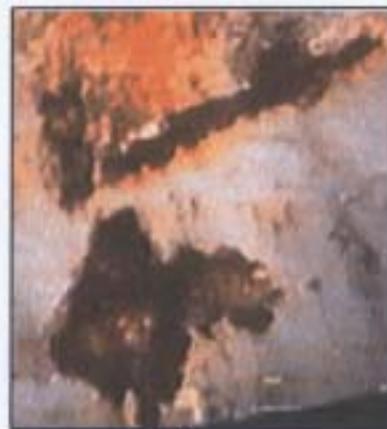
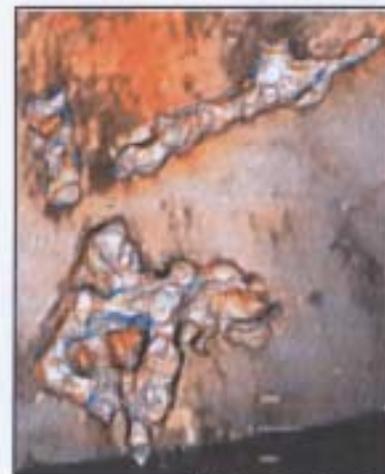
Details of the rust patch: (e) after contrast optimisation, (f) after contrast equalisation and (g) after contouring of edges of different contrast within the area of interest. Both the longitudinal area of damage and the more circular area comprises discoloured plate, but with no obviously very dark regions that would be evidence of perforation.

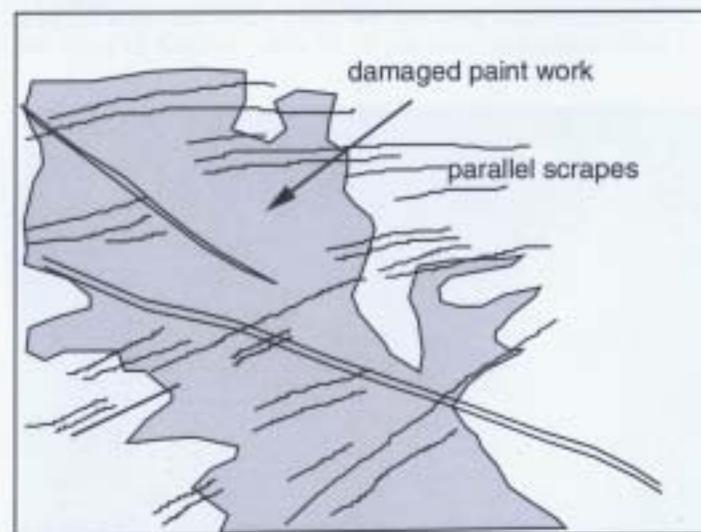
Images of scrapes along the starboard side of the hull. Images (a) and (b) are the areas of interest, and (c) and (d) are line drawings of the essential features in those areas of interest. Significantly, both areas show similar features: a large irregular area of damage to paint work, with parallel and subhorizontal scrapes superimposed upon them. The scrapes clearly cross, and are hence younger than, the damaged paint work.

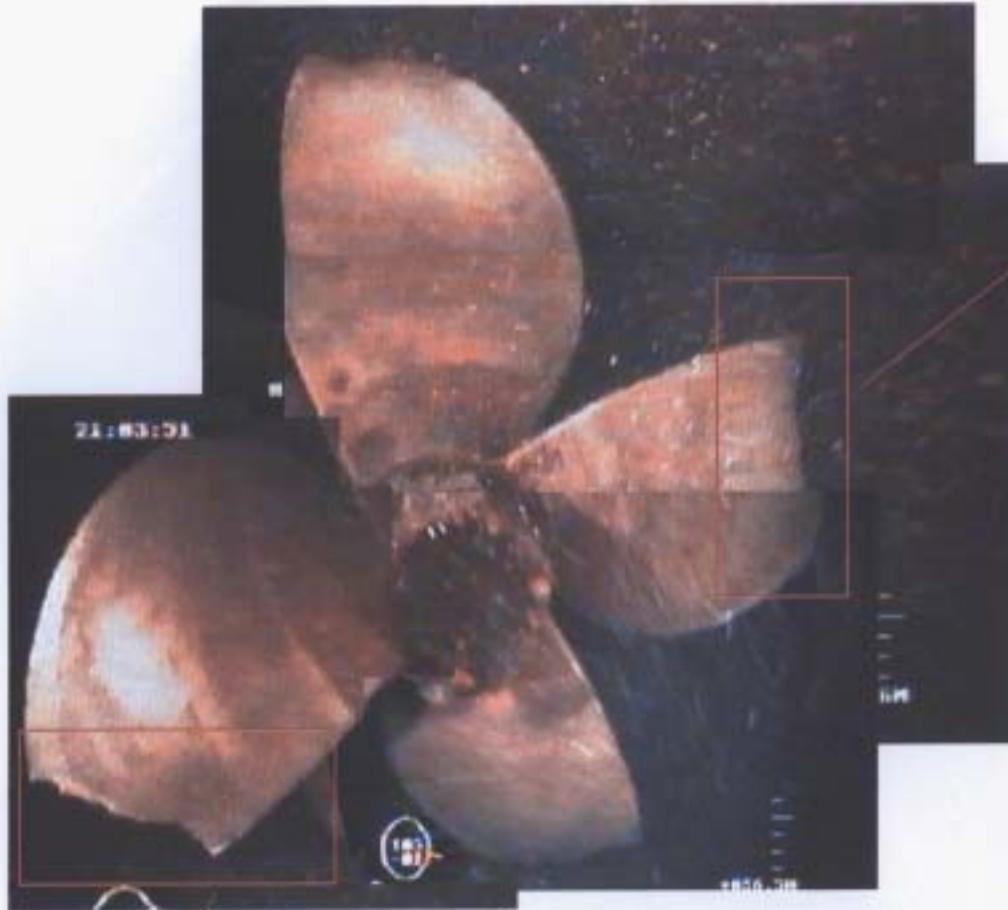
DAMAGED PROPELLER

Mosaic of propeller, showing broken tips to blades

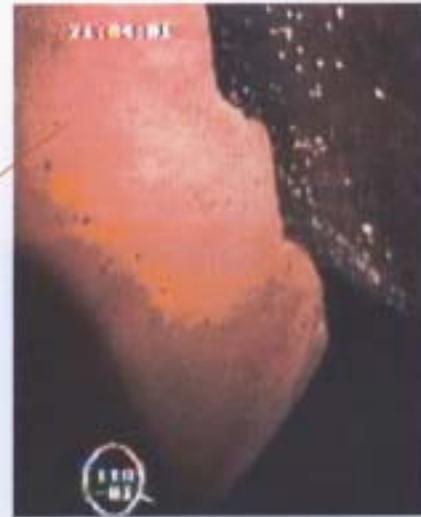
Detail of brittle-style fracture to propeller tip
