NAME OF VESSEL
REMA

At 0221 the Belize registered MV Rema broadcast a Mayday on VHF ch16 its position approximately 22 miles NE of Whitby. A search of the area using RNLI lifeboats, RAF helicopters and several Merchant vessels located the wreck of the vessel but its 4 crew were not found and considered to have perished with the vessel.

The purpose of this investigation was to perform calculations to explore the extent of flooding that would be necessary to sink the "Rema" in a manner that was consistent with the known circumstances of the casualty and the evidence available from the wreck. If possible, the investigation was to attempt to narrow in on the position and extent of damage that, at least on the balance of probabilities, is likely to have been involved.

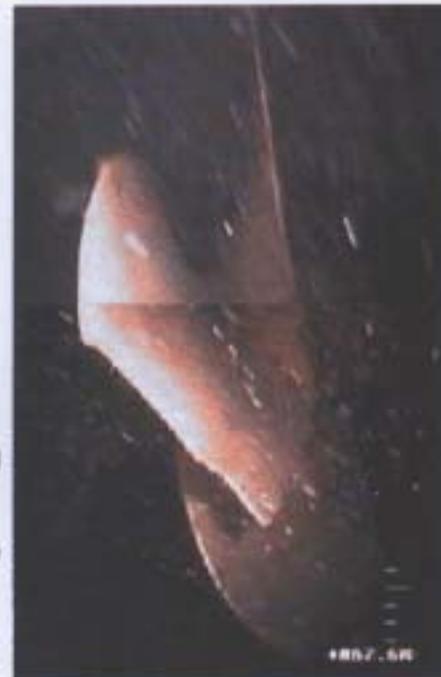
Mosaic showing side profile of propeller and broken blade tip

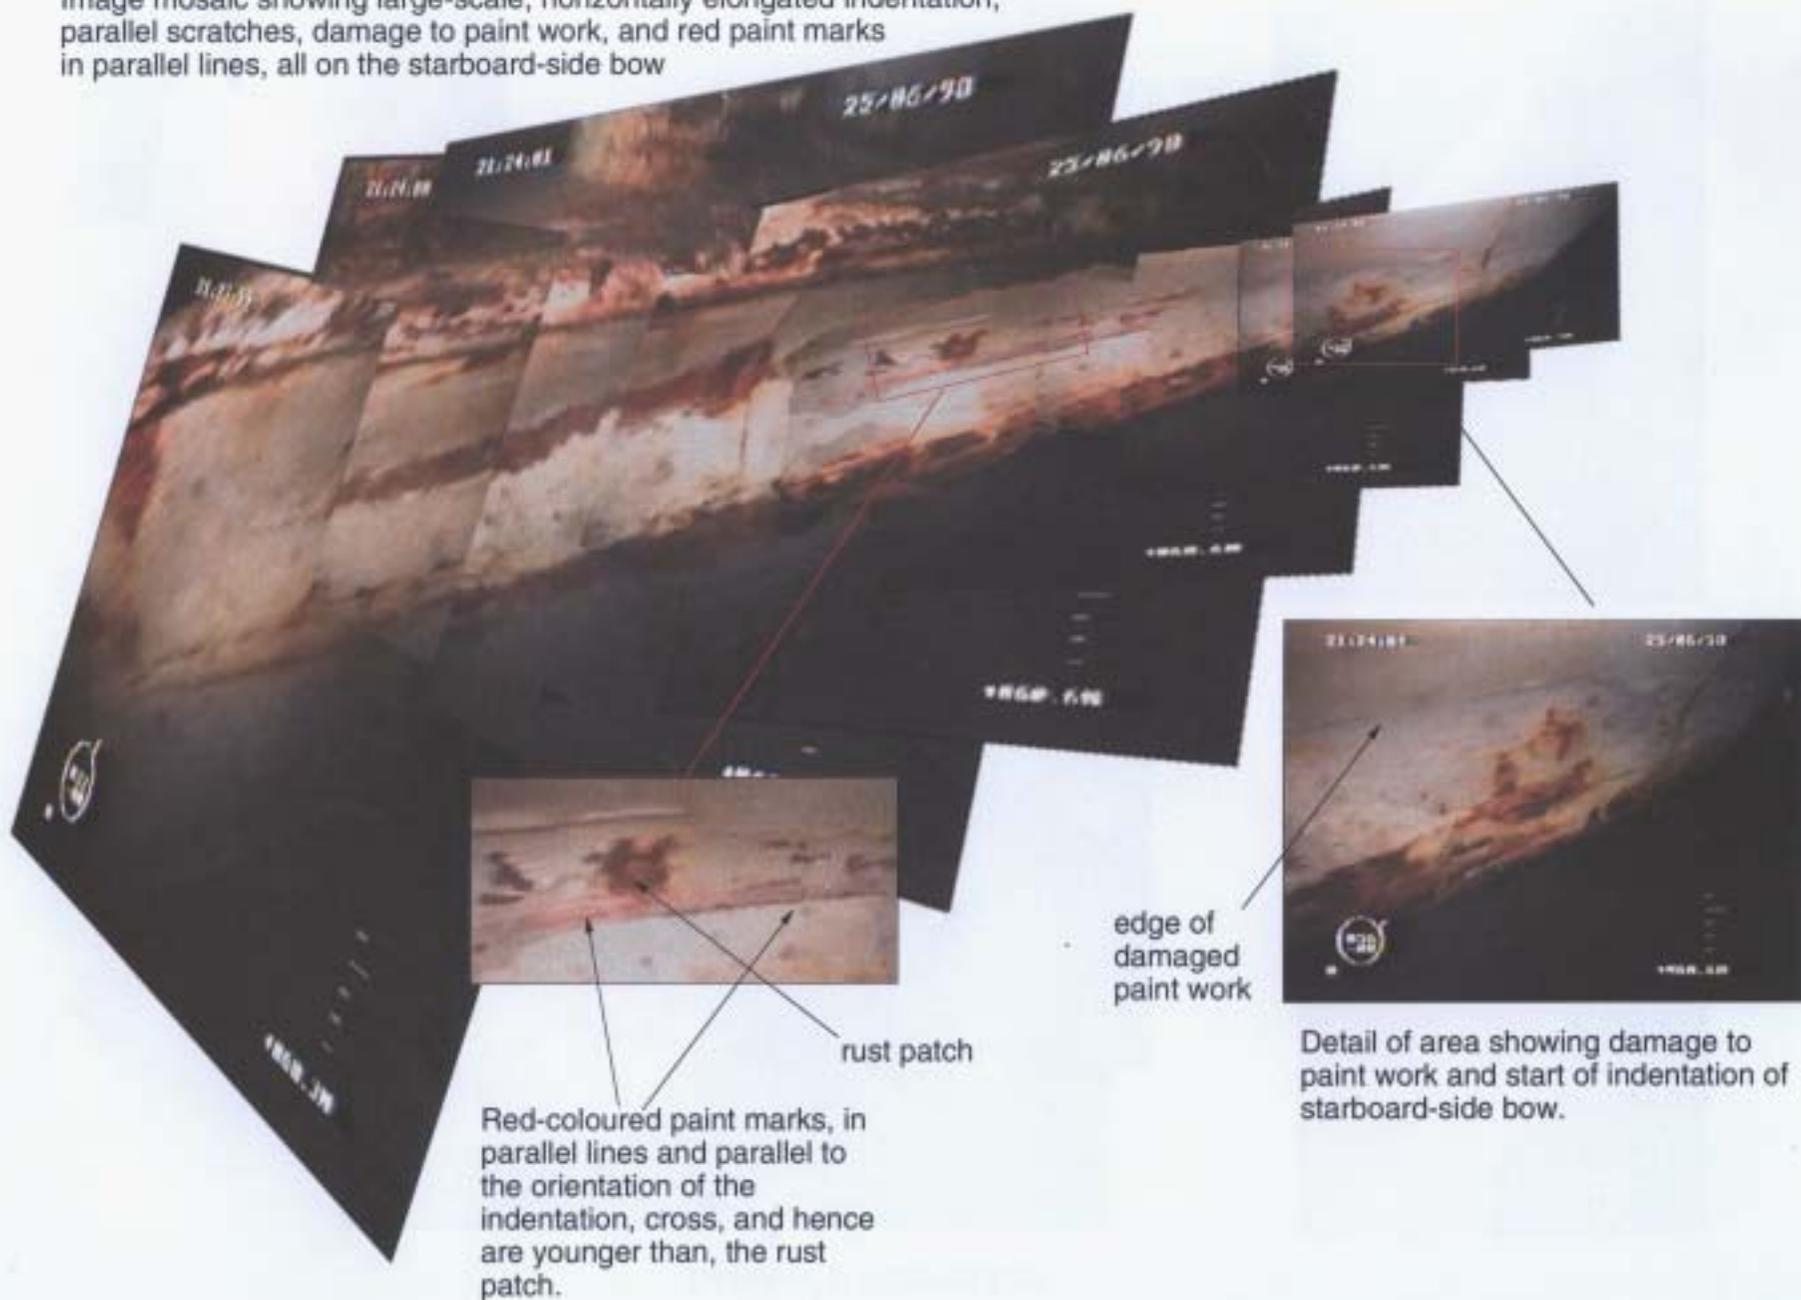
BOW DAMAGE

Image mosaic showing large-scale, horizontally elongated indentation, parallel scratches, damage to paint work, and red paint marks in parallel lines, all on the starboard-side bow

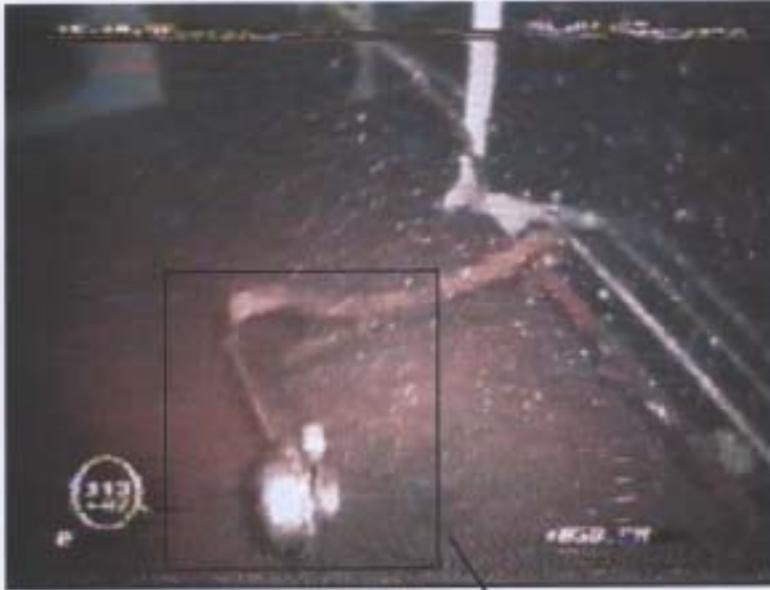
HYDROSTATIC RELEASE

Hydrostatic release (a) and detail (b) showing attached line or strop.

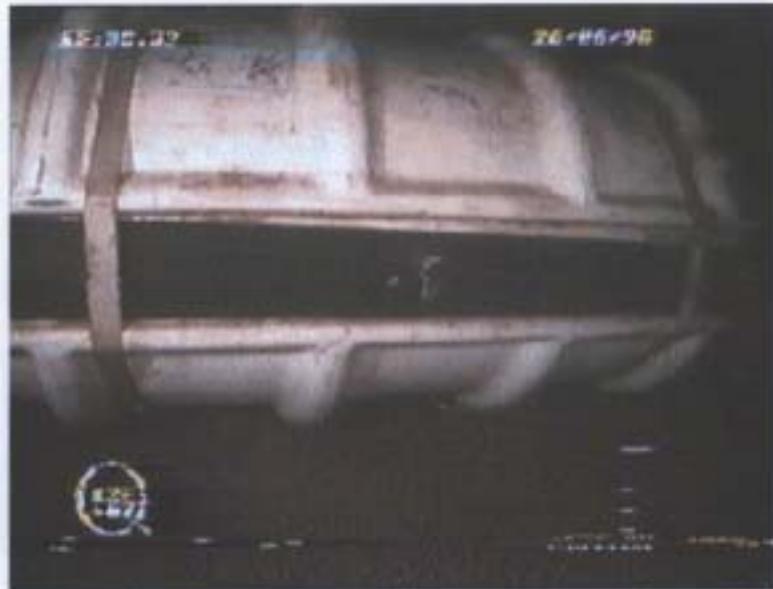
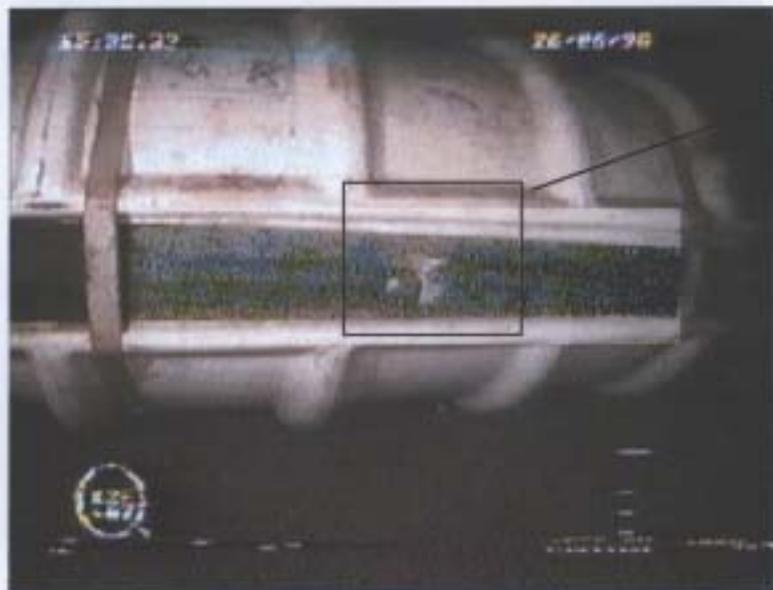
STARBOARD LIFERAFT: DAMAGED SEAL

Images of the starboard liferaft showing: (a) contrast optimised image with a light-coloured mark in the centre of the black seal surrounding the external casing; (b) contrast equalised part of the image, showing the mark as a significant feature; and (c) enlargement of the mark on the casing seal, revealing it as an area of possible damage.

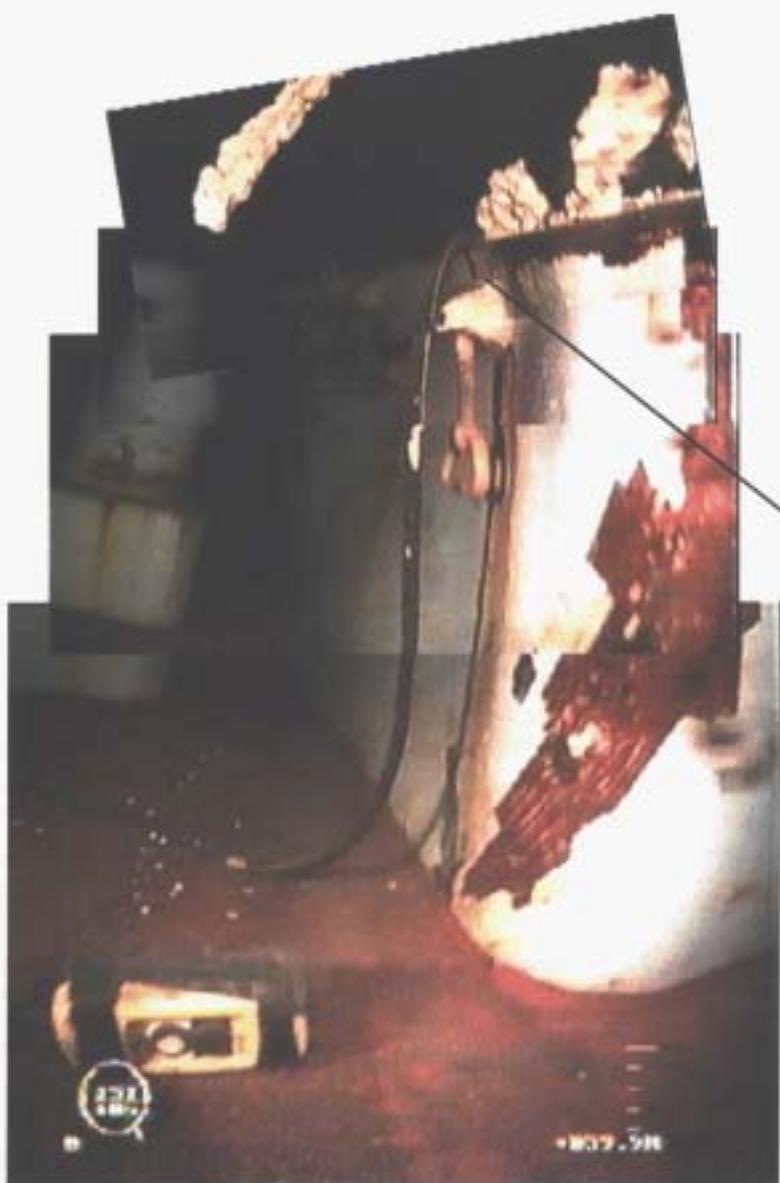
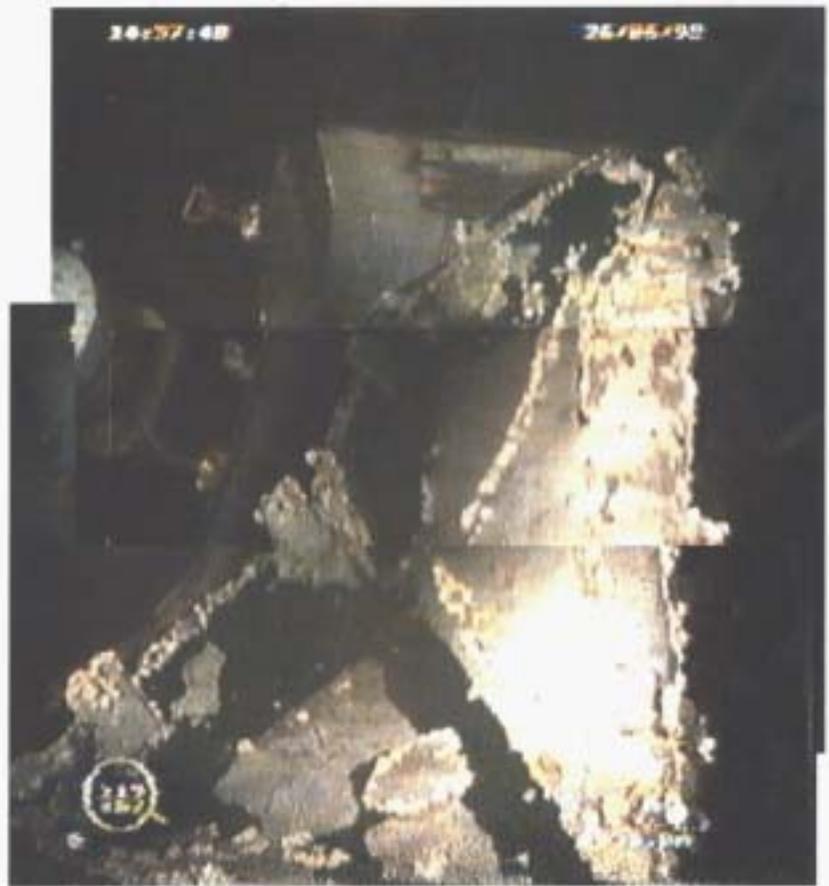
FORWARD HATCH COVER

Mosaics of forward hatch and cover. Hatch cover has suffered pressure damage causing inward buckling of both cover and coaming. A cable leads from under the forward hatch cover to a control device on deck.
