Marine Accident Report 5/99

Report of the Inspector's Inquiry
into the loss of

mv GREEN LILY

on the 19 November 1997
off the East Coast of Bressay, Shetland Islands

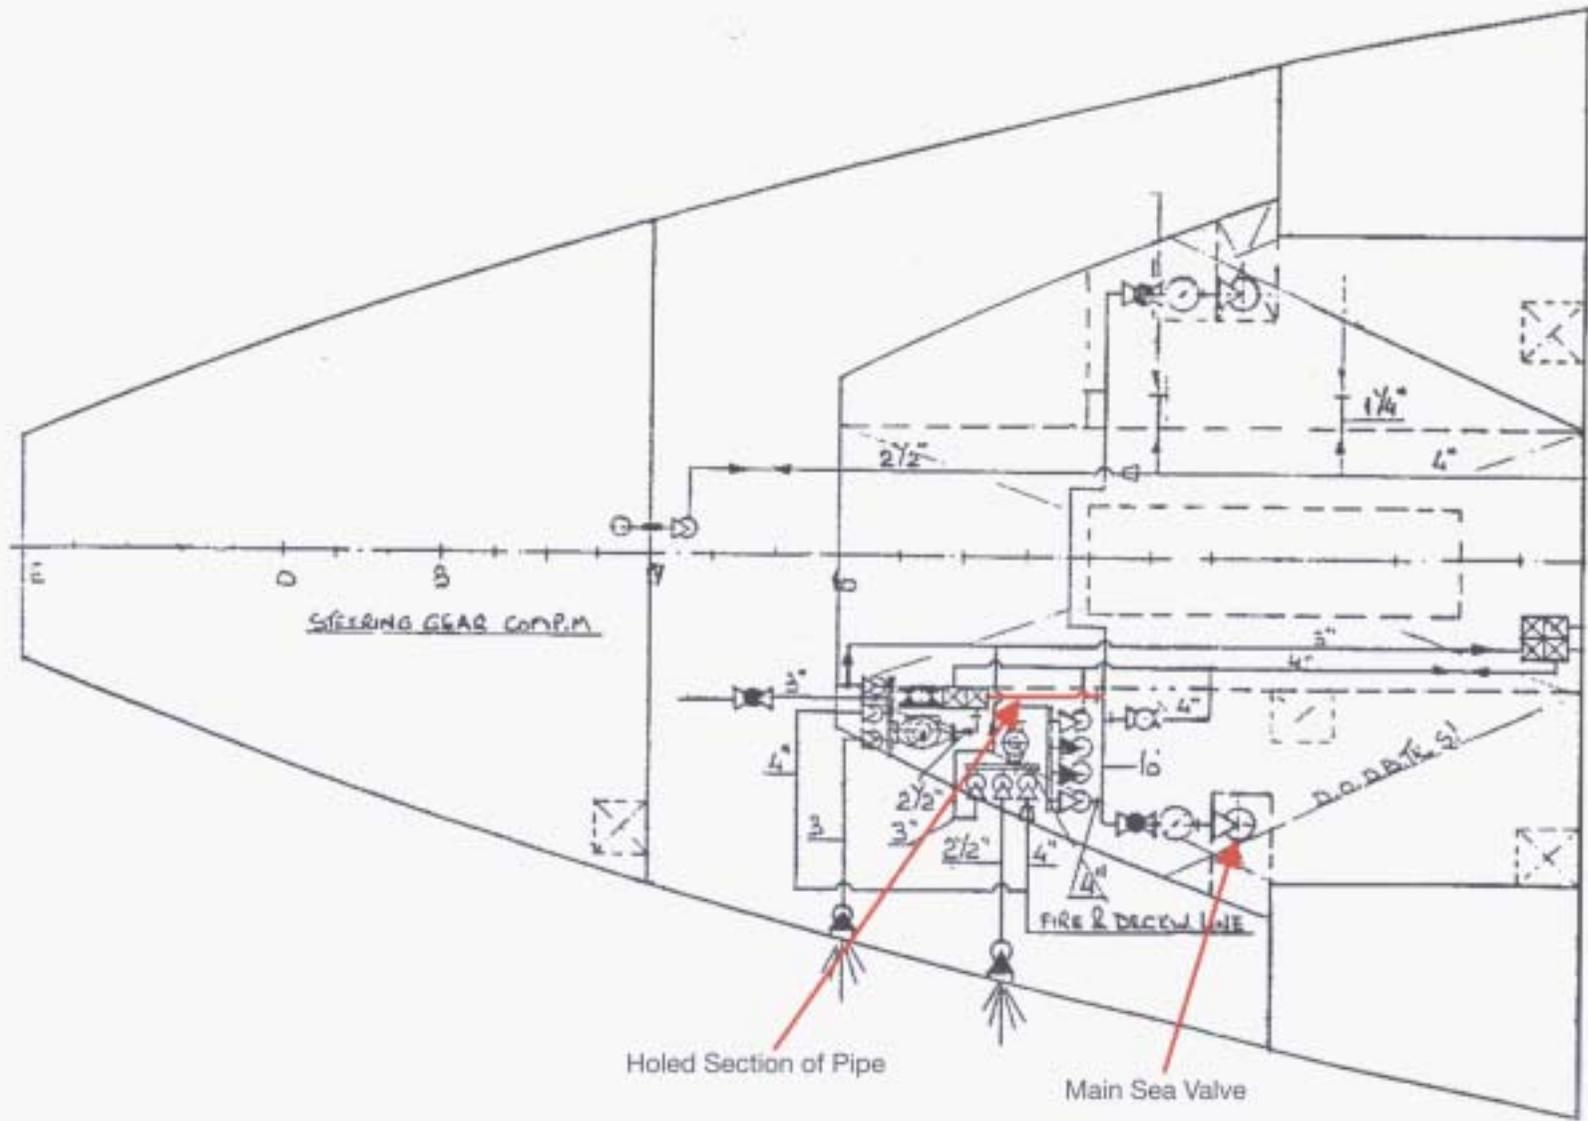
General Service Pump Piping Arrangement

1.14.1 The pipeline that fractured was the 100mm diameter sea suction line to the fire and general service pump on the starboard side aft of the engine room. The fracture occurred between the connection to the sea water main and the isolating valve fitted to the pump. Flooding could only have been prevented by the immediate closing of both main sea water inlet valves.

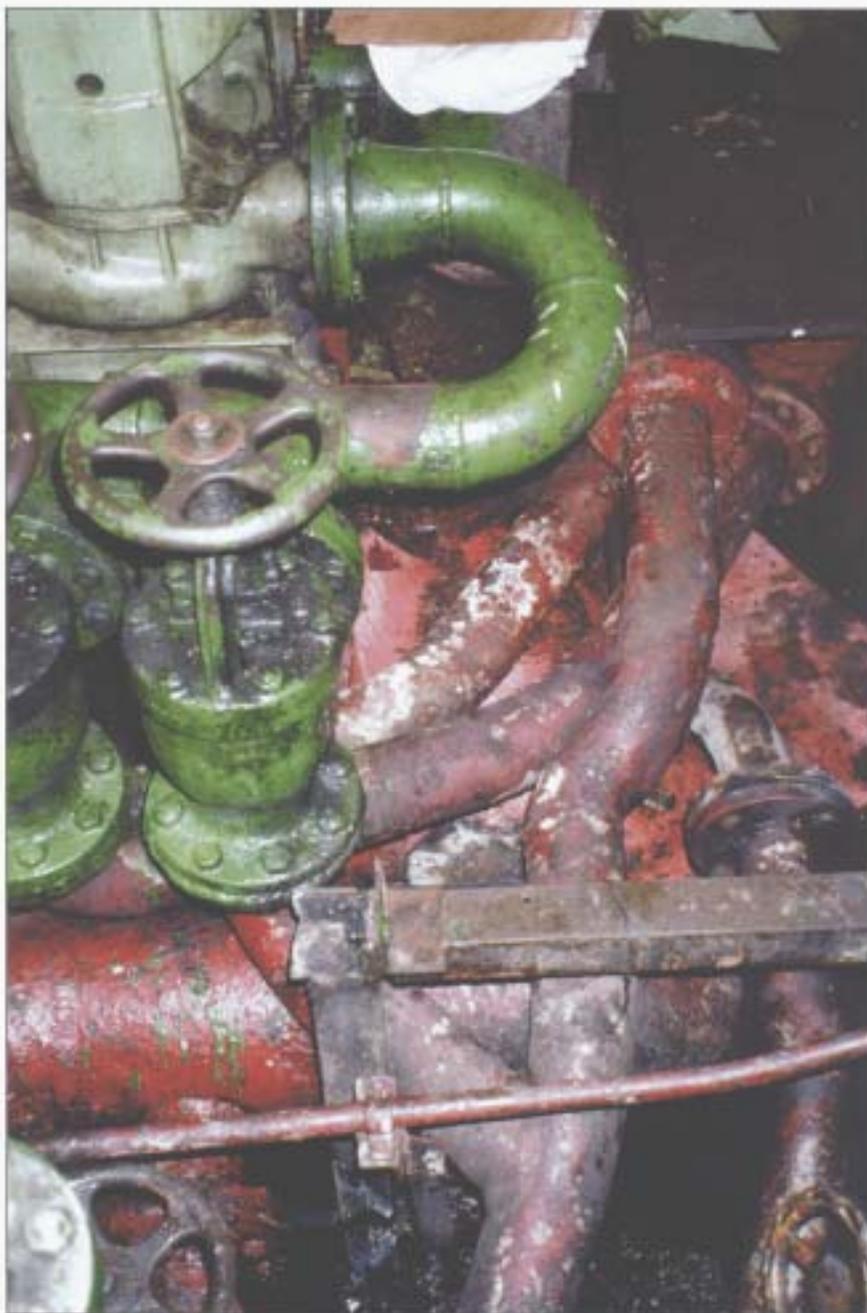
- 2.2.2 A study of the “as fitted” drawings together with a visit to a sister vessel, *Green Tulip*, by an MAIB inspector, confirmed that the fractured pipe consisted of one “L” shaped section, about 1.5m in length, flanged at each end. It ran vertically downwards from the pump valve to the tank top where it passed forward beneath two other pipes to join the main sea water cross-over line. Access to this pipe was very restricted and a full examination of the condition would be difficult without removal of other pipes.

Although the shape and position of this pipe section was not unusual, it did present two potential high risk areas of weakness. One was the outside curve of the 90° bend, which, from an erosion/corrosion point of view is the weakest point, and the other was condensation/water etc dropping down from pipes and floor plates above. Both these points of attack tend to result in local thinning of the pipe material giving rise to pin hole weeping. Once this situation has developed or is close to developing, any sudden shock loading due to rapid changes of draught or heavy vibration due to pitching, can lead to sudden failure. If the thinning area has developed over a relatively wide area, then failure can result in an immediate large hole.

View of General Service Pump on sister vessel *MV GREEN TULIP* showing configuration of pipework below floorplates. The sea water inlet pipe to the G.S. Pump passed below these pipes.

- 2.2.3** At the time of the fracture Green Lily was making way in heavy weather and had been doing so for some 18 hours. During this time she was virtually hove to. Under these conditions, heavy rolling combined with severe pitching occurred giving rise to shock loading and heavy vibrations at the aft end of the vessel.

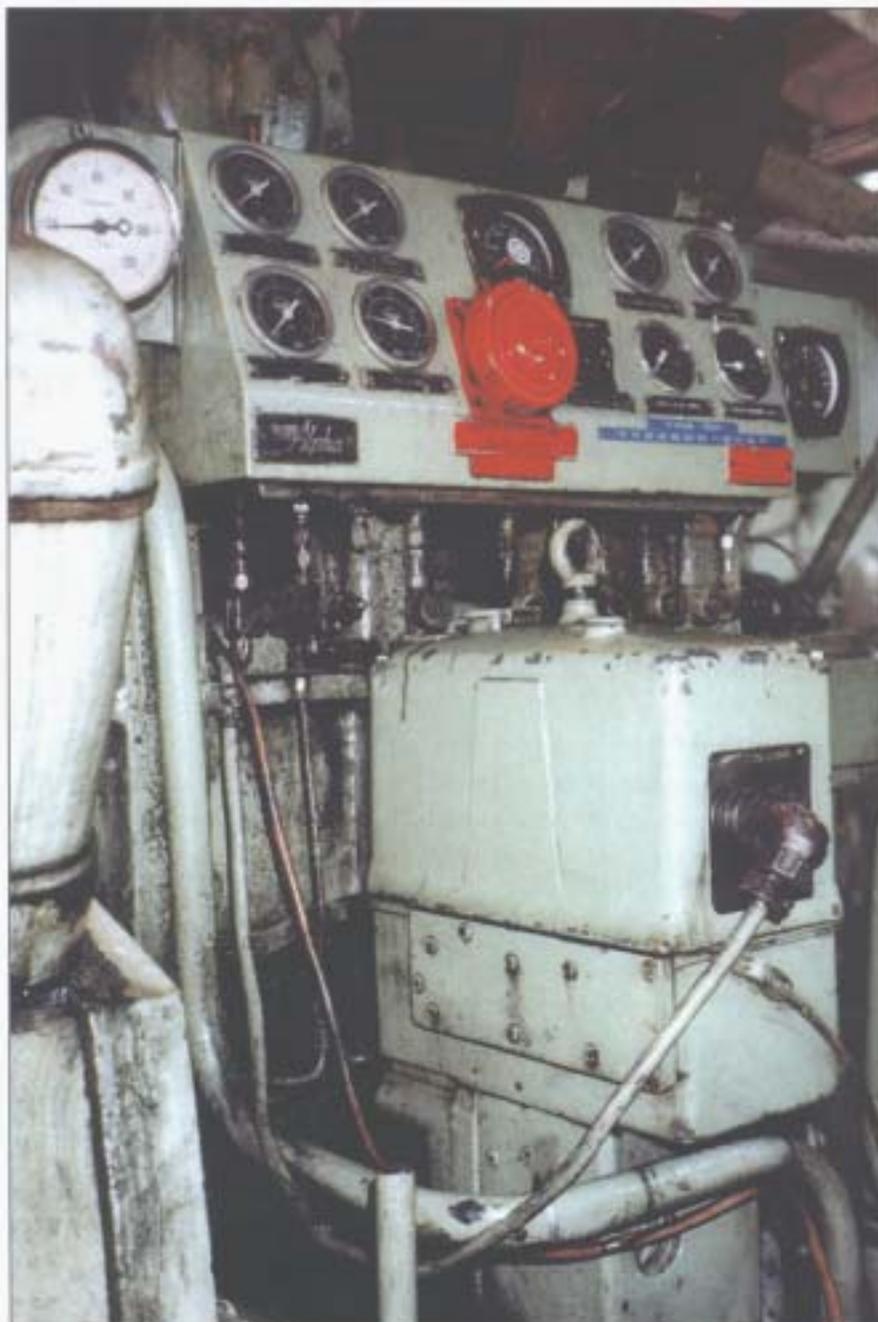
With the electric air start not working, the electrician, by manually holding the starting solenoid over, by-passed the safety system allowing starting air to be admitted to the air start system. Once the engine was turning over, the engine driven lub oil pump pressurised the system and caused the lub oil pressure relay to move into the run position.

View of Main Engine control point showing Governor and Electric Starting Control (red rotary switch). This control point is at the Port Aft end of the Main Engine.

As stated earlier, the electrically operated stop system fitted in the governor is of the "energise to operate" type. Any electrical circuit failure, either within the governor housing itself or in the supply wiring outside, would cause the electrical shut down system to fail. Without a 24V supply, the stop solenoid could not operate and the engine would continue to run. If the engine was in a stop condition at the time of electrical failure, the solenoid would become free and a spring beneath the ball valve would operate and reset the valve. Under this condition, the governor would revert to normal hydraulic control on the engine but without any electrically operated safety devices. Failure of an electrical circuit to the governor, therefore, would not prevent the engine from restarting.

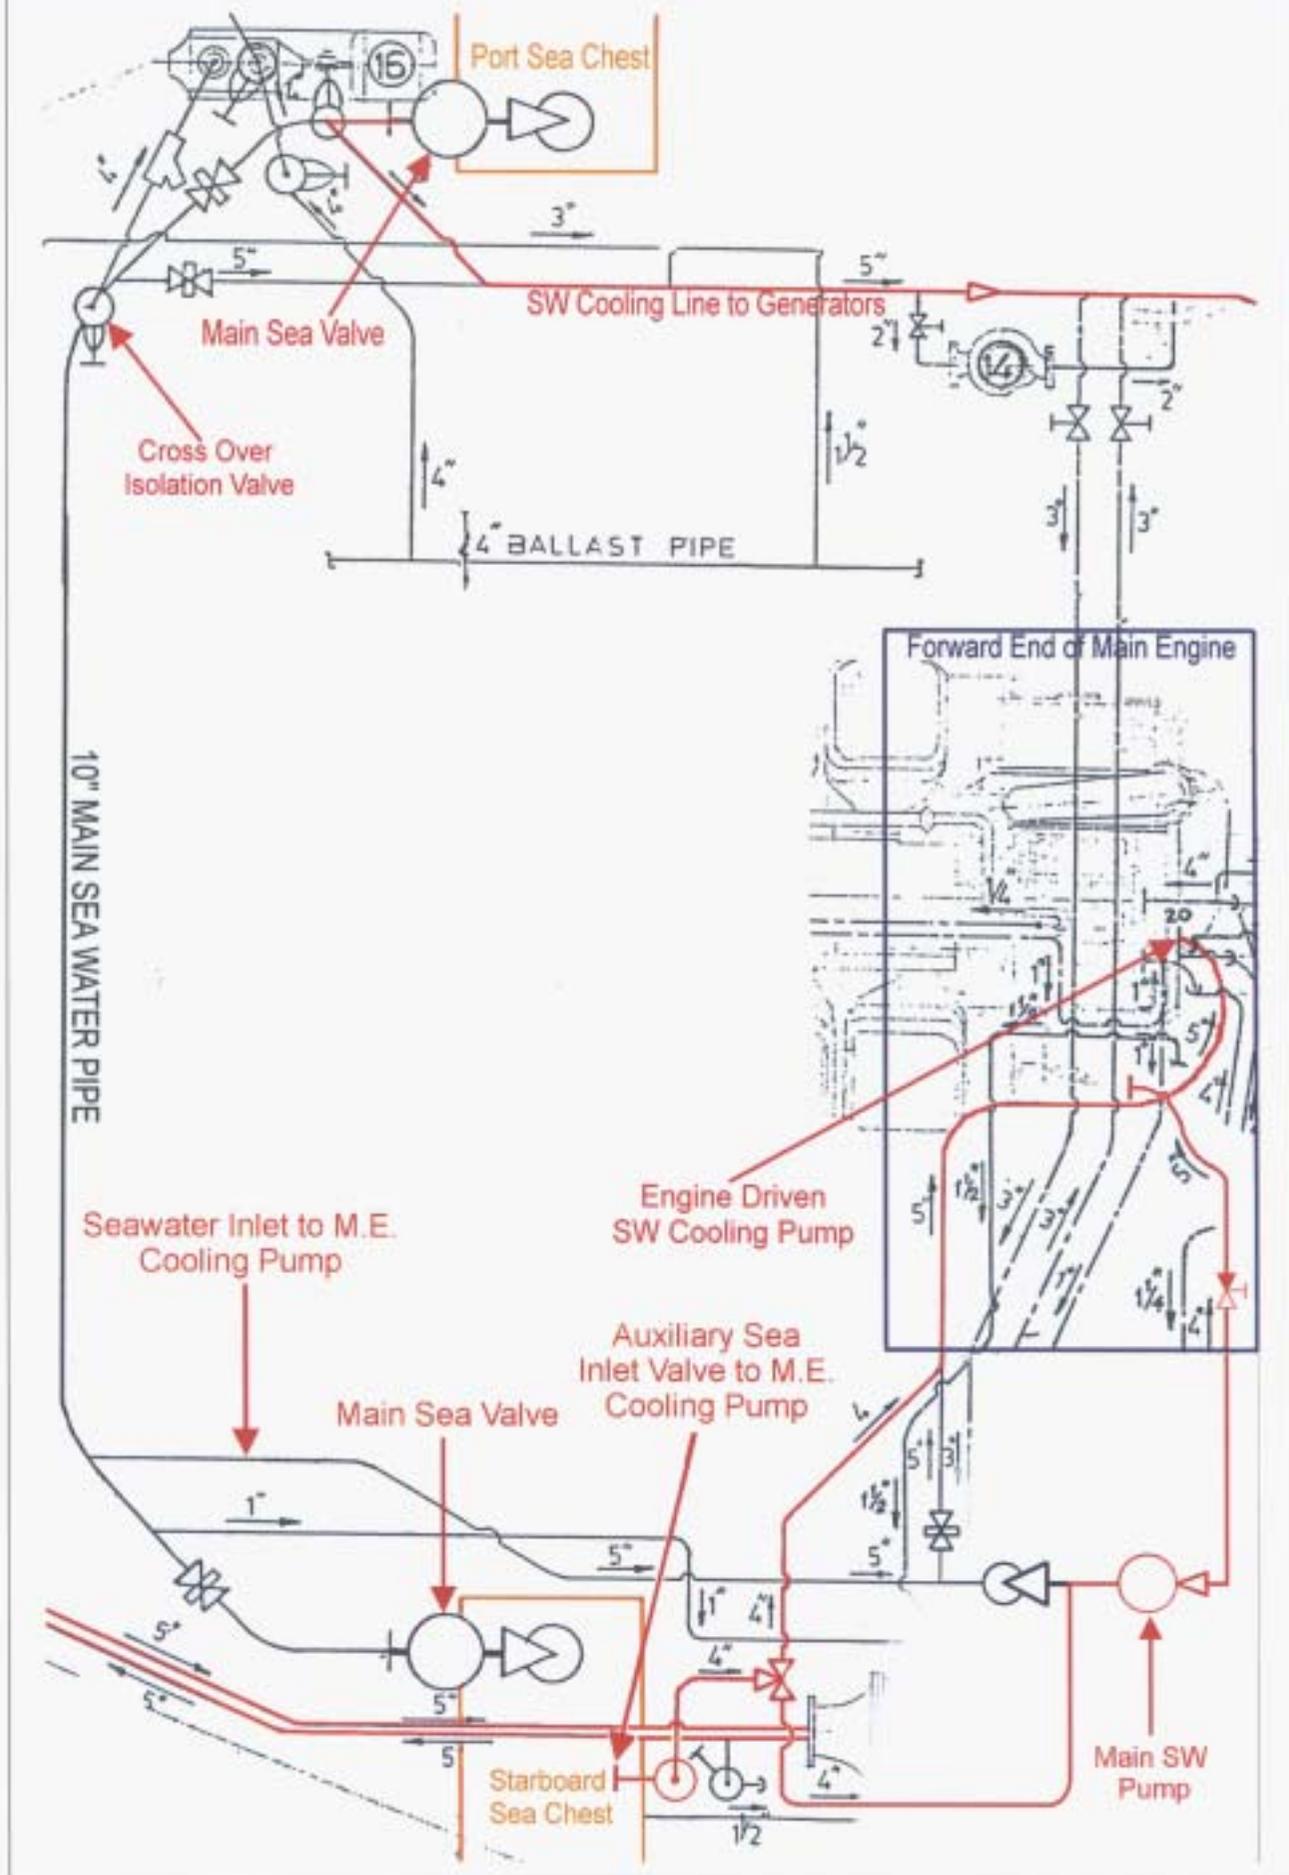
MV GREEN LILY Sea Water Cooling System

The engineers' decision to solve the problem by trying to stop the leak at the pipe itself was flawed. It is possible they thought that closing the main sea water valves would lead to a loss of propulsion power. An alternative cooling water supply to the main engine and generators was available but not used.

According to the machinery drawing of the vessel, a 100mm diameter auxiliary sea water cooling line came directly off the starboard sea chest to supply the main engine driven sea water pump. A similar 75mm diameter direct line from the port sea chest supplied the generators. The main engine would continue to operate therefore, even with the two main sea water inlet valves shut.

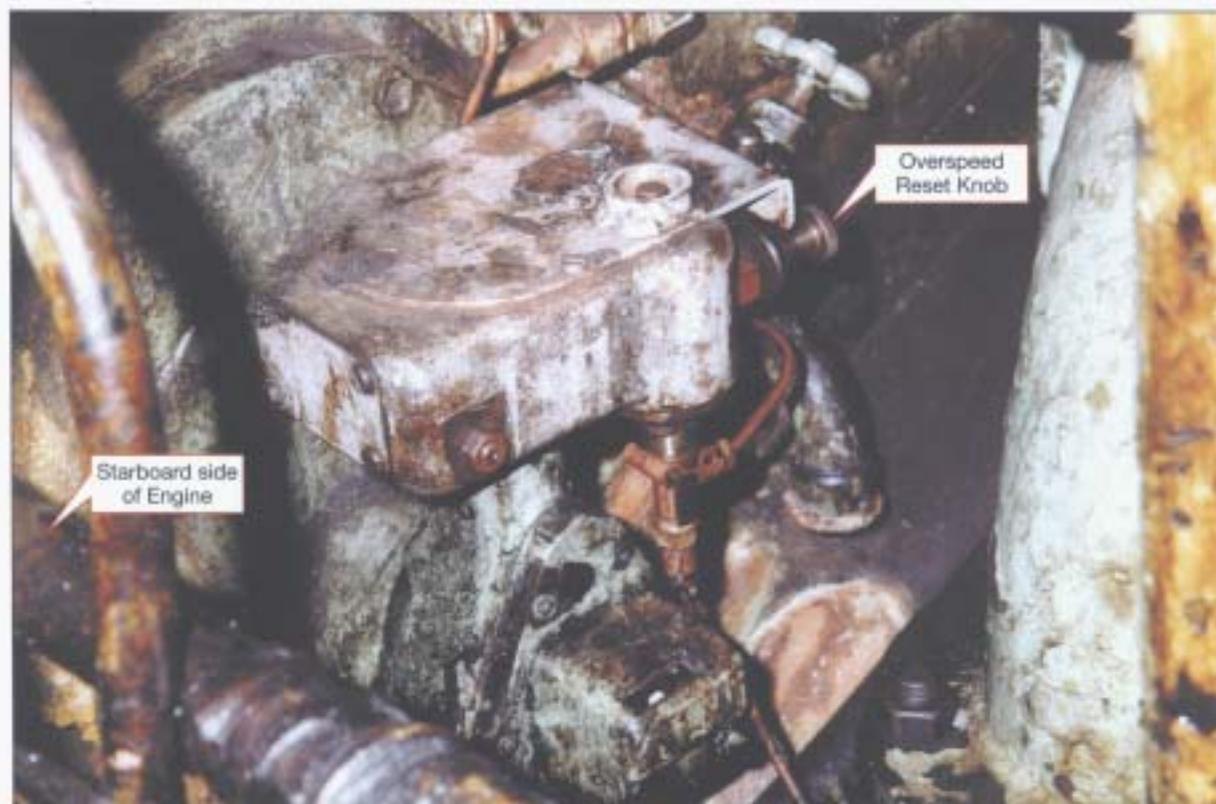
They would have been more aware of the possibility that the over-speed trip had not been reset had the mechanism been easily accessible, and readily identified from the engine control position.

View of Main Engine Mechanical Overspeed Trip fitted at end of Camshaft, Starboard side forward. The Reset Knob faces into the centre of the 'V' Engine and away from the Engine side. Access for operation is difficult from the Engine side. Feel only, no sight. Access from Forward is easier although at arm's reach.

Better siting and identification of the over-speed trip, along with better knowledge of the main engine control system and better diagnostic skills, would probably have enabled the engineers to restart the main engine.
