Marine Accident Report 2/99

Report of the Inspector's Inquiry
into the collision of

mv SAND KITE

with the
THAMES FLOOD BARRIER
on 27 October 1997

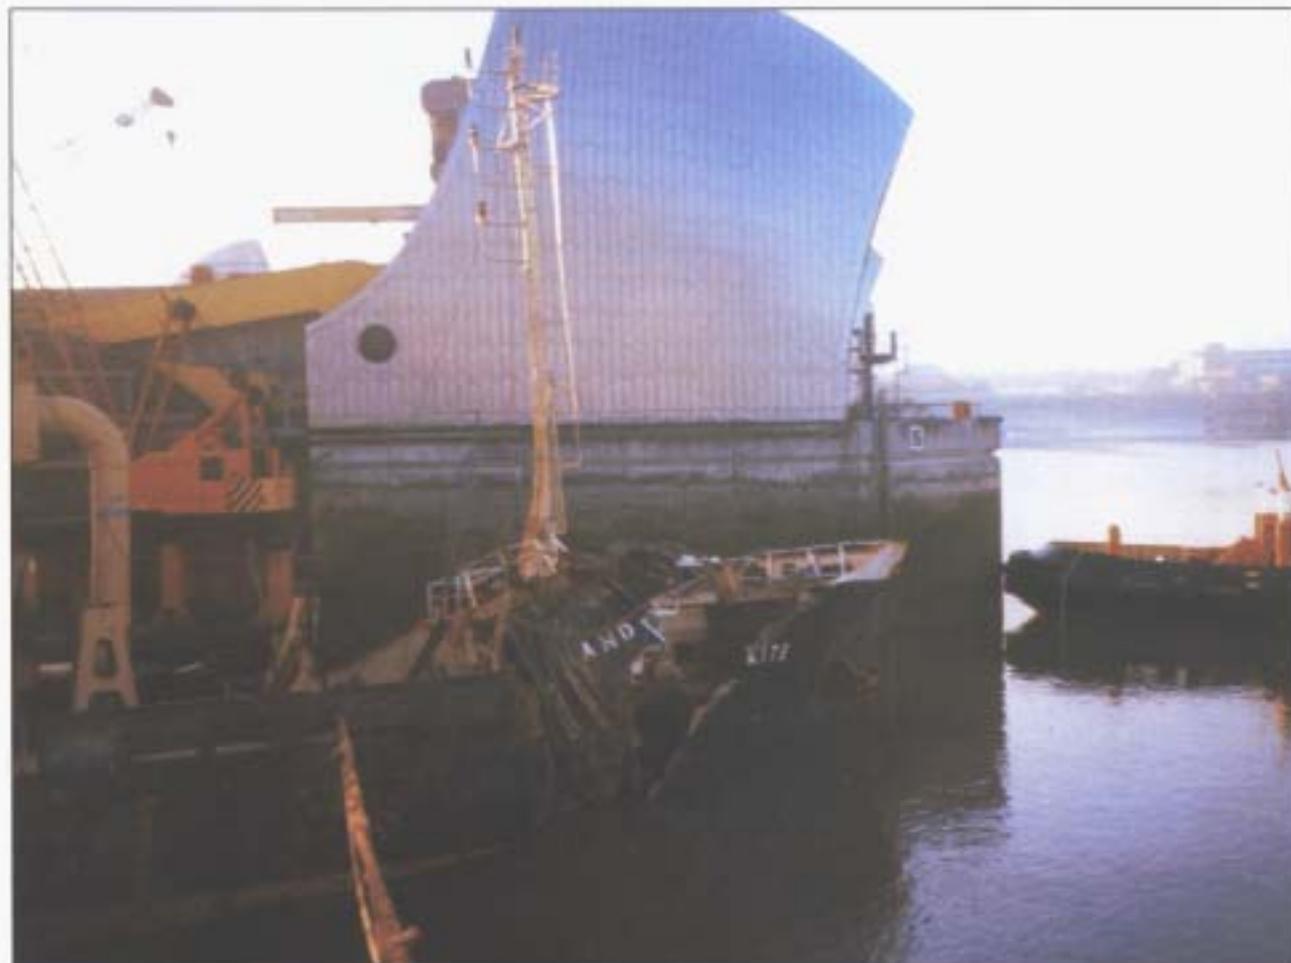
substantial damage to the forward structure as all way came off the vessel. It was subsequently found that a number of tanks and spaces, including the forward pump room, had been holed (Figure 6).

Figure 6: Sand Kite's damaged bow

Sand Kite was towed to a repair yard in north-east England on 13 November. She was fully repaired and back in service by the end of February 1998.

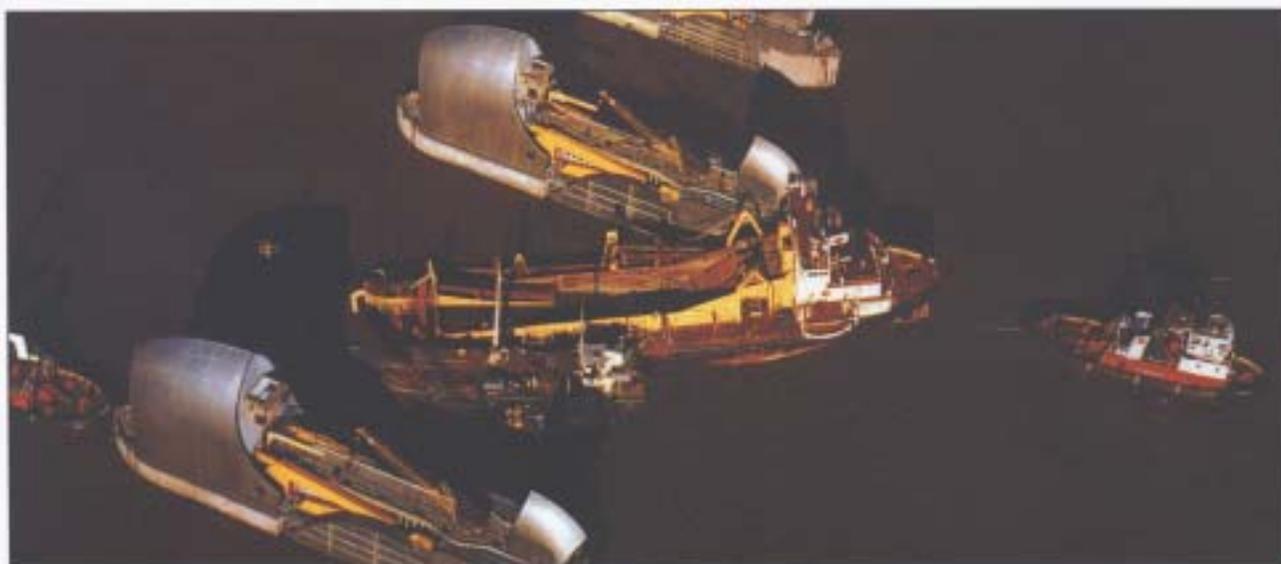
The situation seemed to stabilise with the bow settling on the ground between Piers 4 and 5 in Foxtrot Span and the aft part of the vessel remaining afloat alongside Pier 4 (Figure 7). The engine room staff were able to restore power to the after part of the vessel. The two crew members on the forecastle were rescued by one of the line boats and were taken aft where they were able to reboard and change their clothes. Soon afterwards most of the crew disembarked into the line boat and were taken ashore. Only the master and chief engineer remained on board.

Figure 7: *Sand Kite* blocking Foxtrot Span [photograph courtesy of FotoFlite]

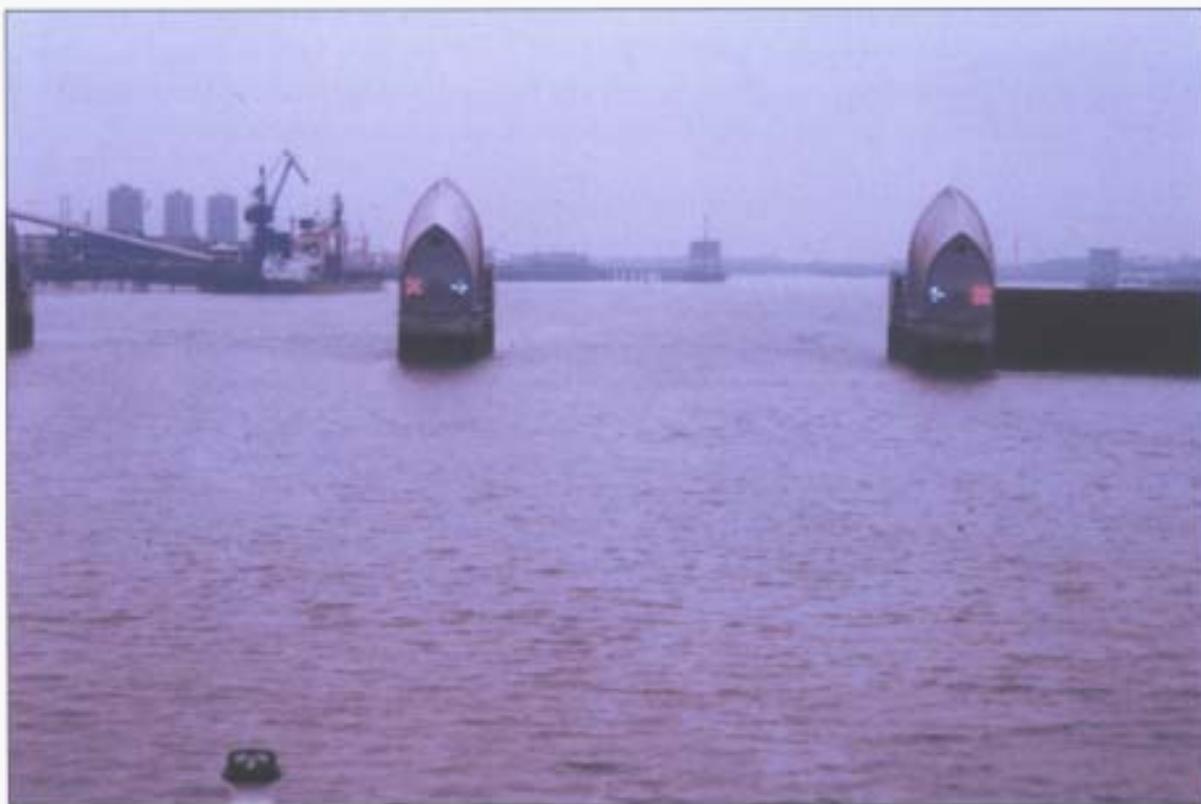
Figure 9: Navigation lights (span open)

The fog lights fitted to each of the piers of the barrier consist of an array of lamps made in the USA for use on locomotives. These lamps are used on other marine applications in the UK and have been found to be effective in certain conditions. Due to the alignment of the barrier and its position upstream of a slight bow in the river, fog lights need to be visible at a range of at least 0.35 miles to be of greatest benefit. This range coincides with the position where an inbound vessel begins to turn to line up with Echo Span. At this range, in thick fog, the existing lights are not visible and are only of benefit in the final stages of a transit. It is questionable whether any conventional fog lights could penetrate 0.35 miles in the thickest conditions. This is a fact not fully appreciated by mariners. The master of *Sand Kite* was expecting to see the fog light at up to 0.5 miles despite knowing that the general horizontal visibility was far less than that.
