MAIB SAFETY BULLETIN 2/2007

Failure of seat attachment in rigid inflatable boat,
resulting in the three crew falling overboard.

July 2007

Issued December 2007

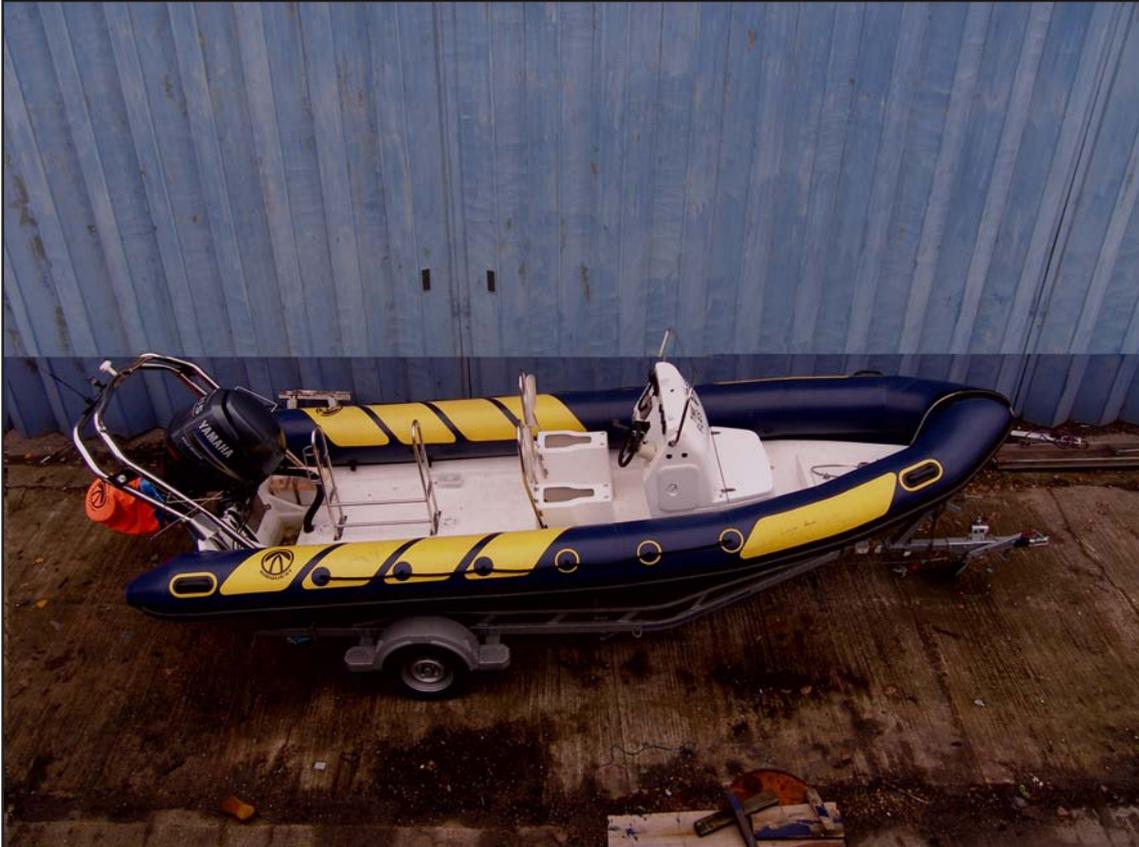
Figure 1 - *Time Flies*

The RIB *Time Flies* was employed as a support boat for an event on the river Thames. The boat, a 6.3 m Ribquest craft, was powered by a 115 horsepower Yamaha outboard engine, giving a potential top speed in excess of 30 knots (**Figure 1**). The hull had been constructed in 2005 and the boat had only been used for a 4-month period prior to the current owners buying the vessel in May 2007.

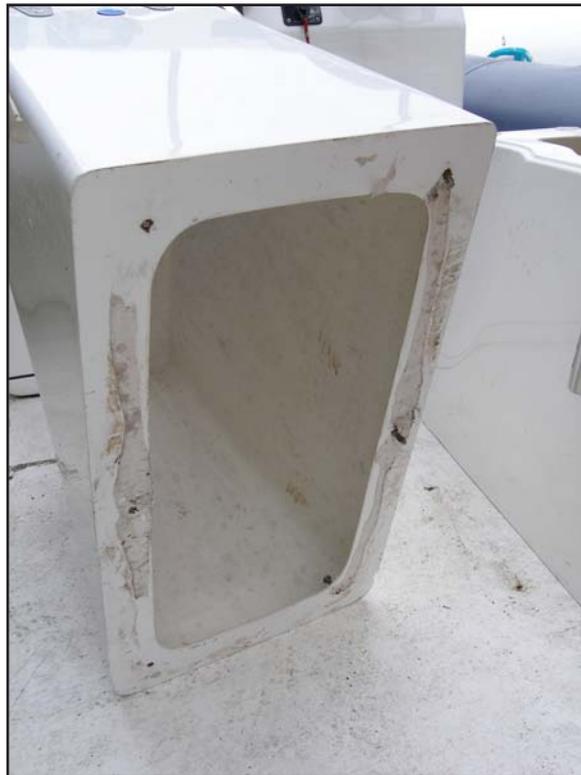
Figure 2 - Bottom of seat pod

The seat pods and boat were examined after the accident. The glass reinforced plastic (GRP) seat pods had each been attached using 6 x 25mm stainless steel self-tapping screws with penny washers and a bead of a sealant-like substance (**Figure 2**).

The deck construction was of 18mm plywood, with a 2-3mm GRP skin which was impregnated with small plastic granules to create a non slip surface. The sealant, although unable to be positively identified as a particular product, was found to contain urethane and was not silicone or acrylic based. Urethane based adhesive sealants normally provide good adhesion but, in this case, poor surface preparation had resulted in ineffective adhesion to the deck (**Figure 3**), leaving the self-tapping screws as the only means of securing the seats. Over time, water had seeped into the six screw holes and softened the plywood, resulting in the screws becoming loose, and as the RIB turned, the weight of the occupants created a lateral pull on the seat pods, which caused the pods to be pulled from their mountings.

- Physically try to move the seats and consoles by hand to ensure there is no movement.
- Check for loose screws and/or evidence of any screw movement.
- Examine the sealant between seat/consoles and the deck to check for breaks or cracks.
- Establish if there is any water seepage under the console/seat that may indicate the sealant is not fully attached.
- Where doubt exists, seek advice from a professional boat builder/repairer to ensure the seat pods/consoles have been attached in accordance with the manufacturer's guidance and remain secure.
