Report on the investigation of
contacts made by the
high speed craft

Norman Arrow

with quays in Portsmouth International Port,

**Report No 7/2011
May 2011**

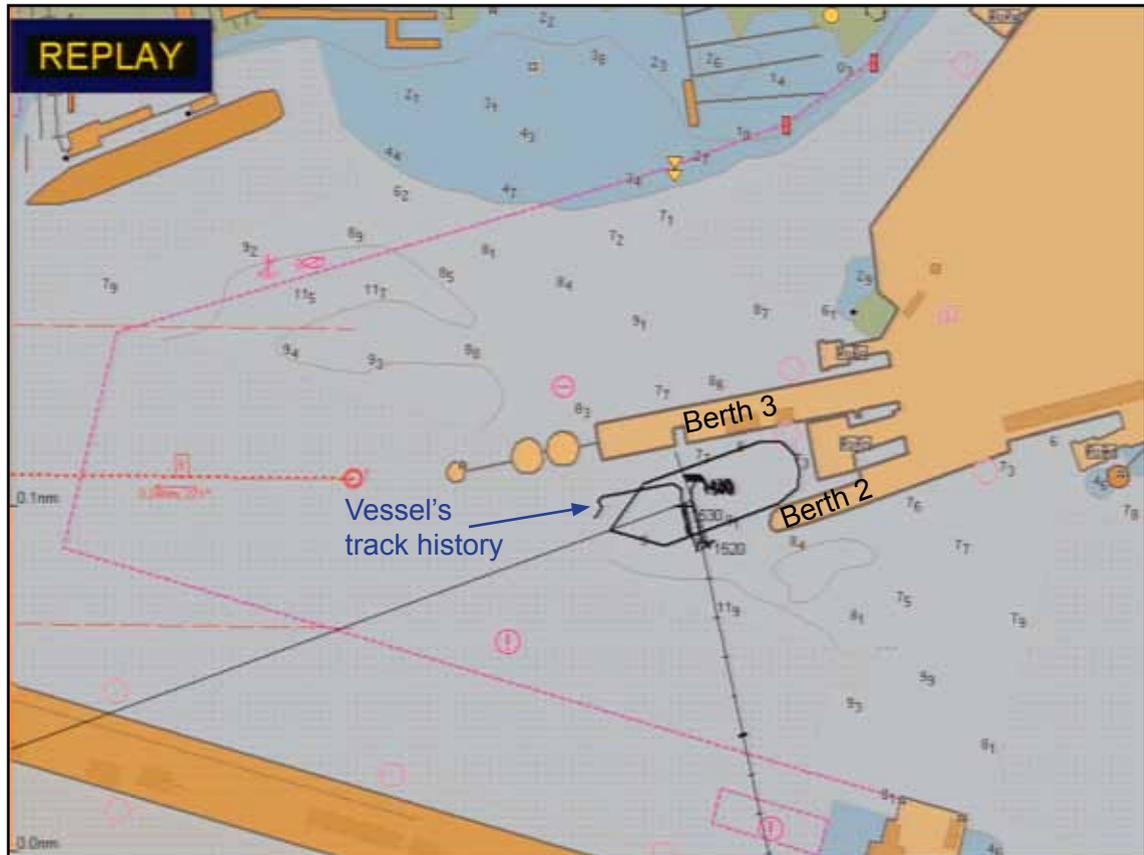
By this time, *Norman Arrow's* heading had passed 250° and the vessel continued to swing very quickly to port until, at 1619, her port side made contact with the northern side of the western end of the finger jetty of berth 2 (**Figure 3**). *Norman Arrow's* bow continued to swing to port, but the master was able to manoeuvre the vessel to prevent her stern from hitting berth 3.

Norman Arrow contact with finger jetty of berth 2

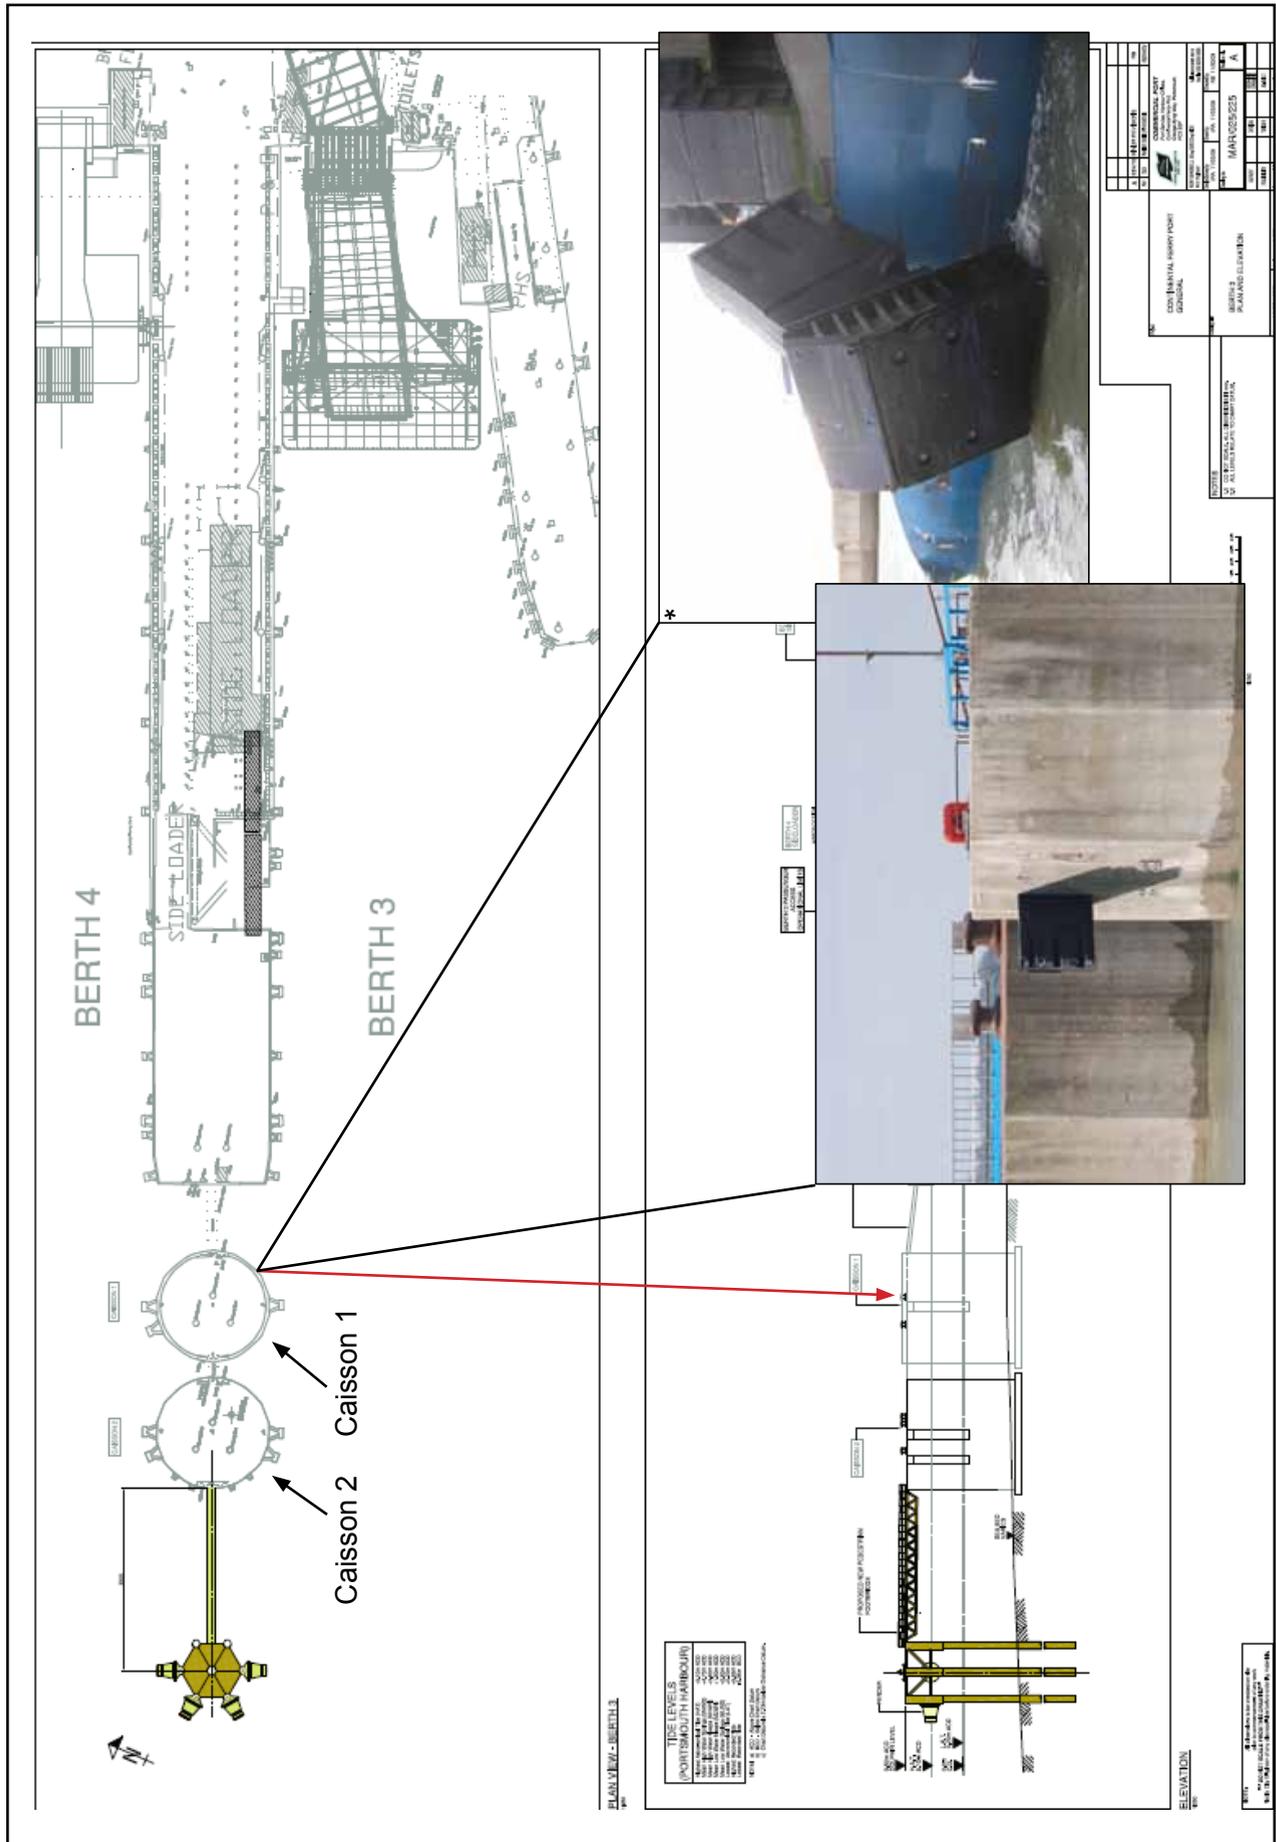
Caisson 1

Fender 1 on caisson 1 was totally removed (**Figure 6**), leaving only a support beam attached to the quay.

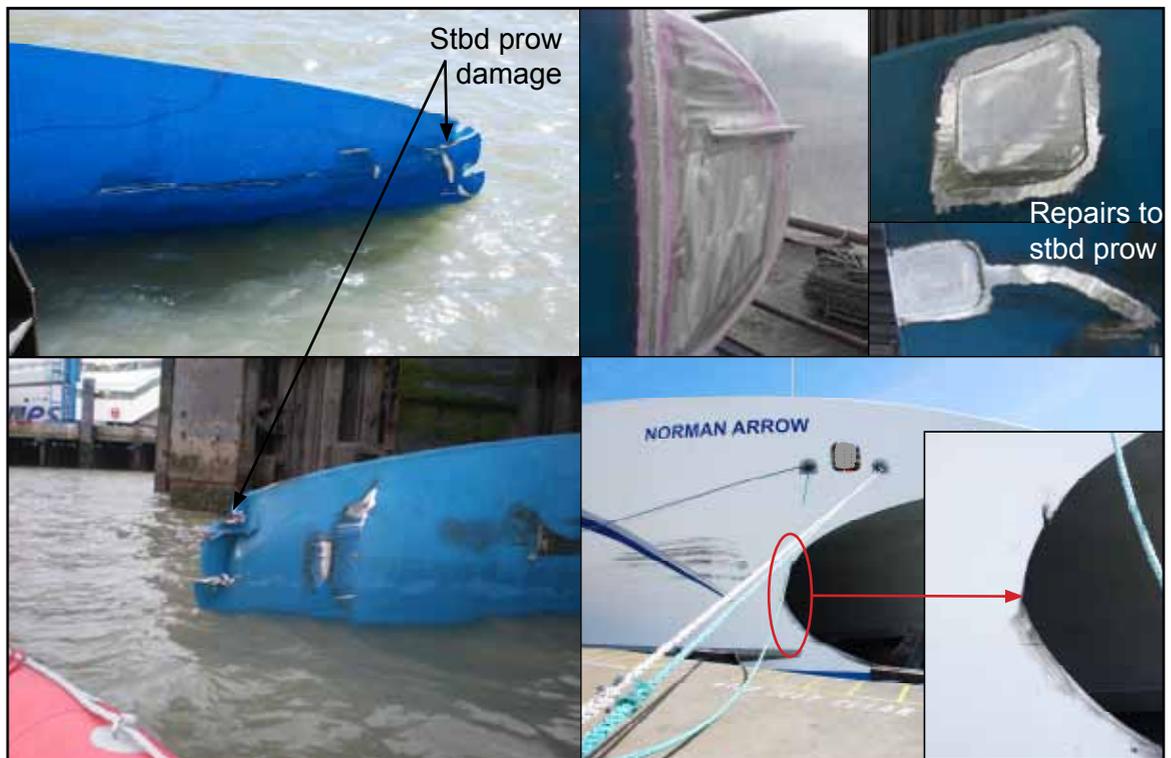
Figure 7

Norman Arrow's starboard prow was torn and indented; its tip was set inboard and split open. The shell plating forward of the collision bulkhead was punctured and gouged (**Figure 7**).

Damage to *Norman Arrow*

Det Norske Veritas (DNV), *Norman Arrow*'s classification society, gave the vessel permission to sail to Dunkerque, subject to:

- Frame 86 plugs and frame 83 hatch and plug remaining secured in place
- Frame 83 being temporarily shored up
- Monitoring of the damaged areas during the voyage
- A speed limitation of 15 knots.

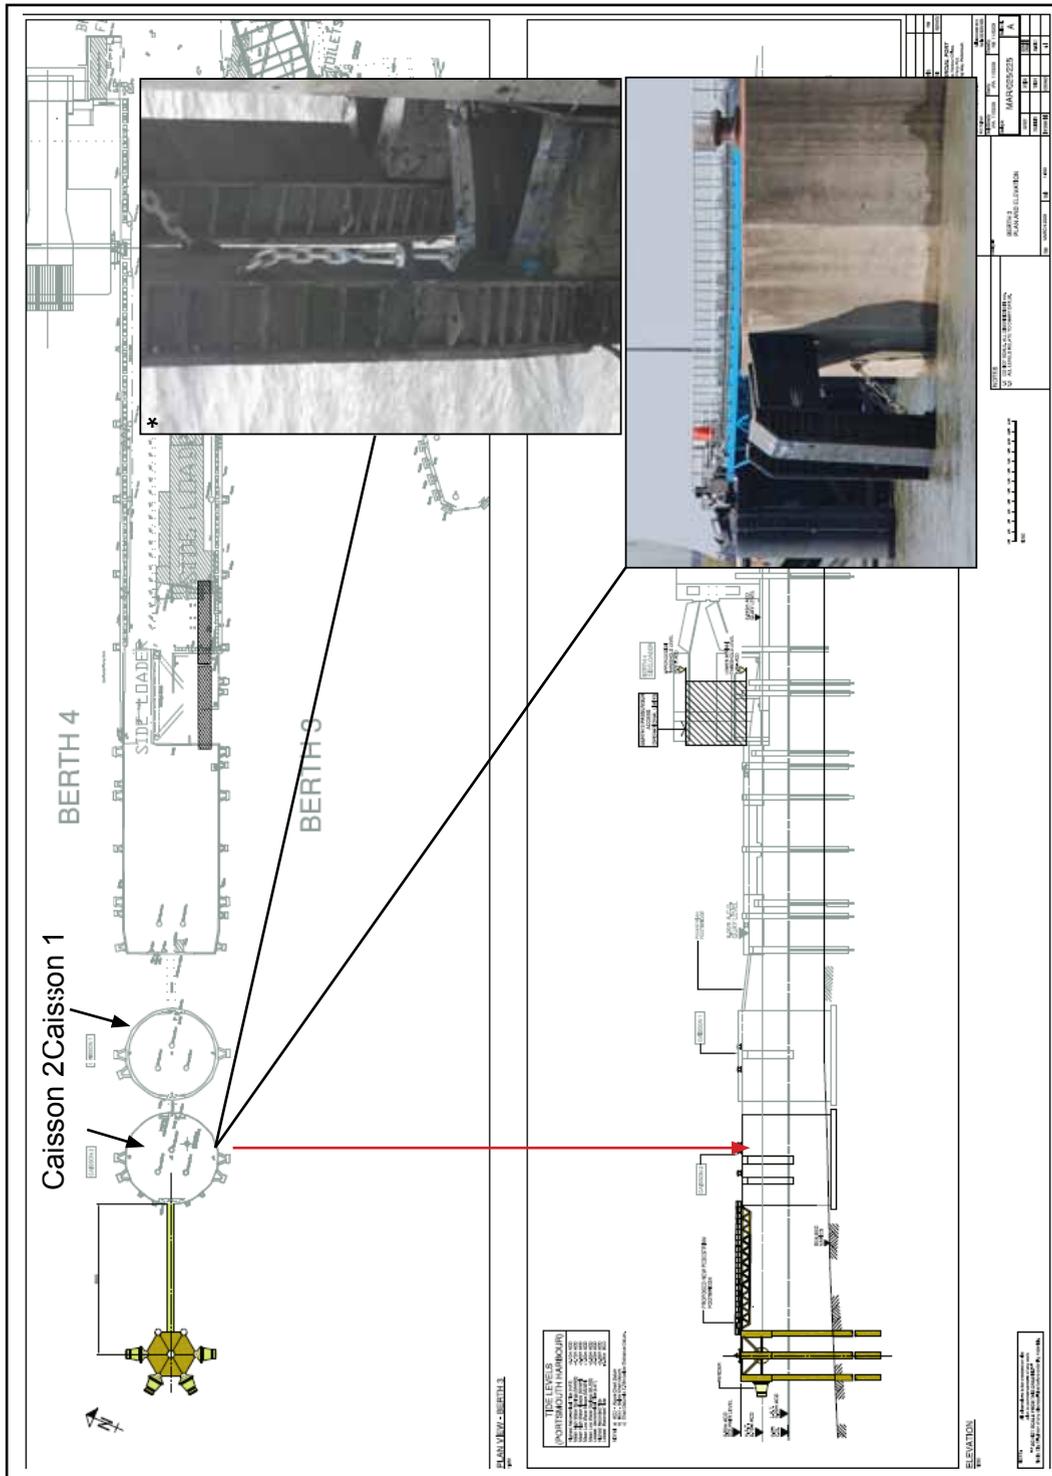
Figure 8

The base plate of fender 1 on caisson 2 (**Figure 8**) was bent and a support chain was severed. Fender 2 on caisson 2 was slightly displaced from the perpendicular.

Caisson 2

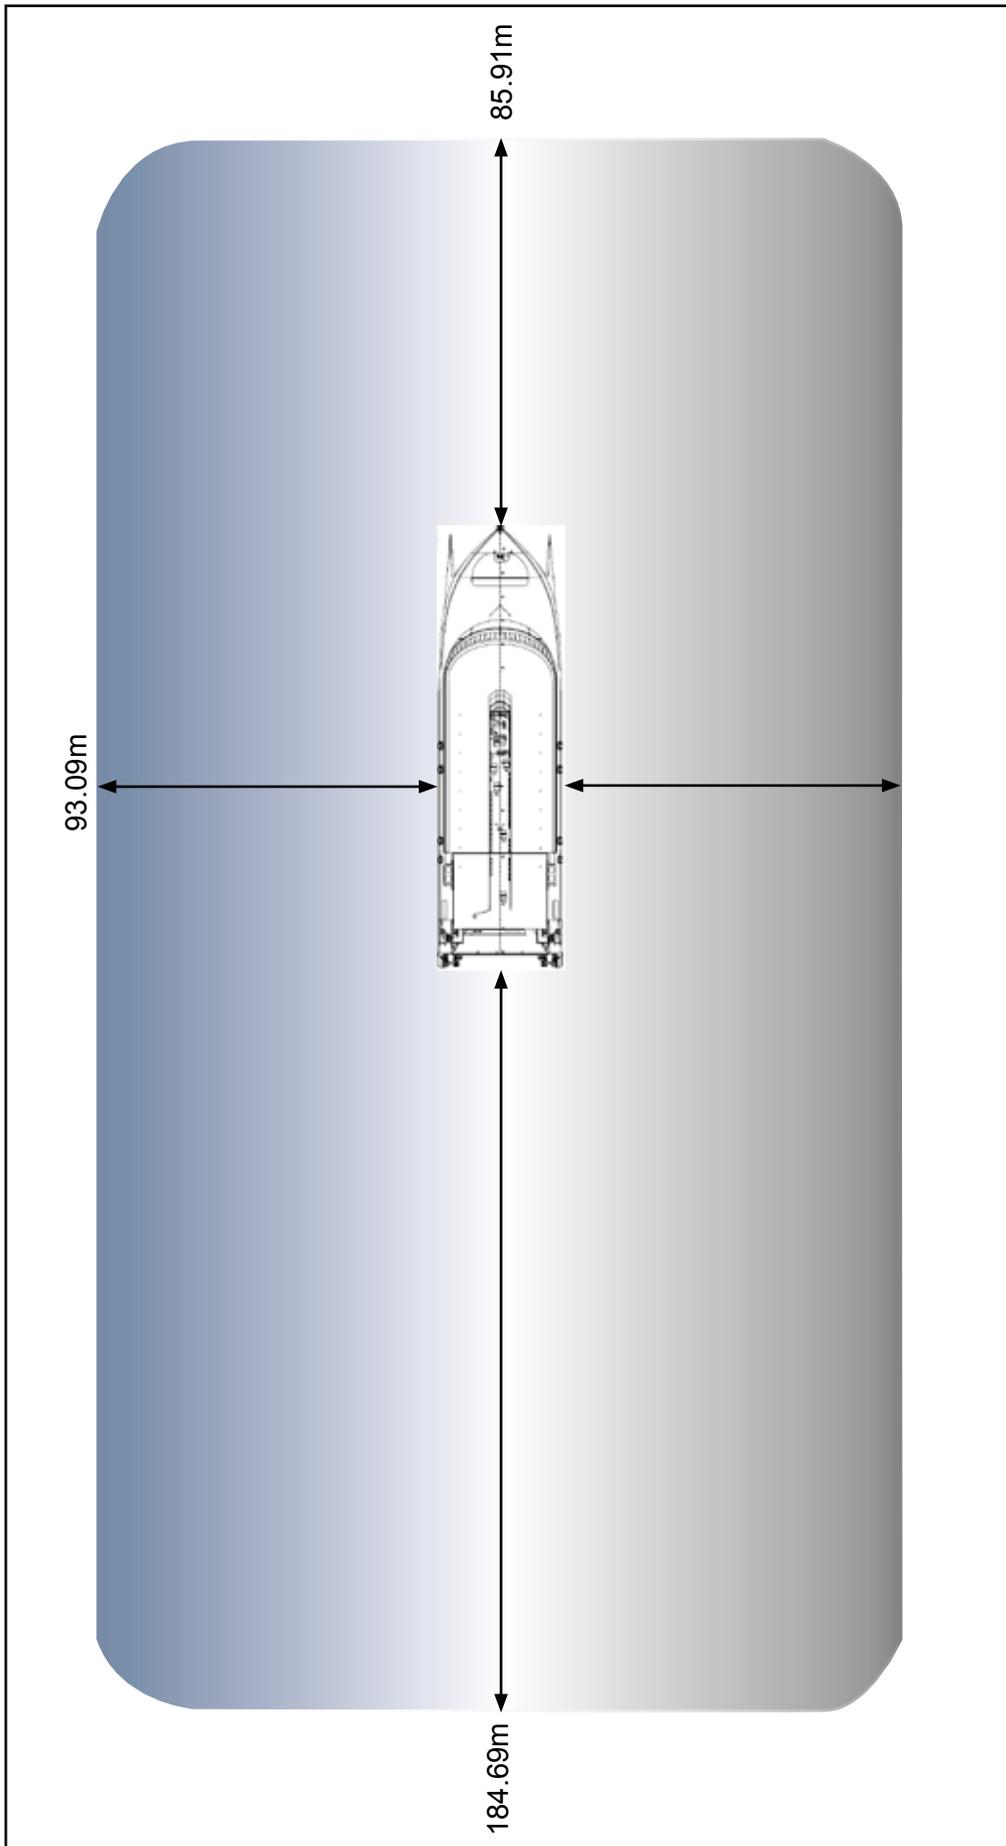
Figure 10

Norman Arrow's bridge was located on the centreline above the passenger accommodation (**Figure 9**). The bridge was fully enclosed and, unlike a conventional ferry, did not have bridge wings extending to the vessel's sides. From within the bridge, an all round 360° view was possible, but the view of the sea surface close to the vessel was obscured by her superstructure (**Figure 10**).

Bridge visibility shadow area at sea surface

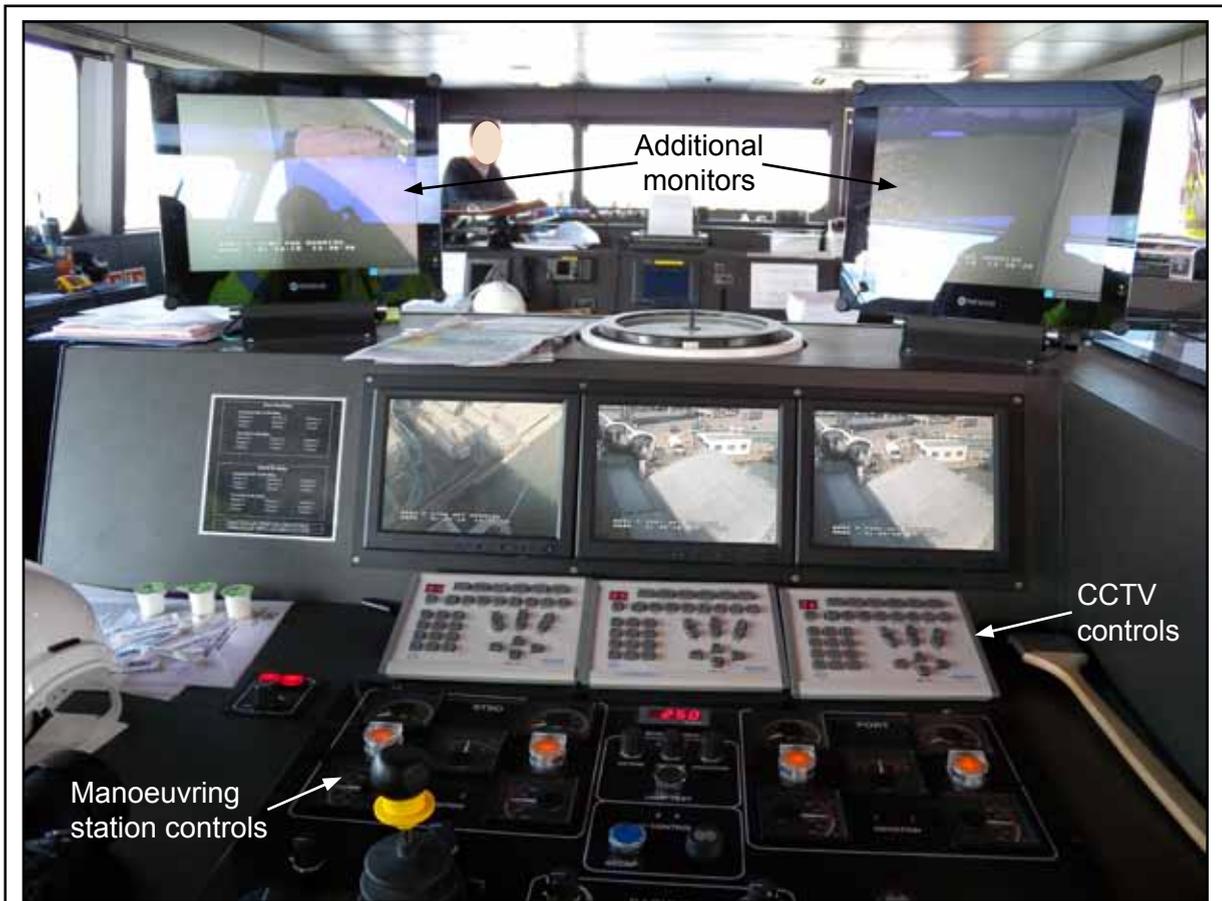
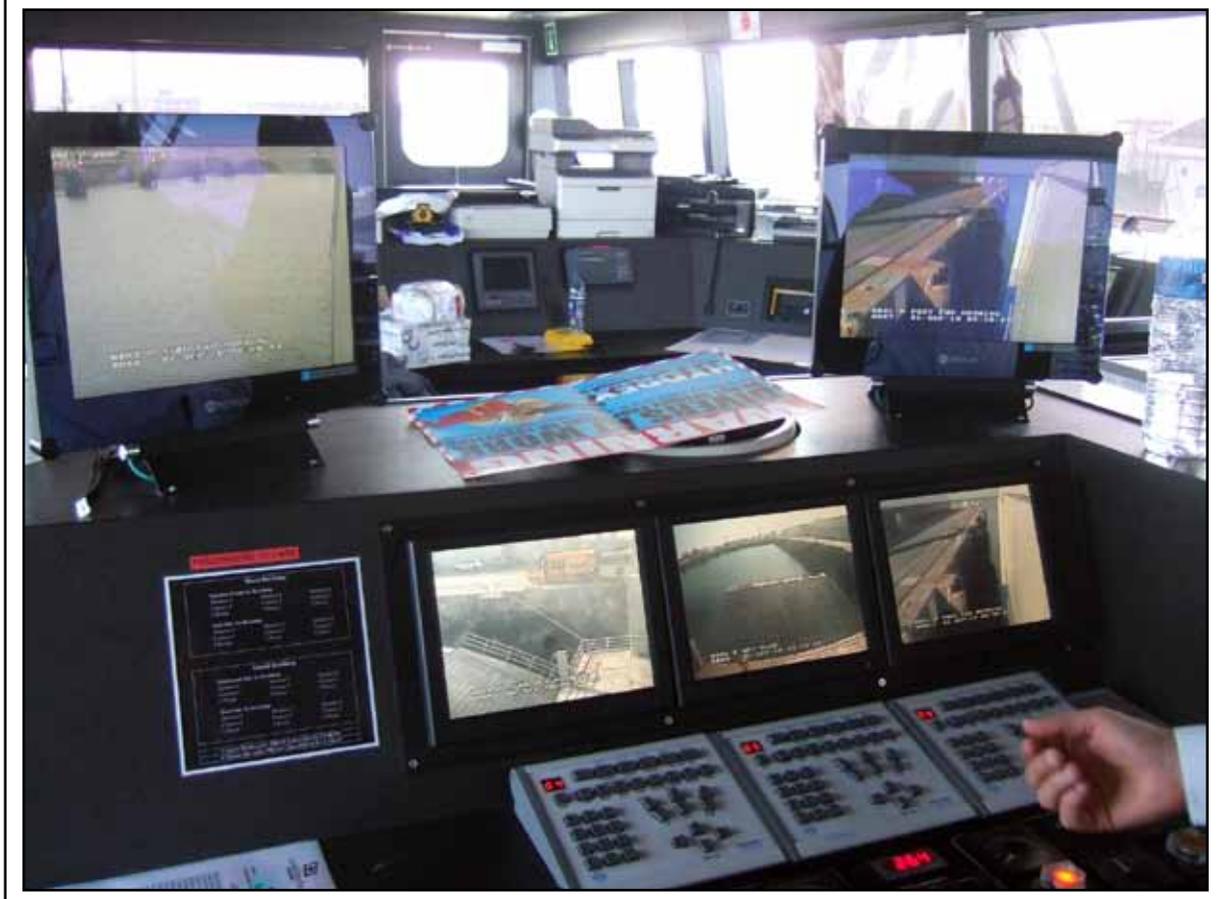
CCTV monitors from different heights of eye

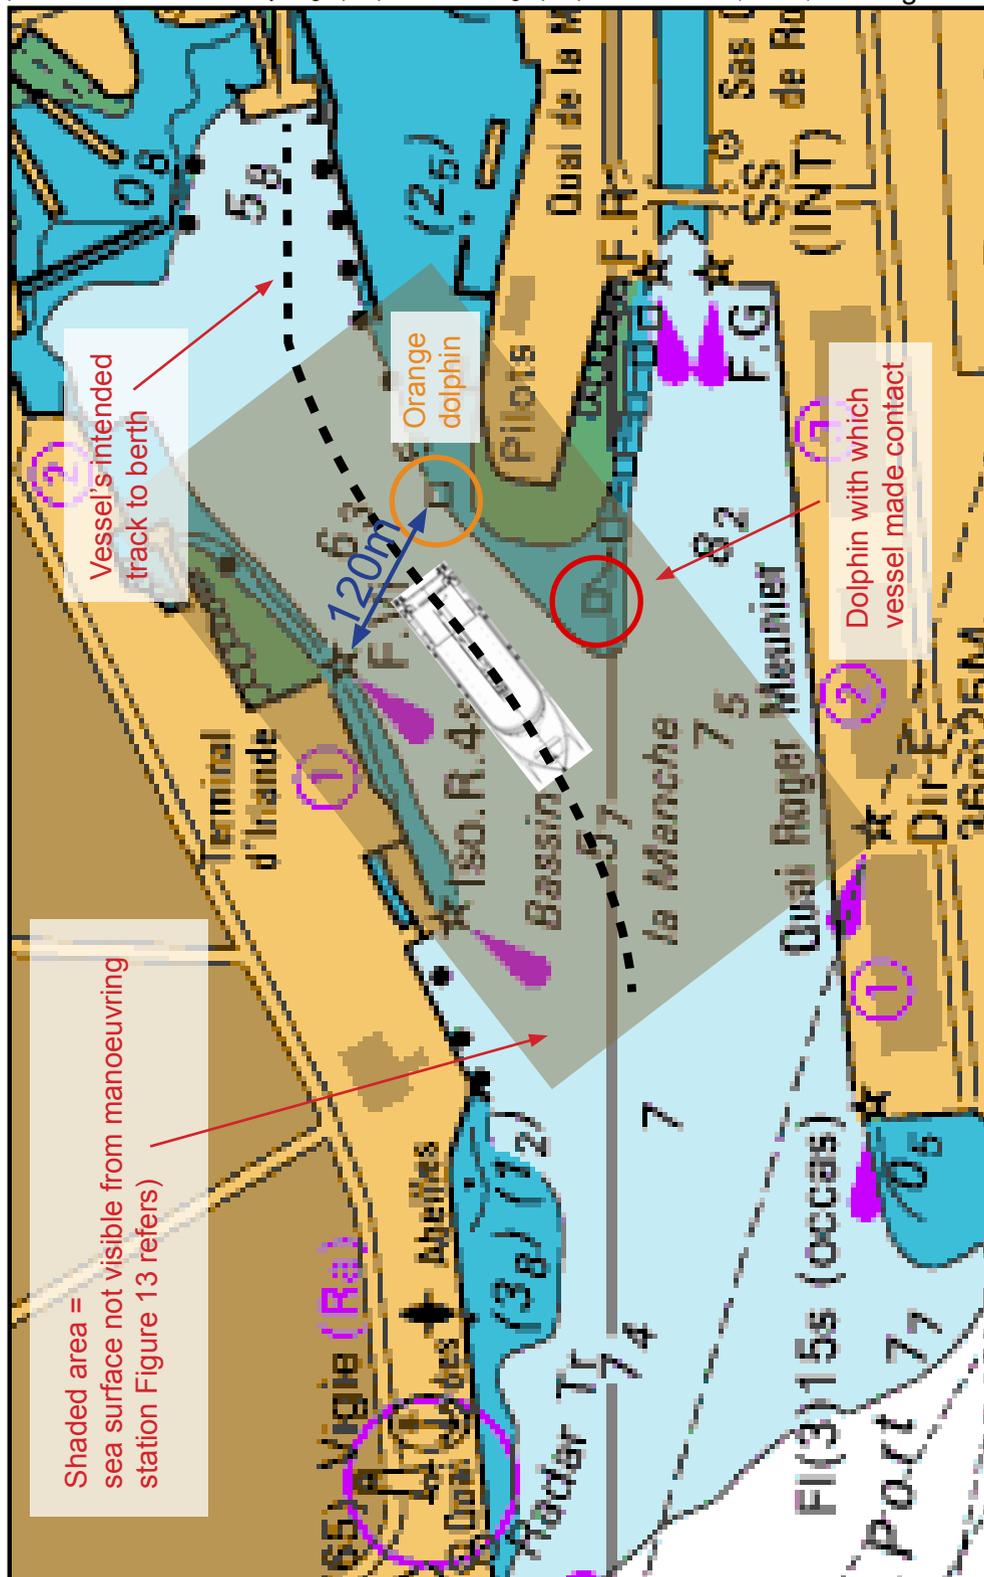
Norman Arrow - approach to the orange dolphin

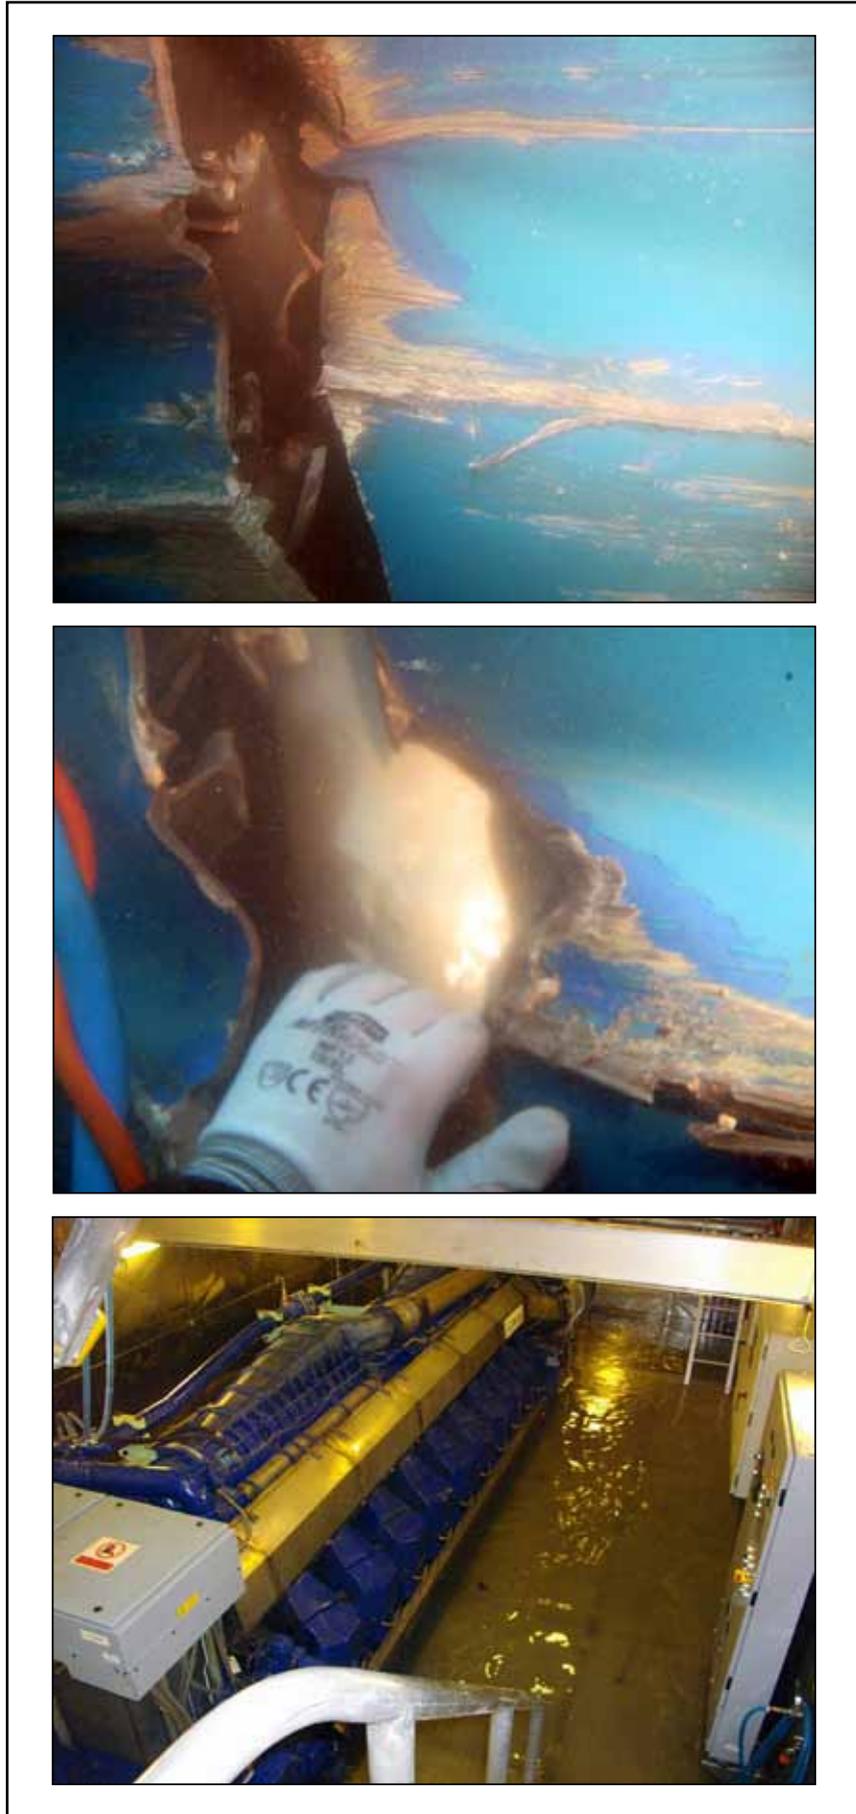
Norman Arrow's port hull was heavily indented and holed about 1m below the waterline, in way of the forward engine room. Water entered through three holes, and the space flooded to cover the engine access platform (**Figure 19**). The extent of the damage was such that the vessel was withdrawn from service for the remainder of the summer season.

Norman Arrow hull damage and flooded engine room
