Report on the investigations of
heavy weather damage
on board the container ship
Maersk Newport
50 miles west of Guernsey
on 10 November 2008
and fire
alongside at the container berth in Algeciras, Spain
on 15 November 2008

Report No 13/2009
June 2009

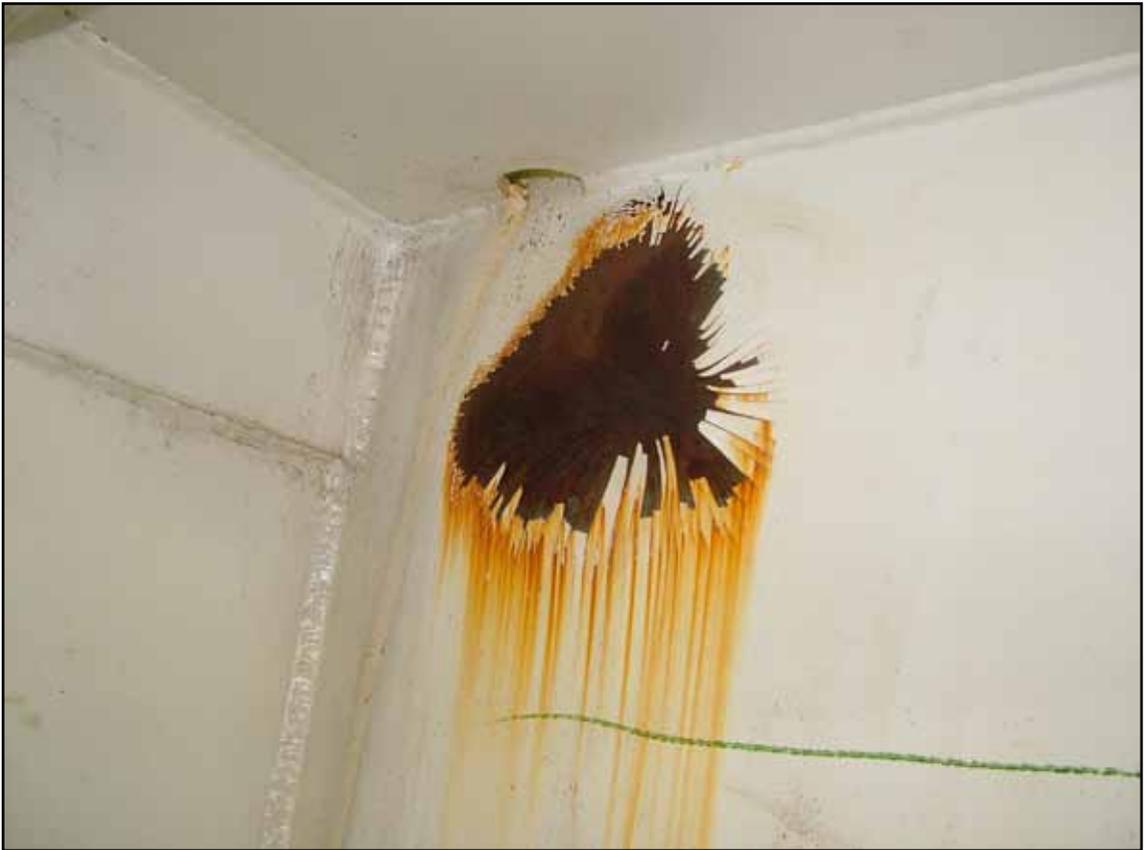
Figure 3

The outgoing chief engineer cautiously opened the bow thruster room hatch and, as there was no evidence of a fire, he went down the ladders. As he descended he immediately noticed three, 150mm by 250mm, holes in the port side of the hull. As the vessel pitched, water was sprayed into the compartment and over the electrical distribution and control panels. The chief engineer also noticed that there were numerous hull indentations (**Figures 3 and 4**) and that the bilge was full of water. He reported the damage to the master on the bridge and that he suspected that the port anchor had been released, causing the damage. He then instructed the fourth engineer to return to the ECR to fully isolate the electrical supplies to the bow thruster room. The bilge suction valve was opened and the 5 ton/hour bilge pump was started in an attempt to lower the water level.

Hull indentations - port side bow thruster room

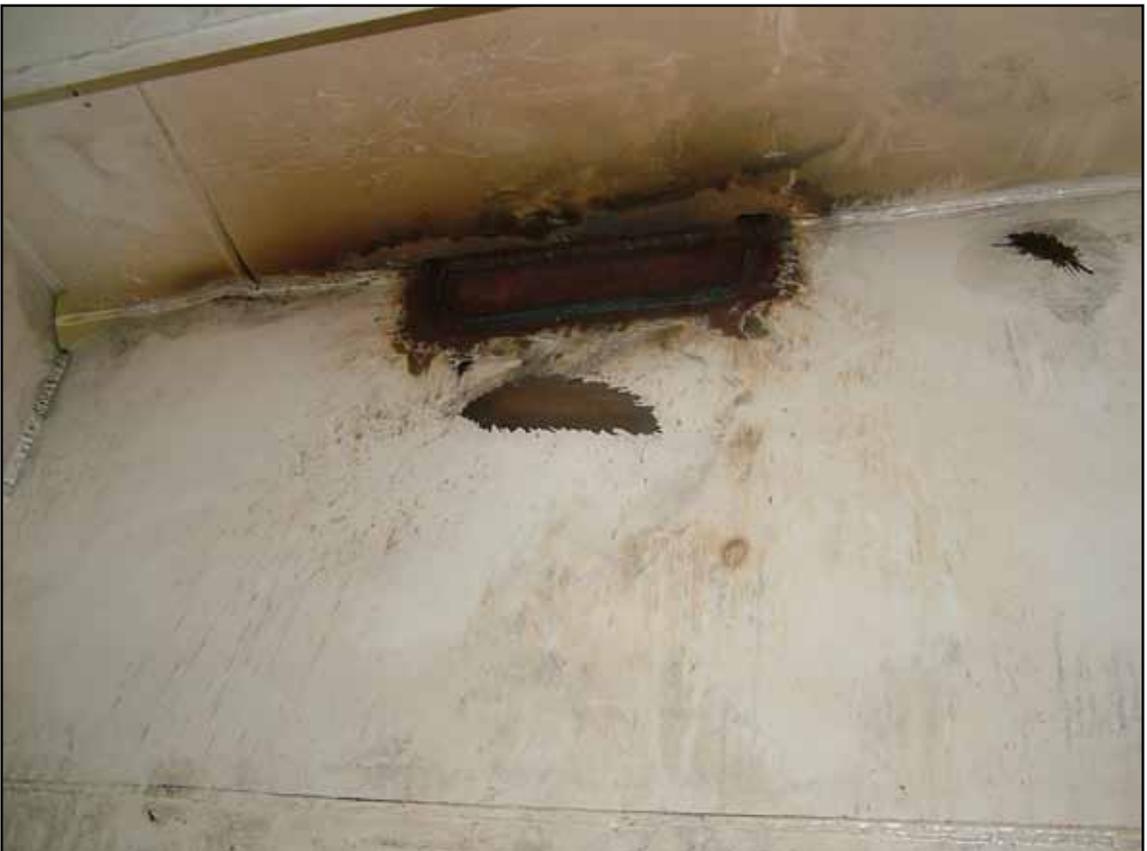
Figure 4

Hull indentations - port side bow thruster room

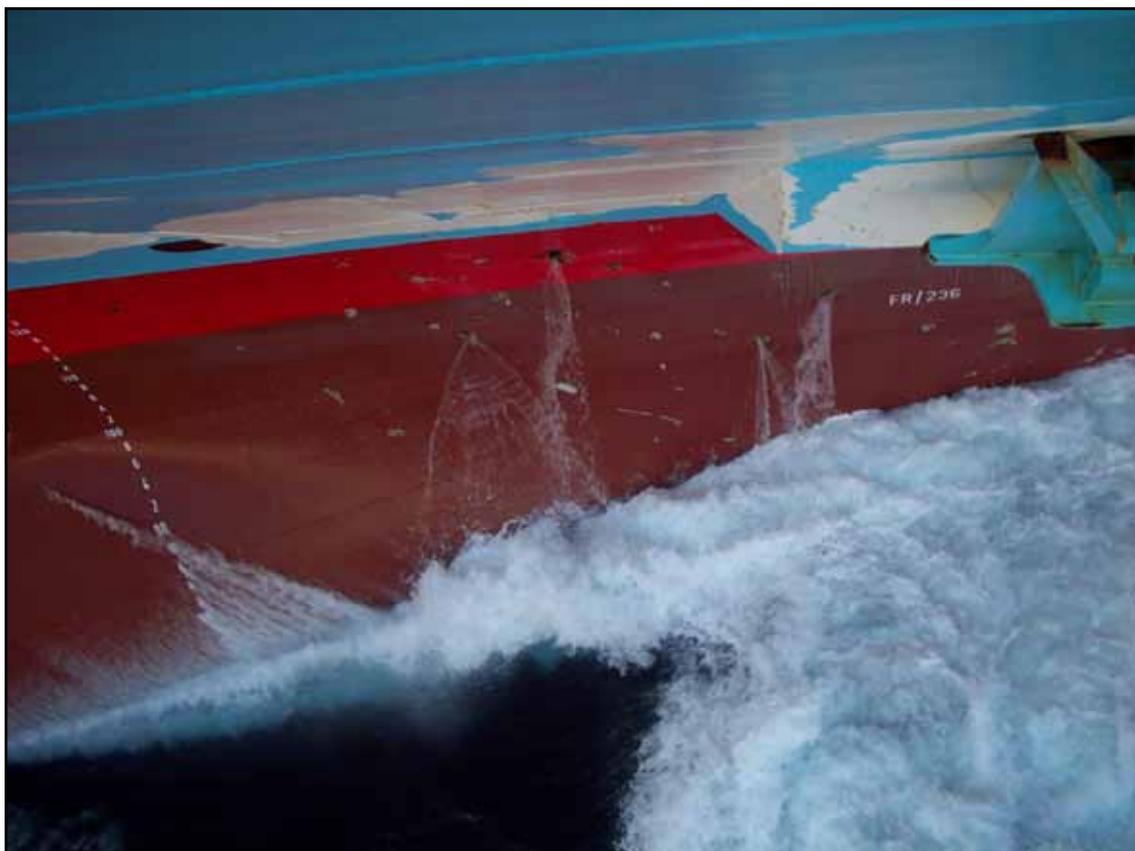
The bosun was sent to get wooden wedges and neoprene rubber with which to stem the flow of water. On his way he went to the forecastle head with the incoming chief engineer and chief officer to investigate the damage from the outside. On looking over the port side, the port anchor was seen to be below the sea surface, and there were numerous indentations and splits in the vicinity of the port side of the bow thruster room. As the bow pitched, water was seen spraying out from more holes in the forepeak area, **Figure 5**.

Damage to the port side of the hull seen from the forecastle

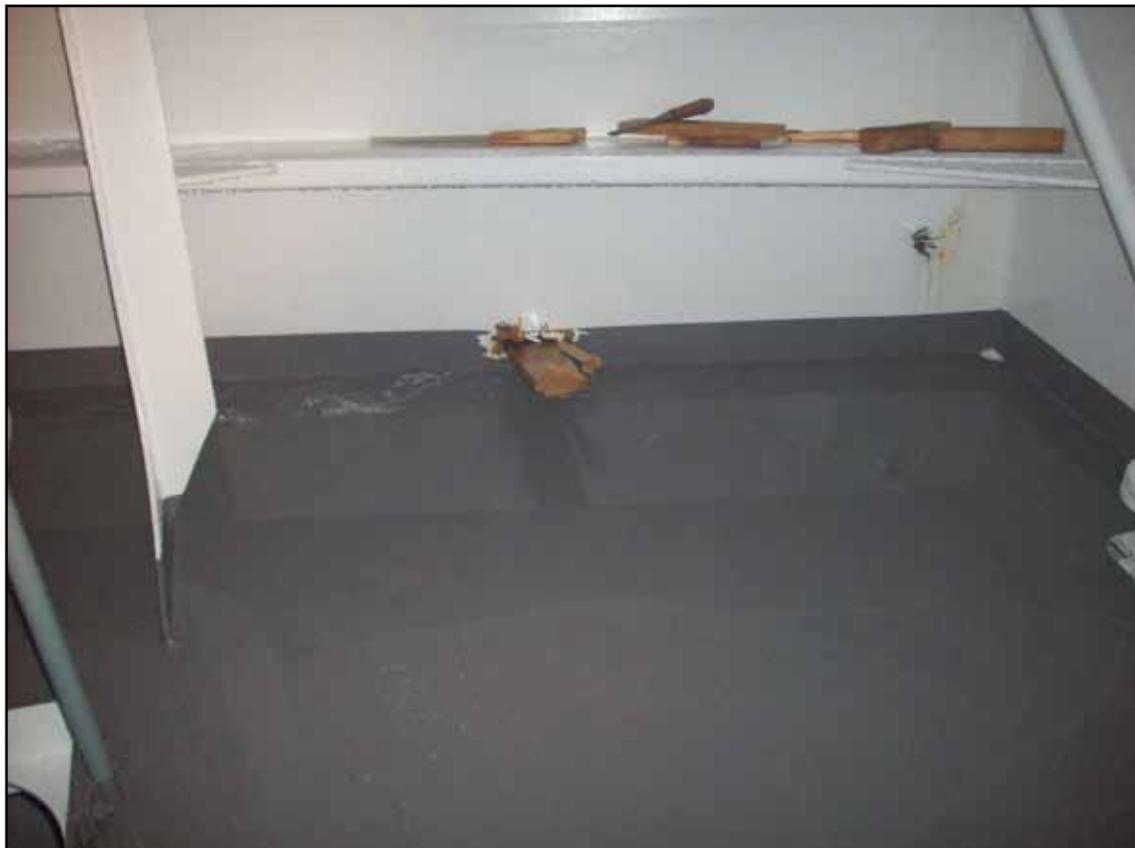
By about 1400 the team in the bow thruster room had managed to significantly reduce the inflow of water (**Figure 6**). The bilge water at this point was about 1.25m deep and appeared constant, so the engineering team believed that the bilge pump was coping with the rate of water ingress. In the meantime, the ship was ballasted with about 400 tonnes of sea water using the after ballast tanks.

Example of bow thruster room damage control measures

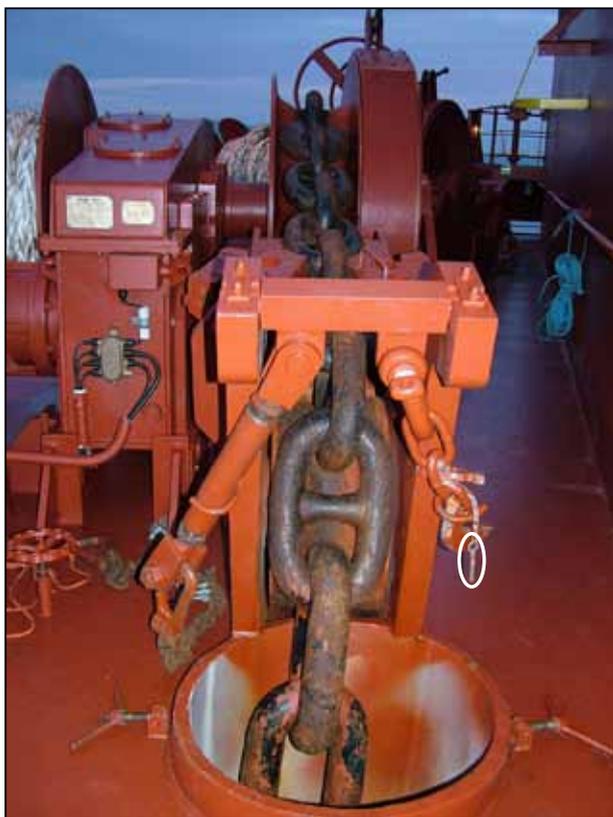
Figure 7

The forecastle team found that about $\frac{1}{2}$ to $\frac{3}{4}$ shackle of the port anchor cable had been released. The lashing chain Senhouse slip tapered securing pin had become detached from the slip and was hanging by its chain (**Figure 7**) and that the lashing chain was hanging loose. It was also found that the forward guillotine block was in the upright open position while the after guillotine block was in the horizontal closed position – **Figure 8**. Before the anchor cable was recovered, the chief officer checked the winch brake and managed to apply one full turn of the brake handwheel. After the port anchor was fully secured, checks were made to confirm that the starboard anchor was also fully secured.

Senhouse slip securing pin in detached position

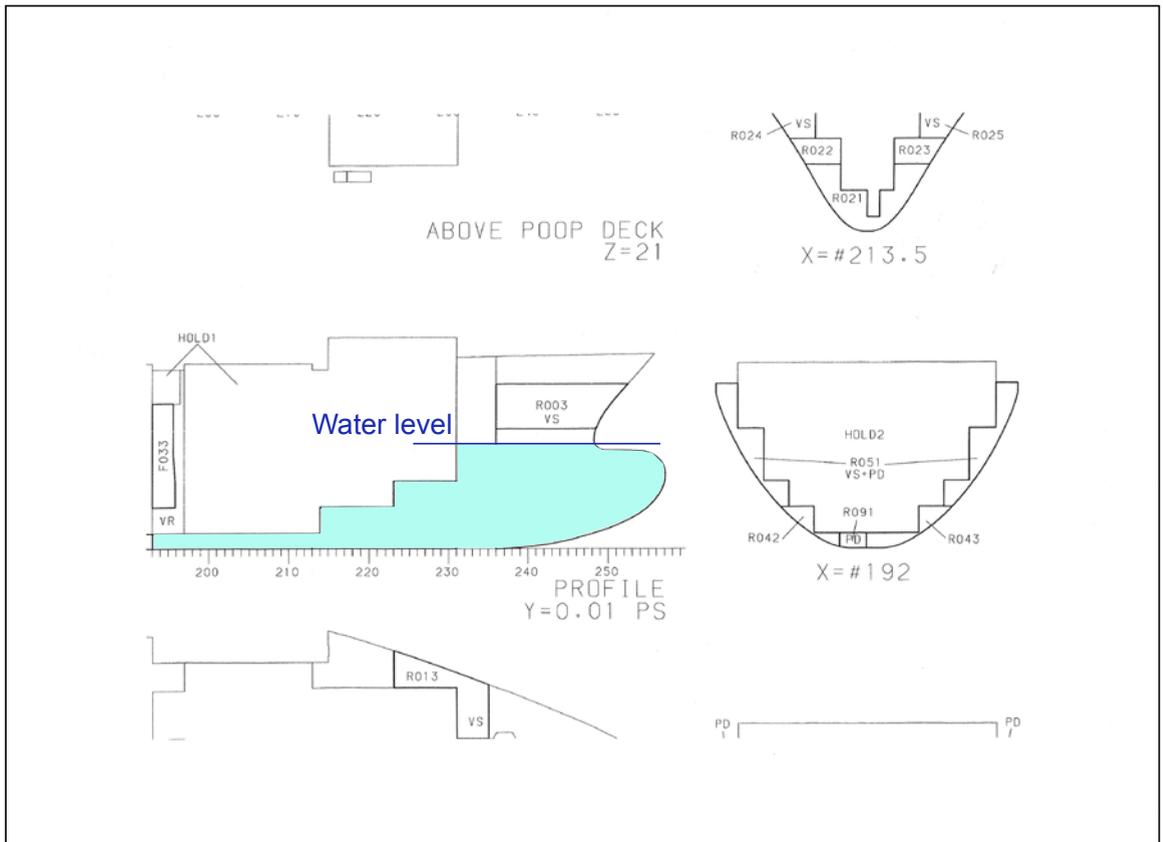
Figure 9

The water level in the bow thruster room was constantly monitored throughout the remainder of the day and night and was found to be slowly rising. By late evening the following tanks/spaces were found to have been breached (**Figure 9**):

Ship's section showing extent of flooding

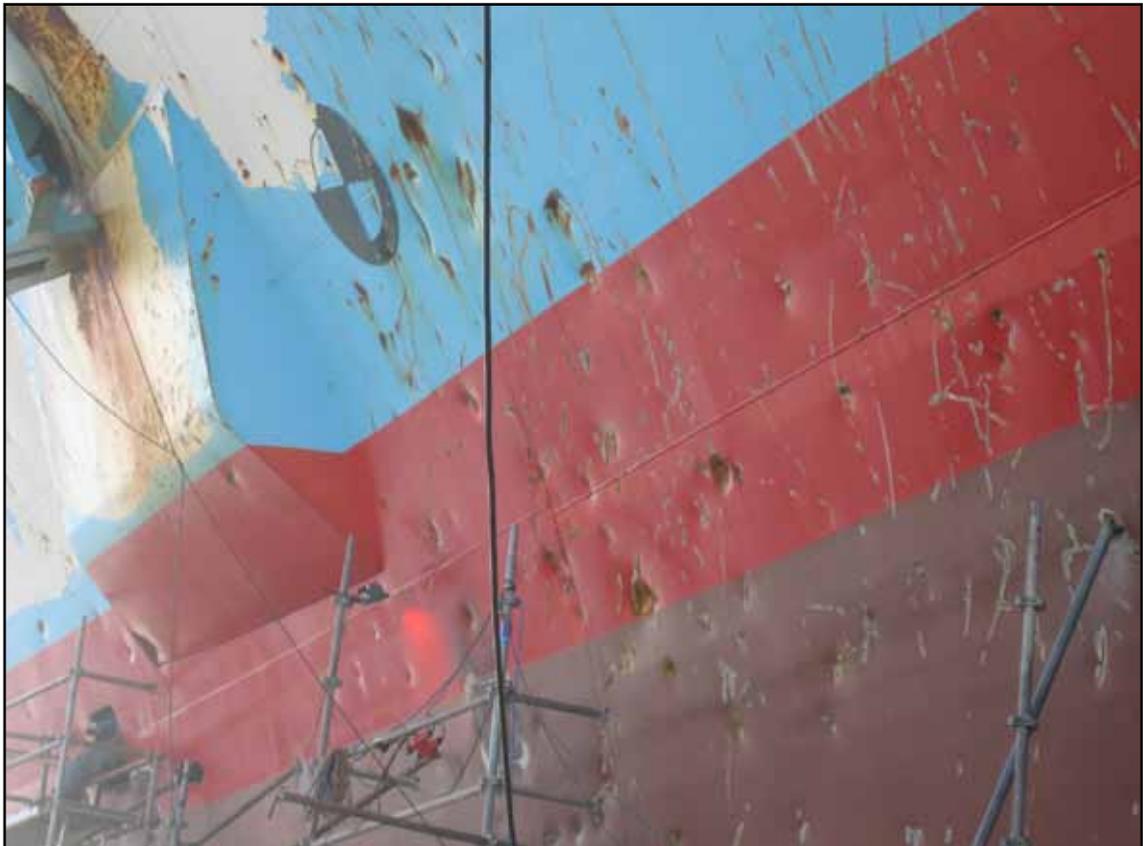
Figure 11

The survey identified numerous indentations and scoring of the shell plating (**Figure 11**) and more severely damaged areas that required 23 insert plate² repairs, to enable the ship to sail from Algeciras without a “Condition of Class”. The locations of the insert plate repairs are shown at **Figure 12**.

Hull indentations

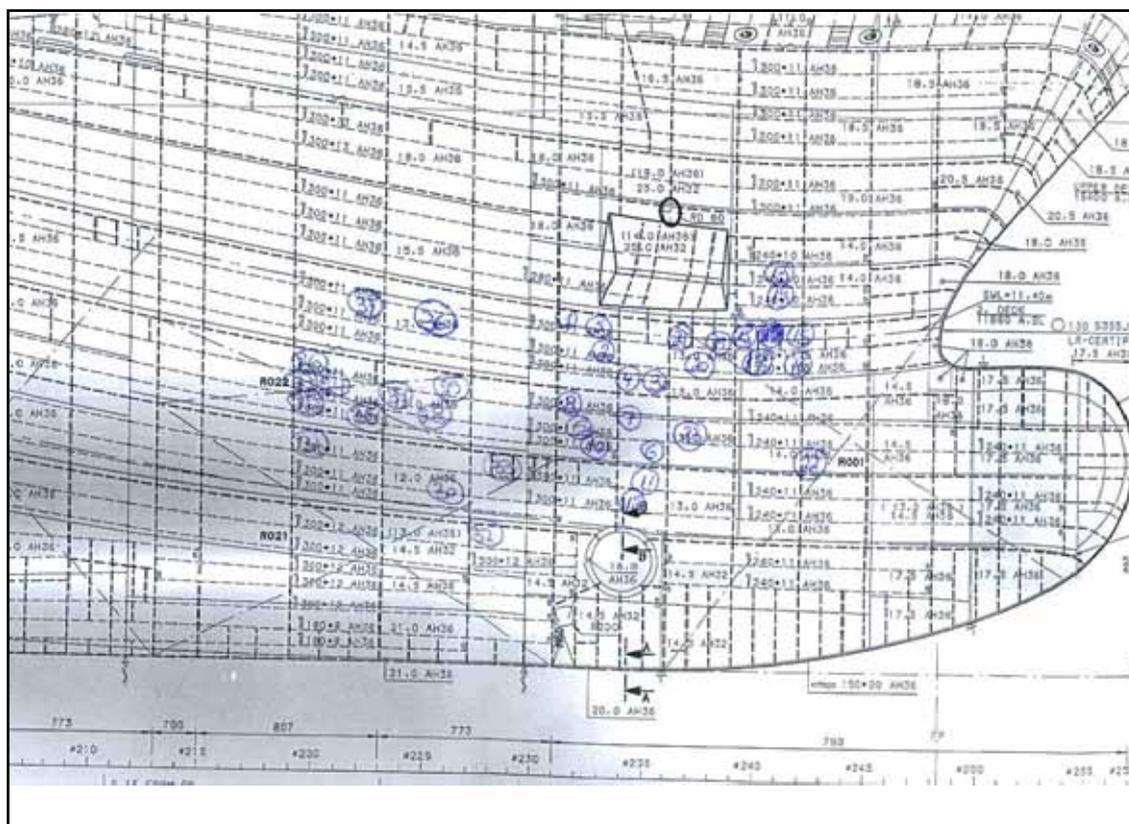
Location of insert plate repairs

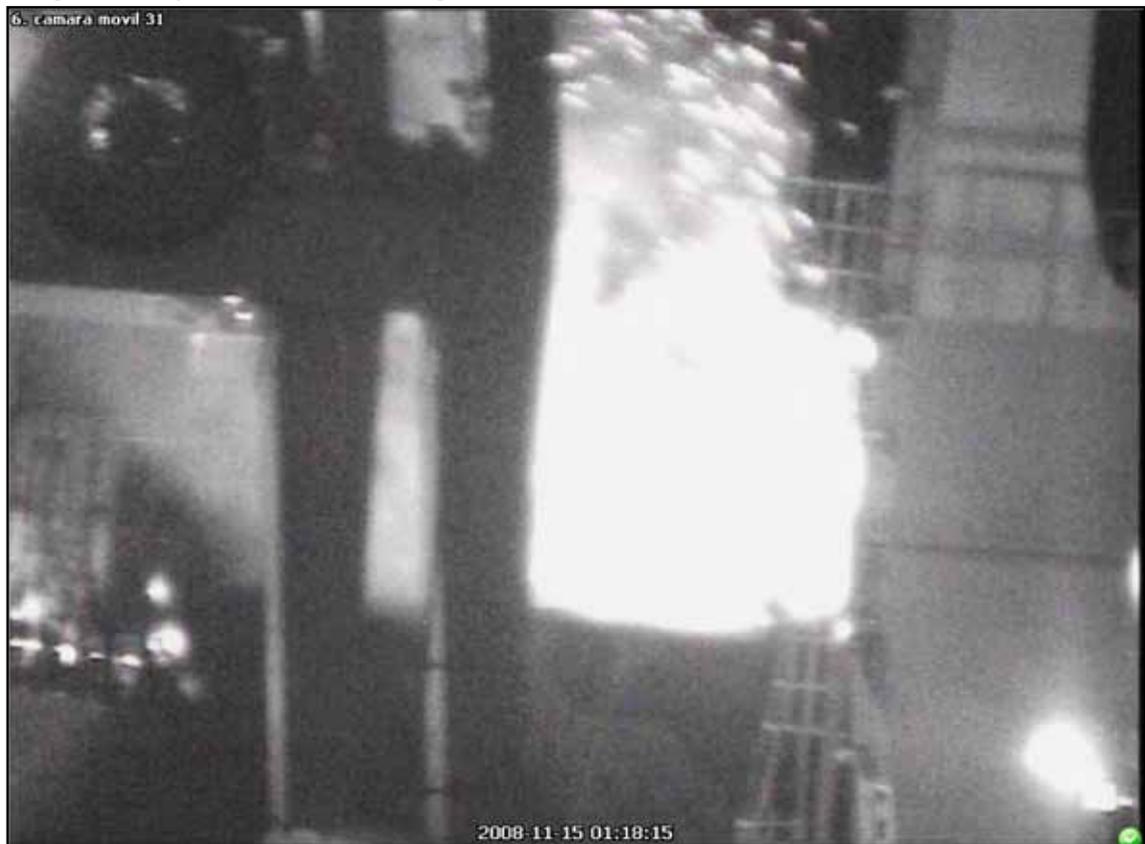
Figure 14

Still of acetylene bottle explosion taken from the APM Terminal's security camera video recording

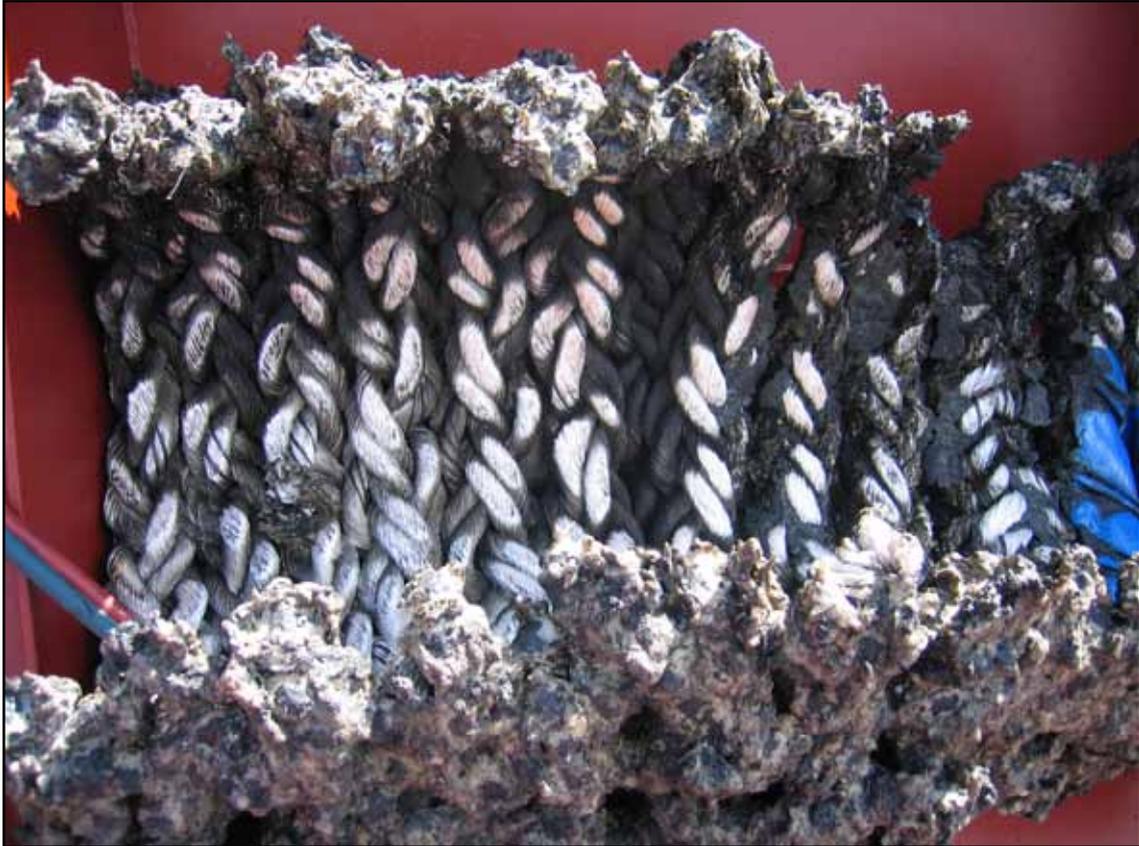
Figure 16

Fire damaged mooring rope from the port windlass winch drum

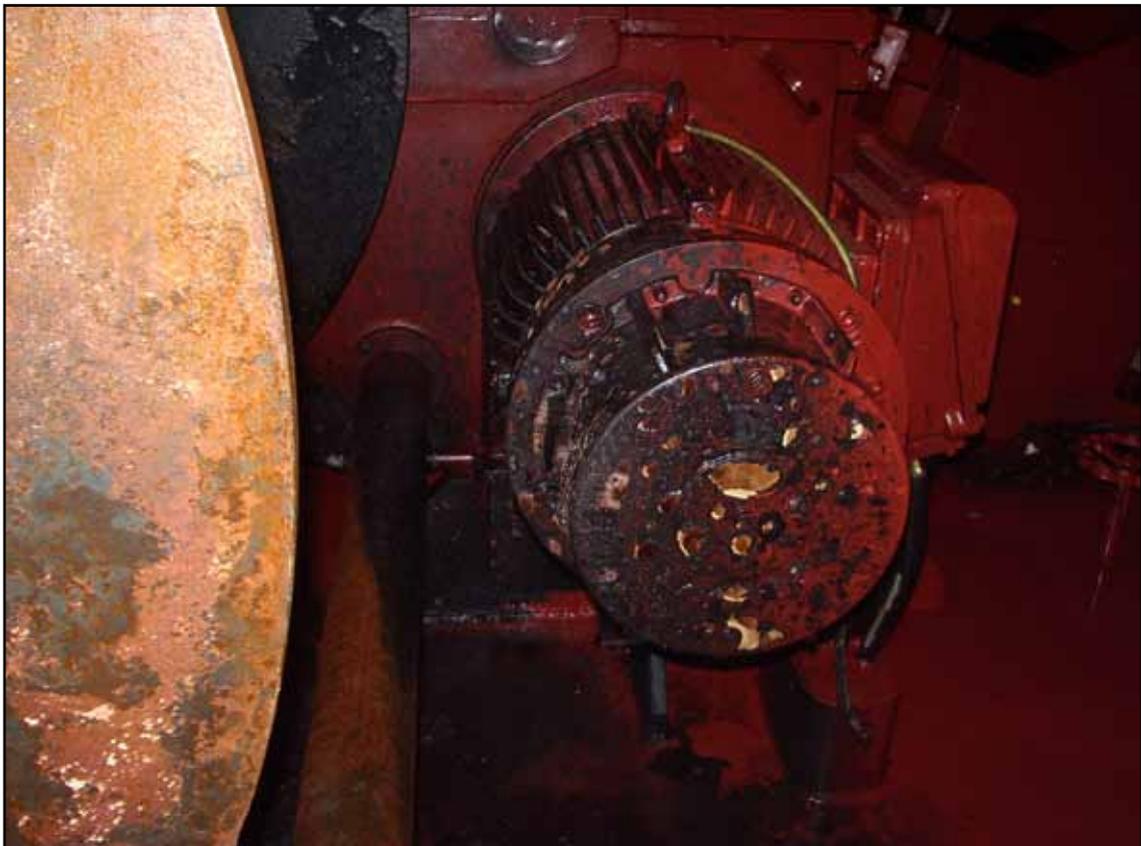
Figure 17

Fire damage to the port windlass winch

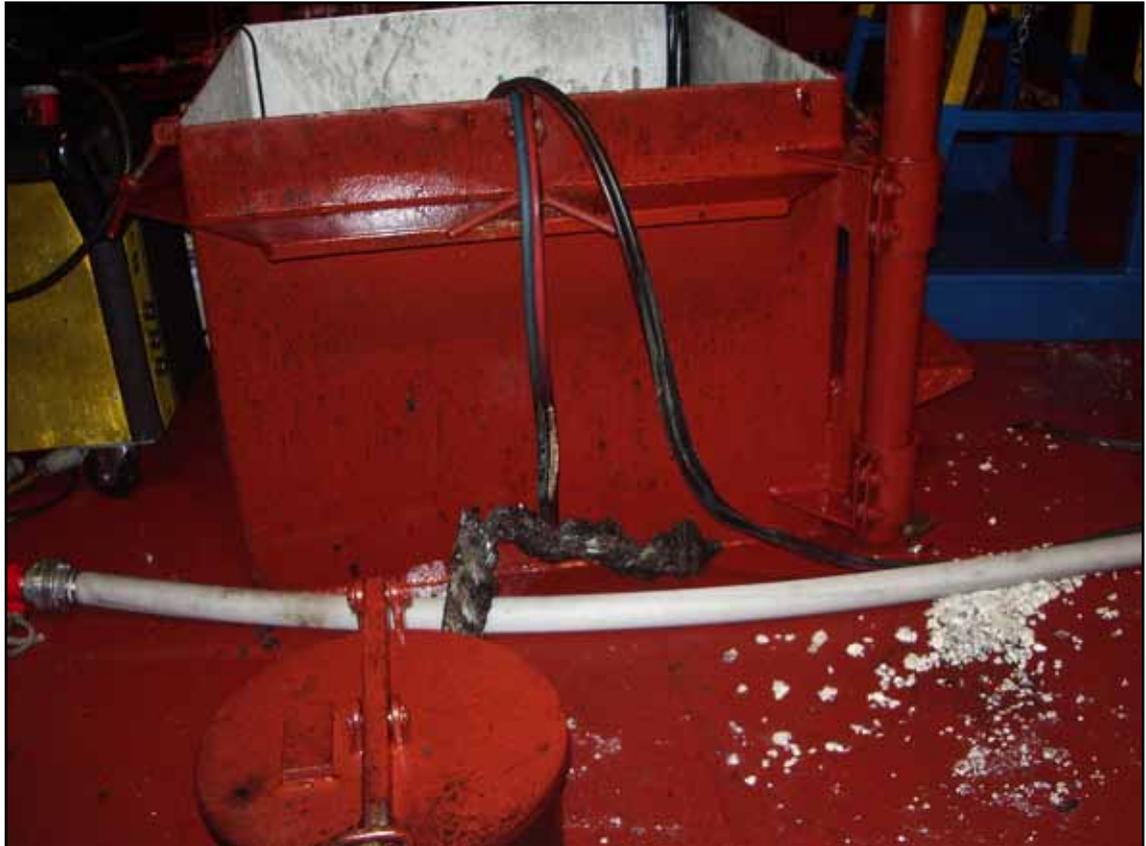
Figure 18

About 10m of the contractor's three oxygen and acetylene gas hoses were burnt through (**Figure 18**), but the remaining 40m were unaffected. The hose non-return valves and flame arrestors fitted to the bottle regulators had been largely destroyed as had most of the acetylene and oxygen bottle regulating valves.

Acetylene and oxygen hose fire damage

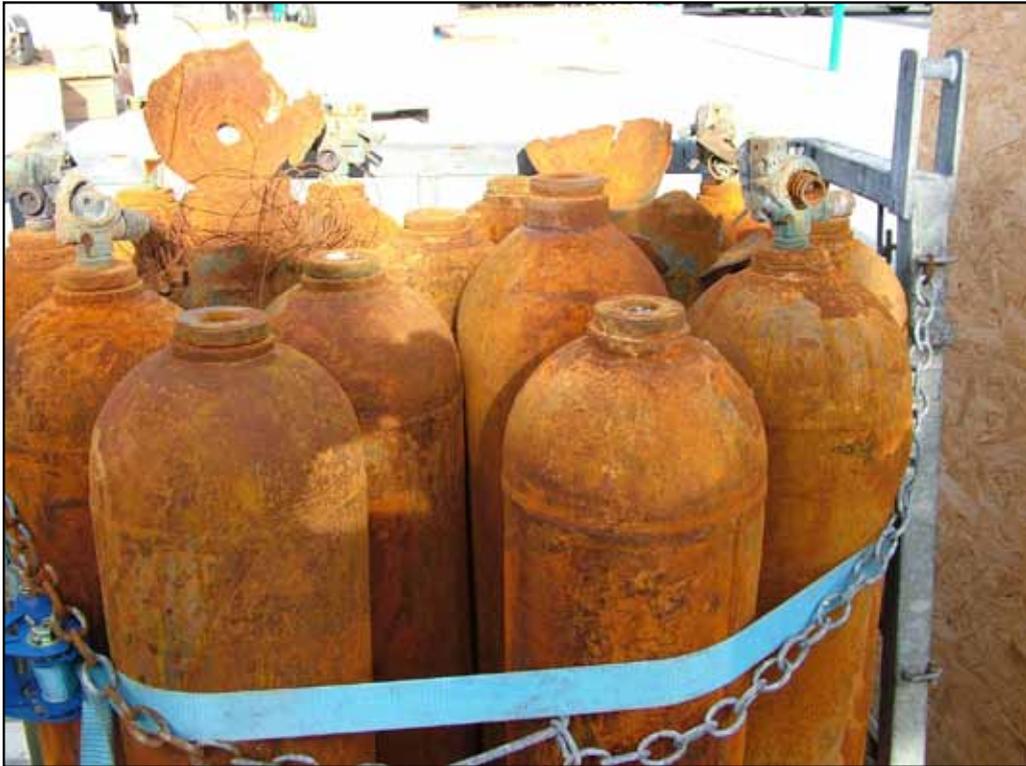
The 15 acetylene and 16 oxygen bottles were damaged beyond use. Two of the acetylene bottles had exploded and many of the others suffered splits and severe distortion (**Figures 19 and 20**). One oxygen bottle had exploded and the rest suffered from severe heat damage (**Figure 21**).

Explosion damaged acetylene bottles

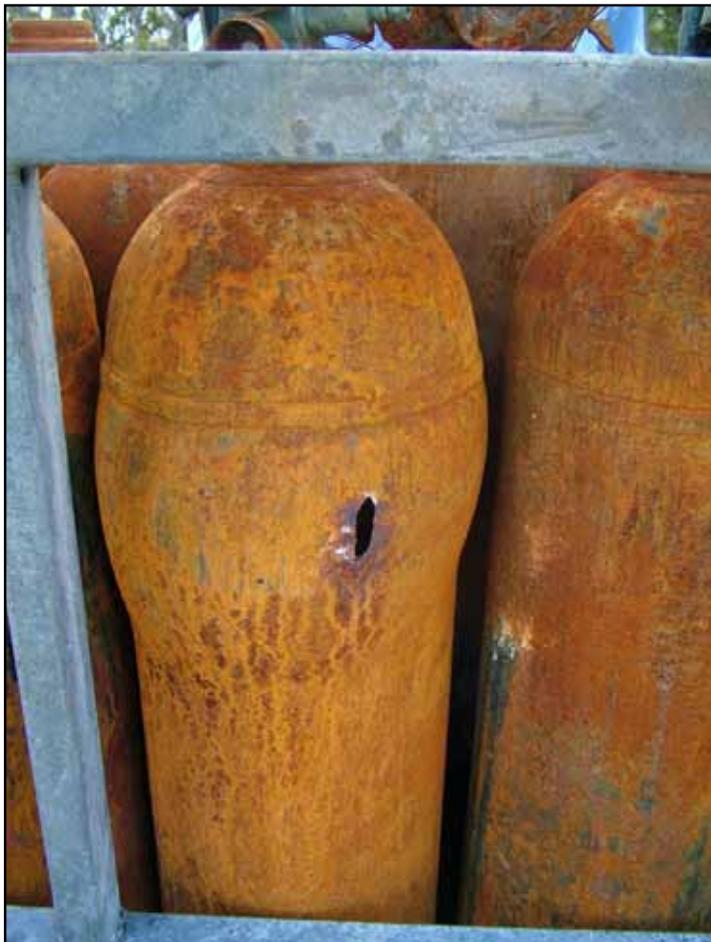
Figure 20

Distorted acetylene bottles

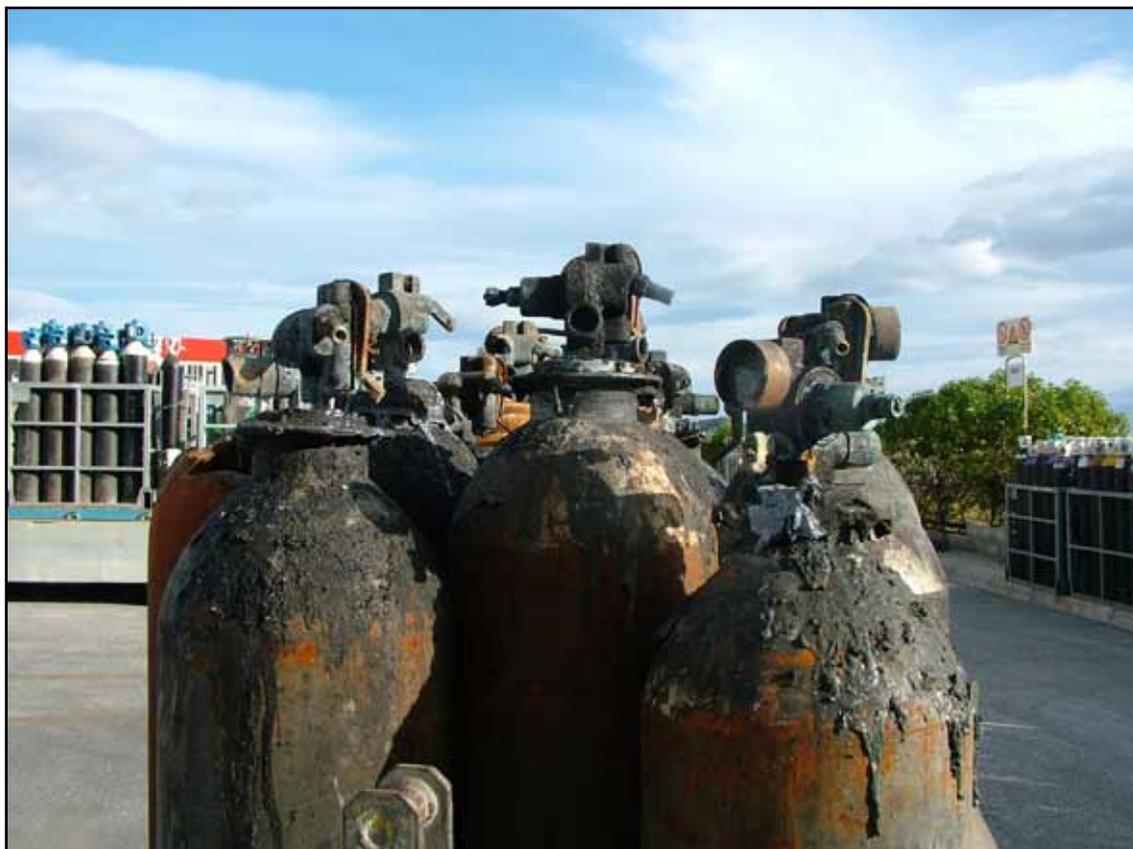
Fire damaged oxygen bottles

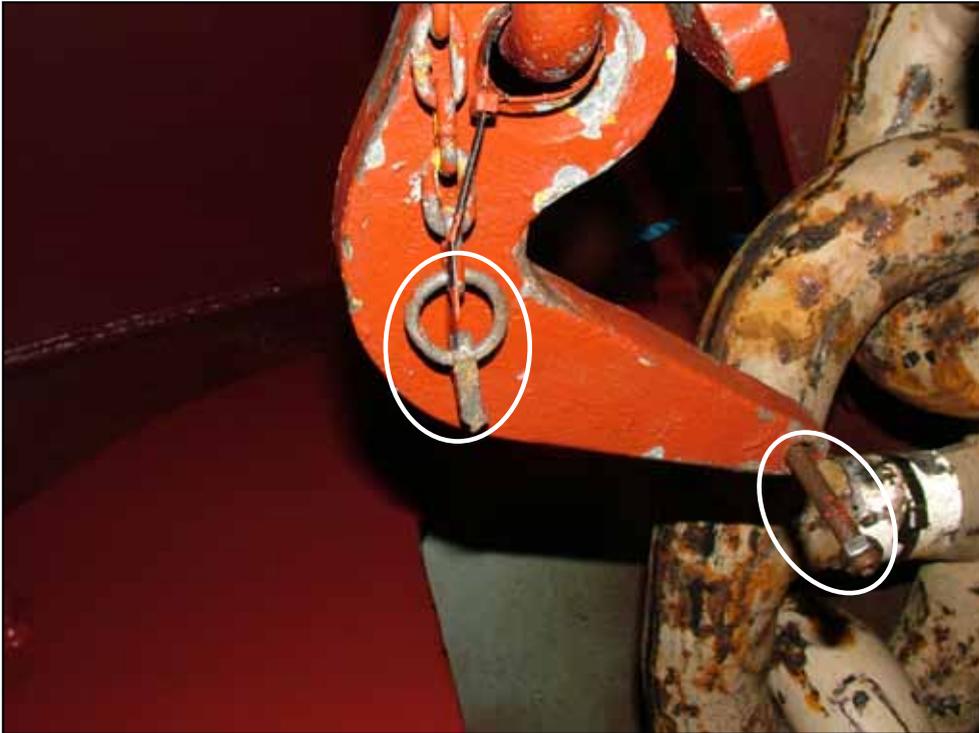
Maersk Newport's starboard anchor Senhouse slip failed tapered securing pin and replaced arrangement

The securing arrangement was subsequently modified by using a bow shackle instead of a Senhouse slip (**Figure 30**), and this was endorsed by the technical management team. However, there is no record of any representation being made to the manufacturer to highlight a possible design shortcoming. Neither was the shortcoming brought to the attention of the rest of A.P. Møller Maersk’s fleet.

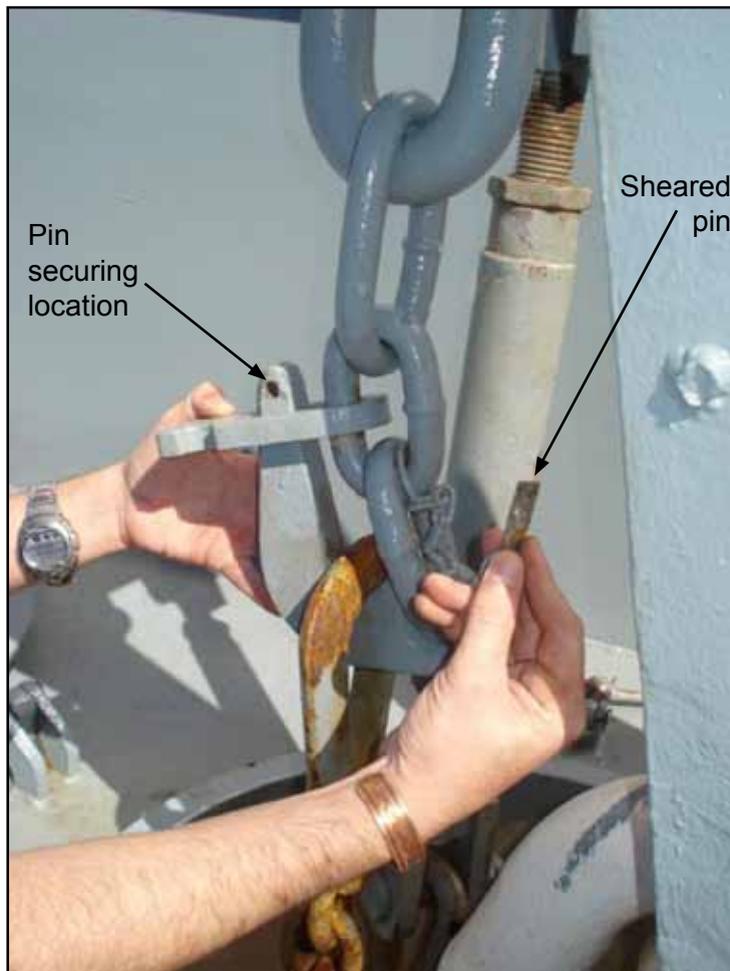
Figure 29

Safmarine Nyassa's starboard anchor Senhouse slip sheared tapered securing pin

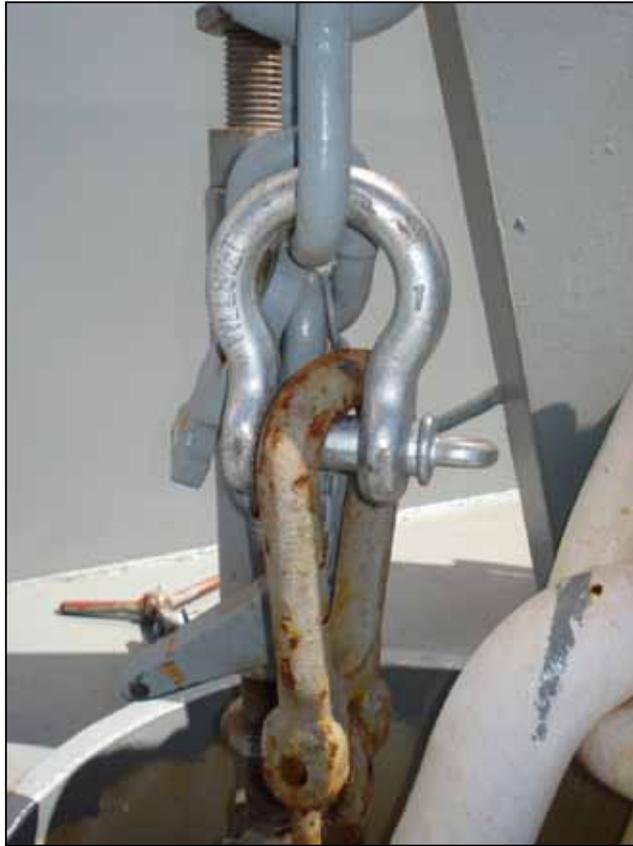
Safmarine Nyassa's starboard anchor Senhouse slip sheared tapered securing pin bow shackle replaced arrangement
