Report of the investigation of
the grounding of
Aqua-boy
Sound of Mull
11 November 2006

Marine Accident Investigation Branch
Carlton House
Carlton Place
Southampton
United Kingdom
SO15 2DZ

Report No 14/2007
July 2007

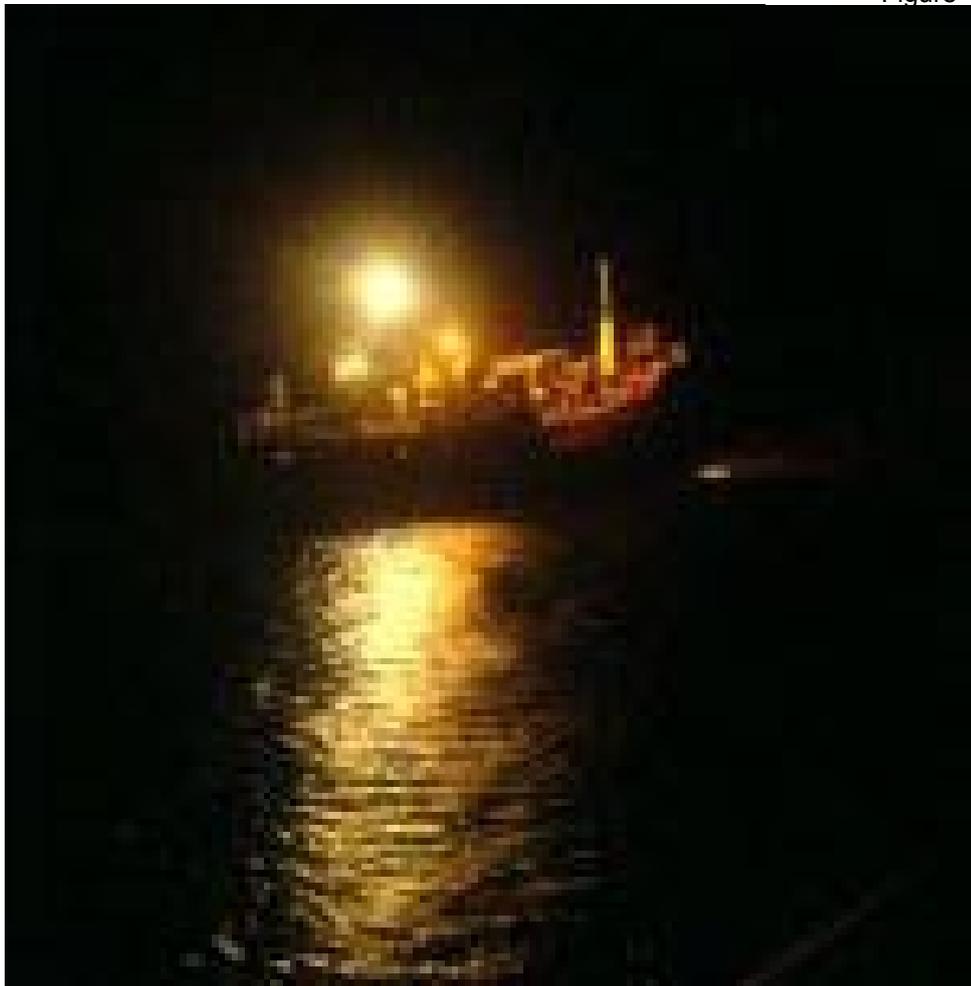
Figure 4

Ronja Commander arrived on scene at about 0400, and *Skán Viking* was released. *Ronja Commander* made her first attempt to tow *Aqua-boy* off at 0408. This failed when again the towline broke. A second unsuccessful attempt was made at 0414. Further attempts were then postponed until the tide had risen. LW had been at 0314, and the vessel was not expected to float until 0600 at the earliest (**Figure 4**).

Photograph taken on scene by RNLI crewman

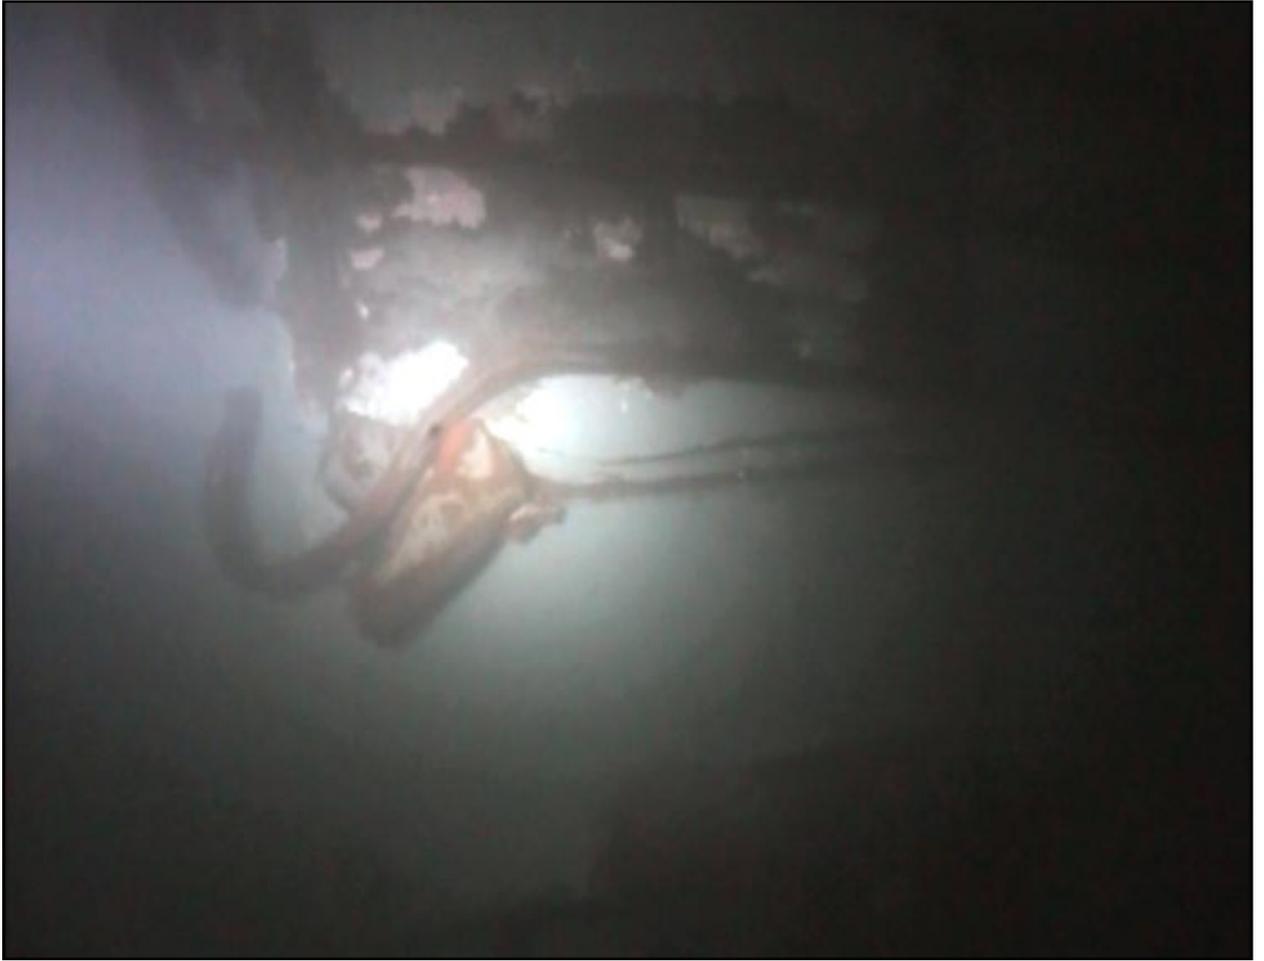
Figure 5a

The resulting damage was restricted to the forward third of the vessel, and consisted of some deep scoring and denting to the hull. In addition, the hull was split in two places. Each split was about 10cm long and both splits were in the vicinity of the bow thruster tunnel, one to port and the other to starboard (**Figures 5a, 5b, 5c**).

Damage to sea valve protection cage

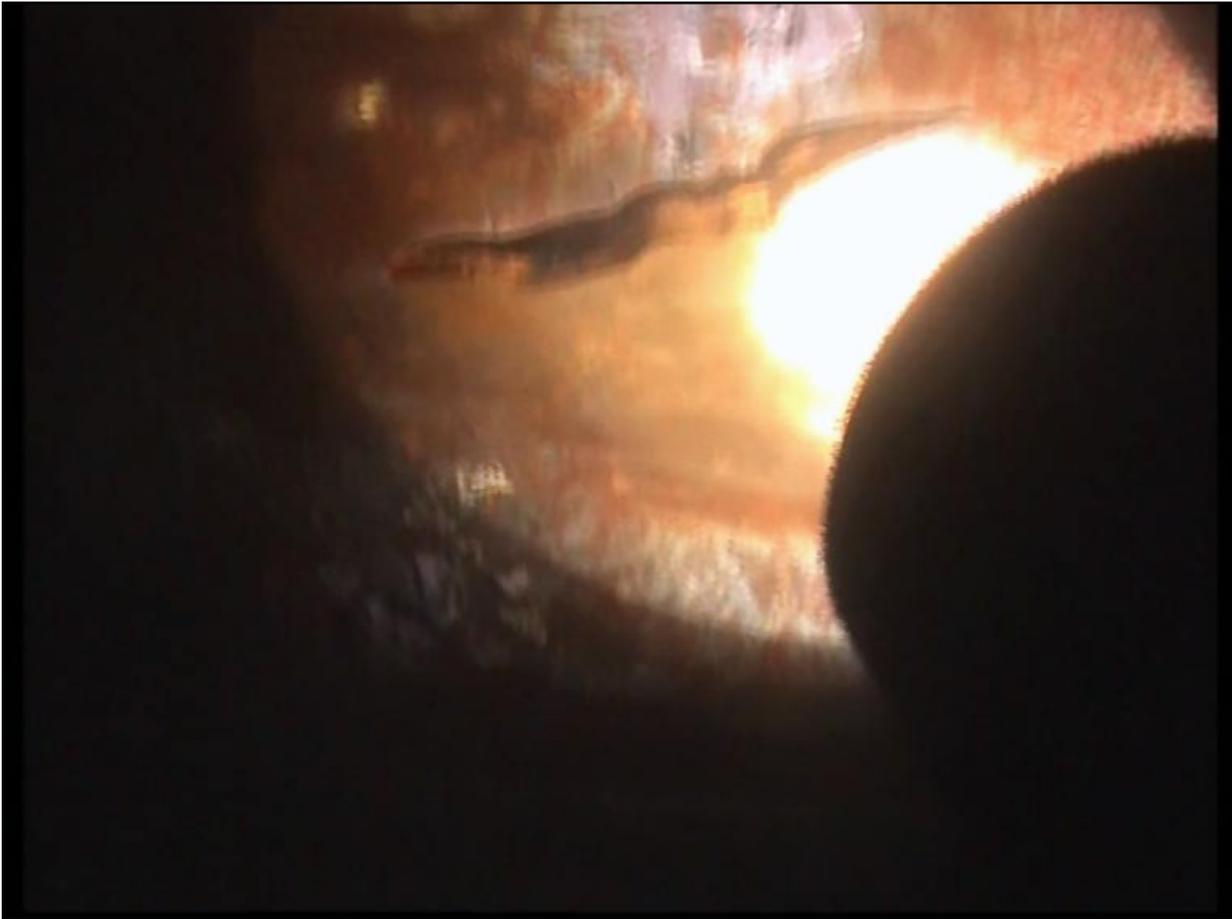
Although the splits in the hull were small, they were below water level and allowed free flooding of the forward ballast tank. Since this had been partly full before the grounding, there was little change to the vessel's draught when she refloated.

Split in starboard side of hull

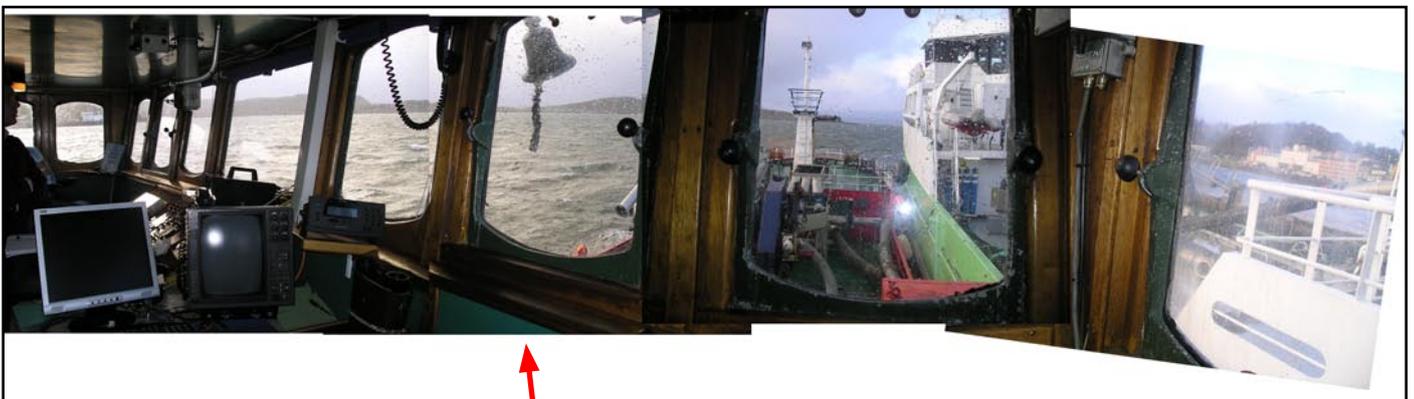
Figure 6

At either end of the console housing the navigation and fish monitoring equipment was a watchkeeper's chair. The steering and engine controls, ECDIS, radar and other navigation electronics were all within reach and view of a person sitting in the starboard chair. However, the chair was fitted close to the bridge front and, in order to fit the footrest in the space available, it had been fixed permanently facing about 45° to port (**Figure 6**). This meant that if the watchkeeper wished to look to starboard, he had to look over his right shoulder (**Figure 7a**). In addition, the view looking ahead from the starboard watchkeeper's chair was partially obscured by the frame of the bridge windows.

View straight ahead from chair

Composite photograph illustrating view from starboard chair

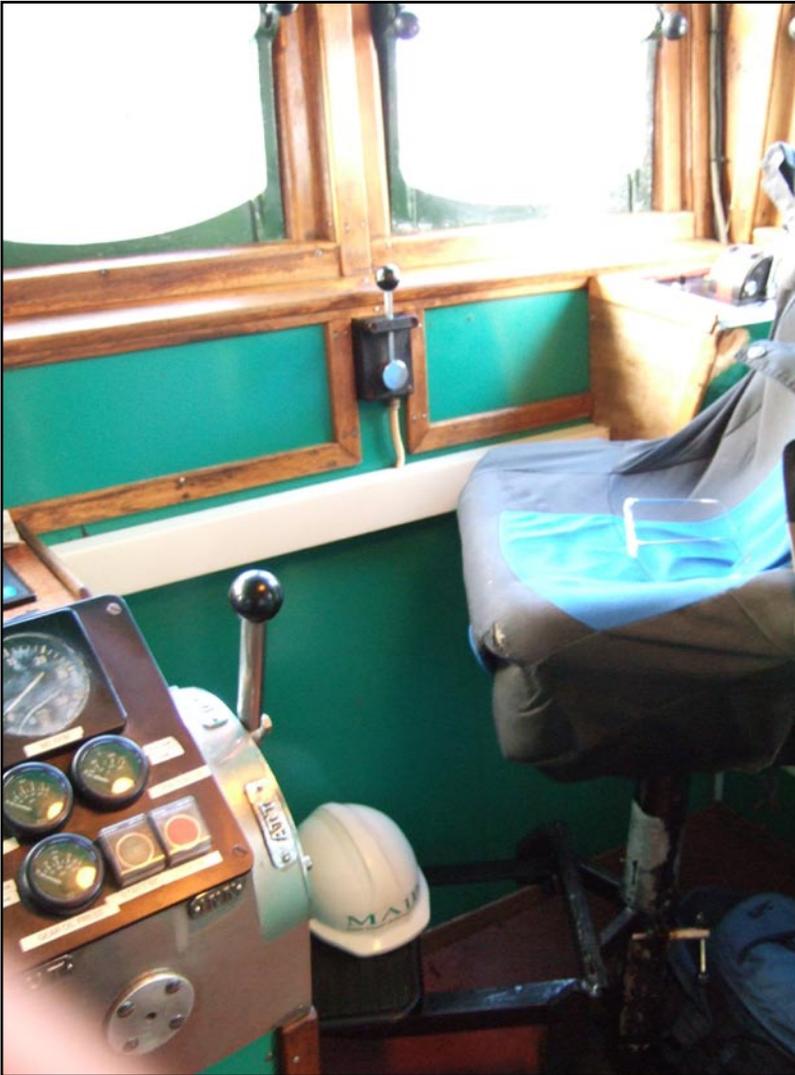
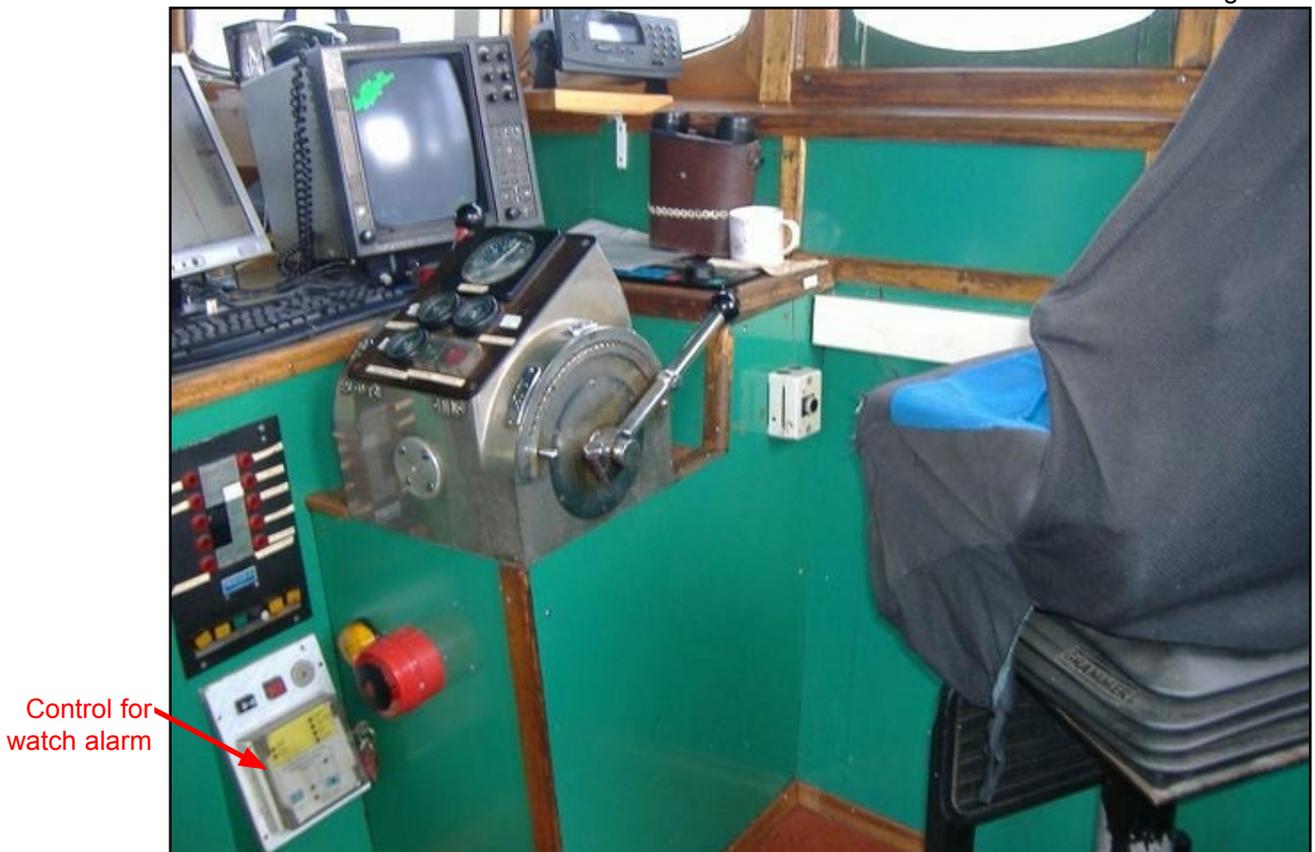
Around the starboard watchkeeper's chair were fitted a radar, ECDIS, the AIS receiver which was linked to the ECDIS, the steering, engine and bow thruster controls and a VHF radio handset (**Figures 7a, 7b**). The operation of each piece of equipment could be carried out without the watchkeeper moving from the chair. This operating position occupied a little under half of the available space at the front of the bridge. The rest of the space was taken up with the console containing the equipment for monitoring the condition of the fish and the second watchkeeper's chair on the port side of the bridge.

A watch alarm was fitted. This consisted of a motion sensor directed at the starboard watchkeeper's chair. Any movement within the viewing arc of the sensor would reset the timer and the alarm would not sound. The control panel was situated to port and within reach of the starboard watchkeeper's chair. The alarm system was turned off at the time of the accident.

The starboard watchkeeper's chair

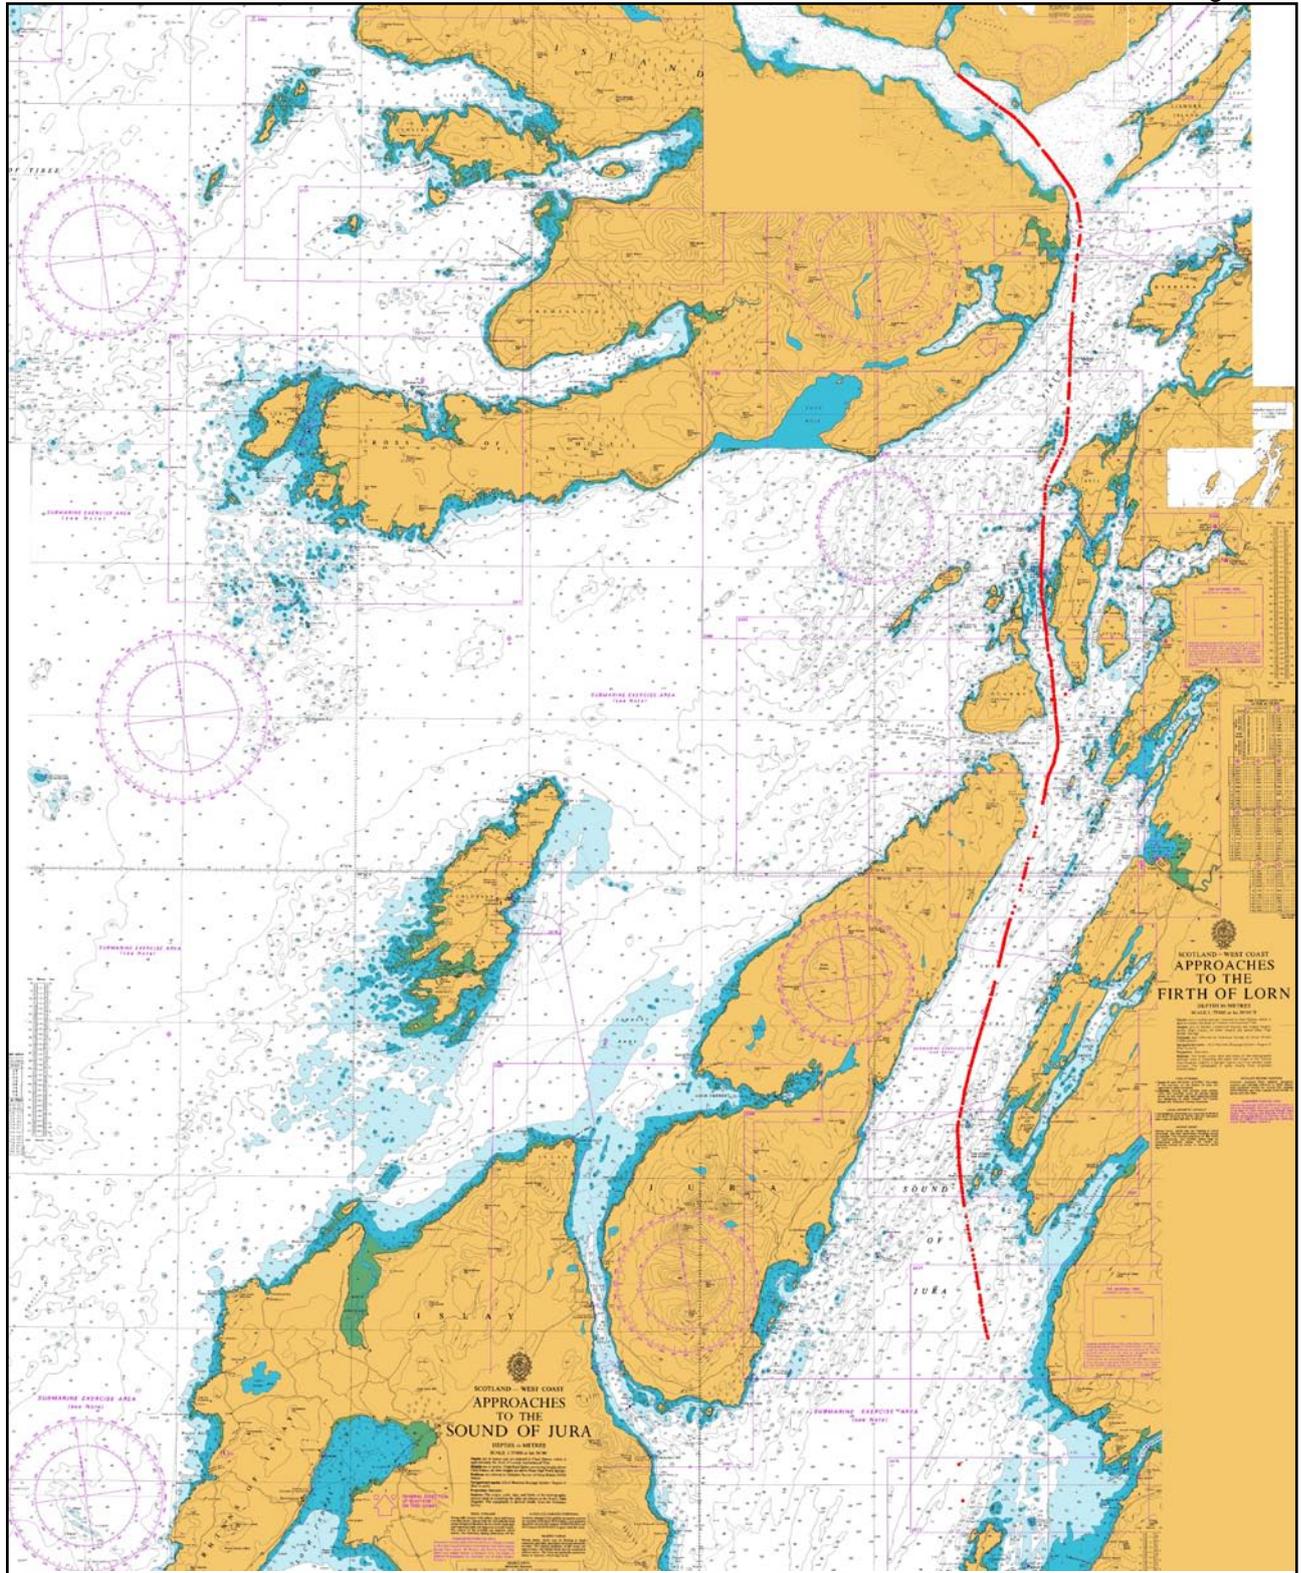
AIS data recorded by the MCA was obtained by the MAIB, and the position and time data from this was entered into a Geographic Information System (GIS). This was then superimposed over charts of the area, and used to recreate the movements of *Aqua-boy* (**Figures 8a, 8b**). From this data, a more precise time for the grounding was obtained – 0112.

AIS data showing voyage from Gigha

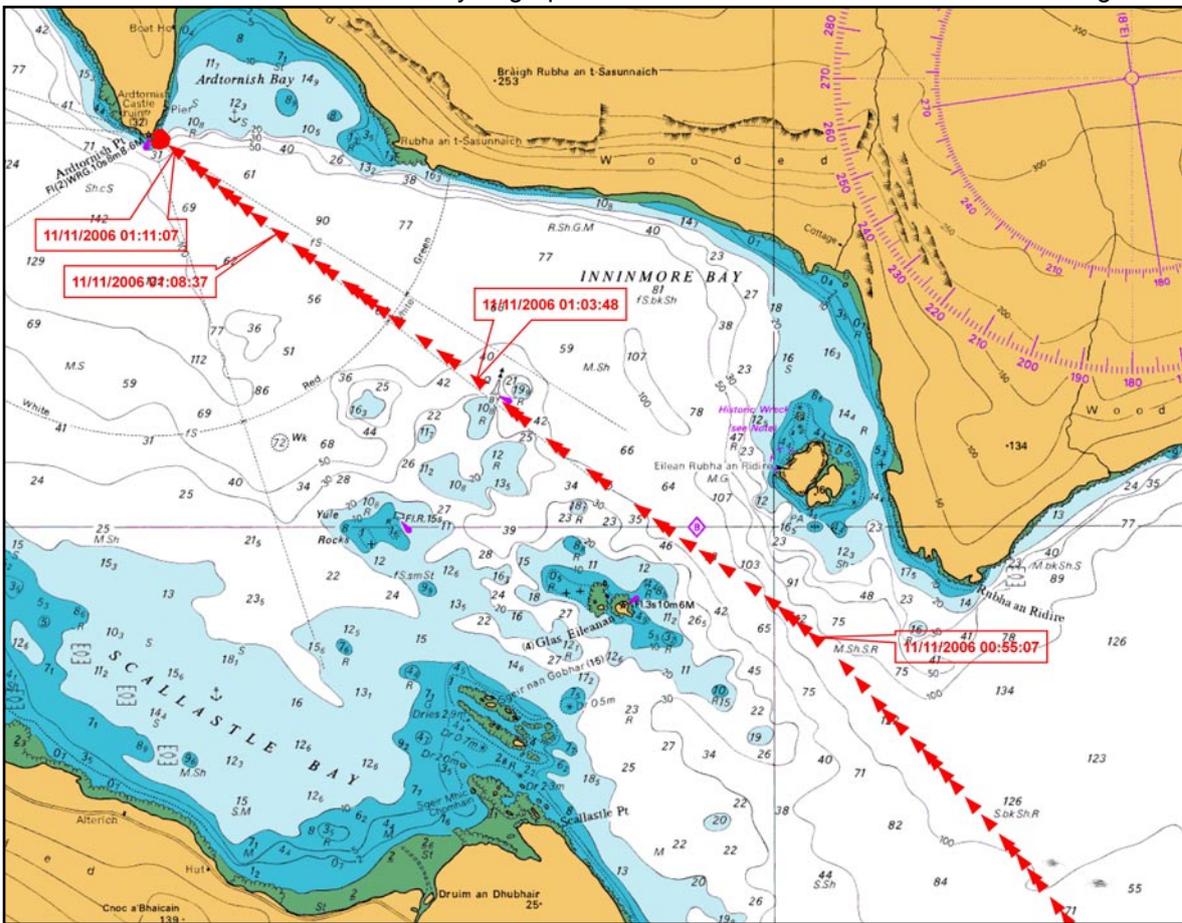
Both sets of data indicate that the vessel passed very close to the Inninmore Bay Buoy, some 10 minutes before the grounding. The condition of the buoy was checked by the Northern Lighthouse Board in the week following the grounding, but no damage was found.

AIS data showing voyage through the Sound of Mull

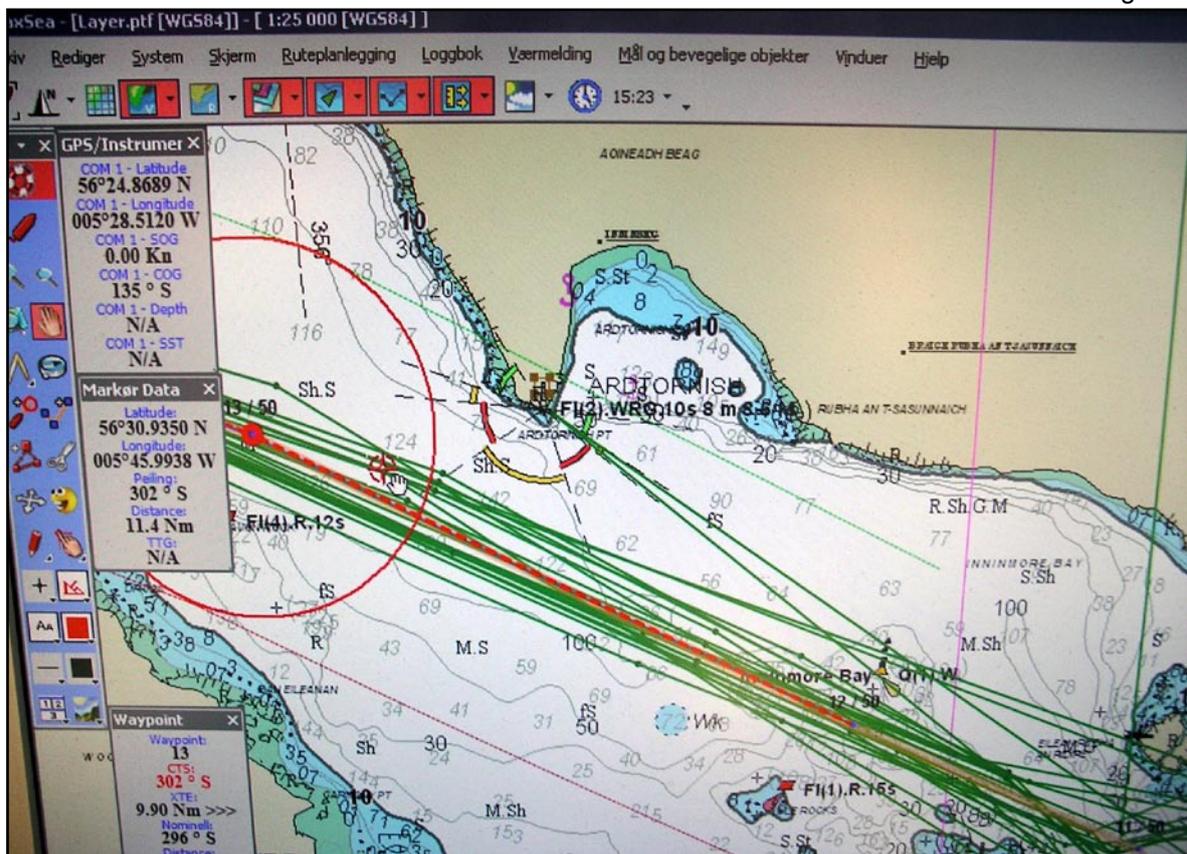
Figure 9

Aqua-boy was not required to be fitted with, and did not have a Voyage Data Recorder. However, position and time data was recovered from the logbook facility of the ECDIS. The logbook stored the position, course and speed of the vessel at 90 minute intervals, and also recorded the times that the vessel passed its waypoints (**Figure 9**). It was possible to display the approximate past track of the vessel from this logged data as a series of lines joining the stored positions.

ECDIS logbook
