Rail Accident Investigation Branch

Rail Accident Report

Passenger train collision with trolley at Bridgeway User Worked Crossing, near Shrewsbury 16 January 2014

Report 25/2014
November 2014

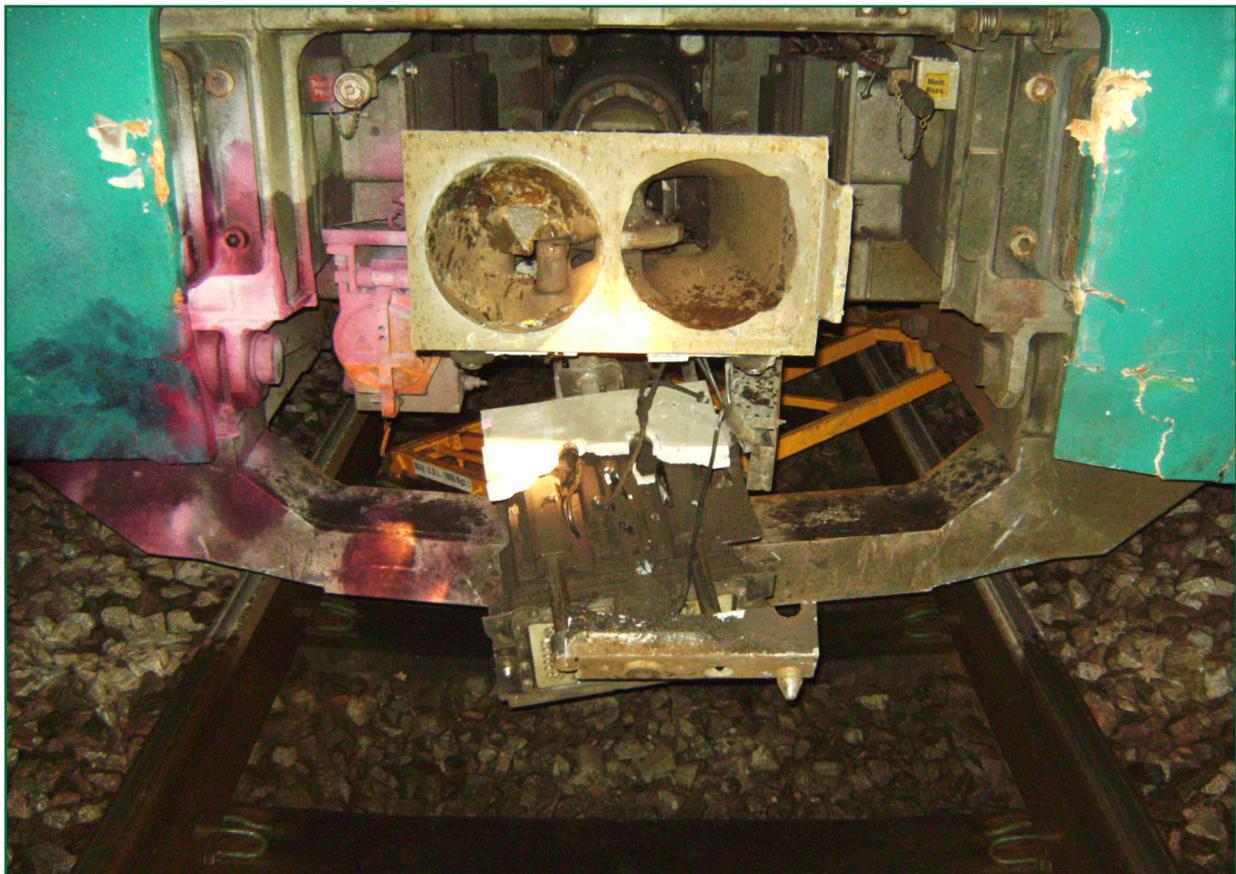
- 9 The train sustained significant damage to its front and to underframe equipment, including the fuel tank, which was ruptured. The trolley was destroyed (figure 2).

Figure 2: Damage to the front of the train. The remains of the yellow trolley can be seen underneath the train (photograph courtesy of British Transport Police).

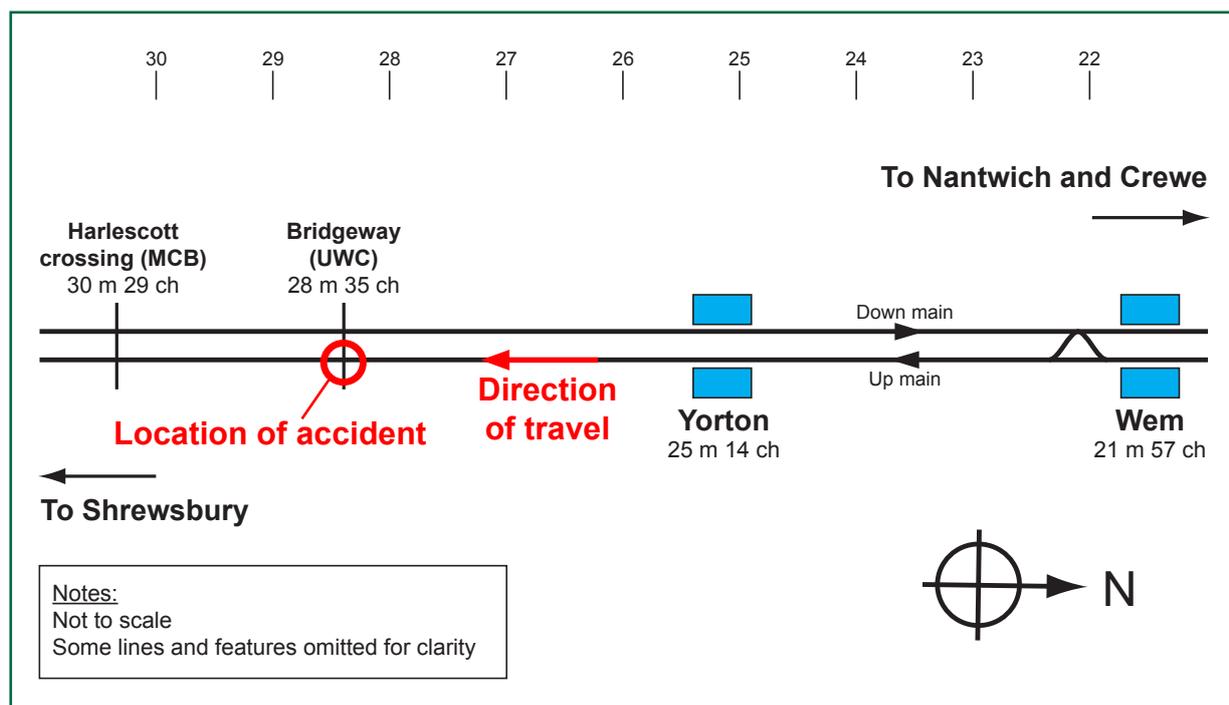
- 10 Bridgeway UWC is located at 28 miles 35 *chains* on the double track railway that runs between Crewe and Shrewsbury (figure 3). The maximum permitted speed for passenger trains running in the normal direction on both lines is 90 mph (145 km/h).

Figure 3: Track diagram showing direction of travel of train and collision location

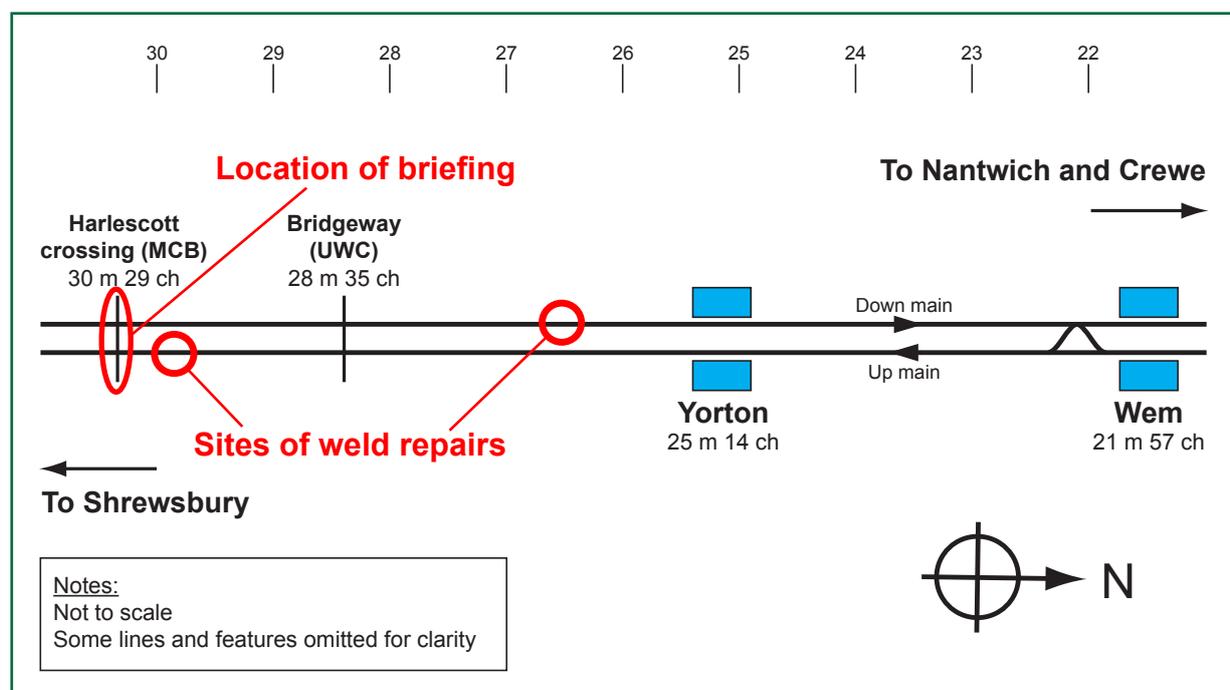
- 24 On the night of 15/16 January 2014 (the night before the accident), the COSS was assigned to work with the welder and the track worker who were involved in the accident the following night, plus another track worker to carry out two *weld repairs* in the vicinity of Bridgeway UWC. One was on the down line at 26 miles 879 yards, and the other was on the up line at 29 miles 1231 yards (figure 4).

Figure 4: Track diagram showing sites of weld repairs and location where the COSS set up the system of work and conducted the site safety briefing
